**Flood Control Project Maintenance  
Levee Inspections**

**Fall 2019 Levee Maintenance Deficiency Summary Report**

**Reclamation District No. 0765 Glide**

Waterway	Bank	Unit Miles	Inspection Start/End	Inspector
Unit No. 01 Sacramento River	Right	1.72	11/12/2019 11/12/2019	Luz Dial

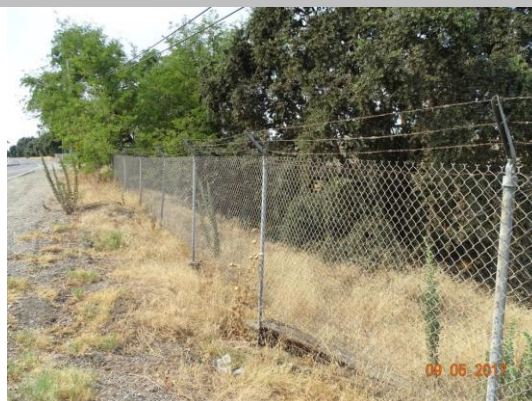
Photo 1 of 1 : FA\_2019\_RD0765\_211\_12\_20190904\_00008.jpg

LM Start	0.00	Rating **	M	Issue No.	12
LM End	0.11	Issue Type +	En	Location *	LS
Category	Earthen Levee			GPS Latitude/Longitude	
				Start	End
Item	Encroachments			38.502962°	38.501373°
				-121.560112°	-121.560402°
DWR ID	DWR_RD0765_01_s_2012_12				
Comment Code					
FE : Fence					
Inspector Comment					
Fence may prevent maintenance on the landside slope.

Looking southwest at the fence on the landside slope. Fall 2017

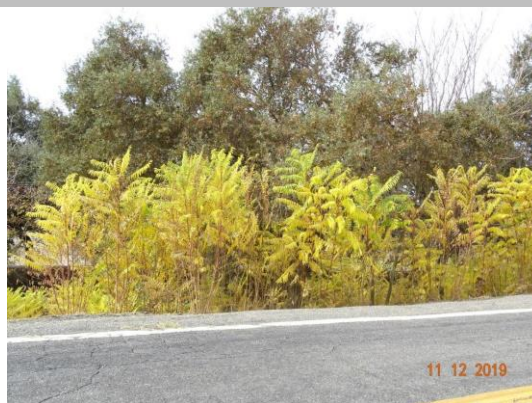
Photo 1 of 1 : FA\_2019\_RD0765\_211\_10\_20191112\_00048.jpg

LM Start	0.43	Rating **	M	Issue No.	10
LM End	0.50	Issue Type +	Ma	Location *	LS
Category	Earthen Levee			GPS Latitude/Longitude	
				Start	End
Item	Vegetation			38.496717 °	38.495810 °
				-121.560023 °	-121.559520 °
DWR ID	DWR_RD0765_01_f_2019_10				
Comment Code					
V2 : Remove the wild growth other than native grasses from the levee slopes.					
Inspector Comment					
Remove wild growth of invasive plants.

View of invasive wild growth on the landside slope. Fall 2019

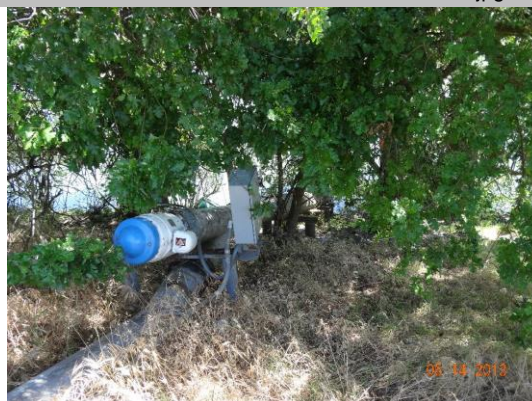
Photo 1 of 3 : UCIP\_FA\_2019\_44403\_60815.jpg

Comment Code					
Inspector Comment					
DS_ID:21138 FS_ID:44403 EP_NO: 3314 Repair Type: Non-Urgent Crossing Status: Found UCIP Comments: Dense vegetation limit's the ability to determine condition of landward slope for potential leaks associated with crossing. Recommend having owner clear slope to be able to properly inspect slopes for leaks. FIELD_STRUCT_DESC: 16-inch steel irrigation pipe through the levee, 4 feet below the crown. Cutoff wall around pipe at center of levee. Slant pump on the waterside (WS) slope, with 22-inch inlet pipe extending from channel. 16-inch pipe connects to 12-inch steel pipe at landside (LS) shoulder, extending to concrete standpipe discharge outlet at the toe. Cobble revetment on WS slope. (16-inch pipe installed and existing 16-inch pipe grouted work authorized under Permit No. 3314, 1960-C.M. Goethe) FS Date: 5/14/2013

View of waterward side-pipe, pump, control panels, and electrical conduit.

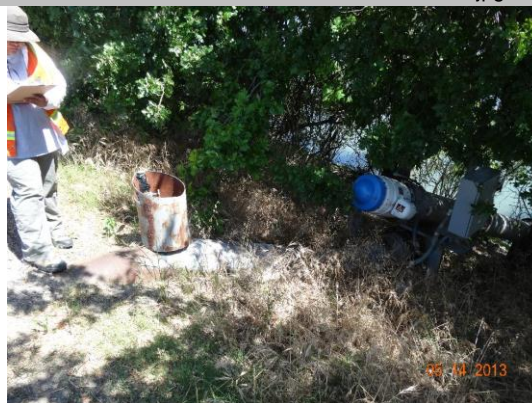
Photo 2 of 3 : UCIP\_FA\_2019\_44403\_60814.jpg

Siphon breaker encased in steel casing located on waterward side.

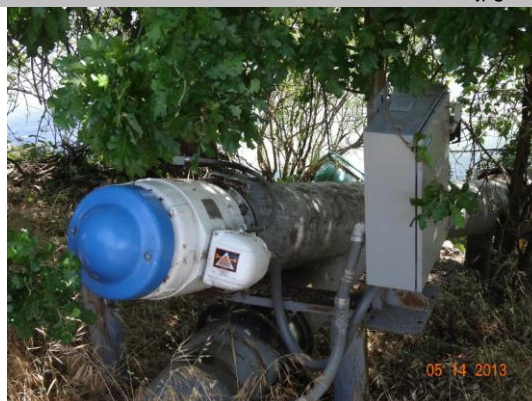
Photo 3 of 3 : UCIP\_FA\_2019\_44403\_60813.jpg

Comment Code						
Inspector Comment						
DS_ID:21138 FS_ID:44403 EP_NO: 3314 Repair Type: Non-Urgent Crossing Status: Found UCIP Comments: Dense vegetation limit's the ability to determine condition of landward slope for potential leaks associated with crossing. Recommend having owner clear slope to be able to properly inspect slopes for leaks. FIELD_STRUCT_DESC: 16-inch steel irrigation pipe through the levee, 4 feet below the crown. Cutoff wall around pipe at center of levee. Slant pump on the waterside (WS) slope, with 22-inch inlet pipe extending from channel. 16-inch pipe connects to 12-inch steel pipe at landside (LS) shoulder, extending to concrete standpipe discharge outlet at the toe. Cobble revetment on WS slope. (16-inch pipe installed and existing 16-inch pipe grouted work authorized under Permit No. 3314, 1960-C.M. Goethe) FS Date: 5/14/2013

Close up of slant pump and control panel on waterward side.

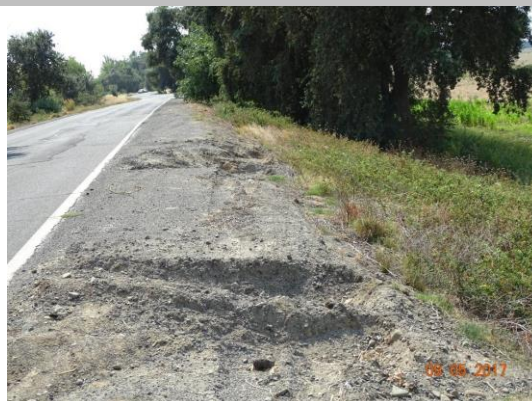
Photo 1 of 2 : FA\_2019\_RD0765\_211\_68\_20190904\_00034.jpg

LM Start	0.75	Rating **	M	Issue No.	68
LM End	0.75	Issue Type +	Ma	Location *	LS
Category	Earthen Levee			GPS Latitude/Longitude	
				Start	End
Item	Slope Stability			38.492705 °	38.492705 °
				-121.557193 °	-121.557193 °
DWR ID	DWR_RD0765_01_s_2017_68				
Comment Code					
S3 : Repair the levee slope damaged by vehicle traffic and prevent access where possible.					
Inspector Comment					
Repair tire rut damage on LS shoulder.

Looking south on landside slope.

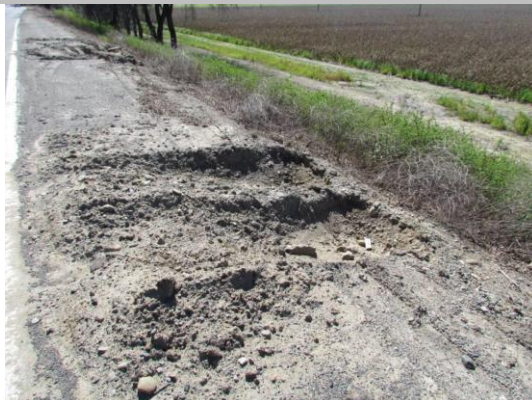
Photo 2 of 2 : FA\_2019\_RD0765\_211\_68\_20190904\_00035.jpg

LM Start	0.75	Rating **	M	Issue No.	68 (cont)	
LM End	0.75	Issue Type +	Ma	Location *	LS	
Category	Earthen Levee			GPS Latitude/Longitude		
				Start	End	
Item	Slope Stability			38.492705 °	38.492705 °	
				-121.557193 °	-121.557193 °	
DWR ID	DWR_RD0765_01_s_2017_68					
Comment Code						
S3 : Repair the levee slope damaged by vehicle traffic and prevent access where possible.						
Inspector Comment						
Repair tire rut damage on LS shoulder.

Looking south at levee damage caused by vehicle traffic. (Spring 2017)

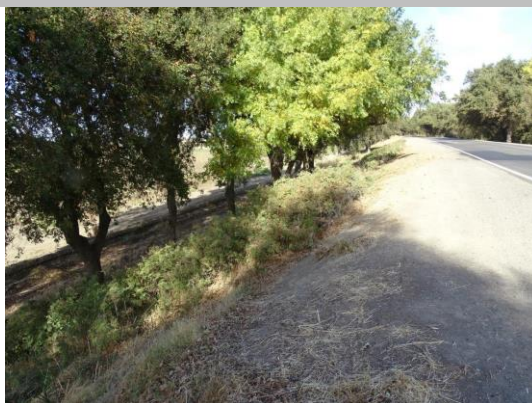
Photo 1 of 1 : FA\_2019\_RD0765\_211\_63\_20190904\_00032.jpg

LM Start	0.75	Rating **	M	Issue No.	63
LM End	0.79	Issue Type +	Ma	Location *	LS
Category	Earthen Levee			GPS Latitude/Longitude	
				Start	End
Item	Vegetation			38.492647 °	38.492145 °
				-121.557192 °	-121.556891 °
DWR ID	DWR_RD0765_01_s_2018_63				
Comment Code					
V2 : Remove the wild growth other than native grasses from the levee slopes.					
Inspector Comment

View of brush on levee slope. Fall 2018

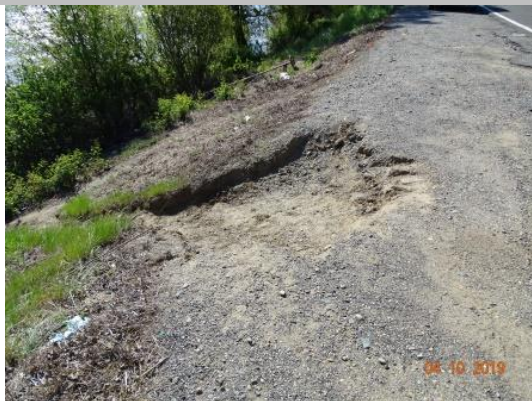
Photo 1 of 1 : FA\_2019\_RD0765\_211\_24\_20190904\_00015.jpg

LM Start	0.94	Rating **	M	Issue No.	24
LM End	0.94	Issue Type +	Ma	Location *	WS
Category	Earthen Levee			GPS Latitude/Longitude	
				Start	End
Item	Slope Stability			38.490265 °	38.490265 °
				-121.555617 °	-121.555617 °
DWR ID	DWR_RD0765_01_s_2019_24				
Comment Code					
S2 : Repair the levee slope damaged by foot traffic and prevent access where possible.					
Inspector Comment

View looking downstream at footpath that cuts into levee slope. Spring 2019

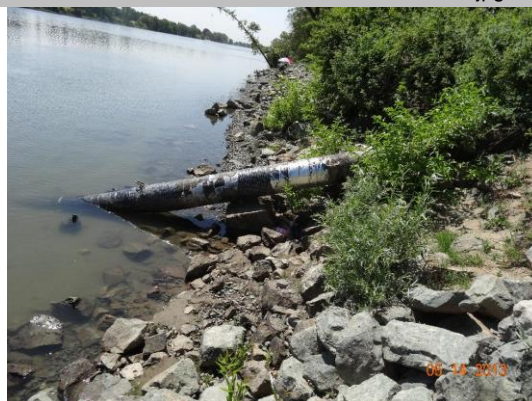
Photo 1 of 3 : UCIP\_FA\_2019\_44404\_60819.jpg

LM Start	0.95	Rating **	M	Issue No.	70	
LM End	0.95	Issue Type +	En	Location *		
Category	Supplemental			GPS Latitude/Longitude		
				Start		End
Item	DRAFT DWR UCIP Field Study			38.490192 °		38.490192 °
				-121.555628 °		-121.555628 °
DWR ID	21139					
Comment Code						
Inspector Comment						
DS_ID:21139 FS_ID:44404 EP_NO: 653 Repair Type: Non-Urgent Crossing Status: Found UCIP Comments: Dense vegetation on landward side limits visual inspection of potential leaks. Recommend clearing slope of vegetation. FIELD_STRUCT_DESC: 16-inch steel irrigation pipe through the levee, 14.3 feet below the crown. Pump on the landside (LS). Gate valve on the waterside (WS) slope. (16-inch pipe authorized under Permit No. 653, 1935-E. G. Elliott) [Additional Reference(s): DWR Levee Logs, 2005. USACE Sacramento O&M Manual Unit No. 114, April 1959, River Mile (RM) 50.29] FS Date: 5/14/2013

Pipe section visible at waterward toe.

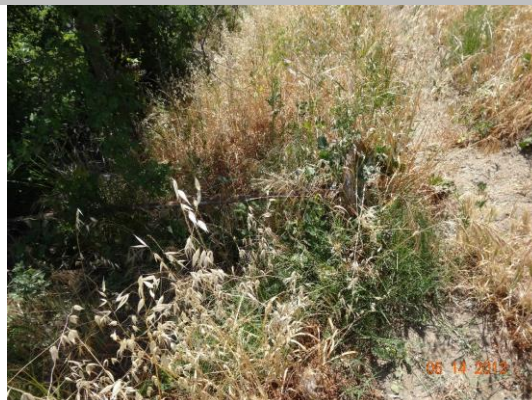
Photo 2 of 3 : UCIP\_FA\_2019\_44404\_60818.jpg

View of waterward side--dense vegetation limits inspection.

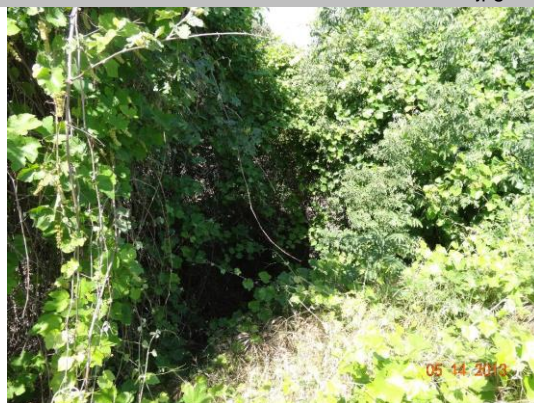
Photo 3 of 3 : UCIP\_FA\_2019\_44404\_60821.jpg

Comment Code						
Inspector Comment						
DS_ID:21139						
FS_ID:44404						
EP_NO: 653						
Repair Type: Non-Urgent						
Crossing Status: Found						
UCIP Comments: Dense vegetation on landward side limits visual inspection of potential leaks. Recommend clearing slope of vegetation.						
FIELD_STRUCT_DESC: 16-inch steel irrigation pipe through the levee, 14.3 feet below the crown. Pump on the landside (LS). Gate valve on the waterside (WS) slope. (16-inch pipe authorized under Permit No. 653, 1935-E. G. Elliott) [Additional Reference(s): DWR Levee Logs, 2005. USACE Sacramento O&M Manual Unit No. 114, April 1959, River Mile (RM) 50.29)]						
FS Date: 5/14/2013

View of landward side--dense vegetation limits inspection.

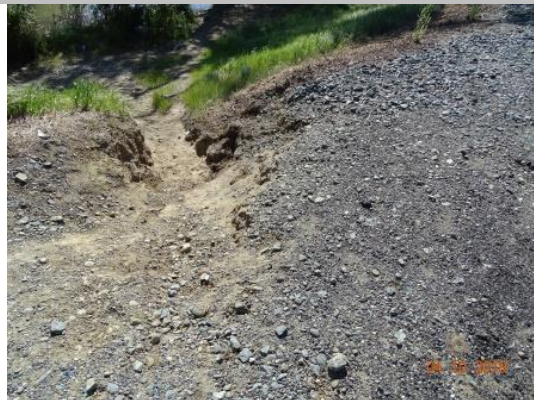
Photo 1 of 1 : FA\_2019\_RD0765\_211\_23\_20190904\_00014.jpg

LM Start	0.95	Rating **	M	Issue No.	23
LM End	0.95	Issue Type +	Ma	Location *	WS
Category	Earthen Levee			GPS Latitude/Longitude	
				Start	End
Item	Slope Stability			38.490067 °	38.490067 °
				-121.555530 °	-121.555530 °
DWR ID	DWR_RD0765_01_s_2019_23				
Comment Code					
S2 : Repair the levee slope damaged by foot traffic and prevent access where possible.					
Inspector Comment

View looking east at footpath that cuts into levee slope. Spring 2019

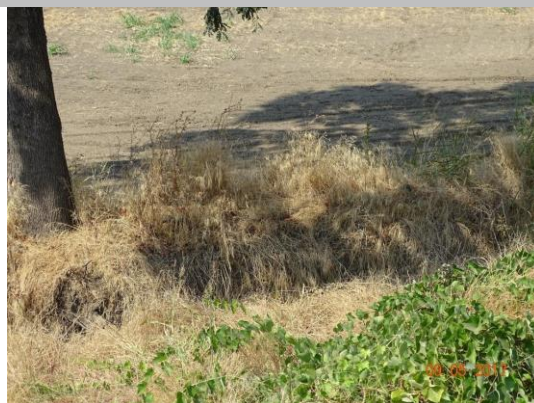
Photo 1 of 2 : FA\_2019\_RD0765\_211\_51\_20190904\_00022.jpg

Looking northwest at the irrigation ditch on the landside toe.

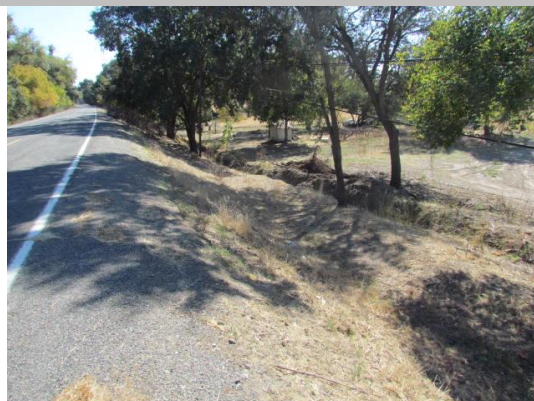
Photo 2 of 2 : FA\_2019\_RD0765\_211\_51\_20190904\_00023.jpg

Looking southwest at irrigation ditch on landward toe.

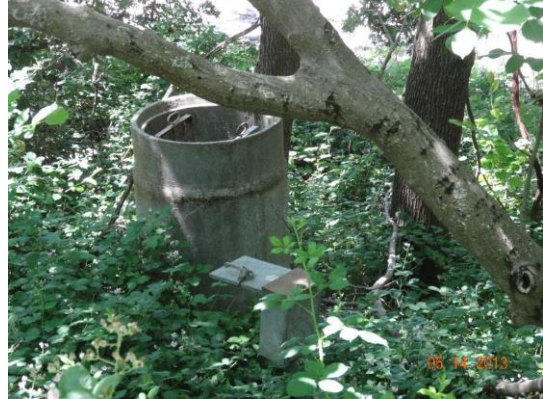
Photo 1 of 3 : UCIP\_FA\_2019\_44407\_73022.jpg

Comment Code					
Inspector Comment					
DS_ID:21140					
FS_ID:44407					
EP_NO: N/A					
Repair Type: Non-Urgent					
Crossing Status: Indicator Found					
UCIP Comments: Dense vegetation on waterward and landward slopes limit visual inspection of potential leaks along pipe alignment.					
Recommend having owner clear vegetation along slopes.					
FIELD_STRUCT_DESC: 6-inch steel pipe of unknown purpose through the levee, 18.8 feet below the crown. Concrete standpipe on the landise (LS) toe. Pump located on the waterside (WS) slope. [Additional Reference(s): USACE Sacramento O&M Manual Unit No. 114, April 1959, (river mile (RM) 50.15)]					
FS Date: 4/9/2015

Overview of landward side--concrete standpipe and control panel located at toe.

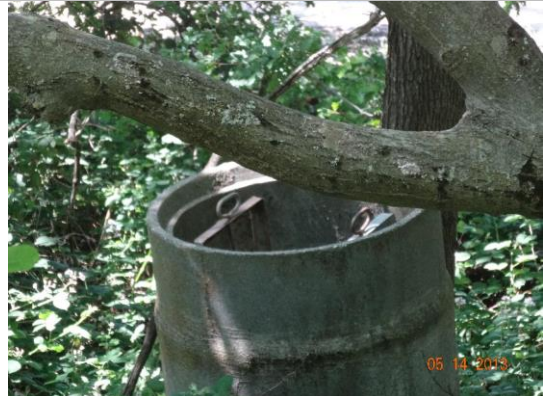
Photo 2 of 3 : UCIP\_FA\_2019\_44407\_73021.jpg

Concrete standpipe with 2 gates inside located on landward side.

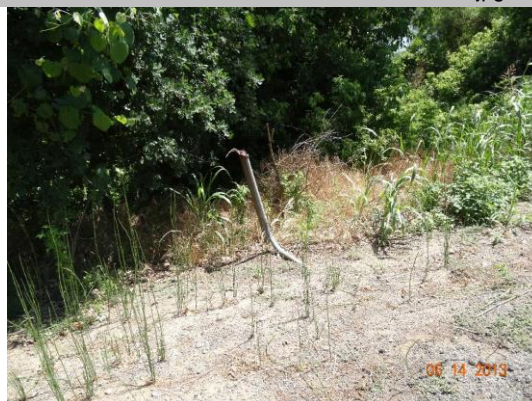
Photo 3 of 3 : UCIP\_FA\_2019\_44407\_73020.jpg

Comment Code						
Inspector Comment						
DS_ID:21140						
FS_ID:44407						
EP_NO: N/A						
Repair Type: Non-Urgent						
Crossing Status: Indicator Found						
UCIP Comments: Dense vegetation on waterward and landward slopes limit visual inspection of potential leaks along pipe alignment.						
Recommend having owner clear vegetation along slopes.						
FIELD_STRUCT_DESC: 6-inch steel pipe of unknown purpose through the levee, 18.8 feet below the crown. Concrete standpipe on the landise (LS) toe. Pump located on the waterside (WS) slope. [Additional						
Reference(s): USACE Sacramento O&M Manual Unit No. 114, April 1959, (river mile (RM) 50.15)]						
FS Date: 4/9/2015

Conduits disconnected and damaged on waterward side.

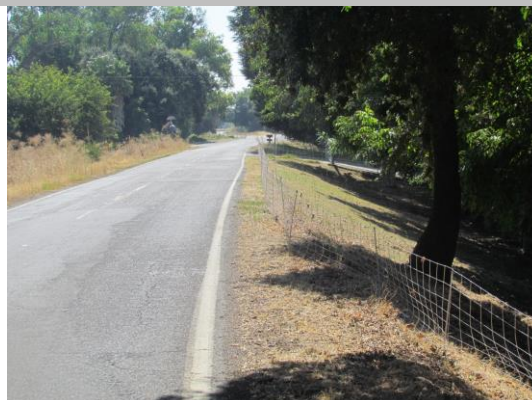
Photo 1 of 3 : FA\_2019\_RD0765\_211\_54\_20190904\_00027.jpg

LM Start	1.16	Rating **	M	Issue No.	54
LM End	1.26	Issue Type +	En	Location *	LS
Category	Earthen Levee			GPS Latitude/Longitude	
				Start	End
Item	Encroachments			38.487348 °	38.485984 °
				-121.554044 °	-121.553202 °
DWR ID	DWR_RD0765_01_s_2015_54				
Comment Code					
FE : Fence					
Inspector Comment					
Landowner installed a temporary fence on landside shoulder and slope.

Looking south at fencing for goats on landward slope. (Fall 2016)

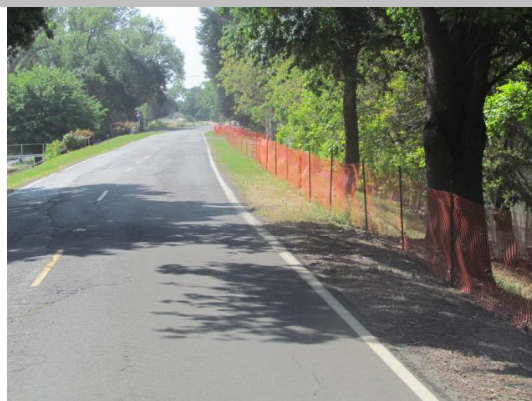
Photo 2 of 3 : FA\_2019\_RD0765\_211\_54\_20190904\_00028.jpg

Looking south at temporary fence on landward shoulder. (Spring 2016)

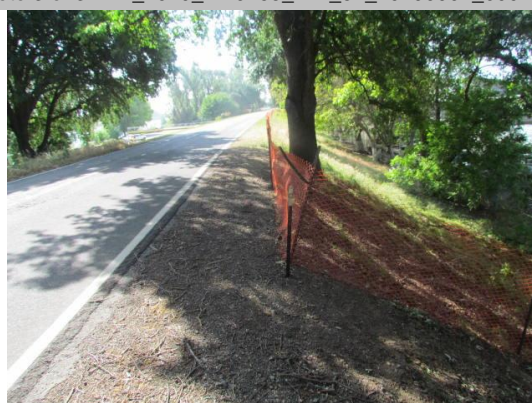
Photo 3 of 3 : FA\_2019\_RD0765\_211\_54\_20190904\_00029.jpg

Looking south at temporary fence on landward slope. (Spring 2016)

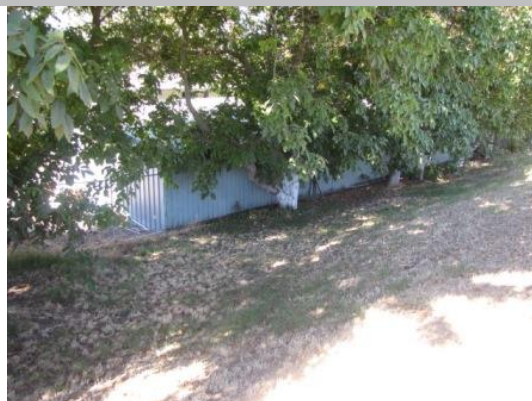
Photo 1 of 1 : FA\_2019\_RD0765\_211\_43\_20190904\_00020.jpg

LM Start	1.18	Rating **	M	Issue No.	43
LM End	1.21	Issue Type +	En	Location *	LS
Category	Earthen Levee			GPS Latitude/Longitude	
				Start	End
Item	Encroachments			38.487127 °	38.486702 °
				-121.553910 °	-121.553652 °
DWR ID	DWR_RD0765_01_s_2012_43				
Comment Code					
BU : Building					
Inspector Comment

Looking northwest at buildings along landside toe.

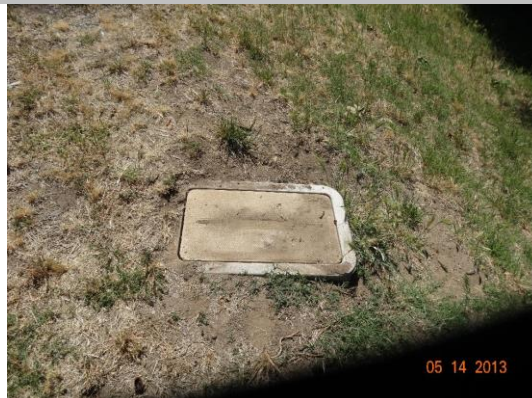
Photo 1 of 2 : UCIP\_FA\_2019\_43203\_71214.jpg

LM Start	1.20	Rating **	M	Issue No.	72
LM End	1.20	Issue Type +	En	Location *	
Category	Supplemental			GPS Latitude/Longitude	
				Start	End
Item	DRAFT DWR UCIP Field Study			38.486830 °	38.486830 °
				-121.553698 °	-121.553698 °
DWR ID	24660				
Comment Code					
Inspector Comment					
DS_ID:24660 FS_ID:43203 EP_NO: N/A Repair Type: Non-Urgent Crossing Status: Indicator Found UCIP Comments: Unable to confirm details of crossing. Need to contact owner to determine additional details about crossing and permit issued. FIELD_STRUCT_DESC: PG&E utility service box located on the landside shoulder. FS Date: 5/14/2013

Utility box located on landward side.

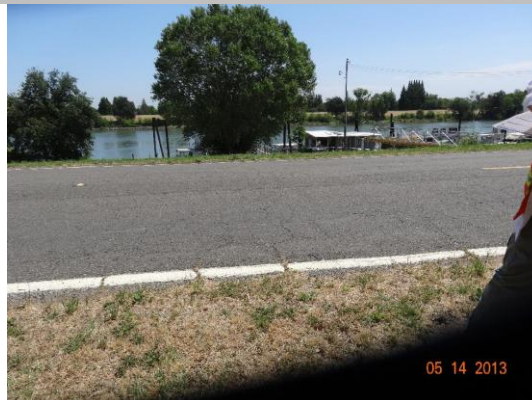
Photo 2 of 2 : UCIP\_FA\_2019\_43203\_71213.jpg

View of levee crown and waterward side.

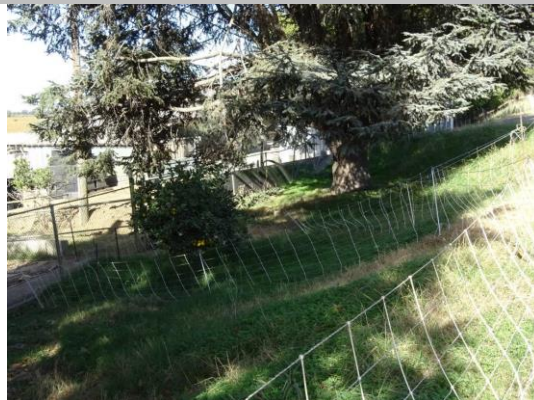
Photo 1 of 1 : FA\_2019\_RD0765\_211\_32\_20190904\_00017.jpg

View of citrus tree within levee easement. Fall 2018

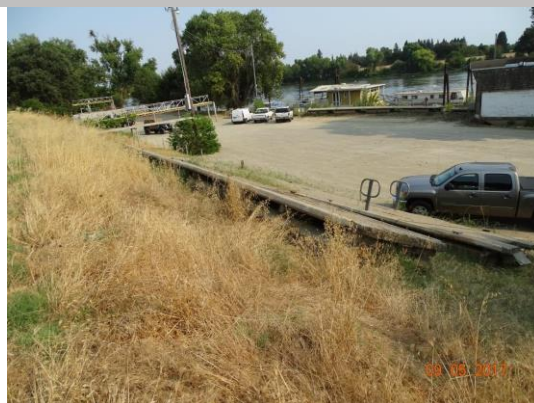
Photo 1 of 1 : FA\_2019\_RD0765\_211\_2\_20190904\_00002.jpg

LM Start	1.24	Rating **	M	Issue No.	2	
LM End	1.24	Issue Type +	En	Location *	WS	
Category	Earthen Levee			GPS Latitude/Longitude		
				Start		End
Item	Encroachments			38.486316 °		38.486316 °
				-121.553349 °		-121.553349 °
DWR ID	DWR_RD0765_01_f_2017_2					
Comment Code						
EQ : Equipment						
Inspector Comment						
Instruct landowner to remove a floating dock platform from the waterside levee slope.

Looking north at the waterside slope. Fall 2017

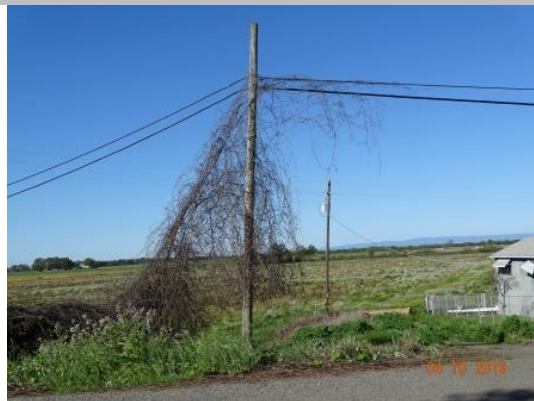
Photo 1 of 1 : FA\_2019\_RD0765\_211\_15\_20190904\_00011.jpg

LM Start	1.28	Rating **	U	Issue No.	15
LM End	1.32	Issue Type +	Ma	Location *	LS
Category	Earthen Levee			GPS Latitude/Longitude	
				Start	End
Item	Vegetation			38.485728 °	38.485210 °
				-121.553042 °	-121.552862 °
DWR ID	DWR_RD0765_01_s_2019_15				
Comment Code					
V2 : Remove the wild growth other than native grasses from the levee slopes.					
Inspector Comment					
Remove wild vines and growth on LS slope

View of vines and grown on LS slope.

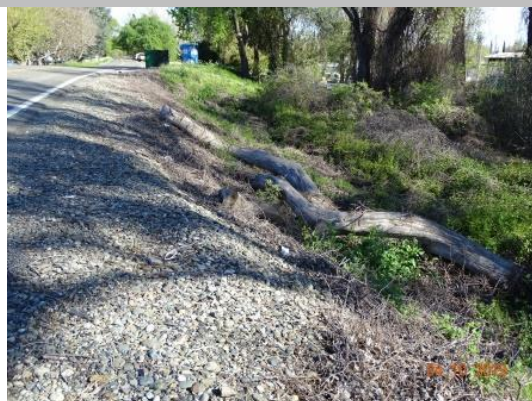
Photo 1 of 1 : FA\_2019\_RD0765\_211\_20\_20190904\_00012.jpg

View looking upstream at fallen tree on levee slope. Spring 2019

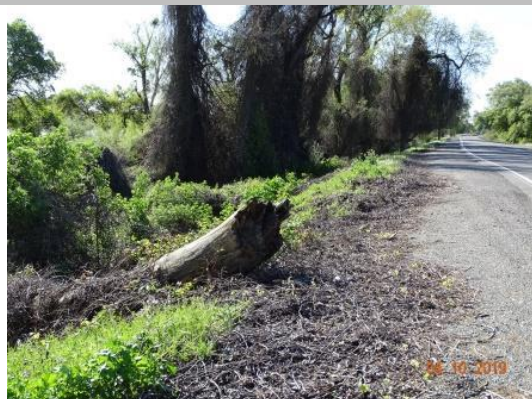
Photo 1 of 2 : FA\_2019\_RD0765\_211\_7\_20190904\_00006.jpg

LM Start	1.32	Rating **	M	Issue No.	7
LM End	1.34	Issue Type +	Ma	Location *	WS
Category	Earthen Levee			GPS Latitude/Longitude	
				Start	End
Item	Encroachments			38.485287 °	38.485014 °
				-121.552818 °	-121.552618 °
DWR ID	DWR_RD0765_01_s_2015_7				
Comment Code					
TR : Tree or limb					
Inspector Comment

View looking downstream at tree log on levee slope. Spring 2019

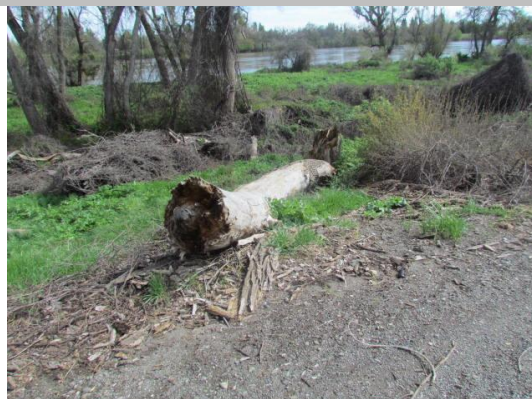
Photo 2 of 2 : FA\_2019\_RD0765\_211\_7\_20190904\_00007.jpg

Looking southeast at branch on waterward slope.

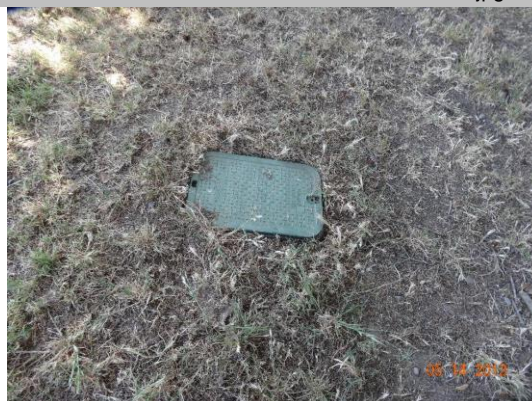
Photo 1 of 1 : UCIP\_FA\_2019\_39022\_71212.jpg

LM Start	1.37	Rating **	M	Issue No.	73
LM End	1.37	Issue Type +	En	Location *	
Category	Supplemental			GPS Latitude/Longitude	
				Start	End
Item	DRAFT DWR UCIP Field Study			38.484656 °	38.484656 °
				-121.552362 °	-121.552362 °
DWR ID	24661				
Comment Code					
Inspector Comment					
DS_ID:24661					
FS_ID:39022					
EP_NO: N/A					
Repair Type: Non-Urgent					
Crossing Status: Indicator Found					
UCIP Comments: Need to contact owner to determine if crossing goes through levee.					
FIELD_STRUCT_DESC: 3-inch irrigation line through levee at unknown depth. Service box located on landside (LS) shoulder.					
FS Date: 5/14/2013

Utility box located on landward shoulder.

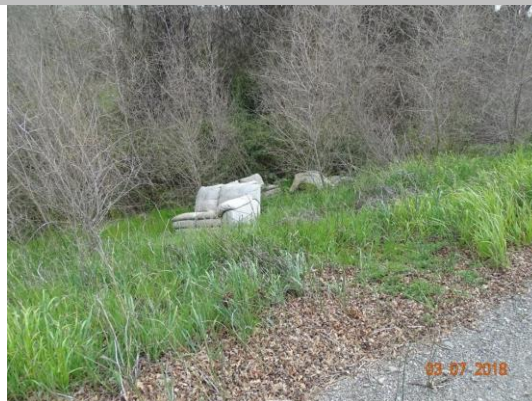
Photo 1 of 1 : FA\_2019\_RD0765\_211\_67\_20190904\_00033.jpg

LM Start	1.43	Rating **	M	Issue No.	67
LM End	1.43	Issue Type +	Ma	Location *	WS
Category	Earthen Levee			GPS Latitude/Longitude	
				Start	End
Item	Encroachments			38.483810 °	38.483810 °
				-121.551747 °	-121.551747 °
DWR ID	DWR_RD0765_01_s_2017_67				
Comment Code					
GA : Garbage					
Inspector Comment					
Remove sofa dumped on waterside slope.

View of sofa debris dumped on slope. Spring 2018

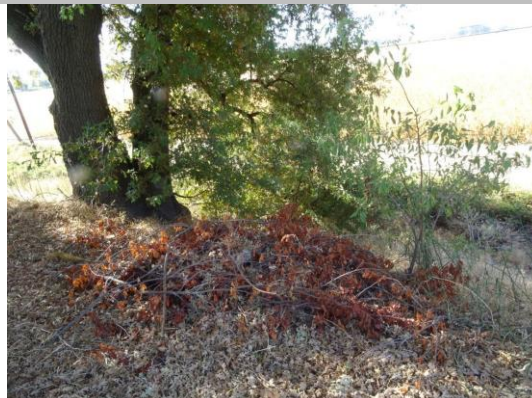
Photo 1 of 1 : FA\_2019\_RD0765\_211\_41\_20190904\_00018.jpg

View of low branches on slope. Fall 2018

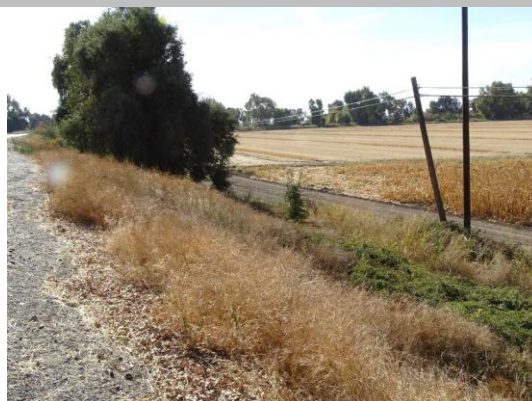
Photo 1 of 3 : FA\_2019\_RD0765\_211\_52\_20190904\_00024.jpg

LM Start	1.47	Rating **	M	Issue No.	52
LM End	1.70	Issue Type +	Ma	Location *	LS
Category	Earthen Levee			GPS Latitude/Longitude	
				Start	End
Item	Vegetation			38.483340 °	38.480345 °
				-121.551565 °	-121.549658 °
DWR ID	DWR_RD0765_01_f_2018_52				
Comment Code					
V2 : Remove the wild growth other than native grasses from the levee slopes.					
Inspector Comment					
Trim tall brush along slope.

View of tall brush on levee slope. Fall 2018

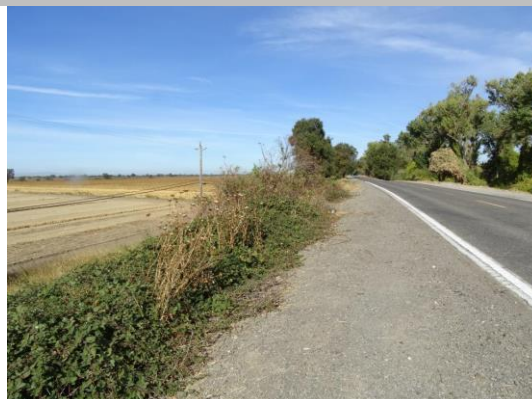
Photo 2 of 3 : FA\_2019\_RD0765\_211\_52\_20190904\_00025.jpg

View of tall brush on levee slope. Fall 2018

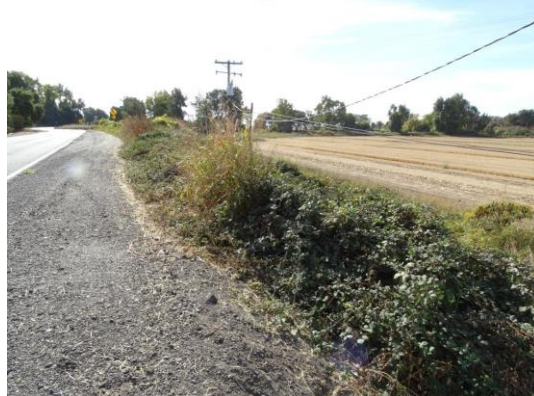
Photo 3 of 3 : FA\_2019\_RD0765\_211\_52\_20190904\_00026.jpg

View of tall brush on levee slope. Fall 2018

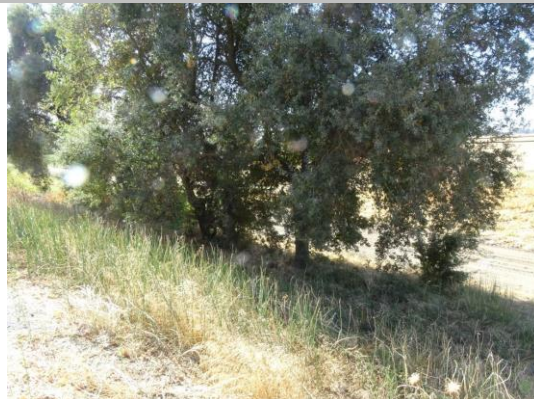
Photo 1 of 1 : FA\_2019\_RD0765\_211\_42\_20190904\_00019.jpg

LM Start	1.48	Rating **	M	Issue No.	42
LM End	1.50	Issue Type +	Ma	Location *	LS
Category	Earthen Levee			GPS Latitude/Longitude	
				Start	End
Item	Trim / Thin Trees			38.483170 °	38.482965 °
				-121.551367 °	-121.551265 °
DWR ID	DWR_RD0765_01_s_2012_42				
Comment Code					
T1 : Trim trees to at least five feet above ground level.					
Inspector Comment

View of low tree branches partially blocking visibility. Fall 2018

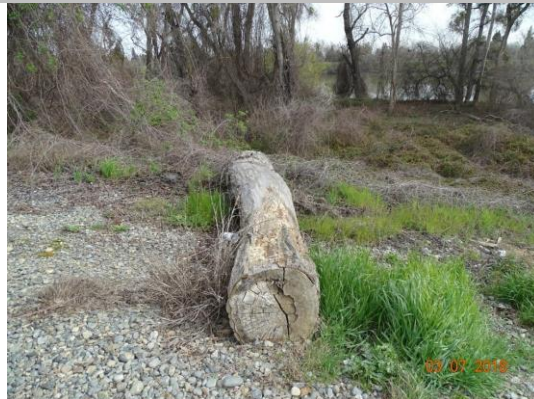
Photo 1 of 1 : FA\_2019\_RD0765\_211\_45\_20190904\_00021.jpg

Log on waterside slope is used to control vehicle access. Spring 2018

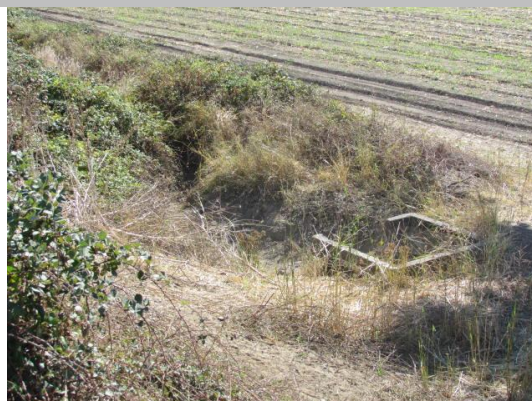
Photo 2 of 2 : FA\_2019\_RD0765\_211\_60\_20190904\_00031.jpg

Looking southwest at irrigation ditch on landward toe.

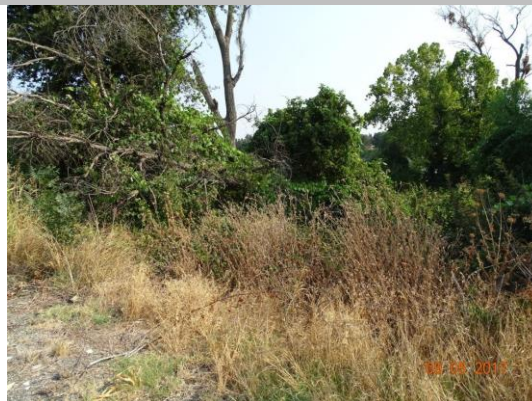
Photo 1 of 1 : FA\_2019\_RD0765\_211\_1\_20190904\_00001.jpg

View looking north at the fallen tree. Fall 2017

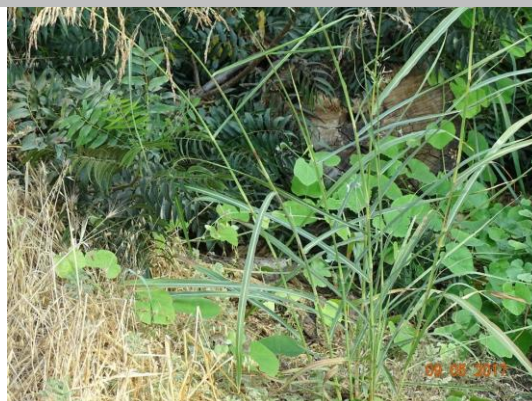
Photo 1 of 2 : FA\_2019\_RD0765\_211\_13\_20190904\_00009.jpg

Looking northwest at tree limb in vegetation on waterside slope. Fall 2017

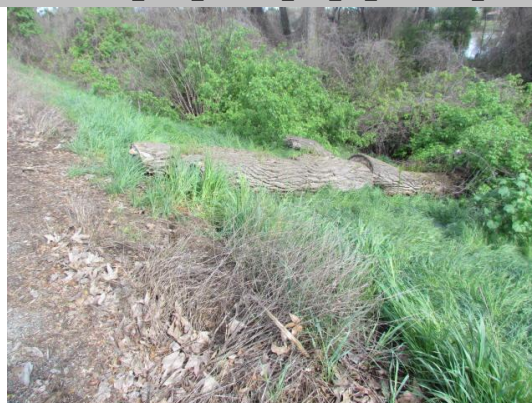
Photo 2 of 2 : FA\_2019\_RD0765\_211\_13\_20190904\_00010.jpg

Looking northwest at large tree limb on waterward slope.
