Flood Control Project Maintenance Levee Inspections

Fall 2020 Levee Maintenance Deficiency Summary Report

Sacramento River Basin

Reclamation District No. 0765 Glide

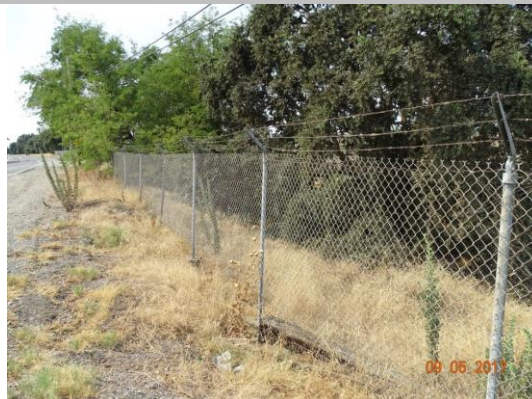
Photo 1 of 1 : FA_2020_RD0765_211_12_20200916_00006.jpg

LM Start	0.00	Rating **	M	Issue No.	12
LM End	0.11	Issue Type +	En	Location *	LS
Category	Earthen Levee			GPS Latitude/Longitude	
				Start	End
Item	Encroachments			38.502962 °	38.501373 °
				-121.560112 °	-121.560402 °
DWR ID	DWR_RD0765_01_s_2020_12				
Comment Code					
FE : Fence					
Inspector Comment					
Fence may prevent maintenance on the landside slope.

Looking southwest at the fence on the landside slope. Fall 2017

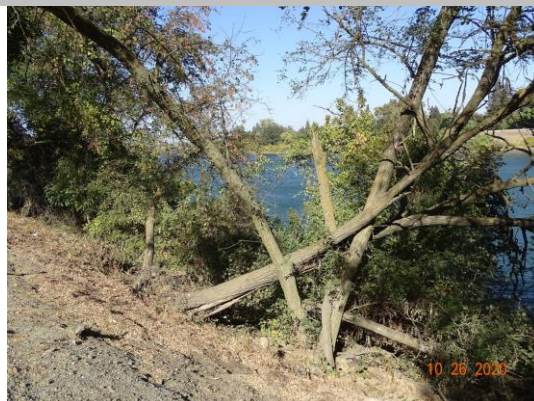
Photo 1 of 1 : FA_2020_RD0765_211_36_20201026_00045.jpg

LM Start	0.51	Rating **	M	Issue No.	36
LM End	0.51	Issue Type +	Ma	Location *	WS
Category	Earthen Levee			GPS Latitude/Longitude	
				Start	End
Item	Encroachments			38.495748 °	38.495748 °
				-121.559525 °	-121.559525 °
DWR ID	DWR_RD0765_01_f _ 2020_36				
Comment Code					
TR : Tree or limb					
Inspector Comment					
Remove a fallen tree from the waterside slope.

View of fallen tree with exposed rootball on the waterside slope. Fall 2020

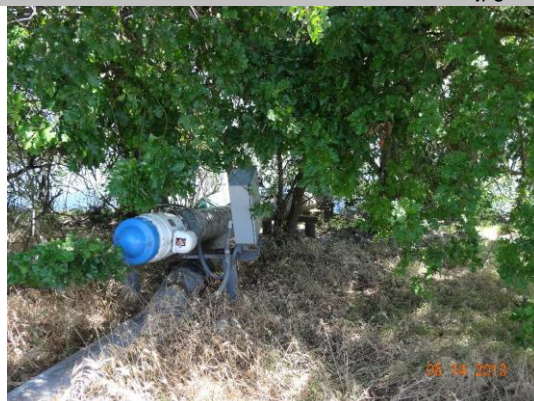
Photo 1 of 3 : UCIP_FA_2020_44403_60815.jpg

Comment Code						
Inspector Comment						
DS_ID:21138 FS_ID:44403 EP_NO: 3314 Repair Type: Non-Urgent EVAL Issue: Crossing Status: Found UCIP Comments: Dense vegetation limit's the ability to determine condition of landward slope for potential leaks associated with crossing. Recommend having owner clear slope to be able to properly inspect slopes for leaks. FIELD_STRUCT_DESC: 16-inch steel irrigation pipe through the levee, 4 feet below the crown. Cutoff wall around pipe at center of levee. Slant pump on the waterside (WS) slope, with 22-inch inlet pipe extending from channel. 16-inch pipe connects to 12-inch steel pipe at landside (LS) shoulder, extending to concrete standpipe discharge outlet at the toe. Cobble revetment on WS slope. (16-inch pipe installed and existing 16-inch pipe grouted work authorized under Permit No. 3314, 1960-C.M. Goethe) FS Date: 5/14/2013

View of waterward side--pipe, pump, control panels, and electrical conduit.

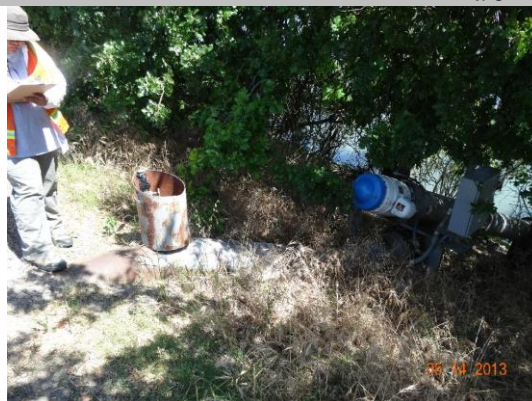
Photo 2 of 3 : UCIP_FA_2020_44403_60814.jpg

Siphon breaker encased in steel casing located on waterward side.

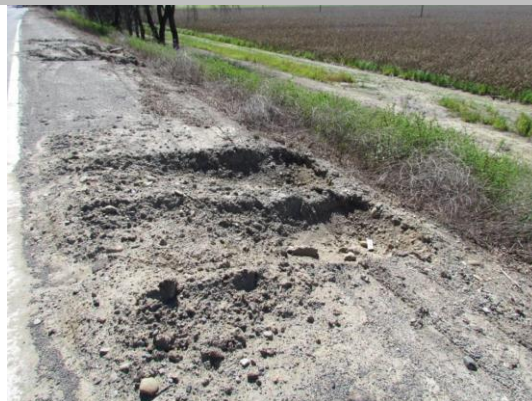
Photo 1 of 1 : FA_2020_RD0765_211_68_20200916_00031.jpg

LM Start	0.75	Rating **	M	Issue No.	68
LM End	0.75	Issue Type +	Ma	Location *	LS
Category	Earthen Levee			GPS Latitude/Longitude	
				Start	End
Item	Slope Stability			38.492705 °	38.492705 °
				-121.557193 °	-121.557193 °
DWR ID	DWR_RD0765_01_s_2017_68				
Comment Code					
S3 : Repair the levee slope damaged by vehicle traffic and prevent access where possible.					
Inspector Comment					
Repair tire rut damage on the LS shoulder.

Looking south at levee damage caused by vehicle traffic. (Spring 2017)

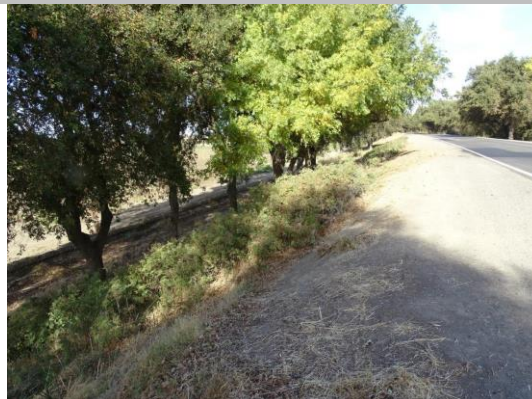
Photo 1 of 1 : FA_2020_RD0765_211_63_20200916_00028.jpg

LM Start	0.75	Rating **	M	Issue No.	63
LM End	0.79	Issue Type +	Ma	Location *	LS
Category	Earthen Levee			GPS Latitude/Longitude	
				Start	End
Item	Vegetation			38.492647 °	38.492145 °
				-121.557192 °	-121.556891 °
DWR ID	DWR_RD0765_01_s _ 2018_63				
Comment Code					
V2 : Remove the wild growth other than native grasses from the levee slopes.					
Inspector Comment					
Trim brush along the landside toe easement.

View of brush on levee slope. Fall 2018

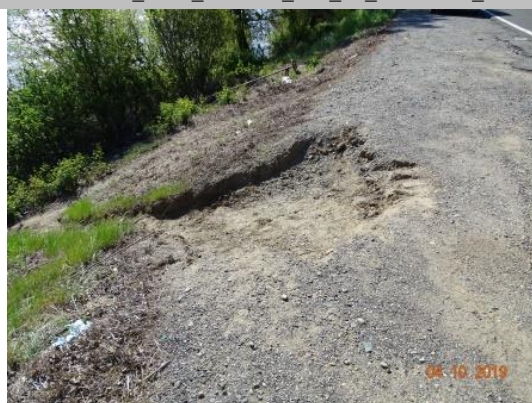
Photo 1 of 1 : FA_2020_RD0765_211_24_20200916_00012.jpg

LM Start	0.94	Rating **	M	Issue No.	24
LM End	0.94	Issue Type +	Ma	Location *	WS
Category	Earthen Levee			GPS Latitude/Longitude	
				Start	End
Item	Slope Stability			38.490265 °	38.490265 °
				-121.555617 °	-121.555617 °
DWR ID	DWR_RD0765_01_s_2019_24				
Comment Code					
S2 : Repair the levee slope damaged by foot traffic and prevent access where possible.					
Inspector Comment

View looking downstream at footpath that cuts into levee slope. Spring 2019

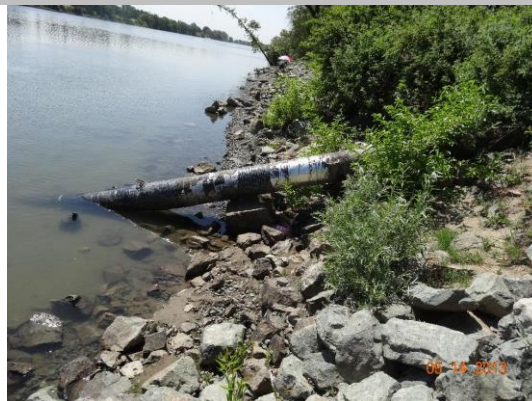
Photo 1 of 3 : UCIP_FA_2020_44404_60819.jpg

LM Start	0.95	Rating **	M	Issue No.	70
LM End	0.95	Issue Type +	En	Location *	
Category	Supplemental			GPS Latitude/Longitude	
				Start	End
Item	DWR UCIP Field Study			38.490192 °	38.490192 °
				-121.555628 °	-121.555628 °
DWR ID	21139				
Comment Code					
Inspector Comment					
DS_ID:21139 FS_ID:44404 EP_NO: 653 Repair Type: Non-Urgent EVAL Issue: Crossing Status: Found UCIP Comments: Dense vegetation on landward side limits visual inspection of potential leaks. Recommend clearing slope of vegetation. FIELD_STRUCT_DESC: 16-inch steel irrigation pipe through the levee, 14.3 feet below the crown. Pump on the landside (LS). Gate valve on the waterside (WS) slope. (16-inch pipe authorized under Permit No. 653, 1935-E. G. Elliott) [Additional Reference(s): DWR Levee Logs, 2005. USACE Sacramento O&M Manual Unit No. 114, April 1959, River Mile (RM) 50.29] FS Date: 5/14/2013

Pipe section visible at waterward toe.

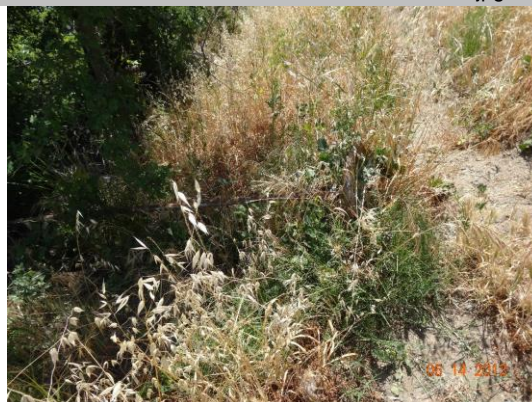
Photo 2 of 3 : UCIP_FA_2020_44404_60818.jpg

View of waterward side--dense vegetation limits inspection.

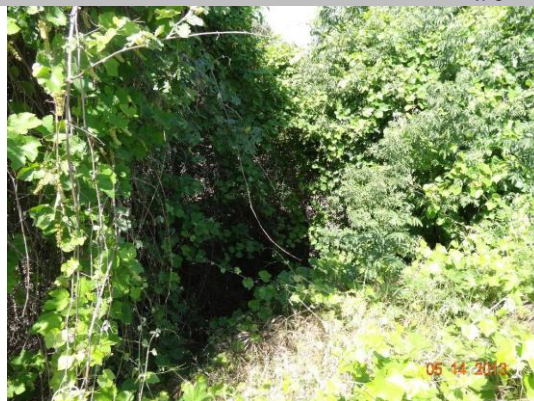
Photo 3 of 3 : UCIP_FA_2020_44404_60821.jpg

View of landward side--dense vegetation limits inspection.

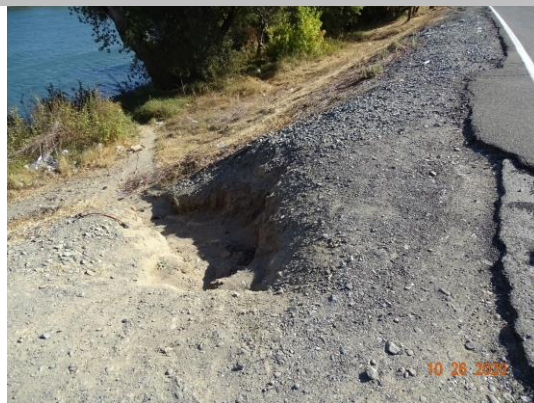
Photo 1 of 1 : FA_2020_RD0765_211_23_20201026_00046.jpg

LM Start	0.95	Rating **	M	Issue No.	23
LM End	0.95	Issue Type +	Ma	Location *	WS
Category	Earthen Levee			GPS Latitude/Longitude	
				Start	End
Item	Slope Stability			38.490067 °	38.490067 °
				-121.555530 °	-121.555530 °
DWR ID	DWR_RD0765_01_s_2019_23				
Comment Code					
S2 : Repair the levee slope damaged by foot traffic and prevent access where possible.					
Inspector Comment

View of footpath on the waterside slope. Fall 2020

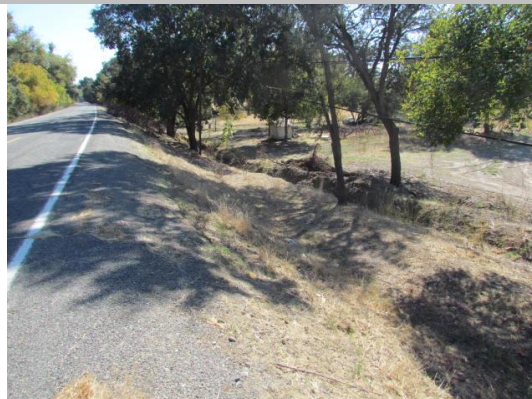
Photo 1 of 1 : FA_2020_RD0765_211_51_20200916_00019.jpg

LM Start	0.96	Rating **	M	Issue No.	51
LM End	1.02	Issue Type +	En	Location *	LS
Category	Earthen Levee			GPS Latitude/Longitude	
				Start	End
Item	Encroachments			38.489949 °	38.489230 °
				-121.555544 °	-121.555168 °
DWR ID	DWR_RD0765_01_s_2013_51				
Comment Code					
DT : Ditch					
Inspector Comment					
This ditch has been in place for several years. Most of the ditch appears to be outside the 15 foot right-of-way.

Looking southwest at irrigation ditch on landward toe.

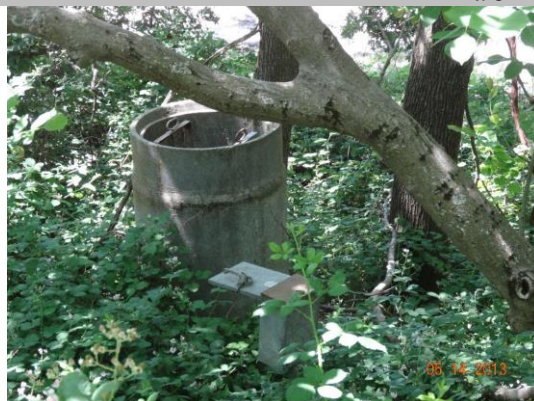
Photo 1 of 3 : UCIP_FA_2020_44407_73022.jpg

Comment Code					
Inspector Comment					
DS_ID:21140					
FS_ID:44407					
EP_NO: N/A					
Repair Type: Non-Urgent					
EVAL Issue:					
Crossing Status: Indicator Found					
UCIP Comments: Dense vegetation on waterward and landward slopes limit visual inspection of potential leaks along pipe alignment.					
Recommend having owner clear vegetation along slopes.					
FIELD_STRUCT_DESC: 6-inch steel pipe of unknown purpose through the levee, 18.8 feet below the crown. Concrete standpipe on the landise (LS) toe. Pump located on the waterside (WS) slope. [Additional					
Reference(s): USACE Sacramento O&M Manual Unit No. 114, April 1959, (river mile (RM) 50.15)]					
FS Date: 4/9/2015

Overview of landward side--concrete standpipe and control panel located at toe.

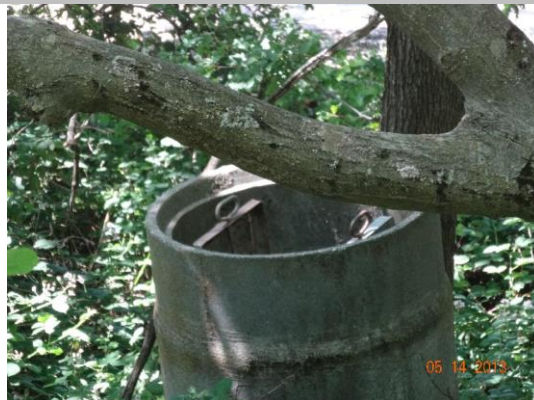
Photo 2 of 3 : UCIP_FA_2020_44407_73021.jpg

Concrete standpipe with 2 gates inside located on landward side.

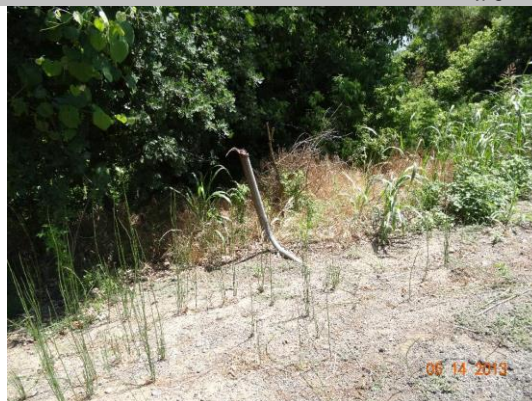
Photo 3 of 3 : UCIP_FA_2020_44407_73020.jpg

Conduits disconnected and damaged on waterward side.

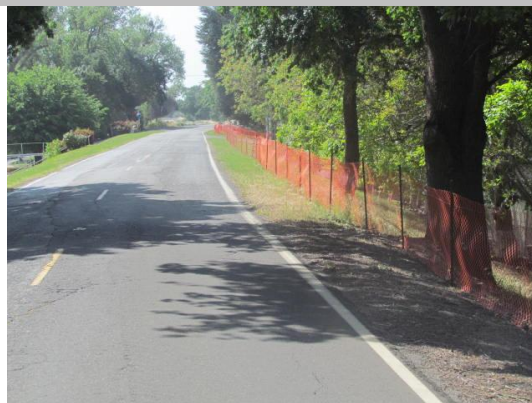
Photo 1 of 1 : FA_2020_RD0765_211_54_20200916_00024.jpg

LM Start	1.16	Rating **	M	Issue No.	54
LM End	1.26	Issue Type +	En	Location *	LS
Category	Earthen Levee			GPS Latitude/Longitude	
				Start	End
Item	Encroachments			38.487348 °	38.485984 °
				-121.554044 °	-121.553202 °
DWR ID	DWR_RD0765_01_s_2015_54				
Comment Code					
FE : Fence					
Inspector Comment					
The landowner installed a temporary fence on the landside shoulder and slope.

Looking south at temporary fence on landside shoulder. (Spring 2016)

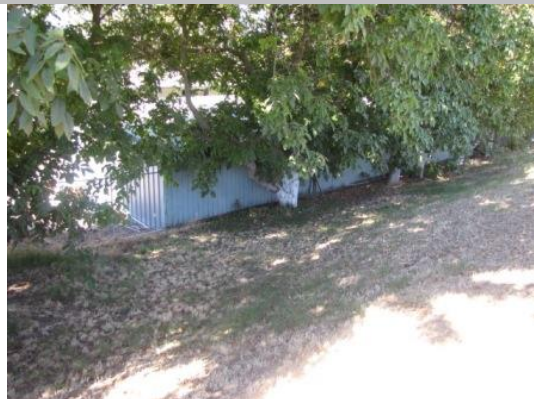
Photo 1 of 1 : FA_2020_RD0765_211_43_20200916_00016.jpg

LM Start	1.18	Rating **	M	Issue No.	43
LM End	1.21	Issue Type +	En	Location *	LS
Category	Earthen Levee			GPS Latitude/Longitude	
				Start	End
Item	Encroachments			38.487127 °	38.486702 °
				-121.553910 °	-121.553652 °
DWR ID	DWR_RD0765_01_s_2012_43				
Comment Code					
BU : Building					
Inspector Comment

Looking northwest at buildings along landside toe.

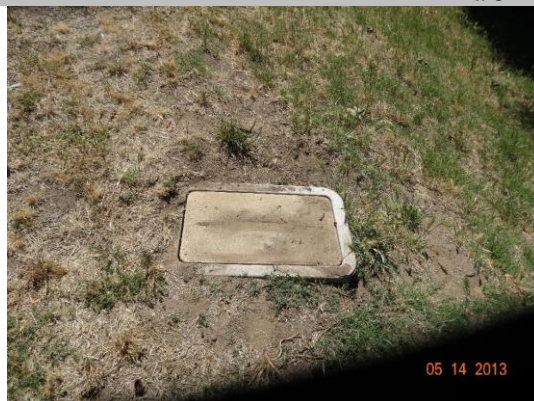
Photo 1 of 2 : UCIP_FA_2020_43203_71214.jpg

LM Start	1.20	Rating **	M	Issue No.	72
LM End	1.20	Issue Type +	En	Location *	
Category	Supplemental			GPS Latitude/Longitude	
				Start	End
Item	DWR UCIP Field Study			38.486830 °	38.486830 °
				-121.553698 °	-121.553698 °
DWR ID	24660				
Comment Code					
Inspector Comment					
DS_ID:24660					
FS_ID:43203					
EP_NO: N/A					
Repair Type: Non-Urgent					
EVAL Issue:					
Crossing Status: Indicator Found					
UCIP Comments: Unable to confirm details of crossing. Need to contact owner to determine additional details about crossing and permit issued.					
FIELD_STRUCT_DESC: PG&E utility service box located on the landside shoulder.					
FS Date: 5/14/2013

Utility box located on landward side.

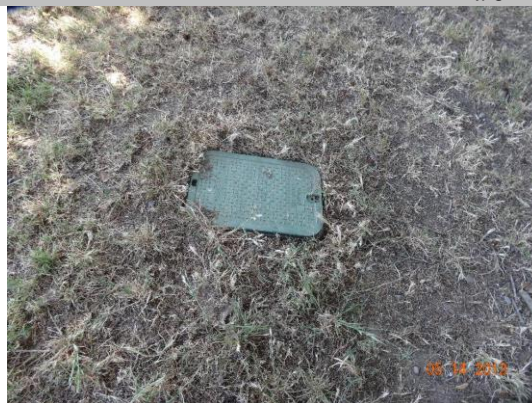
Photo 1 of 1 : UCIP_FA_2020_39022_71212.jpg

LM Start	1.37	Rating **	M	Issue No.	73	
LM End	1.37	Issue Type +	En	Location *		
Category	Supplemental			GPS Latitude/Longitude		
				Start	End	
Item	DWR UCIP Field Study			38.484656 °	38.484656 °	
				-121.552362 °	-121.552362 °	
DWR ID	24661					
Comment Code						
Inspector Comment						
DS_ID:24661						
FS_ID:39022						
EP_NO: N/A						
Repair Type: Non-Urgent						
EVAL Issue:						
Crossing Status: Indicator Found						
UCIP Comments: Need to contact owner to determine if crossing goes through levee.						
FIELD_STRUCT_DESC: 3-inch irrigation line through levee at unknown depth. Service box located on landside (LS) shoulder.						
FS Date: 5/14/2013

Utility box located on landward shoulder.

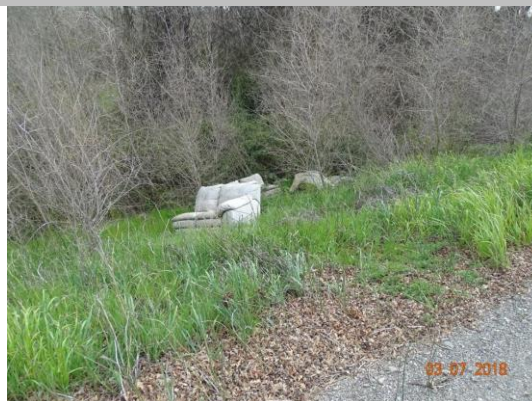
Photo 1 of 1 : FA_2020_RD0765_211_67_20200916_00029.jpg

View of sofa debris dumped on slope. Spring 2018

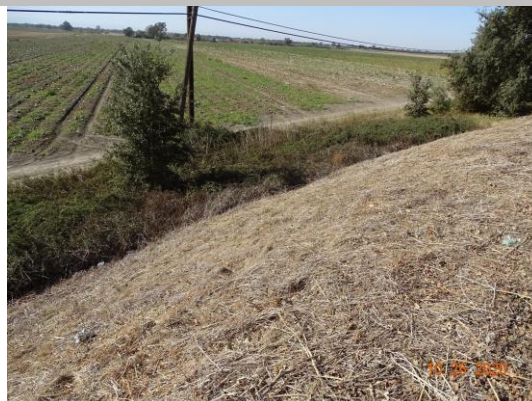
Photo 1 of 1 : FA_2020_RD0765_211_52_20201026_00047.jpg

View of wild growth at the landside toe easement. Fall 2020

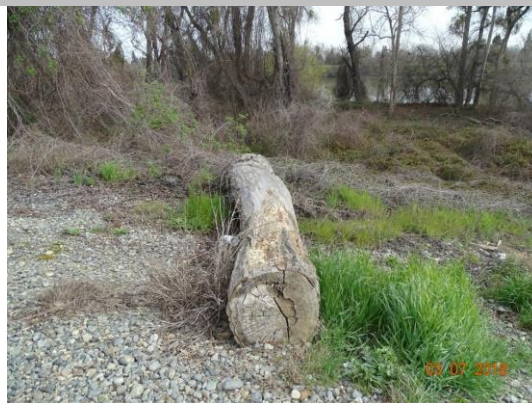
Photo 1 of 1 : FA_2020_RD0765_211_45_20200916_00017.jpg

LM Start	1.51	Rating **	A/W	Issue No.	45
LM End	1.51	Issue Type +	Ma	Location *	WS
Category	Earthen Levee			GPS Latitude/Longitude	
				Start	End
Item	Encroachments			38.482835 °	38.482835 °
				-121.551083 °	-121.551083 °
DWR ID	DWR_RD0765_01_s_2018_45				
Comment Code					
TR : Tree or limb					
Inspector Comment					
A log is used to prevent vehicle access onto the levee slope.

Log on waterside slope is used to control vehicle access. Spring 2018

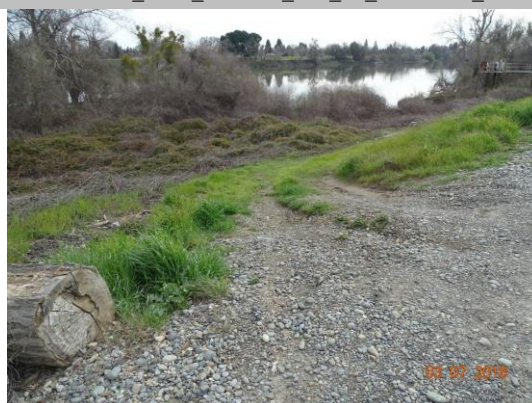
Photo 1 of 1 : FA_2020_RD0765_211_31_20200916_00013.jpg

LM Start	1.51	Rating **	M	Issue No.	31
LM End	1.51	Issue Type +	Ma	Location *	WS
Category	Earthen Levee			GPS Latitude/Longitude	
				Start	End
Item	Slope Stability			38.482788 °	38.482788 °
				-121.551048 °	-121.551048 °
DWR ID	DWR_RD0765_01_f_2019_31				
Comment Code					
S3 : Repair the levee slope damaged by vehicle traffic and prevent access where possible.					
Inspector Comment

View looking southeast at slope instability due to vehicle traffic. Spring 2018

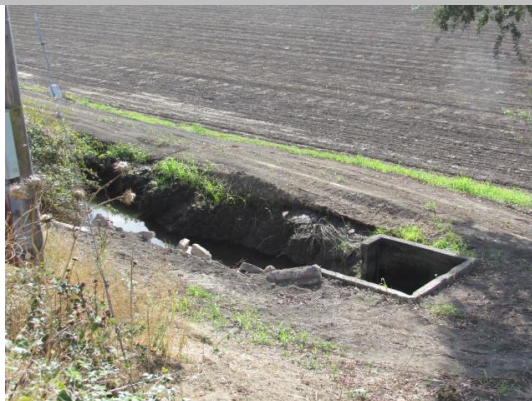
Photo 1 of 1 : FA_2020_RD0765_211_60_20200916_00026.jpg

Looking southwest at irrigation ditch at landward toe. (Fall 2014)

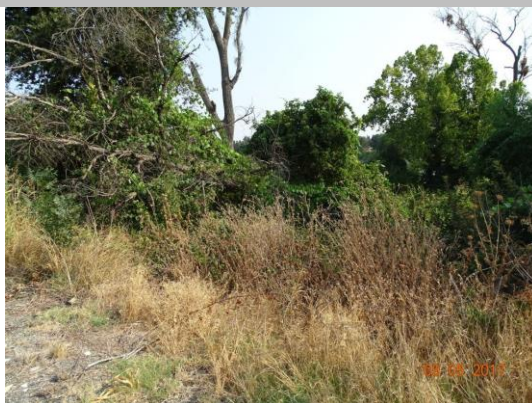
Photo 1 of 1 : FA_2020_RD0765_211_1_20200916_00001.jpg

LM Start	1.58	Rating **	M	Issue No.	1
LM End	1.58	Issue Type +	Ma	Location *	WS
Category	Earthen Levee			GPS Latitude/Longitude	
				Start	End
Item	Encroachments			38.481959 °	38.481959 °
				-121.550527 °	-121.550527 °
DWR ID	DWR_RD0765_01_f _ 2017_1				
Comment Code					
TR : Tree or limb					
Inspector Comment					
Remove a fallen tree on the waterside slope.

View looking north at the fallen tree. Fall 2017

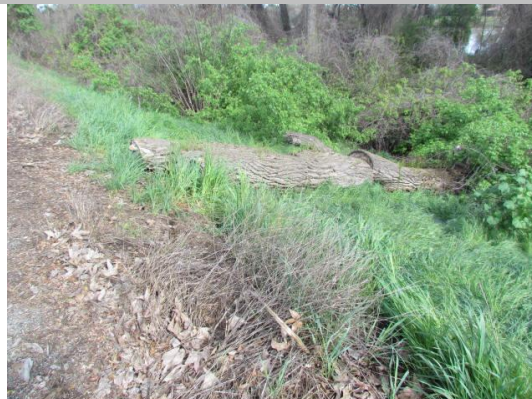
Photo 1 of 1 : FA_2020_RD0765_211_13_20200916_00008.jpg

Looking northwest at large tree limb on waterward slope.
