Flood Control Project Maintenance Levee Inspections

Fall 2021 Levee Maintenance Deficiency Summary Report

Sacramento River Basin

Reclamation District No. 0765 Glide

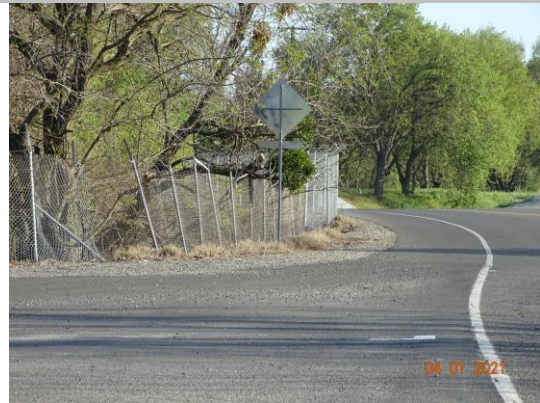
Photo 1 of 1 : FA_2021_RD0765_211_12_20210823_00005.jpg

LM Start	0.00	Rating **	M	Issue No.	12
LM End	0.08	Issue Type +	En	Location *	LS
Category	Earthen Levee			GPS Latitude/Longitude	
				Start	End
Item	Encroachments			38.502962 °	38.501772 °
				-121.560112 °	-121.560250 °
DWR ID	DWR_RD0765_01_s_2020_12				
Comment Code					
FE : Fence					
Inspector Comment					
Fence prevents access on the landside slope.

View of the fence on the LS levee slope. Spring 2021.

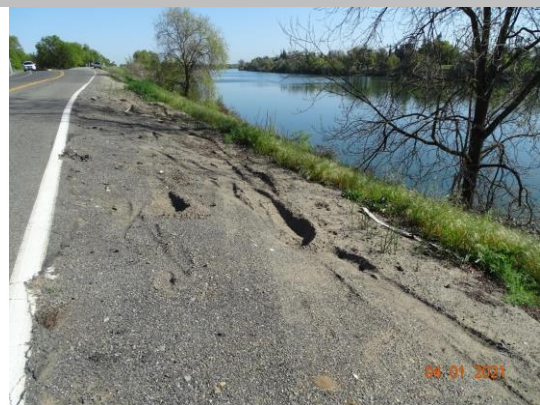
Photo 1 of 1 : FA_2021_RD0765_211_42_20210823_00020.jpg

LM Start	0.07	Rating **	M	Issue No.	42
LM End	0.07	Issue Type +	Ma	Location *	WS
Category	Earthen Levee			GPS Latitude/Longitude	
				Start	End
Item	Slope Stability			38.501920 °	38.501920 °
				-121.560368 °	-121.560368 °
DWR ID	DWR_RD0765_01_s_2021_42				
Comment Code					
S3 : Repair the levee slope damaged by vehicle traffic and prevent access where possible.					
Inspector Comment					
Repair rutting on the WS shoulder.

View of the WS levee slope damaged by vehicle traffic. Spring 2021.

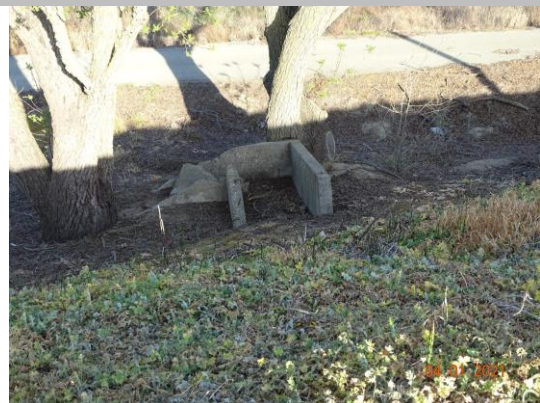
Photo 1 of 1 : FA_2021_RD0765_211_11_20210823_00004.jpg

LM Start	0.11	Rating **	M	Issue No.	11
LM End	0.11	Issue Type +	En	Location *	LS
Category	Earthen Levee			GPS Latitude/Longitude	
				Start	End
Item	Encroachments			38.501423 °	38.501423 °
				-121.560409 °	-121.560409 °
DWR ID	DWR_RD0765_01_s_2021_11				
Comment Code					
DE : Debris					
Inspector Comment					
There is concrete debris on the LS levee toe.

View of the concrete debris on the LS levee toe. Spring 2021.

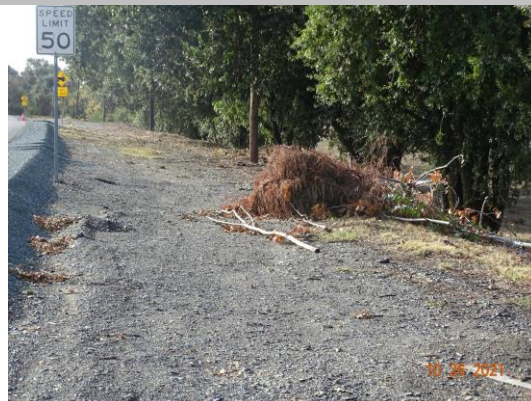
Photo 1 of 1 : FA_2021_RD0765_211_17_20211027_00042.jpg

LM Start	0.18	Rating **	M	Issue No.	17
LM End	0.18	Issue Type +	Ma	Location *	LS
Category	Earthen Levee			GPS Latitude/Longitude	
				Start	End
Item	Encroachments			38.500317 °	38.500317 °
				-121.560546 °	-121.560546 °
DWR ID	DWR_RD0765_01_s_2021_17				
Comment Code					
PR : Prunings					
Inspector Comment					
Remove prunings from LS crown/Slope

Prunings on the LS shoulder. Fall 2021

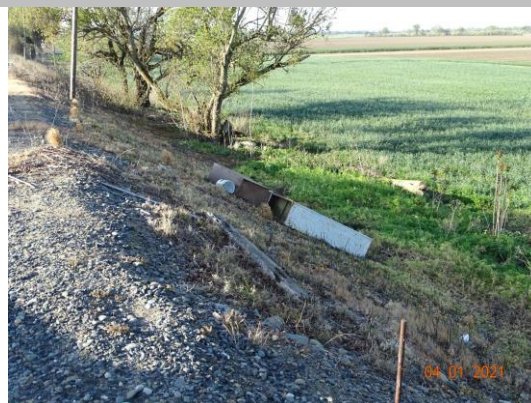
Photo 1 of 1 : FA_2021_RD0765_211_34_20210823_00017.jpg

LM Start	0.29	Rating **	M	Issue No.	34
LM End	0.29	Issue Type +	En	Location *	LS
Category	Earthen Levee			GPS Latitude/Longitude	
				Start	End
Item	Encroachments			38.498798 °	38.498798 °
				-121.560501 °	-121.560501 °
DWR ID	DWR_RD0765_01_f_2020_34				
Comment Code					
DE : Debris					
Inspector Comment					
Remove sofas (three) from the LS slope/toe.

View of the filing cabinets on the LS levee slope. Spring 2021.

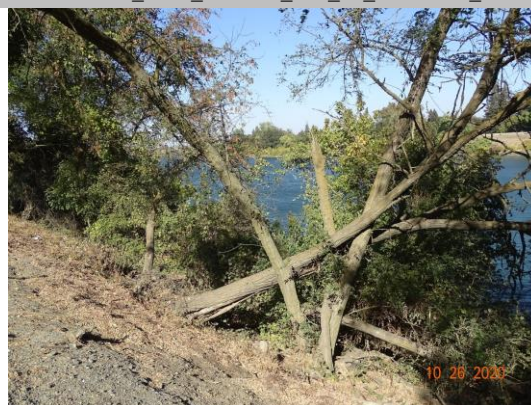
Photo 1 of 1 : FA_2021_RD0765_211_36_20210823_00018.jpg

LM Start	0.51	Rating **	A/W	Issue No.	36
LM End	0.51	Issue Type +	Ma	Location *	WS
Category	Earthen Levee			GPS Latitude/Longitude	
				Start	End
Item	Vegetation			38.495748 °	38.495748 °
				-121.559525 °	-121.559525 °
DWR ID	DWR_RD0765_01_f_2020_36				
Comment Code					
V7 : Trees / Woody Vegetation					
Inspector Comment					
Fallen tree with exposed rootball.

View of fallen tree with exposed rootball on the waterside slope. Fall 2020

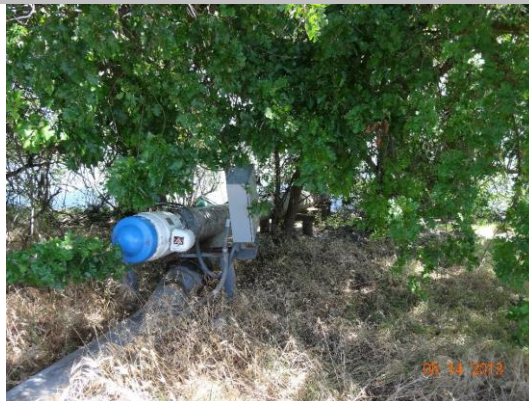
Photo 1 of 3 : UCIP_FA_2021_44403_60815.jpg

Comment Code						
Inspector Comment						
DS_ID:21138 FS_ID:44403 EP_NO: 3314 Repair Type: Non-Urgent EVAL Issue: Crossing Status: Found UCIP Comments: Dense vegetation limit's the ability to determine condition of landward slope for potential leaks associated with crossing. Recommend having owner clear slope to be able to properly inspect slopes for leaks. FIELD_STRUCT_DESC: 16-inch steel irrigation pipe through the levee, 4 feet below the crown. Cutoff wall around pipe at center of levee. Slant pump on the waterside (WS) slope, with 22-inch inlet pipe extending from channel. 16-inch pipe connects to 12-inch steel pipe at landside (LS) shoulder, extending to concrete standpipe discharge outlet at the toe. Cobble revetment on WS slope. (16-inch pipe installed and existing 16-inch pipe grouted work authorized under Permit No. 3314, 1960-C.M. Goethe) FS Date: 5/14/2013

View of waterward side--pipe, pump, control panels, and electrical conduit.

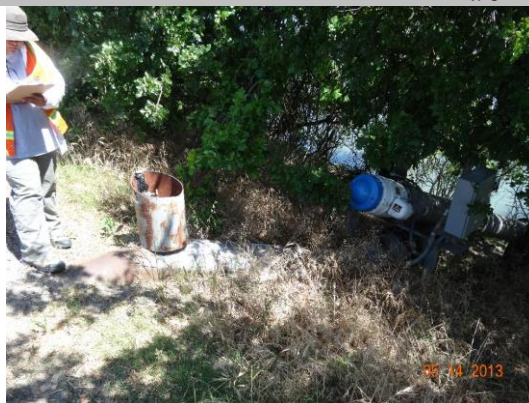
Photo 2 of 3 : UCIP_FA_2021_44403_60814.jpg

Siphon breaker encased in steel casing located on waterward side.

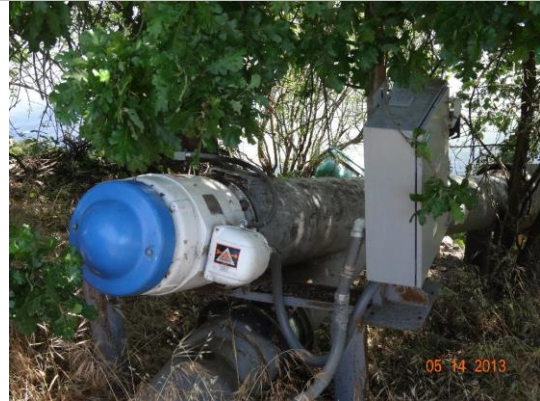
Photo 3 of 3 : UCIP_FA_2021_44403_60813.jpg

Close up of slant pump and control panel on waterward side.

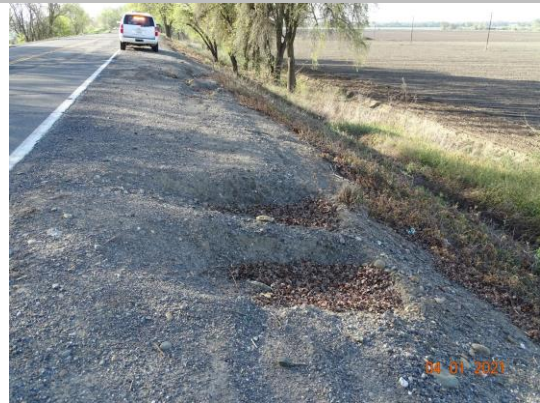
Photo 1 of 1 : FA_2021_RD0765_211_68_20210823_00029.jpg

LM Start	0.75	Rating **	M	Issue No.	68
LM End	0.75	Issue Type +	Ma	Location *	LS
Category	Earthen Levee			GPS Latitude/Longitude	
				Start	End
Item	Slope Stability			38.492705 °	38.492705 °
				-121.557193 °	-121.557193 °
DWR ID	DWR_RD0765_01_s_2017_68				
Comment Code					
S3 : Repair the levee slope damaged by vehicle traffic and prevent access where possible.					
Inspector Comment					
Repair tire rut damage on the LS shoulder.

View of the LS levee shoulder damaged by vehicle traffic. Spring 2021.

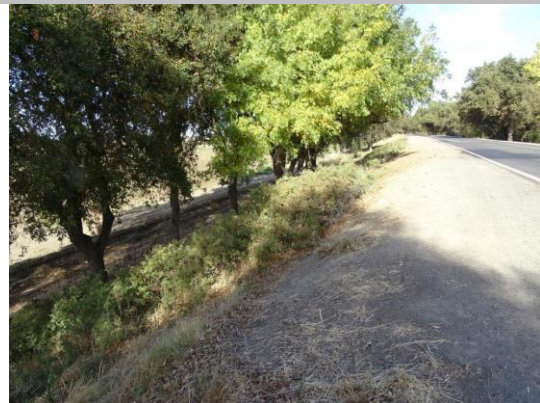
Photo 1 of 1 : FA_2021_RD0765_211_63_20210823_00027.jpg

LM Start	0.75	Rating **	M	Issue No.	63
LM End	0.79	Issue Type +	Ma	Location *	LS
Category	Earthen Levee			GPS Latitude/Longitude	
				Start	End
Item	Vegetation			38.492647 °	38.492145 °
				-121.557192 °	-121.556891 °
DWR ID	DWR_RD0765_01_s_2018_63				
Comment Code					
V2 : Remove the wild growth other than native grasses from the levee slopes.					
Inspector Comment					
Trim brush along the landside toe easement.

View of brush on levee slope. Fall 2018

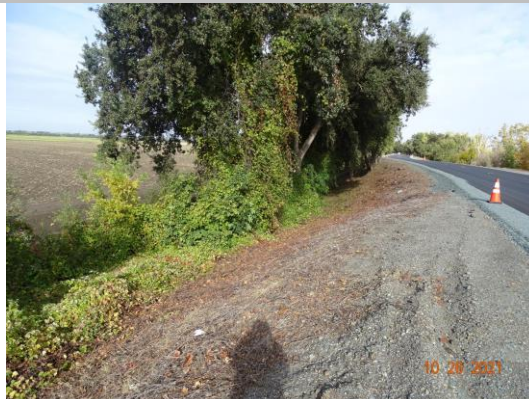
Photo 1 of 1 : FA_2021_RD0765_211_28_20211027_00043.jpg

LM Start	0.83	Rating **	M	Issue No.	28
LM End	0.83	Issue Type +	Ma	Location *	LS
Category	Earthen Levee			GPS Latitude/Longitude	
				Start	End
Item	Vegetation			38.491610 °	38.491610 °
				-121.556603 °	-121.556603 °
DWR ID	DWR_RD0765_01_s _ 2020_28				
Comment Code					
V2 : Remove the wild growth other than native grasses from the levee slopes.					
Inspector Comment					
Trim brush and remove berries near the landside toe.

Berry/brush growth on the LS slope and in the easement. Fall 2021

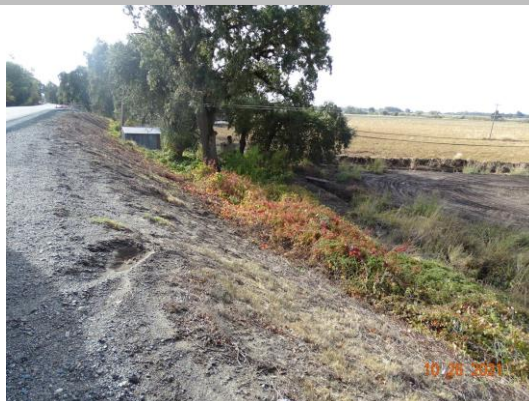
Photo 1 of 1 : FA_2021_RD0765_211_29_20211027_00044.jpg

LM Start	0.87	Rating **	M	Issue No.	29
LM End	0.87	Issue Type +	Ma	Location *	LS
Category	Earthen Levee			GPS Latitude/Longitude	
				Start	End
Item	Vegetation			38.491172 °	38.491172 °
				-121.556227 °	-121.556227 °
DWR ID	DWR_RD0765_01_s _ 2020_29				
Comment Code					
V2 : Remove the wild growth other than native grasses from the levee slopes.					
Inspector Comment					
Remove brush/berry growth from the LS slope and easement.

Berry and brush growth on the LS slope and in the easement. Fall 2021

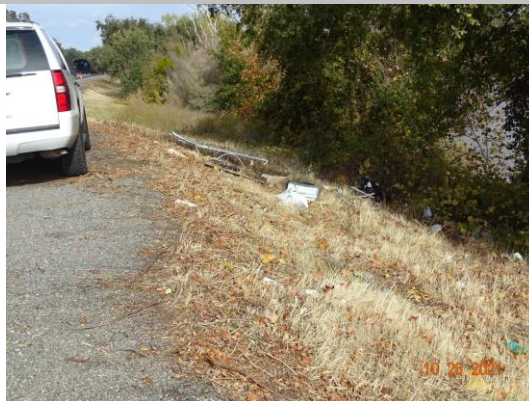
Photo 1 of 1 : FA_2021_RD0765_211_25_20211027_00045.jpg

LM Start	0.88	Rating **	M	Issue No.	25
LM End	0.88	Issue Type +	Ma	Location *	WS
Category	Earthen Levee			GPS Latitude/Longitude	
				Start	End
Item	Encroachments			38.491023 °	38.491023 °
				-121.556046 °	-121.556046 °
DWR ID	DWR_RD0765_01_f _ 2021_25				
Comment Code					
DE : Debris					
Inspector Comment					
Remove debris from WS slope.

Debris pile on the WS slope. Fall 2021

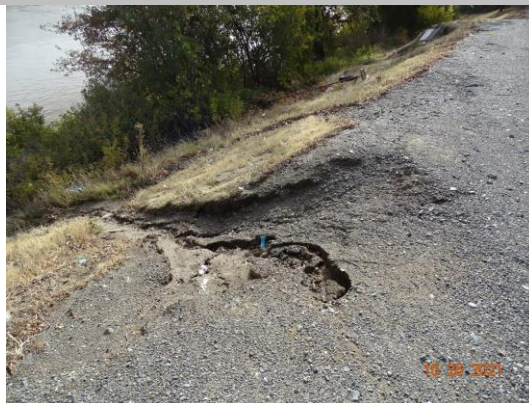
Photo 1 of 1 : FA_2021_RD0765_211_24_20211027_00046.jpg

LM Start	0.94	Rating **	U	Issue No.	24
LM End	0.94	Issue Type +	Ma	Location *	WS
Category	Earthen Levee			GPS Latitude/Longitude	
				Start	End
Item	Slope Stability			38.490265 °	38.490265 °
				-121.555617 °	-121.555617 °
DWR ID	DWR_RD0765_01_s_2019_24				
Comment Code					
S2 : Repair the levee slope damaged by foot traffic and prevent access where possible.					
Inspector Comment					
Erosion and footpath on the WS slope need to be repaired.

Erosion on the WS footpath. Fall 2021

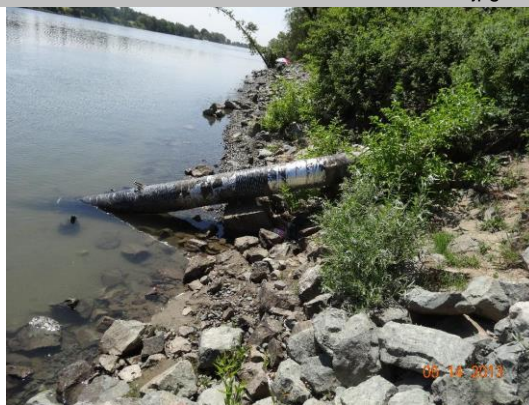
Photo 1 of 3 : UCIP_FA_2021_44404_60819.jpg

LM Start	0.95	Rating **	M	Issue No.	70
LM End	0.95	Issue Type +	En	Location *	
Category	Supplemental			GPS Latitude/Longitude	
				Start	End
Item	DWR UCIP Field Study			38.490192 °	38.490192 °
				-121.555628 °	-121.555628 °
DWR ID	21139				
Comment Code					
Inspector Comment					
DS_ID:21139 FS_ID:44404 EP_NO: 653 Repair Type: Non-Urgent EVAL Issue: Crossing Status: Found UCIP Comments: Dense vegetation on landward side limits visual inspection of potential leaks. Recommend clearing slope of vegetation. FIELD_STRUCT_DESC: 16-inch steel irrigation pipe through the levee, 14.3 feet below the crown. Pump on the landside (LS). Gate valve on the waterside (WS) slope. (16-inch pipe authorized under Permit No. 653, 1935-E. G. Elliott) [Additional Reference(s): DWR Levee Logs, 2005. USACE Sacramento O&M Manual Unit No. 114, April 1959, River Mile (RM) 50.29] FS Date: 5/14/2013

Pipe section visible at waterward toe.

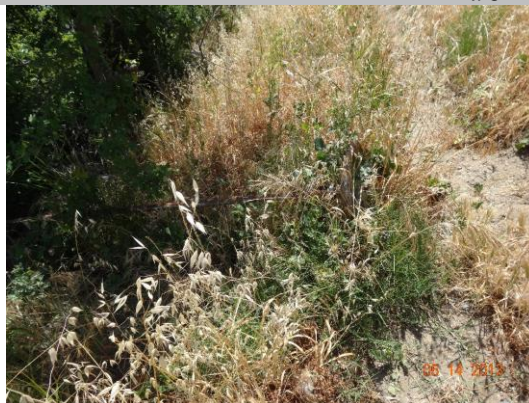
Photo 2 of 3 : UCIP_FA_2021_44404_60818.jpg

View of waterward side--dense vegetation limits inspection.

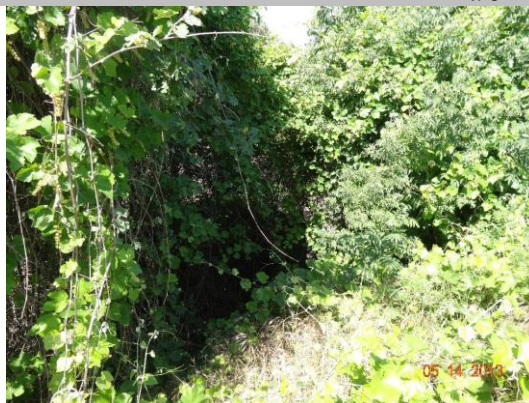
Photo 3 of 3 : UCIP_FA_2021_44404_60821.jpg

View of landward side--dense vegetation limits inspection.

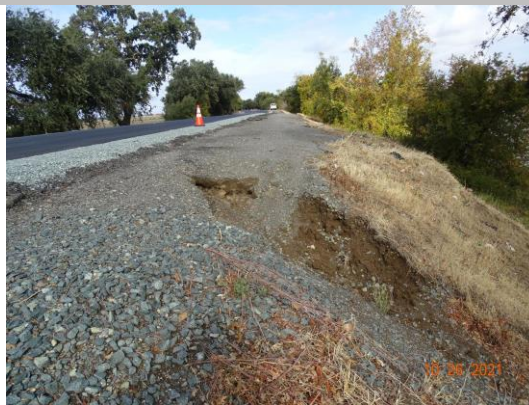
Photo 1 of 1 : FA_2021_RD0765_211_23_20211027_00047.jpg

LM Start	0.95	Rating **	U	Issue No.	23
LM End	0.95	Issue Type +	Ma	Location *	WS
Category	Earthen Levee			GPS Latitude/Longitude	
				Start	End
Item	Slope Stability			38.490067 °	38.490067 °
				-121.555530 °	-121.555530 °
DWR ID	DWR_RD0765_01_s_2019_23				
Comment Code					
S2 : Repair the levee slope damaged by foot traffic and prevent access where possible.					
Inspector Comment					
Repair the erosion at the footpath on the WS slope.

Erosion at the footpath on the WS slope. Fall 2021

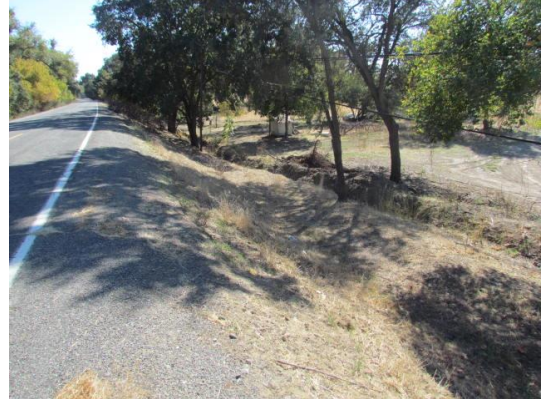
Photo 1 of 1 : FA_2021_RD0765_211_51_20210823_00023.jpg

Looking southwest at irrigation ditch on landward toe.

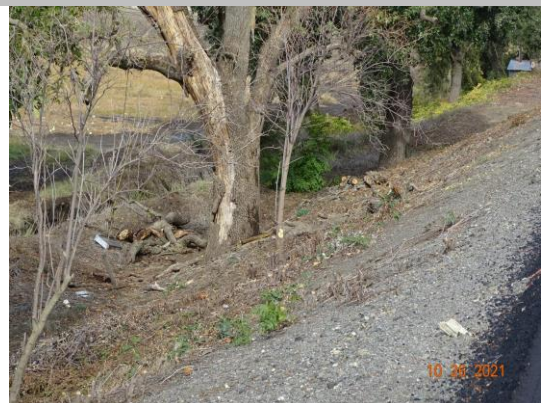
Photo 1 of 1 : FA_2021_RD0765_211_21_20211027_00048.jpg

Wood/prunings pile in the WS easement. Fall 2021

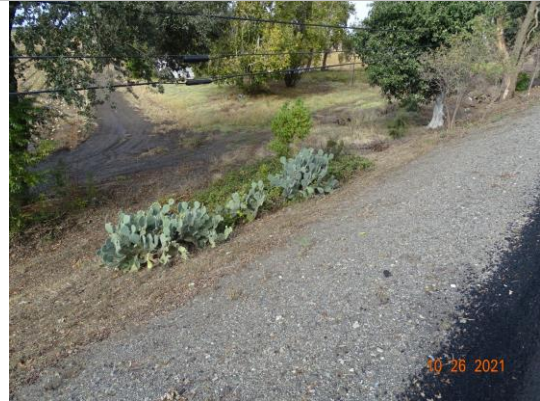
Photo 1 of 1 : FA_2021_RD0765_211_19_20211027_00049.jpg

Cactus on the LS slope. Fall 2021

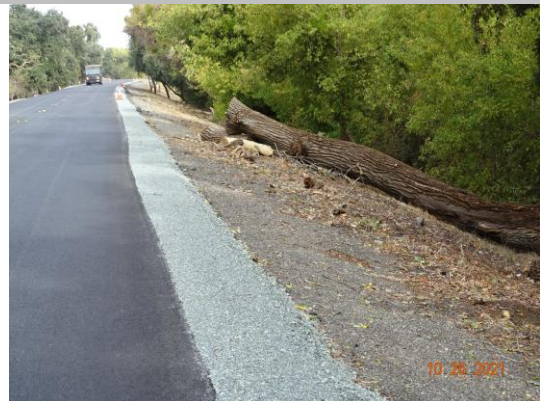
Photo 1 of 1 : FA_2021_RD0765_211_14_20211027_00050.jpg

Fallen tree log within 20' of the WS crown. Fall 2021

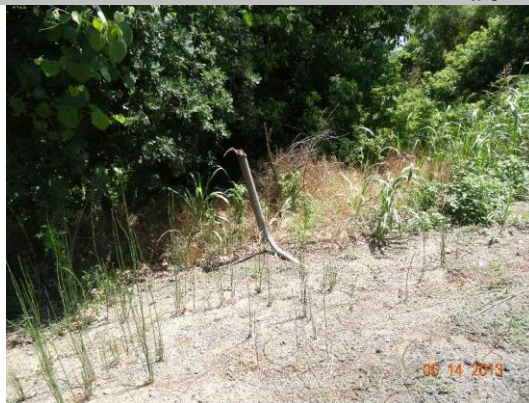
Photo 3 of 3 : UCIP_FA_2021_44407_73020.jpg

Conduits disconnected and damaged on waterward side.

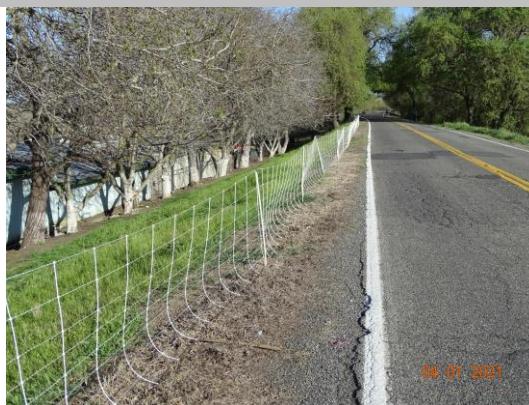
Photo 1 of 1 : FA_2021_RD0765_211_54_20210823_00025.jpg

LM Start	1.16	Rating **	M	Issue No.	54
LM End	1.26	Issue Type +	En	Location *	LS
Category	Earthen Levee			GPS Latitude/Longitude	
				Start	End
Item	Encroachments			38.487348 °	38.485984 °
				-121.554044 °	-121.553202 °
DWR ID	DWR_RD0765_01_s_2015_54				
Comment Code					
FE : Fence					
Inspector Comment					
The landowner installed a temporary fence on the landside shoulder and slope.

View of the fence on the LS levee shoulder. Spring 2021.

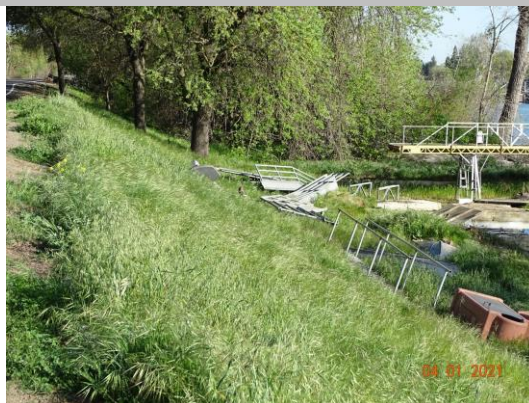
Photo 1 of 1 : FA_2021_RD0765_211_16_20210823_00008.jpg

LM Start	1.18	Rating **	M	Issue No.	16
LM End	1.18	Issue Type +	En	Location *	WS
Category	Earthen Levee			GPS Latitude/Longitude	
				Start	End
Item	Encroachments			38.487142 °	38.487142 °
				-121.553877 °	-121.553877 °
DWR ID	DWR_RD0765_01_s_2020_16				
Comment Code					
EQ : Equipment					
Inspector Comment					
Instruct the landowner to remove equipment from the WS slope.

View of the equipment on the WS levee slope. Spring 2021.

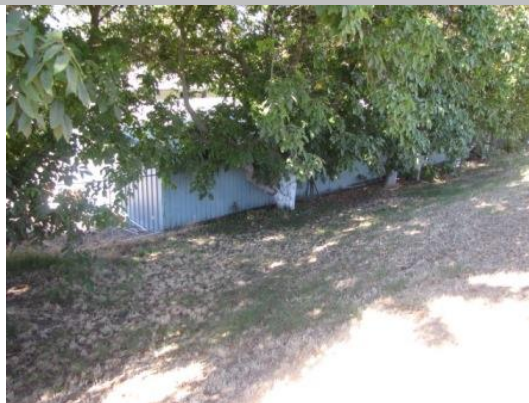
Photo 1 of 1 : FA_2021_RD0765_211_43_20210823_00021.jpg

Looking northwest at buildings along landside toe.

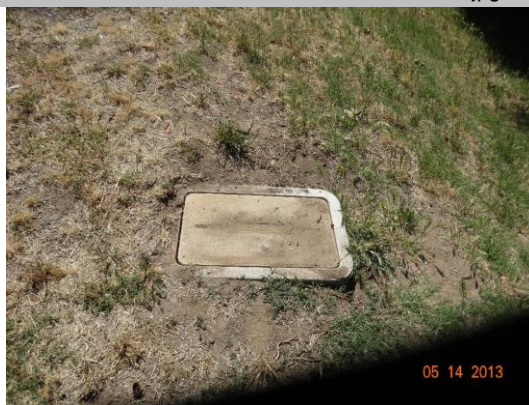
Photo 1 of 2 : UCIP_FA_2021_43203_71214.jpg

LM Start	1.20	Rating **	M	Issue No.	72	
LM End	1.20	Issue Type +	En	Location *		
Category	Supplemental			GPS Latitude/Longitude		
				Start	End	
Item	DWR UCIP Field Study			38.486830 °	38.486830 °	
				-121.553698 °	-121.553698 °	
DWR ID	24660					
Comment Code						
Inspector Comment						
DS_ID:24660						
FS_ID:43203						
EP_NO: N/A						
Repair Type: Non-Urgent						
EVAL Issue:						
Crossing Status: Indicator Found						
UCIP Comments: Unable to confirm details of crossing. Need to contact owner to determine additional details about crossing and permit issued.						
FIELD_STRUCT_DESC: PG&E utility service box located on the landside shoulder.						
FS Date: 5/14/2013

Utility box located on landward side.

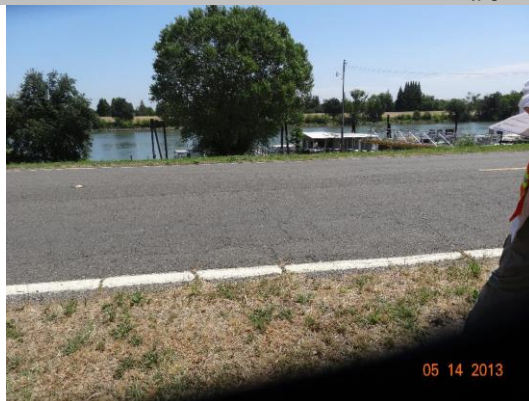
Photo 2 of 2 : UCIP_FA_2021_43203_71213.jpg

View of levee crown and waterward side.

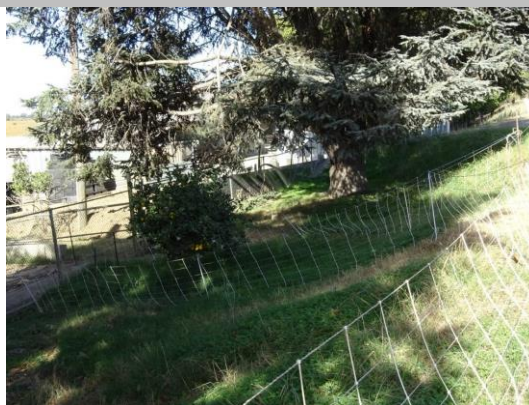
Photo 1 of 1 : FA_2021_RD0765_211_32_20210823_00016.jpg

View of citrus tree within levee easement. Fall 2018

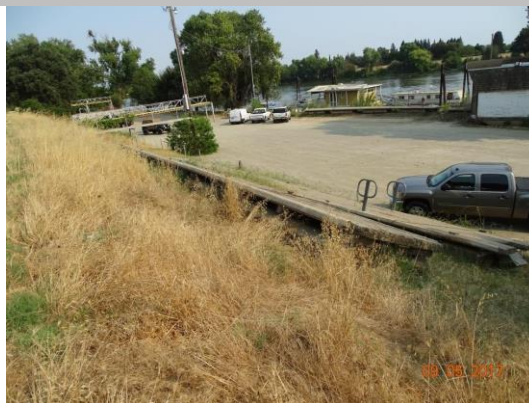
Photo 1 of 1 : FA_2021_RD0765_211_2_20210823_00002.jpg

Looking north at the waterside slope. Fall 2017

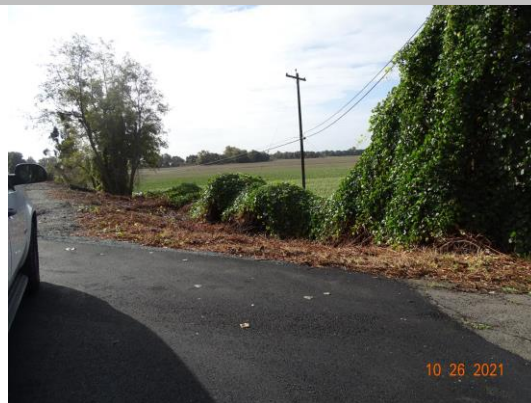
Photo 1 of 1 : FA_2021_RD0765_211_15_20211027_00051.jpg

Ivy growth on the LS slope. Fall 2021

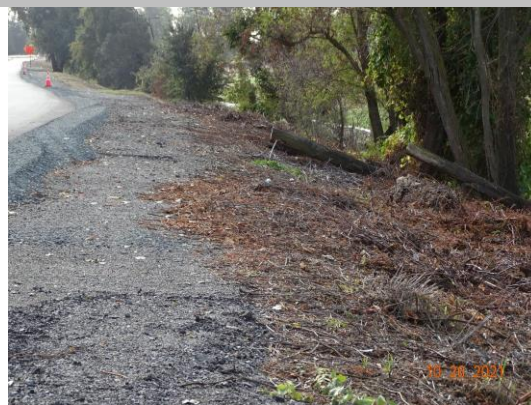
Photo 1 of 1 : FA_2021_RD0765_211_26_20211027_00052.jpg

Tree logs on the LS slope. Fall 2021

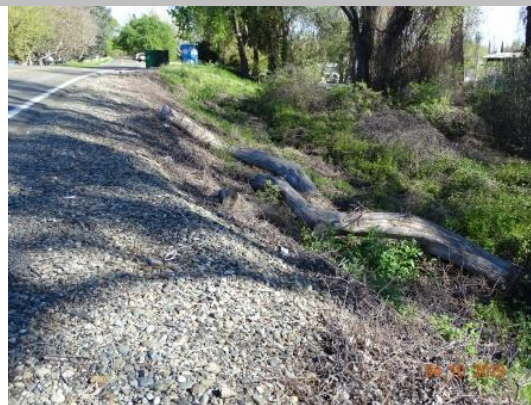
Photo 1 of 1 : FA_2021_RD0765_211_20_20210823_00010.jpg

View looking upstream at fallen tree on levee slope. Spring 2019

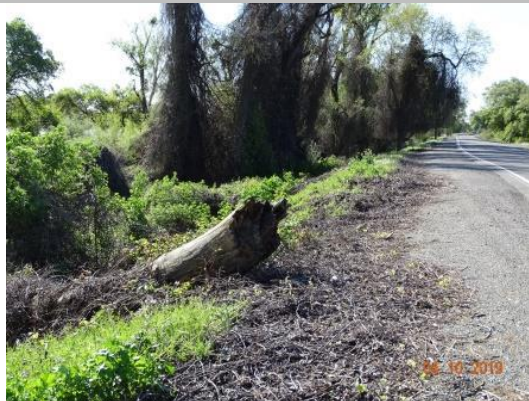
Photo 1 of 1 : FA_2021_RD0765_211_7_20210823_00003.jpg

View looking downstream at tree log on levee slope. Spring 2019

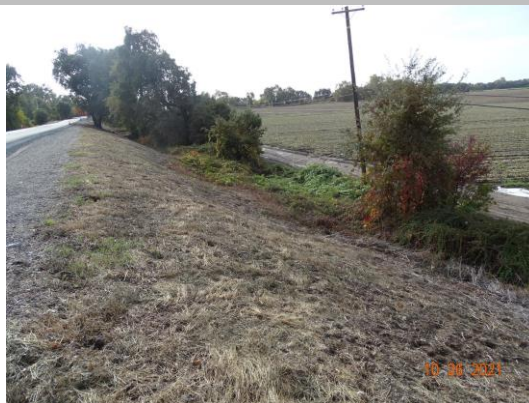
Photo 1 of 1 : FA_2021_RD0765_211_33_20211027_00053.jpg

Berry growth on the LS toe. Fall 2021

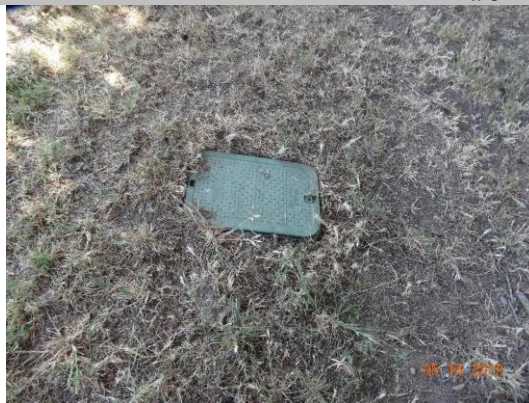
Photo 1 of 1 : UCIP_FA_2021_39022_71212.jpg

LM Start	1.37	Rating **	M	Issue No.	73	
LM End	1.37	Issue Type +	En	Location *		
Category	Supplemental			GPS Latitude/Longitude		
				Start	End	
Item	DWR UCIP Field Study			38.484656 °	38.484656 °	
				-121.552362 °	-121.552362 °	
DWR ID	24661					
Comment Code						
Inspector Comment						
DS_ID:24661						
FS_ID:39022						
EP_NO: N/A						
Repair Type: Non-Urgent						
EVAL Issue:						
Crossing Status: Indicator Found						
UCIP Comments: Need to contact owner to determine if crossing goes through levee.						
FIELD_STRUCT_DESC: 3-inch irrigation line through levee at unknown depth. Service box located on landside (LS) shoulder.						
FS Date: 5/14/2013

Utility box located on landward shoulder.

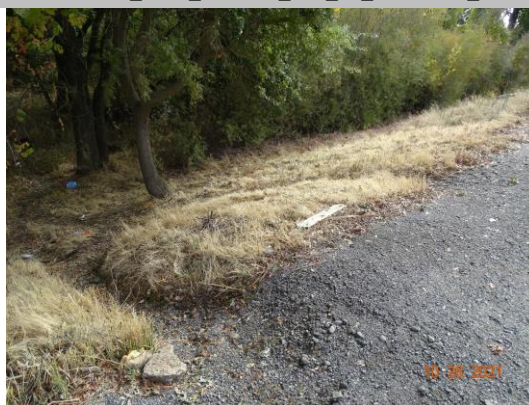
Photo 1 of 1 : FA_2021_RD0765_211_10_20211027_00054.jpg

LM Start	1.42	Rating **	A/W	Issue No.	10
LM End	1.42	Issue Type +	Ma	Location *	WS
Category	Earthen Levee			GPS Latitude/Longitude	
				Start	End
Item	Slope Stability			38.483973 °	38.483973 °
				-121.551855 °	-121.551855 °
DWR ID	DWR_RD0765_01_f_2021_10				
Comment Code					
S2 : Repair the levee slope damaged by foot traffic and prevent access where possible.					
Inspector Comment					
Monitor two footpaths for erosion.

Footpaths on the WS slope. Fall 2021

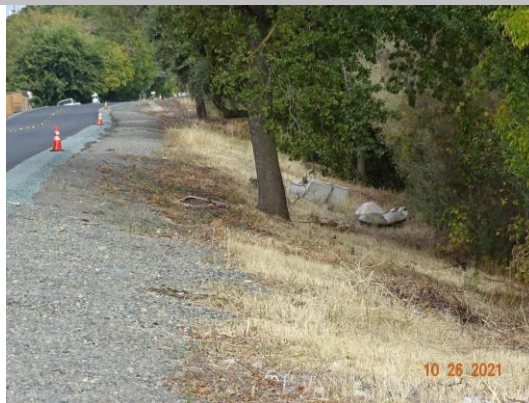
Photo 1 of 1 : FA_2021_RD0765_211_67_20211027_00055.jpg

Sofas on the WS slope. Fall 2021

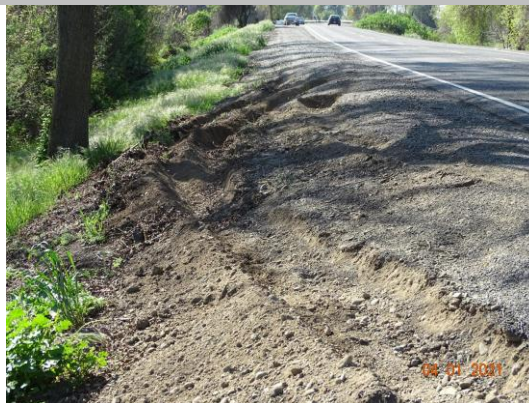
Photo 1 of 1 : FA_2021_RD0765_211_41_20210823_00019.jpg

LM Start	1.45	Rating **	M	Issue No.	41
LM End	1.45	Issue Type +	Ma	Location *	WS
Category	Earthen Levee			GPS Latitude/Longitude	
				Start	End
Item	Slope Stability			38.483609 °	38.483609 °
				-121.551628 °	-121.551628 °
DWR ID	DWR_RD0765_01_s_2021_41				
Comment Code					
S3 : Repair the levee slope damaged by vehicle traffic and prevent access where possible.					
Inspector Comment					
Repair rutting on the WS slope.

View of the WS levee slope damaged by vehicle traffic. Spring 2021.

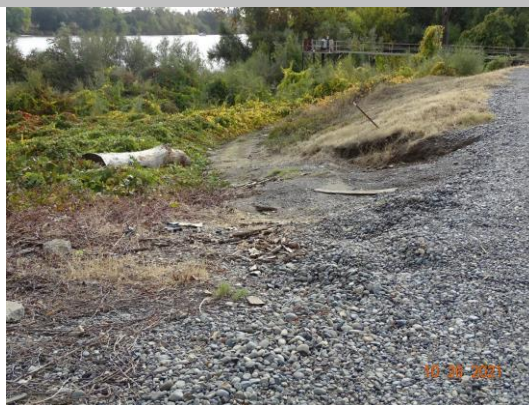
Photo 1 of 1 : FA_2021_RD0765_211_31_20211027_00056.jpg

LM Start	1.51	Rating **	M	Issue No.	31
LM End	1.51	Issue Type +	Ma	Location *	WS
Category	Earthen Levee			GPS Latitude/Longitude	
				Start	End
Item	Slope Stability			38.482788 °	38.482788 °
				-121.551048 °	-121.551048 °
DWR ID	DWR_RD0765_01_f_2019_31				
Comment Code					
S3 : Repair the levee slope damaged by vehicle traffic and prevent access where possible.					
Inspector Comment					
Repair slope damage caused by vehicle traffic.

Erosion and rutting from vehicle traffic on the WS slope. Fall 2021

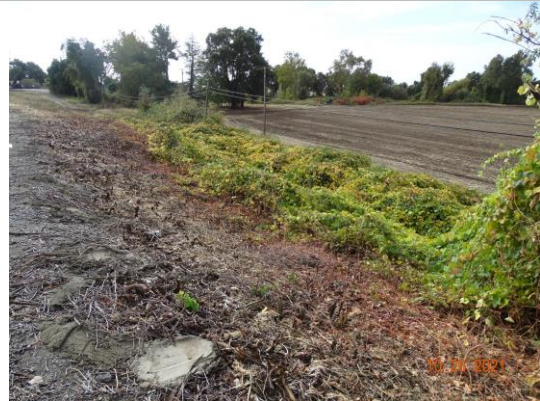
Photo 1 of 1 : FA_2021_RD0765_211_60_20211027_00057.jpg

View of the overgrown ditch along the LS levee toe. Fall 2021

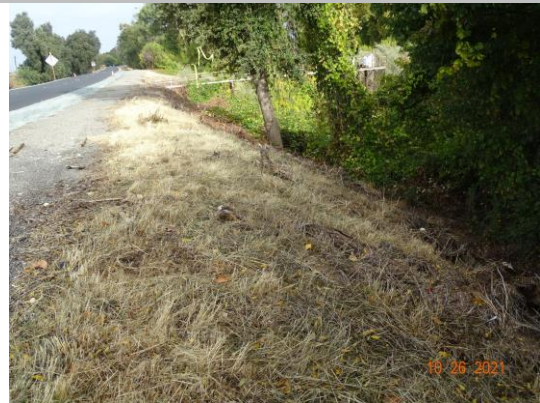
Photo 1 of 1 : FA_2021_RD0765_211_1_20211027_00058.jpg

Decaying logs within 20' of the WS crown. Fall 2021
