**Flood Control Project Maintenance
Levee Inspections
Fall 2022 Levee Maintenance Deficiency Summary Report**

Sacramento River Basin

Reclamation District No. 0765 Glide

Levee Inspection Report By Mile - Fall 2022

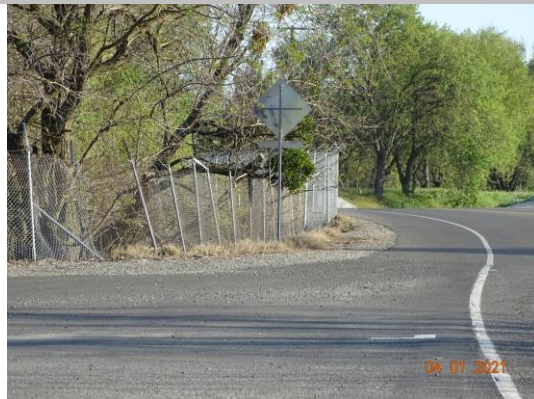
Photo 1 of 1 : FA_2022_RD0765_211_12_20220822_00004.jpg

LM Start	0.00	Rating **	M	Issue No.	12
LM End	0.08	Issue Type +	En	Location *	LS
Category	Earthen Levee			GPS Latitude/Longitude	
				Start	End
Item	Encroachments			38.502962 °	38.501772 °
				-121.560112 °	-121.560250 °
DWR ID	DWR_RD0765_01_s_2020_12				
Comment Code					
FE : Fence					
Inspector Comment					
Fence prevents access on the landside slope.

View of the fence on the LS levee slope. Spring 2021.

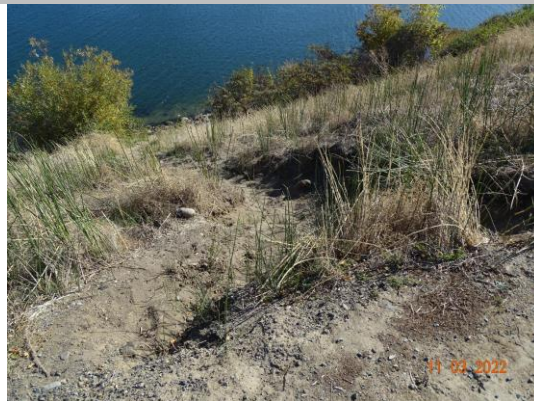
Photo 1 of 1 : FA_2022_RD0765_211_20_20221103_00030.jpg

LM Start	0.02	Rating **	U	Issue No.	20
LM End	0.02	Issue Type +	Ma	Location *	WS
Category	Earthen Levee			GPS Latitude/Longitude	
				Start	End
Item	Erosion / Foot Traffic			38.502711 °	38.502711 °
				-121.560019 °	-121.560019 °
DWR ID	DWR_RD0765_01_f_2022_20				
Comment Code					
E3 : Repair the levee slope damaged by foot traffic and prevent access where possible.					
Inspector Comment					
Repair erosion caused by foot traffic.

Footpath on the WS slope. Fall 2022

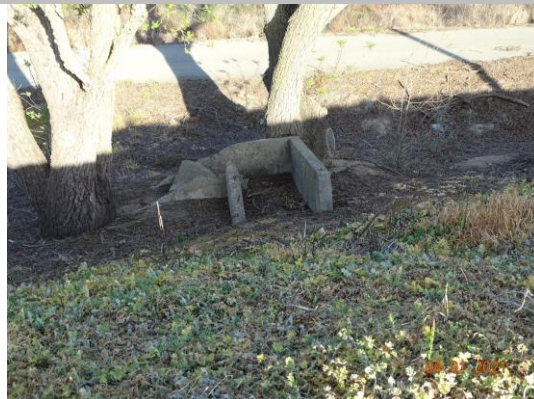
Photo 1 of 1 : FA_2022_RD0765_211_11_20220822_00003.jpg

LM Start	0.11	Rating **	M	Issue No.	11
LM End	0.11	Issue Type +	En	Location *	LS
Category	Earthen Levee			GPS Latitude/Longitude	
				Start	End
Item	Encroachments			38.501423 °	38.501423 °
				-121.560409 °	-121.560409 °
DWR ID	DWR_RD0765_01_s_2021_11				
Comment Code					
DE : Debris					
Inspector Comment					
Remove concrete debris on the LS levee toe.

View of the concrete debris on the LS levee toe. Spring 2021.

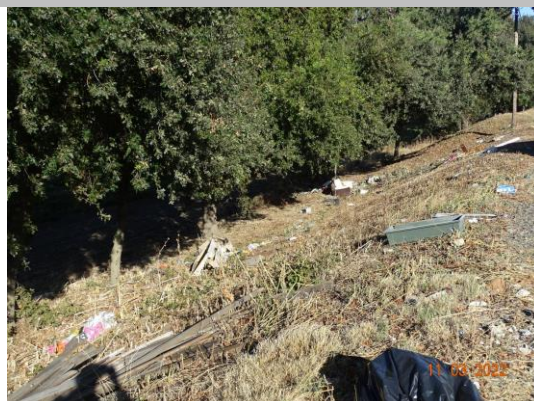
Photo 1 of 1 : FA_2022_RD0765_211_34_20221103_00031.jpg

LM Start	0.29	Rating **	M	Issue No.	34
LM End	0.29	Issue Type +	Ma	Location *	LS
Category	Earthen Levee			GPS Latitude/Longitude	
				Start	End
Item	Encroachments			38.498798 °	38.498798 °
				-121.560501 °	-121.560501 °
DWR ID	DWR_RD0765_01_f_2020_34				
Comment Code					
DE : Debris					
Inspector Comment					
Clean up debris at illegal dumping site.

Debris on LS slope. Fall 2022

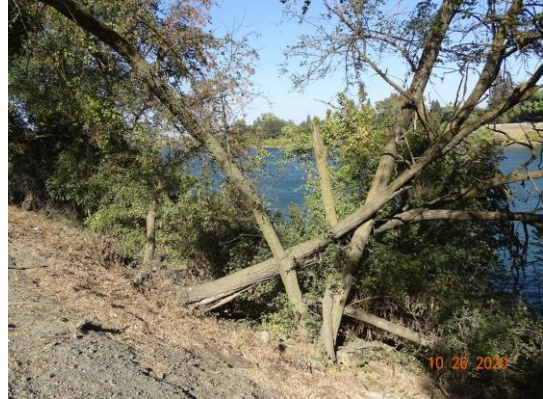
Photo 1 of 1 : FA_2022_RD0765_211_36_20220822_00018.jpg

LM Start	0.51	Rating **	M	Issue No.	36
LM End	0.51	Issue Type +	Ma	Location *	WS
Category	Earthen Levee			GPS Latitude/Longitude	
				Start	End
Item	Trim / Thin Trees			38.495748 °	38.495748 °
				-121.559525 °	-121.559525 °
DWR ID	DWR_RD0765_01_f _ 2020_36				
Comment Code					
T3 : Fallen tree with root ball.					
Inspector Comment					
Fallen tree with exposed rootball.

View of fallen tree with exposed rootball on the waterside slope. Fall 2020

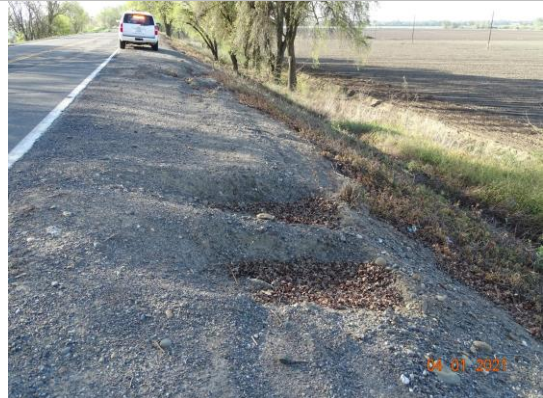
Photo 1 of 1 : FA_2022_RD0765_211_68_20220822_00027.jpg

LM Start	0.75	Rating **	M	Issue No.	68
LM End	0.75	Issue Type +	Ma	Location *	LS
Category	Earthen Levee			GPS Latitude/Longitude	
				Start	End
Item	Erosion / Vehicle Traffic			38.492705 °	38.492705 °
				-121.557193 °	-121.557193 °
DWR ID	DWR_RD0765_01_s_2017_68				
Comment Code					
E6 : Repair the levee slope damaged by vehicle traffic and prevent access where possible.					
Inspector Comment					
Repair tire rut damage on the LS shoulder.

View of the LS levee shoulder damaged by vehicle traffic. Spring 2021.

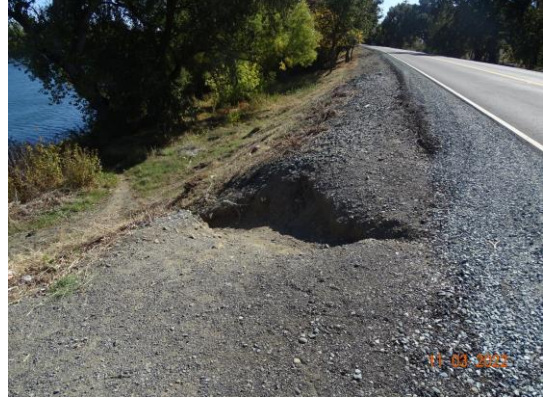
Photo 1 of 1 : FA_2022_RD0765_211_24_20221103_00029.jpg

LM Start	0.94	Rating **	U	Issue No.	24
LM End	0.94	Issue Type +	Ma	Location *	WS
Category	Earthen Levee			GPS Latitude/Longitude	
				Start	End
Item	Erosion / Foot Traffic			38.490265 °	38.490265 °
				-121.555617 °	-121.555617 °
DWR ID	DWR_RD0765_01_s_2019_24				
Comment Code					
E3 : Repair the levee slope damaged by foot traffic and prevent access where possible.					
Inspector Comment					
Erosion and footpath on the WS slope need to be repaired.

Erosion on the WS footpath. Fall 2022

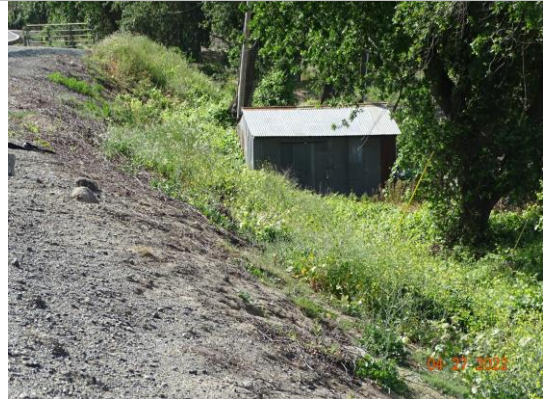
Photo 1 of 1 : FA_2022_RD0765_211_40_20220822_00021.jpg

LM Start	0.94	Rating **	M	Issue No.	40
LM End	0.94	Issue Type +	En	Location *	LS
Category	Earthen Levee			GPS Latitude/Longitude	
				Start	End
Item	Encroachments			38.490206 °	38.490206 °
				-121.555677 °	-121.555677 °
DWR ID	DWR_RD0765_01_s_2022_40				
Comment Code					
BU : Building					
Inspector Comment					
Building in the easement blocks access and visibility.

Building in the landside easement. Spring 2022

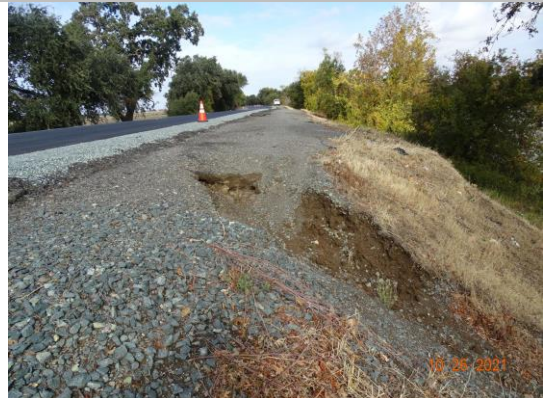
Photo 1 of 1 : FA_2022_RD0765_211_23_20220822_00010.jpg

LM Start	0.95	Rating **	U	Issue No.	23
LM End	0.95	Issue Type +	Ma	Location *	WS
Category	Earthen Levee			GPS Latitude/Longitude	
				Start	End
Item	Erosion / Foot Traffic			38.490067 °	38.490067 °
				-121.555530 °	-121.555530 °
DWR ID	DWR_RD0765_01_s_2019_23				
Comment Code					
E3 : Repair the levee slope damaged by foot traffic and prevent access where possible.					
Inspector Comment					
Repair the erosion at the footpath on the WS slope.

Erosion at the footpath on the WS slope. Fall 2021

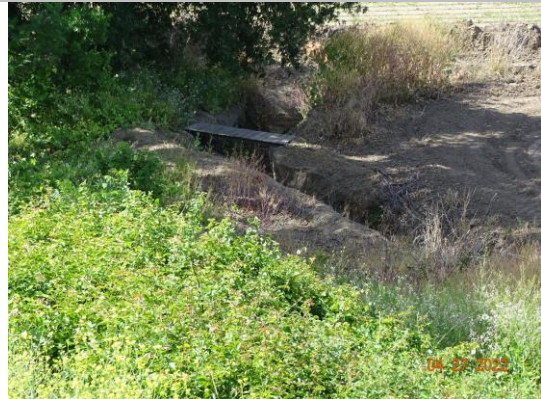
Photo 1 of 1 : FA_2022_RD0765_211_51_20220822_00023.jpg

LM Start	0.96	Rating **	M	Issue No.	51
LM End	1.02	Issue Type +	En	Location *	LS
Category	Earthen Levee			GPS Latitude/Longitude	
				Start	End
Item	Encroachments			38.489949 °	38.489230 °
				-121.555544 °	-121.555168 °
DWR ID	DWR_RD0765_01_s_2013_51				
Comment Code					
DT : Ditch					
Inspector Comment					
This ditch has been in place for several years. Most of the ditch appears to be outside the 15 foot right-of-way.

Ditch near the landside toe. Spring 2022

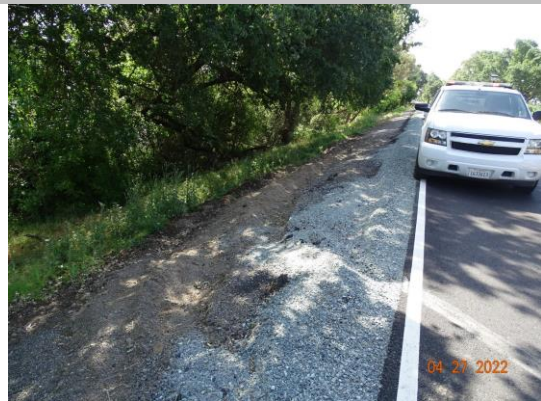
Photo 1 of 1 : FA_2022_RD0765_211_35_20220822_00017.jpg

LM Start	0.99	Rating **	M	Issue No.	35
LM End	0.99	Issue Type +	Ma	Location *	WS
Category	Earthen Levee			GPS Latitude/Longitude	
				Start	End
Item	Erosion / Vehicle Traffic			38.489574 °	38.489574 °
				-121.555308 °	-121.555308 °
DWR ID	DWR_RD0765_01_s_2022_35				
Comment Code					
E6 : Repair the levee slope damaged by vehicle traffic and prevent access where possible.					
Inspector Comment					
Repair rutting on the waterside shoulder.

Rutting on the waterside shoulder. Spring 2022

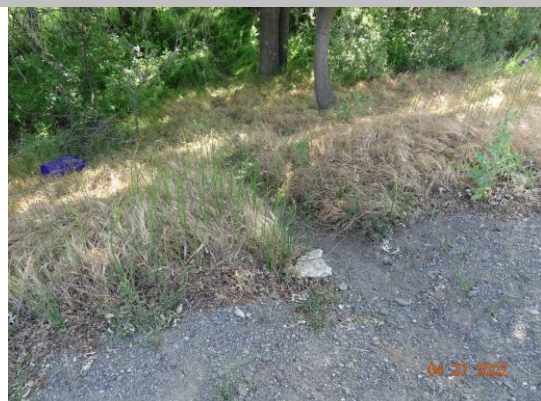
Photo 1 of 1 : FA_2022_RD0765_211_30_20220822_00013.jpg

LM Start	1.00	Rating **	A/W	Issue No.	30
LM End	1.00	Issue Type +	Ma	Location *	WS
Category	Earthen Levee			GPS Latitude/Longitude	
				Start	End
Item	Erosion / Foot Traffic			38.489503 °	38.489503 °
				-121.555272 °	-121.555272 °
DWR ID	DWR_RD0765_01_s_2022_30				
Comment Code					
E3 : Repair the levee slope damaged by foot traffic and prevent access where possible.					
Inspector Comment					
Monitor footpath for further erosion.

Footpath on the waterside slope. Spring 2022

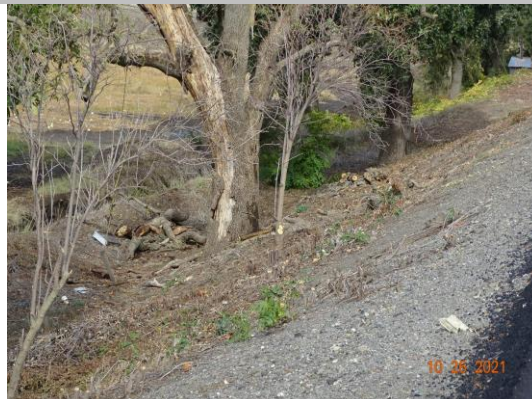
Photo 1 of 1 : FA_2022_RD0765_211_21_20220822_00008.jpg

LM Start	1.02	Rating **	M	Issue No.	21
LM End	1.02	Issue Type +	En	Location *	LS
Category	Earthen Levee			GPS Latitude/Longitude	
				Start	End
Item	Encroachments			38.489187 °	38.489187 °
				-121.555110 °	-121.555110 °
DWR ID	DWR_RD0765_01_f_2021_21				
Comment Code					
FW : Firewood					
Inspector Comment					
Remove wood pile from LS slope.

Wood/prunings pile in the LS easement. Fall 2021

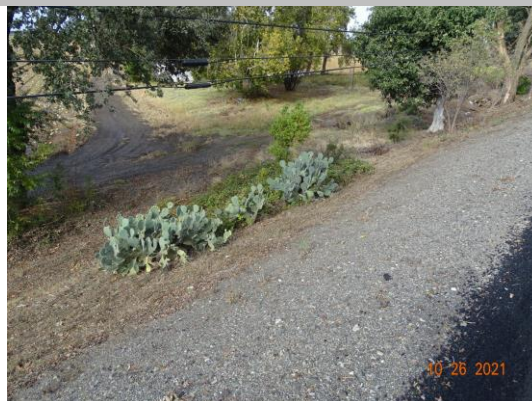
Photo 1 of 1 : FA_2022_RD0765_211_19_20220822_00007.jpg

LM Start	1.03	Rating **	M	Issue No.	19
LM End	1.03	Issue Type +	En	Location *	LS
Category	Earthen Levee			GPS Latitude/Longitude	
				Start	End
Item	Vegetation			38.489011 °	38.489011 °
				-121.554990 °	-121.554990 °
DWR ID	DWR_RD0765_01_f_2021_19				
Comment Code					
V6 : Landscaping					
Inspector Comment					
Remove cactus from LS slope.

Cactus on the LS slope. Fall 2021

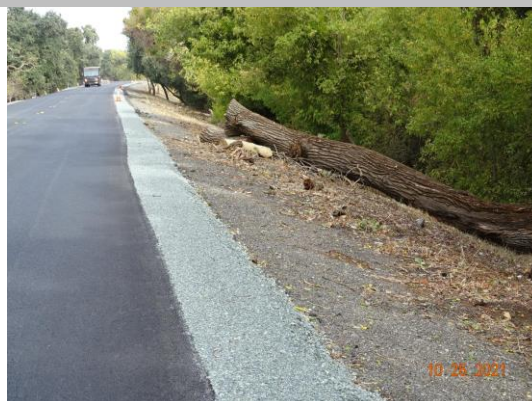
Photo 1 of 1 : FA_2022_RD0765_211_14_20220822_00005.jpg

LM Start	1.08	Rating **	M	Issue No.	14
LM End	1.08	Issue Type +	Ma	Location *	WS
Category	Earthen Levee			GPS Latitude/Longitude	
				Start	End
Item	Trim / Thin Trees			38.488401 °	38.488401 °
				-121.554658 °	-121.554658 °
DWR ID	DWR_RD0765_01_f_2021_14				
Comment Code					
T2 : Tree or limb.					
Inspector Comment					
Remove fallen tree from with 20' of the crown.

Fallen tree log within 20 of the WS crown. Fall 2021

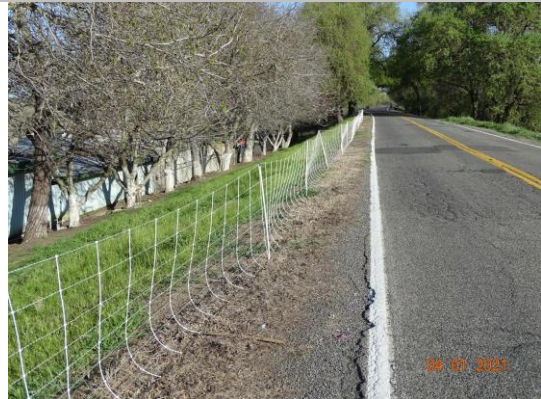
Photo 1 of 1 : FA_2022_RD0765_211_54_20220822_00024.jpg

LM Start	1.16	Rating **	M	Issue No.	54
LM End	1.26	Issue Type +	En	Location *	LS
Category	Earthen Levee			GPS Latitude/Longitude	
				Start	End
Item	Encroachments			38.487348 °	38.485984 °
				-121.554044 °	-121.553202 °
DWR ID	DWR_RD0765_01_s_2015_54				
Comment Code					
FE : Fence					
Inspector Comment					
The landowner installed a temporary fence on the landside shoulder and slope.

View of the fence on the LS levee shoulder. Spring 2021.

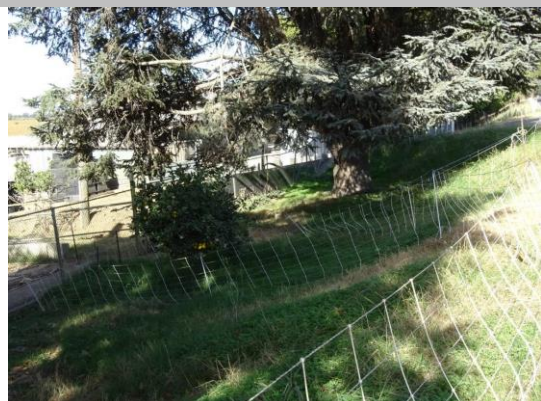
Photo 1 of 1 : FA_2022_RD0765_211_32_20220822_00015.jpg

LM Start	1.23	Rating **	M	Issue No.	32
LM End	1.23	Issue Type +	En	Location *	LS
Category	Earthen Levee			GPS Latitude/Longitude	
				Start	End
Item	Encroachments			38.486403 °	38.486403 °
				-121.553437 °	-121.553437 °
DWR ID	DWR_RD0765_01_f_2018_32				
Comment Code					
CR : Crops					
Inspector Comment					
Citrus tree is unpermitted within the levee easement.

View of citrus tree within levee easement. Fall 2018

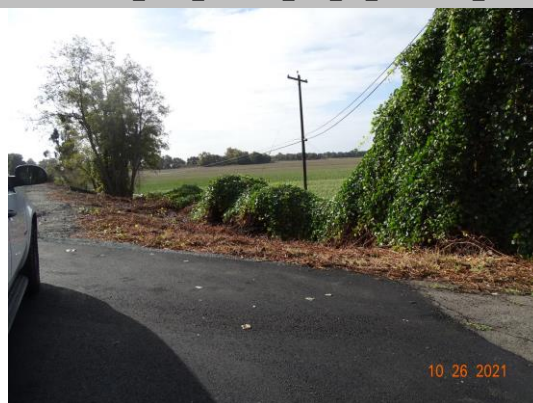
Photo 1 of 1 : FA_2022_RD0765_211_15_20220822_00006.jpg

LM Start	1.29	Rating **	M	Issue No.	15
LM End	1.30	Issue Type +	Ma	Location *	LS
Category	Earthen Levee			GPS Latitude/Longitude	
				Start	End
Item	Vegetation			38.485644 °	38.485445 °
				-121.553128 °	-121.553014 °
DWR ID	DWR_RD0765_01_s_2019_15				
Comment Code					
V2 : Remove the wild growth and woody vegetation other than native grasses from the levee slopes.					
Inspector Comment					
Remove wild vines and growth on the LS slope.

Ivy growth on the LS slope. Fall 2021

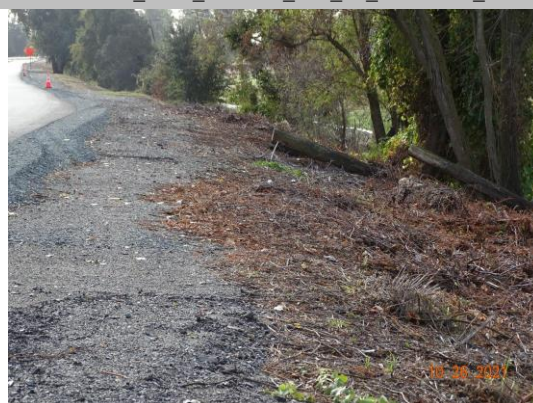
Photo 1 of 1 : FA_2022_RD0765_211_26_20220822_00012.jpg

LM Start	1.31	Rating **	M	Issue No.	26
LM End	1.31	Issue Type +	En	Location *	LS
Category	Earthen Levee			GPS Latitude/Longitude	
				Start	End
Item	Trim / Thin Trees			38.485387 °	38.485387 °
				-121.552975 °	-121.552975 °
DWR ID	DWR_RD0765_01_s_2021_26				
Comment Code					
T2 : Tree or limb.					
Inspector Comment					
Remove the cut trees from the LS levee slope.

Tree logs on the LS slope. Fall 2021

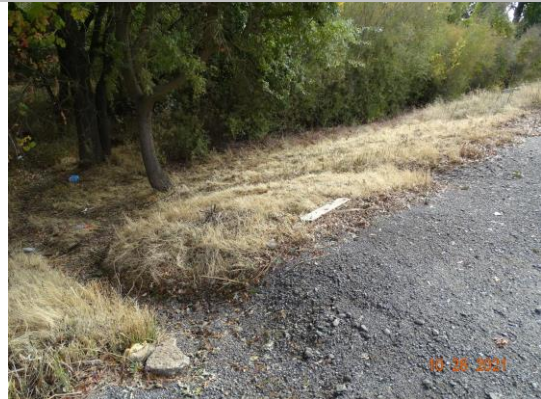
Photo 1 of 1 : FA_2022_RD0765_211_10_20220822_00002.jpg

LM Start	1.42	Rating **	A/W	Issue No.	10
LM End	1.42	Issue Type +	Ma	Location *	WS
Category	Earthen Levee			GPS Latitude/Longitude	
				Start	End
Item	Erosion / Foot Traffic			38.483973 °	38.483973 °
				-121.551855 °	-121.551855 °
DWR ID	DWR_RD0765_01_f_2021_10				
Comment Code					
E3 : Repair the levee slope damaged by foot traffic and prevent access where possible.					
Inspector Comment					
Monitor two footpaths for erosion.

Footpaths on the WS slope. Fall 2021

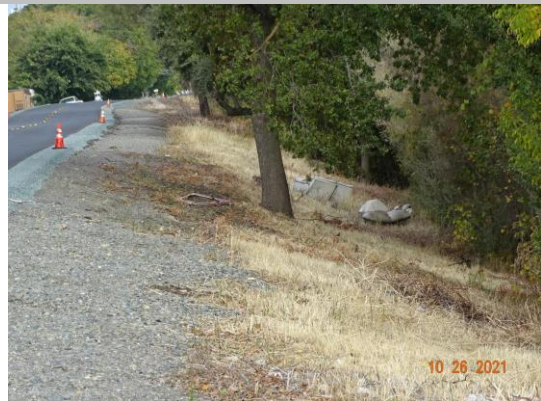
Photo 1 of 1 : FA_2022_RD0765_211_67_20220822_00026.jpg

LM Start	1.43	Rating **	M	Issue No.	67
LM End	1.43	Issue Type +	Ma	Location *	WS
Category	Earthen Levee			GPS Latitude/Longitude	
				Start	End
Item	Encroachments			38.483810 °	38.483810 °
				-121.551747 °	-121.551747 °
DWR ID	DWR_RD0765_01_s_2017_67				
Comment Code					
GA : Garbage					
Inspector Comment					
Remove sofas dumped on waterside slope.

Sofas on the WS slope. Fall 2021

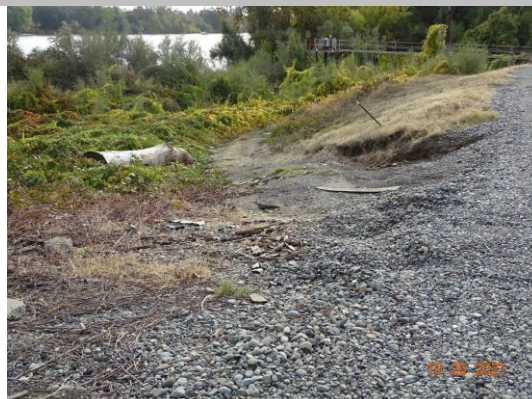
Photo 1 of 1 : FA_2022_RD0765_211_31_20220822_00014.jpg

LM Start	1.51	Rating **	M	Issue No.	31
LM End	1.51	Issue Type +	Ma	Location *	WS
Category	Earthen Levee			GPS Latitude/Longitude	
				Start	End
Item	Erosion / Vehicle Traffic			38.482788 °	38.482788 °
				-121.551048 °	-121.551048 °
DWR ID	DWR_RD0765_01_f_2019_31				
Comment Code					
E6 : Repair the levee slope damaged by vehicle traffic and prevent access where possible.					
Inspector Comment					
Repair slope damage caused by vehicle traffic.

Erosion and rutting from vehicle traffic on the WS slope. Fall 2021

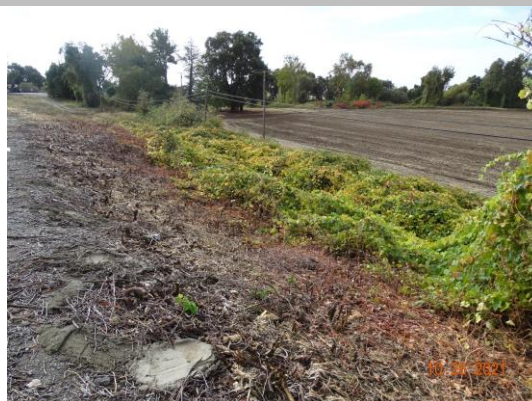
Photo 1 of 1 : FA_2022_RD0765_211_60_20220822_00025.jpg

LM Start	1.55	Rating **	U	Issue No.	60
LM End	1.61	Issue Type +	En	Location *	LS
Category	Earthen Levee			GPS Latitude/Longitude	
				Start	End
Item	Encroachments			38.482300 °	38.481482 °
				-121.550808 °	-121.550283 °
DWR ID	DWR_RD0765_01_f_2013_60				
Comment Code					
DT : Ditch					
Inspector Comment					
An old irrigation ditch located at the landside toe is covered with wild growth.

View of the overgrown ditch along the LS levee toe. Fall 2021

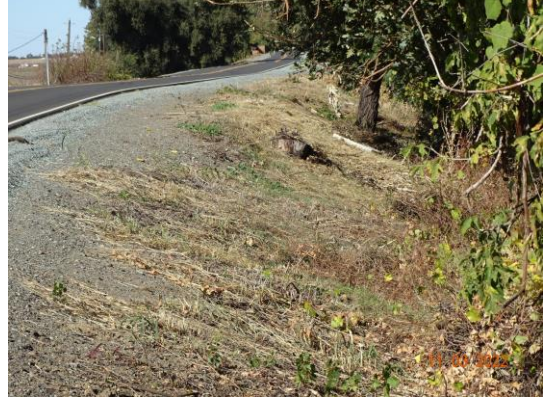
Photo 1 of 1 : FA_2022_RD0765_211_9_20221103_00028.jpg

LM Start	1.61	Rating **	N	Issue No.	9
LM End	1.61	Issue Type +	Ma	Location *	WS
Category	Earthen Levee			GPS Latitude/Longitude	
				Start	End
Item	Trim / Thin Trees			38.481560 °	38.481560 °
				-121.550295 °	-121.550295 °
DWR ID	DWR_RD0765_01_s_2020_9				
Comment Code					
T5 : Tree stumps.					
Inspector Comment					
Remove stump on the WS slope.

Tree stump on the WS slope. Fall 2022
