**Flood Control Project Maintenance
Levee Inspections
Fall 2023 Levee Maintenance Deficiency Summary Report**

Sacramento River Basin

Reclamation District No. 0765 Glide

Levee Inspection Report By Mile - Fall 2023

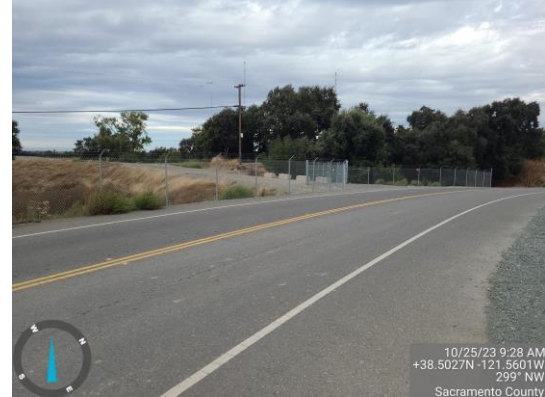
Photo 1 of 1 : FA_2023_RD0765_211_12_20231025_00025.jpg

LM Start	0.00	Rating **	M	Issue No.	12
LM End	0.08	Issue Type +	En	Location *	LS
Category	Earthen Levee			GPS Latitude/Longitude	
				Start	End
Item	Encroachments			38.502962°	38.501772°
				-121.560112°	-121.560250°
DWR ID	DWR_RD0765_01_s_2020_12				
Comment Code					
FE : Fence					
Inspector Comment					
Fence prevents access on the landside slope.

Fence on the LS shoulder. Fall 2023

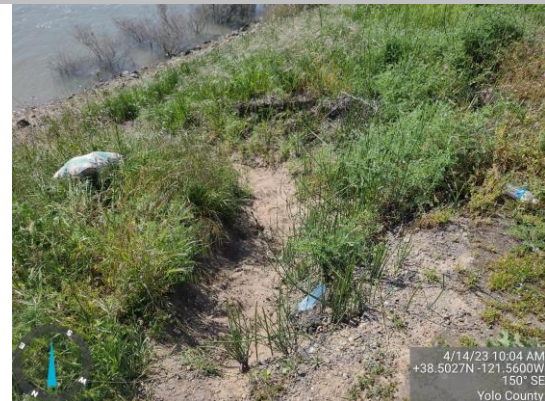
Photo 1 of 1 : FA_2023_RD0765_211_20_20230905_00013.jpg

LM Start	0.02	Rating **	U	Issue No.	20
LM End	0.02	Issue Type +	Ma	Location *	WS
Category	Earthen Levee			GPS Latitude/Longitude	
				Start	End
Item	Erosion / Foot Traffic			38.502711°	38.502711°
				-121.560019°	-121.560019°
DWR ID	DWR_RD0765_01_f _ 2023_20				
Comment Code					
E3 : Repair the levee slope damaged by foot traffic and prevent access where possible.					
Inspector Comment					
Repair erosion caused by foot traffic.

Footpath on the WS slope. Spring 2023

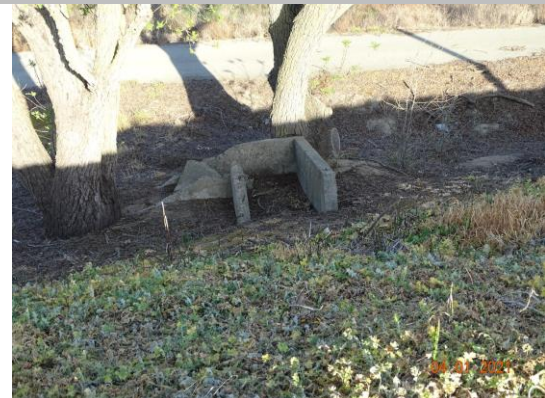
Photo 1 of 1 : FA_2023_RD0765_211_11_20230905_00009.jpg

LM Start	0.11	Rating **	M	Issue No.	11
LM End	0.11	Issue Type +	En	Location *	LS
Category	Earthen Levee			GPS Latitude/Longitude	
				Start	End
Item	Encroachments			38.501423°	38.501423°
				-121.560409°	-121.560409°
DWR ID	DWR_RD0765_01_s_2021_11				
Comment Code					
DE : Debris					
Inspector Comment					
Remove concrete on the LS levee toe.

View of the concrete debris on the LS levee toe. Spring 2021.

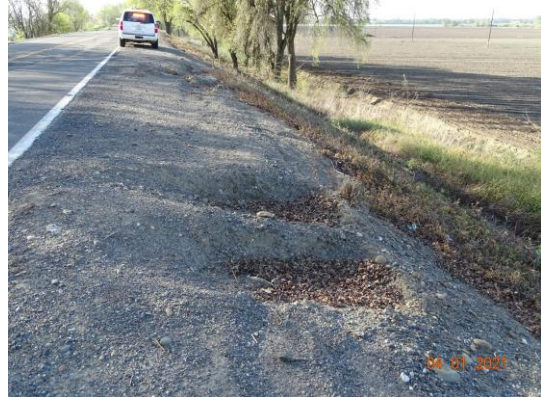
Photo 1 of 1 : FA_2023_RD0765_211_68_20230905_00024.jpg

LM Start	0.75	Rating **	M	Issue No.	68
LM End	0.75	Issue Type +	Ma	Location *	LS
Category	Earthen Levee			GPS Latitude/Longitude	
				Start	End
Item	Erosion / Vehicle Traffic			38.492705°	38.492705°
				-121.557193°	-121.557193°
DWR ID	DWR_RD0765_01_s_2017_68				
Comment Code					
E6 : Repair the levee slope damaged by vehicle traffic and prevent access where possible.					
Inspector Comment					
Repair tire rut damage on the LS shoulder.

View of the LS levee shoulder damaged by vehicle traffic. Spring 2021.

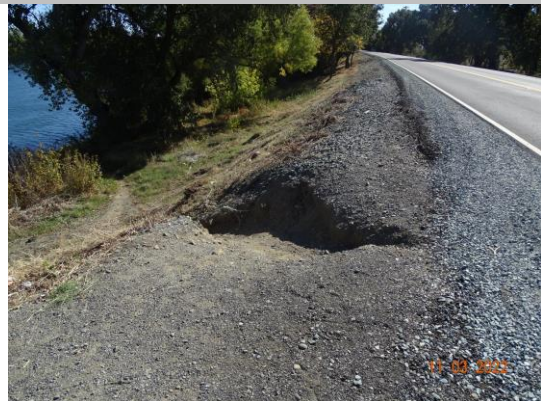
Photo 1 of 1 : FA_2023_RD0765_211_24_20230905_00016.jpg

LM Start	0.94	Rating **	U	Issue No.	24
LM End	0.94	Issue Type +	Ma	Location *	WS
Category	Earthen Levee			GPS Latitude/Longitude	
				Start	End
Item	Erosion / Foot Traffic			38.490265°	38.490265°
				-121.555617°	-121.555617°
DWR ID	DWR_RD0765_01_s_2019_24				
Comment Code					
E3 : Repair the levee slope damaged by foot traffic and prevent access where possible.					
Inspector Comment					
Erosion and footpath on the WS slope need to be repaired.

Erosion on the WS footpath. Fall 2022

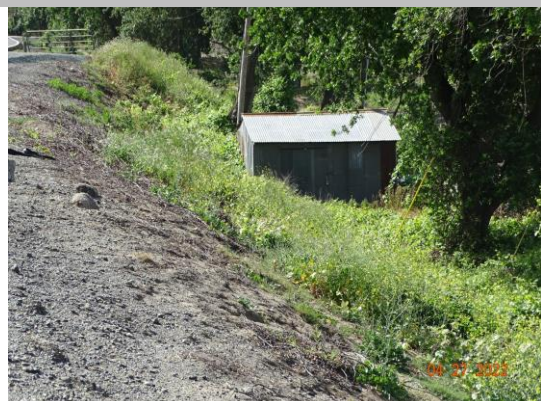
Photo 1 of 1 : FA_2023_RD0765_211_40_20230905_00020.jpg

LM Start	0.94	Rating **	M	Issue No.	40
LM End	0.94	Issue Type +	En	Location *	LS
Category	Earthen Levee			GPS Latitude/Longitude	
				Start	End
Item	Encroachments			38.490206°	38.490206°
				-121.555677°	-121.555677°
DWR ID	DWR_RD0765_01_s_2022_40				
Comment Code					
BU : Building					
Inspector Comment					
Building in the easement blocks access and visibility.

Building in the landside easement. Spring 2022

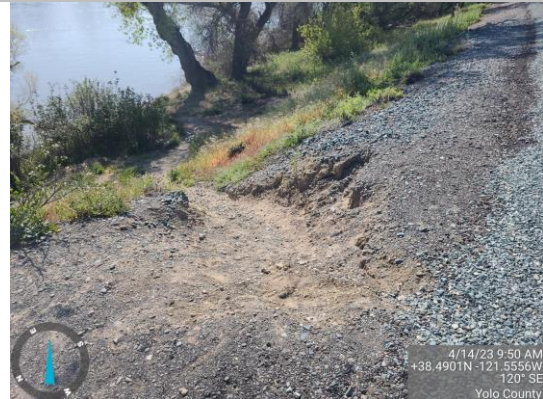
Photo 1 of 1 : FA_2023_RD0765_211_23_20230905_00015.jpg

LM Start	0.95	Rating **	U	Issue No.	23
LM End	0.95	Issue Type +	Ma	Location *	WS
Category	Earthen Levee			GPS Latitude/Longitude	
				Start	End
Item	Erosion / Foot Traffic			38.490067°	38.490067°
				-121.555530°	-121.555530°
DWR ID	DWR_RD0765_01_s_2019_23				
Comment Code					
E3 : Repair the levee slope damaged by foot traffic and prevent access where possible.					
Inspector Comment					
Repair the erosion at the footpath on the WS slope.

Erosion at the footpath on the WS slope. Spring 2023

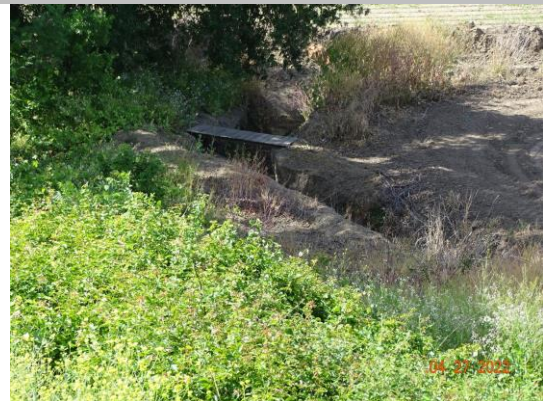
Photo 1 of 1 : FA_2023_RD0765_211_51_20230905_00021.jpg

LM Start	0.96	Rating **	M	Issue No.	51
LM End	1.02	Issue Type +	En	Location *	LS
Category	Earthen Levee			GPS Latitude/Longitude	
				Start	End
Item	Encroachments			38.489949°	38.489230°
				-121.555544°	-121.555168°
DWR ID	DWR_RD0765_01_s_2013_51				
Comment Code					
DT : Ditch					
Inspector Comment					
This ditch has been in place for several years. Most of the ditch appears to be outside the 15 foot right-of-way.

Ditch near the landside toe. Spring 2022

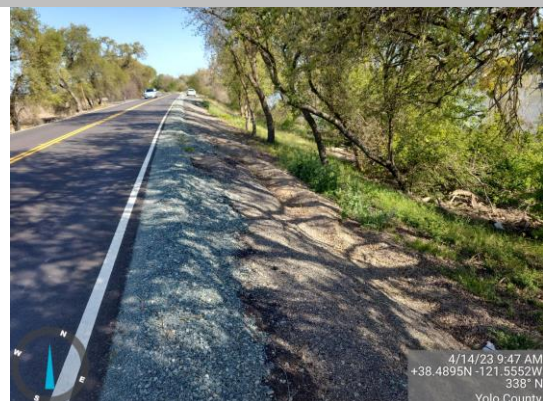
Photo 1 of 1 : FA_2023_RD0765_211_35_20230905_00019.jpg

LM Start	0.99	Rating **	M	Issue No.	35
LM End	0.99	Issue Type +	Ma	Location *	WS
Category	Earthen Levee			GPS Latitude/Longitude	
				Start	End
Item	Erosion / Vehicle Traffic			38.489574°	38.489574°
				-121.555308°	-121.555308°
DWR ID	DWR_RD0765_01_s_2022_35				
Comment Code					
E6 : Repair the levee slope damaged by vehicle traffic and prevent access where possible.					
Inspector Comment					
Repair rutting on the waterside shoulder.

Rutting on the waterside shoulder. Spring 2023

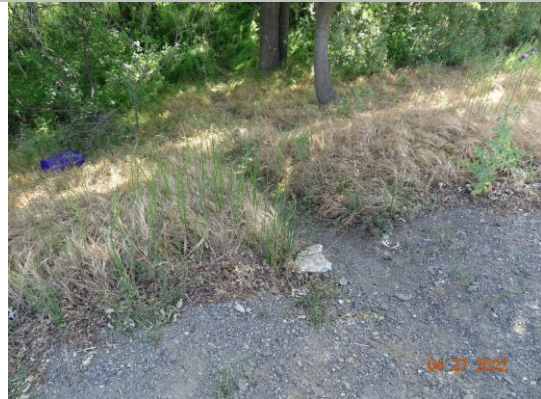
Photo 1 of 1 : FA_2023_RD0765_211_30_20230905_00017.jpg

LM Start	1.00	Rating **	A/W	Issue No.	30
LM End	1.00	Issue Type +	Ma	Location *	WS
Category	Earthen Levee			GPS Latitude/Longitude	
				Start	End
Item	Erosion / Foot Traffic			38.489503°	38.489503°
				-121.555272°	-121.555272°
DWR ID	DWR_RD0765_01_s_2022_30				
Comment Code					
E3 : Repair the levee slope damaged by foot traffic and prevent access where possible.					
Inspector Comment					
Monitor footpath for further erosion.

Footpath on the waterside slope. Spring 2022

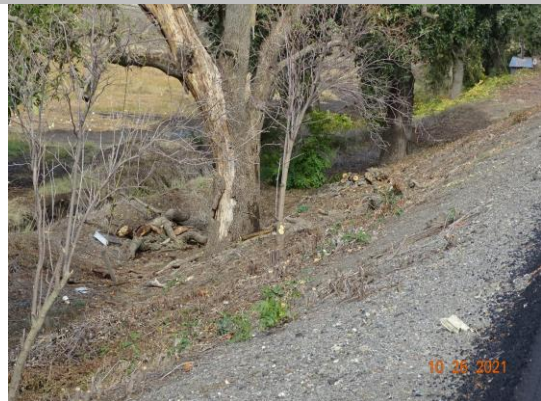
Photo 1 of 1 : FA_2023_RD0765_211_21_20230905_00014.jpg

LM Start	1.02	Rating **	M	Issue No.	21
LM End	1.02	Issue Type +	En	Location *	LS
Category	Earthen Levee			GPS Latitude/Longitude	
				Start	End
Item	Encroachments			38.489187°	38.489187°
				-121.555110°	-121.555110°
DWR ID	DWR_RD0765_01_f_2021_21				
Comment Code					
FW : Firewood					
Inspector Comment					
Remove wood pile from LS slope.

Wood/prunings pile in the LS easement. Fall 2021

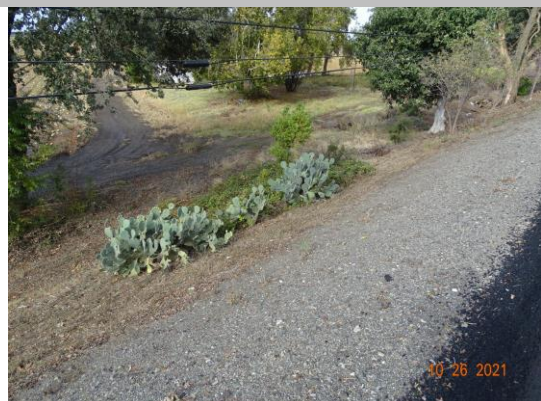
Photo 1 of 1 : FA_2023_RD0765_211_19_20230905_00012.jpg

LM Start	1.03	Rating **	M	Issue No.	19
LM End	1.03	Issue Type +	En	Location *	LS
Category	Earthen Levee			GPS Latitude/Longitude	
				Start	End
Item	Vegetation			38.489011 °	38.489011 °
				-121.554990 °	-121.554990 °
DWR ID	DWR_RD0765_01_f_2021_19				
Comment Code					
V6 : Landscaping					
Inspector Comment					
Remove cactus from LS slope.

Cactus on the LS slope. Fall 2021

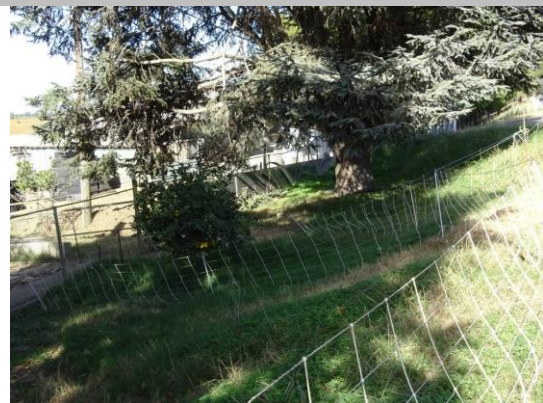
Photo 1 of 1 : FA_2023_RD0765_211_32_20230905_00018.jpg

LM Start	1.23	Rating **	M	Issue No.	32
LM End	1.23	Issue Type +	En	Location *	LS
Category	Earthen Levee			GPS Latitude/Longitude	
				Start	End
Item	Encroachments			38.486403°	38.486403°
				-121.553437°	-121.553437°
DWR ID	DWR_RD0765_01_f _ 2018_32				
Comment Code					
CR : Crops					
Inspector Comment					
Citrus tree is unpermitted within the levee easement.

View of citrus tree within levee easement. Fall 2018

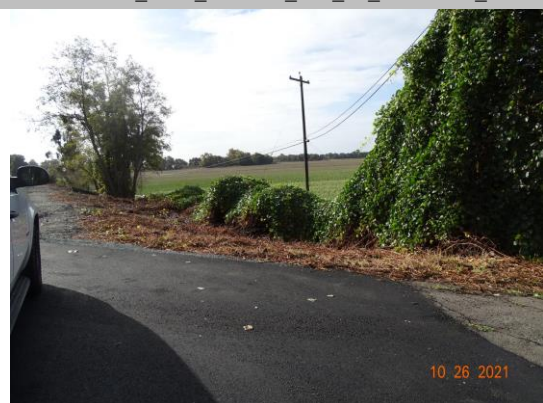
Photo 1 of 1 : FA_2023_RD0765_211_15_20230905_00011.jpg

LM Start	1.29	Rating **	U	Issue No.	15
LM End	1.30	Issue Type +	Ma	Location *	LS
Category	Earthen Levee			GPS Latitude/Longitude	
				Start	End
Item	Vegetation			38.485644°	38.485445°
				-121.553128°	-121.553014°
DWR ID	DWR_RD0765_01_s_2019_15				
Comment Code					
V2 : Remove the wild growth and woody vegetation other than native grasses from the levee slopes.					
Inspector Comment					
Remove wild vines and growth on the LS slope.

Ivy growth on the LS slope. Fall 2021

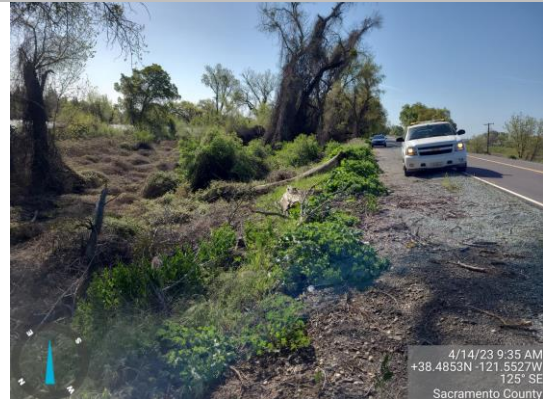
Photo 1 of 1 : FA_2023_RD0765_211_4_20230905_00003.jpg

LM Start	1.33	Rating **	U	Issue No.	4
LM End	1.33	Issue Type +	Ma	Location *	WS
Category	Earthen Levee			GPS Latitude/Longitude	
				Start	End
Item	Trim / Thin Trees			38.485062°	38.485062°
				-121.552635°	-121.552635°
DWR ID	DWR_RD0765_01_s_2023_4				
Comment Code					
T2 : Tree or limb.					
Inspector Comment					
Remove logs and limbs from WS slope within 20' of the crown.

Logs on the WS slope. Spring 2023

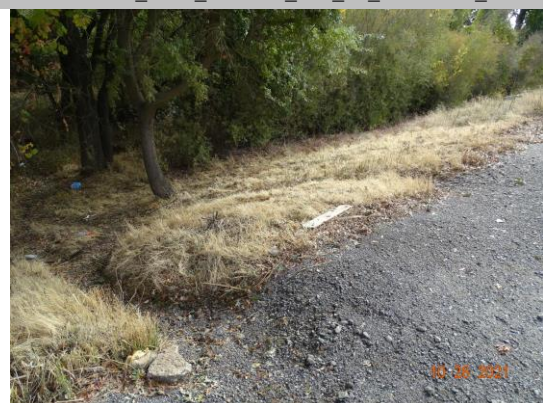
Photo 1 of 1 : FA_2023_RD0765_211_10_20230905_00008.jpg

LM Start	1.42	Rating **	A/W	Issue No.	10
LM End	1.42	Issue Type +	Ma	Location *	WS
Category	Earthen Levee			GPS Latitude/Longitude	
				Start	End
Item	Erosion / Foot Traffic			38.483973°	38.483973°
				-121.551855°	-121.551855°
DWR ID	DWR_RD0765_01_f_2021_10				
Comment Code					
E3 : Repair the levee slope damaged by foot traffic and prevent access where possible.					
Inspector Comment					
Monitor two footpaths for erosion.

Footpaths on the WS slope. Fall 2021

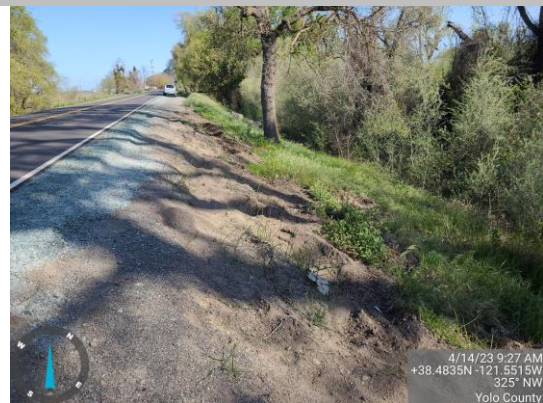
Photo 1 of 1 : FA_2023_RD0765_211_2_20230905_00001.jpg

LM Start	1.46	Rating **	M	Issue No.	2
LM End	1.46	Issue Type +	Ma	Location *	WS
Category	Earthen Levee			GPS Latitude/Longitude	
				Start	End
Item	Erosion / Vehicle Traffic			38.483414°	38.483414°
				-121.551472°	-121.551472°
DWR ID	DWR_RD0765_01_s_2023_2				
Comment Code					
E6 : Repair the levee slope damaged by vehicle traffic and prevent access where possible.					
Inspector Comment					
Repair rutting on the WS shoulder.

Rutting on the WS shoulder. Spring 2023

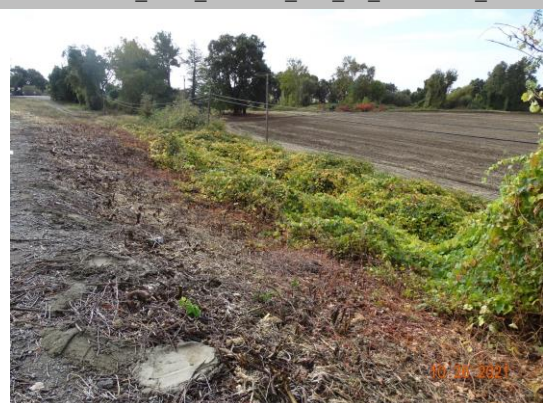
Photo 1 of 1 : FA_2023_RD0765_211_60_20230905_00022.jpg

LM Start	1.55	Rating **	U	Issue No.	60
LM End	1.61	Issue Type +	En	Location *	LS
Category	Earthen Levee			GPS Latitude/Longitude	
				Start	End
Item	Encroachments			38.482300°	38.481482°
				-121.550808°	-121.550283°
DWR ID	DWR_RD0765_01_f_2013_60				
Comment Code					
DT : Ditch					
Inspector Comment					
An old irrigation ditch located at the landside toe is covered with wild growth.

View of the overgrown ditch along the LS levee toe. Fall 2021

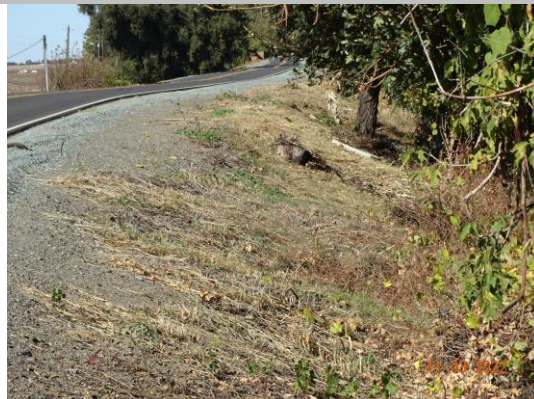
Photo 1 of 1 : FA_2023_RD0765_211_9_20230905_00007.jpg

LM Start	1.61	Rating **	N	Issue No.	9
LM End	1.61	Issue Type +	Ma	Location *	WS
Category	Earthen Levee			GPS Latitude/Longitude	
				Start	End
Item	Trim / Thin Trees			38.481560°	38.481560°
				-121.550295°	-121.550295°
DWR ID	DWR_RD0765_01_s_2020_9				
Comment Code					
T5 : Tree stumps.					
Inspector Comment					
Remove stump on the WS slope.

Tree stump on the WS slope. Fall 2022

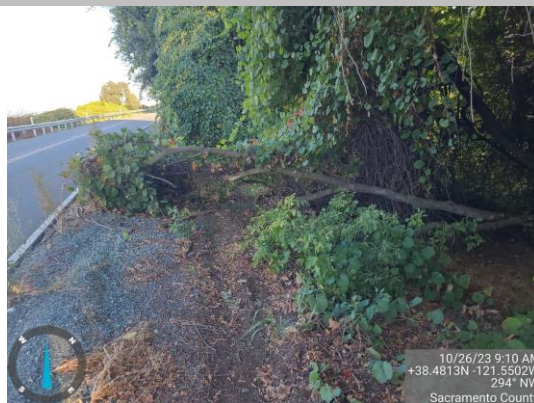
Photo 1 of 1 : FA_2023_RD0765_211_1_20231026_00026.jpg

LM Start	1.64	Rating **	M	Issue No.	1
LM End	1.64	Issue Type +	Ma	Location *	WS
Category	Earthen Levee			GPS Latitude/Longitude	
				Start	End
Item	Trim / Thin Trees			38.481151°	38.481151°
				-121.549866°	-121.549866°
DWR ID	DWR_RD0765_01_s_2023_1				
Comment Code					
T2 : Tree or limb.					
Inspector Comment					
Remove limbs from within 20' of the crown.

Tree limb on the WS slope. Fall 2023
