## Flood Control Project Maintenance Levee Inspections

### Fall 2024 Levee Maintenance Deficiency Summary Report

#### Sacramento River Basin

**Reclamation District No. 0765 Glide**

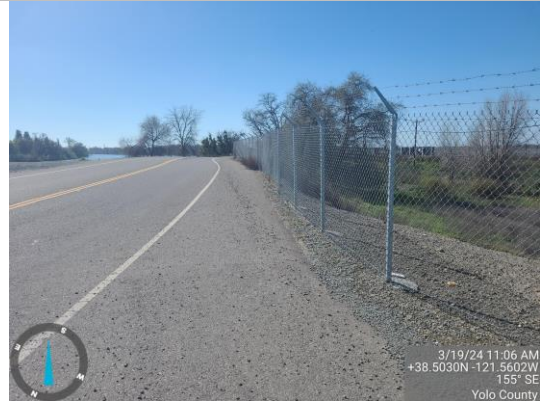
Photo 1 of 1 : FA\_2024\_RD0765\_211\_12\_20240911\_00007.jpg

LM Start	0.00	Rating **	M	Issue No.	12
LM End	0.08	Issue Type +	En	Location *	LS
Category	Earthen Levee			GPS Latitude/Longitude	
				Start	End
Item	Encroachments			38.502962 °	38.501772 °
				-121.560112 °	-121.560250 °
DWR ID	DWR_RD0765_01_s_2020_12				
Comment Code					
FE : Fence					
Inspector Comment					
Fence prevents access on the landside slope.

Fence on the LS shoulder. Spring 2024

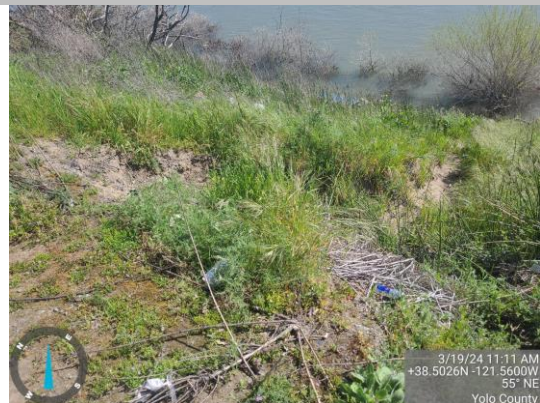
Photo 1 of 1 : FA\_2024\_RD0765\_211\_20\_20240911\_00010.jpg

LM Start	0.02	Rating **	U	Issue No.	20
LM End	0.02	Issue Type +	Ma	Location *	WS
Category	Earthen Levee			GPS Latitude/Longitude	
				Start	End
Item	Erosion / Foot Traffic			38.502711 °	38.502711 °
				-121.560019 °	-121.560019 °
DWR ID	DWR_RD0765_01_f_2023_20				
Comment Code					
E3 : Repair the levee slope damaged by foot traffic and prevent access where possible.					
Inspector Comment					
Repair erosion caused by foot traffic.

Footpath on the WS slope. Spring 2024

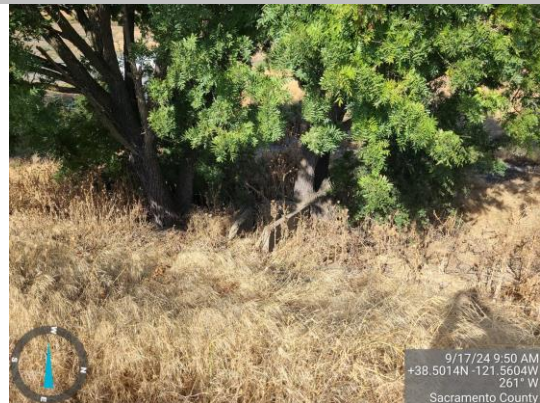
Photo 1 of 1 : FA\_2024\_RD0765\_211\_11\_20240918\_00016.jpg

LM Start	0.11	Rating **	M	Issue No.	11
LM End	0.11	Issue Type +	En	Location *	LS
Category	Earthen Levee			GPS Latitude/Longitude	
				Start	End
Item	Encroachments			38.501423 °	38.501423 °
				-121.560409 °	-121.560409 °
DWR ID	DWR_RD0765_01_s_2021_11				
Comment Code					
DE : Debris					
Inspector Comment					
Remove concrete on the LS levee toe.

Concrete footing on the LS levee toe. Spring 2024

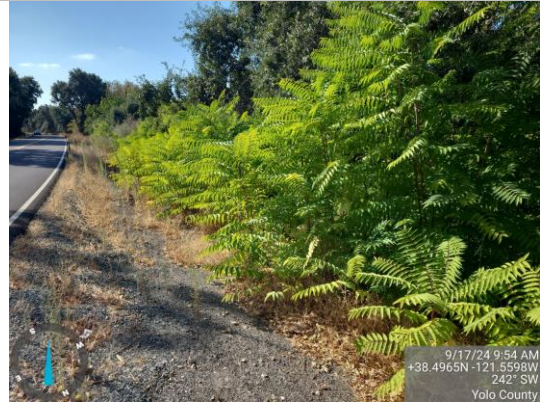
Photo 1 of 1 : FA\_2024\_RD0765\_211\_5\_20240918\_00017.jpg

LM Start	0.43	Rating **	U	Issue No.	5
LM End	0.50	Issue Type +	Ma	Location *	LS
Category	Earthen Levee			GPS Latitude/Longitude	
				Start	End
Item	Trim / Thin Trees			38.496750 °	38.495772 °
				-121.560018 °	-121.559551 °
DWR ID	DWR_RD0765_01_f _ 2024_5				
Comment Code					
T1 : Trim and thin trees to at least five feet above ground level to allow visibility of the ground and room to flood fight.					
Inspector Comment

Trees on the LS slope. Fall 2024

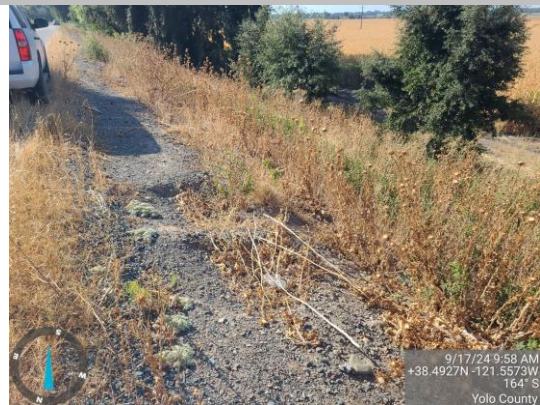
Photo 1 of 1 : FA\_2024\_RD0765\_211\_68\_20240918\_00018.jpg

LM Start	0.75	Rating **	M	Issue No.	68
LM End	0.75	Issue Type +	Ma	Location *	LS
Category	Earthen Levee			GPS Latitude/Longitude	
				Start	End
Item	Erosion / Rills			38.492705 °	38.492705 °
				-121.557193 °	-121.557193 °
DWR ID	DWR_RD0765_01_s_2017_68				
Comment Code					
E5 : Schedule repair of rills prior to the next inspection.					
Inspector Comment

Erosion on the LS slope. Fall 2024

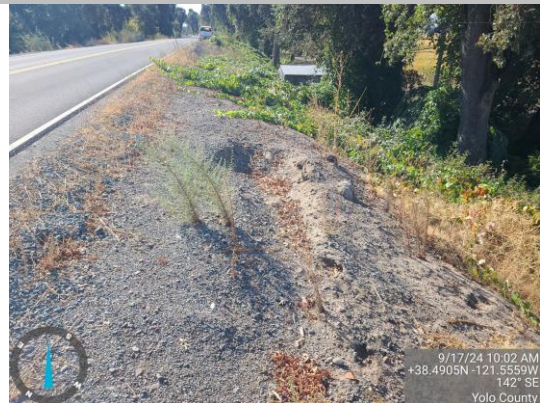
Photo 1 of 1 : FA\_2024\_RD0765\_211\_6\_20240918\_00019.jpg

LM Start	0.92	Rating **	M	Issue No.	6
LM End	0.92	Issue Type +	Ma	Location *	LS
Category	Earthen Levee			GPS Latitude/Longitude	
				Start	End
Item	Erosion / Vehicle Traffic			38.490514 °	38.490514 °
				-121.555831 °	-121.555831 °
DWR ID	DWR_RD0765_01_f_2024_6				
Comment Code					
E6 : Repair the levee slope damaged by vehicle traffic and prevent access where possible.					
Inspector Comment

Rutting on the LS shoulder. Fall 2024

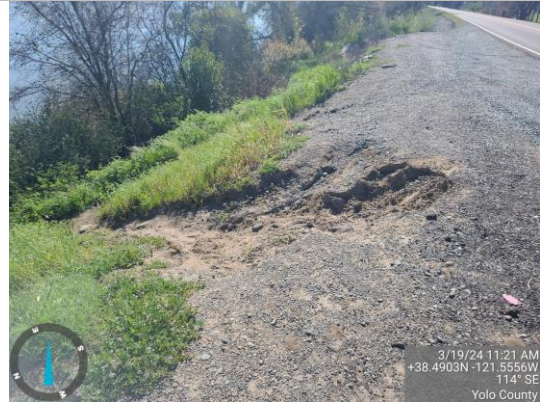
Photo 1 of 1 : FA\_2024\_RD0765\_211\_24\_20240911\_00012.jpg

LM Start	0.94	Rating **	U	Issue No.	24
LM End	0.94	Issue Type +	Ma	Location *	WS
Category	Earthen Levee			GPS Latitude/Longitude	
				Start	End
Item	Erosion / Foot Traffic			38.490265 °	38.490265 °
				-121.555617 °	-121.555617 °
DWR ID	DWR_RD0765_01_s _ 2019_24				
Comment Code					
E3 : Repair the levee slope damaged by foot traffic and prevent access where possible.					
Inspector Comment					
Erosion and footpath on the WS slope need to be repaired.

Erosion on the WS footpath. Spring 2024

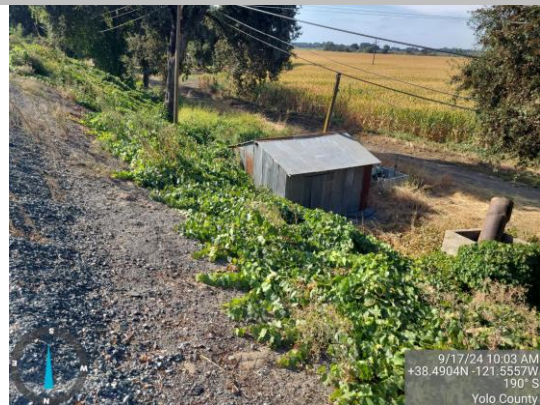
Photo 1 of 1 : FA\_2024\_RD0765\_211\_40\_20240918\_00020.jpg

LM Start	0.94	Rating **	M	Issue No.	40
LM End	0.94	Issue Type +	En	Location *	LS
Category	Earthen Levee			GPS Latitude/Longitude	
				Start	End
Item	Encroachments			38.490206 °	38.490206 °
				-121.555677 °	-121.555677 °
DWR ID	DWR_RD0765_01_s _ 2022_40				
Comment Code					
BU : Building					
Inspector Comment					
Building in the easement blocks access and visibility.

Building in the landside easement. Fall 2024

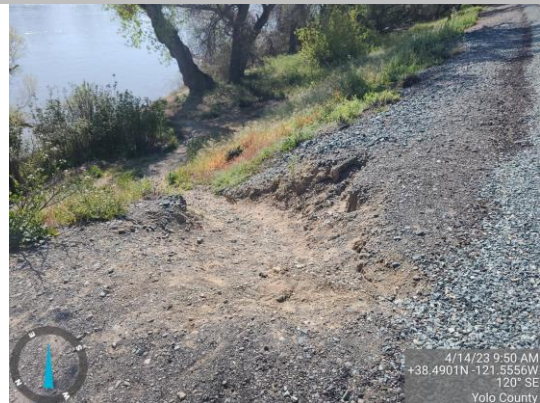
Photo 1 of 1 : FA\_2024\_RD0765\_211\_23\_20240911\_00011.jpg

LM Start	0.95	Rating **	U	Issue No.	23
LM End	0.95	Issue Type +	Ma	Location *	WS
Category	Earthen Levee			GPS Latitude/Longitude	
				Start	End
Item	Erosion / Foot Traffic			38.490067 °	38.490067 °
				-121.555530 °	-121.555530 °
DWR ID	DWR_RD0765_01_s _ 2019_23				
Comment Code					
E3 : Repair the levee slope damaged by foot traffic and prevent access where possible.					
Inspector Comment					
Repair the erosion at the footpath on the WS slope.

Erosion at the footpath on the WS slope. Spring 2023

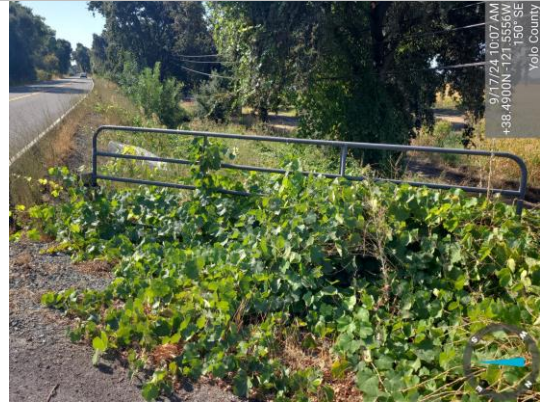
Photo 1 of 1 : FA\_2024\_RD0765\_211\_7\_20240918\_00021.jpg

LM Start	0.96	Rating **	M	Issue No.	7
LM End	0.96	Issue Type +	En	Location *	LS
Category	Earthen Levee			GPS Latitude/Longitude	
				Start	End
Item	Encroachments			38.490008 °	38.490008 °
				-121.555596 °	-121.555596 °
DWR ID	DWR_RD0765_01_f_2024_7				
Comment Code					
RA : Ramp					
Inspector Comment

Ramp and gate on the LS slope. Fall 2024

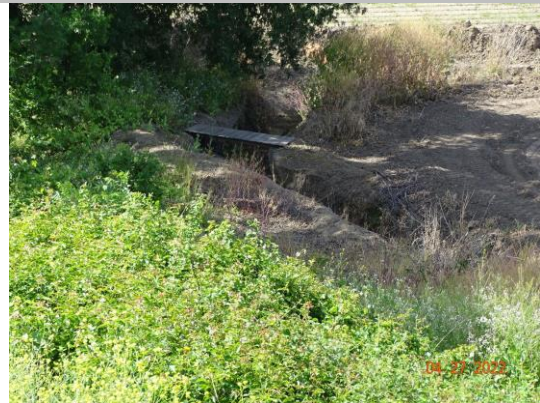
Photo 1 of 1 : FA\_2024\_RD0765\_211\_51\_20240911\_00015.jpg

LM Start	0.96	Rating **	M	Issue No.	51
LM End	1.02	Issue Type +	En	Location *	LS
Category	Earthen Levee			GPS Latitude/Longitude	
				Start	End
Item	Encroachments			38.489949 °	38.489230 °
				-121.555544 °	-121.555168 °
DWR ID	DWR_RD0765_01_s_2013_51				
Comment Code					
DT : Ditch					
Inspector Comment					
This ditch has been in place for several years. Most of the ditch appears to be outside the 15 foot right-of-way.

Ditch near the landside toe. Spring 2022

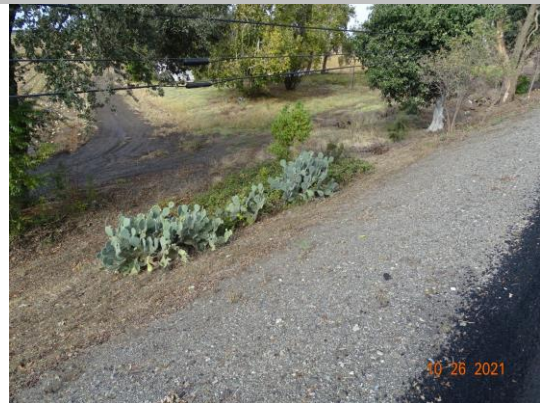
Photo 1 of 1 : FA\_2024\_RD0765\_211\_19\_20240911\_00009.jpg

LM Start	1.03	Rating **	M	Issue No.	19
LM End	1.03	Issue Type +	En	Location *	LS
Category	Earthen Levee			GPS Latitude/Longitude	
				Start	End
Item	Vegetation			38.489011 °	38.489011 °
				-121.554990 °	-121.554990 °
DWR ID	DWR_RD0765_01_f_2021_19				
Comment Code					
V6 : Landscaping					
Inspector Comment					
Remove cactus from LS slope.

Cactus on the LS slope. Fall 2021

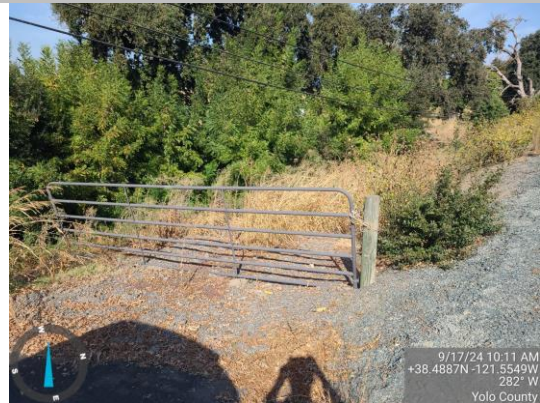
Photo 1 of 1 : FA\_2024\_RD0765\_211\_8\_20240918\_00022.jpg

LM Start	1.06	Rating **	M	Issue No.	8
LM End	1.06	Issue Type +	En	Location *	LS
Category	Earthen Levee			GPS Latitude/Longitude	
				Start	End
Item	Encroachments			38.488643 °	38.488643 °
				-121.554878 °	-121.554878 °
DWR ID	DWR_RD0765_01_f_2024_8				
Comment Code					
RA : Ramp					
Inspector Comment

Ramp and gate on the LS slope. Fall 2024

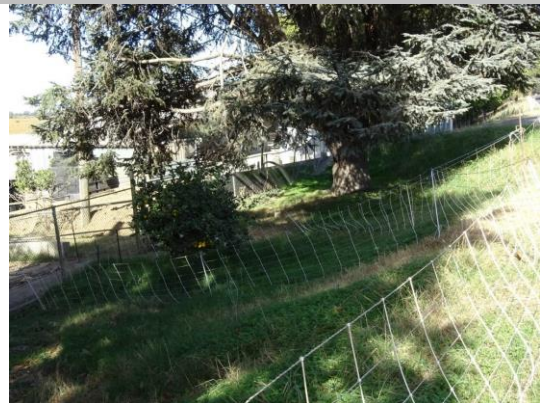
Photo 1 of 1 : FA\_2024\_RD0765\_211\_32\_20240911\_00013.jpg

LM Start	1.23	Rating **	M	Issue No.	32
LM End	1.23	Issue Type +	En	Location *	LS
Category	Earthen Levee			GPS Latitude/Longitude	
				Start	End
Item	Encroachments			38.486403 °	38.486403 °
				-121.553437 °	-121.553437 °
DWR ID	DWR_RD0765_01_f_2018_32				
Comment Code					
CR : Crops					
Inspector Comment					
Citrus tree is unpermitted within the levee easement.

View of citrus tree within levee easement. Fall 2018

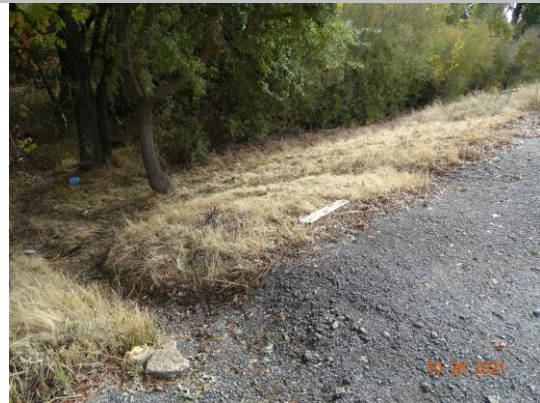
Photo 1 of 1 : FA\_2024\_RD0765\_211\_10\_20240911\_00005.jpg

LM Start	1.42	Rating **	M	Issue No.	10
LM End	1.42	Issue Type +	Ma	Location *	WS
Category	Earthen Levee			GPS Latitude/Longitude	
				Start	End
Item	Erosion / Foot Traffic			38.483973 °	38.483973 °
				-121.551855 °	-121.551855 °
DWR ID	DWR_RD0765_01_f_2021_10				
Comment Code					
E3 : Repair the levee slope damaged by foot traffic and prevent access where possible.					
Inspector Comment

Footpaths on the WS slope. Fall 2021

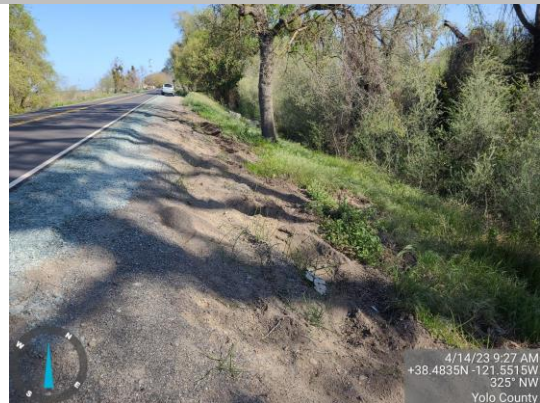
Photo 1 of 1 : FA\_2024\_RD0765\_211\_2\_20240911\_00002.jpg

LM Start	1.46	Rating **	M	Issue No.	2
LM End	1.46	Issue Type +	Ma	Location *	WS
Category	Earthen Levee			GPS Latitude/Longitude	
				Start	End
Item	Erosion / Vehicle Traffic			38.483414 °	38.483414 °
				-121.551472 °	-121.551472 °
DWR ID	DWR_RD0765_01_s_2023_2				
Comment Code					
E6 : Repair the levee slope damaged by vehicle traffic and prevent access where possible.					
Inspector Comment					
Repair rutting on the WS shoulder.

Rutting on the WS shoulder. Spring 2023

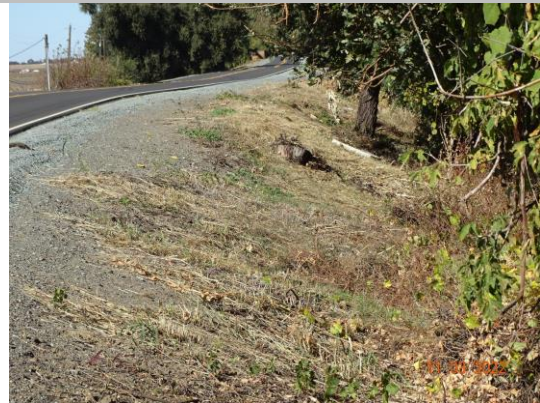
Photo 1 of 1 : FA\_2024\_RD0765\_211\_9\_20240911\_00004.jpg

LM Start	1.61	Rating **	N	Issue No.	9
LM End	1.61	Issue Type +	Ma	Location *	WS
Category	Earthen Levee			GPS Latitude/Longitude	
				Start	End
Item	Trim / Thin Trees			38.481560 °	38.481560 °
				-121.550295 °	-121.550295 °
DWR ID	DWR_RD0765_01_s_2020_9				
Comment Code					
T5 : Tree stumps.					
Inspector Comment					
Remove stump on the WS slope.

Tree stump on the WS slope. Fall 2022

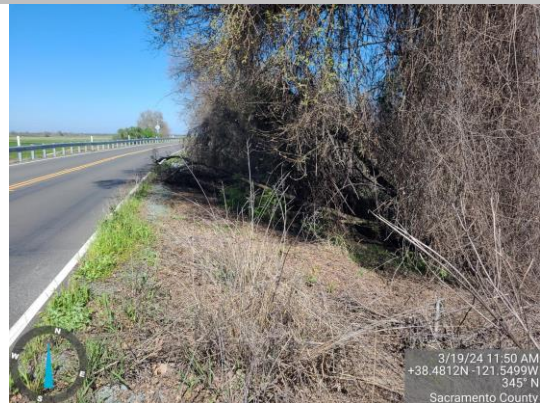
Photo 1 of 1 : FA\_2024\_RD0765\_211\_1\_20240911\_00001.jpg

LM Start	1.64	Rating **	M	Issue No.	1
LM End	1.64	Issue Type +	Ma	Location *	WS
Category	Earthen Levee			GPS Latitude/Longitude	
				Start	End
Item	Vegetation			38.481151 °	38.481151 °
				-121.549866 °	-121.549866 °
DWR ID	DWR_RD0765_01_s_2023_1				
Comment Code					
V2 : Remove the wild growth and woody vegetation other than native grasses from the levee slopes.					
Inspector Comment					
Remove woody vegetation from within 20' of the crown. Trim trees to 5' above grade.

Limbs and woody growth on the WS slope. Spring 2023
