**Flood Control Project Maintenance
Levee Inspections
LMA District Cover Sheet
Spring 2011 Levee Inspection Results**

Reclamation District No. 0765 Glide

Spring 2011 Levee Inspection Results

Waterway	Bank	Unit Miles
Unit No. 01 Sacramento River	Right	1.74

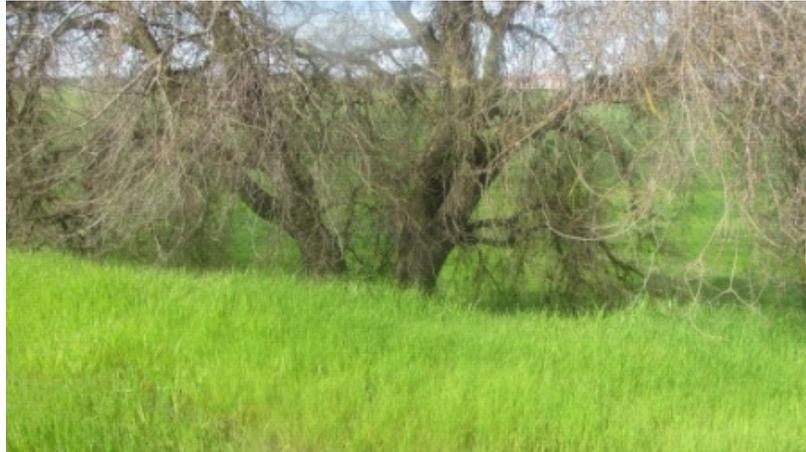
Levee Mile Report Line	5
Start Levee Mile	0.12
End Levee Mile	0.19
Location	Land Side
Category	Earthen Levee
Item	Trim / Thin Trees
Looking west at trees on landside toe.	
richard_s_20110215_310.jpg

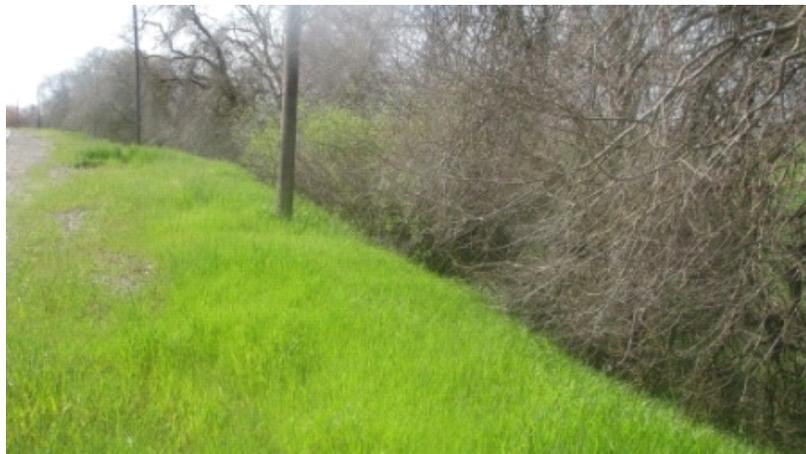
Levee Mile Report Line	5
Start Levee Mile	0.12
End Levee Mile	0.19
Location	Land Side
Category	Earthen Levee
Item	Trim / Thin Trees
Looking downstream (south) at trees on landside slope & toe.	
richard_s_20110215_311.jpg

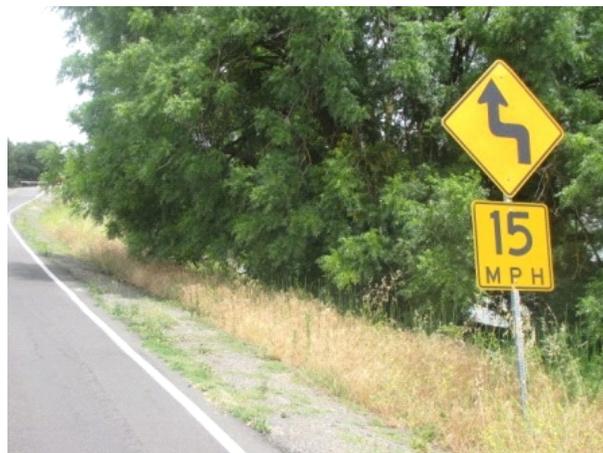
Levee Mile Report Line	8
Start Levee Mile	0.25
End Levee Mile	0.28
Location	Water Side
Category	Earthen Levee
Item	Trim / Thin Trees
Looking northeast at overgrown trees on waterside slope.	
richard_s_20110215_305.jpg

7	0.19	0.35	Earthen Levee	Trim / Thin Trees	LS	M	Trim trees to at least five feet above ground level.	38.500343 ° -121.560507 °	38.498032 ° -121.560337 °	14
8	0.25	0.28	Earthen Levee	Trim / Thin Trees	WS	U	Thin trees to allow visibility of the ground and room to flood fight.	38.499405 ° -121.560445 °	38.499042 ° -121.560430 °	11 Y
9	0.32	0.32	Earthen Levee	Trim / Thin Trees	WS	M	Trim trees to at least five feet above ground level.	38.498453 ° -121.560360 °	38.498453 ° -121.560360 °	23
10	0.41	0.41	Earthen Levee	Trim / Thin Trees	LS	M	Trim trees to at least five feet above ground level.	38.497196 ° -121.560147 °	38.497196 ° -121.560147 °	21
11	0.41	0.52	Earthen Levee	Trim / Thin Trees	WS	M	Trim trees to at least five feet above ground level.	38.497125 ° -121.560087 °	38.495648 ° -121.559391 °	24
12	0.43	0.47	Earthen Levee	Trim / Thin Trees	LS	M	Trim and thin trees to allow visibility of the ground and room to flood fight.	38.496792 ° -121.560026 °	38.496321 ° -121.559842 °	32

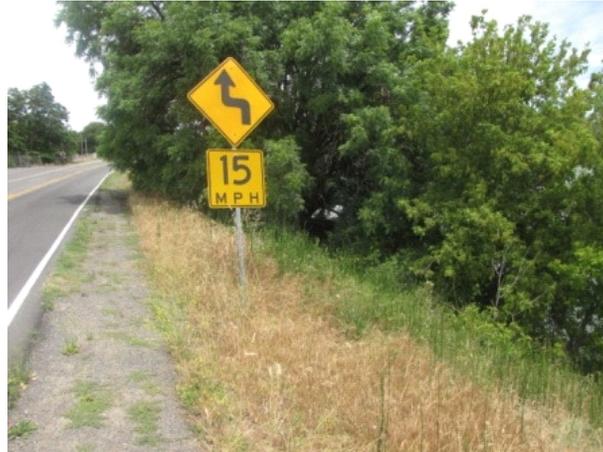
Levee Mile Report Line	8
Start Levee Mile	0.25
End Levee Mile	0.28
Location	Water Side
Category	Earthen Levee
Item	Trim / Thin Trees
Looking north at dense trees on waterside slope from fall 2010 inspection.	
richard_s_20110215_306.jpg

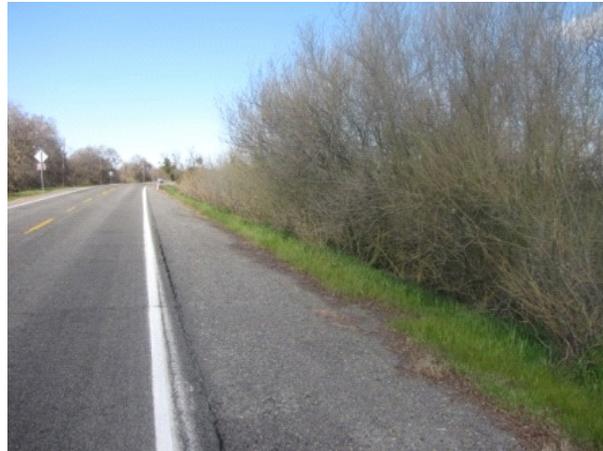
Levee Mile Report Line	8
Start Levee Mile	0.25
End Levee Mile	0.28
Location	Water Side
Category	Earthen Levee
Item	Trim / Thin Trees
Looking upstream (north) at dense vegetation and trees from 2011 spring inspection.	
richard_s_20110304_432.jpg

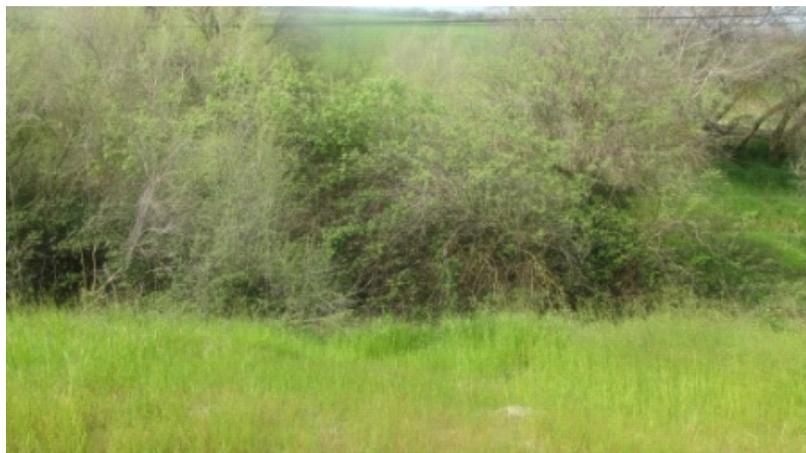
Levee Mile Report Line	13
Start Levee Mile	0.48
End Levee Mile	0.50
Location	Land Side
Category	Earthen Levee
Item	Vegetation
Looking northwest at trees on landside toe from 2010 fall inspection.	
richard_s_20110215_317.jpg

13	0.48	0.50	Earthen Levee	Vegetation	LS	U	Remove the wild growth other than native grasses from the levee slopes.	38.496217 ° -121.559788 °	38.495855 ° -121.559586 °	33 Y
14	0.54	0.54	Earthen Levee	Trim / Thin Trees	LS	M	Trim trees to at least five feet above ground level.	38.495347 ° -121.559291 °	38.495347 ° -121.559291 °	34
15	0.57	0.60	Earthen Levee	Trim / Thin Trees	WS	M	Trim trees to at least five feet above ground level.	38.495035 ° -121.559027 °	38.494642 ° -121.558697 °	10
16	0.62	0.65	Earthen Levee	Trim / Thin Trees	LS	M	Trim trees to at least five feet above ground level.	38.494468 ° -121.558577 °	38.494037 ° -121.558192 °	16
17	0.65	0.65	Earthen Levee	Trim / Thin Trees	WS	M	Trim trees to at least five feet above ground level.	38.494097 ° -121.558192 °	38.494097 ° -121.558192 °	19
18	0.66	0.66	Earthen Levee	Trim / Thin Trees	WS	M	Trim trees to at least five feet above ground level.	38.493917 ° -121.558041 °	38.493917 ° -121.558041 °	18

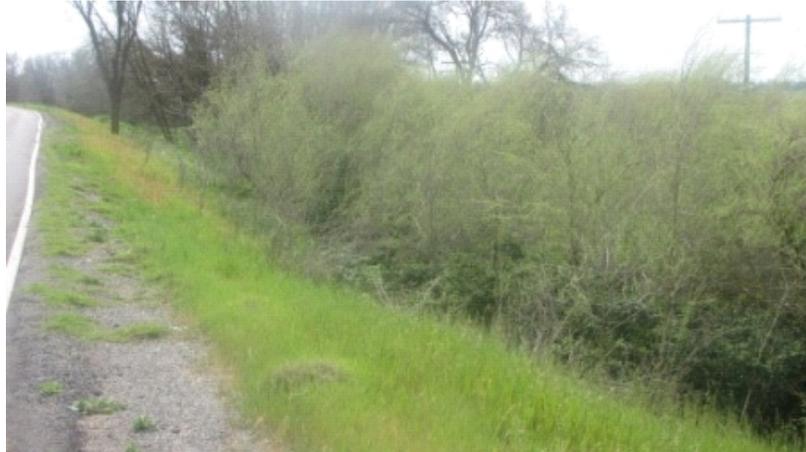
Levee Mile Report Line	13
Start Levee Mile	0.48
End Levee Mile	0.50
Location	Land Side
Category	Earthen Levee
Item	Vegetation

Looking downstream (south) at trees on landside slope & toe.

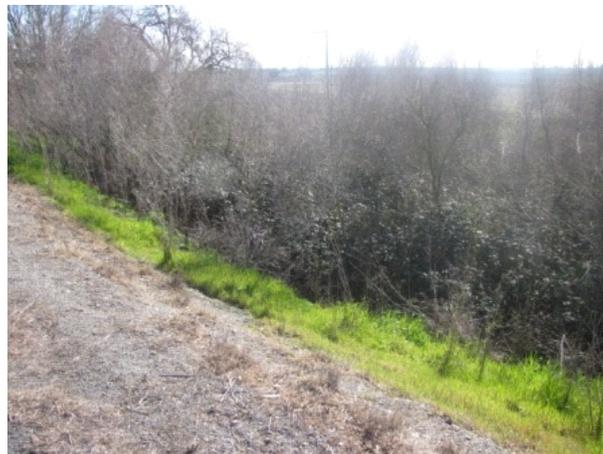
Levee Mile Report Line	13
Start Levee Mile	0.48
End Levee Mile	0.50
Location	Land Side
Category	Earthen Levee
Item	Vegetation

Looking downstream (southwest) at dense vegetation on landside slope.

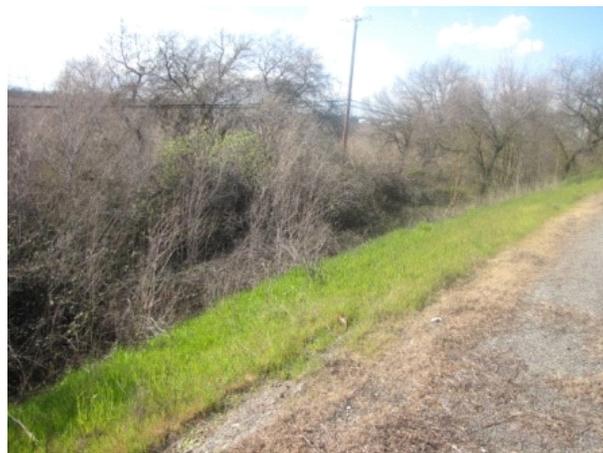
Levee Mile Report Line	13
Start Levee Mile	0.48
End Levee Mile	0.50
Location	Land Side
Category	Earthen Levee
Item	Vegetation

Looking upstream (northwest) at dense vegetation on landside slope.

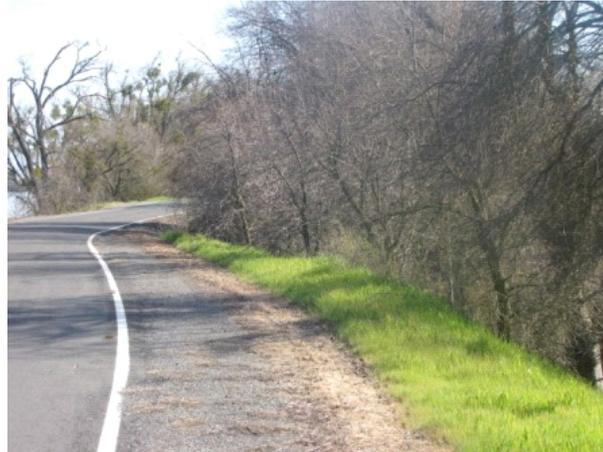
Levee Mile Report Line	22
Start Levee Mile	0.87
End Levee Mile	1.03
Location	Land Side
Category	Earthen Levee
Item	Trim / Thin Trees
Looking downstream (south) at dense trees on landside slope and toe.	
richard_s_20110304_435.jpg

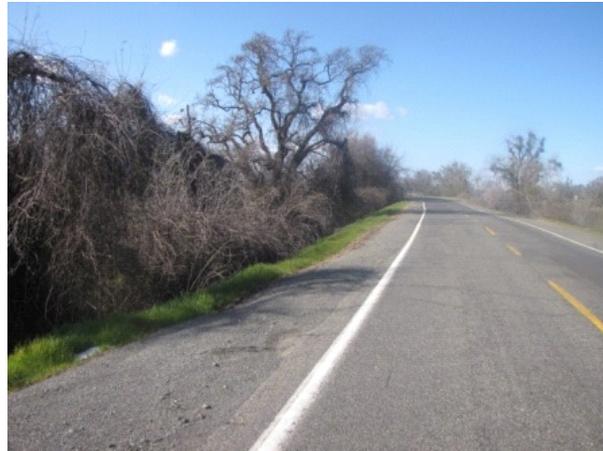
Levee Mile Report Line	22
Start Levee Mile	0.87
End Levee Mile	1.03
Location	Land Side
Category	Earthen Levee
Item	Trim / Thin Trees
Looking upstream (north) at dense trees on landside slope and toe.	
richard_s_20110304_436.jpg

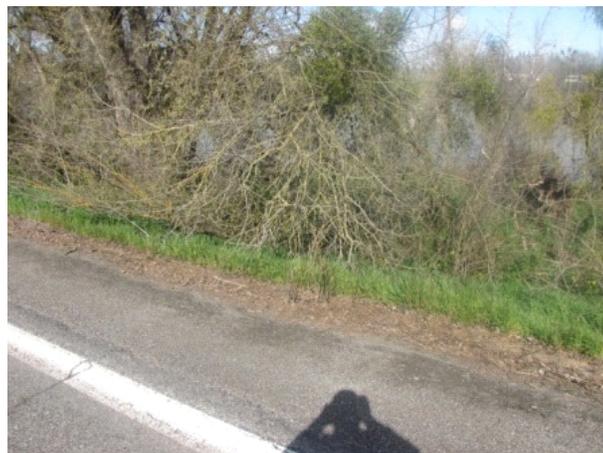
Levee Mile Report Line	23
Start Levee Mile	0.99
End Levee Mile	1.05
Location	Water Side
Category	Earthen Levee
Item	Trim / Thin Trees
Looking upstream (northeast) at dense vegetation on waterside slope.	
richard_s_20110304_430.jpg

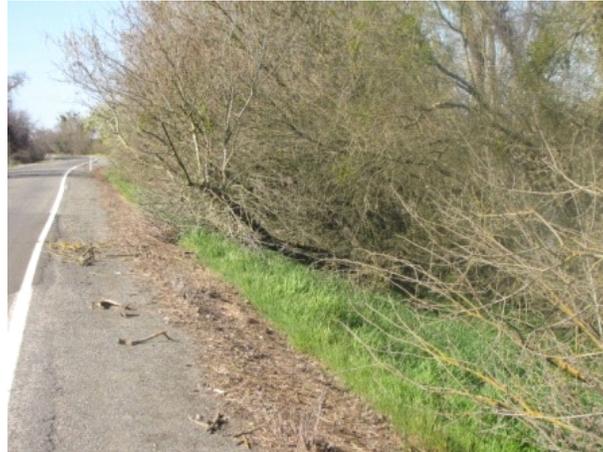
Levee Mile Report Line	23
Start Levee Mile	0.99
End Levee Mile	1.05
Location	Water Side
Category	Earthen Levee
Item	Trim / Thin Trees
Looking upstream (north) dense vegetation and trees on waterside shoulder and slope.	
richard_s_20110304_431.jpg

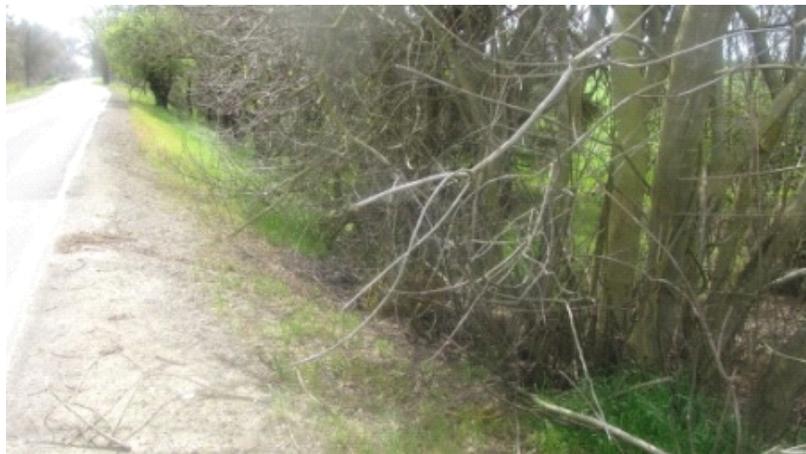
Levee Mile Report Line	24
Start Levee Mile	1.08
End Levee Mile	1.08
Location	Land Side
Category	Earthen Levee
Item	Trim / Thin Trees
Looking downstream (south) at trees on landside slope & toe from 2010 fall inspection.	
richard_s_20110215_319.jpg

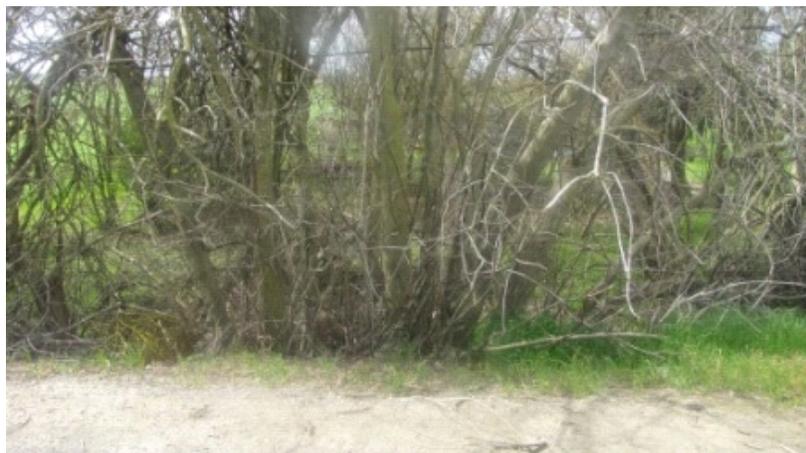
Levee Mile Report Line	24
Start Levee Mile	1.08
End Levee Mile	1.08
Location	Land Side
Category	Earthen Levee
Item	Trim / Thin Trees
Looking west at trees on landside slope & toe.	
richard_s_20110215_320.jpg

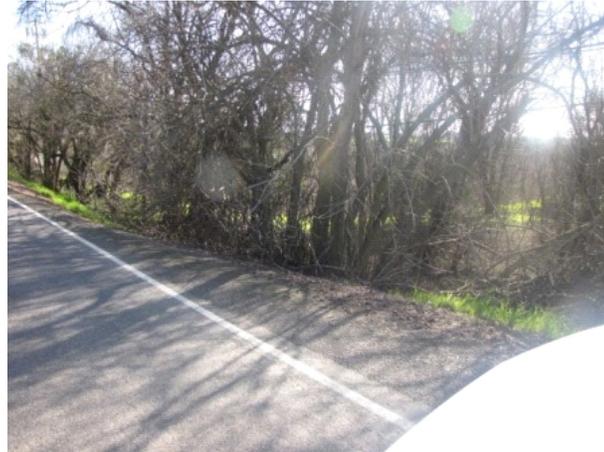
Levee Mile Report Line	24
Start Levee Mile	1.08
End Levee Mile	1.08
Location	Land Side
Category	Earthen Levee
Item	Trim / Thin Trees
Looking downstream (southwest) at dense trees on landside slope and toe.	
richard_s_20110304_438.jpg

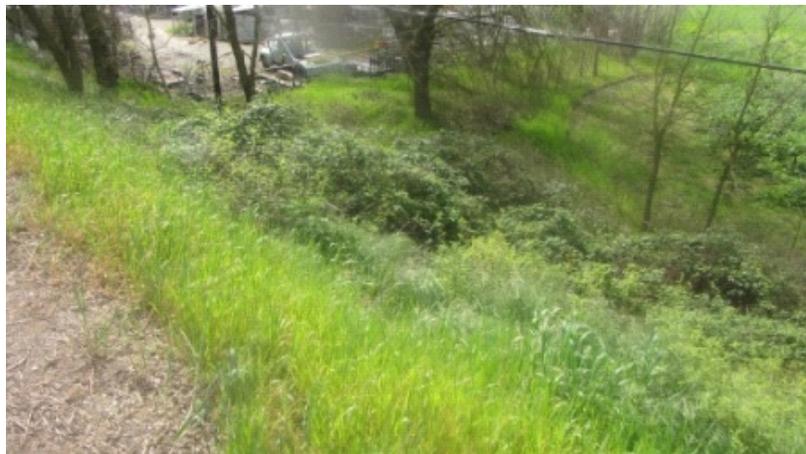
Levee Mile Report Line	26
Start Levee Mile	1.15
End Levee Mile	1.15
Location	Land Side
Category	Earthen Levee
Item	Vegetation
Looking downstream (southwest) at wild roses on landside slope & toe.	
richard_s_20110215_321.jpg

25	1.10	1.16	Earthen Levee	Trim / Thin Trees	LS	M	Trim trees to at least five feet above ground level.	38.488279 ° -121.554615 °	38.487465 ° -121.554117 °	38
26	1.15	1.15	Earthen Levee	Vegetation	LS	M	Remove the wild growth other than native grasses from the levee slopes.	38.487653 ° -121.554248 °	38.487653 ° -121.554248 °	39 Y
27	1.16	1.16	Earthen Levee	Trim / Thin Trees	WS	M	Trim trees to at least five feet above ground level.	38.487473 ° -121.554080 °	38.487473 ° -121.554080 °	9
28	1.19	1.22	Earthen Levee	Encroachments	LS	CO	Buildings	38.487127 ° -121.553910 °	38.486702 ° -121.553652 °	43 Y
29	1.32	1.32	Earthen Levee	Trim / Thin Trees	LS	M	Trim trees to at least five feet above ground level.	38.485280 ° -121.552860 °	38.485280 ° -121.552860 °	26
30	1.36	1.36	Earthen Levee	Trim / Thin Trees	WS	U	Trim trees to at least five feet above ground level.	38.484877 ° -121.552540 °	38.484877 ° -121.552540 °	7 Y

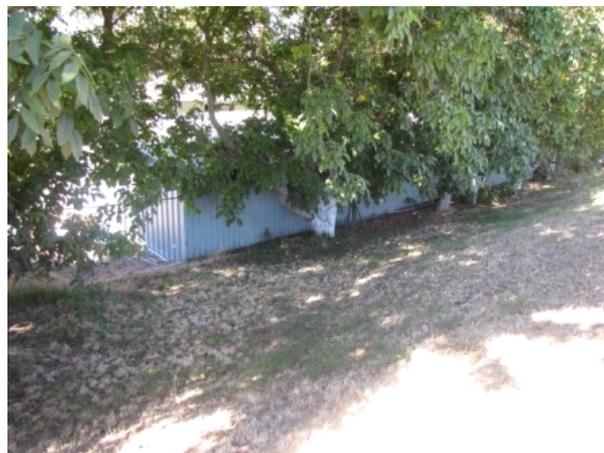
Levee Mile Report Line	28
Start Levee Mile	1.19
End Levee Mile	1.22
Location	Land Side
Category	Earthen Levee
Item	Encroachments
Looking northwest at buildings along landside toe.	
richard_s_20110215_322.jpg

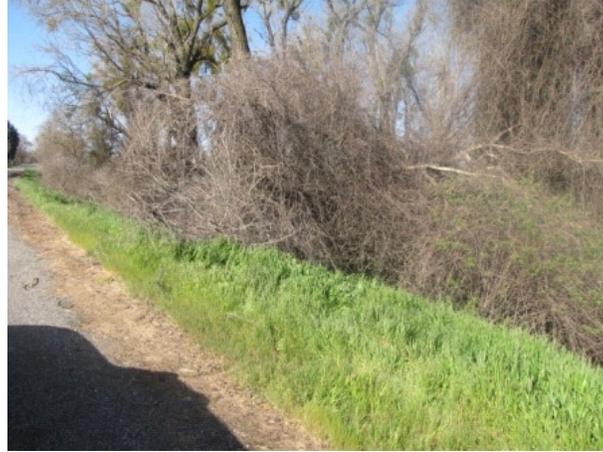
Levee Mile Report Line	30
Start Levee Mile	1.36
End Levee Mile	1.36
Location	Water Side
Category	Earthen Levee
Item	Trim / Thin Trees
Looking upstream (north) at dense vegetation on waterside slope.	
richard_s_20110304_429.jpg

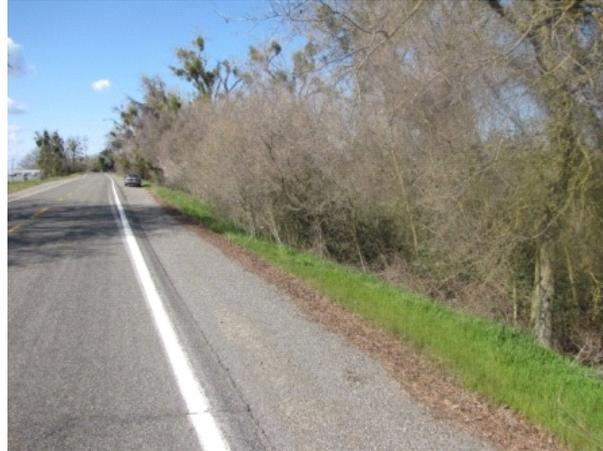
Levee Mile Report Line	32
Start Levee Mile	1.44
End Levee Mile	1.47
Location	Water Side
Category	Earthen Levee
Item	Trim / Thin Trees
Looking upstream (north) at dense trees on waterside slope.	
richard_s_20110304_428.jpg

31	1.41	1.41	Earthen Levee	Trim / Thin Trees	WS	M	Trim trees to at least five feet above ground level.	38.484316 ° -121.552115 °	38.484316 ° -121.552115 °	4
32	1.44	1.47	Earthen Levee	Trim / Thin Trees	WS	M	Thin trees to allow visibility of the ground and room to flood fight.	38.483925 ° -121.551845 °	38.483530 ° -121.551587 °	5 Y
33	1.50	1.50	Earthen Levee	Trim / Thin Trees	LS	M	Trim trees to at least five feet above ground level.	38.483170 ° -121.551367 °	38.483170 ° -121.551367 °	42
34	1.54	1.60	Earthen Levee	Vegetation	LS	M	Remove the wild growth other than native grasses from the levee slopes.	38.482627 ° -121.551038 °	38.481810 ° -121.550538 °	20
35	1.54	1.54	Earthen Levee	Vegetation	LS	U	Remove the wild growth other than native grasses from the levee slopes.	38.482590 ° -121.551020 °	38.482590 ° -121.551020 °	29 Y
36	1.60	1.67	Earthen Levee	Trim / Thin Trees	WS	M	Trim trees to at least five feet above ground level.	38.480913 ° -121.549677 °	38.480993 ° -121.549738 °	2 Y

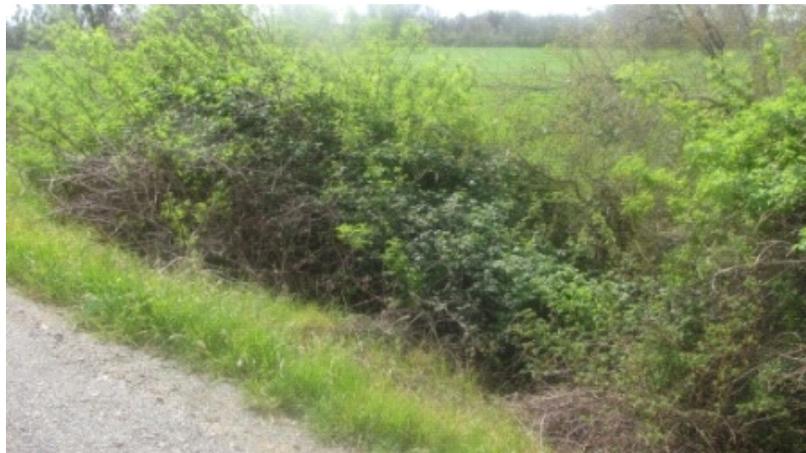
Levee Mile Report Line	35
Start Levee Mile	1.54
End Levee Mile	1.54
Location	Land Side
Category	Earthen Levee
Item	Vegetation
Looking downstream (southwest) at trees, vines & wildroses on landside slope & toe from 2010 fall inspection	
richard_s_20110215_312.jpg

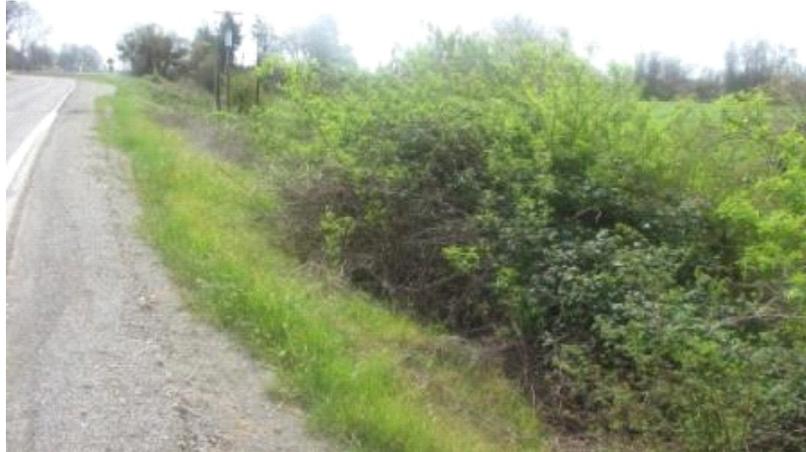
Levee Mile Report Line	35
Start Levee Mile	1.54
End Levee Mile	1.54
Location	Land Side
Category	Earthen Levee
Item	Vegetation
Looking downstream (south) at trees, vines & wildroses on landside slope & toe.	
richard_s_20110215_313.jpg

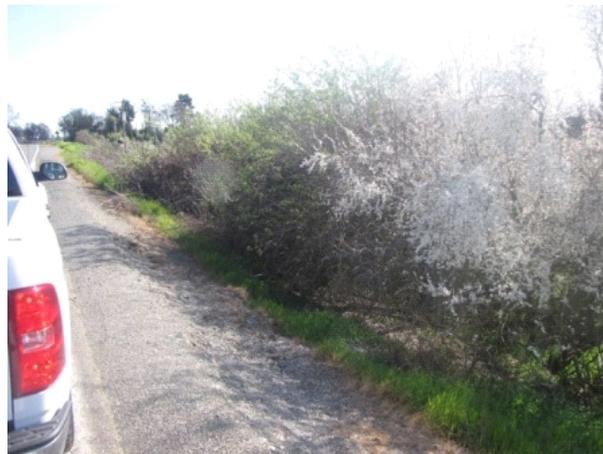
Levee Mile Report Line	35
Start Levee Mile	1.54
End Levee Mile	1.54
Location	Land Side
Category	Earthen Levee
Item	Vegetation
Looking downstream (south) at dense vegetation on landside slope and toe.	
richard_s_20110304_437.jpg

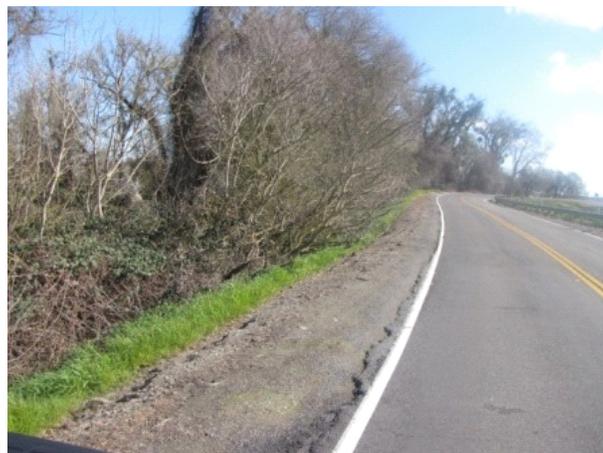
Levee Mile Report Line	36
Start Levee Mile	1.60
End Levee Mile	1.67
Location	Water Side
Category	Earthen Levee
Item	Trim / Thin Trees
Looking south at dense trees on waterside slope.	
richard_s_20110304_426.jpg

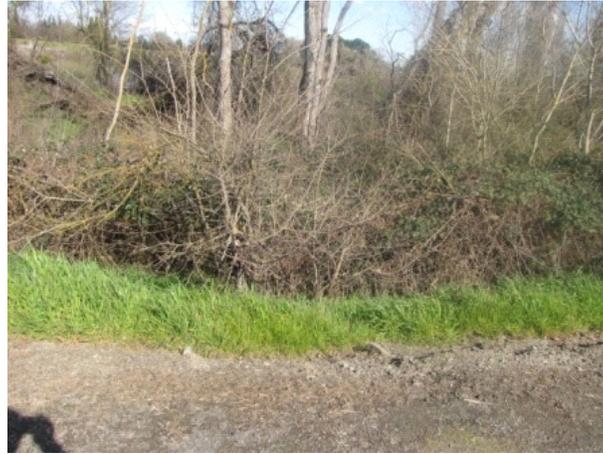
Levee Mile Report Line	36
Start Levee Mile	1.60
End Levee Mile	1.67
Location	Water Side
Category	Earthen Levee
Item	Trim / Thin Trees
Looking east at dense vegetation on waterside slope.	
richard_s_20110304_427.jpg

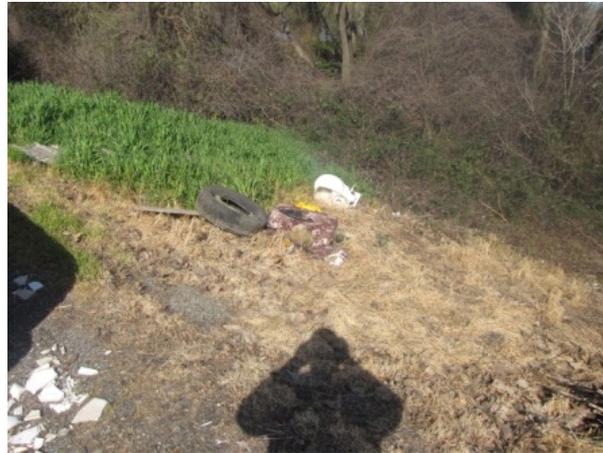
37	1.60	1.60	Earthen Levee	Vegetation	WS	M	Remove the wild growth other than native grasses from the levee slopes.	38.481841 ° -121.550438 °	38.482028 ° -121.550512 °	31
38	1.69	1.69	Earthen Levee	Encroachments	WS	M	Garbage	38.480770 ° -121.549514 °	38.480895 ° -121.549556 °	30 Y

Levee Mile Report Line	38
Start Levee Mile	1.69
End Levee Mile	1.69
Location	Water Side
Category	Earthen Levee
Item	Encroachments
Looking northeast at garbage on waterside slope.	
richard_s_20110304_425.jpg

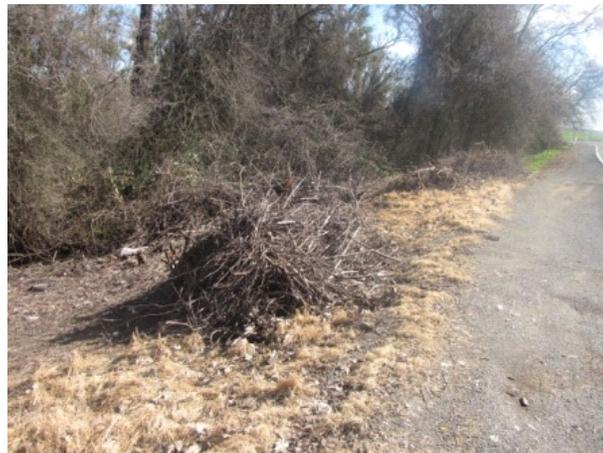
Levee Mile Report Line	39
Start Levee Mile	1.70
End Levee Mile	1.70
Location	Water Side
Category	Earthen Levee
Item	Encroachments
Looking southeast at pruning piles on waterside shoulder & slope.	
richard_s_20110304_424.jpg

LMR No.	Levee Mile		Category	Item	* Location	** Rating	Action/Comment	GPS Latitude/Longitude		Issue No. Photo
	Start	End						Start	End	
39	1.70	1.70	Earthen Levee	Encroachments	WS	M	Prunings	38.480632 ° -121.549543 °	38.480632 ° -121.549543 °	13 Y
40	1.70	1.73	Earthen Levee	Trim / Thin Trees	WS	M	Trim trees to at least five feet above ground level.	38.480602 ° -121.549523 °	38.480257 ° -121.549458 °	1 Y

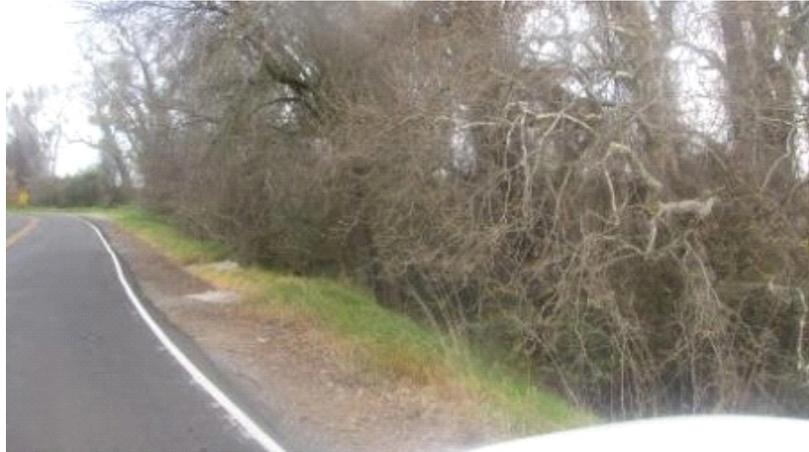
Levee Mile Report Line	40
Start Levee Mile	1.70
End Levee Mile	1.73
Location	Water Side
Category	Earthen Levee
Item	Trim / Thin Trees
Looking upstream (north) at trees on waterside slope.	
richard_s_20110215_296.jpg

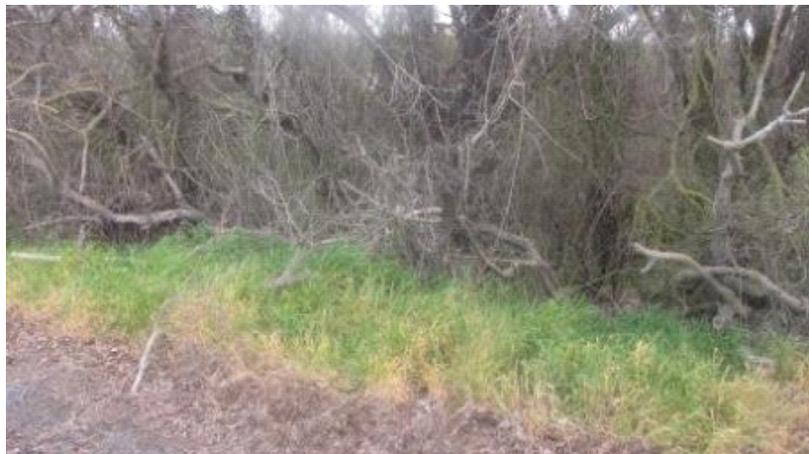
Levee Mile Report Line	40
Start Levee Mile	1.70
End Levee Mile	1.73
Location	Water Side
Category	Earthen Levee
Item	Trim / Thin Trees
Looking east at trees on waterside slope.	
richard_s_20110215_297.jpg
