**Flood Control Project Maintenance
Levee Inspections**

Maintenance Issue Types Only, Levee Inspection Report By Mile - Fall 2014

Reclamation District No. 0765 Glide

Waterway	Bank	Unit Miles	Inspection Start/End	Inspector
Unit No. 01 Sacramento River	Right	1.72	10/27/2014 10/27/2014	Richard Willoughby

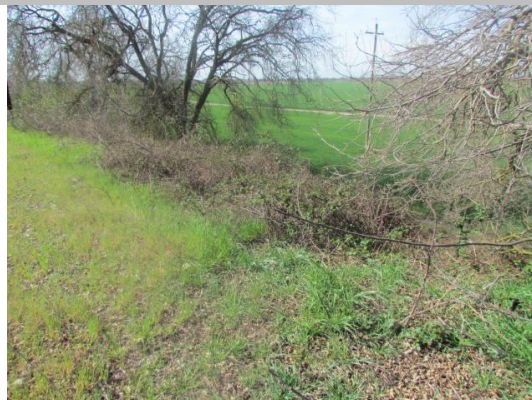
Photo 1 of 1 : FA_2014_RD0765_211_49_20141020_00057.jpg

LM Start	0.24	Rating **	M	Issue No.	49
LM End	0.24	Issue Type +	Ma	Location *	LS
Category	Earthen Levee			GPS Latitude/Longitude	
				Start	End
Item	Vegetation			38.499530 °	38.499530 °
				-121.560490 °	-121.560490 °
DWR ID	DWR_RD0765_01_s_2013_49				
Action/Comments					
Remove the wild growth other than native grasses from the levee slopes.					
Inspector Comments: Wild berryvines on landside slope.

Looking at wild berryvines or wild roses on landside slope and toe.

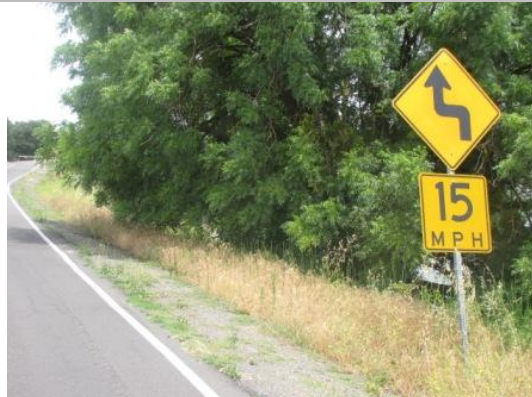
Photo 1 of 5 : FA_2014_RD0765_211_11_20141020_00015.jpg

LM Start	0.25	Rating **	A/W	Issue No.	11
LM End	0.28	Issue Type +	Ma	Location *	WS
Category	Earthen Levee			GPS Latitude/Longitude	
				Start	End
Item	Trim / Thin Trees			38.499405 °	38.499042 °
				-121.560445 °	-121.560430 °
DWR ID	DWR_RD0765_01_s_2012_11				
Action/Comments					
Thin trees to allow visibility of the ground and room to flood fight.

Looking northeast at overgrown trees on waterside slope.

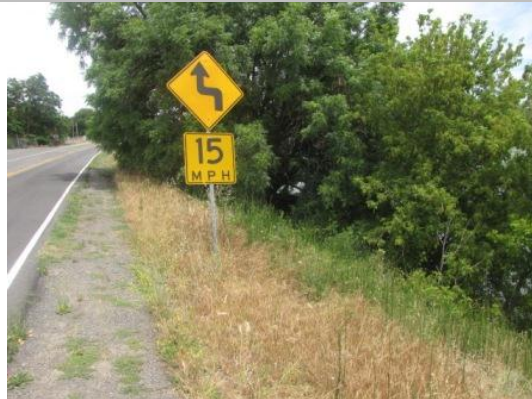
Photo 2 of 5 : FA_2014_RD0765_211_11_20141020_00016.jpg

Looking north at dense trees on waterside slope from fall 2010 inspection.

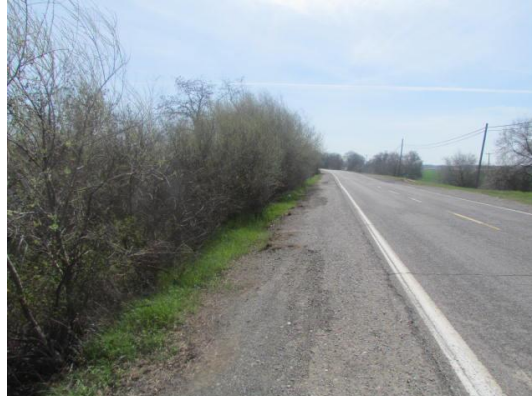
Photo 3 of 5 : FA_2014_RD0765_211_11_20141020_00017.jpg

Looking south (downstream) at dense trees on landside slope and shoulder. (Spring 2013)

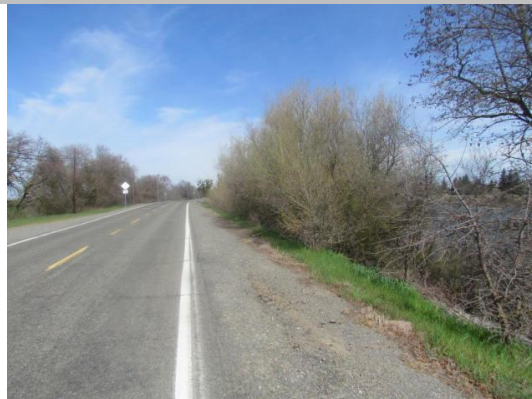
Photo 4 of 5 : FA_2014_RD0765_211_11_20141020_00018.jpg

Looking north (upstream) at dense trees on landside slope and shoulder. (Spring 2013)

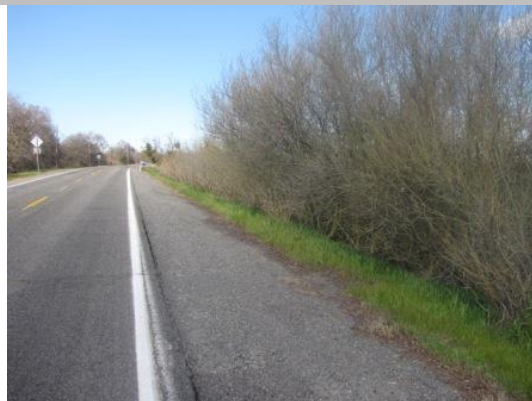
Photo 5 of 5 : FA_2014_RD0765_211_11_20141020_00019.jpg

Looking upstream (north) at dense vegetation and trees from 2011 spring inspection.

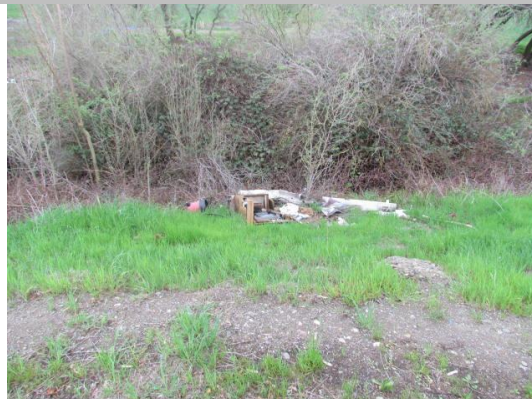
Photo 2 of 2 : FA_2014_RD0765_211_55_20141020_00064.jpg

LM Start	0.47	Rating **	A/W	Issue No.	55 (cont)
LM End	0.47	Issue Type +	Ma	Location *	LS
Category	Earthen Levee			GPS Latitude/Longitude	
				Start	End
Item	Encroachments			38.496235 °	38.496235 °
				-121.559796 °	-121.559796 °
DWR ID	DWR_RD0765_01_f_2013_55				
Action/Comments					
Garbage					
Inspector Comments: Trash dumped on landside slope.

Looking west at garbage on landside slope.

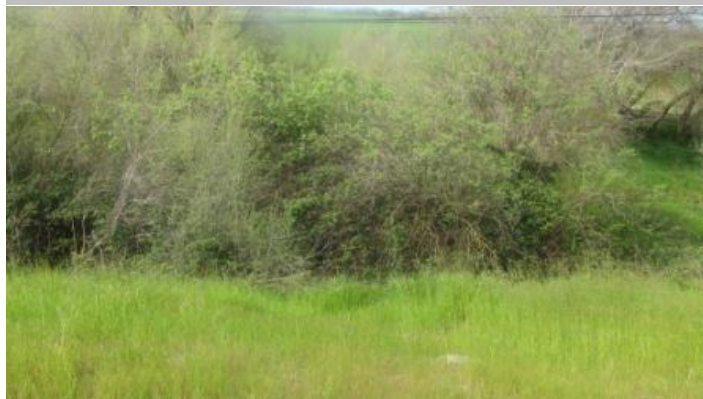
Photo 1 of 5 : FA_2014_RD0765_211_33_20141020_00044.jpg

LM Start	0.48	Rating **	M	Issue No.	33
LM End	0.50	Issue Type +	Ma	Location *	LS
Category	Earthen Levee			GPS Latitude/Longitude	
				Start	End
Item	Vegetation			38.496217 °	38.495855 °
				-121.559788 °	-121.559586 °
DWR ID	DWR_RD0765_01_s_2012_33				
Action/Comments					
Remove the wild growth other than native grasses from the levee slopes.					
Inspector Comments: District removed some of the wild growth on landside slope and toe.

Looking northwest at trees on landside toe from 2010 fall inspection.

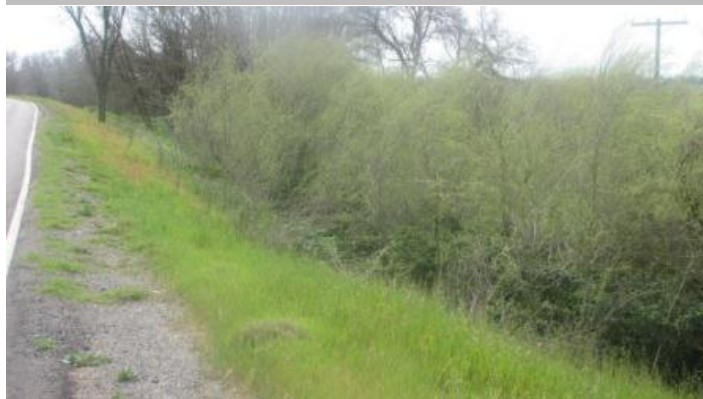
Photo 2 of 5 : FA_2014_RD0765_211_33_20141020_00045.jpg

Looking downstream (south) at trees on landside slope & toe.

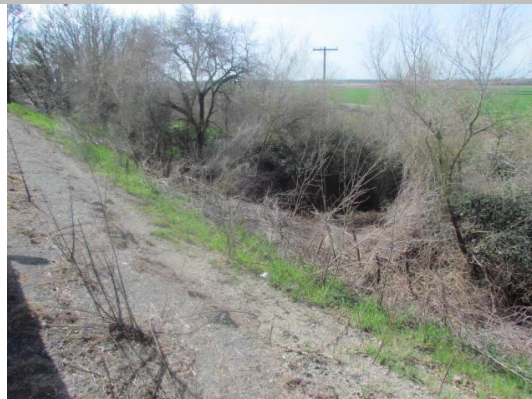
Photo 3 of 5 : FA_2014_RD0765_211_33_20141020_00046.jpg

Looking southwest at dense vegetation on landside slope and toe.

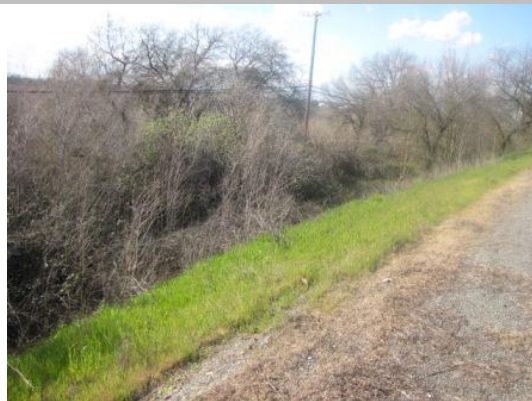
Photo 4 of 5 : FA_2014_RD0765_211_33_20141020_00047.jpg

Looking upstream (northwest) at dense vegetation on landside slope.

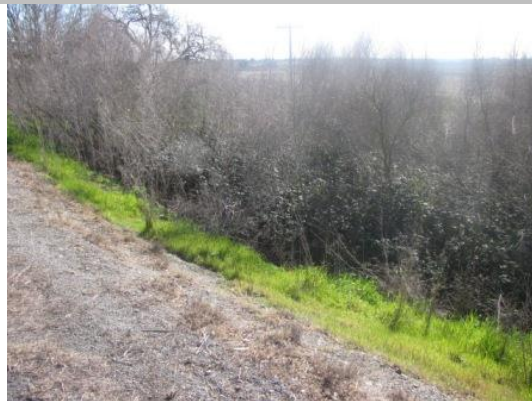
Photo 5 of 5 : FA_2014_RD0765_211_33_20141020_00048.jpg

Looking downstream (southwest) at dense vegetation on landside slope.

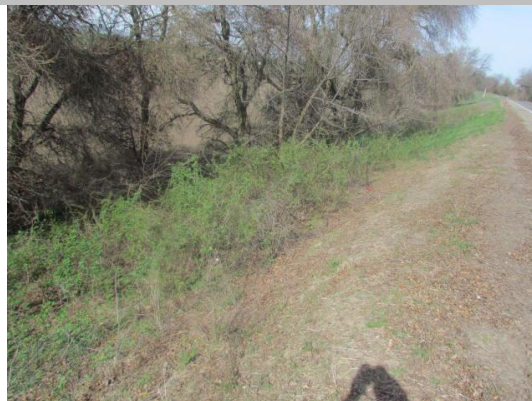
Photo 1 of 1 : FA_2014_RD0765_211_50_20141020_00058.jpg

LM Start	0.76	Rating **	M	Issue No.	50
LM End	0.80	Issue Type +	Ma	Location *	LS
Category	Earthen Levee			GPS Latitude/Longitude	
				Start	End
Item	Vegetation			38.492713 °	38.492176 °
				-121.557224 °	-121.556893 °
DWR ID	DWR_RD0765_01_s_2013_50				
Action/Comments					
Remove the wild growth other than native grasses from the levee slopes.

Looking northwest at vegetation on landside slope.

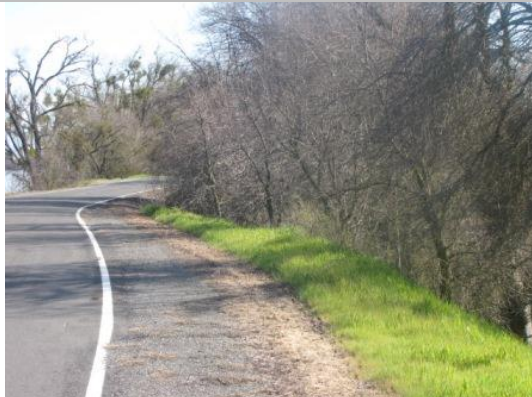
Photo 1 of 6 : FA_2014_RD0765_211_17_20141020_00024.jpg

LM Start	0.87	Rating **	A/W	Issue No.	17
LM End	0.99	Issue Type +	Ma	Location *	LS
Category	Earthen Levee			GPS Latitude/Longitude	
				Start	End
Item	Trim / Thin Trees			38.491283 °	38.489771 °
				-121.556360 °	-121.555451 °
DWR ID	DWR_RD0765_01_s_2012_17				
Action/Comments					
Trim trees to at least five feet above ground level.

Looking downstream (south) at dense trees on landside slope and toe.

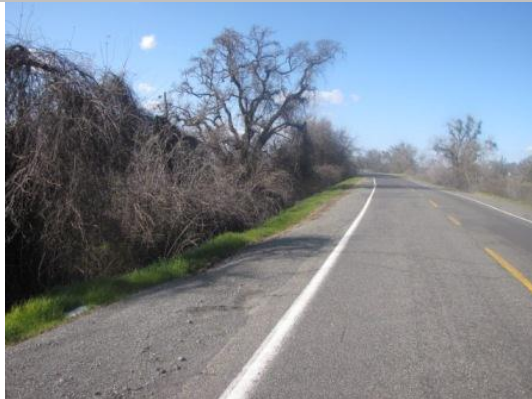
Photo 2 of 6 : FA_2014_RD0765_211_17_20141020_00025.jpg

Looking upstream (north) at dense trees on landside slope and toe.

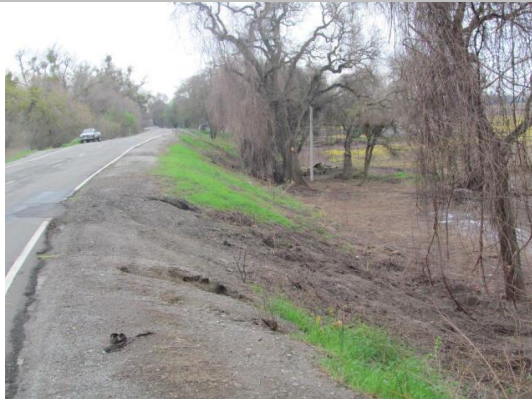
Photo 3 of 6 : FA_2014_RD0765_211_17_20141020_00026.jpg

Looking south at trimmed trees and vegetation on landside slope and toe.

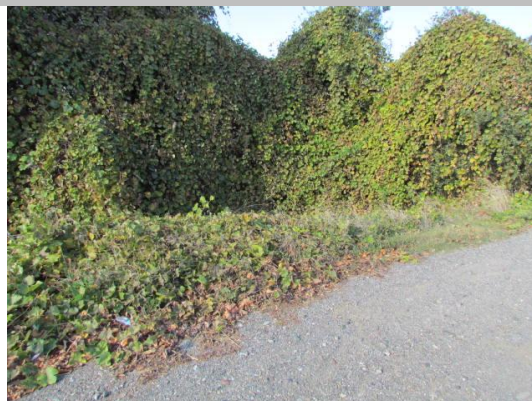
Photo 1 of 5 : FA_2014_RD0765_211_81_20141020_00069.jpg

Looking west at dense berryvines and wildroses on landside shoulder and slope. (November 2011)

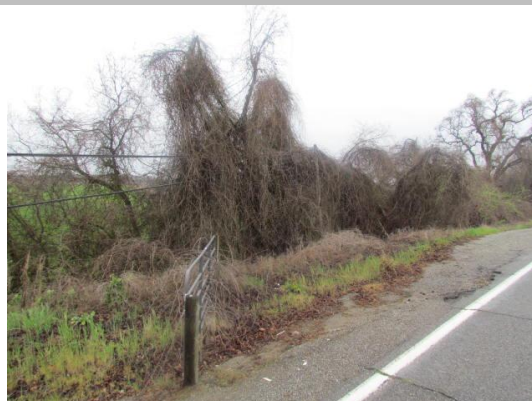
Photo 2 of 5 : FA_2014_RD0765_211_81_20141020_00070.jpg

Looking northwest at vines on landside toe spring 2012.

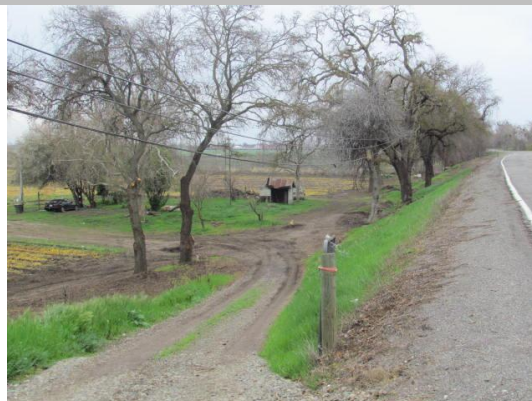
Photo 3 of 5 : FA_2014_RD0765_211_81_20141020_00071.jpg

Looking northwest at trimmed trees and vegetation on landside slope and toe.

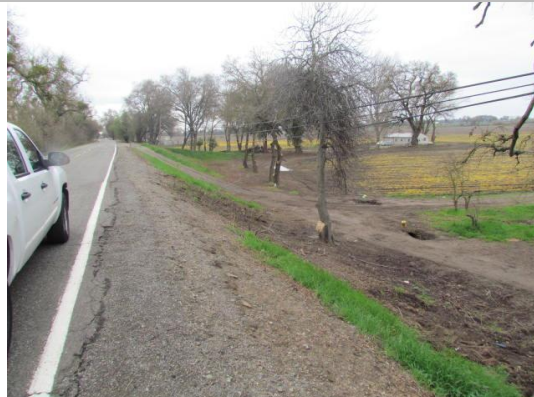
Photo 4 of 5 : FA_2014_RD0765_211_81_20141020_00072.jpg

Looking southwest at trimmed trees and vegetation on landside slope and toe.

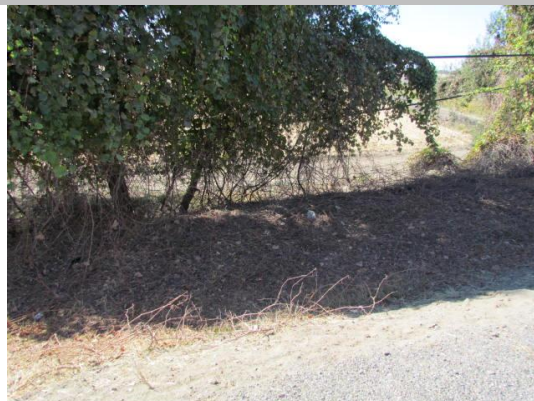
Photo 5 of 5 : FA_2014_RD0765_211_81_20141020_00073.jpg

Looking west at trimmed trees on landward slope.

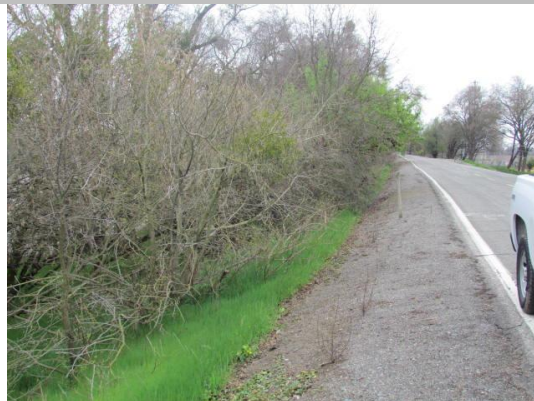
Photo 1 of 2 : FA_2014_RD0765_211_6_20141020_00007.jpg

LM Start	0.99	Rating **	A/W	Issue No.	6
LM End	1.15	Issue Type +	Ma	Location *	WS
Category	Earthen Levee			GPS Latitude/Longitude	
				Start	End
Item	Trim / Thin Trees			38.489664 °	38.487617 °
				-121.555370 °	-121.554200 °
DWR ID	DWR_RD0765_01_f_2012_6				
Action/Comments					
Trim trees to at least five feet above ground level.

Looking south (downstream) at untrimmed trees on waterward slope.

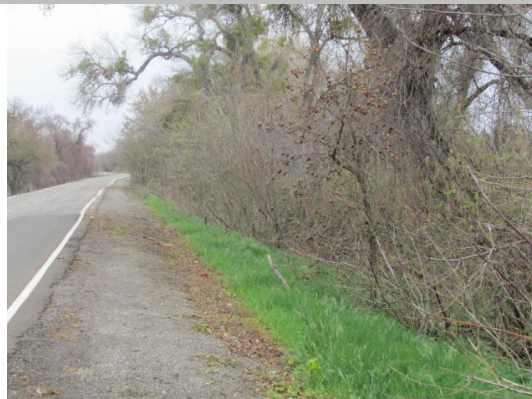
Photo 2 of 2 : FA_2014_RD0765_211_6_20141020_00008.jpg

Looking north (upstream) at untrimmed trees on waterward slope.

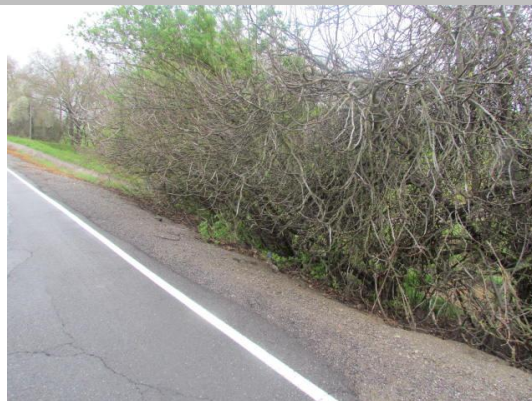
Photo 1 of 1 : FA_2014_RD0765_211_40_20141020_00053.jpg

LM Start	1.02	Rating **	A/W	Issue No.	40
LM End	1.02	Issue Type +	Ma	Location *	LS
Category	Earthen Levee			GPS Latitude/Longitude	
				Start	End
Item	Vegetation			38.489283 °	38.489283 °
				-121.555223 °	-121.555223 °
DWR ID	DWR_RD0765_01_s_2012_40				
Action/Comments					
Trees / Woody Vegetation					
Inspector Comments: Fig trees on landside slope

Looking southwest at fig trees and other trees on landside slope and toe.

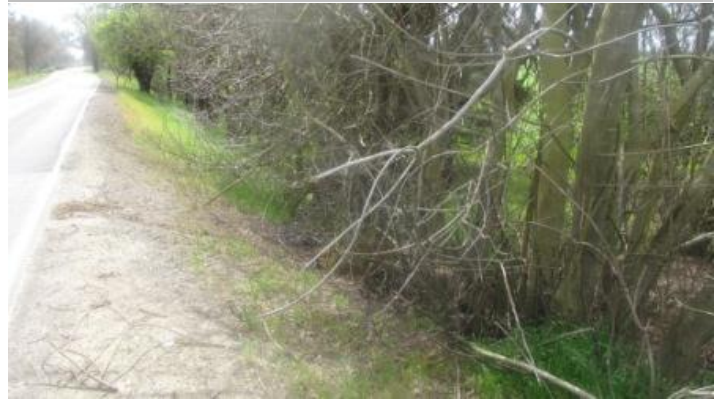
Photo 1 of 4 : FA_2014_RD0765_211_37_20141020_00049.jpg

Looking downstream (south) at trees on landside slope & toe from 2010 fall inspection.

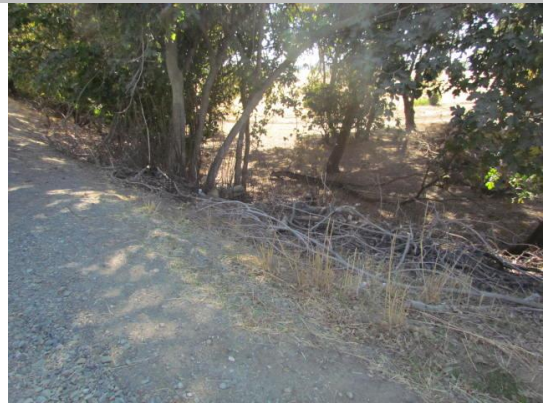
Photo 2 of 4 : FA_2014_RD0765_211_37_20141020_00050.jpg

Looking southwest at trees on landward slope.

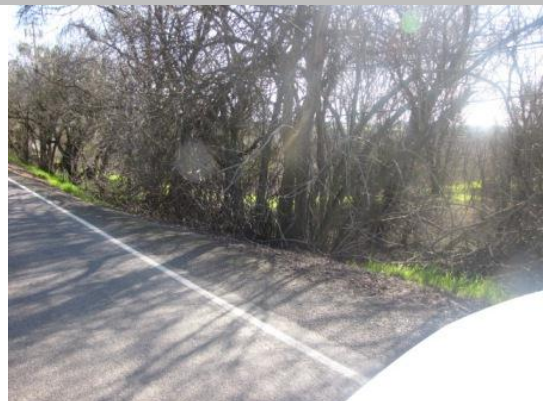
Photo 3 of 4 : FA_2014_RD0765_211_37_20141020_00051.jpg

Looking downstream (southwest) at dense trees on landside slope and toe.

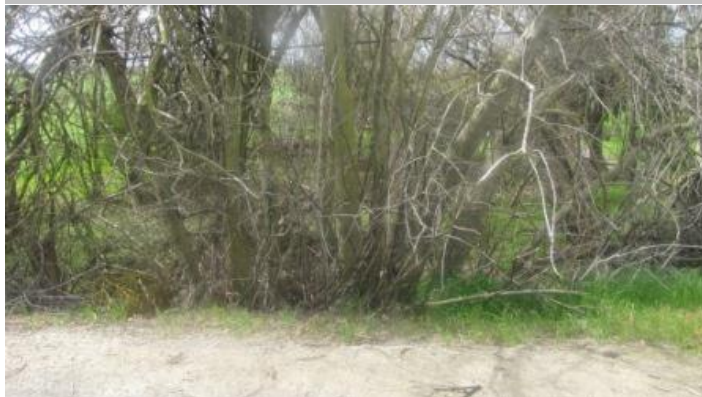
Photo 4 of 4 : FA_2014_RD0765_211_37_20141020_00052.jpg

Looking west at trees on landside slope & toe.

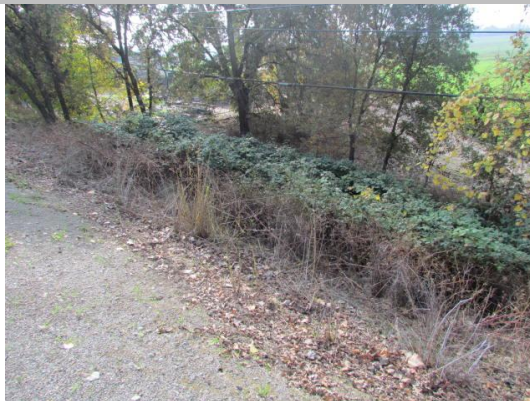
Photo 1 of 1 : FA_2014_RD0765_211_48_20141020_00056.jpg

Looking southwest at dense vegetation on landside slope and toe.

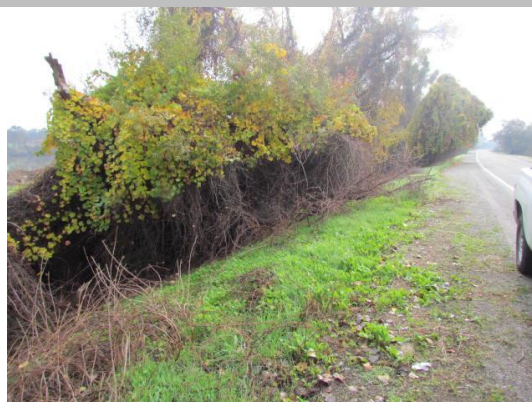
Photo 1 of 2 : FA_2014_RD0765_211_7_20141020_00009.jpg

Looking southeast at dense vegetation on waterside slope. (Fall Inspection 2012)

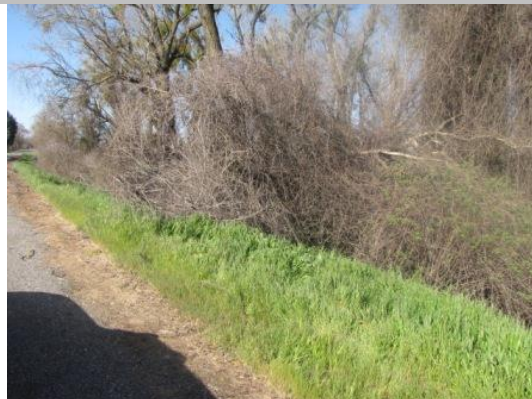
Photo 2 of 2 : FA_2014_RD0765_211_7_20141020_00010.jpg

Looking upstream (north) at dense vegetation on waterside slope.

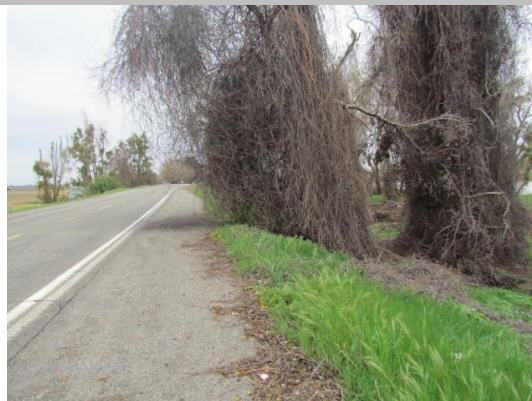
Photo 1 of 1 : FA_2014_RD0765_211_4_20141020_00004.jpg

LM Start	1.41	Rating **	A/W	Issue No.	4
LM End	1.41	Issue Type +	Ma	Location *	WS
Category	Earthen Levee			GPS Latitude/Longitude	
				Start	End
Item	Trim / Thin Trees			38.484316 °	38.484316 °
				-121.552115 °	-121.552115 °
DWR ID	DWR_RD0765_01_s_2012_4				
Action/Comments					
Trim trees to at least five feet above ground level.

Looking north at untrimmed trees on waterward slope.

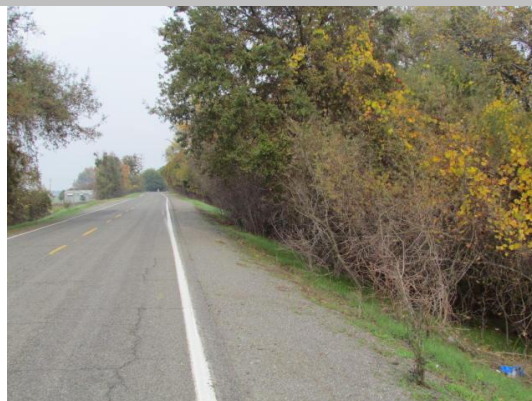
Photo 1 of 2 : FA_2014_RD0765_211_5_20141020_00005.jpg

LM Start	1.44	Rating **	A/W	Issue No.	5
LM End	1.47	Issue Type +	Ma	Location *	WS
Category	Earthen Levee			GPS Latitude/Longitude	
				Start	End
Item	Trim / Thin Trees			38.483925 °	38.483530 °
				-121.551845 °	-121.551587 °
DWR ID	DWR_RD0765_01_s_2012_5				
Action/Comments					
Thin trees to allow visibility of the ground and room to flood fight.

Looking north at dense vegetation on waterside slope. (Fall Inspection 2012)

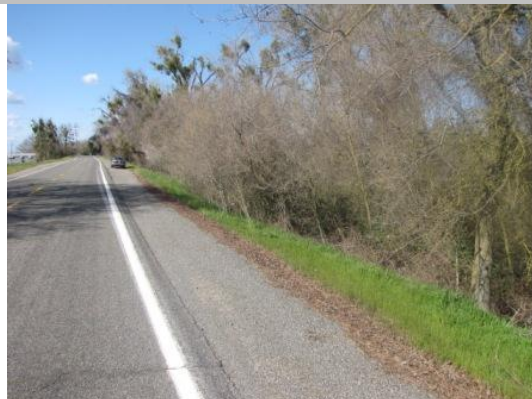
Photo 2 of 2 : FA_2014_RD0765_211_5_20141020_00006.jpg

Looking upstream (north) at dense trees on waterside slope.

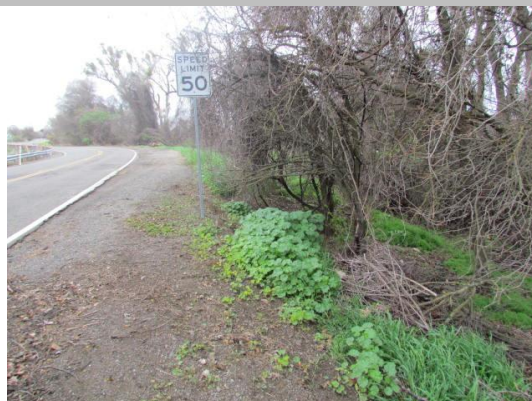
Photo 1 of 2 : FA_2014_RD0765_211_1_20141020_00001.jpg

Looking north at vegetation on waterward slope.

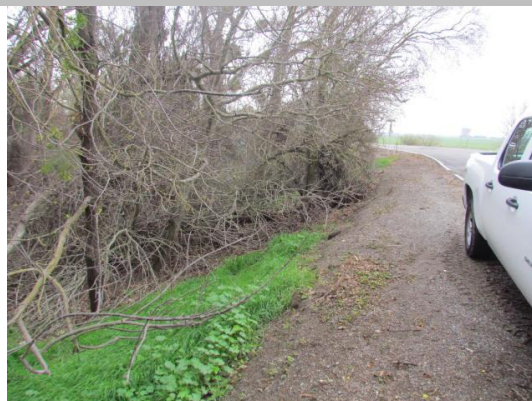
Photo 2 of 2 : FA_2014_RD0765_211_1_20141020_00002.jpg

Looking southeast at vegetation on waterward slope.

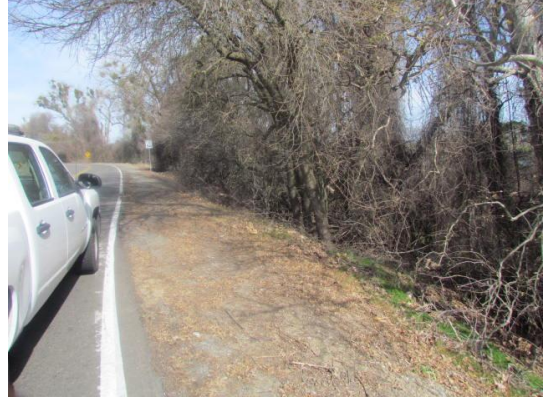
Photo 2 of 2 : FA_2014_RD0765_211_52_20141020_00060.jpg

Looking north (upstream) at dense trees on landside slope.
