**Flood Control Project Maintenance  
Levee Inspections**

## Maintenance Issue Types Only, Levee Inspection Report By Mile - Fall 2015

### Reclamation District No. 0765 Glide

Waterway	Bank	Unit Miles	Inspection Start/End	Inspector
Unit No. 01 Sacramento River	Right	1.72	09/25/2015 09/25/2015	Richard Willoughby

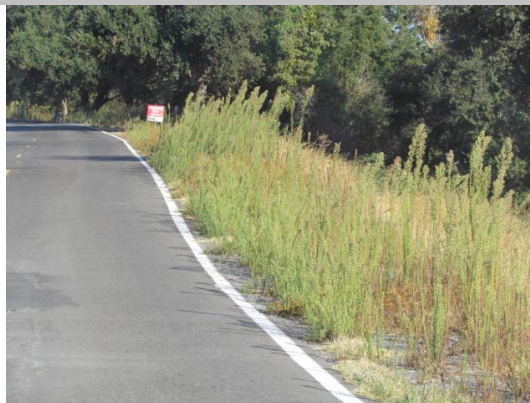
Photo 1 of 2 : FA\_2015\_RD0765\_211\_59\_20150925\_00065.jpg

LM Start	0.00	Rating **	U	Issue No.	59
LM End	1.17	Issue Type +	Ma	Location *	WS
Category	Earthen Levee			GPS Latitude/Longitude	
				Start	End
Item	Vegetation			38.502916 °	38.487256 °
				-121.559947 °	-121.553949 °
DWR ID	DWR_RD0765_01_f_2015_59				
Action/Comments					
Remove the wild growth other than native grasses from the levee slopes. Inspector Comments: Dense vegetation blocking view of waterward slope.

Looking south at typical view of vegetation on waterward slope.

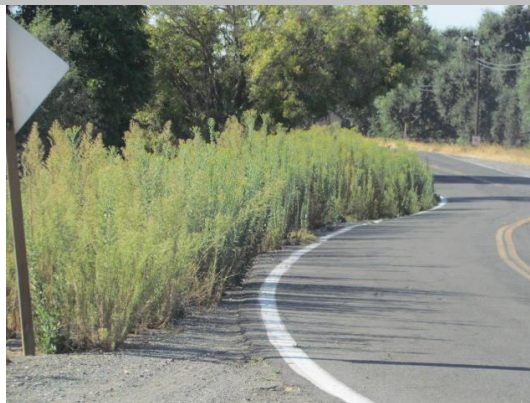
Photo 2 of 2 : FA\_2015\_RD0765\_211\_59\_20150925\_00066.jpg

Looking north at typical view of vegetation on waterward slope.

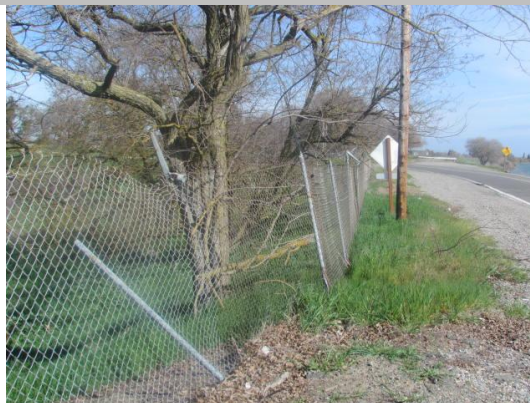
Photo 1 of 1 : FA\_2015\_RD0765\_211\_3\_20150914\_00001.jpg

LM Start	0.05	Rating **	M	Issue No.	3
LM End	0.05	Issue Type +	Ma	Location *	LS
Category	Earthen Levee			GPS Latitude/Longitude	
				Start	End
Item	Trim / Thin Trees			38.502253 °	38.502253 °
				-121.560192 °	-121.560192 °
DWR ID	DWR_RD0765_01_s_2012_3				
Action/Comments					
Trim trees to at least five feet above ground level.

Looking north (upstream) at trees on landside slope.

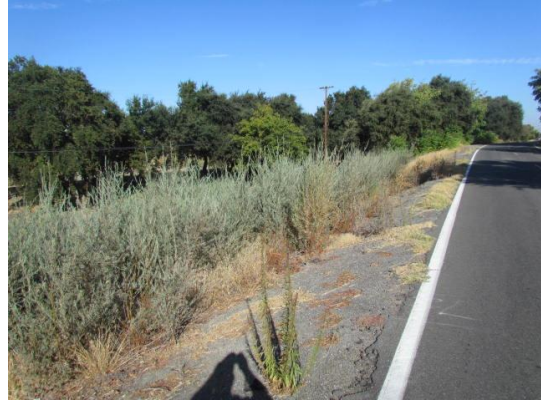
Photo 1 of 2 : FA\_2015\_RD0765\_211\_61\_20150925\_00067.jpg

LM Start	0.08	Rating **	U	Issue No.	61
LM End	1.15	Issue Type +	Ma	Location *	LS
Category	Earthen Levee			GPS Latitude/Longitude	
				Start	End
Item	Vegetation			38.501832 °	38.487471 °
				-121.560301 °	-121.554125 °
DWR ID	DWR_RD0765_01_f_2015_61				
Action/Comments					
Remove the wild growth other than native grasses from the levee slopes.

Looking south at typical view of vegetation on landward slope.

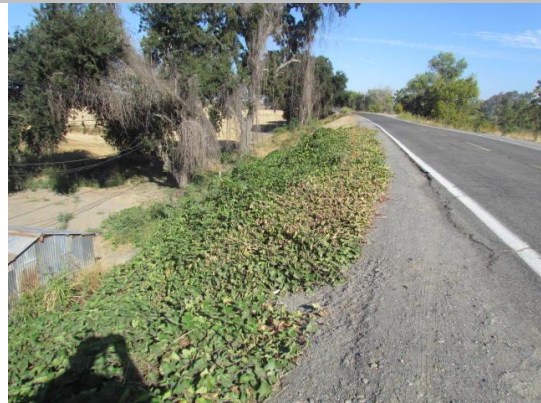
Photo 2 of 2 : FA\_2015\_RD0765\_211\_61\_20150925\_00068.jpg

LM Start	<b>0.08</b>	Rating **	U	Issue No.	<b>61 (cont)</b>
LM End	<b>1.15</b>	Issue Type +	Ma	Location *	LS

Looking north at typical view of vegetation on landward slope.

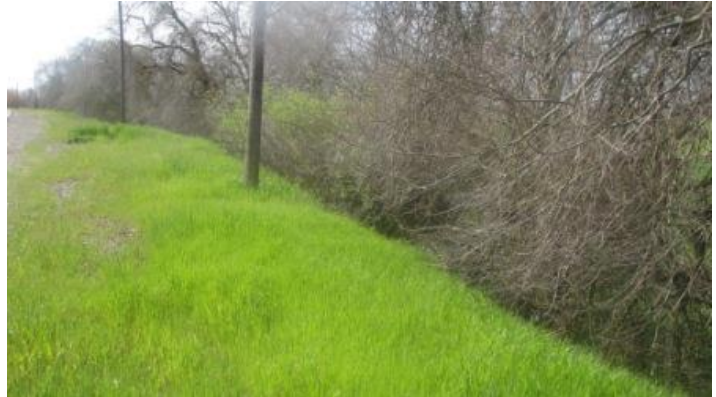
Photo 1 of 2 : FA\_2015\_RD0765\_211\_28\_20150914\_00025.jpg

LM Start	0.12	Rating **	M	Issue No.	28
LM End	0.19	Issue Type +	Ma	Location *	LS
Category	Earthen Levee			GPS Latitude/Longitude	
				Start	End
Item	Trim / Thin Trees			38.501215 °	38.500271 °
				-121.560432 °	-121.560434 °
DWR ID	DWR_RD0765_01_s _ 2012_28				
Action/Comments					
Trim and thin trees to allow visibility of the ground and room to flood fight.

Looking downstream (south) at trees on landside slope &amp; toe.

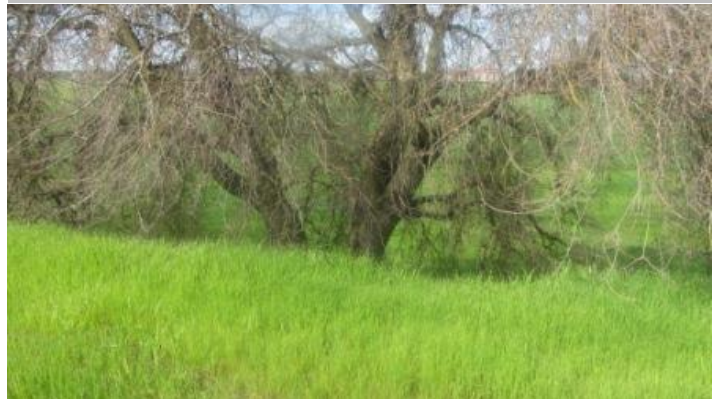
Photo 2 of 2 : FA\_2015\_RD0765\_211\_28\_20150914\_00026.jpg

LM Start	<b>0.12</b>	Rating **	M	Issue No.	<b>28 (cont)</b>
LM End	<b>0.19</b>	Issue Type +	Ma	Location *	LS

Looking west at trees on landside toe.

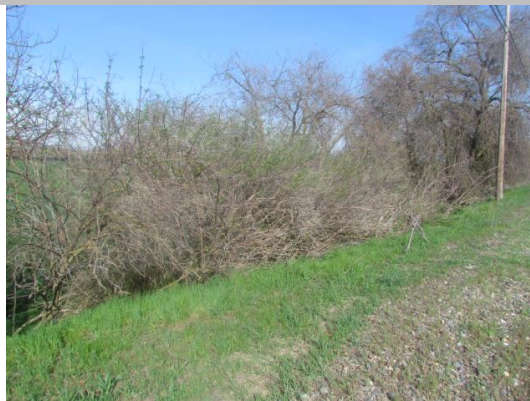
Photo 1 of 1 : FA\_2015\_RD0765\_211\_22\_20150914\_00022.jpg

LM Start	0.14	Rating **	M	Issue No.	22
LM End	0.14	Issue Type +	Ma	Location *	LS
Category	Earthen Levee			GPS Latitude/Longitude	
				Start	End
Item	Vegetation			38.500928 °	38.500928 °
				-121.560431 °	-121.560431 °
DWR ID	DWR_RD0765_01_s _ 2012_22				
Action/Comments					
Elderberries are blocking visibility and flood fight capability.

Looking northwest at dense vegetation on landside slope.

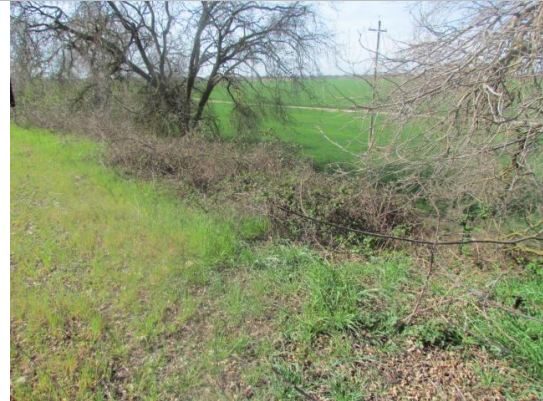
Photo 1 of 1 : FA\_2015\_RD0765\_211\_49\_20150914\_00047.jpg

LM Start	0.24	Rating **	M	Issue No.	49
LM End	0.24	Issue Type +	Ma	Location *	LS
Category	Earthen Levee			GPS Latitude/Longitude	
				Start	End
Item	Vegetation			38.499530 °	38.499530
				-121.560490 °	-121.560490
DWR ID	DWR_RD0765_01_s _ 2013_49				
Action/Comments					
Remove the wild growth other than native grasses from the levee slopes.					
Inspector Comments: Wild berryvines on landside slope.

Looking at wild berryvines or wild roses on landside slope and toe.

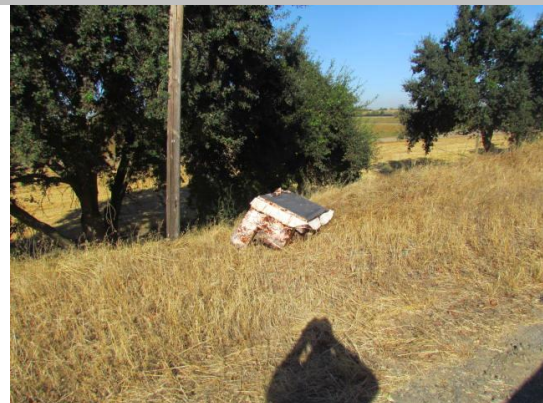
Photo 1 of 1 : FA\_2015\_RD0765\_211\_62\_20150925\_00069.jpg

LM Start	0.27	Rating **	M	Issue No.	62
LM End	0.27	Issue Type +	Ma	Location *	LS
Category	Earthen Levee			GPS Latitude/Longitude	
				Start	End
Item	Encroachments			38.499015 °	38.499015 °
				-121.560463 °	-121.560463 °
DWR ID	DWR_RD0765_01_f _ 2015_62				
Action/Comments					
Garbage					
Inspector Comments: Garbage on landward shoulder.

Looking westly at garbage on landward shoulder.

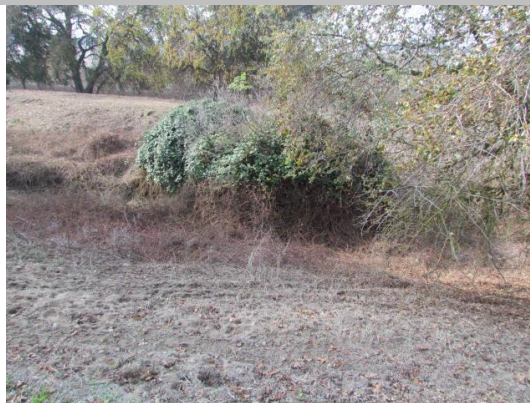
Photo 1 of 1 : FA\_2015\_RD0765\_211\_47\_20150914\_00045.jpg

Looking west at dense berryvines on landside toe.

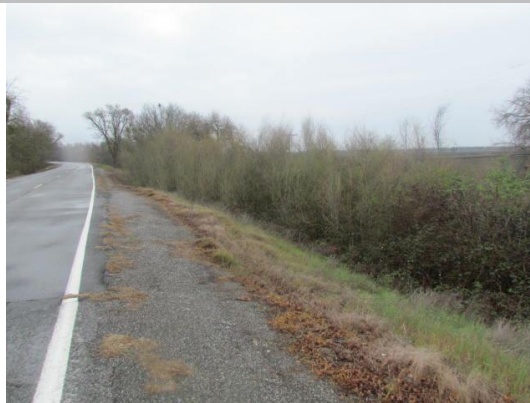
Photo 1 of 1 : FA\_2015\_RD0765\_211\_32\_20150914\_00033.jpg

LM Start	0.43	Rating **	M	Issue No.	32
LM End	0.46	Issue Type +	Ma	Location *	LS
Category	Earthen Levee			GPS Latitude/Longitude	
				Start	End
Item	Trim / Thin Trees			38.496792 °	38.496321 °
				-121.560026 °	-121.559842 °
DWR ID	DWR_RD0765_01_s _ 2012_32				
Action/Comments					
Trim and thin trees to allow visibility of the ground and room to flood fight.

Looking southwest at dense vegetation on landside slope and toe.

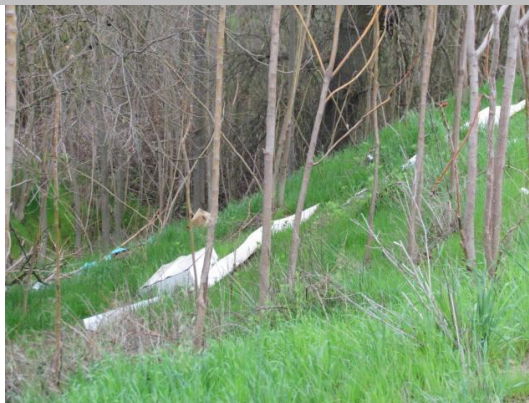
Photo 1 of 2 : FA\_2015\_RD0765\_211\_55\_20150914\_00056.jpg

Looking northwest at garbage on landside slope.

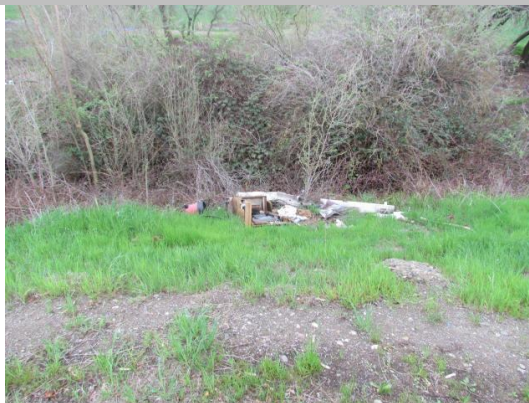
Photo 2 of 2 : FA\_2015\_RD0765\_211\_55\_20150914\_00057.jpg

LM Start	<b>0.47</b>	Rating **	A/W	Issue No.	<b>55 (cont)</b>
LM End	<b>0.47</b>	Issue Type +	Ma	Location *	LS

Looking west at garbage on landside slope.

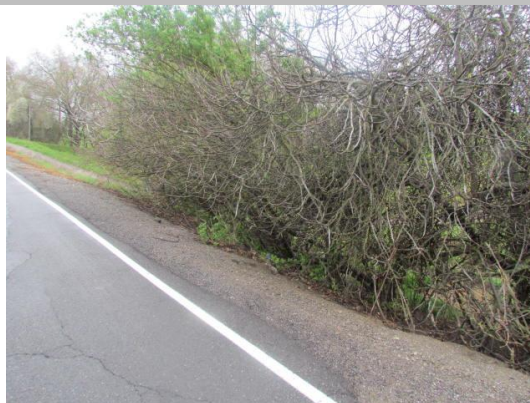
Photo 1 of 1 : FA\_2015\_RD0765\_211\_40\_20150914\_00043.jpg

Looking southwest at fig trees and other trees on landside slope and toe.

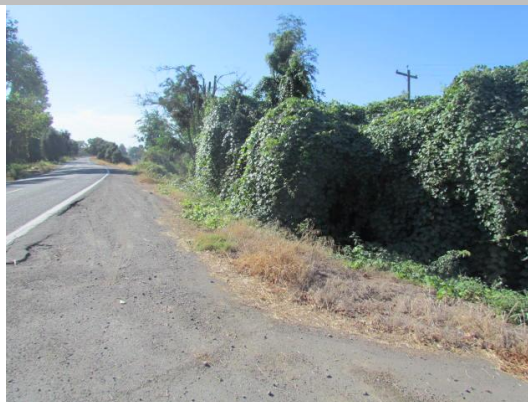
Photo 1 of 3 : FA\_2015\_RD0765\_211\_33\_20150925\_00070.jpg

Looking south from LM 1.28 at typical view of vegetation on landward slope.

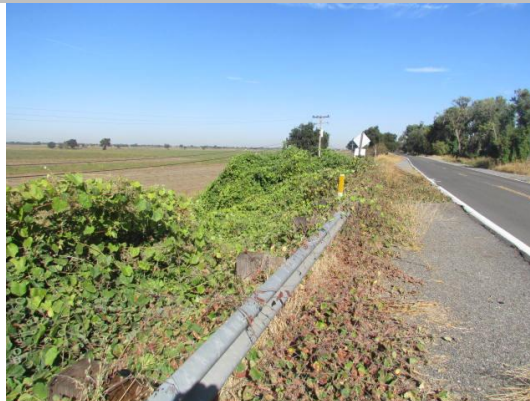
Photo 2 of 3 : FA\_2015\_RD0765\_211\_33\_20150925\_00071.jpg

Looking north from LM. 1.65 at dense vegetation on landward slope.

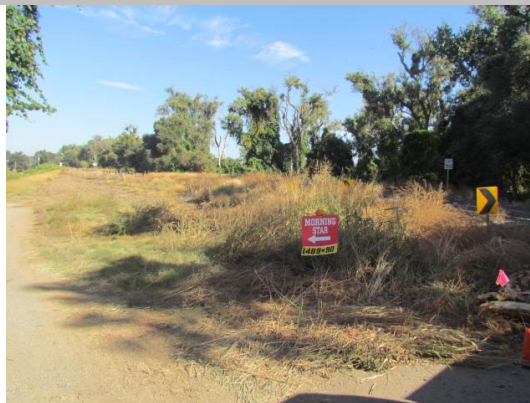
Photo 3 of 3 : FA\_2015\_RD0765\_211\_33\_20150925\_00072.jpg

Looking northeast from LM 1.71 at typical view of vegetation on landward slope.

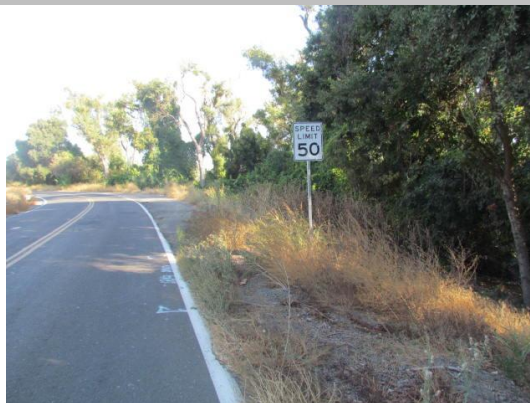
Photo 1 of 2 : FA\_2015\_RD0765\_211\_39\_20150925\_00073.jpg

LM Start	1.29	Rating **	U	Issue No.	39
LM End	1.70	Issue Type +	Ma	Location *	WS
Category	Earthen Levee			GPS Latitude/Longitude	
				Start	End
Item	Vegetation			38.485630 °	38.480394 °
				-121.553006 °	-121.549474 °
DWR ID	DWR_RD0765_01_f_2015_39				
Action/Comments					
Remove the wild growth other than native grasses from the levee slopes.					
Inspector Comments: Vegetation blocking view of waterward slope.

Looking north from LM 1.70 at typical view of vegetation on waterward slope.

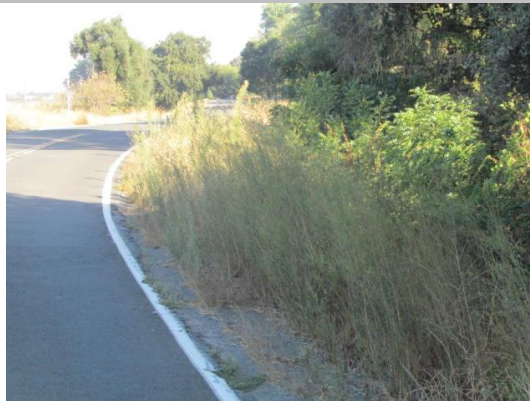
Photo 2 of 2 : FA\_2015\_RD0765\_211\_39\_20150925\_00074.jpg

Looking northeast from LM 1.29 at typical view of vegetation on waterward slope.

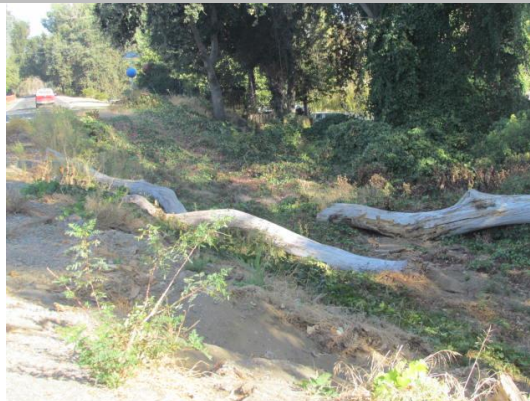
Photo 1 of 2 : FA\_2015\_RD0765\_211\_7\_20150925\_00075.jpg

Looking at several tree branches on waterward slope and berm.

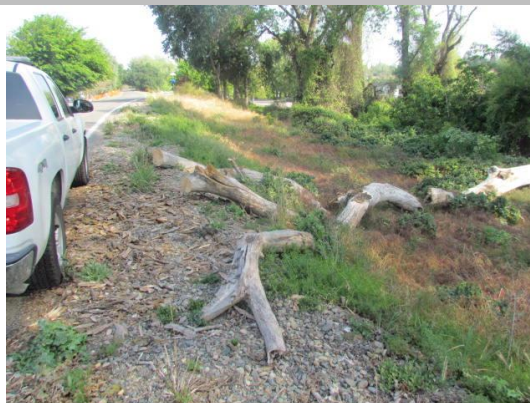
Photo 2 of 2 : FA\_2015\_RD0765\_211\_7\_20150914\_00007.jpg

Looking north at down tree across waterward slope.

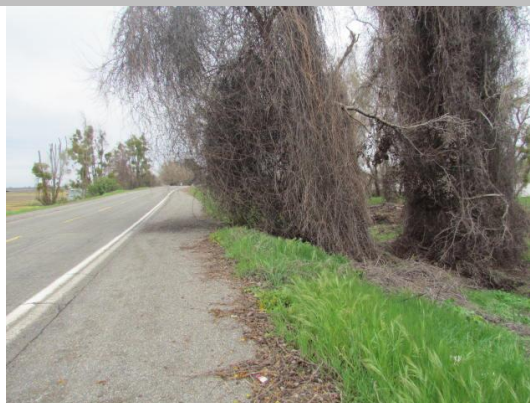
Photo 1 of 1 : FA\_2015\_RD0765\_211\_4\_20150914\_00002.jpg

LM Start	1.39	Rating **	M	Issue No.	4
LM End	1.39	Issue Type +	Ma	Location *	WS
Category	Earthen Levee			GPS Latitude/Longitude	
				Start	End
Item	Trim / Thin Trees			38.484316 °	38.484316 °
				-121.552115 °	-121.552115 °
DWR ID	DWR_RD0765_01_s _ 2012_4				
Action/Comments					
Trim trees to at least five feet above ground level.

Looking north at untrimmed trees on waterward slope.

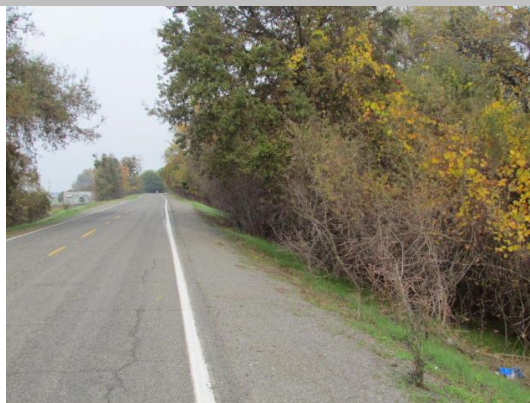
Photo 1 of 2 : FA\_2015\_RD0765\_211\_5\_20150914\_00003.jpg

LM Start	1.42	Rating **	M	Issue No.	5
LM End	1.45	Issue Type +	Ma	Location *	WS
Category	Earthen Levee			GPS Latitude/Longitude	
				Start	End
Item	Trim / Thin Trees			38.483925 °	38.483530 °
				-121.551845 °	-121.551587 °
DWR ID	DWR_RD0765_01_s _ 2012_5				
Action/Comments					
Thin trees to allow visibility of the ground and room to flood fight.

Looking north at dense vegetation on waterside slope. (Fall Inspection 2012)

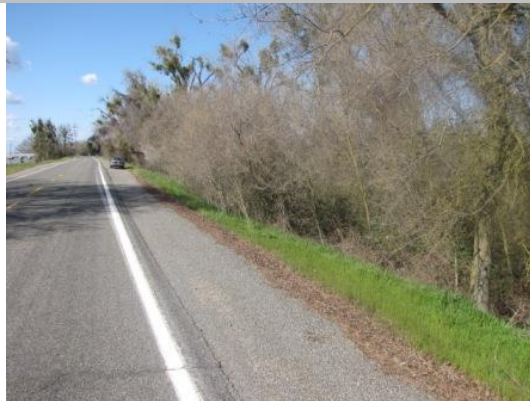
Photo 2 of 2 : FA\_2015\_RD0765\_211\_5\_20150914\_00004.jpg

Looking upstream (north) at dense trees on waterside slope.

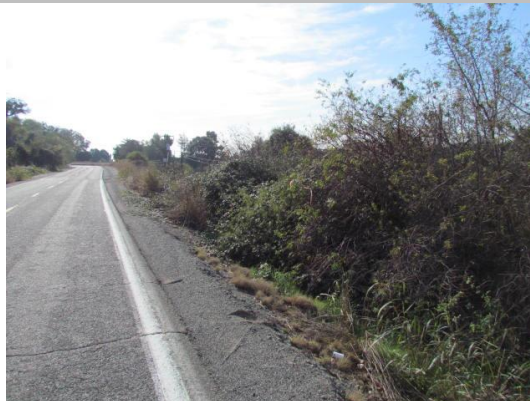
Photo 1 of 6 : FA\_2015\_RD0765\_211\_29\_20150914\_00027.jpg

Looking south at dense vegetation on landside shoulder and slope. (November 2011)

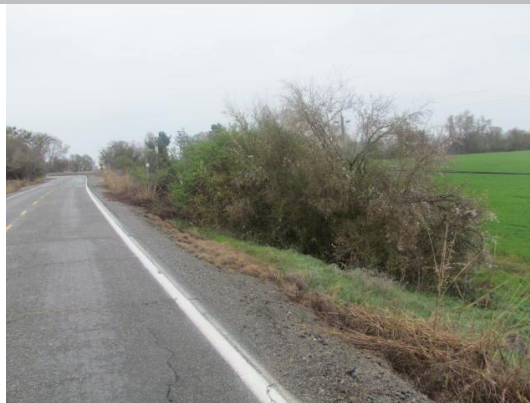
Photo 2 of 6 : FA\_2015\_RD0765\_211\_29\_20150914\_00028.jpg

LM Start	<b>1.52</b>	Rating **	M	Issue No.	<b>29 (cont)</b>
LM End	<b>1.62</b>	Issue Type +	Ma	Location *	LS

Looking south at dense vegetation on landside slope and toe spring 2012.

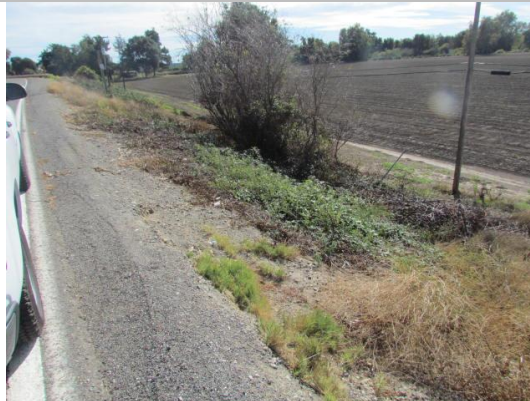
Photo 3 of 6 : FA\_2015\_RD0765\_211\_29\_20150914\_00029.jpg

LM Start	<b>1.52</b>	Rating **	M	Issue No.	<b>29 (cont)</b>
LM End	<b>1.62</b>	Issue Type +	Ma	Location *	LS

Looking south at moderate vegetation on landward slope and toe. (Fall 2014)

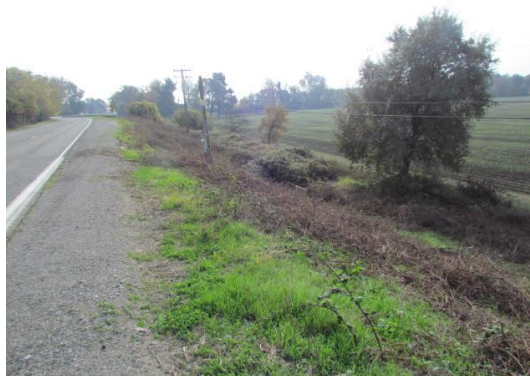
Photo 4 of 6 : FA\_2015\_RD0765\_211\_29\_20150914\_00030.jpg

Looking southwest at vegetation on landside slope and toe. (Fall Inspection 2012)

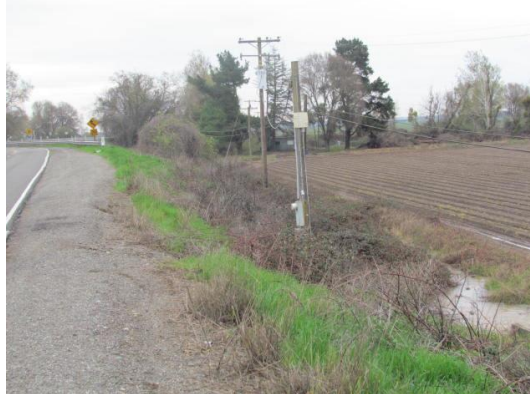
Photo 5 of 6 : FA\_2015\_RD0765\_211\_29\_20150914\_00031.jpg

LM Start	<b>1.52</b>	Rating **	M	Issue No.	<b>29 (cont)</b>
LM End	<b>1.62</b>	Issue Type +	Ma	Location *	LS

Looking southwest at berryvines on landside slope.

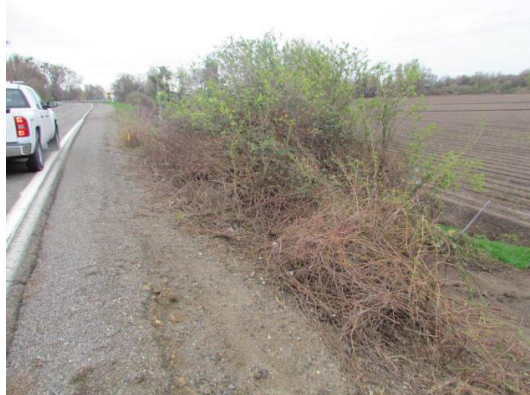
Photo 6 of 6 : FA\_2015\_RD0765\_211\_29\_20150914\_00032.jpg

LM Start	<b>1.52</b>	Rating **	M	Issue No.	<b>29 (cont)</b>
LM End	<b>1.62</b>	Issue Type +	Ma	Location *	LS

Looking southwest at vegetation on landside slope.

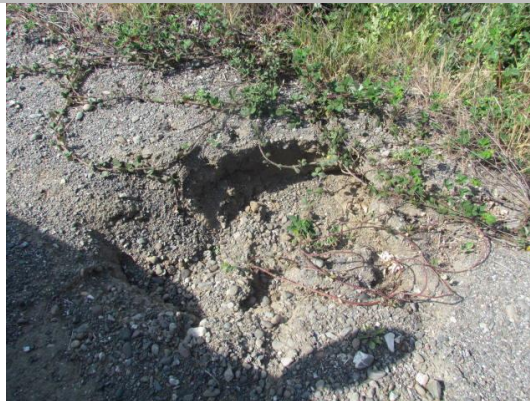
Photo 1 of 2 : FA\_2015\_RD0765\_211\_57\_20150914\_00061.jpg

Looking east at caving on landward shoulder.

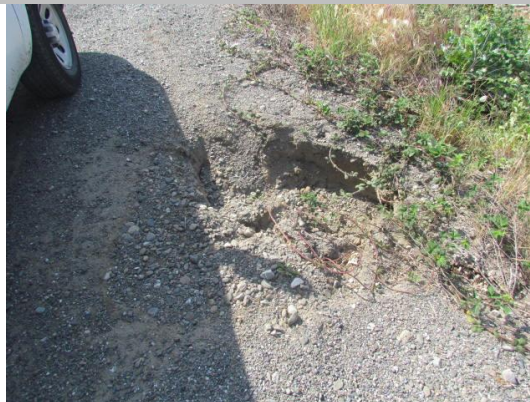
Photo 2 of 2 : FA\_2015\_RD0765\_211\_57\_20150914\_00062.jpg

LM Start	<b>1.55</b>	Rating **	U	Issue No.	<b>57 (cont)</b>
LM End	<b>1.55</b>	Issue Type +	Ma	Location *	LS

Looking south at caving on landward shoulder.

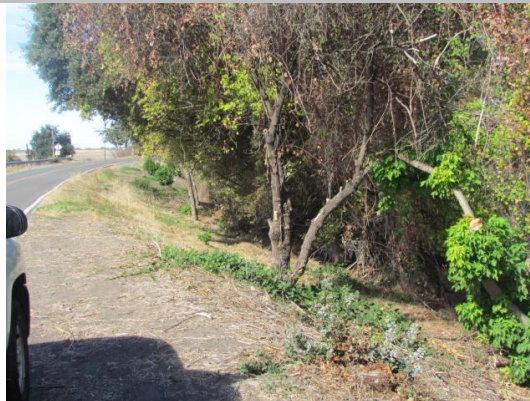
Photo 1 of 1 : FA\_2015\_RD0765\_211\_53\_20150914\_00052.jpg

Looking north at trimmed trees on waterward slope. (Fall 2014)

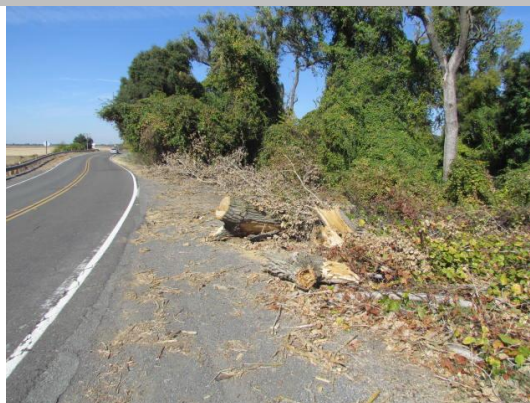
Photo 1 of 3 : FA\_2015\_RD0765\_211\_13\_20150914\_00013.jpg

Looking northeast at tree limbs on waterward slope.

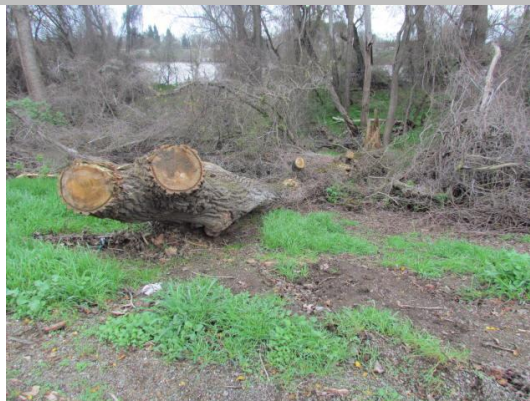
Photo 2 of 3 : FA\_2015\_RD0765\_211\_13\_20150914\_00014.jpg

LM Start	<b>1.67</b>	Rating **	M	Issue No.	<b>13 (cont)</b>
LM End	<b>1.68</b>	Issue Type +	Ma	Location *	WS

Looking east at large tree limb on waterward slope.

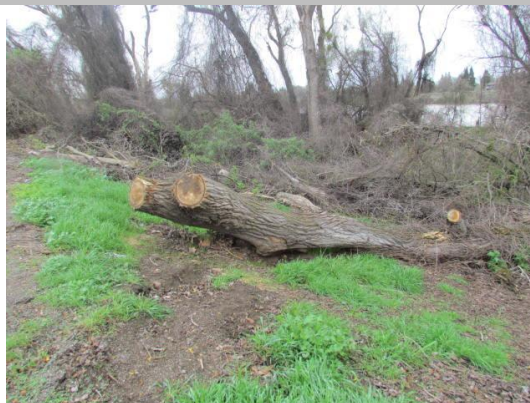
Photo 3 of 3 : FA\_2015\_RD0765\_211\_13\_20150914\_00015.jpg

Looking north at large tree limb on waterward slope.

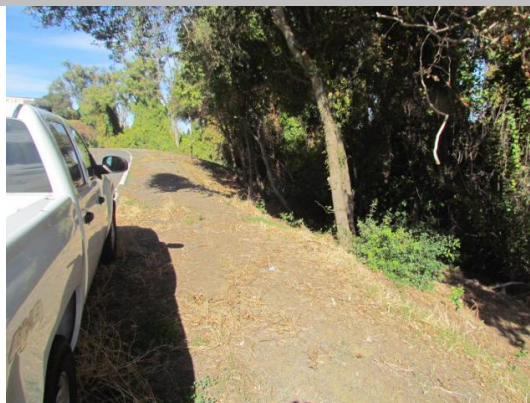
Photo 1 of 1 : FA\_2015\_RD0765\_211\_52\_20150914\_00050.jpg

Looking north (upstream) at trimmed trees on landward slope. (Fall 2014)

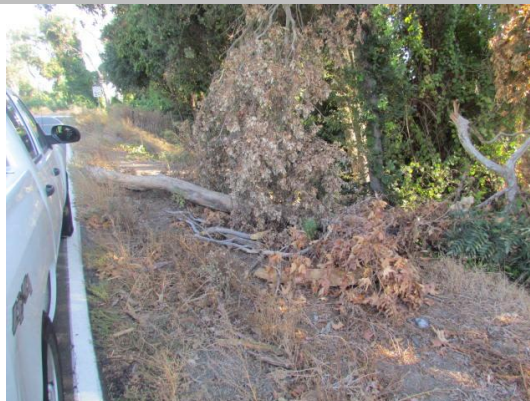
Photo 1 of 2 : FA\_2015\_RD0765\_211\_20\_20150925\_00076.jpg

LM Start	1.71	Rating **	M	Issue No.	20
LM End	1.71	Issue Type +	Ma	Location *	WS
Category	Earthen Levee			GPS Latitude/Longitude	
				Start	End
Item	Encroachments			38.480236 °	38.480236 °
				-121.549442 °	-121.549442 °
DWR ID	DWR_RD0765_01_f _ 2015_20				
Action/Comments					
Tree or limb					
Inspector Comments: Broken tree limbs on waterward slope.

Looking northeast at broken and cracked tree branches on waterward slope.

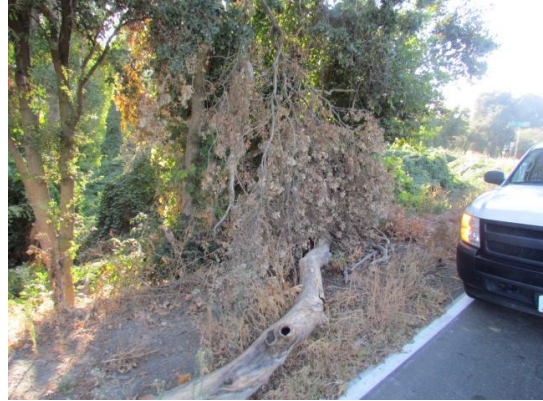
Photo 2 of 2 : FA\_2015\_RD0765\_211\_20\_20150925\_00077.jpg

LM Start	1.71	Rating **	M	Issue No.	20 (cont)
LM End	1.71	Issue Type +	Ma	Location *	WS
Category	Earthen Levee			GPS Latitude/Longitude	
				Start	End
Item	Encroachments			38.480236 °	38.480236 °
				-121.549442 °	-121.549442 °
DWR ID	DWR_RD0765_01_f_2015_20				
Action/Comments					
Tree or limb					
Inspector Comments: Broken tree limbs on waterward slope.

Looking south at broken and cracked tree branches on waterward slope.
