**Flood Control Project Maintenance
Levee Inspections**

Maintenance Issue Types Only, Levee Inspection Report By Mile - Fall 2016

Reclamation District No. 0765 Glide

Waterway	Bank	Unit Miles	Inspection Start/End	Inspector
Unit No. 01 Sacramento River	Right	1.72	09/07/2016 09/07/2016	Richard Willoughby

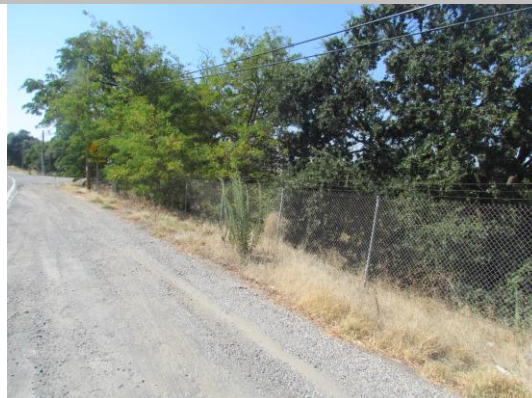
Photo 1 of 2 : FA_2016_RD0765_211_3_20160909_00063.jpg

LM Start	0.05	Rating **	U	Issue No.	3
LM End	0.05	Issue Type +	Ma	Location *	LS
Category	Earthen Levee			GPS Latitude/Longitude	
				Start	End
Item	Trim / Thin Trees			38.502253 °	38.502253 °
				-121.560192 °	-121.560192 °
DWR ID	DWR_RD0765_01_s_2012_3				
Comment Code					
T1 : Trim trees to at least five feet above ground level.					
Inspector Comment					
Trees blocking view of landward slope.

Looking southwest at untrimmed trees on landward slope.(Fall 2016)

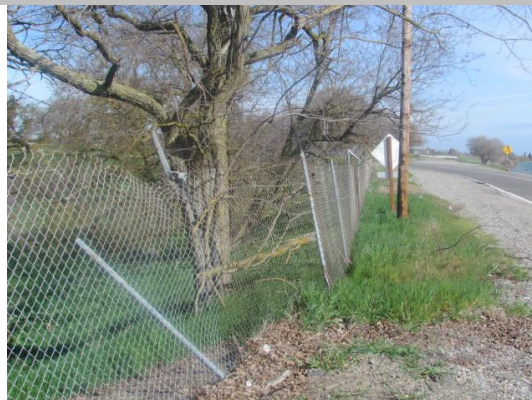
Photo 2 of 2 : FA_2016_RD0765_211_3_20160907_00003.jpg

Looking north (upstream) at trees on landside slope. (Spring 2016)

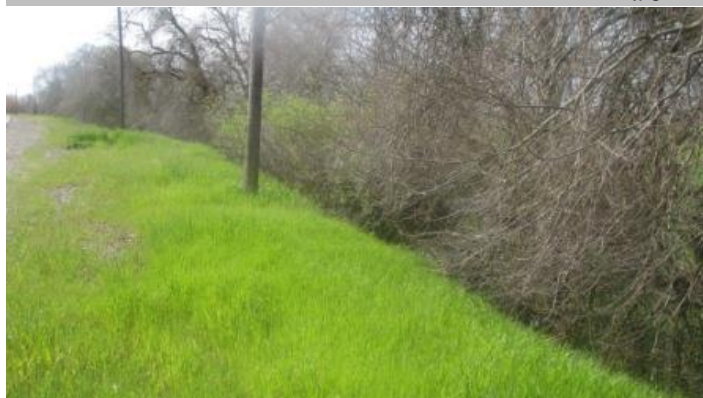
Photo 1 of 2 : FA_2016_RD0765_211_28_20160907_00019.jpg

LM Start	0.12	Rating **	M	Issue No.	28
LM End	0.19	Issue Type +	Ma	Location *	LS
Category	Earthen Levee			GPS Latitude/Longitude	
				Start	End
Item	Trim / Thin Trees			38.501215 °	38.500271 °
				-121.560432 °	-121.560434 °
DWR ID	DWR_RD0765_01_s _ 2012_28				
Comment Code					
T3 : Trim and thin trees to allow visibility of the ground and room to flood fight.					
Inspector Comment

Looking downstream (south) at trees on landside slope & toe.

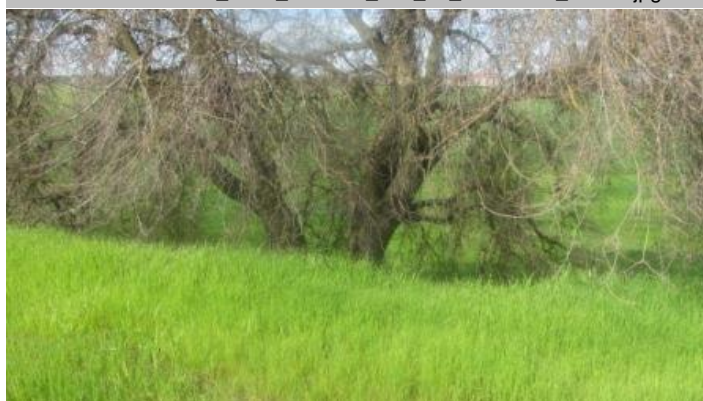
Photo 2 of 2 : FA_2016_RD0765_211_28_20160907_00020.jpg

Looking west at trees on landside toe.

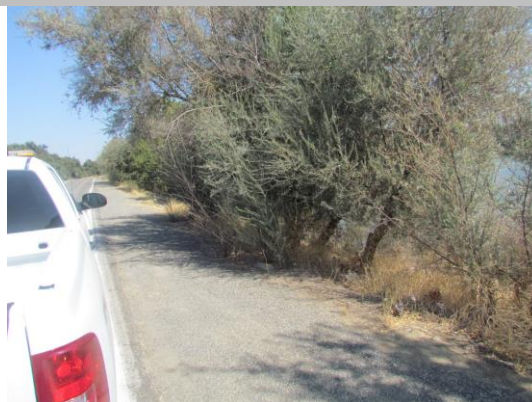
Photo 1 of 2 : FA_2016_RD0765_211_23_20160909_00065.jpg

LM Start	0.31	Rating **	M	Issue No.	23
LM End	0.31	Issue Type +	Ma	Location *	WS
Category	Earthen Levee			GPS Latitude/Longitude	
				Start	End
Item	Trim / Thin Trees			38.498453 °	38.498453 °
				-121.560360 °	-121.560360 °
DWR ID	DWR_RD0765_01_s_2012_23				
Comment Code					
T3 : Trim and thin trees to allow visibility of the ground and room to flood fight.					
Inspector Comment					
Trees should be trimmed and thinned.

Looking northeast at untrimmed trees on waterward shoulder. (Fall 2016)

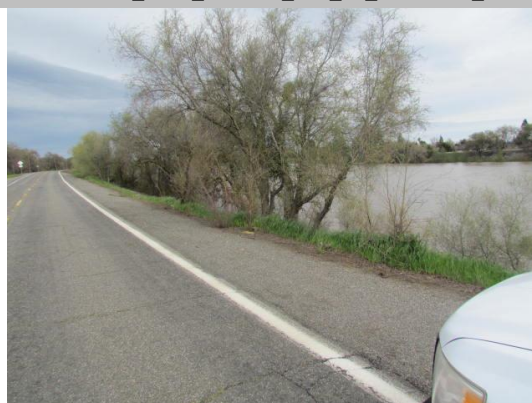
Photo 2 of 2 : FA_2016_RD0765_211_23_20160907_00017.jpg

Looking northeast at trees along waterward shoulder and slope. (Spring 2016)

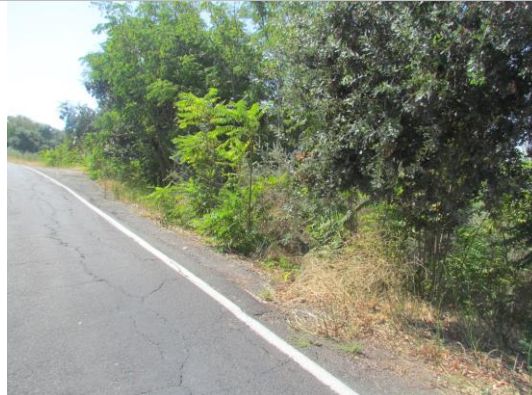
Photo 1 of 1 : FA_2016_RD0765_211_47_20160909_00066.jpg

LM Start	0.41	Rating **	U	Issue No.	47
LM End	0.46	Issue Type +	Ma	Location *	LS
Category	Earthen Levee			GPS Latitude/Longitude	
				Start	End
Item	Vegetation			38.497069 °	38.496389 °
				-121.560106 °	-121.559863 °
DWR ID	DWR_RD0765_01_f_2012_47				
Comment Code					
V2 : Remove the wild growth other than native grasses from the levee slopes.					
Inspector Comment					
Control wild berryvines on landside toe.

Looking southwest at dense vegetation on landward shoulder and slope.

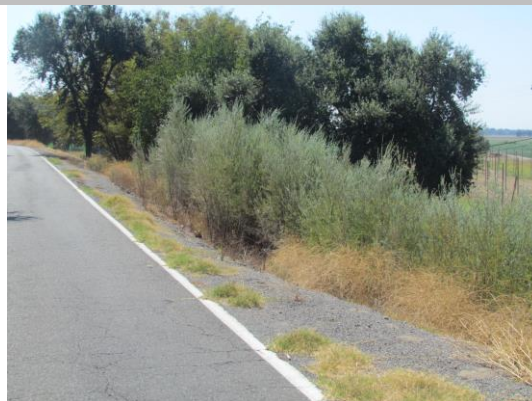
Photo 1 of 2 : FA_2016_RD0765_211_59_20160909_00068.jpg

LM Start	0.48	Rating **	U	Issue No.	59
LM End	0.48	Issue Type +	Ma	Location *	LS
Category	Earthen Levee			GPS Latitude/Longitude	
				Start	End
Item	Vegetation			38.496053 °	38.496053 °
				-121.559690 °	-121.559690 °
DWR ID	DWR_RD0765_01_s_2016_59				
Comment Code					
V2 : Remove the wild growth other than native grasses from the levee slopes.					
Inspector Comment					
Dense vegetation on landward slope.

Looking northwest at dense vegetation on landward slope. (Fall 2016)

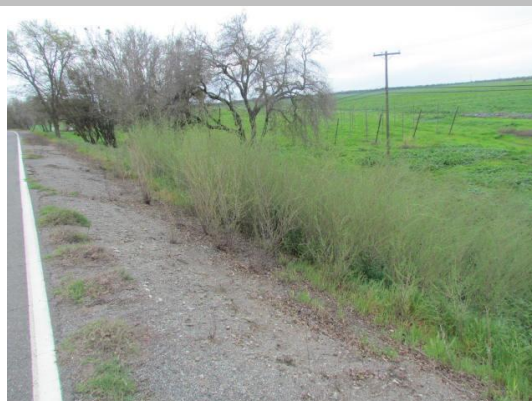
Photo 2 of 2 : FA_2016_RD0765_211_59_20160907_00045.jpg

Looking northwest at dense vegetation on landward slope. (Spring 2016)

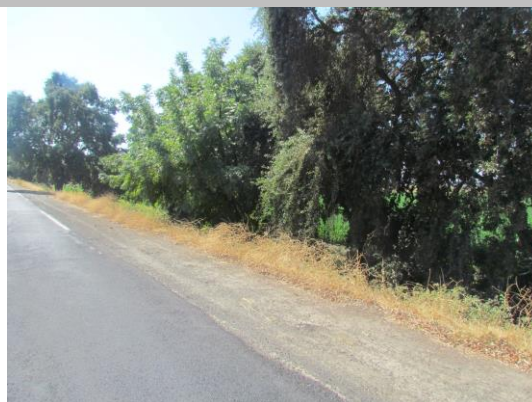
Photo 1 of 1 : FA_2016_RD0765_211_36_20160909_00069.jpg

LM Start	0.77	Rating **	U	Issue No.	36
LM End	0.80	Issue Type +	Ma	Location *	LS
Category	Earthen Levee			GPS Latitude/Longitude	
				Start	End
Item	Trim / Thin Trees			38.492392 °	38.492034 °
				-121.557026 °	-121.556820 °
DWR ID	DWR_RD0765_01_s_2012_36				
Comment Code					
T1 : Trim trees to at least five feet above ground level.					
Inspector Comment					
Untrimmed trees on landward slope.

Looking northwest at untrimmed trees on landward slope.

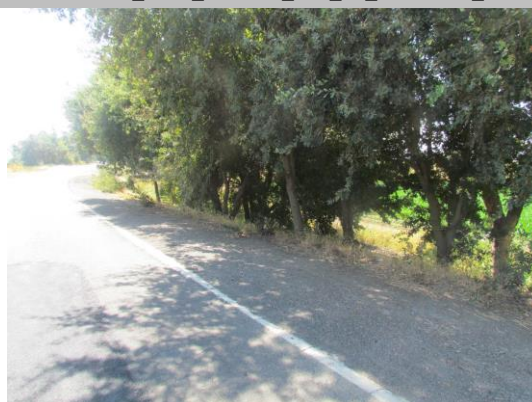
Photo 1 of 1 : FA_2016_RD0765_211_17_20160909_00070.jpg

LM Start	0.86	Rating **	U	Issue No.	17
LM End	0.98	Issue Type +	Ma	Location *	LS
Category	Earthen Levee			GPS Latitude/Longitude	
				Start	End
Item	Trim / Thin Trees			38.491283 °	38.489771 °
				-121.556360 °	-121.555451 °
DWR ID	DWR_RD0765_01_s_2012_17				
Comment Code					
T1 : Trim trees to at least five feet above ground level.					
Inspector Comment					
Untrimmed trees on landward slope.

Looking northwest at untrimmed trees on landward slope.

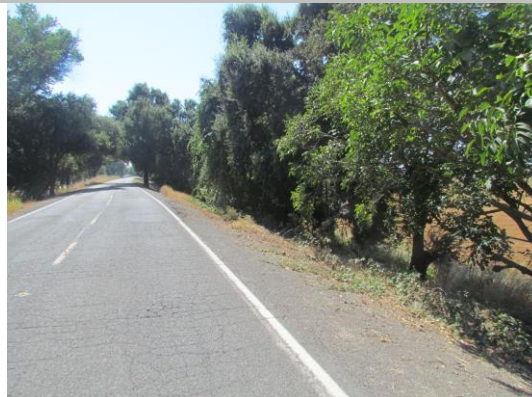
Photo 1 of 1 : FA_2016_RD0765_211_38_20160909_00073.jpg

LM Start	1.09	Rating **	M	Issue No.	38
LM End	1.15	Issue Type +	Ma	Location *	LS
Category	Earthen Levee			GPS Latitude/Longitude	
				Start	End
Item	Trim / Thin Trees			38.488279 °	38.487465 °
				-121.554615 °	-121.554117 °
DWR ID	DWR_RD0765_01_s_2012_38				
Comment Code					
T1 : Trim trees to at least five feet above ground level.					
Inspector Comment

Looking southwest at untrimmed trees on landward slope.

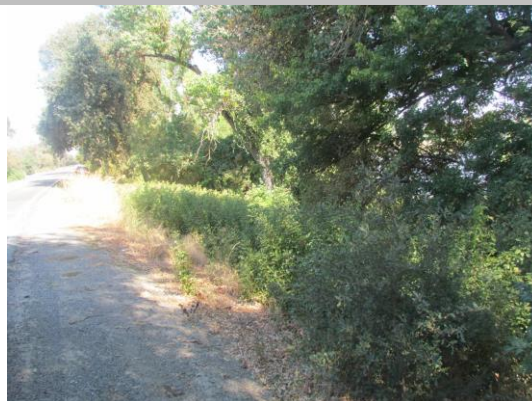
Photo 1 of 1 : FA_2016_RD0765_211_65_20160909_00074.jpg

LM Start	1.10	Rating **	U	Issue No.	65
LM End	1.14	Issue Type +	Ma	Location *	WS
Category	Earthen Levee			GPS Latitude/Longitude	
				Start	End
Item	Vegetation			38.488058 °	38.487646 °
				-121.554461 °	-121.554212 °
DWR ID	DWR_RD0765_01_f_2016_65				
Comment Code					
V2 : Remove the wild growth other than native grasses from the levee slopes.					
Inspector Comment					
wild roses on waterward slope.

Looking north at wildroses and untrimmed trees on waterward shoulder and slope.

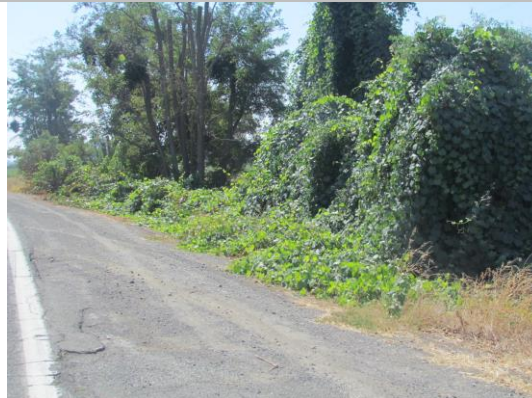
Photo 1 of 2 : FA_2016_RD0765_211_33_20160909_00076.jpg

LM Start	1.28	Rating **	U	Issue No.	33
LM End	1.32	Issue Type +	Ma	Location *	LS
Category	Earthen Levee			GPS Latitude/Longitude	
				Start	End
Item	Vegetation			38.485699 °	38.485161 °
				-121.553107 °	-121.552806 °
DWR ID	DWR_RD0765_01_f_2015_33				
Comment Code					
V2 : Remove the wild growth other than native grasses from the levee slopes.					
Inspector Comment					
Dense vines on landward slope and toe.

Looking west at dense vegetation (grapevines) on landward slope. (Fall 2016)

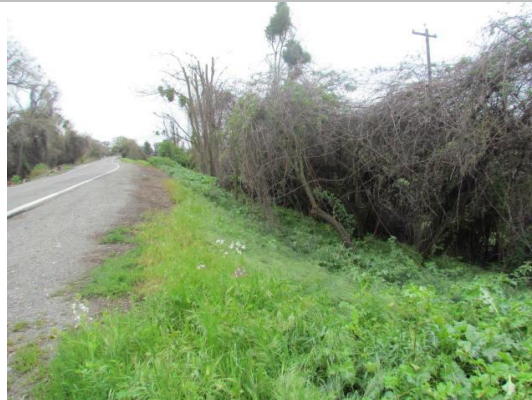
Photo 2 of 2 : FA_2016_RD0765_211_33_20160907_00026.jpg

Looking west at dense vegetation on landward toe.

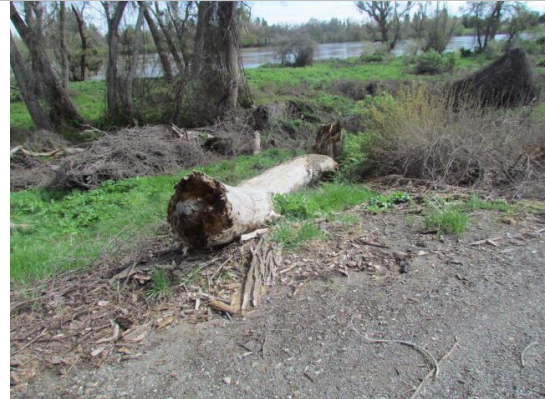
Photo 1 of 4 : FA_2016_RD0765_211_7_20160907_00005.jpg

Looking southeast at branch on waterward slope.

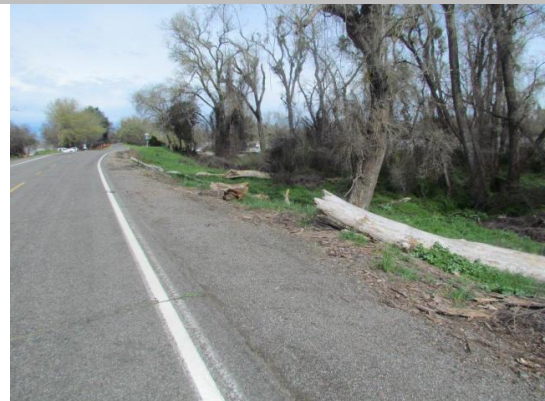
Photo 2 of 4 : FA_2016_RD0765_211_7_20160907_00006.jpg

Looking northeast at tree limbs on waterward slope.

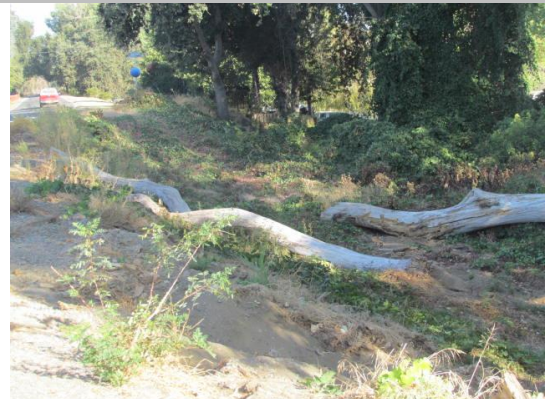
Photo 3 of 4 : FA_2016_RD0765_211_7_20160907_00007.jpg

Looking at several tree branches on waterward slope and berm.(2015)

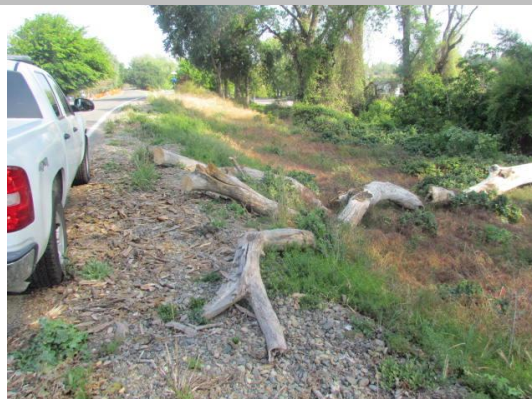
Photo 4 of 4 : FA_2016_RD0765_211_7_20160907_00008.jpg

Looking north at down tree across waterward slope.(2015)

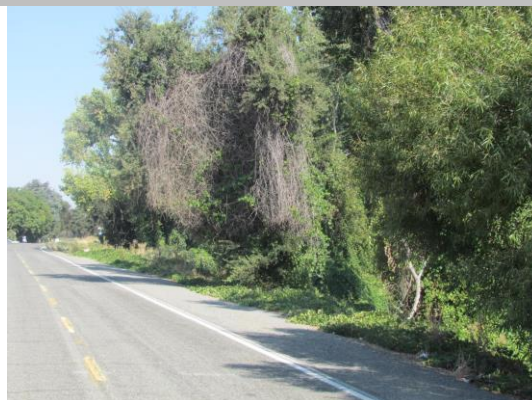
Photo 1 of 3 : FA_2016_RD0765_211_4_20160909_00078.jpg

LM Start	1.39	Rating **	M	Issue No.	4
LM End	1.39	Issue Type +	Ma	Location *	WS
Category	Earthen Levee			GPS Latitude/Longitude	
				Start	End
Item	Trim / Thin Trees			38.484316 °	38.484316 °
				-121.552115 °	-121.552115 °
DWR ID	DWR_RD0765_01_s_2012_4				
Comment Code					
T1 : Trim trees to at least five feet above ground level.					
Inspector Comment

Looking northeast at untrimmed trees and other vegetation on waterward slope. (Fall 2016)

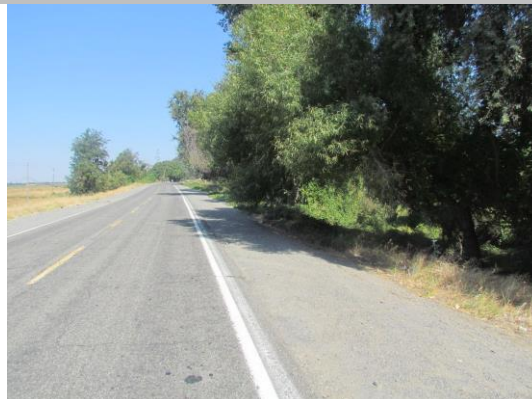
Photo 2 of 3 : FA_2016_RD0765_211_4_20160909_00077.jpg

Looking northeast at untrimmed trees on waterward slope. (Spring 2016)

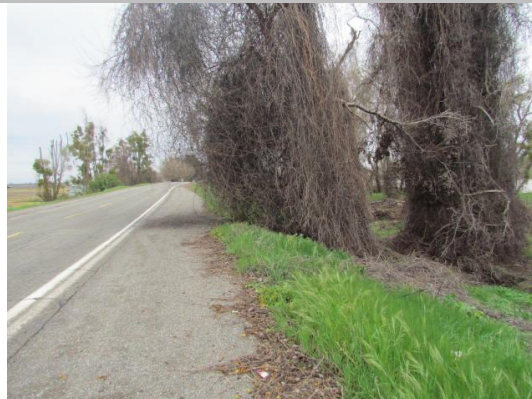
Photo 3 of 3 : FA_2016_RD0765_211_4_20160907_00004.jpg

Looking north at untrimmed trees on waterward slope. (Spring 2016)

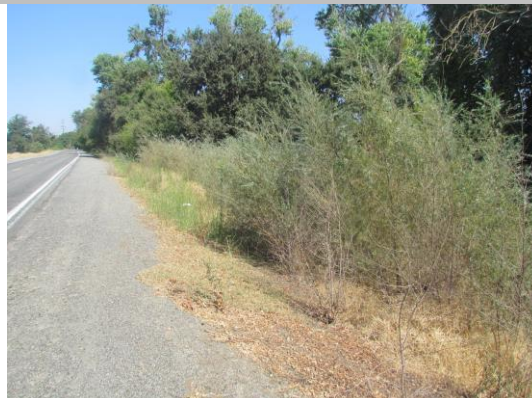
Photo 1 of 1 : FA_2016_RD0765_211_5_20160909_00079.jpg

LM Start	1.42	Rating **	U	Issue No.	5
LM End	1.45	Issue Type +	Ma	Location *	WS
Category	Earthen Levee			GPS Latitude/Longitude	
				Start	End
Item	Trim / Thin Trees			38.483925 °	38.483530 °
				-121.551845 °	-121.551587 °
DWR ID	DWR_RD0765_01_s_2012_5				
Comment Code					
T2 : Thin trees to allow visibility of the ground and room to flood fight.					
Inspector Comment					
Control willow trees on waterward slope.

Looking northwest at willows on waterward slope.

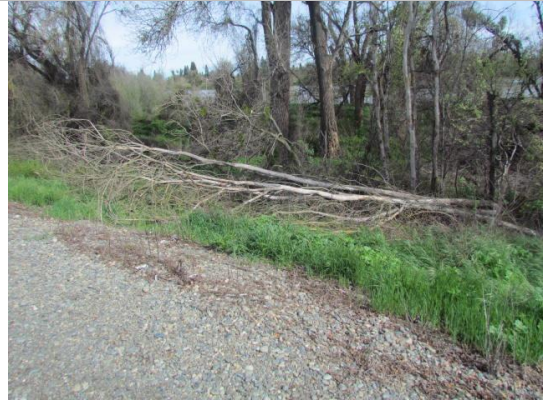
Photo 1 of 1 : FA_2016_RD0765_211_64_20160907_00050.jpg

Looking at fallen tree on waterward slope and toe.

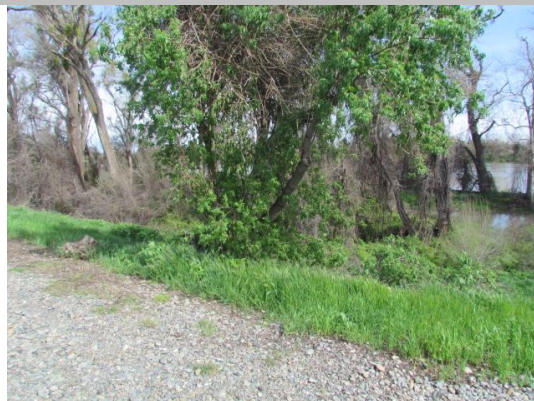
Photo 1 of 1 : FA_2016_RD0765_211_50_20160907_00031.jpg

Looking east at untrimmed tree on waterward slope.

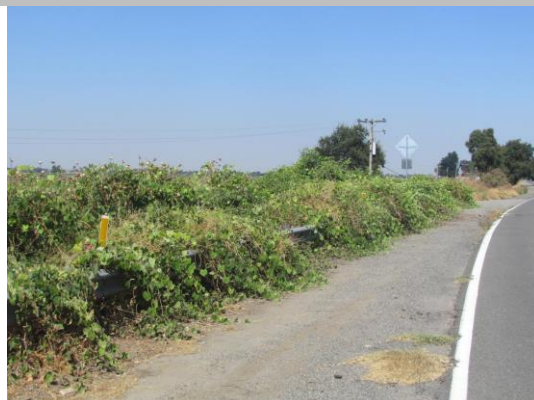
Photo 1 of 3 : FA_2016_RD0765_211_29_20160909_00081.jpg

LM Start	1.52	Rating **	U	Issue No.	29
LM End	1.62	Issue Type +	Ma	Location *	LS
Category	Earthen Levee			GPS Latitude/Longitude	
				Start	End
Item	Vegetation			38.482665 °	38.481421 °
				-121.551036 °	-121.550207 °
DWR ID	DWR_RD0765_01_s_2012_29				
Comment Code					
V2 : Remove the wild growth other than native grasses from the levee slopes.					
Inspector Comment					
Dense berryvines and dense trees on landward slope.

Looking northwest at berryvines on landward slope and toe. (Fall 2016)

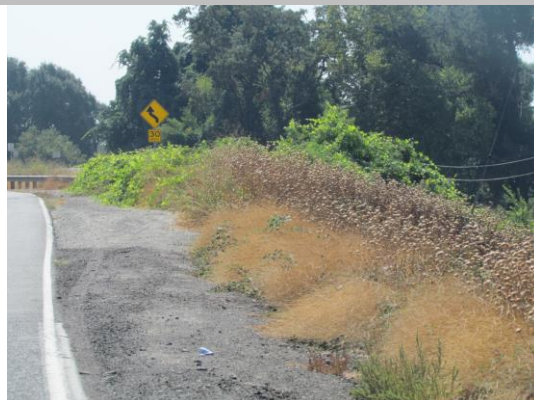
Photo 2 of 3 : FA_2016_RD0765_211_29_20160909_00080.jpg

Looking southwest at dense berry vines and other vegetation on landward slope. (Fall 2016)

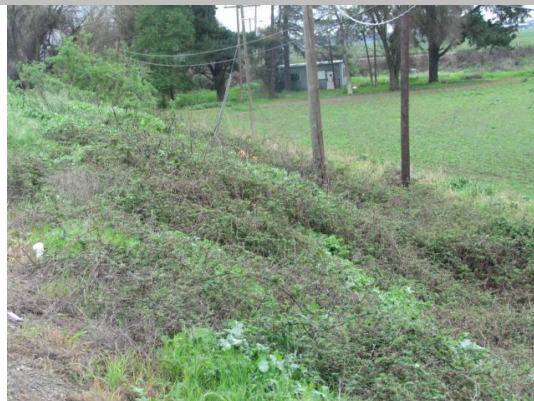
Photo 3 of 3 : FA_2016_RD0765_211_29_20160907_00022.jpg

Looking southwest at ground cover on landward slope. (Spring 2016)

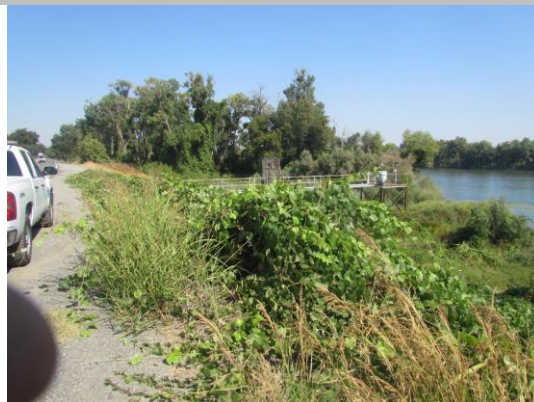
Photo 1 of 2 : FA_2016_RD0765_211_48_20160909_00082.jpg

Looking northeast at vines on waterward slope.

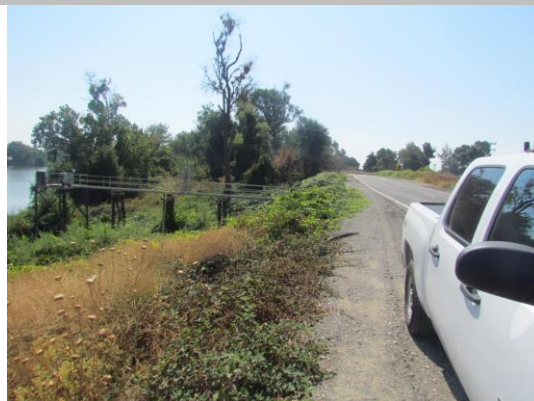
Photo 2 of 2 : FA_2016_RD0765_211_48_20160909_00083.jpg

Looking southeast at vines on waterward slope.

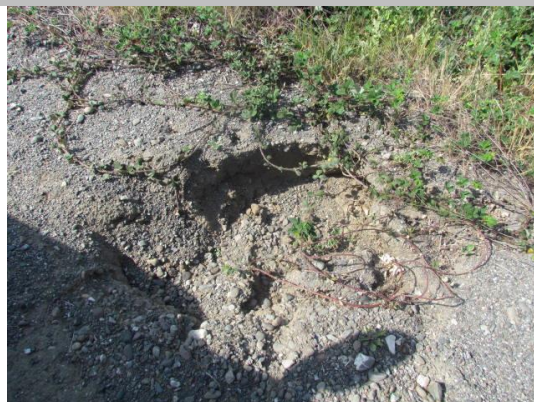
Photo 1 of 7 : FA_2016_RD0765_211_57_20160907_00037.jpg

LM Start	1.55	Rating **	U	Issue No.	57
LM End	1.55	Issue Type +	Ma	Location *	LS
Category	Earthen Levee			GPS Latitude/Longitude	
				Start	End
Item	Erosion / Bank Caving			38.482327 °	38.482327 °
				-121.550848 °	-121.550848 °
DWR ID	DWR_RD0765_01_s_2015_57				
Comment Code					
E2 : Schedule repair of erosion site prior to the next inspection.					
Inspector Comment					
Caving greater than one inch deep and greater that three inches in length on landward shoulder. Caving has grew to 3ft deep, 3ft wide and 10ft long. Erosion starting to undermine toward crown of levee.

Looking east at caving on landward shoulder.

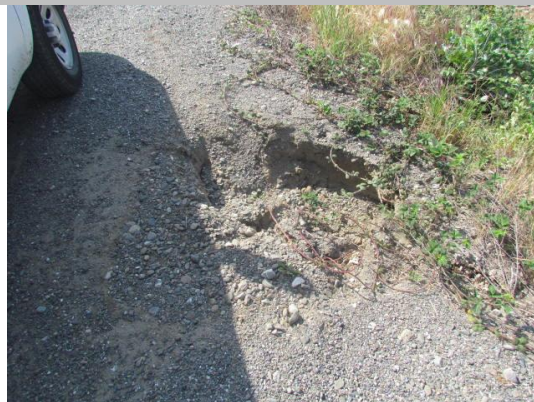
Photo 2 of 7 : FA_2016_RD0765_211_57_20160907_00038.jpg

Looking south at caving on landward shoulder.

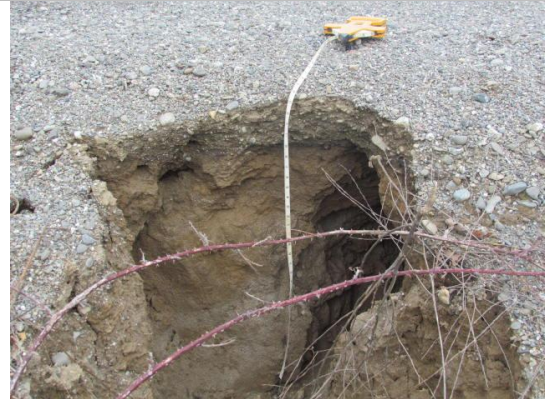
Photo 3 of 7 : FA_2016_RD0765_211_57_20160907_00039.jpg

LM Start	1.55	Rating **	U	Issue No.	57 (cont)
LM End	1.55	Issue Type +	Ma	Location *	LS
Category	Earthen Levee			GPS Latitude/Longitude	
				Start	End
Item	Erosion / Bank Caving			38.482327 °	38.482327 °
				-121.550848 °	-121.550848 °
DWR ID	DWR_RD0765_01_s_2015_57				
Comment Code					
E2 : Schedule repair of erosion site prior to the next inspection.					
Inspector Comment					
Caving greater than one inch deep and greater that three inches in length on landward shoulder. Caving has grew to 3ft deep, 3ft wide and 10ft long. Erosion starting to undermine toward crown of levee.

Looking east at large hole on landward shoulder and slope.

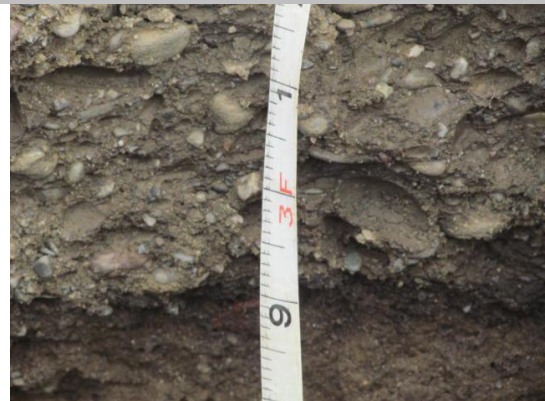
Photo 4 of 7 : FA_2016_RD0765_211_57_20160907_00040.jpg

Looking depth of hole on landward shoulder and slope.

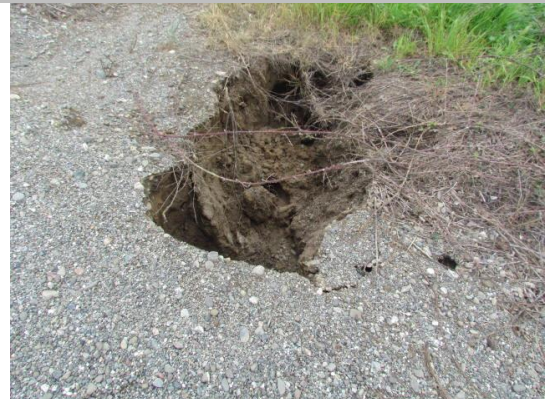
Photo 5 of 7 : FA_2016_RD0765_211_57_20160907_00041.jpg

Looking southwest at large hole on landward shoulder and slope.

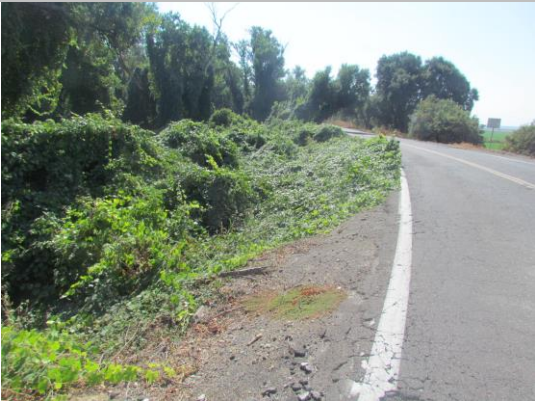
Photo 1 of 2 : FA_2016_RD0765_211_25_20160909_00086.jpg

Looking south on at dense berryvines on waterward slope.
