**Flood Control Project Maintenance
Levee Inspections**

Maintenance Issue Types Only, Levee Inspection Report By Mile - Fall 2017

Reclamation District No. 0765 Glide

Waterway	Bank	Unit Miles	Inspection Start/End	Inspector
Unit No. 01 Sacramento River	Right	1.72	09/05/2017 09/05/2017	Dave Torres

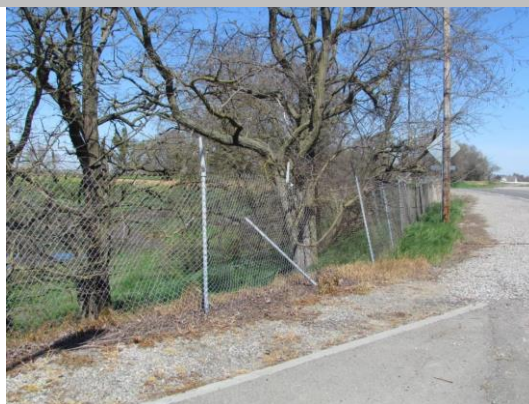
Photo 1 of 3 : FA_2017_RD0765_211_3_20170901_00001.jpg

LM Start	0.05	Rating **	U	Issue No.	3
LM End	0.05	Issue Type +	Ma	Location *	LS
Category	Earthen Levee			GPS Latitude/Longitude	
				Start	End
Item	Trim / Thin Trees			38.502253 °	38.502253 °
				-121.560192 °	-121.560192 °
DWR ID	DWR_RD0765_01_s_2012_3				
Comment Code					
T1 : Trim trees to at least five feet above ground level.					
Inspector Comment					
Trees blocking view of landward slope.

Looking north at untrimmed trees along landward slope. (Spring 2017)

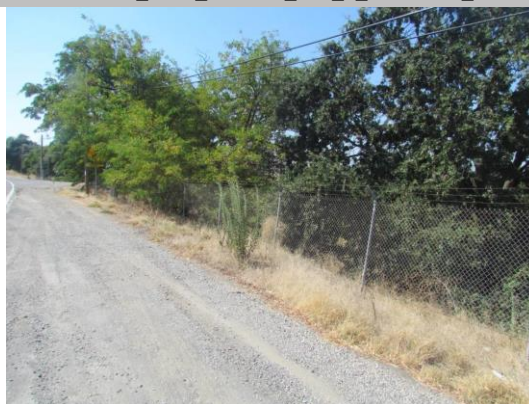
Photo 2 of 3 : FA_2017_RD0765_211_3_20170901_00002.jpg

Looking southwest at untrimmed trees on landward slope.(Fall 2016)

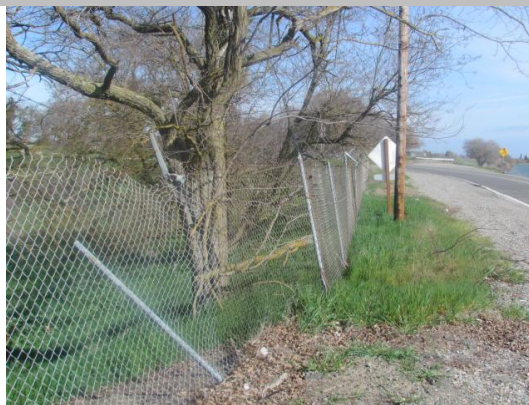
Photo 3 of 3 : FA_2017_RD0765_211_3_20170901_00003.jpg

LM Start	0.05	Rating **	U	Issue No.	3 (cont)	
LM End	0.05	Issue Type +	Ma	Location *	LS	
Category	Earthen Levee			GPS Latitude/Longitude		
				Start		End
Item	Trim / Thin Trees			38.502253 °		38.502253 °
				-121.560192 °		-121.560192 °
DWR ID	DWR_RD0765_01_s_2012_3					
Comment Code						
T1 : Trim trees to at least five feet above ground level.						
Inspector Comment						
Trees blocking view of landward slope.

Looking north (upstream) at trees on landside slope. (Spring 2016)

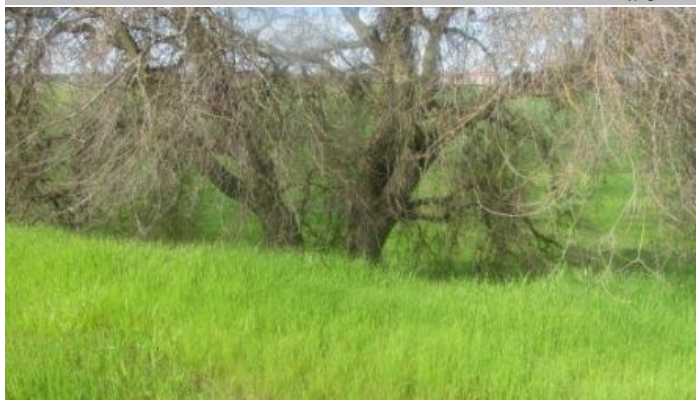
Photo 2 of 2 : FA_2017_RD0765_211_28_20170901_00029.jpg

LM Start	0.12	Rating **	M	Issue No.	28
LM End	0.25	Issue Type +	Ma	Location *	LS
Category	Earthen Levee			GPS Latitude/Longitude	
				Start	End
Item	Trim / Thin Trees			38.501215 °	38.499421 °
				-121.560432 °	-121.560471 °
DWR ID	DWR_RD0765_01_s_2012_28				
Comment Code					
T3 : Trim and thin trees to allow visibility of the ground and room to flood fight.					
Inspector Comment

Looking west at trees on landside toe.

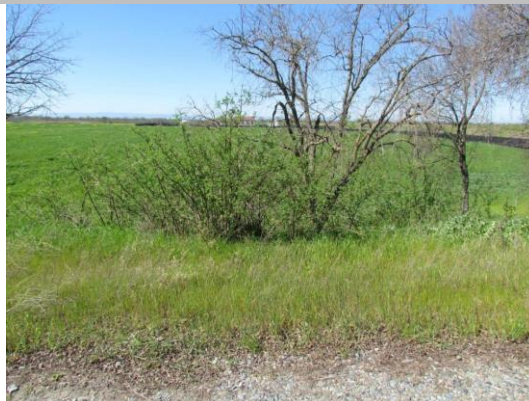
Photo 1 of 1 : FA_2017_RD0765_211_22_20170901_00019.jpg

LM Start	0.14	Rating **	M	Issue No.	22
LM End	0.14	Issue Type +	Ma	Location *	LS
Category	Earthen Levee			GPS Latitude/Longitude	
				Start	End
Item	Vegetation			38.500928 °	38.500928 °
				-121.560431 °	-121.560431 °
DWR ID	DWR_RD0765_01_s_2012_22				
Comment Code					
V2 : Remove the wild growth other than native grasses from the levee slopes.					
Inspector Comment					
Control growth on landward slope.

Looking west at moderate veg on landward slope.

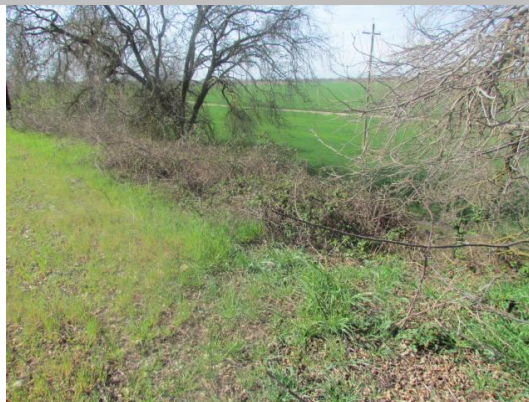
Photo 1 of 1 : FA_2017_RD0765_211_49_20170901_00049.jpg

LM Start	0.24	Rating **	M	Issue No.	49
LM End	0.24	Issue Type +	Ma	Location *	LS
Category	Earthen Levee			GPS Latitude/Longitude	
				Start	End
Item	Vegetation			38.499530 °	38.499530 °
				-121.560490 °	-121.560490 °
DWR ID	DWR_RD0765_01_s_2013_49				
Comment Code					
V2 : Remove the wild growth other than native grasses from the levee slopes.					
Inspector Comment					
Control wild berryvines on landside slope.

Looking at wild berryvines or wild roses on landside slope and toe.

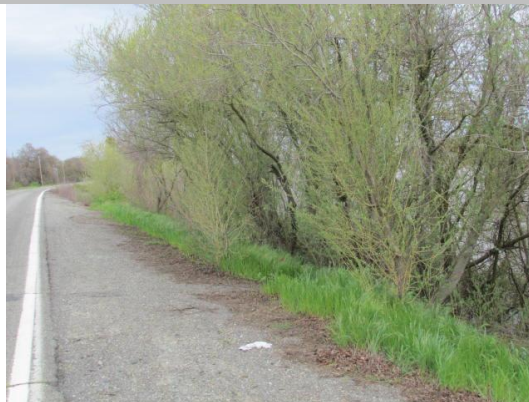
Photo 1 of 1 : FA_2017_RD0765_211_11_20170901_00013.jpg

LM Start	0.25	Rating **	U	Issue No.	11
LM End	0.27	Issue Type +	Ma	Location *	WS
Category	Earthen Levee			GPS Latitude/Longitude	
				Start	End
Item	Trim / Thin Trees			38.499405 °	38.499042 °
				-121.560445 °	-121.560430 °
DWR ID	DWR_RD0765_01_s_2012_11				
Comment Code					
T3 : Trim and thin trees to allow visibility of the ground and room to flood fight.					
Inspector Comment					
Trees shall be trimmed and thinned on waterward slope.

Looking southwest at trees along landward shoulder and slope.

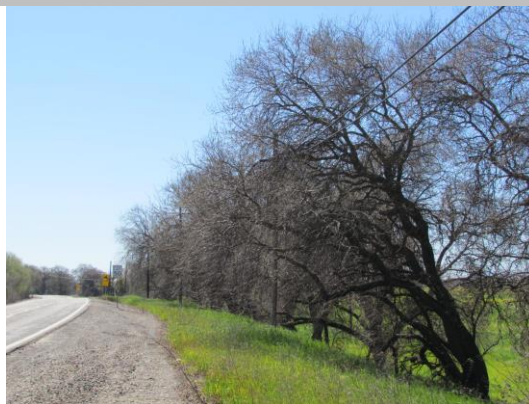
Photo 1 of 2 : FA_2017_RD0765_211_14_20170901_00016.jpg

LM Start	0.27	Rating **	U	Issue No.	14
LM End	0.34	Issue Type +	Ma	Location *	LS
Category	Earthen Levee			GPS Latitude/Longitude	
				Start	End
Item	Trim / Thin Trees			38.499065 °	38.498032 °
				-121.560468 °	-121.560337 °
DWR ID	DWR_RD0765_01_s_2012_14				
Comment Code					
T1 : Trim trees to at least five feet above ground level.					
Inspector Comment					
Untrimmed trees on landward slope has been untrimmed for multiple inspection cycles.

Looking southwest at untrimmed trees on landward slope. (Spring 2017)

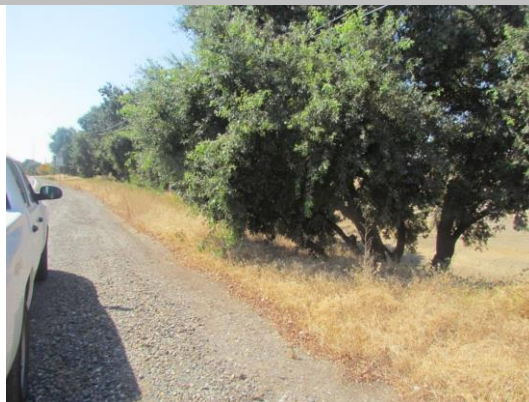
Photo 2 of 2 : FA_2017_RD0765_211_14_20170901_00017.jpg

Looking southwest at untrimmed trees on landward slope. (Fall 2016)

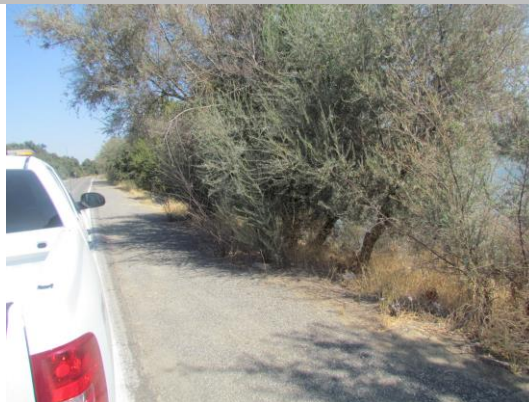
Photo 1 of 2 : FA_2017_RD0765_211_23_20170901_00020.jpg

LM Start	0.31	Rating **	M	Issue No.	23
LM End	0.31	Issue Type +	Ma	Location *	WS
Category	Earthen Levee			GPS Latitude/Longitude	
				Start	End
Item	Trim / Thin Trees			38.498453 °	38.498453 °
				-121.560360 °	-121.560360 °
DWR ID	DWR_RD0765_01_s_2012_23				
Comment Code					
T3 : Trim and thin trees to allow visibility of the ground and room to flood fight.					
Inspector Comment					
Trees should be trimmed and thinned.

Looking northeast at untrimmed trees on waterward shoulder. (Fall 2016)

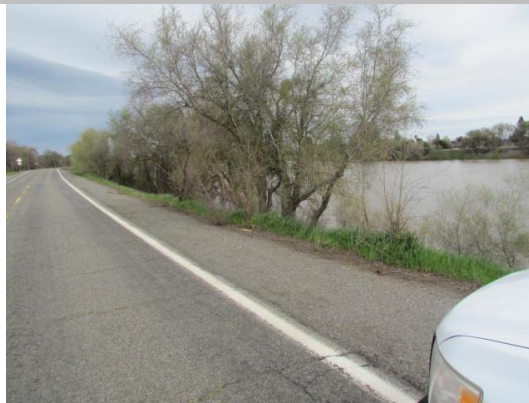
Photo 2 of 2 : FA_2017_RD0765_211_23_20170901_00021.jpg

Looking northeast at trees along waterward shoulder and slope. (Spring 2016)

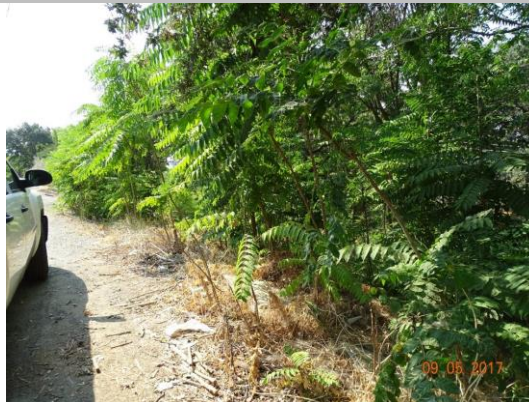
Photo 1 of 3 : FA_2017_RD0765_211_47_20170919_00081.jpg

Looking south at the landside slope.

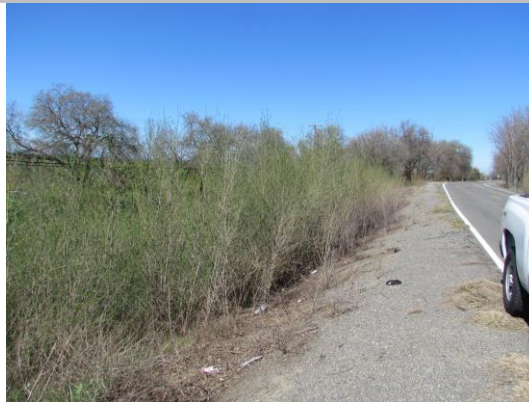
Photo 2 of 3 : FA_2017_RD0765_211_47_20170901_00045.jpg

Looking north at dense willows on landward slope. (Spring 2017)

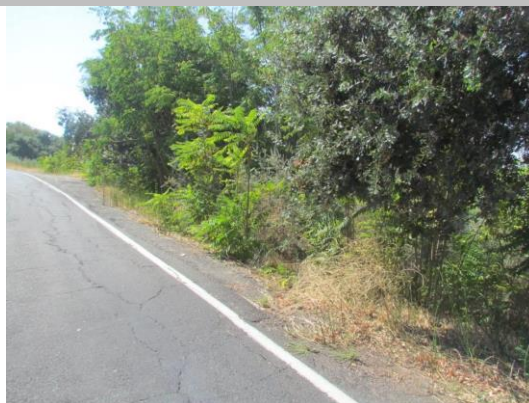
Photo 3 of 3 : FA_2017_RD0765_211_47_20170901_00046.jpg

Looking southwest at dense vegetation on landward shoulder and slope. (Fall 2016)

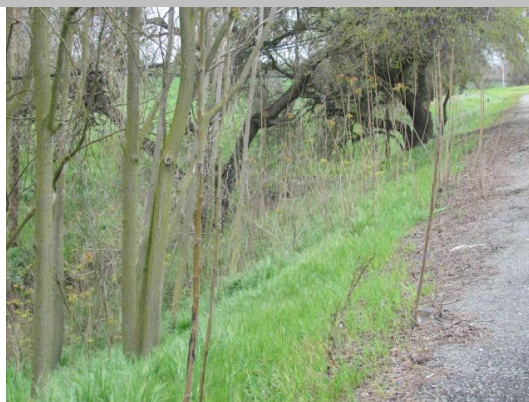
Photo 1 of 2 : FA_2017_RD0765_211_32_20170901_00034.jpg

LM Start	0.43	Rating **	U	Issue No.	32
LM End	0.46	Issue Type +	Ma	Location *	LS
Category	Earthen Levee			GPS Latitude/Longitude	
				Start	End
Item	Trim / Thin Trees			38.496792 °	38.496321 °
				-121.560026 °	-121.559842 °
DWR ID	DWR_RD0765_01_s_2012_32				
Comment Code					
T3 : Trim and thin trees to allow visibility of the ground and room to flood fight.					
Inspector Comment					
New saplings and other wild veg should be removed.

Looking northwest at trees (saplings) on landward slope.

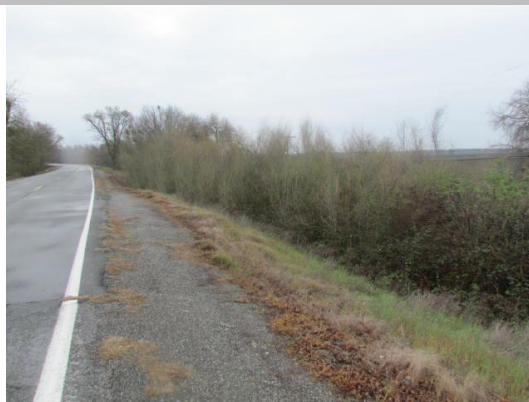
Photo 2 of 2 : FA_2017_RD0765_211_32_20170901_00035.jpg

Looking southwest at dense vegetation on landside slope and toe. (2015)

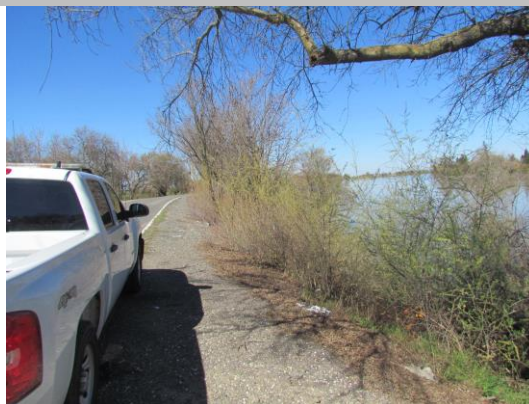
Photo 1 of 4 : FA_2017_RD0765_211_24_20170901_00022.jpg

Looking north at willows and other veg. on waterward slope. (Spring 2017)

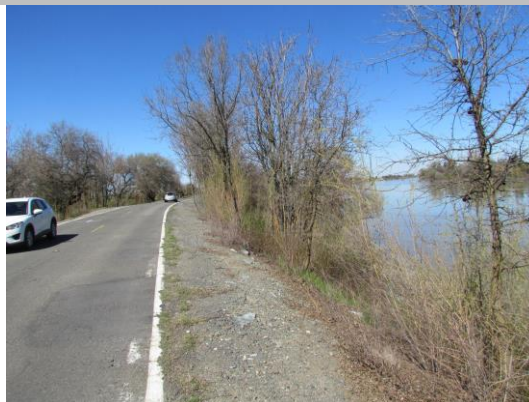
Photo 2 of 4 : FA_2017_RD0765_211_24_20170901_00023.jpg

Looking north at dense veg on waterward slope. (Spring 2017)

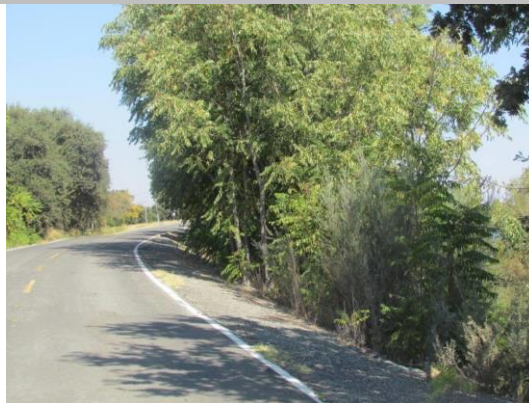
Photo 3 of 4 : FA_2017_RD0765_211_24_20170901_00024.jpg

Looking northeast at large cluster of trees on waterward slope. (Fall 2016)

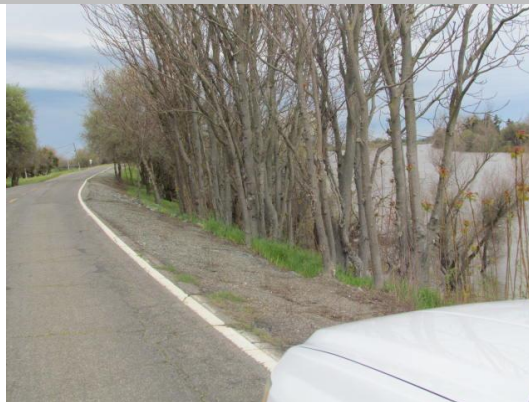
Photo 4 of 4 : FA_2017_RD0765_211_24_20170901_00025.jpg

Looking northeast at cluster of trees on waterward slope. (Spring 2016)

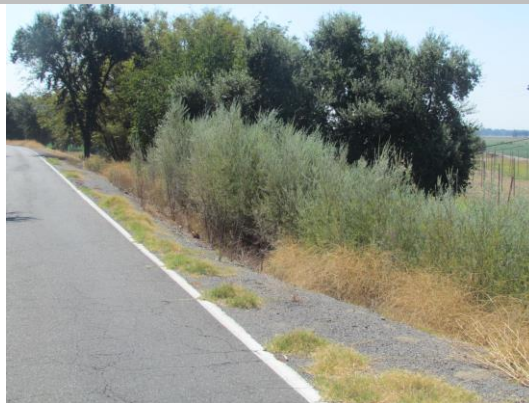
Photo 2 of 2 : FA_2017_RD0765_211_59_20170901_00058.jpg

Looking northwest at dense vegetation on landward slope. (Fall 2016)

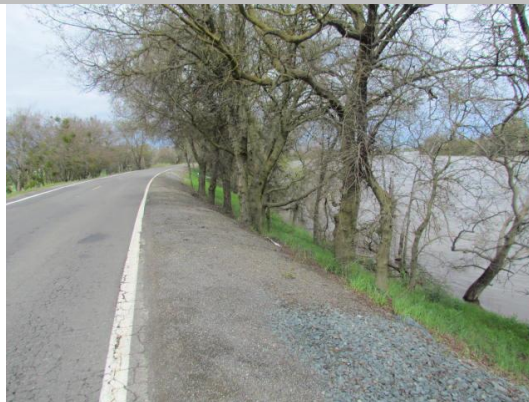
Photo 1 of 1 : FA_2017_RD0765_211_10_20170901_00012.jpg

Looking northeast at trees on waterward slope.

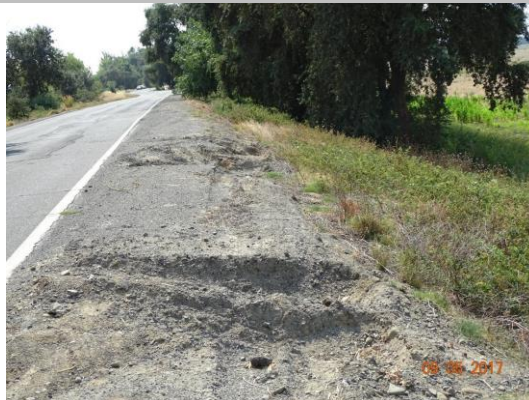
Photo 1 of 2 : FA_2017_RD0765_211_68_20170919_00084.jpg

LM Start	0.75	Rating **	M	Issue No.	68
LM End	0.75	Issue Type +	Ma	Location *	LS
Category	Earthen Levee			GPS Latitude/Longitude	
				Start	End
Item	Slope Stability			38.492705 °	38.492705 °
				-121.557193 °	-121.557193 °
DWR ID	DWR_RD0765_01_s_2017_68				
Comment Code					
S3 : Repair the levee slope damaged by vehicle traffic and prevent access where possible.					
Inspector Comment					
Damage caused by a truck.

Looking south on landside slope.

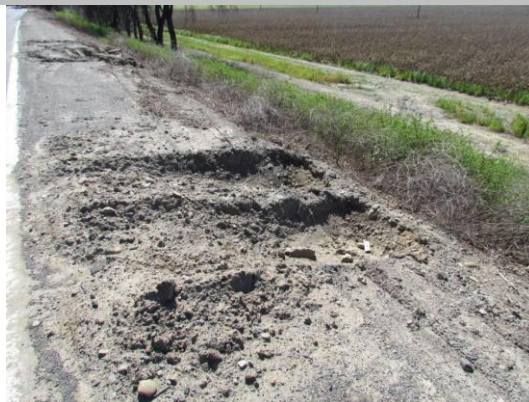
Photo 2 of 2 : FA_2017_RD0765_211_68_20170901_00069.jpg

Looking south at levee damage caused by vehicle traffic. (Spring 2017)

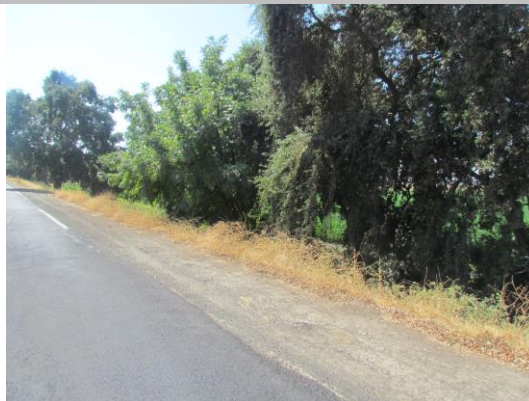
Photo 1 of 1 : FA_2017_RD0765_211_36_20170901_00038.jpg

Looking northwest at untrimmed trees on landward slope.

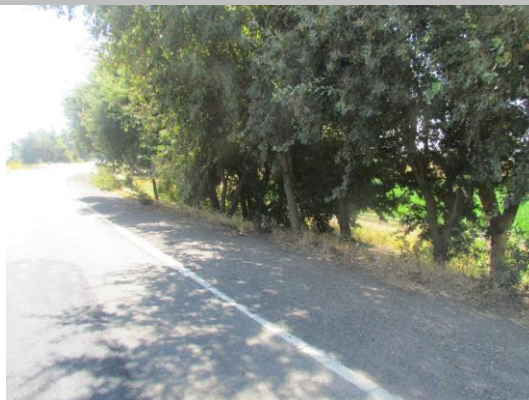
Photo 1 of 1 : FA_2017_RD0765_211_17_20170901_00018.jpg

Looking northwest at untrimmed trees on landward slope.

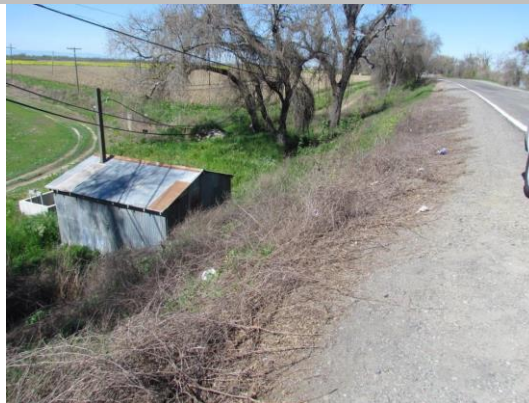
Photo 1 of 3 : FA_2017_RD0765_211_61_20170901_00062.jpg

Looking northwest at dense dead berryvines on landward slope. (Spring 2017)

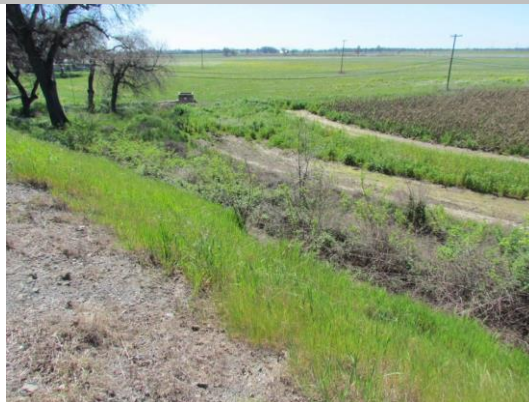
Photo 2 of 3 : FA_2017_RD0765_211_61_20170901_00063.jpg

Looking west at berryvine at bottom half of landward slope. (Spring 2017)

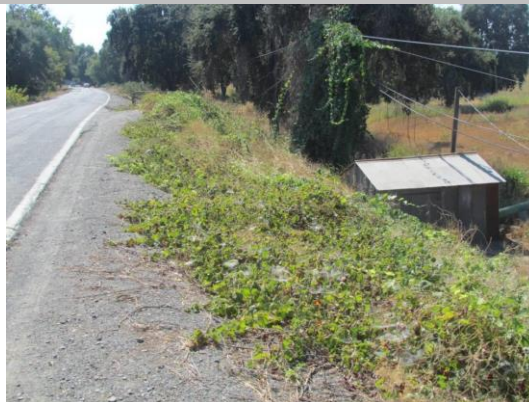
Photo 3 of 3 : FA_2017_RD0765_211_61_20170901_00064.jpg

Looking south at dense wildroses on landward slope. (Fall 2016)

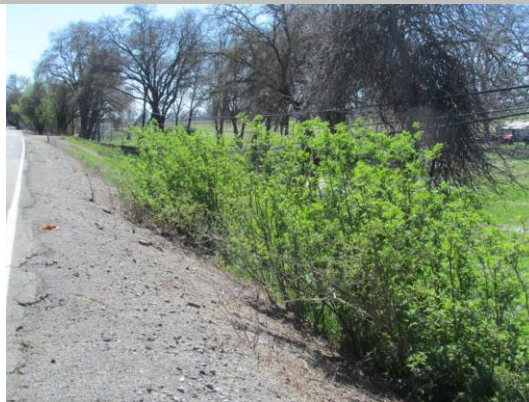
Photo 1 of 2 : FA_2017_RD0765_211_40_20170901_00042.jpg

Looking south at new growth on landward slope. (Spring 2017)

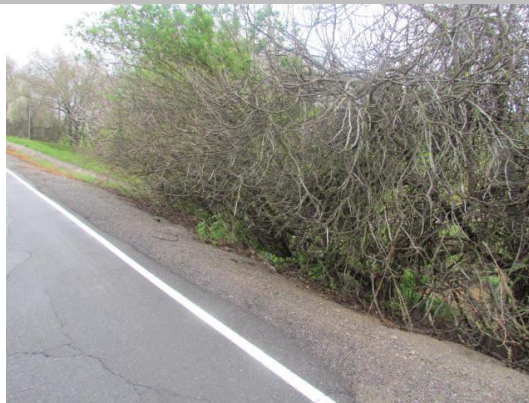
Photo 2 of 2 : FA_2017_RD0765_211_40_20170901_00043.jpg

Looking southwest at fig trees and other trees on landside slope and toe.
(Fall 2016)

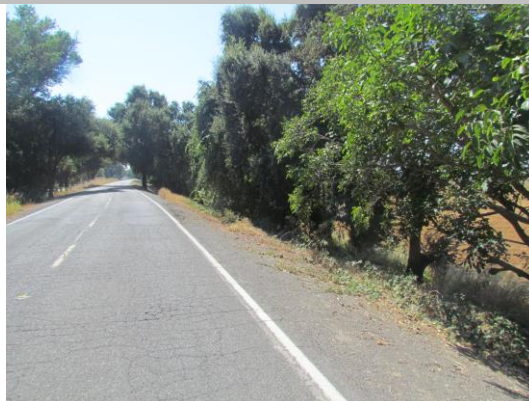
Photo 1 of 1 : FA_2017_RD0765_211_38_20170901_00039.jpg

Looking southwest at untrimmed trees on landward slope.

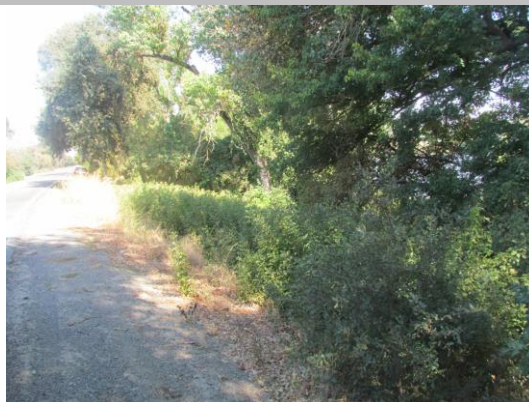
Photo 1 of 1 : FA_2017_RD0765_211_65_20170901_00066.jpg

Looking north at wildroses and untrimmed trees on waterward shoulder and slope.

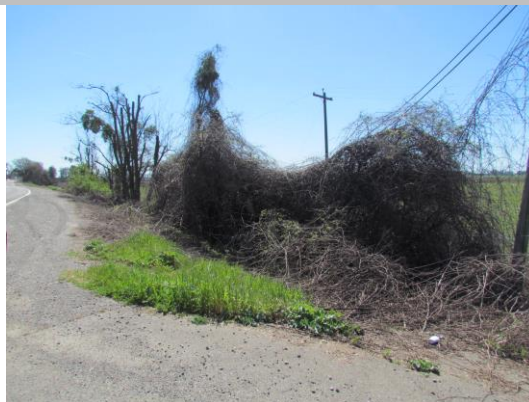
Photo 2 of 3 : FA_2017_RD0765_211_33_20170901_00036.jpg

Looking west at dead vines on landward slope. (Spring 2017)

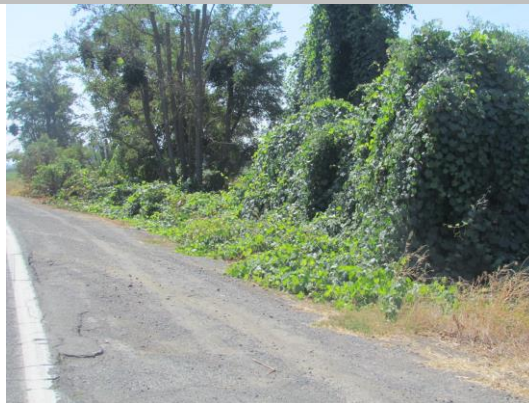
Photo 3 of 3 : FA_2017_RD0765_211_33_20170901_00037.jpg

Looking west at dense vegetation (grapevines) on landward slope. (Fall 2016)

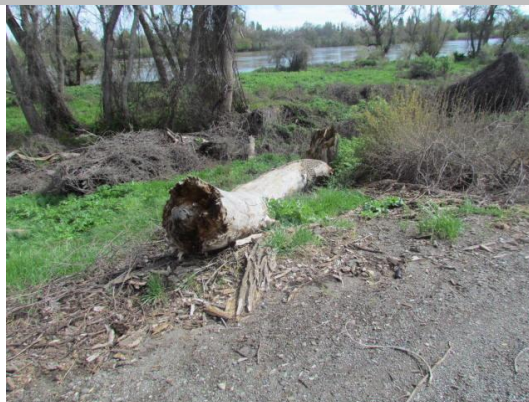
Photo 1 of 4 : FA_2017_RD0765_211_7_20170901_00008.jpg

Looking southeast at branch on waterward slope.

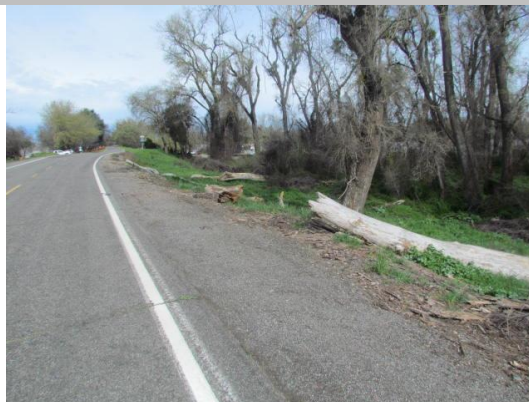
Photo 2 of 4 : FA_2017_RD0765_211_7_20170901_00009.jpg

Looking northeast at tree limbs on waterward slope.

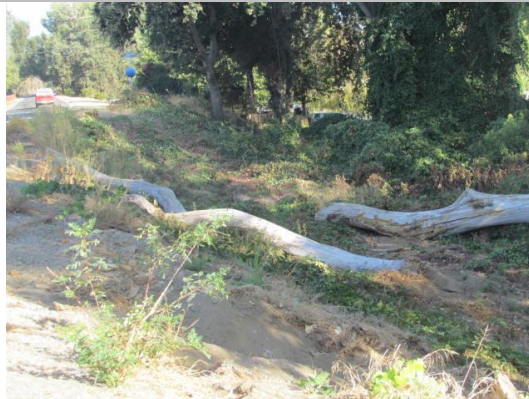
Photo 3 of 4 : FA_2017_RD0765_211_7_20170901_00010.jpg

Looking at several tree branches on waterward slope and berm.(2015)

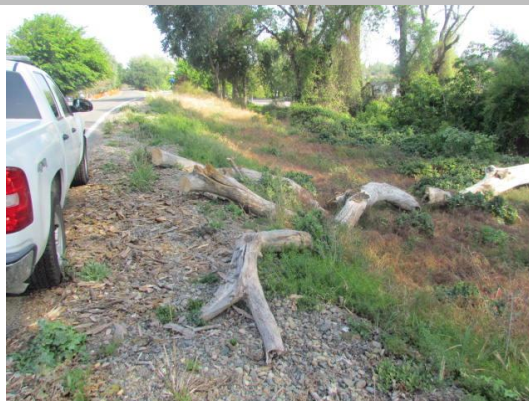
Photo 4 of 4 : FA_2017_RD0765_211_7_20170901_00011.jpg

Looking north at down tree across waterward slope.(2015)

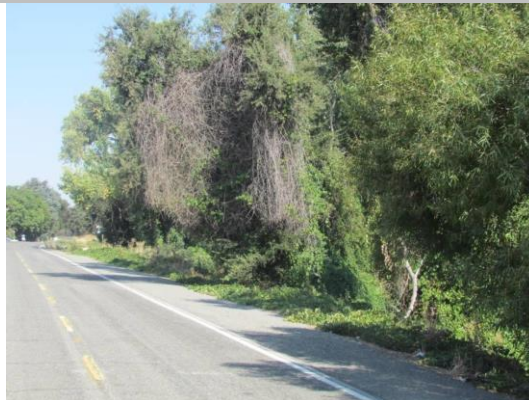
Photo 1 of 3 : FA_2017_RD0765_211_4_20170901_00004.jpg

Looking northeast at untrimmed trees and other vegetation on waterward slope. (Fall 2016)

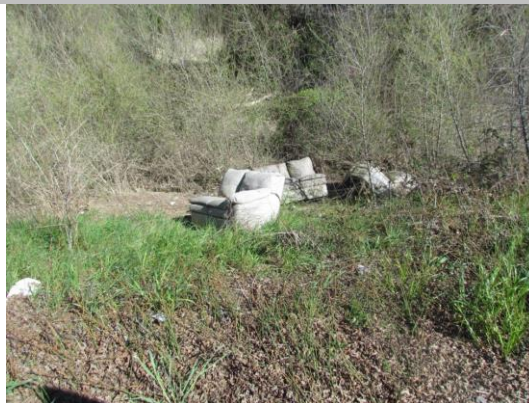
Photo 1 of 1 : FA_2017_RD0765_211_67_20170901_00067.jpg

Looking east at sofa on waterward slope.

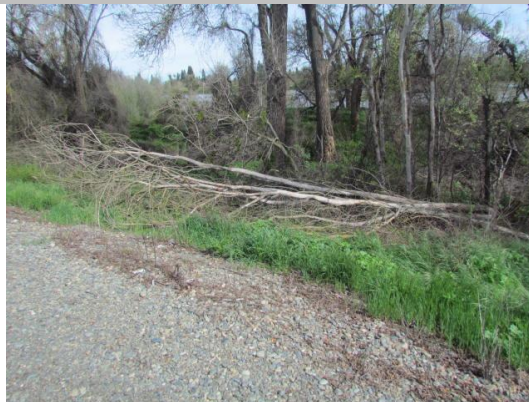
Photo 1 of 1 : FA_2017_RD0765_211_64_20170901_00065.jpg

Looking at fallen tree on waterward slope and toe.

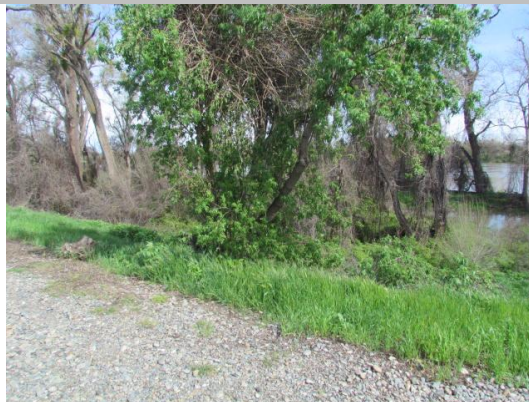
Photo 2 of 2 : FA_2017_RD0765_211_50_20170901_00050.jpg

Looking east at untrimmed tree on waterward slope.

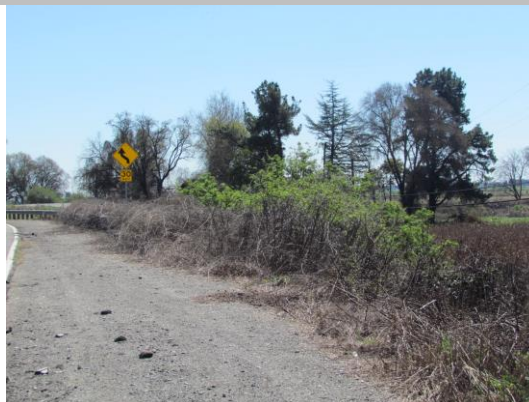
Photo 2 of 5 : FA_2017_RD0765_211_29_20170901_00030.jpg

Looking southwest at dead vines and other veg on landward slope.
(Spring 2017)

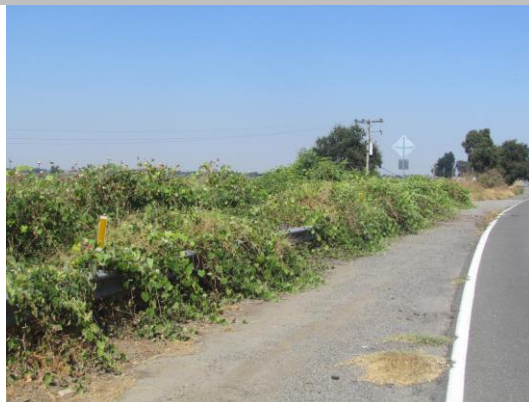
Photo 3 of 5 : FA_2017_RD0765_211_29_20170901_00031.jpg

Looking northwest at berryvines on landward slope and toe. (Fall 2016)

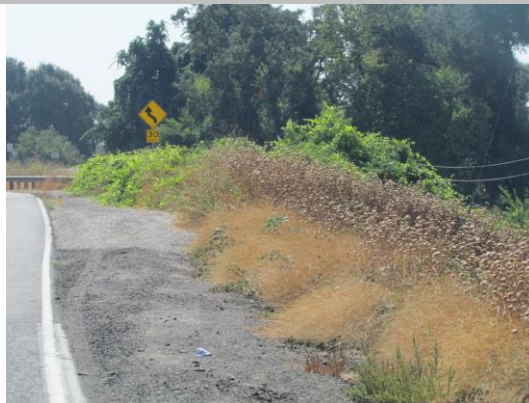
Photo 4 of 5 : FA_2017_RD0765_211_29_20170901_00032.jpg

Looking southwest at dense berry vines and other vegetation on landward slope. (Fall 2016)

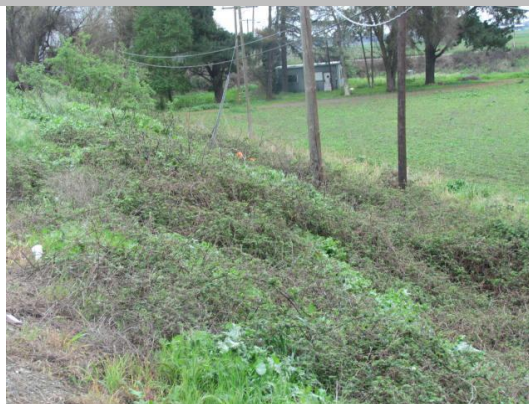
Photo 5 of 5 : FA_2017_RD0765_211_29_20170901_00033.jpg

Looking southwest at ground cover on landward slope. (Spring 2016)

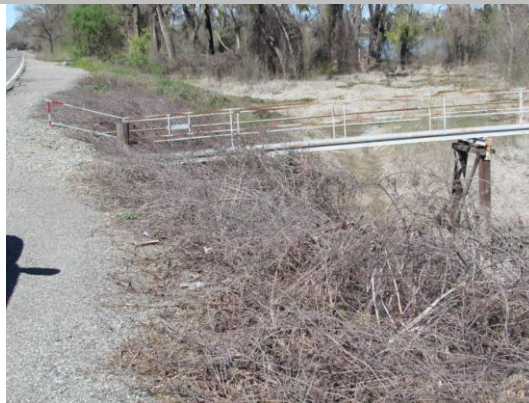
Photo 2 of 3 : FA_2017_RD0765_211_48_20170901_00047.jpg

Looking north at dead vines on waterward slope. (Spring 2017)

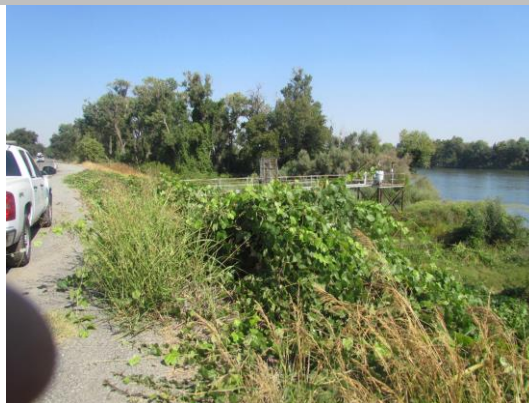
Photo 3 of 3 : FA_2017_RD0765_211_48_20170901_00048.jpg

Looking northeast at vines on waterward slope. (Fall 2016)

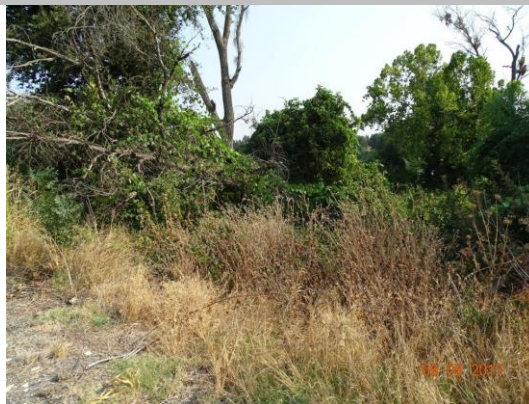
Photo 1 of 1 : FA_2017_RD0765_211_1_20170919_00070.jpg

Looking north at the downed tree.

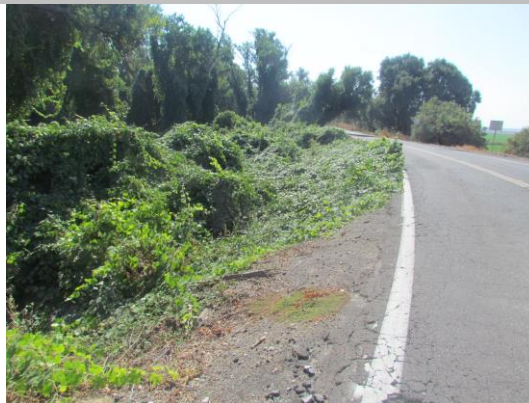
Photo 2 of 2 : FA_2017_RD0765_211_25_20170901_00026.jpg

Looking south on at dense berryvines on waterward slope.

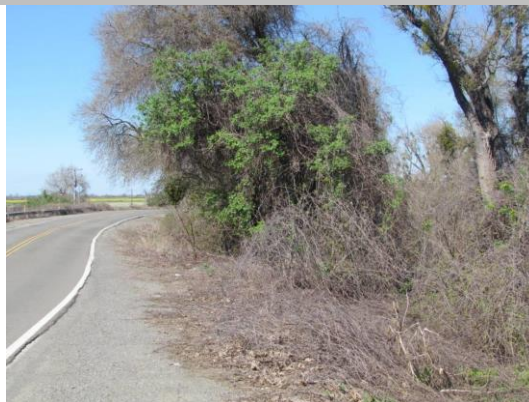
Photo 1 of 2 : FA_2017_RD0765_211_53_20170901_00052.jpg

Looking north at dense untrimmed trees on waterward slope. (Spring 2017)

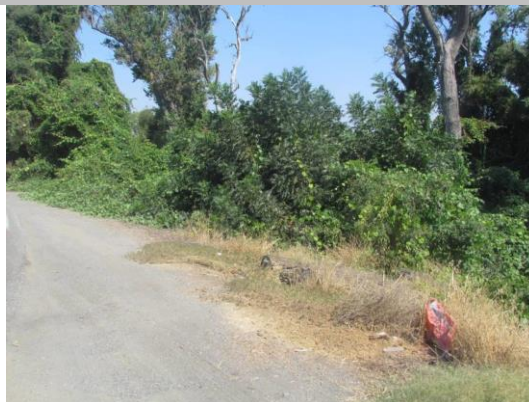
Photo 2 of 2 : FA_2017_RD0765_211_53_20170901_00053.jpg

Looking north at dense vegetation on waterward slope. (Fall 2016)

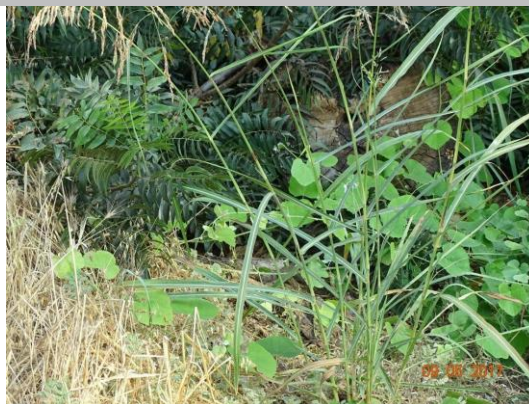
Photo 1 of 2 : FA_2017_RD0765_211_13_20170919_00086.jpg

Looking northwest at tree limb in vegetation on waterside slope.

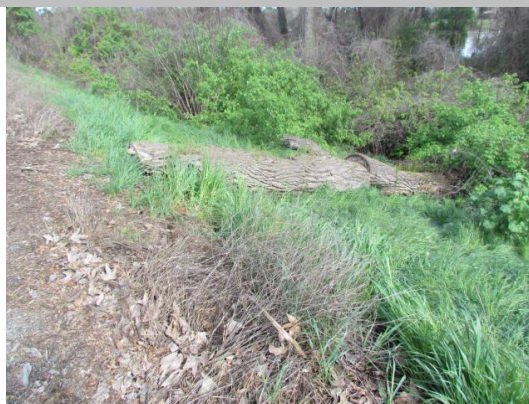
Photo 2 of 2 : FA_2017_RD0765_211_13_20170901_00015.jpg

Looking northwest at large tree limb on waterward slope.
