**Flood Control Project Maintenance
Levee Inspections**

Maintenance Issue Types Only, Levee Inspection Report By Mile - Fall 2018

Reclamation District No. 0765 Glide

Waterway	Bank	Unit Miles	Inspection Start/End	Inspector
Unit No. 01 Sacramento River	Right	1.72	11/01/2018 11/01/2018	Luz Dial

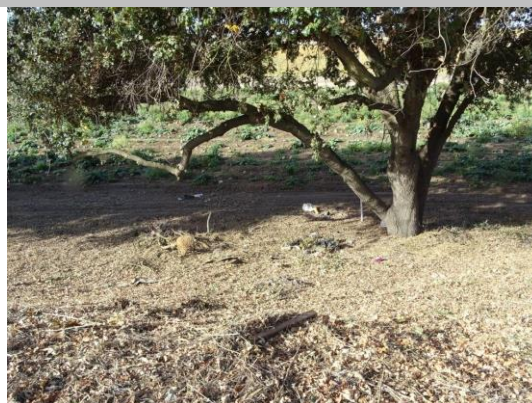
Photo 1 of 1 : FA_2018_RD0765_211_57_20181101_00093.jpg

LM Start	0.28	Rating **	A/W	Issue No.	57
LM End	0.28	Issue Type +	Ma	Location *	LS
Category	Earthen Levee			GPS Latitude/Longitude	
				Start	End
Item	Encroachments			38.498988 °	38.498988 °
				-121.560473 °	-121.560473 °
DWR ID	DWR_RD0765_01_s _ 2018_57				
Comment Code					
DE : Debris					
Inspector Comment

View of trash on levee. Fall 2018

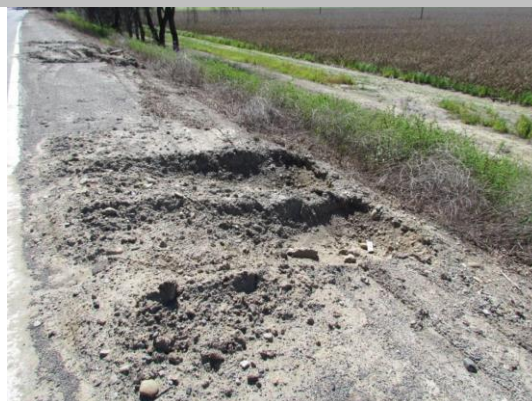
Photo 2 of 2 : FA_2018_RD0765_211_68_20180910_00078.jpg

LM Start	0.75	Rating **	M	Issue No.	68 (cont)	
LM End	0.75	Issue Type +	Ma	Location *	LS	
Category	Earthen Levee			GPS Latitude/Longitude		
				Start		End
Item	Slope Stability			38.492705 °		38.492705 °
				-121.557193 °		-121.557193 °
DWR ID	DWR_RD0765_01_s_2017_68					
Comment Code						
S3 : Repair the levee slope damaged by vehicle traffic and prevent access where possible.						
Inspector Comment						
Damage caused by a truck.

Looking south at levee damage caused by vehicle traffic. (Spring 2017)

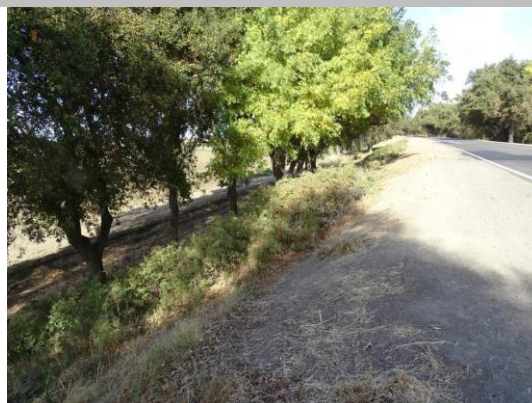
Photo 1 of 1 : FA_2018_RD0765_211_63_20181101_00094.jpg

LM Start	0.77	Rating **	M	Issue No.	63
LM End	0.79	Issue Type +	Ma	Location *	LS
Category	Earthen Levee			GPS Latitude/Longitude	
				Start	End
Item	Vegetation			38.492457°	38.492145°
				-121.557084°	-121.556891°
DWR ID	DWR_RD0765_01_s_2018_63				
Comment Code					
V2 : Remove the wild growth other than native grasses from the levee slopes.					
Inspector Comment

View of wild brush on levee slope. Fall 2018

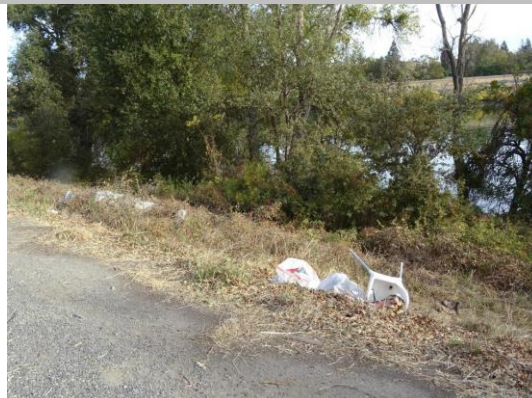
Photo 1 of 1 : FA_2018_RD0765_211_30_20181101_00092.jpg

LM Start	0.79	Rating **	M	Issue No.	30
LM End	0.79	Issue Type +	Ma	Location *	WS
Category	Earthen Levee			GPS Latitude/Longitude	
				Start	End
Item	Encroachments			38.492247°	38.492247°
				-121.556872°	-121.556872°
DWR ID	DWR_RD0765_01_f_2018_30				
Comment Code					
DE : Debris					
Inspector Comment					
Sofa and debris dumped on slope.

View of debris dumped on slope. Fall 2018

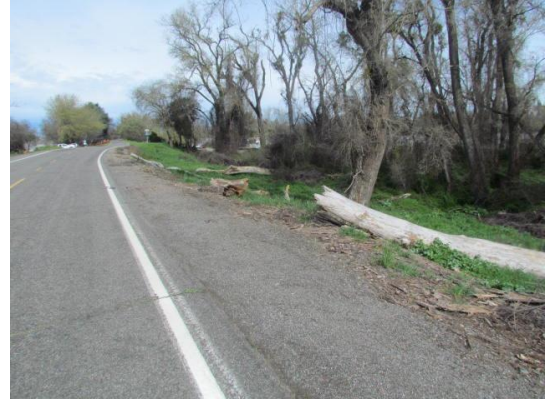
Photo 2 of 4 : FA_2018_RD0765_211_7_20180910_00011.jpg

LM Start	1.32	Rating **	M	Issue No.	7 (cont)	
LM End	1.34	Issue Type +	Ma	Location *	WS	
Category	Earthen Levee			GPS Latitude/Longitude		
				Start	End	
Item	Encroachments			38.485287 °	38.485014 °	
				-121.552818 °	-121.552618 °	
DWR ID	DWR_RD0765_01_s_2015_7					
Comment Code						
TR : Tree or limb						
Inspector Comment						
Downed tree branches across waterside slope.

Looking northeast at tree limbs on waterward slope.

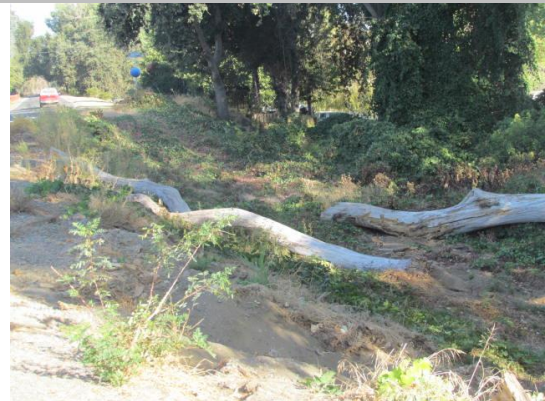
Photo 3 of 4 : FA_2018_RD0765_211_7_20180910_00012.jpg

Looking at several tree branches on waterward slope and berm.(2015)

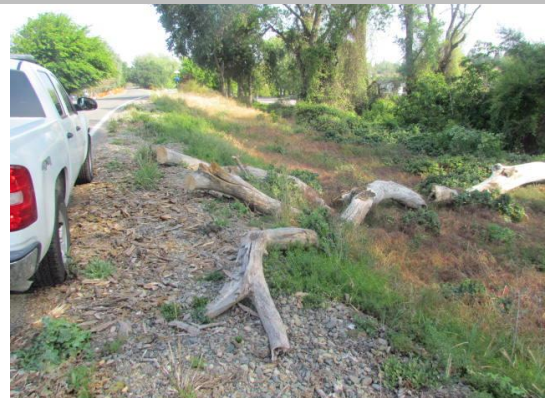
Photo 4 of 4 : FA_2018_RD0765_211_7_20180910_00013.jpg

Looking north at down tree across waterward slope.(2015)

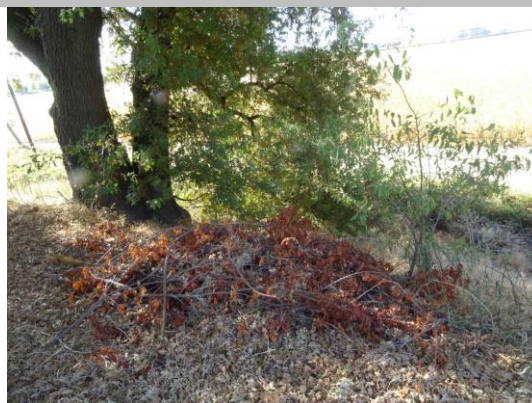
Photo 1 of 1 : FA_2018_RD0765_211_41_20181101_00098.jpg

LM Start	1.44	Rating **	M	Issue No.	41
LM End	1.44	Issue Type +	Ma	Location *	LS
Category	Earthen Levee			GPS Latitude/Longitude	
				Start	End
Item	Trim / Thin Trees			38.483640 °	38.483640 °
				-121.551727 °	-121.551727 °
DWR ID	DWR_RD0765_01_s_2012_41				
Comment Code					
T1 : Trim trees to at least five feet above ground level.					
Inspector Comment					
Trim trees at least five feet above slope and remove prunings.

View of low branches and prunings on slope. Fall 2018

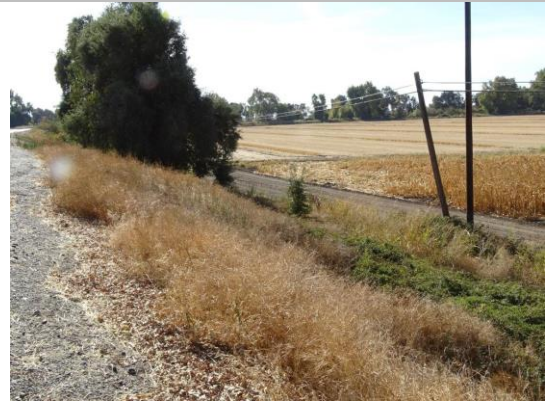
Photo 1 of 3 : FA_2018_RD0765_211_52_20181101_00099.jpg

LM Start	1.47	Rating **	M	Issue No.	52
LM End	1.70	Issue Type +	Ma	Location *	LS
Category	Earthen Levee			GPS Latitude/Longitude	
				Start	End
Item	Vegetation			38.483340°	38.480345°
				-121.551565°	-121.549658°
DWR ID	DWR_RD0765_01_f _ 2018_52				
Comment Code					
V2 : Remove the wild growth other than native grasses from the levee slopes.					
Inspector Comment					
Trim tall brush along slope.

View of tall brush on levee slope. Fall 2018

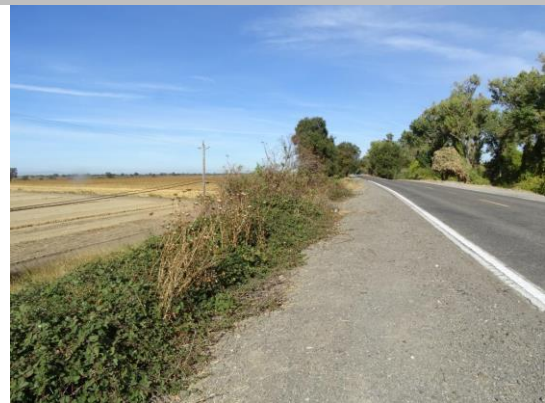
Photo 2 of 3 : FA_2018_RD0765_211_52_20181101_00101.jpg

View of tall brush on levee slope. Fall 2018

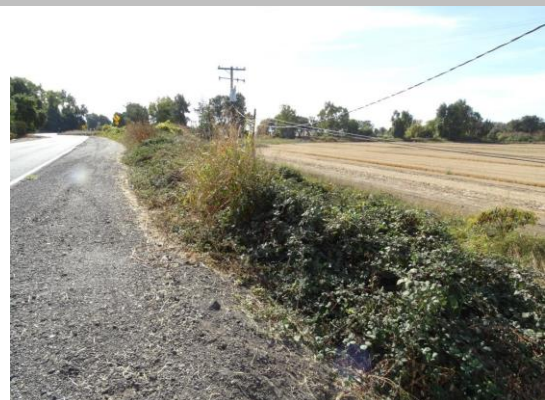
Photo 3 of 3 : FA_2018_RD0765_211_52_20181101_00100.jpg

View of tall brush on levee slope. Fall 2018

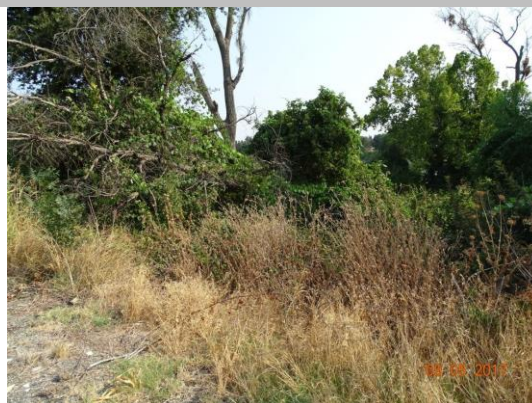
Photo 1 of 1 : FA_2018_RD0765_211_1_20180910_00001.jpg

LM Start	1.58	Rating **	M	Issue No.	1
LM End	1.58	Issue Type +	Ma	Location *	WS
Category	Earthen Levee			GPS Latitude/Longitude	
				Start	End
Item	Encroachments			38.481959 °	38.481959 °
				-121.550527 °	-121.550527 °
DWR ID	DWR_RD0765_01_f_2017_1				
Comment Code					
TR : Tree or limb					
Inspector Comment					
Downed tree on waterside slope.

Looking north at the downed tree.

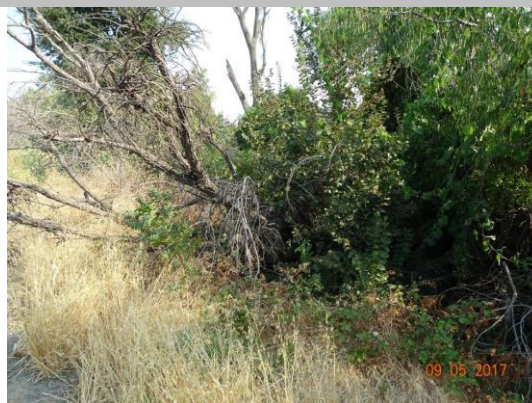
Photo 1 of 1 : FA_2018_RD0765_211_39_20180910_00045.jpg

LM Start	1.59	Rating **	M	Issue No.	39
LM End	1.59	Issue Type +	Ma	Location *	WS
Category	Earthen Levee			GPS Latitude/Longitude	
				Start	End
Item	Encroachments			38.481798 °	38.481798 °
				-121.550449 °	-121.550449 °
DWR ID	DWR_RD0765_01_f_2016_39				
Comment Code					
TR : Tree or limb					
Inspector Comment					
Downed tree on waterside slope.

Looking north at the waterside slope.
