**Flood Control Project Maintenance  
Levee Inspections**

## Maintenance Issue Types Only, Levee Inspection Report By Mile - Fall 2019

### Reclamation District No. 0765 Glide

Waterway	Bank	Unit Miles	Inspection Start/End	Inspector
Unit No. 01 Sacramento River	Right	1.72	11/12/2019 11/12/2019	Luz Dial

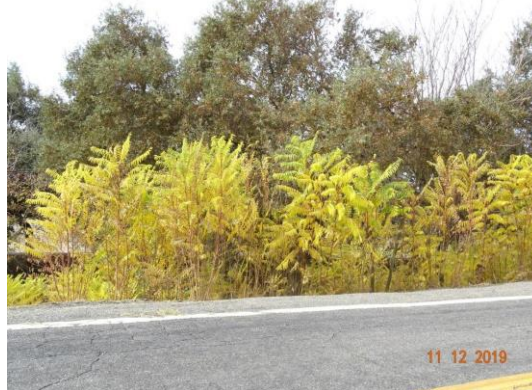
Photo 1 of 1 : FA\_2019\_RD0765\_211\_10\_20191112\_00048.jpg

LM Start	0.43	Rating **	M	Issue No.	10
LM End	0.50	Issue Type +	Ma	Location *	LS
Category	Earthen Levee			GPS Latitude/Longitude	
				Start	End
Item	Vegetation			38.496717 °	38.495810 °
				-121.560023 °	-121.559520 °
DWR ID	DWR_RD0765_01_f_2019_10				
Comment Code					
V2 : Remove the wild growth other than native grasses from the levee slopes.					
Inspector Comment					
Remove wild growth of invasive plants.

View of invasive wild growth on the landside slope. Fall 2019

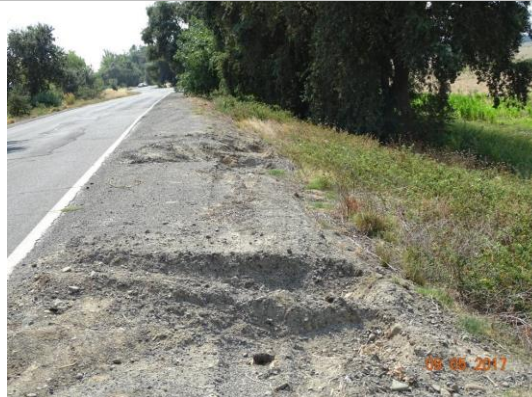
Photo 1 of 2 : FA\_2019\_RD0765\_211\_68\_20190904\_00034.jpg

LM Start	0.75	Rating **	M	Issue No.	68
LM End	0.75	Issue Type +	Ma	Location *	LS
Category	Earthen Levee			GPS Latitude/Longitude	
				Start	End
Item	Slope Stability			38.492705 °	38.492705 °
				-121.557193 °	-121.557193 °
DWR ID	DWR_RD0765_01_s_2017_68				
Comment Code					
S3 : Repair the levee slope damaged by vehicle traffic and prevent access where possible.					
Inspector Comment					
Repair tire rut damage on LS shoulder.

Looking south on landside slope.

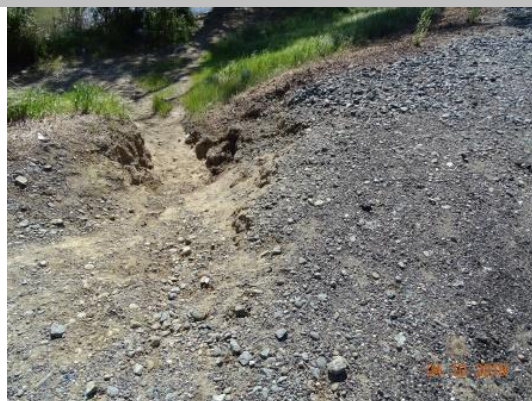
Photo 1 of 1 : FA\_2019\_RD0765\_211\_23\_20190904\_00014.jpg

LM Start	0.95	Rating **	M	Issue No.	23
LM End	0.95	Issue Type +	Ma	Location *	WS
Category	Earthen Levee			GPS Latitude/Longitude	
				Start	End
Item	Slope Stability			38.490067°	38.490067°
				-121.555530°	-121.555530°
DWR ID	DWR_RD0765_01_s_2019_23				
Comment Code					
S2 : Repair the levee slope damaged by foot traffic and prevent access where possible.					
Inspector Comment

View looking east at footpath that cuts into levee slope. Spring 2019

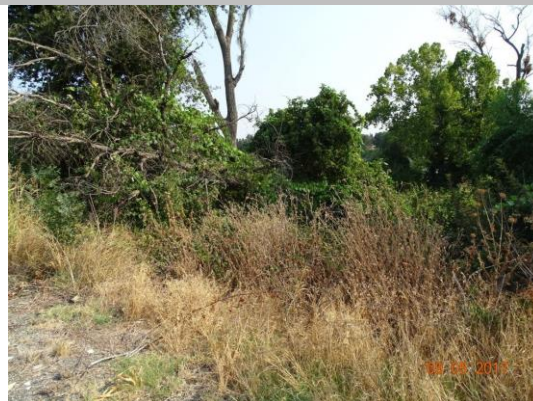
Photo 1 of 1 : FA\_2019\_RD0765\_211\_1\_20190904\_00001.jpg

LM Start	1.58	Rating **	M	Issue No.	1
LM End	1.58	Issue Type +	Ma	Location *	WS
Category	Earthen Levee			GPS Latitude/Longitude	
				Start	End
Item	Encroachments			38.481959 °	38.481959 °
				-121.550527 °	-121.550527 °
DWR ID	DWR_RD0765_01_f_2017_1				
Comment Code					
TR : Tree or limb					
Inspector Comment					
Remove fallen tree on waterside slope.

View looking north at the fallen tree. Fall 2017

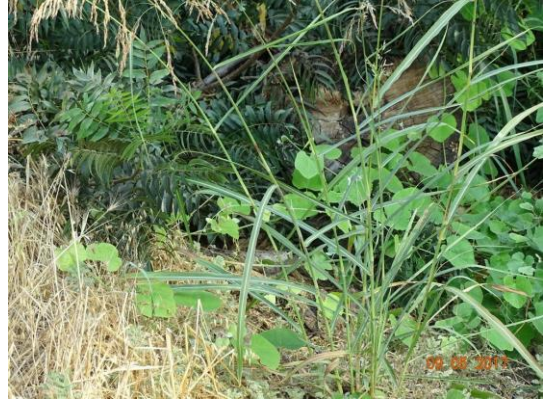
Photo 1 of 2 : FA\_2019\_RD0765\_211\_13\_20190904\_00009.jpg

LM Start	1.67	Rating **	M	Issue No.	13
LM End	1.68	Issue Type +	Ma	Location *	WS
Category	Earthen Levee			GPS Latitude/Longitude	
				Start	End
Item	Encroachments			38.480763 °	38.480632 °
				-121.549581 °	-121.549543 °
DWR ID	DWR_RD0765_01_s_2012_13				
Comment Code					
TR : Tree or limb					
Inspector Comment					
Remove large tree branch on waterside slope.

Looking northwest at tree limb in vegetation on waterside slope. Fall 2017

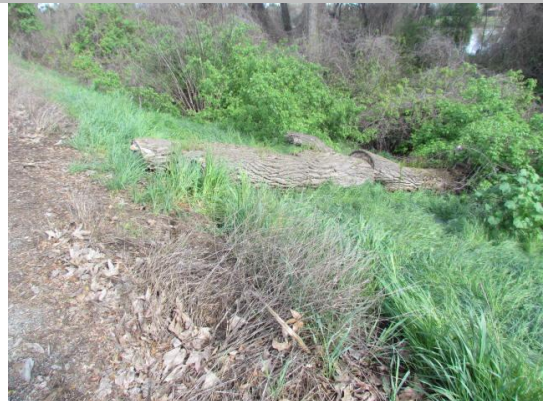
Photo 2 of 2 : FA\_2019\_RD0765\_211\_13\_20190904\_00010.jpg

Looking northwest at large tree limb on waterward slope.
