**Flood Control Project Maintenance  
Levee Inspections**

**Maintenance Issue Types Only, Levee Inspection Report By Mile - Fall 2020**

**Reclamation District No. 0765 Glide**

Waterway	Bank	Unit Miles	Inspection Start/End	Inspector
Unit No. 01 Sacramento River	Right	1.72	10/26/2020 10/26/2020	Luz Dial

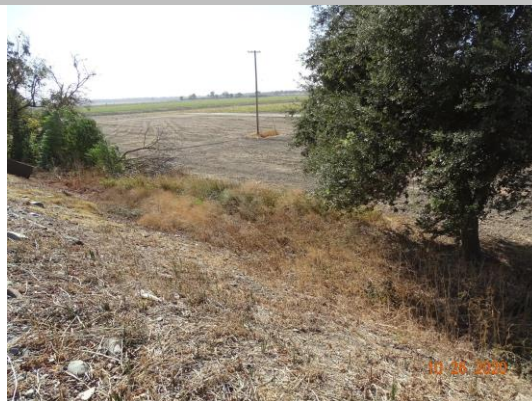
Photo 1 of 1 : FA\_2020\_RD0765\_211\_25\_20201026\_00044.jpg

LM Start	<b>0.30</b>	Rating **	M	Issue No.	<b>25</b>
LM End	<b>0.30</b>	Issue Type +	Ma	Location *	LS
Category	Earthen Levee		GPS Latitude/Longitude		
			Start	End	
Item	Vegetation		38.498693 °	38.498693 °	
			-121.560512 °	-121.560512 °	
DWR ID	DWR_RD0765_01_s_2020_25				
Comment Code					
V2 : Remove the wild growth other than native grasses from the levee slopes.					
Inspector Comment					
Trim brush at the landside toe easement.

View of wild growth at the landside toe easement. Fall 2020

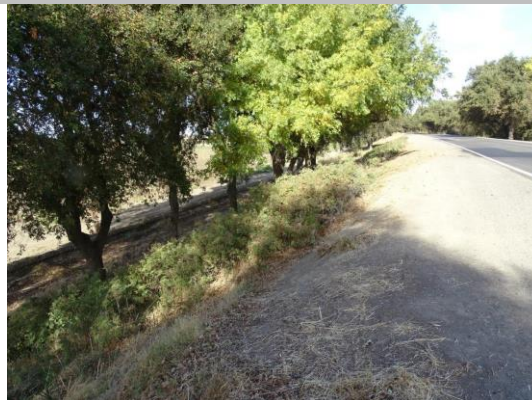
Photo 1 of 1 : FA\_2020\_RD0765\_211\_63\_20200916\_00028.jpg

LM Start	0.75	Rating **	M	Issue No.	63
LM End	0.79	Issue Type +	Ma	Location *	LS
Category	Earthen Levee			GPS Latitude/Longitude	
				Start	End
Item	Vegetation			38.492647 °	38.492145 °
				-121.557192 °	-121.556891 °
DWR ID	DWR_RD0765_01_s_2018_63				
Comment Code					
V2 : Remove the wild growth other than native grasses from the levee slopes.					
Inspector Comment					
Trim brush along the landside toe easement.

View of brush on levee slope. Fall 2018

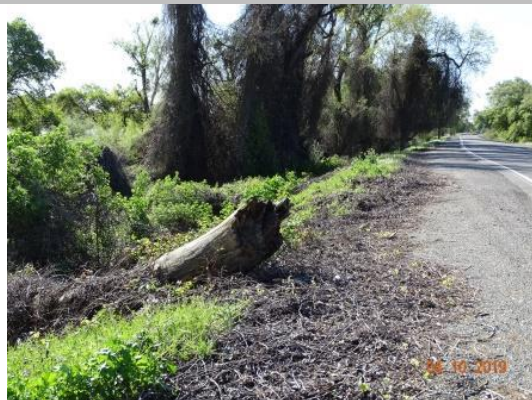
Photo 1 of 1 : FA\_2020\_RD0765\_211\_7\_20200916\_00003.jpg

LM Start	1.32	Rating **	M	Issue No.	7
LM End	1.34	Issue Type +	Ma	Location *	WS
Category	Earthen Levee			GPS Latitude/Longitude	
				Start	End
Item	Encroachments			38.485287 °	38.485014 °
				-121.552818 °	-121.552618 °
DWR ID	DWR_RD0765_01_s_2015_7				
Comment Code					
TR : Tree or limb					
Inspector Comment

View looking downstream at tree log on levee slope. Spring 2019

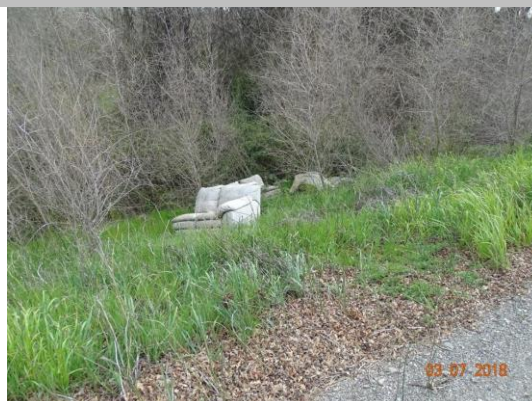
Photo 1 of 1 : FA\_2020\_RD0765\_211\_67\_20200916\_00029.jpg

LM Start	1.43	Rating **	M	Issue No.	67
LM End	1.43	Issue Type +	Ma	Location *	WS
Category	Earthen Levee			GPS Latitude/Longitude	
				Start	End
Item	Encroachments			38.483810 °	38.483810 °
				-121.551747 °	-121.551747 °
DWR ID	DWR_RD0765_01_s_2017_67				
Comment Code					
GA : Garbage					
Inspector Comment					
Remove sofa dumped on waterside slope.

View of sofa debris dumped on slope. Spring 2018

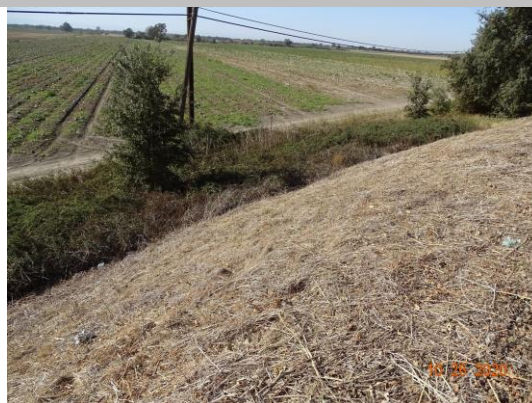
Photo 1 of 1 : FA\_2020\_RD0765\_211\_52\_20201026\_00047.jpg

LM Start	1.47	Rating **	M	Issue No.	52
LM End	1.70	Issue Type +	Ma	Location *	LS
Category	Earthen Levee			GPS Latitude/Longitude	
				Start	End
Item	Vegetation			38.483340 °	38.480345 °
				-121.551565 °	-121.549658 °
DWR ID	DWR_RD0765_01_f_2018_52				
Comment Code					
V2 : Remove the wild growth other than native grasses from the levee slopes.					
Inspector Comment					
Trim tall brush along the slope and within the toe easement.

View of wild growth at the landside toe easement. Fall 2020

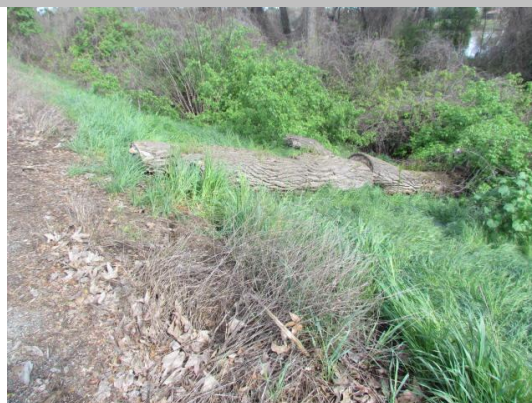
Photo 1 of 1 : FA\_2020\_RD0765\_211\_13\_20200916\_00008.jpg

LM Start	1.67	Rating **	M	Issue No.	13
LM End	1.68	Issue Type +	Ma	Location *	WS
Category	Earthen Levee			GPS Latitude/Longitude	
				Start	End
Item	Encroachments			38.480763 °	38.480632 °
				-121.549581 °	-121.549543 °
DWR ID	DWR_RD0765_01_s_2012_13				
Comment Code					
TR : Tree or limb					
Inspector Comment					
Remove a large tree branch on the waterside slope.

Looking northwest at large tree limb on waterward slope.
