**Flood Control Project Maintenance
Levee Inspections**

Maintenance Issue Types Only, Levee Inspection Report By Mile - Fall 2021

Reclamation District No. 0765 Glide

Waterway	Bank	Unit Miles	Inspection Start/End	Inspector
Unit No. 01 Sacramento River	Right	1.72	10/26/2021 10/26/2021	Marvin Marshall

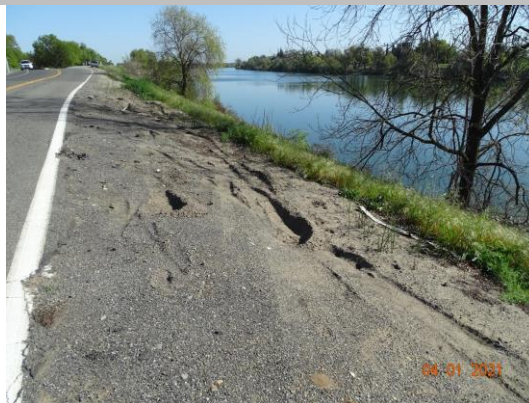
Photo 1 of 1 : FA_2021_RD0765_211_42_20210823_00020.jpg

LM Start	0.07	Rating **	M	Issue No.	42
LM End	0.07	Issue Type +	Ma	Location *	WS
Category	Earthen Levee			GPS Latitude/Longitude	
				Start	End
Item	Slope Stability			38.501920 °	38.501920 °
				-121.560368 °	-121.560368 °
DWR ID	DWR_RD0765_01_s_2021_42				
Comment Code					
S3 : Repair the levee slope damaged by vehicle traffic and prevent access where possible.					
Inspector Comment					
Repair rutting on the WS shoulder.

View of the WS levee slope damaged by vehicle traffic. Spring 2021.

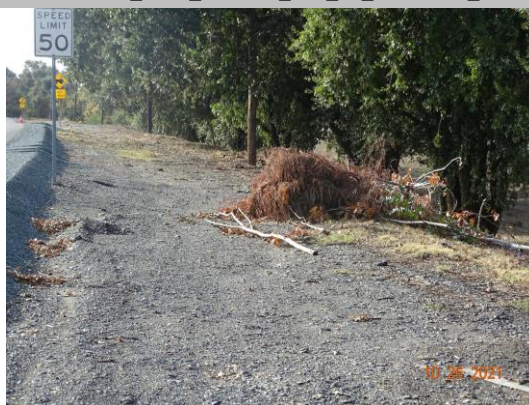
Photo 1 of 1 : FA_2021_RD0765_211_17_20211027_00042.jpg

LM Start	0.18	Rating **	M	Issue No.	17
LM End	0.18	Issue Type +	Ma	Location *	LS
Category	Earthen Levee			GPS Latitude/Longitude	
				Start	End
Item	Encroachments			38.500317 °	38.500317 °
				-121.560546 °	-121.560546 °
DWR ID	DWR_RD0765_01_s_2021_17				
Comment Code					
PR : Prunings					
Inspector Comment					
Remove prunings from LS crown/Slope

Prunings on the LS shoulder. Fall 2021

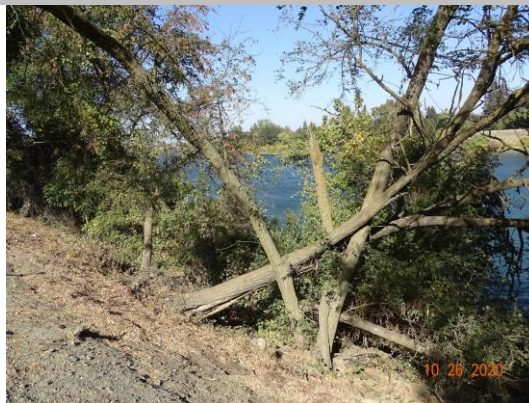
Photo 1 of 1 : FA_2021_RD0765_211_36_20210823_00018.jpg

LM Start	0.51	Rating **	A/W	Issue No.	36
LM End	0.51	Issue Type +	Ma	Location *	WS
Category	Earthen Levee			GPS Latitude/Longitude	
				Start	End
Item	Vegetation			38.495748 °	38.495748 °
				-121.559525 °	-121.559525 °
DWR ID	DWR_RD0765_01_f_2020_36				
Comment Code					
V7 : Trees / Woody Vegetation					
Inspector Comment					
Fallen tree with exposed rootball.

View of fallen tree with exposed rootball on the waterside slope. Fall 2020

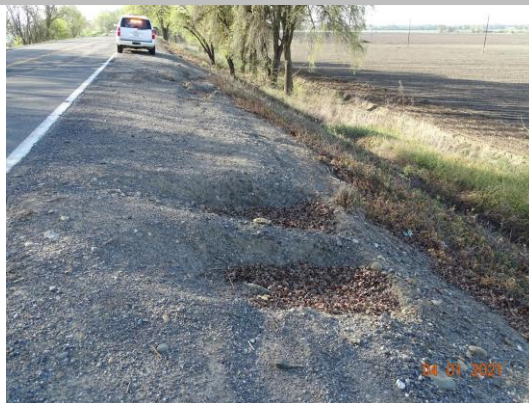
Photo 1 of 1 : FA_2021_RD0765_211_68_20210823_00029.jpg

LM Start	0.75	Rating **	M	Issue No.	68
LM End	0.75	Issue Type +	Ma	Location *	LS
Category	Earthen Levee			GPS Latitude/Longitude	
				Start	End
Item	Slope Stability			38.492705 °	38.492705 °
				-121.557193 °	-121.557193 °
DWR ID	DWR_RD0765_01_s_2017_68				
Comment Code					
S3 : Repair the levee slope damaged by vehicle traffic and prevent access where possible.					
Inspector Comment					
Repair tire rut damage on the LS shoulder.

View of the LS levee shoulder damaged by vehicle traffic. Spring 2021.

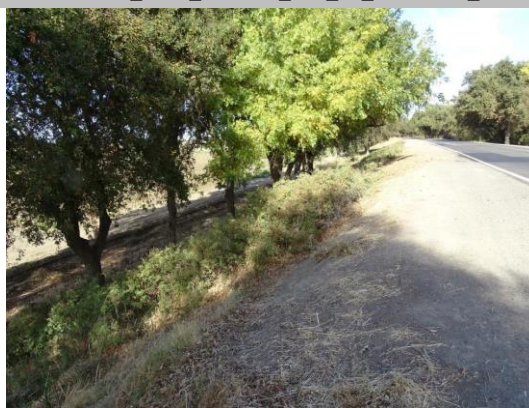
Photo 1 of 1 : FA_2021_RD0765_211_63_20210823_00027.jpg

LM Start	0.75	Rating **	M	Issue No.	63
LM End	0.79	Issue Type +	Ma	Location *	LS
Category	Earthen Levee			GPS Latitude/Longitude	
				Start	End
Item	Vegetation			38.492647 °	38.492145 °
				-121.557192 °	-121.556891 °
DWR ID	DWR_RD0765_01_s_2018_63				
Comment Code					
V2 : Remove the wild growth other than native grasses from the levee slopes.					
Inspector Comment					
Trim brush along the landside toe easement.

View of brush on levee slope. Fall 2018

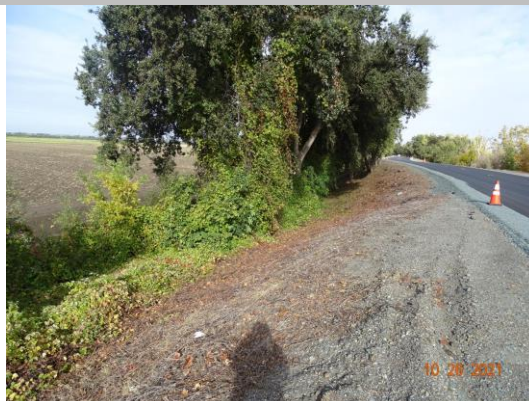
Photo 1 of 1 : FA_2021_RD0765_211_28_20211027_00043.jpg

LM Start	0.83	Rating **	M	Issue No.	28
LM End	0.83	Issue Type +	Ma	Location *	LS
Category	Earthen Levee			GPS Latitude/Longitude	
				Start	End
Item	Vegetation			38.491610 °	38.491610 °
				-121.556603 °	-121.556603 °
DWR ID	DWR_RD0765_01_s_2020_28				
Comment Code					
V2 : Remove the wild growth other than native grasses from the levee slopes.					
Inspector Comment					
Trim brush and remove berries near the landside toe.

Berry/brush growth on the LS slope and in the easement. Fall 2021

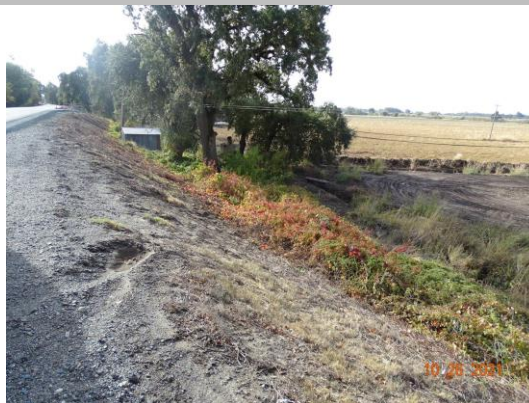
Photo 1 of 1 : FA_2021_RD0765_211_29_20211027_00044.jpg

LM Start	0.87	Rating **	M	Issue No.	29
LM End	0.87	Issue Type +	Ma	Location *	LS
Category	Earthen Levee			GPS Latitude/Longitude	
				Start	End
Item	Vegetation			38.491172 °	38.491172 °
				-121.556227 °	-121.556227 °
DWR ID	DWR_RD0765_01_s_2020_29				
Comment Code					
V2 : Remove the wild growth other than native grasses from the levee slopes.					
Inspector Comment					
Remove brush/berry growth from the LS slope and easement.

Berry and brush growth on the LS slope and in the easement. Fall 2021

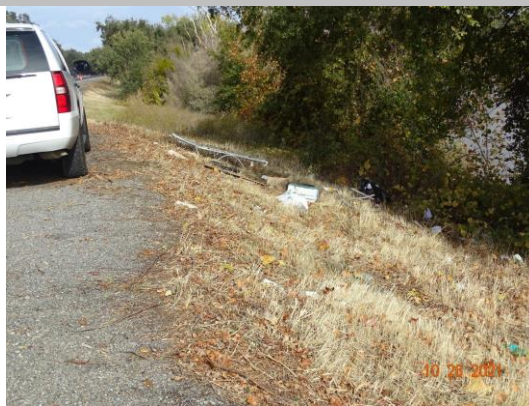
Photo 1 of 1 : FA_2021_RD0765_211_25_20211027_00045.jpg

LM Start	0.88	Rating **	M	Issue No.	25
LM End	0.88	Issue Type +	Ma	Location *	WS
Category	Earthen Levee			GPS Latitude/Longitude	
				Start	End
Item	Encroachments			38.491023 °	38.491023 °
				-121.556046 °	-121.556046 °
DWR ID	DWR_RD0765_01_f_2021_25				
Comment Code					
DE : Debris					
Inspector Comment					
Remove debris from WS slope.

Debris pile on the WS slope. Fall 2021

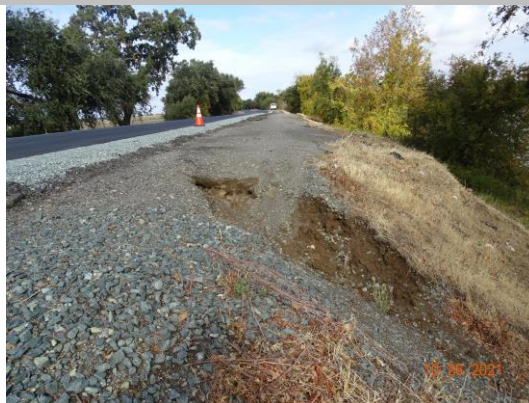
Photo 1 of 1 : FA_2021_RD0765_211_23_20211027_00047.jpg

LM Start	0.95	Rating **	U	Issue No.	23
LM End	0.95	Issue Type +	Ma	Location *	WS
Category	Earthen Levee			GPS Latitude/Longitude	
				Start	End
Item	Slope Stability			38.490067 °	38.490067 °
				-121.555530 °	-121.555530 °
DWR ID	DWR_RD0765_01_s_2019_23				
Comment Code					
S2 : Repair the levee slope damaged by foot traffic and prevent access where possible.					
Inspector Comment					
Repair the erosion at the footpath on the WS slope.

Erosion at the footpath on the WS slope. Fall 2021

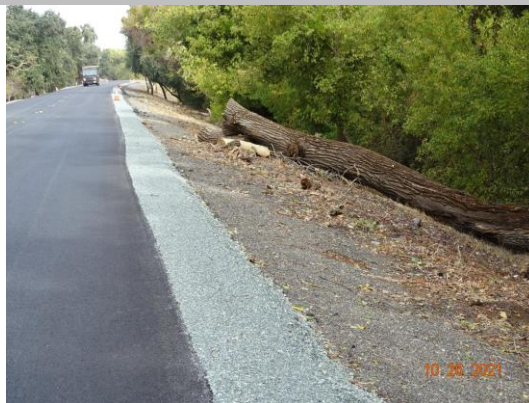
Photo 1 of 1 : FA_2021_RD0765_211_14_20211027_00050.jpg

LM Start	1.08	Rating **	M	Issue No.	14
LM End	1.08	Issue Type +	Ma	Location *	WS
Category	Earthen Levee			GPS Latitude/Longitude	
				Start	End
Item	Encroachments			38.488401 °	38.488401 °
				-121.554658 °	-121.554658 °
DWR ID	DWR_RD0765_01_f_2021_14				
Comment Code					
TR : Tree or limb					
Inspector Comment					
Remove fallen tree from with 20' of the crown.

Fallen tree log within 20 of the WS crown. Fall 2021

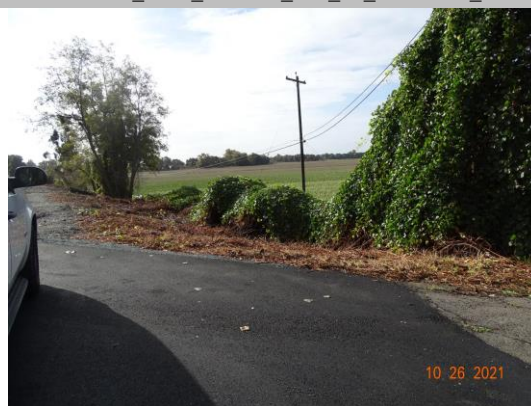
Photo 1 of 1 : FA_2021_RD0765_211_15_20211027_00051.jpg

LM Start	1.29	Rating **	M	Issue No.	15
LM End	1.30	Issue Type +	Ma	Location *	LS
Category	Earthen Levee			GPS Latitude/Longitude	
				Start	End
Item	Vegetation			38.485644 °	38.485445 °
				-121.553128 °	-121.553014 °
DWR ID	DWR_RD0765_01_s_2019_15				
Comment Code					
V2 : Remove the wild growth other than native grasses from the levee slopes.					
Inspector Comment					
Remove wild vines and growth on the LS slope.

Ivy growth on the LS slope. Fall 2021

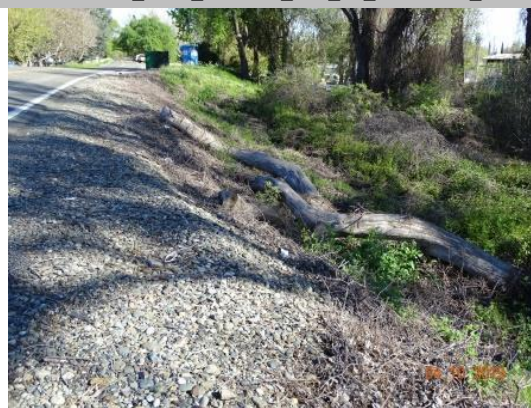
Photo 1 of 1 : FA_2021_RD0765_211_20_20210823_00010.jpg

LM Start	1.31	Rating **	M	Issue No.	20
LM End	1.31	Issue Type +	Ma	Location *	WS
Category	Earthen Levee			GPS Latitude/Longitude	
				Start	End
Item	Encroachments			38.485382 °	38.485382 °
				-121.552842 °	-121.552842 °
DWR ID	DWR_RD0765_01_s_2019_20				
Comment Code					
TR : Tree or limb					
Inspector Comment					
Remove a fallen tree from the levee slope.

View looking upstream at fallen tree on levee slope. Spring 2019

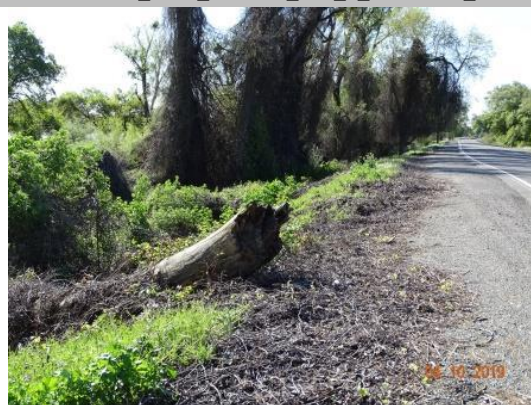
Photo 1 of 1 : FA_2021_RD0765_211_7_20210823_00003.jpg

LM Start	1.33	Rating **	M	Issue No.	7
LM End	1.33	Issue Type +	Ma	Location *	WS
Category	Earthen Levee			GPS Latitude/Longitude	
				Start	End
Item	Encroachments			38.485045 °	38.485045 °
				-121.552767 °	-121.552767 °
DWR ID	DWR_RD0765_01_s_2015_7				
Comment Code					
TR : Tree or limb					
Inspector Comment

View looking downstream at tree log on levee slope. Spring 2019

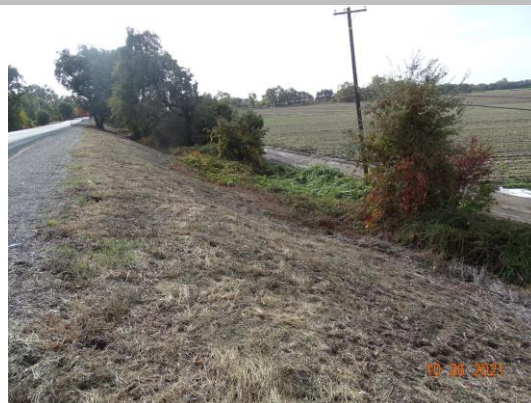
Photo 1 of 1 : FA_2021_RD0765_211_33_20211027_00053.jpg

LM Start	1.36	Rating **	M	Issue No.	33
LM End	1.43	Issue Type +	Ma	Location *	LS
Category	Earthen Levee			GPS Latitude/Longitude	
				Start	End
Item	Vegetation			38.484698 °	38.483852 °
				-121.552490 °	-121.551890 °
DWR ID	DWR_RD0765_01_s_2020_33				
Comment Code					
V2 : Remove the wild growth other than native grasses from the levee slopes.					
Inspector Comment					
Remove wild berry bushes at the landside toe.

Berry growth on the LS toe. Fall 2021

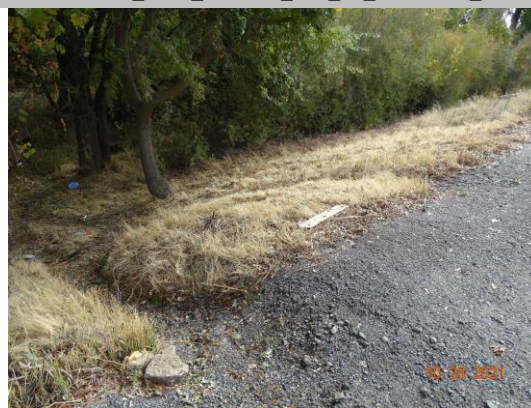
Photo 1 of 1 : FA_2021_RD0765_211_10_20211027_00054.jpg

LM Start	1.42	Rating **	A/W	Issue No.	10
LM End	1.42	Issue Type +	Ma	Location *	WS
Category	Earthen Levee			GPS Latitude/Longitude	
				Start	End
Item	Slope Stability			38.483973 °	38.483973 °
				-121.551855 °	-121.551855 °
DWR ID	DWR_RD0765_01_f_2021_10				
Comment Code					
S2 : Repair the levee slope damaged by foot traffic and prevent access where possible.					
Inspector Comment					
Monitor two footpaths for erosion.

Footpaths on the WS slope. Fall 2021

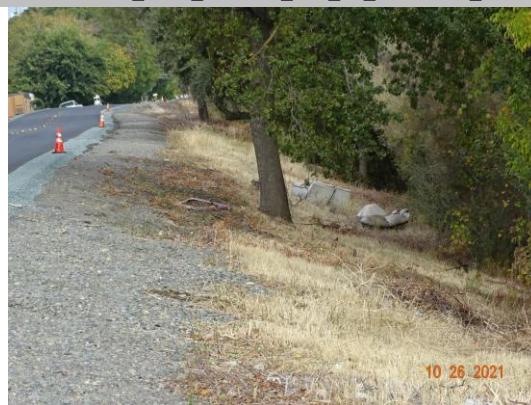
Photo 1 of 1 : FA_2021_RD0765_211_67_20211027_00055.jpg

LM Start	1.43	Rating **	M	Issue No.	67
LM End	1.43	Issue Type +	Ma	Location *	WS
Category	Earthen Levee			GPS Latitude/Longitude	
				Start	End
Item	Encroachments			38.483810 °	38.483810 °
				-121.551747 °	-121.551747 °
DWR ID	DWR_RD0765_01_s_2017_67				
Comment Code					
GA : Garbage					
Inspector Comment					
Remove sofas dumped on waterside slope.

Sofas on the WS slope. Fall 2021

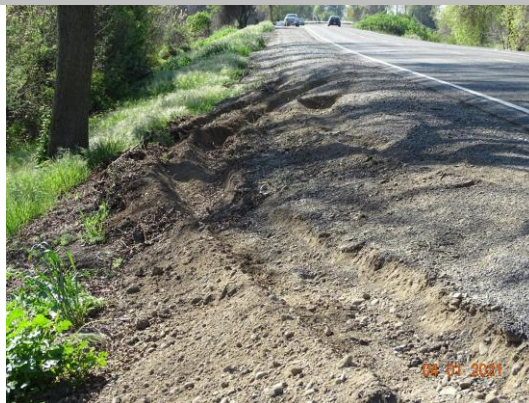
Photo 1 of 1 : FA_2021_RD0765_211_41_20210823_00019.jpg

LM Start	1.45	Rating **	M	Issue No.	41
LM End	1.45	Issue Type +	Ma	Location *	WS
Category	Earthen Levee			GPS Latitude/Longitude	
				Start	End
Item	Slope Stability			38.483609 °	38.483609 °
				-121.551628 °	-121.551628 °
DWR ID	DWR_RD0765_01_s_2021_41				
Comment Code					
S3 : Repair the levee slope damaged by vehicle traffic and prevent access where possible.					
Inspector Comment					
Repair rutting on the WS slope.

View of the WS levee slope damaged by vehicle traffic. Spring 2021.

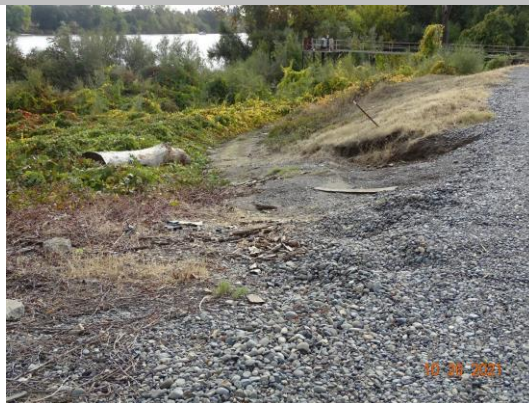
Photo 1 of 1 : FA_2021_RD0765_211_31_20211027_00056.jpg

LM Start	1.51	Rating **	M	Issue No.	31
LM End	1.51	Issue Type +	Ma	Location *	WS
Category	Earthen Levee			GPS Latitude/Longitude	
				Start	End
Item	Slope Stability			38.482788 °	38.482788 °
				-121.551048 °	-121.551048 °
DWR ID	DWR_RD0765_01_f_2019_31				
Comment Code					
S3 : Repair the levee slope damaged by vehicle traffic and prevent access where possible.					
Inspector Comment					
Repair slope damage caused by vehicle traffic.

Erosion and rutting from vehicle traffic on the WS slope. Fall 2021

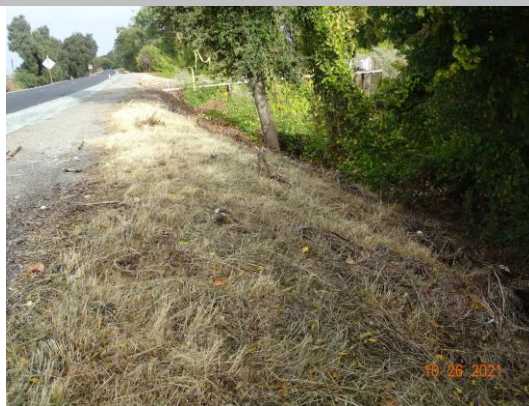
Photo 1 of 1 : FA_2021_RD0765_211_1_20211027_00058.jpg

LM Start	1.58	Rating **	M	Issue No.	1
LM End	1.58	Issue Type +	Ma	Location *	WS
Category	Earthen Levee			GPS Latitude/Longitude	
				Start	End
Item	Encroachments			38.481959 °	38.481959 °
				-121.550527 °	-121.550527 °
DWR ID	DWR_RD0765_01_f_2017_1				
Comment Code					
TR : Tree or limb					
Inspector Comment					
Remove logs/limbs within 20' of the crown.

Decaying logs within 20' of the WS crown. Fall 2021
