**Flood Control Project Maintenance
Levee Inspections**

Maintenance Issue Types Only, Levee Inspection Report By Mile - Fall 2022

Reclamation District No. 0765 Glide

Waterway	Bank	Unit Miles	Inspection Start/End	Inspector
Unit No. 01 Sacramento River	Right	1.72	11/03/2022 11/03/2022	Marvin Marshall

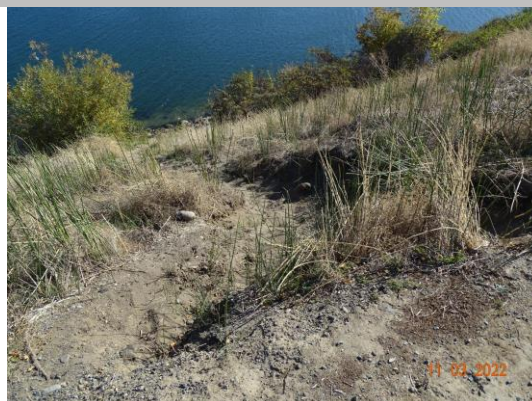
Photo 1 of 1 : FA_2022_RD0765_211_20_20221103_00030.jpg

LM Start	0.02	Rating **	U	Issue No.	20
LM End	0.02	Issue Type +	Ma	Location *	WS
Category	Earthen Levee			GPS Latitude/Longitude	
				Start	End
Item	Erosion / Foot Traffic			38.502711 °	38.502711 °
				-121.560019 °	-121.560019 °
DWR ID	DWR_RD0765_01_f_2022_20				
Comment Code					
E3 : Repair the levee slope damaged by foot traffic and prevent access where possible.					
Inspector Comment					
Repair erosion caused by foot traffic.

Footpath on the WS slope. Fall 2022

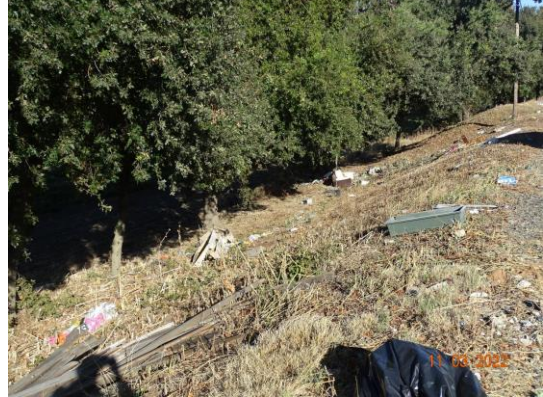
Photo 1 of 1 : FA_2022_RD0765_211_34_20221103_00031.jpg

LM Start	0.29	Rating **	M	Issue No.	34
LM End	0.29	Issue Type +	Ma	Location *	LS
Category	Earthen Levee			GPS Latitude/Longitude	
				Start	End
Item	Encroachments			38.498798 °	38.498798 °
				-121.560501 °	-121.560501 °
DWR ID	DWR_RD0765_01_f_2020_34				
Comment Code					
DE : Debris					
Inspector Comment					
Clean up debris at illegal dumping site.

Debris on LS slope. Fall 2022

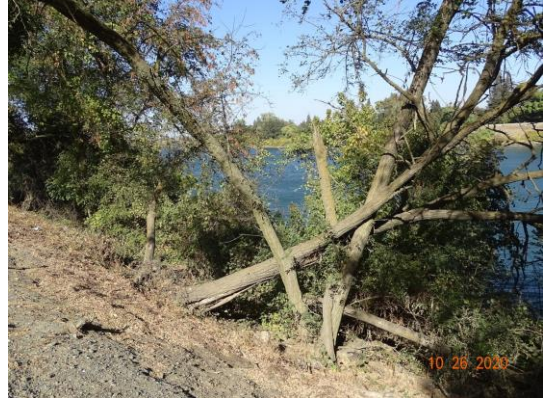
Photo 1 of 1 : FA_2022_RD0765_211_36_20220822_00018.jpg

LM Start	0.51	Rating **	M	Issue No.	36
LM End	0.51	Issue Type +	Ma	Location *	WS
Category	Earthen Levee			GPS Latitude/Longitude	
				Start	End
Item	Trim / Thin Trees			38.495748 °	38.495748 °
				-121.559525 °	-121.559525 °
DWR ID	DWR_RD0765_01_f_2020_36				
Comment Code					
T3 : Fallen tree with root ball.					
Inspector Comment					
Fallen tree with exposed rootball.

View of fallen tree with exposed rootball on the waterside slope. Fall 2020

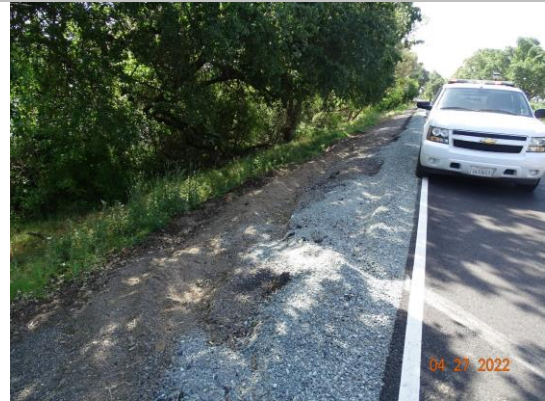
Photo 1 of 1 : FA_2022_RD0765_211_35_20220822_00017.jpg

LM Start	0.99	Rating **	M	Issue No.	35
LM End	0.99	Issue Type +	Ma	Location *	WS
Category	Earthen Levee			GPS Latitude/Longitude	
				Start	End
Item	Erosion / Vehicle Traffic			38.489574 °	38.489574 °
				-121.555308 °	-121.555308 °
DWR ID	DWR_RD0765_01_s_2022_35				
Comment Code					
E6 : Repair the levee slope damaged by vehicle traffic and prevent access where possible.					
Inspector Comment					
Repair rutting on the waterside shoulder.

Rutting on the waterside shoulder. Spring 2022

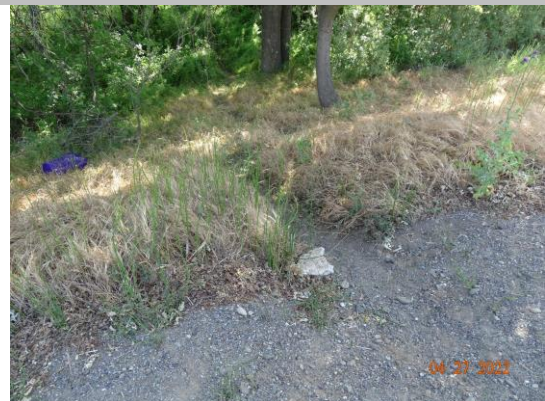
Photo 1 of 1 : FA_2022_RD0765_211_30_20220822_00013.jpg

LM Start	1.00	Rating **	A/W	Issue No.	30
LM End	1.00	Issue Type +	Ma	Location *	WS
Category	Earthen Levee			GPS Latitude/Longitude	
				Start	End
Item	Erosion / Foot Traffic			38.489503 °	38.489503 °
				-121.555272 °	-121.555272 °
DWR ID	DWR_RD0765_01_s_2022_30				
Comment Code					
E3 : Repair the levee slope damaged by foot traffic and prevent access where possible.					
Inspector Comment					
Monitor footpath for further erosion.

Footpath on the waterside slope. Spring 2022

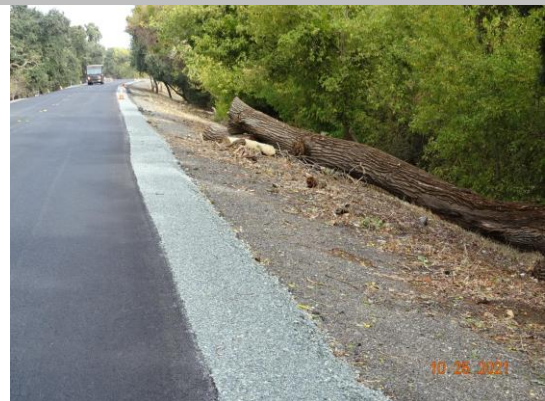
Photo 1 of 1 : FA_2022_RD0765_211_14_20220822_00005.jpg

LM Start	1.08	Rating **	M	Issue No.	14
LM End	1.08	Issue Type +	Ma	Location *	WS
Category	Earthen Levee			GPS Latitude/Longitude	
				Start	End
Item	Trim / Thin Trees			38.488401 °	38.488401 °
				-121.554658 °	-121.554658 °
DWR ID	DWR_RD0765_01_f_2021_14				
Comment Code					
T2 : Tree or limb.					
Inspector Comment					
Remove fallen tree from within 20' of the crown.

Fallen tree log within 20' of the WS crown. Fall 2021

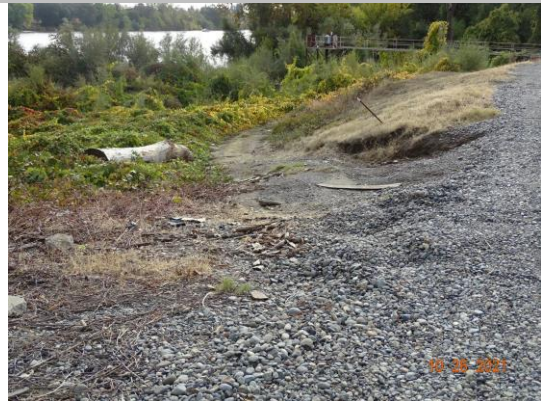
Photo 1 of 1 : FA_2022_RD0765_211_31_20220822_00014.jpg

LM Start	1.51	Rating **	M	Issue No.	31
LM End	1.51	Issue Type +	Ma	Location *	WS
Category	Earthen Levee			GPS Latitude/Longitude	
				Start	End
Item	Erosion / Vehicle Traffic			38.482788 °	38.482788 °
				-121.551048 °	-121.551048 °
DWR ID	DWR_RD0765_01_f _ 2019_31				
Comment Code					
E6 : Repair the levee slope damaged by vehicle traffic and prevent access where possible.					
Inspector Comment					
Repair slope damage caused by vehicle traffic.

Erosion and rutting from vehicle traffic on the WS slope. Fall 2021

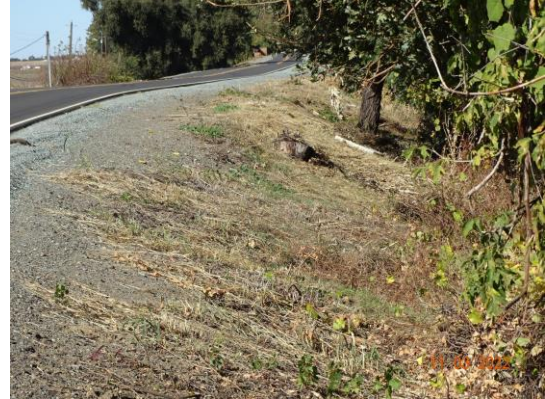
Photo 1 of 1 : FA_2022_RD0765_211_9_20221103_00028.jpg

LM Start	1.61	Rating **	N	Issue No.	9
LM End	1.61	Issue Type +	Ma	Location *	WS
Category	Earthen Levee			GPS Latitude/Longitude	
				Start	End
Item	Trim / Thin Trees			38.481560 °	38.481560 °
				-121.550295 °	-121.550295 °
DWR ID	DWR_RD0765_01_s_2020_9				
Comment Code					
T5 : Tree stumps.					
Inspector Comment					
Remove stump on the WS slope.

Tree stump on the WS slope. Fall 2022
