**Flood Control Project Maintenance  
Levee Inspections**

**Maintenance Issue Types Only, Levee Inspection Report By Mile - Fall 2023**

**Reclamation District No. 0765 Glide**

Waterway	Bank	Unit Miles	Inspection Start/End	Inspector
Unit No. 01 Sacramento River	Right	1.72	10/25/2023 10/25/2023	Marvin Marshall

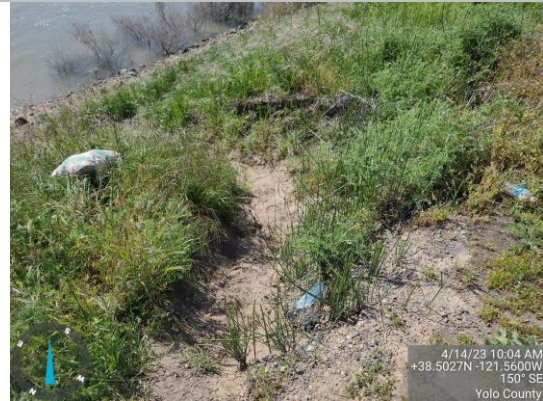
Photo 1 of 1 : FA\_2023\_RD0765\_211\_20\_20230905\_00013.jpg

LM Start	0.02	Rating **	U	Issue No.	20
LM End	0.02	Issue Type +	Ma	Location *	WS
Category	Earthen Levee			GPS Latitude/Longitude	
				Start	End
Item	Erosion / Foot Traffic			38.502711°	38.502711°
				-121.560019°	-121.560019°
DWR ID	DWR_RD0765_01_f_2023_20				
Comment Code					
E3 : Repair the levee slope damaged by foot traffic and prevent access where possible.					
Inspector Comment					
Repair erosion caused by foot traffic.

Footpath on the WS slope. Spring 2023

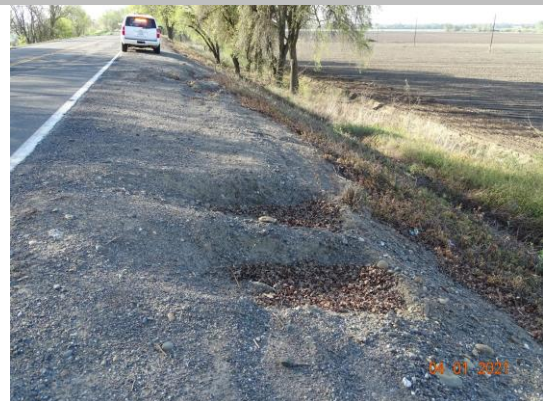
Photo 1 of 1 : FA\_2023\_RD0765\_211\_68\_20230905\_00024.jpg

LM Start	0.75	Rating **	M	Issue No.	68
LM End	0.75	Issue Type +	Ma	Location *	LS
Category	Earthen Levee			GPS Latitude/Longitude	
				Start	End
Item	Erosion / Vehicle Traffic			38.492705°	38.492705°
				-121.557193°	-121.557193°
DWR ID	DWR_RD0765_01_s_2017_68				
Comment Code					
E6 : Repair the levee slope damaged by vehicle traffic and prevent access where possible.					
Inspector Comment					
Repair tire rut damage on the LS shoulder.

View of the LS levee shoulder damaged by vehicle traffic. Spring 2021.

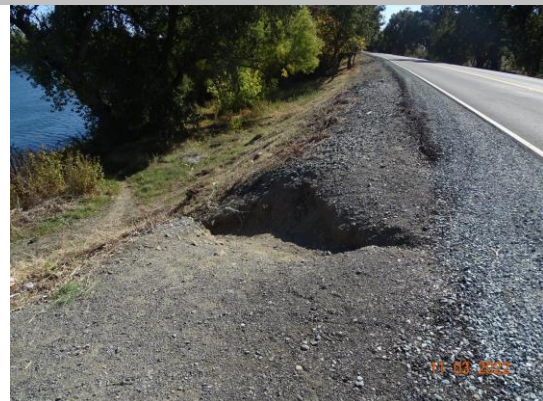
Photo 1 of 1 : FA\_2023\_RD0765\_211\_24\_20230905\_00016.jpg

LM Start	0.94	Rating **	U	Issue No.	24
LM End	0.94	Issue Type +	Ma	Location *	WS
Category	Earthen Levee			GPS Latitude/Longitude	
				Start	End
Item	Erosion / Foot Traffic			38.490265°	38.490265°
				-121.555617°	-121.555617°
DWR ID	DWR_RD0765_01_s_2019_24				
Comment Code					
E3 : Repair the levee slope damaged by foot traffic and prevent access where possible.					
Inspector Comment					
Erosion and footpath on the WS slope need to be repaired.

Erosion on the WS footpath. Fall 2022

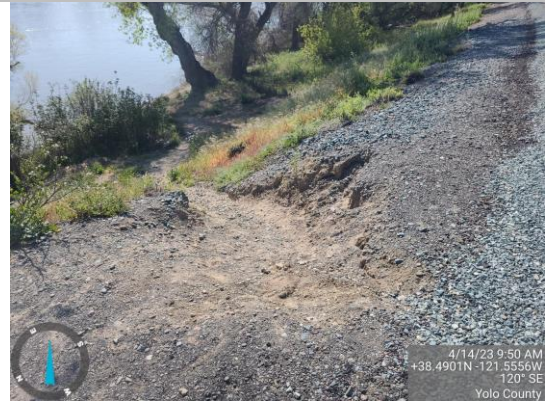
Photo 1 of 1 : FA\_2023\_RD0765\_211\_23\_20230905\_00015.jpg

LM Start	0.95	Rating **	U	Issue No.	23
LM End	0.95	Issue Type +	Ma	Location *	WS
Category	Earthen Levee			GPS Latitude/Longitude	
				Start	End
Item	Erosion / Foot Traffic			38.490067°	38.490067°
				-121.555530°	-121.555530°
DWR ID	DWR_RD0765_01_s_2019_23				
Comment Code					
E3 : Repair the levee slope damaged by foot traffic and prevent access where possible.					
Inspector Comment					
Repair the erosion at the footpath on the WS slope.

Erosion at the footpath on the WS slope. Spring 2023

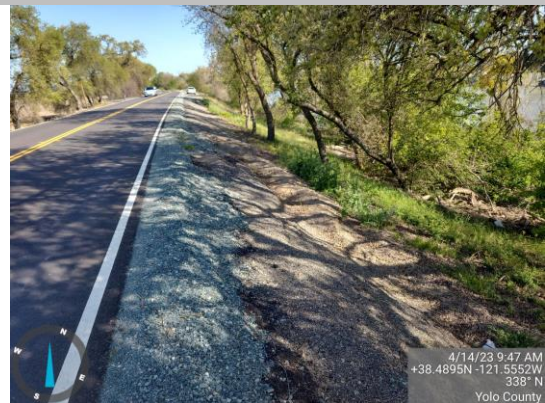
Photo 1 of 1 : FA\_2023\_RD0765\_211\_35\_20230905\_00019.jpg

LM Start	0.99	Rating **	M	Issue No.	35
LM End	0.99	Issue Type +	Ma	Location *	WS
Category	Earthen Levee			GPS Latitude/Longitude	
				Start	End
Item	Erosion / Vehicle Traffic			38.489574°	38.489574°
				-121.555308°	-121.555308°
DWR ID	DWR_RD0765_01_s_2022_35				
Comment Code					
E6 : Repair the levee slope damaged by vehicle traffic and prevent access where possible.					
Inspector Comment					
Repair rutting on the waterside shoulder.

Rutting on the waterside shoulder. Spring 2023

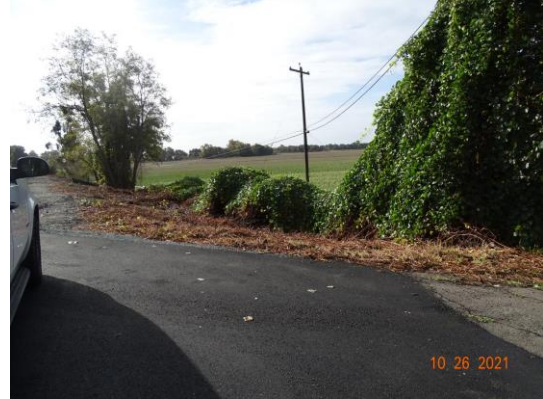
Photo 1 of 1 : FA\_2023\_RD0765\_211\_15\_20230905\_00011.jpg

LM Start	1.29	Rating **	U	Issue No.	15
LM End	1.30	Issue Type +	Ma	Location *	LS
Category	Earthen Levee			GPS Latitude/Longitude	
				Start	End
Item	Vegetation			38.485644°	38.485445°
				-121.553128°	-121.553014°
DWR ID	DWR_RD0765_01_s_2019_15				
Comment Code					
V2 : Remove the wild growth and woody vegetation other than native grasses from the levee slopes.					
Inspector Comment					
Remove wild vines and growth on the LS slope.

Ivy growth on the LS slope. Fall 2021

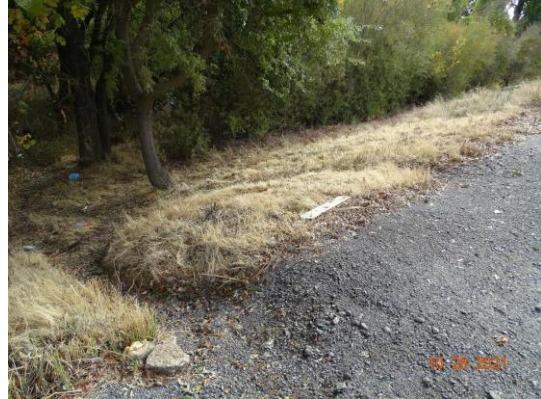
Photo 1 of 1 : FA\_2023\_RD0765\_211\_10\_20230905\_00008.jpg

LM Start	1.42	Rating **	A/W	Issue No.	10
LM End	1.42	Issue Type +	Ma	Location *	WS
Category	Earthen Levee			GPS Latitude/Longitude	
				Start	End
Item	Erosion / Foot Traffic			38.483973°	38.483973°
				-121.551855°	-121.551855°
DWR ID	DWR_RD0765_01_f _ 2021_10				
Comment Code					
E3 : Repair the levee slope damaged by foot traffic and prevent access where possible.					
Inspector Comment					
Monitor two footpaths for erosion.

Footpaths on the WS slope. Fall 2021

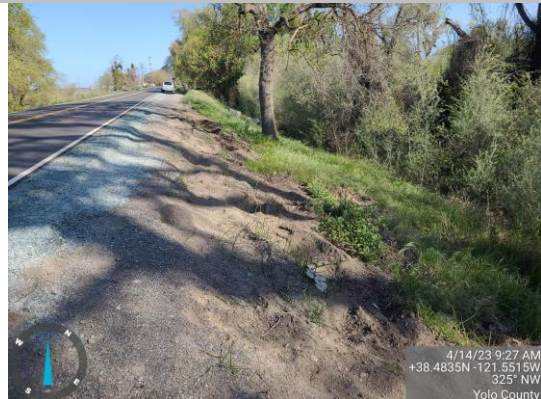
Photo 1 of 1 : FA\_2023\_RD0765\_211\_2\_20230905\_00001.jpg

LM Start	1.46	Rating **	M	Issue No.	2
LM End	1.46	Issue Type +	Ma	Location *	WS
Category	Earthen Levee			GPS Latitude/Longitude	
				Start	End
Item	Erosion / Vehicle Traffic			38.483414°	38.483414°
				-121.551472°	-121.551472°
DWR ID	DWR_RD0765_01_s_2023_2				
Comment Code					
E6 : Repair the levee slope damaged by vehicle traffic and prevent access where possible.					
Inspector Comment					
Repair rutting on the WS shoulder.

Rutting on the WS shoulder. Spring 2023

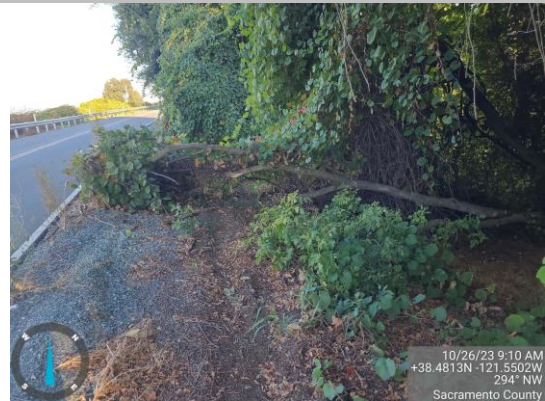
Photo 1 of 1 : FA\_2023\_RD0765\_211\_1\_20231026\_00026.jpg

LM Start	1.64	Rating **	M	Issue No.	1
LM End	1.64	Issue Type +	Ma	Location *	WS
Category	Earthen Levee			GPS Latitude/Longitude	
				Start	End
Item	Trim / Thin Trees			38.481151°	38.481151°
				-121.549866°	-121.549866°
DWR ID	DWR_RD0765_01_s_2023_1				
Comment Code					
T2 : Tree or limb.					
Inspector Comment					
Remove limbs from within 20' of the crown.

Tree limb on the WS slope. Fall 2023
