**Flood Control Project Maintenance  
Levee Inspections**

## Maintenance Issue Types Only, Levee Inspection Report By Mile - Fall 2024

### Reclamation District No. 0765 Glide

Waterway	Bank	Unit Miles	Inspection Start/End	Inspector
Unit No. 01 Sacramento River	Right	1.72	09/17/2024 09/17/2024	Marvin Marshall

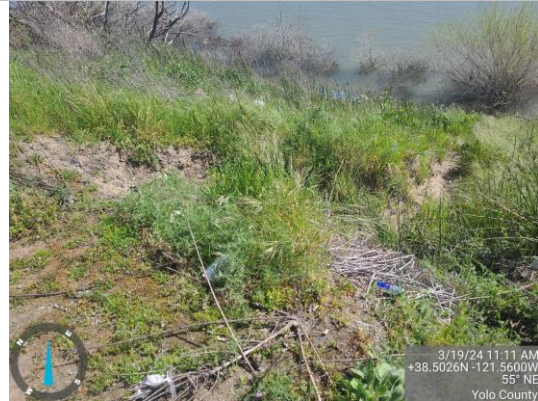
Photo 1 of 1 : FA\_2024\_RD0765\_211\_20\_20240911\_00010.jpg

LM Start	0.02	Rating **	U	Issue No.	20
LM End	0.02	Issue Type +	Ma	Location *	WS
Category	Earthen Levee			GPS Latitude/Longitude	
				Start	End
Item	Erosion / Foot Traffic			38.502711°	38.502711°
				-121.560019°	-121.560019°
DWR ID	DWR_RD0765_01_f_2023_20				
Comment Code					
E3 : Repair the levee slope damaged by foot traffic and prevent access where possible.					
Inspector Comment					
Repair erosion caused by foot traffic.

Footpath on the WS slope. Spring 2024

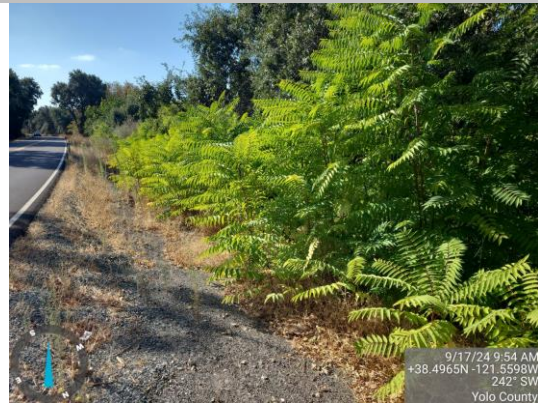
Photo 1 of 1 : FA\_2024\_RD0765\_211\_5\_20240918\_00017.jpg

LM Start	0.43	Rating **	U	Issue No.	5
LM End	0.50	Issue Type +	Ma	Location *	LS
Category	Earthen Levee			GPS Latitude/Longitude	
				Start	End
Item	Trim / Thin Trees			38.496750°	38.495772°
				-121.560018°	-121.559551°
DWR ID	DWR_RD0765_01_f_2024_5				
Comment Code					
T1 : Trim and thin trees to at least five feet above ground level to allow visibility of the ground and room to flood fight.					
Inspector Comment

Trees on the LS slope. Fall 2024

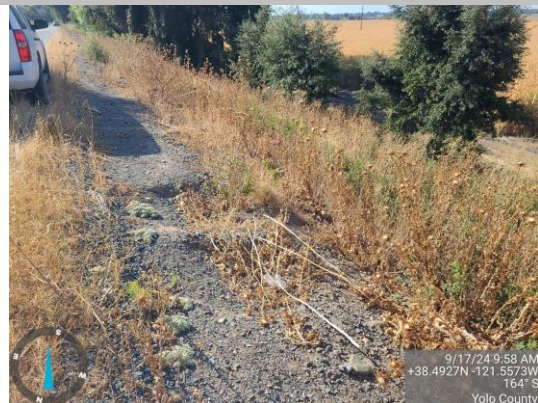
Photo 1 of 1 : FA\_2024\_RD0765\_211\_68\_20240918\_00018.jpg

LM Start	0.75	Rating **	M	Issue No.	68
LM End	0.75	Issue Type +	Ma	Location *	LS
Category	Earthen Levee			GPS Latitude/Longitude	
				Start	End
Item	Erosion / Rills			38.492705°	38.492705°
				-121.557193°	-121.557193°
DWR ID	DWR_RD0765_01_s_2017_68				
Comment Code					
E5 : Schedule repair of rills prior to the next inspection.					
Inspector Comment

Erosion on the LS slope. Fall 2024

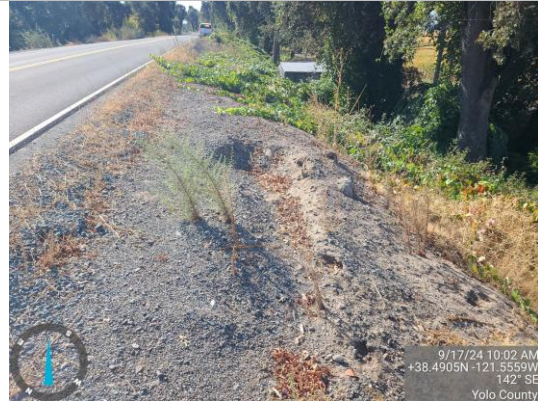
Photo 1 of 1 : FA\_2024\_RD0765\_211\_6\_20240918\_00019.jpg

LM Start	0.92	Rating **	M	Issue No.	6
LM End	0.92	Issue Type +	Ma	Location *	LS
Category	Earthen Levee			GPS Latitude/Longitude	
				Start	End
Item	Erosion / Vehicle Traffic			38.490514°	38.490514°
				-121.555831°	-121.555831°
DWR ID	DWR_RD0765_01_f_2024_6				
Comment Code					
E6 : Repair the levee slope damaged by vehicle traffic and prevent access where possible.					
Inspector Comment

Rutting on the LS shoulder. Fall 2024

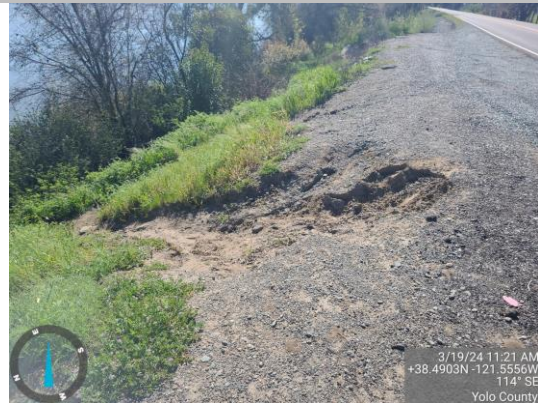
Photo 1 of 1 : FA\_2024\_RD0765\_211\_24\_20240911\_00012.jpg

LM Start	0.94	Rating **	U	Issue No.	24
LM End	0.94	Issue Type +	Ma	Location *	WS
Category	Earthen Levee			GPS Latitude/Longitude	
				Start	End
Item	Erosion / Foot Traffic			38.490265°	38.490265°
				-121.555617°	-121.555617°
DWR ID	DWR_RD0765_01_s_2019_24				
Comment Code					
E3 : Repair the levee slope damaged by foot traffic and prevent access where possible.					
Inspector Comment					
Erosion and footpath on the WS slope need to be repaired.

Erosion on the WS footpath. Spring 2024

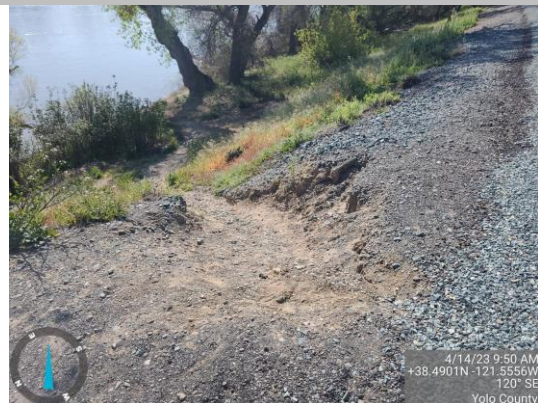
Photo 1 of 1 : FA\_2024\_RD0765\_211\_23\_20240911\_00011.jpg

LM Start	0.95	Rating **	U	Issue No.	23
LM End	0.95	Issue Type +	Ma	Location *	WS
Category	Earthen Levee			GPS Latitude/Longitude	
				Start	End
Item	Erosion / Foot Traffic			38.490067°	38.490067°
				-121.555530°	-121.555530°
DWR ID	DWR_RD0765_01_s_2019_23				
Comment Code					
E3 : Repair the levee slope damaged by foot traffic and prevent access where possible.					
Inspector Comment					
Repair the erosion at the footpath on the WS slope.

Erosion at the footpath on the WS slope. Spring 2023

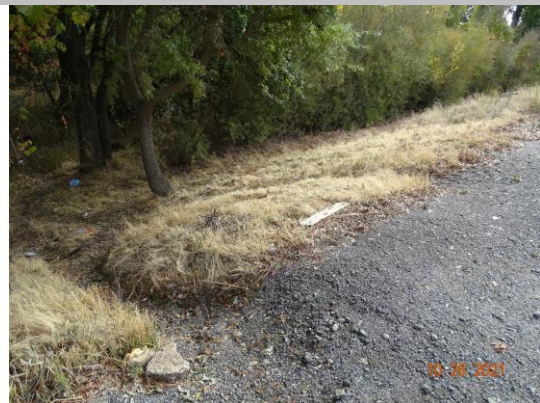
Photo 1 of 1 : FA\_2024\_RD0765\_211\_10\_20240911\_00005.jpg

LM Start	1.42	Rating **	M	Issue No.	10
LM End	1.42	Issue Type +	Ma	Location *	WS
Category	Earthen Levee			GPS Latitude/Longitude	
				Start	End
Item	Erosion / Foot Traffic			38.483973°	38.483973°
				-121.551855°	-121.551855°
DWR ID	DWR_RD0765_01_f_2021_10				
Comment Code					
E3 : Repair the levee slope damaged by foot traffic and prevent access where possible.					
Inspector Comment

Footpaths on the WS slope. Fall 2021

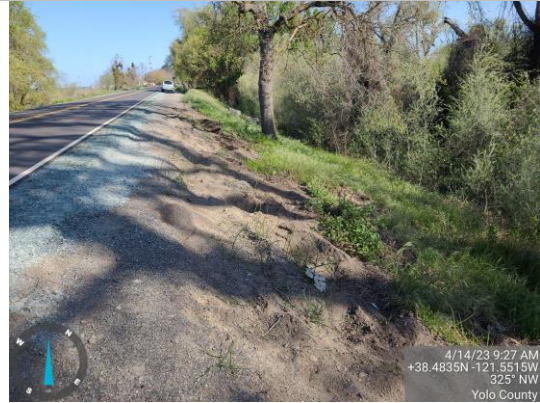
Photo 1 of 1 : FA\_2024\_RD0765\_211\_2\_20240911\_00002.jpg

LM Start	1.46	Rating **	M	Issue No.	2
LM End	1.46	Issue Type +	Ma	Location *	WS
Category	Earthen Levee			GPS Latitude/Longitude	
				Start	End
Item	Erosion / Vehicle Traffic			38.483414°	38.483414°
				-121.551472°	-121.551472°
DWR ID	DWR_RD0765_01_s _ 2023_2				
Comment Code					
E6 : Repair the levee slope damaged by vehicle traffic and prevent access where possible.					
Inspector Comment					
Repair rutting on the WS shoulder.

Rutting on the WS shoulder. Spring 2023

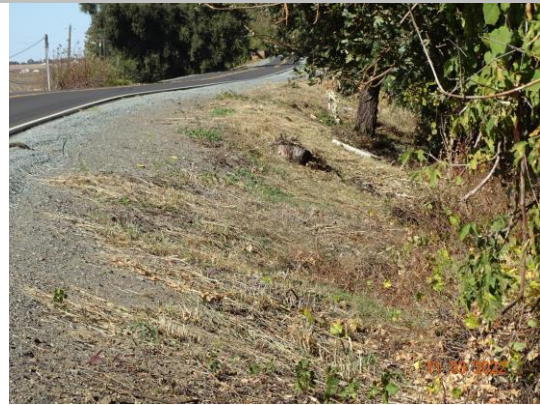
Photo 1 of 1 : FA\_2024\_RD0765\_211\_9\_20240911\_00004.jpg

LM Start	1.61	Rating **	N	Issue No.	9
LM End	1.61	Issue Type +	Ma	Location *	WS
Category	Earthen Levee			GPS Latitude/Longitude	
				Start	End
Item	Trim / Thin Trees			38.481560°	38.481560°
				-121.550295°	-121.550295°
DWR ID	DWR_RD0765_01_s _ 2020_9				
Comment Code					
T5 : Tree stumps.					
Inspector Comment					
Remove stump on the WS slope.

Tree stump on the WS slope. Fall 2022

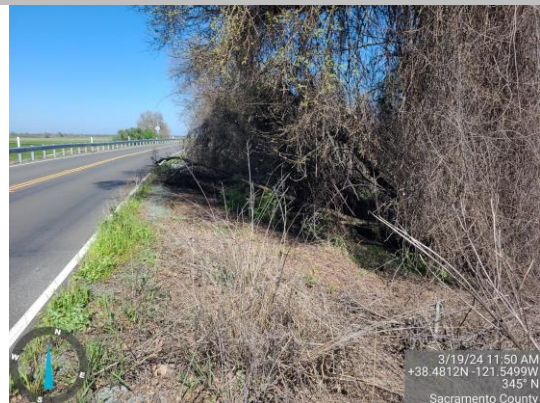
Photo 1 of 1 : FA\_2024\_RD0765\_211\_1\_20240911\_00001.jpg

LM Start	1.64	Rating **	M	Issue No.	1
LM End	1.64	Issue Type +	Ma	Location *	WS
Category	Earthen Levee			GPS Latitude/Longitude	
				Start	End
Item	Vegetation			38.481151°	38.481151°
				-121.549866°	-121.549866°
DWR ID	DWR_RD0765_01_s _ 2023_1				
Comment Code					
V2 : Remove the wild growth and woody vegetation other than native grasses from the levee slopes.					
Inspector Comment					
Remove woody vegetation from within 20' of the crown. Trim trees to 5' above grade.

Limbs and woody growth on the WS slope. Spring 2023
