**Flood Control Project Maintenance  
Levee Inspections**

## Maintenance Issue Types Only, Levee Inspection Report By Mile - Spring 2016

### Reclamation District No. 0765 Glide

Waterway	Bank	Unit Miles	Inspection Start/End	Inspector
Unit No. 01 Sacramento River	Right	1.72	03/08/2016 03/08/2016	Richard Willoughby

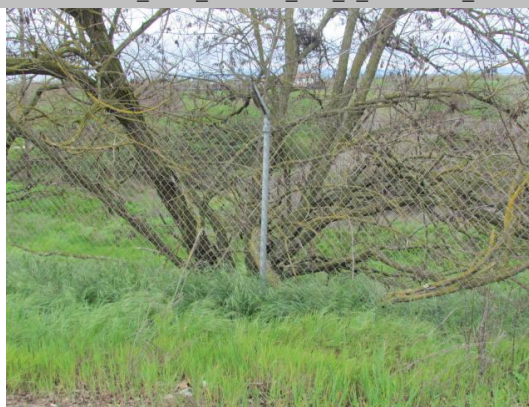
Photo 1 of 3 : SP\_2016\_RD0765\_211\_3\_20160311\_00063.jpg

LM Start	0.05	Rating **	U	Issue No.	3
LM End	0.05	Issue Type +	Ma	Location *	LS
Category	Earthen Levee			GPS Latitude/Longitude	
				Start	End
Item	Trim / Thin Trees			38.502253 °	38.502253 °
				-121.560192 °	-121.560192 °
DWR ID	DWR_RD0765_01_s _ 2012_3				
Comment Code					
T1 : Trim trees to at least five feet above ground level.					
Inspector Comment					
Trees blocking view of landward slope.

Looking west at tree on landward slope.

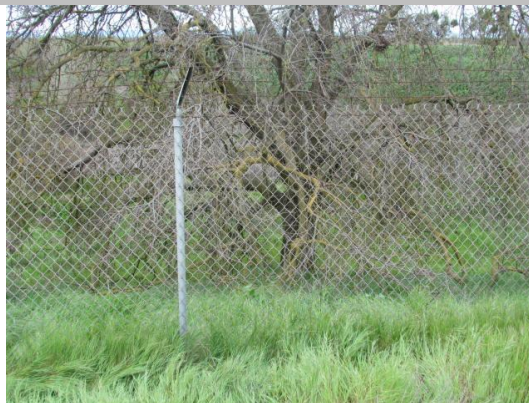
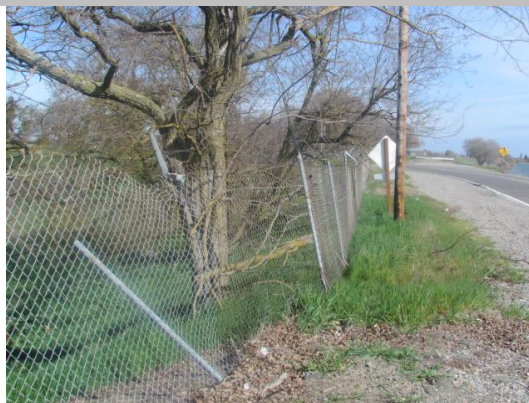
LM Start	0.05	Rating **	U	Issue No.	3 (cont)	
LM End	0.05	Issue Type +	Ma	Location *	LS	
Category	Earthen Levee			GPS Latitude/Longitude		
				Start		End
Item	Trim / Thin Trees			38.502253 °		38.502253 °
				-121.560192 °		-121.560192 °
DWR ID	DWR_RD0765_01_s _ 2012_3					
Comment Code						
T1 : Trim trees to at least five feet above ground level.						
Inspector Comment						
Trees blocking view of landward slope.

Looking north (upstream) at trees on landside slope.

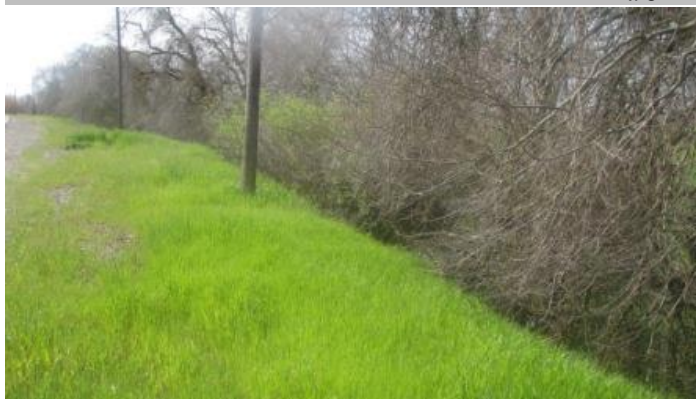
Photo 1 of 2 : SP\_2016\_RD0765\_211\_28\_20160224\_00013.jpg

LM Start	0.12	Rating **	M	Issue No.	28
LM End	0.19	Issue Type +	Ma	Location *	LS
Category	Earthen Levee			GPS Latitude/Longitude	
				Start	End
Item	Trim / Thin Trees			38.501215 °	38.500271 °
				-121.560432 °	-121.560434 °
DWR ID	DWR_RD0765_01_s_2012_28				
Comment Code					
T3 : Trim and thin trees to allow visibility of the ground and room to flood fight.					
Inspector Comment

Looking downstream (south) at trees on landside slope &amp; toe.

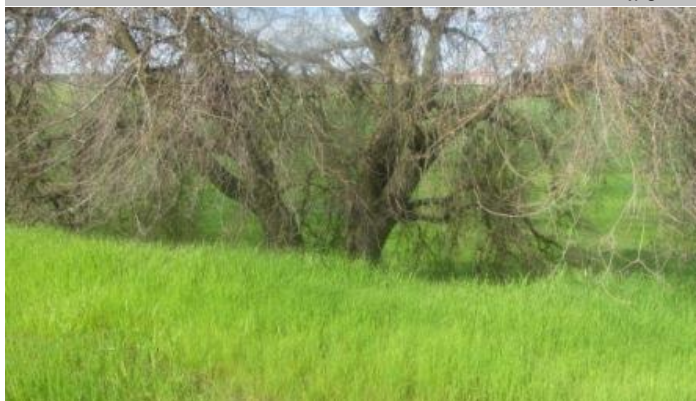
Photo 2 of 2 : SP\_2016\_RD0765\_211\_28\_20160224\_00014.jpg

Looking west at trees on landside toe.

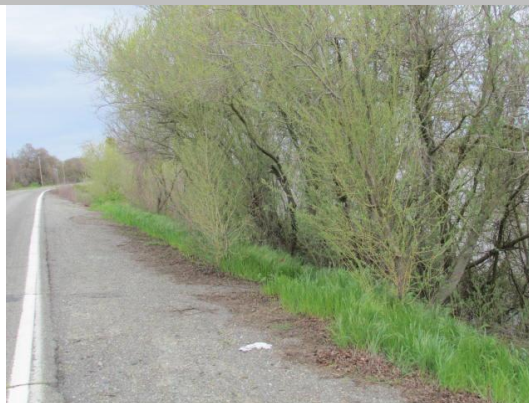
Photo 1 of 1 : SP\_2016\_RD0765\_211\_11\_20160311\_00065.jpg

LM Start	0.25	Rating **	U	Issue No.	11
LM End	0.27	Issue Type +	Ma	Location *	WS
Category	Earthen Levee			GPS Latitude/Longitude	
				Start	End
Item	Trim / Thin Trees			38.499405 °	38.499042 °
				-121.560445 °	-121.560430 °
DWR ID	DWR_RD0765_01_s_2012_11				
Comment Code					
T3 : Trim and thin trees to allow visibility of the ground and room to flood fight.					
Inspector Comment					
Trees shall be trimmed and thinned on waterward slope.

Looking southwest at trees along landward shoulder and slope.

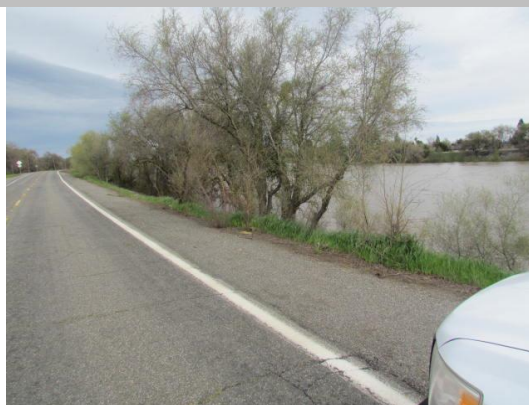
Photo 1 of 1 : SP\_2016\_RD0765\_211\_23\_20160311\_00066.jpg

Looking northeast at trees along waterward shoulder and slope.

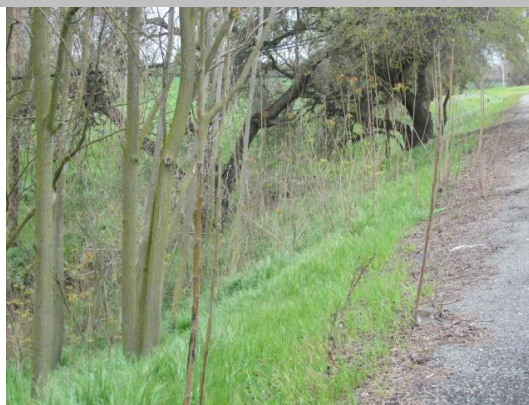
Photo 1 of 2 : SP\_2016\_RD0765\_211\_32\_20160311\_00067.jpg

LM Start	0.43	Rating **	U	Issue No.	32
LM End	0.46	Issue Type +	Ma	Location *	LS
Category	Earthen Levee			GPS Latitude/Longitude	
				Start	End
Item	Trim / Thin Trees			38.496792 °	38.496321 °
				-121.560026 °	-121.559842 °
DWR ID	DWR_RD0765_01_s_2012_32				
Comment Code					
T3 : Trim and thin trees to allow visibility of the ground and room to flood fight.					
Inspector Comment					
New saplings should be removed.

Looking northwest at trees (saplings) on landward slope.

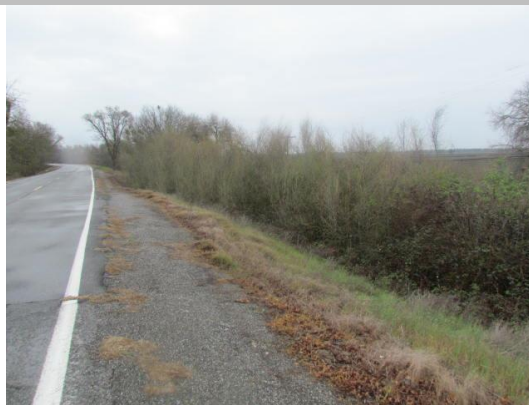
Photo 2 of 2 : SP\_2016\_RD0765\_211\_32\_20160224\_00021.jpg

Looking southwest at dense vegetation on landside slope and toe. (2015)

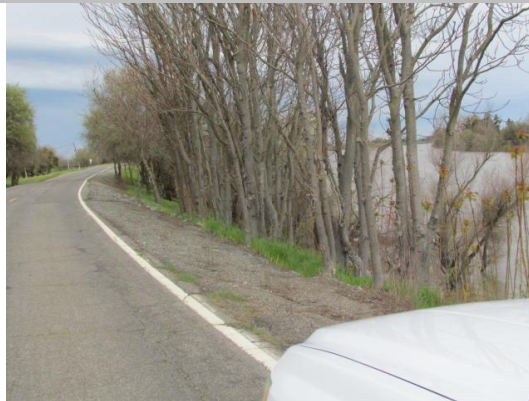
Photo 1 of 1 : SP\_2016\_RD0765\_211\_24\_20160311\_00068.jpg

Looking northeast at cluster of trees on waterward slope.

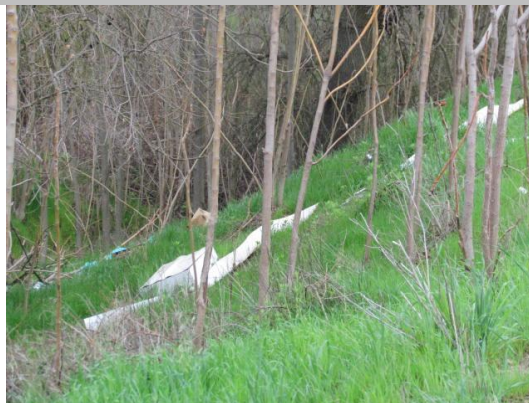
Photo 1 of 2 : SP\_2016\_RD0765\_211\_55\_20160224\_00036.jpg

LM Start	0.47	Rating **	A/W	Issue No.	55
LM End	0.47	Issue Type +	Ma	Location *	LS
Category	Earthen Levee			GPS Latitude/Longitude	
				Start	End
Item	Encroachments			38.496235 °	38.496235 °
				-121.559796 °	-121.559796 °
DWR ID	DWR_RD0765_01_f_2013_55				
Comment Code					
GA : Garbage					
Inspector Comment					
Trash dumped on landside slope.

Looking northwest at garbage on landside slope.

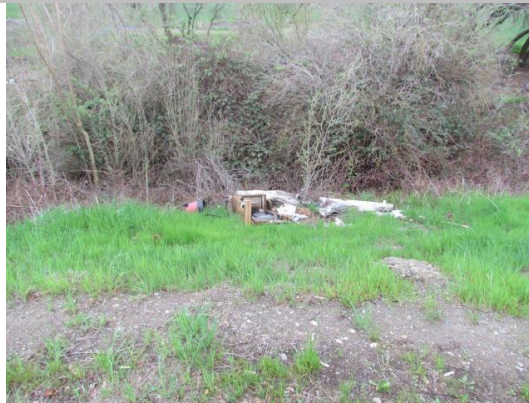
Photo 2 of 2 : SP\_2016\_RD0765\_211\_55\_20160224\_00037.jpg

Looking west at garbage on landside slope.

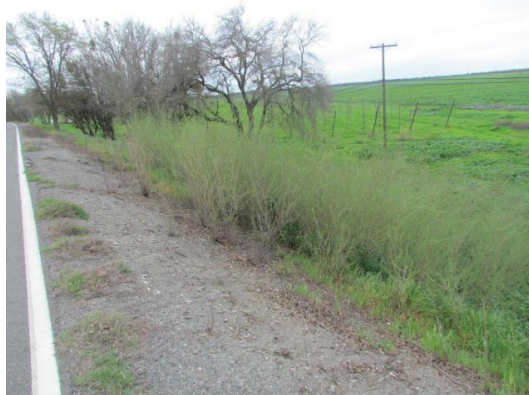
Photo 1 of 2 : SP\_2016\_RD0765\_211\_59\_20160311\_00069.jpg

Looking northwest at dense vegetation on landward slope.

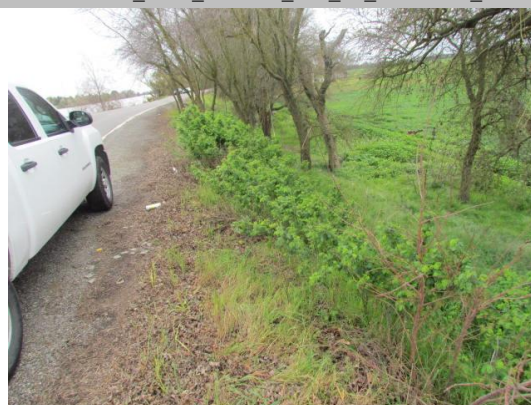
Photo 1 of 1 : SP\_2016\_RD0765\_211\_61\_20160311\_00072.jpg

Looking southwest at wildroses on landward slope.

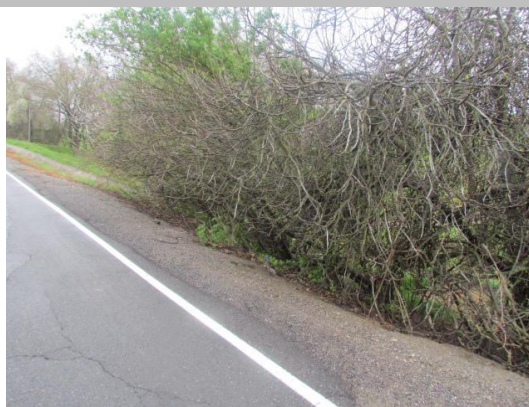
Photo 1 of 1 : SP\_2016\_RD0765\_211\_40\_20160224\_00027.jpg

Looking southwest at fig trees and other trees on landside slope and toe.

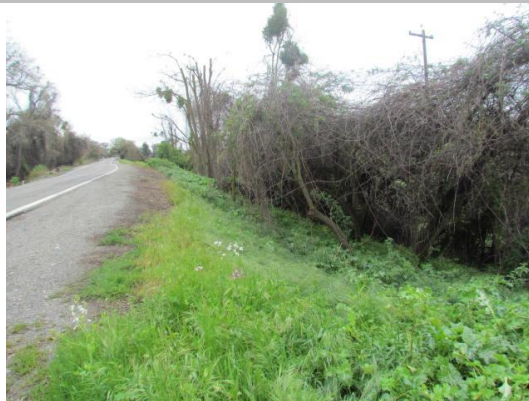
Photo 1 of 2 : SP\_2016\_RD0765\_211\_33\_20160311\_00073.jpg

Looking west at dense vegetation on landward toe.

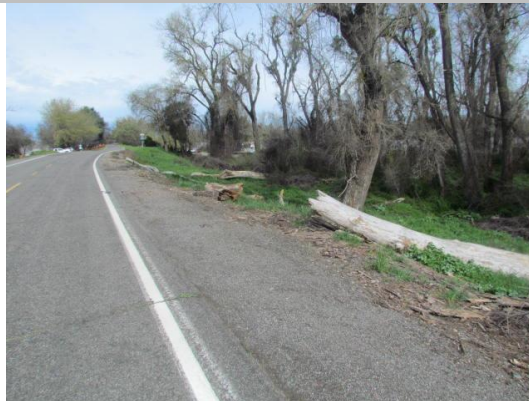
Photo 1 of 4 : SP\_2016\_RD0765\_211\_7\_20160311\_00075.jpg

Looking northeast at tree limbs on waterward slope.

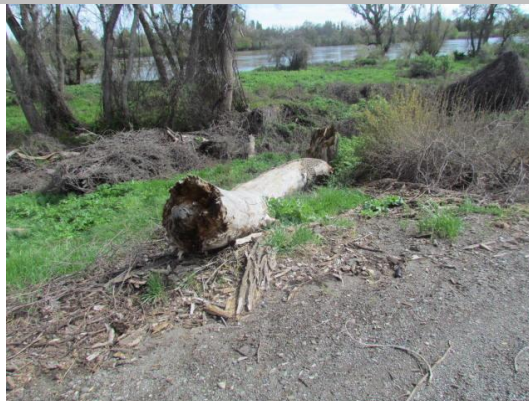
Photo 2 of 4 : SP\_2016\_RD0765\_211\_7\_20160311\_00076.jpg

Looking southeast at branch on waterward slope.

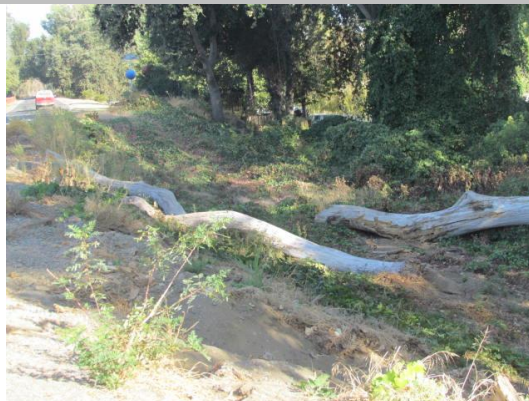
Photo 3 of 4 : SP\_2016\_RD0765\_211\_7\_20160224\_00005.jpg

Looking at several tree branches on waterward slope and berm.(2015)

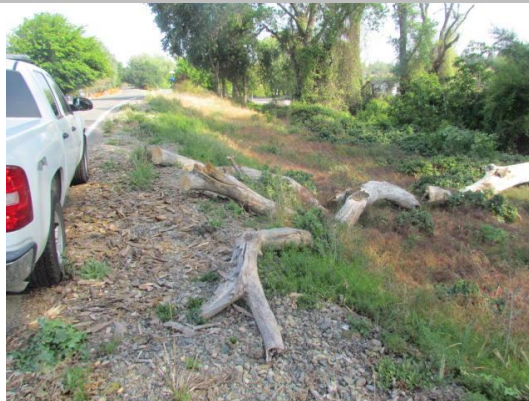
Photo 4 of 4 : SP\_2016\_RD0765\_211\_7\_20160224\_00006.jpg

Looking north at down tree across waterward slope.(2015)

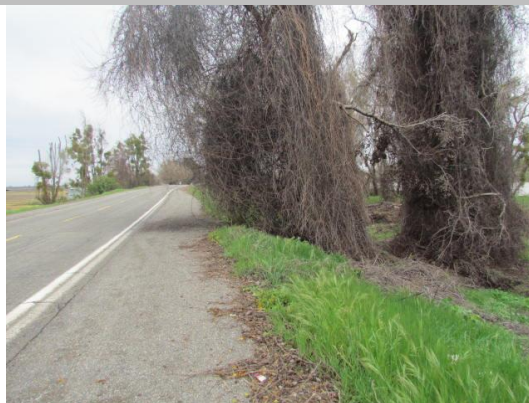
Photo 1 of 1 : SP\_2016\_RD0765\_211\_4\_20160224\_00002.jpg

LM Start	1.39	Rating **	A/W	Issue No.	4
LM End	1.39	Issue Type +	Ma	Location *	WS
Category	Earthen Levee			GPS Latitude/Longitude	
				Start	End
Item	Trim / Thin Trees			38.484316 °	38.484316 °
				-121.552115 °	-121.552115 °
DWR ID	DWR_RD0765_01_s _ 2012_4				
Comment Code					
T1 : Trim trees to at least five feet above ground level.					
Inspector Comment

Looking north at untrimmed trees on waterward slope.

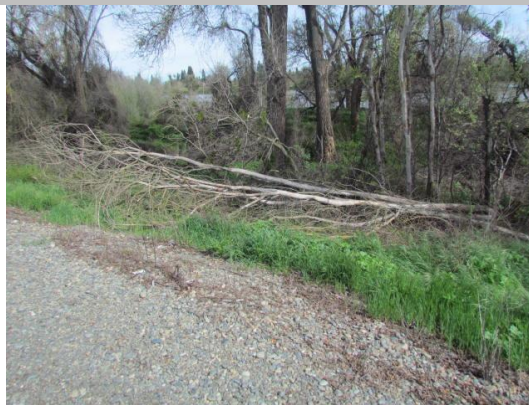
Photo 1 of 1 : SP\_2016\_RD0765\_211\_64\_20160311\_00077.jpg

Looking at fallen tree on waterward slope and toe.

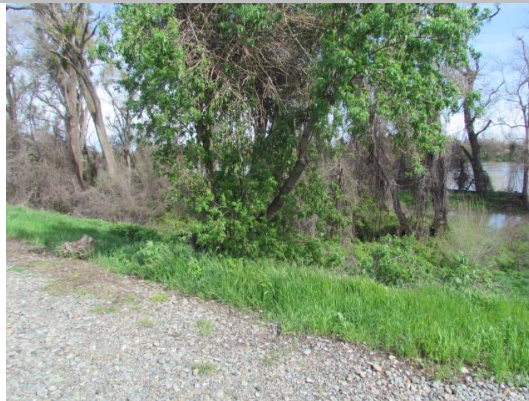
Photo 1 of 1 : SP\_2016\_RD0765\_211\_50\_20160311\_00079.jpg

Looking east at untrimmed tree on waterward slope.

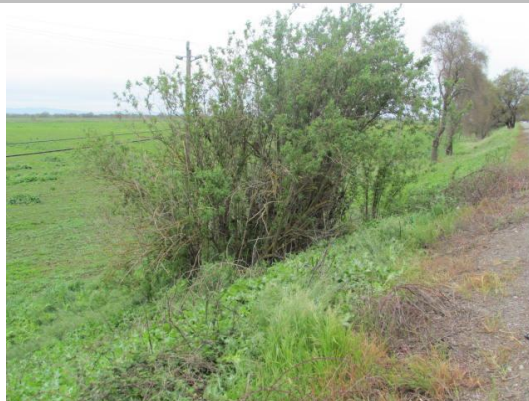
Photo 1 of 2 : SP\_2016\_RD0765\_211\_29\_20160311\_00080.jpg

LM Start	1.52	Rating **	U	Issue No.	29
LM End	1.62	Issue Type +	Ma	Location *	LS
Category	Earthen Levee			GPS Latitude/Longitude	
				Start	End
Item	Vegetation			38.482665 °	38.481421 °
				-121.551036 °	-121.550207 °
DWR ID	DWR_RD0765_01_s_2012_29				
Comment Code					
V2 : Remove the wild growth other than native grasses from the levee slopes.					
Inspector Comment					
Dense berryvines and dense trees on landward slope. The LMA removed a sizeable amount of vines, but some still remain.

Looking northwest at dense vegetation on landward slope and toe.

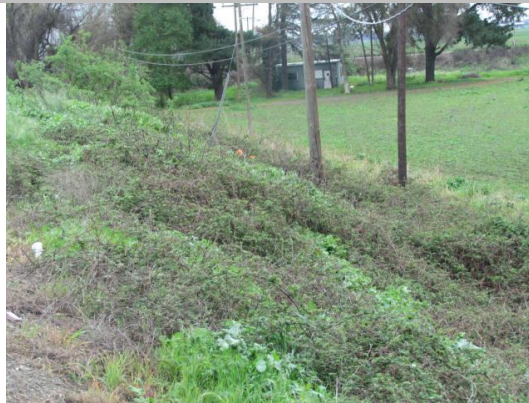
Photo 2 of 2 : SP\_2016\_RD0765\_211\_29\_20160311\_00081.jpg

Looking southwest at ground cover on landward slope.

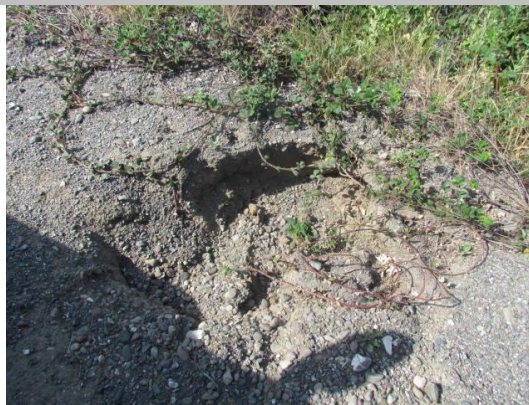
Photo 1 of 7 : SP\_2016\_RD0765\_211\_57\_20160224\_00041.jpg

LM Start	1.55	Rating **	U	Issue No.	57
LM End	1.55	Issue Type +	Ma	Location *	LS
Category	Earthen Levee			GPS Latitude/Longitude	
				Start	End
Item	Erosion / Bank Caving			38.482327 °	38.482327 °
				-121.550848 °	-121.550848 °
DWR ID	DWR_RD0765_01_s_2015_57				
Comment Code					
E2 : Schedule repair of erosion site prior to the next inspection.					
Inspector Comment					
Caving greater than one inch deep and greater that three inches in length on landward shoulder. Caving has grew to 3ft deep, 3ft wide and 10ft long. Erosion starting to undermine toward crown of levee.

Looking east at caving on landward shoulder.

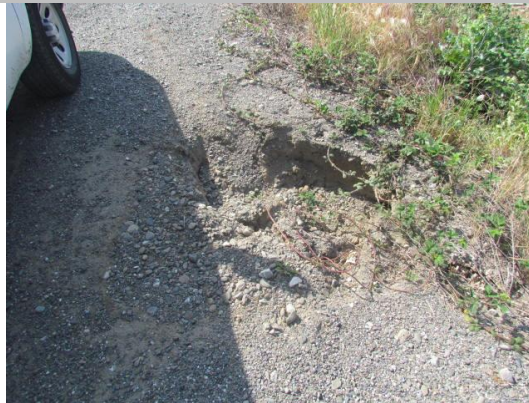
Photo 2 of 7 : SP\_2016\_RD0765\_211\_57\_20160224\_00042.jpg

Looking south at caving on landward shoulder.

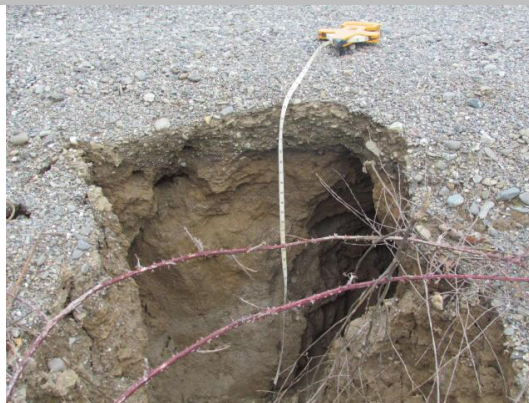
Photo 3 of 7 : SP\_2016\_RD0765\_211\_57\_20160311\_00083.jpg

LM Start	1.55	Rating **	U	Issue No.	57 (cont)	
LM End	1.55	Issue Type +	Ma	Location *	LS	
Category	Earthen Levee			GPS Latitude/Longitude		
				Start		End
Item	Erosion / Bank Caving			38.482327 °		38.482327 °
				-121.550848 °		-121.550848 °
DWR ID	DWR_RD0765_01_s_2015_57					
Comment Code						
E2 : Schedule repair of erosion site prior to the next inspection.						
Inspector Comment						
Caving greater than one inch deep and greater that three inches in length on landward shoulder. Caving has grew to 3ft deep, 3ft wide and 10ft long. Erosion starting to undermine toward crown of levee.

Looking east at large hole on landward shoulder and slope.

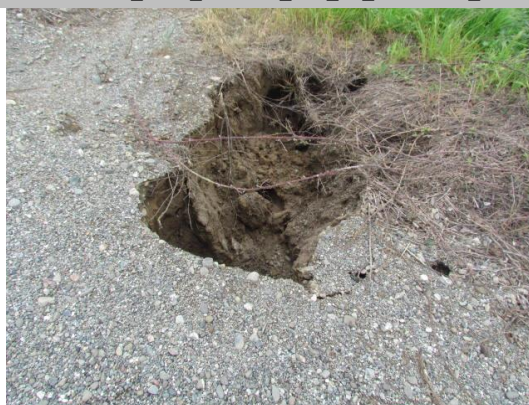
Photo 4 of 7 : SP\_2016\_RD0765\_211\_57\_20160311\_00082.jpg

Looking southwest at large hole on landward shoulder and slope.

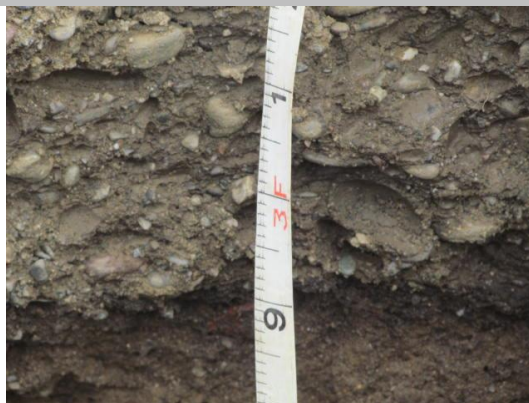
Photo 5 of 7 : SP\_2016\_RD0765\_211\_57\_20160311\_00084.jpg

Looking depth of hole on landward shoulder and slope.

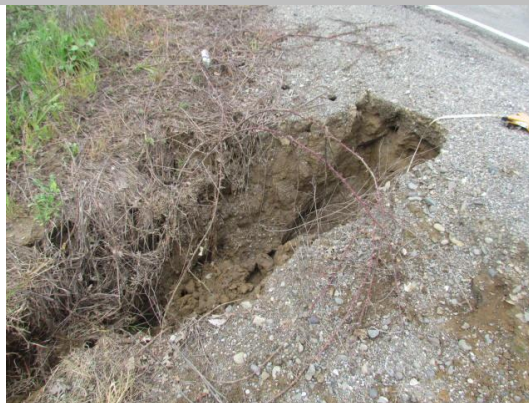
Photo 6 of 7 : SP\_2016\_RD0765\_211\_57\_20160311\_00085.jpg

LM Start	1.55	Rating **	U	Issue No.	57 (cont)	
LM End	1.55	Issue Type +	Ma	Location *	LS	
Category	Earthen Levee			GPS Latitude/Longitude		
				Start		End
Item	Erosion / Bank Caving			38.482327 °		38.482327 °
				-121.550848 °		-121.550848 °
DWR ID	DWR_RD0765_01_s _ 2015_57					
Comment Code						
E2 : Schedule repair of erosion site prior to the next inspection.						
Inspector Comment						
Caving greater than one inch deep and greater that three inches in length on landward shoulder. Caving has grew to 3ft deep, 3ft wide and 10ft long. Erosion starting to undermine toward crown of levee.

Looking north at hole on landward shoulder and slope.

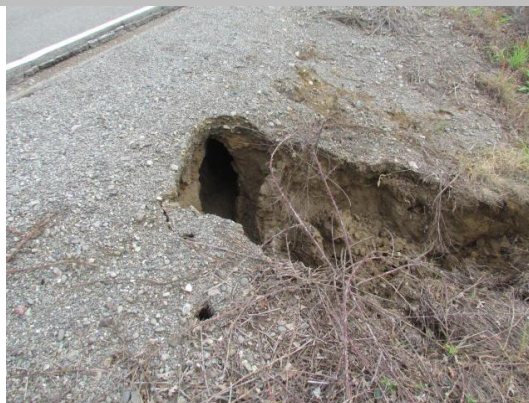
Photo 7 of 7 : SP\_2016\_RD0765\_211\_57\_20160311\_00086.jpg

Looking south at large hole on landward shoulder and slope.

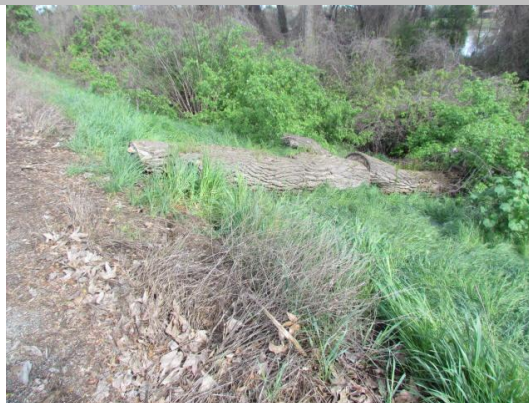
Photo 1 of 4 : SP\_2016\_RD0765\_211\_13\_20160311\_00087.jpg

Looking northwest at tree limb on waterward slope.

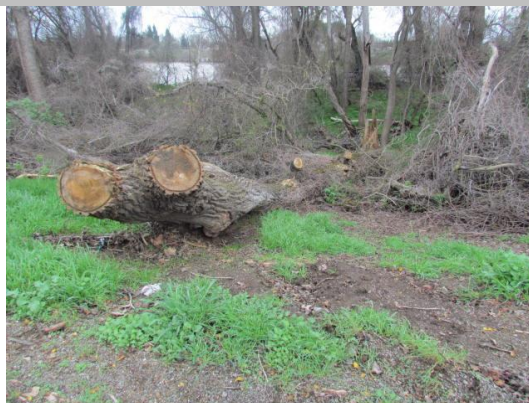
Photo 2 of 4 : SP\_2016\_RD0765\_211\_13\_20160224\_00008.jpg

Looking east at large tree limb on waterward slope. (2015)

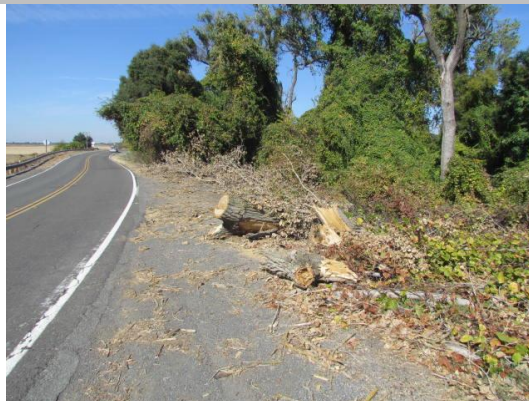
Photo 3 of 4 : SP\_2016\_RD0765\_211\_13\_20160224\_00007.jpg

Looking northeast at tree limbs on waterward slope.(2015)

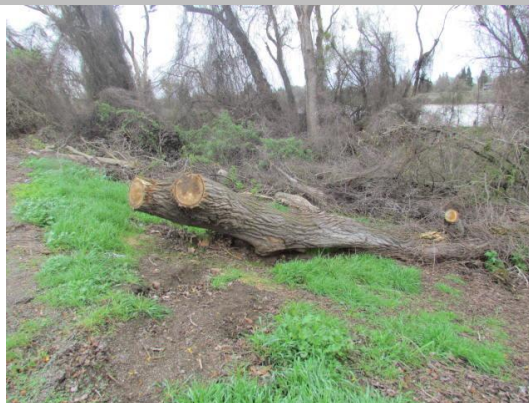
Photo 4 of 4 : SP\_2016\_RD0765\_211\_13\_20160224\_00009.jpg

Looking north at large tree limb on waterward slope.(2015)
