**Flood Control Project Maintenance
Levee Inspections**

Maintenance Issue Types Only, Levee Inspection Report By Mile - Spring 2017

Reclamation District No. 0765 Glide

Waterway	Bank	Unit Miles	Inspection Start/End	Inspector
Unit No. 01 Sacramento River	Right	1.72	03/13/2017 03/13/2017	Richard Willoughby

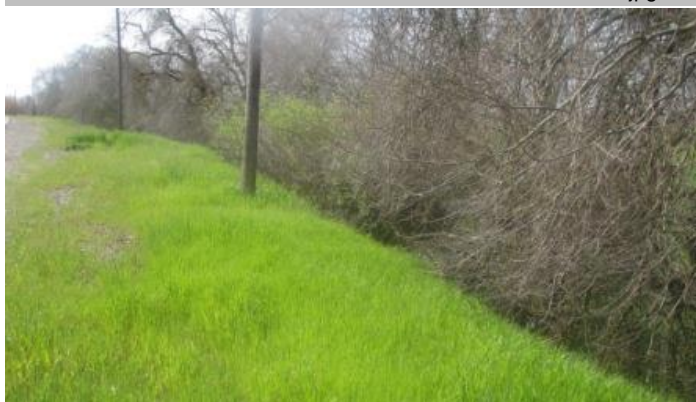
Photo 1 of 2 : SP_2017_RD0765_211_28_20170313_00024.jpg

LM Start	0.12	Rating **	M	Issue No.	28
LM End	0.19	Issue Type +	Ma	Location *	LS
Category	Earthen Levee			GPS Latitude/Longitude	
				Start	End
Item	Trim / Thin Trees			38.501215 °	38.500271 °
				-121.560432 °	-121.560434 °
DWR ID	DWR_RD0765_01_s _ 2012_28				
Comment Code					
T3 : Trim and thin trees to allow visibility of the ground and room to flood fight.					
Inspector Comment

Looking downstream (south) at trees on landside slope & toe.

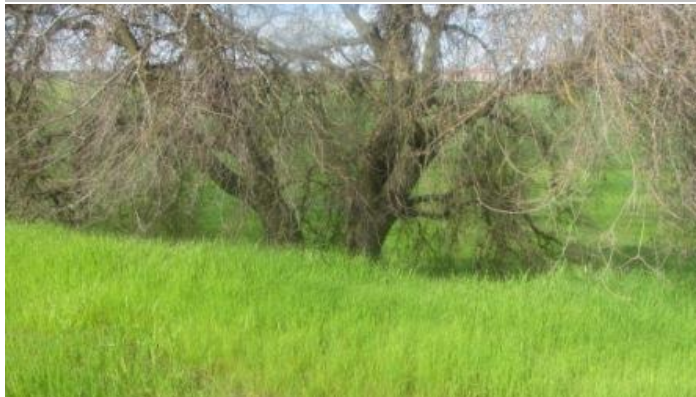
Photo 2 of 2 : SP_2017_RD0765_211_28_20170313_00025.jpg

LM Start	0.12	Rating **	M	Issue No.	28 (cont)	
LM End	0.19	Issue Type +	Ma	Location *	LS	
Category	Earthen Levee			GPS Latitude/Longitude		
				Start		End
Item	Trim / Thin Trees			38.501215 °		38.500271 °
				-121.560432 °		-121.560434 °
DWR ID	DWR_RD0765_01_s_2012_28					
Comment Code						
T3 : Trim and thin trees to allow visibility of the ground and room to flood fight.						
Inspector Comment

Looking west at trees on landside toe.

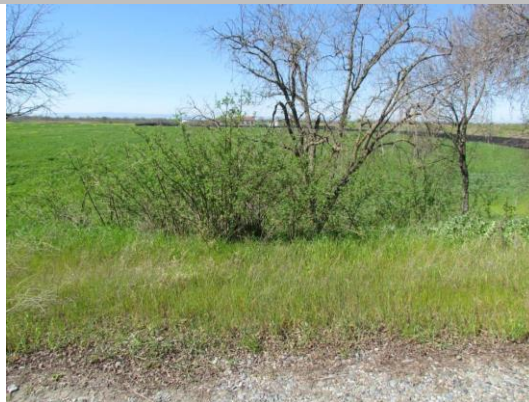
Photo 1 of 1 : SP_2017_RD0765_211_22_20170314_00080.jpg

Looking west at moderate veg on landward slope.

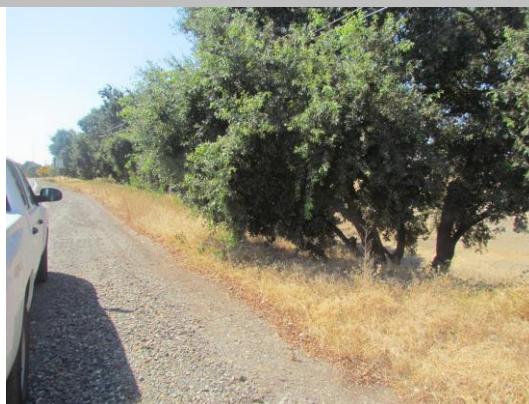
Photo 2 of 2 : SP_2017_RD0765_211_14_20170313_00015.jpg

Looking southwest at untrimmed trees on landward slope. (Fall 2016)

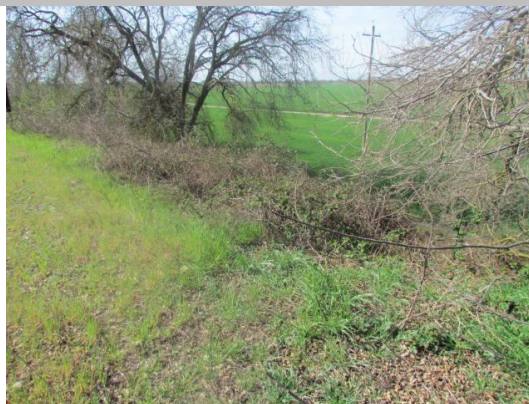
Photo 1 of 1 : SP_2017_RD0765_211_49_20170313_00042.jpg

LM Start	0.24	Rating **	M	Issue No.	49
LM End	0.24	Issue Type +	Ma	Location *	LS
Category	Earthen Levee			GPS Latitude/Longitude	
				Start	End
Item	Vegetation			38.499530 °	38.499530 °
				-121.560490 °	-121.560490 °
DWR ID	DWR_RD0765_01_s_2013_49				
Comment Code					
V2 : Remove the wild growth other than native grasses from the levee slopes.					
Inspector Comment					
Control wild berryvines on landside slope.

Looking at wild berryvines or wild roses on landside slope and toe.

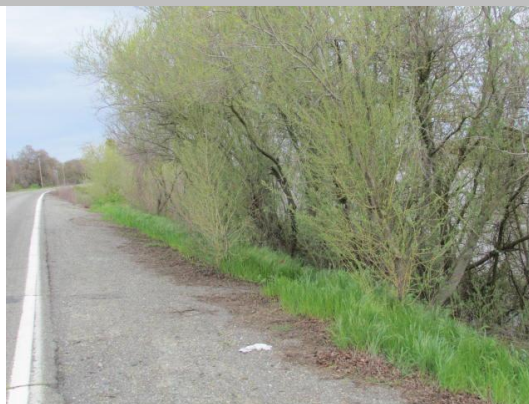
Photo 1 of 1 : SP_2017_RD0765_211_11_20170313_00012.jpg

Looking southwest at trees along landward shoulder and slope.

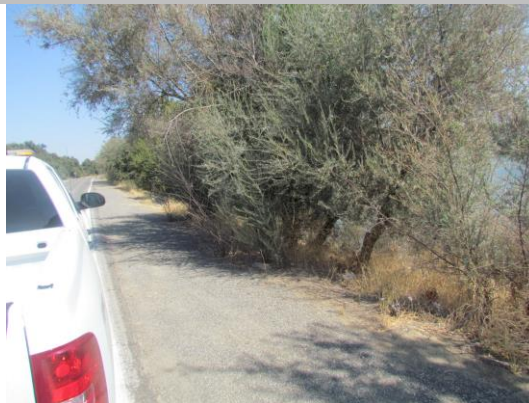
Photo 1 of 2 : SP_2017_RD0765_211_23_20170313_00018.jpg

Looking northeast at untrimmed trees on waterward shoulder. (Fall 2016)

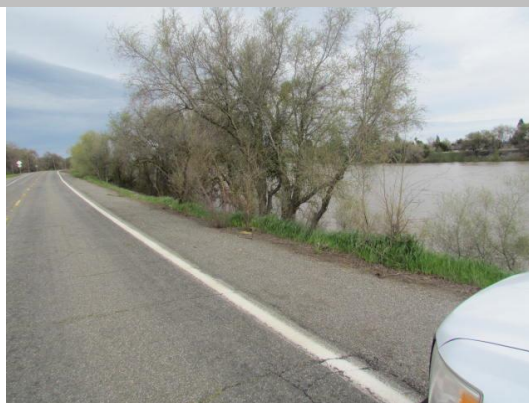
Photo 2 of 2 : SP_2017_RD0765_211_23_20170313_00019.jpg

Looking northeast at trees along waterward shoulder and slope. (Spring 2016)

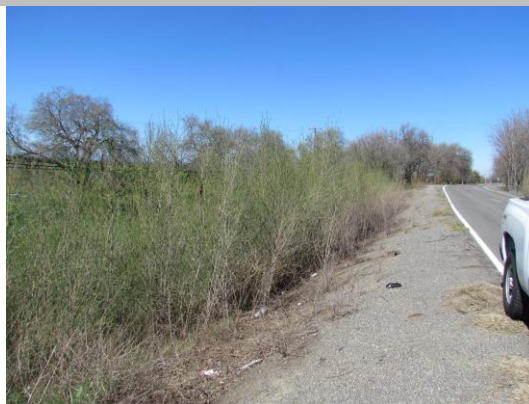
Photo 1 of 2 : SP_2017_RD0765_211_47_20170314_00082.jpg

Looking north at dense willows on landward slope. (Spring 2017)

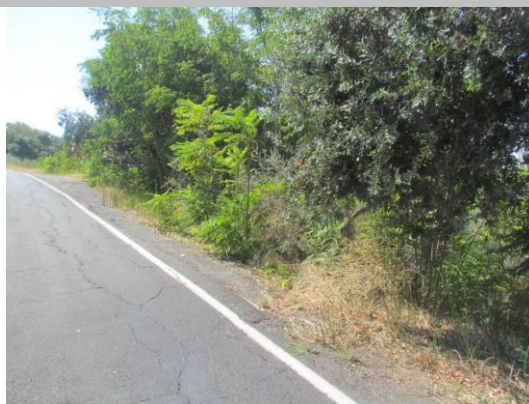
Photo 2 of 2 : SP_2017_RD0765_211_47_20170313_00039.jpg

Looking southwest at dense vegetation on landward shoulder and slope. (Fall 2016)

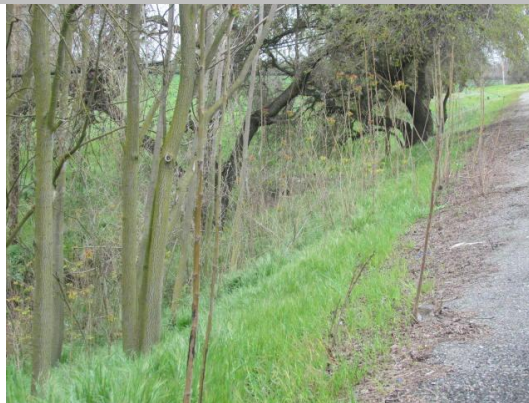
Photo 1 of 2 : SP_2017_RD0765_211_32_20170313_00029.jpg

Looking northwest at trees (saplings) on landward slope.

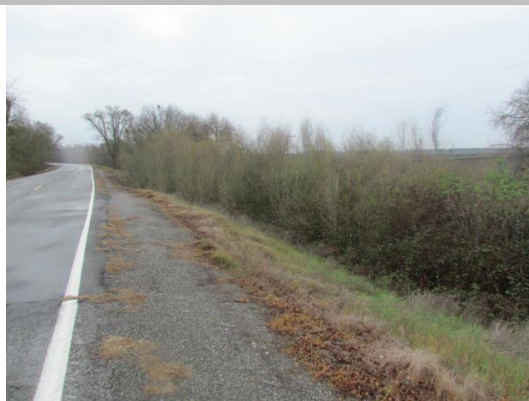
Photo 2 of 2 : SP_2017_RD0765_211_32_20170313_00030.jpg

Looking southwest at dense vegetation on landside slope and toe. (2015)

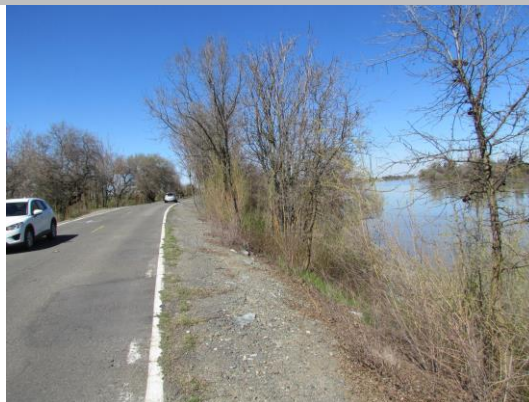
Photo 1 of 4 : SP_2017_RD0765_211_24_20170314_00083.jpg

LM Start	0.45	Rating **	U	Issue No.	24
LM End	0.47	Issue Type +	Ma	Location *	WS
Category	Earthen Levee			GPS Latitude/Longitude	
				Start	End
Item	Trim / Thin Trees			38.496534 °	38.496249 °
				-121.559880 °	-121.559760 °
DWR ID	DWR_RD0765_01_s_2012_24				
Comment Code					
T2 : Thin trees to allow visibility of the ground and room to flood fight.					
Inspector Comment					
Dense willows and untrimmed trees on waterward slope has been untrimmed for several inspection cycles.

Looking north at dense veg on waterward slope. (Spring 2017)

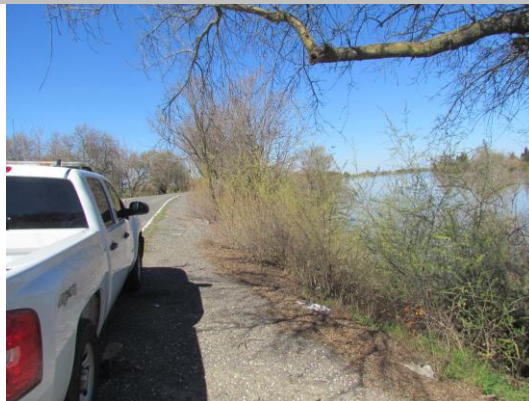
Photo 2 of 4 : SP_2017_RD0765_211_24_20170314_00084.jpg

Looking north at willows and other veg. on waterward slope. (Spring 2017)

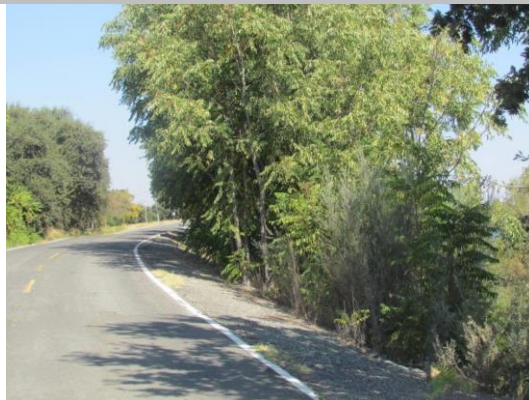
Photo 3 of 4 : SP_2017_RD0765_211_24_20170313_00020.jpg

Looking northeast at large cluster of trees on waterward slope. (Fall 2016)

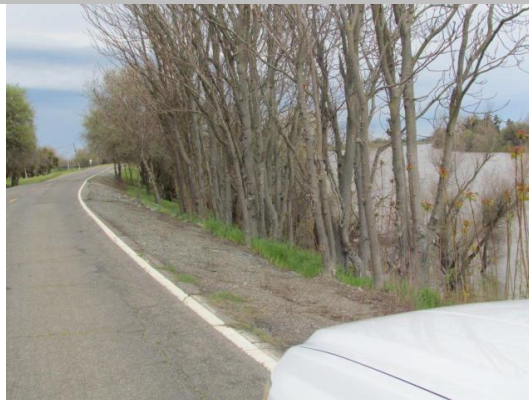
Photo 4 of 4 : SP_2017_RD0765_211_24_20170313_00021.jpg

Looking northeast at cluster of trees on waterward slope. (Spring 2016)

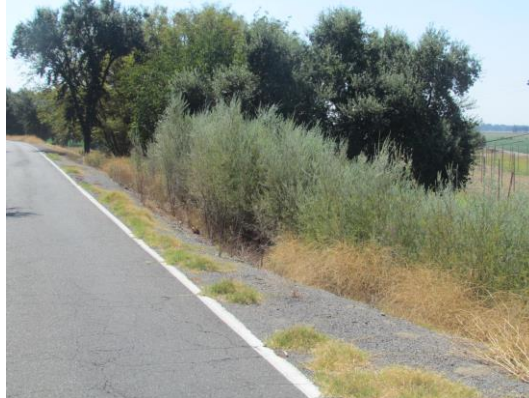
Photo 1 of 2 : SP_2017_RD0765_211_59_20170313_00059.jpg

Looking northwest at dense vegetation on landward slope. (Fall 2016)

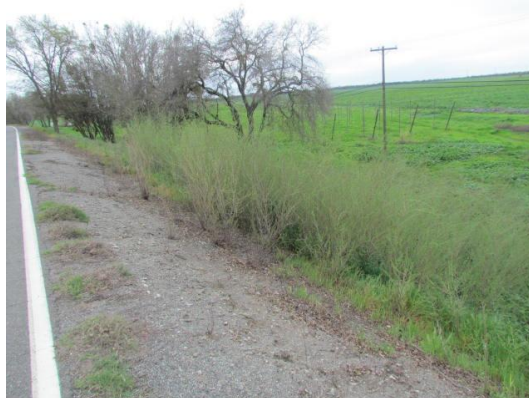
Photo 2 of 2 : SP_2017_RD0765_211_59_20170313_00060.jpg

Looking northwest at dense vegetation on landward slope. (Spring 2016)

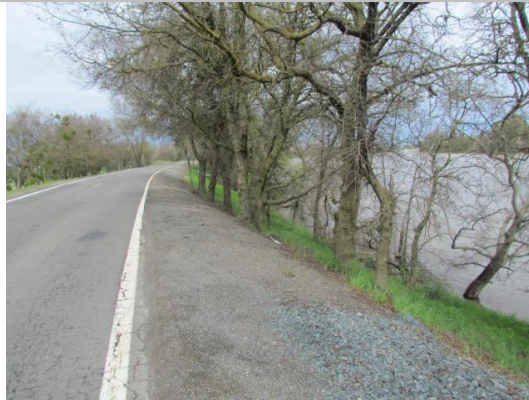
Photo 1 of 1 : SP_2017_RD0765_211_10_20170313_00011.jpg

Looking northeast at trees on waterward slope.

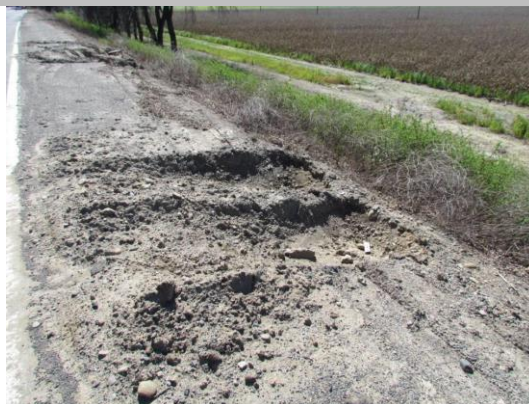
Photo 1 of 2 : SP_2017_RD0765_211_68_20170314_00085.jpg

LM Start	0.75	Rating **	M	Issue No.	68
LM End	0.75	Issue Type +	Ma	Location *	LS
Category	Earthen Levee			GPS Latitude/Longitude	
				Start	End
Item	Slope Stability			38.492705 °	38.492705 °
				-121.557193 °	-121.557193 °
DWR ID	DWR_RD0765_01_s_2017_68				
Comment Code					
S3 : Repair the levee slope damaged by vehicle traffic and prevent access where possible.					
Inspector Comment					
Damage cause by truck.

Looking south at levee damage caused by vehicle traffic. (Spring 2017)

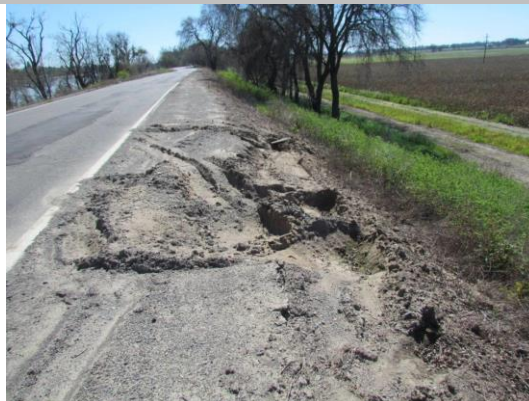
Photo 2 of 2 : SP_2017_RD0765_211_68_20170314_00086.jpg

LM Start	0.75	Rating **	M	Issue No.	68 (cont)	
LM End	0.75	Issue Type +	Ma	Location *	LS	
Category	Earthen Levee			GPS Latitude/Longitude		
				Start	End	
Item	Slope Stability			38.492705 °	38.492705 °	
				-121.557193 °	-121.557193 °	
DWR ID	DWR_RD0765_01_s_2017_68					
Comment Code						
S3 : Repair the levee slope damaged by vehicle traffic and prevent access where possible.						
Inspector Comment						
Damage cause by truck.

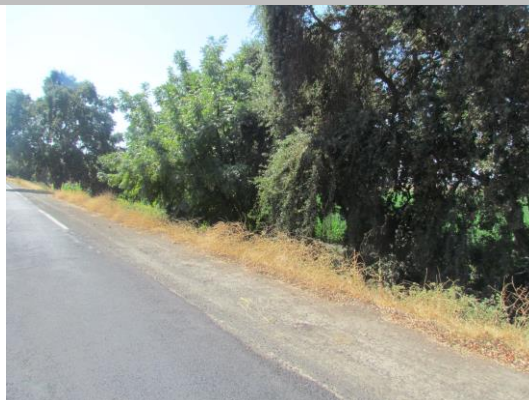
Photo 1 of 1 : SP_2017_RD0765_211_36_20170313_00033.jpg

LM Start	0.77	Rating **	U	Issue No.	36
LM End	0.80	Issue Type +	Ma	Location *	LS
Category	Earthen Levee			GPS Latitude/Longitude	
				Start	End
Item	Trim / Thin Trees			38.492392 °	38.492034 °
				-121.557026 °	-121.556820 °
DWR ID	DWR_RD0765_01_s_2012_36				
Comment Code					
T1 : Trim trees to at least five feet above ground level.					
Inspector Comment					
Untrimmed trees on landward slope.

Looking northwest at untrimmed trees on landward slope.

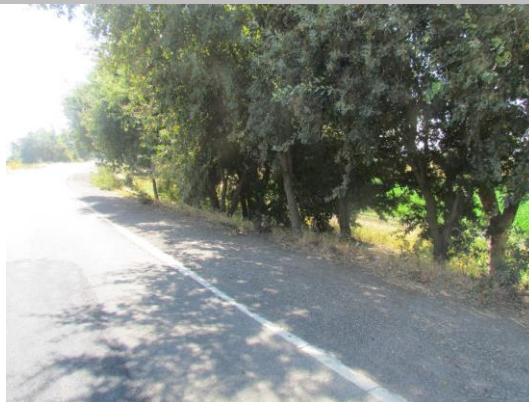
Photo 1 of 1 : SP_2017_RD0765_211_17_20170313_00016.jpg

Looking northwest at untrimmed trees on landward slope.

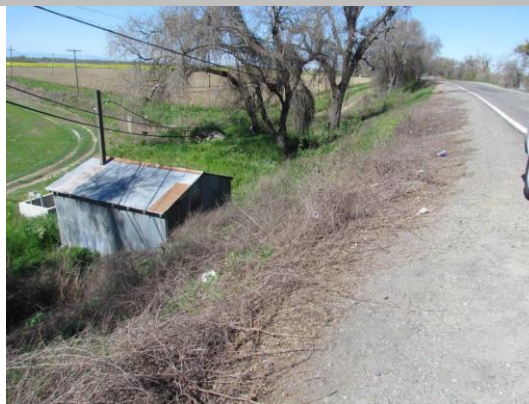
Photo 1 of 3 : SP_2017_RD0765_211_61_20170314_00088.jpg

Looking northwest at dense dead berryvines on landward slope. (Spring 2017)

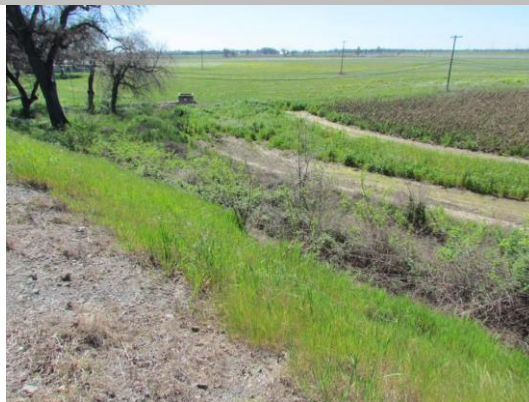
Photo 2 of 3 : SP_2017_RD0765_211_61_20170314_00087.jpg

Looking west at berryvine at bottom half of landward slope. (Spring 2017)

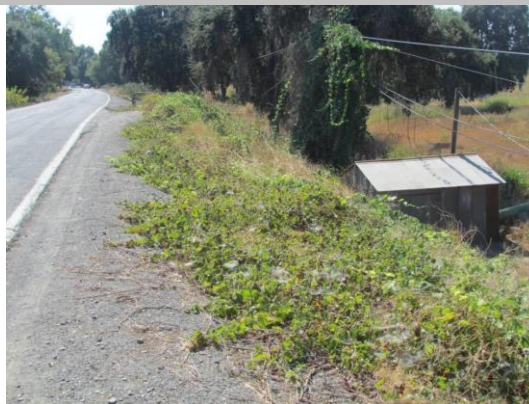
Photo 3 of 3 : SP_2017_RD0765_211_61_20170313_00063.jpg

Looking south at dense wildroses on landward slope. (Fall 2016)

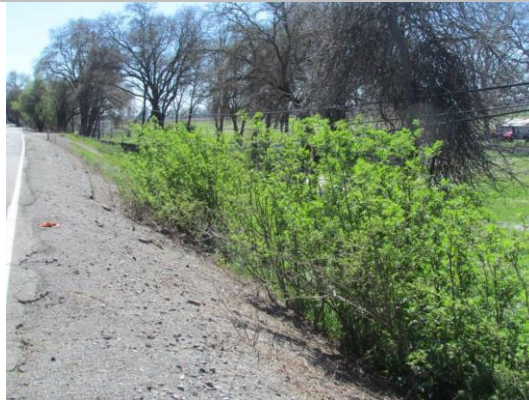
Photo 1 of 2 : SP_2017_RD0765_211_40_20170314_00089.jpg

Looking south at new growth on landward slope. (Spring 2017)

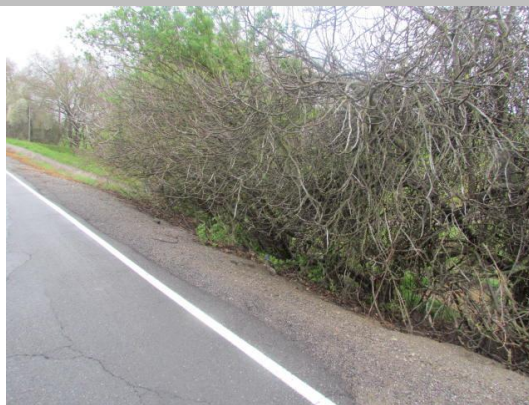
Photo 2 of 2 : SP_2017_RD0765_211_40_20170313_00037.jpg

Looking southwest at fig trees and other trees on landside slope and toe.
(Fall 2016)

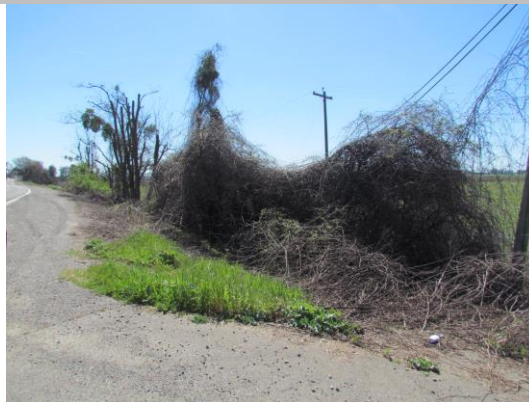
Photo 1 of 2 : SP_2017_RD0765_211_33_20170314_00090.jpg

Looking west at dead vines on landward slope. (Spring 2017)

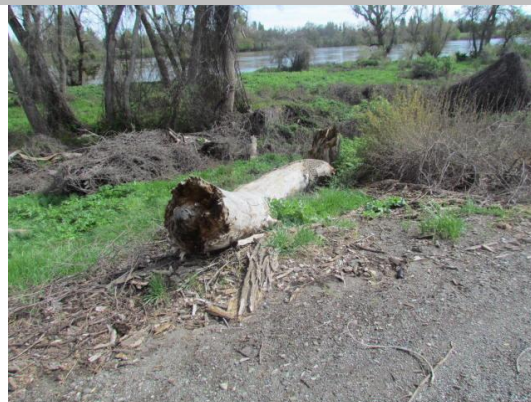
Photo 1 of 4 : SP_2017_RD0765_211_7_20170313_00007.jpg

Looking southeast at branch on waterward slope.

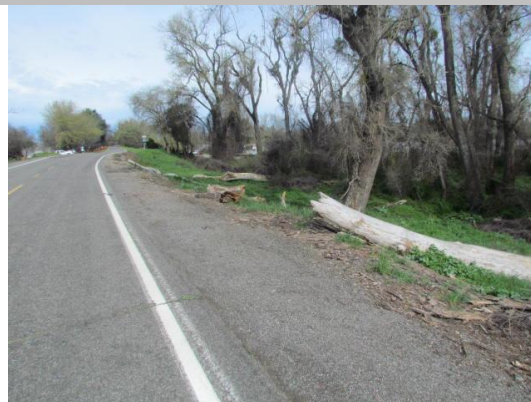
Photo 2 of 4 : SP_2017_RD0765_211_7_20170313_00008.jpg

Looking northeast at tree limbs on waterward slope.

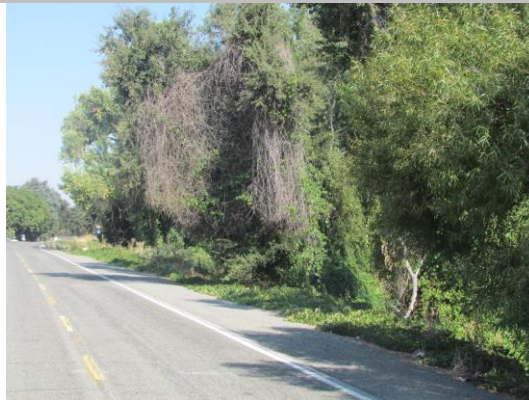
Photo 1 of 3 : SP_2017_RD0765_211_4_20170313_00003.jpg

Looking northeast at untrimmed trees and other vegetation on waterward slope. (Fall 2016)

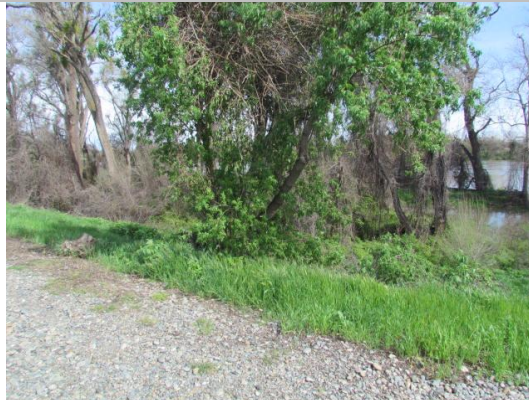
Photo 1 of 1 : SP_2017_RD0765_211_50_20170313_00043.jpg

Looking east at untrimmed tree on waterward slope.

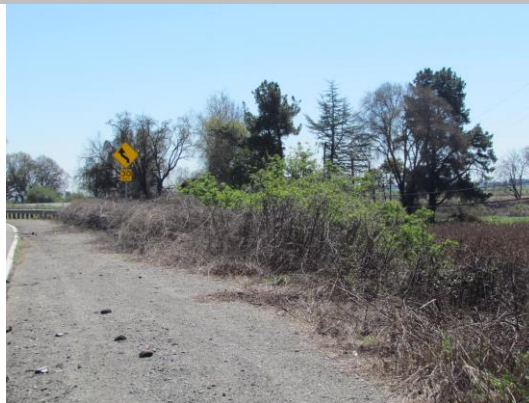
Photo 1 of 4 : SP_2017_RD0765_211_29_20170314_00092.jpg

Looking southwest at dead vines and other veg on landward slope. (Spring 2017)

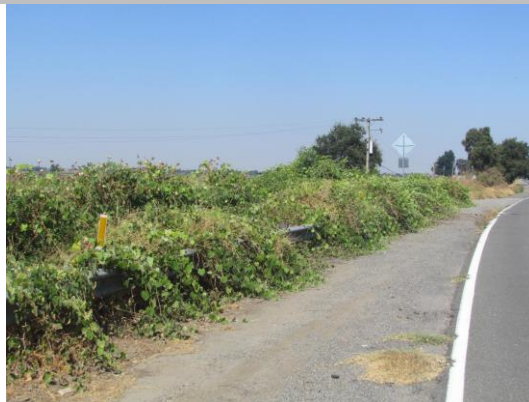
Photo 2 of 4 : SP_2017_RD0765_211_29_20170313_00026.jpg

Looking northwest at berryvines on landward slope and toe. (Fall 2016)

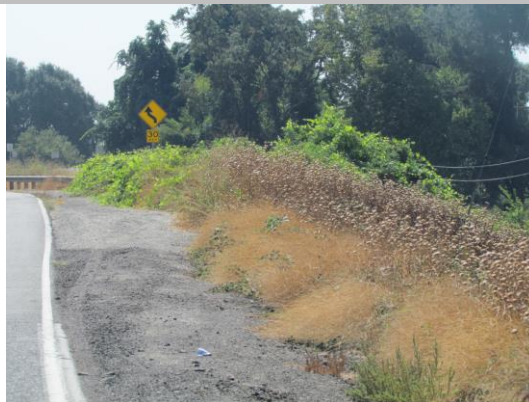
Photo 3 of 4 : SP_2017_RD0765_211_29_20170313_00027.jpg

Looking southwest at dense berry vines and other vegetation on landward slope. (Fall 2016)

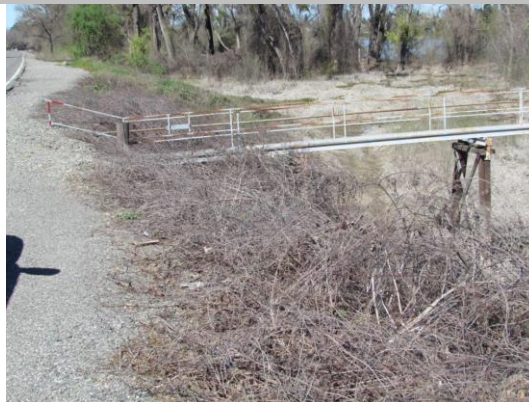
Photo 1 of 2 : SP_2017_RD0765_211_48_20170314_00093.jpg

Looking north at dead vines on waterward slope. (Spring 2017)

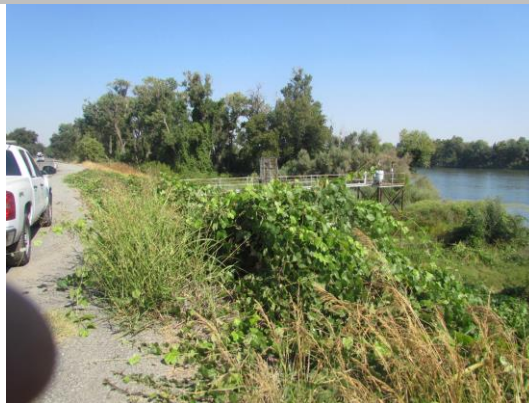
Photo 2 of 2 : SP_2017_RD0765_211_48_20170313_00040.jpg

Looking northeast at vines on waterward slope. (Fall 2016)

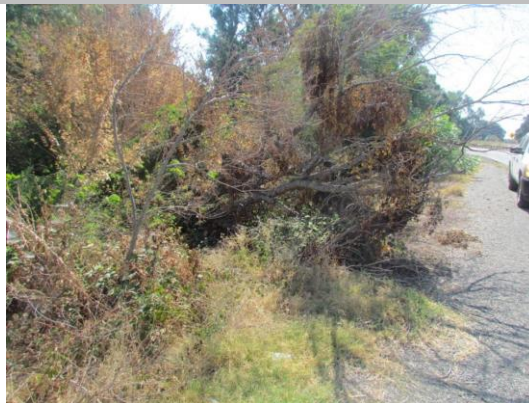
Photo 2 of 2 : SP_2017_RD0765_211_39_20170313_00036.jpg

Looking north at fallen tree on waterward slope.

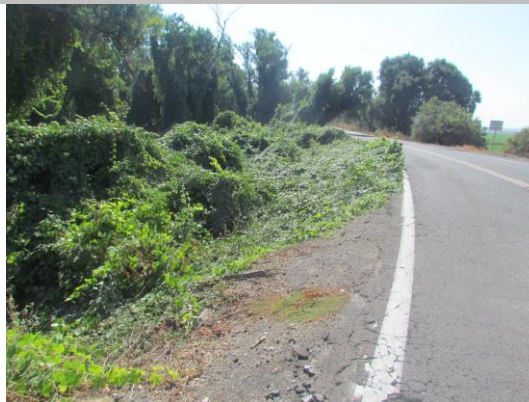
Photo 1 of 2 : SP_2017_RD0765_211_25_20170313_00022.jpg

Looking south on at dense berryvines on waterward slope.

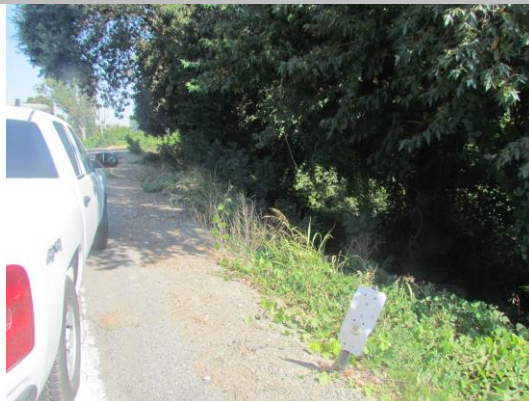
Photo 2 of 2 : SP_2017_RD0765_211_25_20170313_00023.jpg

Looking north at dense vegetation on waterward slope.
