**Flood Control Project Maintenance
Levee Inspections**

Maintenance Issue Types Only, Levee Inspection Report By Mile - Spring 2018

Reclamation District No. 0765 Glide

Waterway	Bank	Unit Miles	Inspection Start/End	Inspector
Unit No. 01 Sacramento River	Right	1.72	03/07/2018 03/07/2018	Dave Torres

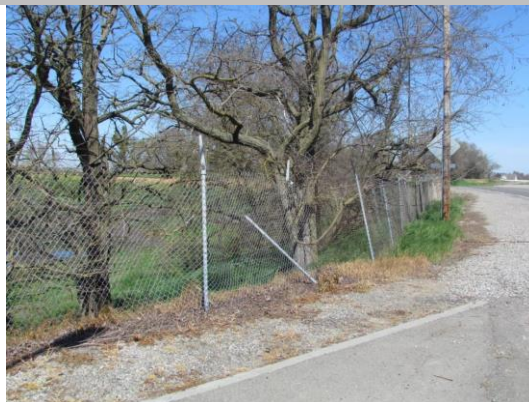
Photo 1 of 3 : SP_2018_RD0765_211_3_20180301_00003.jpg

LM Start	0.05	Rating **	U	Issue No.	3
LM End	0.05	Issue Type +	Ma	Location *	LS
Category	Earthen Levee			GPS Latitude/Longitude	
				Start	End
Item	Trim / Thin Trees			38.502253 °	38.502253 °
				-121.560192 °	-121.560192 °
DWR ID	DWR_RD0765_01_s_2012_3				
Comment Code					
T1 : Trim trees to at least five feet above ground level.					
Inspector Comment					
Trees blocking view of landside slope.

Looking north at untrimmed trees along lanward slope. (Spring 2017)

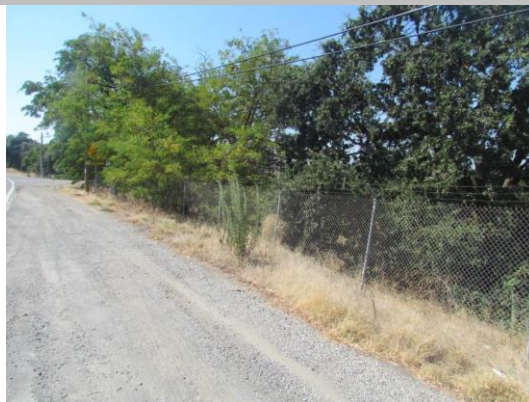
Photo 2 of 3 : SP_2018_RD0765_211_3_20180301_00004.jpg

Looking southwest at untrimmed trees on landward slope.(Fall 2016)

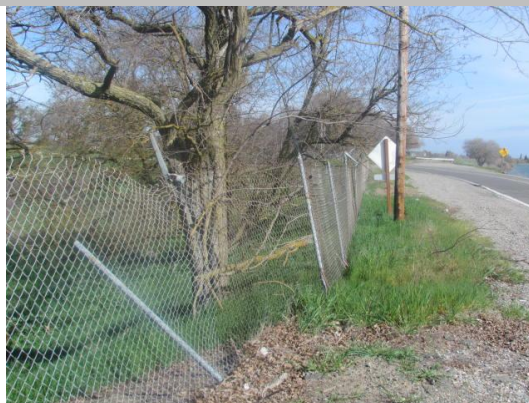
Photo 3 of 3 : SP_2018_RD0765_211_3_20180301_00005.jpg

LM Start	0.05	Rating **	U	Issue No.	3 (cont)	
LM End	0.05	Issue Type +	Ma	Location *	LS	
Category	Earthen Levee			GPS Latitude/Longitude		
				Start		End
Item	Trim / Thin Trees			38.502253 °		38.502253 °
				-121.560192 °		-121.560192 °
DWR ID	DWR_RD0765_01_s_2012_3					
Comment Code						
T1 : Trim trees to at least five feet above ground level.						
Inspector Comment						
Trees blocking view of landside slope.

Looking north (upstream) at trees on landside slope. (Spring 2016)

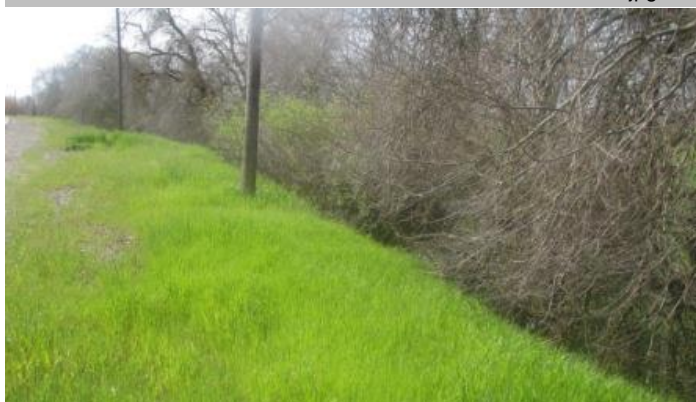
Photo 1 of 2 : SP_2018_RD0765_211_28_20180301_00031.jpg

LM Start	0.12	Rating **	M	Issue No.	28	
LM End	0.25	Issue Type +	Ma	Location *	LS	
Category	Earthen Levee			GPS Latitude/Longitude		
				Start		End
Item	Trim / Thin Trees			38.501215 °		38.499421 °
				-121.560432 °		-121.560471 °
DWR ID	DWR_RD0765_01_s_2012_28					
Comment Code						
T3 : Trim and thin trees to allow visibility of the ground and room to flood fight.						
Inspector Comment

Looking downstream (south) at trees on landside slope & toe.

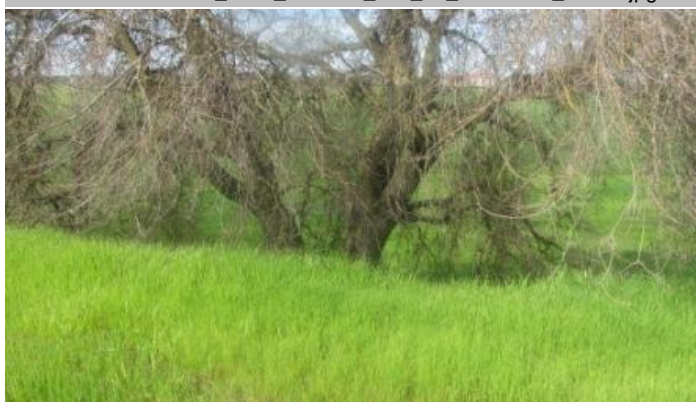
Photo 2 of 2 : SP_2018_RD0765_211_28_20180301_00032.jpg

Looking west at trees on landside toe.

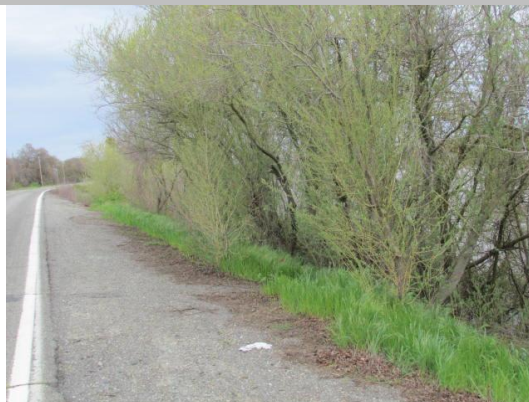
Photo 1 of 1 : SP_2018_RD0765_211_11_20180301_00015.jpg

LM Start	0.25	Rating **	U	Issue No.	11
LM End	0.27	Issue Type +	Ma	Location *	WS
Category	Earthen Levee			GPS Latitude/Longitude	
				Start	End
Item	Trim / Thin Trees			38.499405 °	38.499042 °
				-121.560445 °	-121.560430 °
DWR ID	DWR_RD0765_01_s_2012_11				
Comment Code					
T3 : Trim and thin trees to allow visibility of the ground and room to flood fight.					
Inspector Comment					
Trees shall be trimmed and thinned on watersided slope.

Looking southwest at trees along landward shoulder and slope.

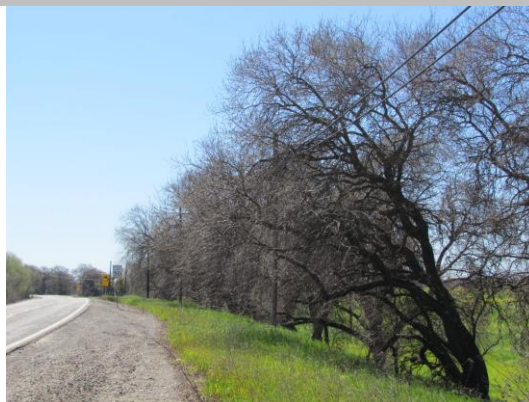
Photo 1 of 2 : SP_2018_RD0765_211_14_20180301_00019.jpg

LM Start	0.27	Rating **	M	Issue No.	14
LM End	0.30	Issue Type +	Ma	Location *	LS
Category	Earthen Levee			GPS Latitude/Longitude	
				Start	End
Item	Trim / Thin Trees			38.499065 °	38.498714 °
				-121.560468 °	-121.560460 °
DWR ID	DWR_RD0765_01_s_2012_14				
Comment Code					
T1 : Trim trees to at least five feet above ground level.					
Inspector Comment					
Untrimmed trees on landside slope has been untrimmed for multiple inspection cycles.

Looking southwest at untrimmed trees on landward slope. (Spring 2017)

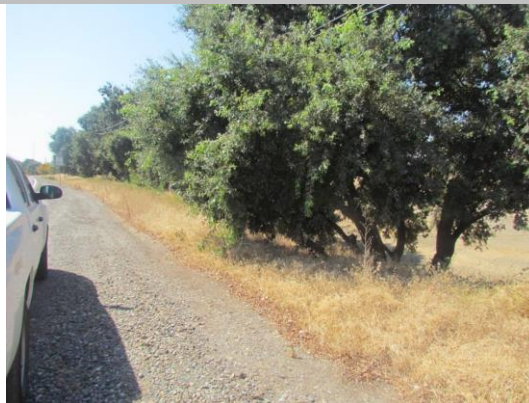
Photo 2 of 2 : SP_2018_RD0765_211_14_20180301_00020.jpg

LM Start	0.27	Rating **	M	Issue No.	14 (cont)
LM End	0.30	Issue Type +	Ma	Location *	LS
Category	Earthen Levee			GPS Latitude/Longitude	
				Start	End
Item	Trim / Thin Trees			38.499065 °	38.498714 °
				-121.560468 °	-121.560460 °
DWR ID	DWR_RD0765_01_s_2012_14				
Comment Code					
T1 : Trim trees to at least five feet above ground level.					
Inspector Comment					
Untrimmed trees on landside slope has been untrimmed for multiple inspection cycles.

Looking southwest at untrimmed trees on landward slope. (Fall 2016)

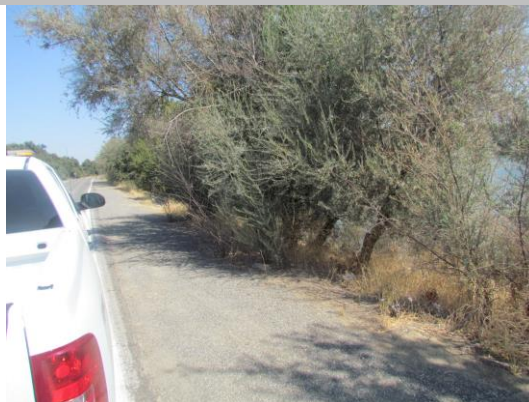
Photo 1 of 2 : SP_2018_RD0765_211_23_20180301_00023.jpg

LM Start	0.31	Rating **	M	Issue No.	23
LM End	0.31	Issue Type +	Ma	Location *	WS
Category	Earthen Levee			GPS Latitude/Longitude	
				Start	End
Item	Trim / Thin Trees			38.498453 °	38.498453 °
				-121.560360 °	-121.560360 °
DWR ID	DWR_RD0765_01_s_2012_23				
Comment Code					
T3 : Trim and thin trees to allow visibility of the ground and room to flood fight.					
Inspector Comment					
Trees should be trimmed and thinned.

Looking northeast at untrimmed trees on waterward shoulder. (Fall 2016)

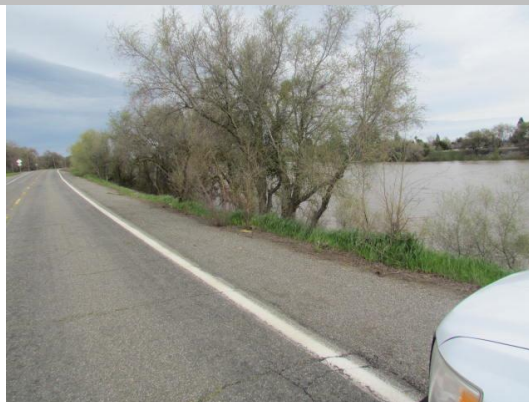
Photo 2 of 2 : SP_2018_RD0765_211_23_20180301_00024.jpg

Looking northeast at trees along waterward shoulder and slope. (Spring 2016)

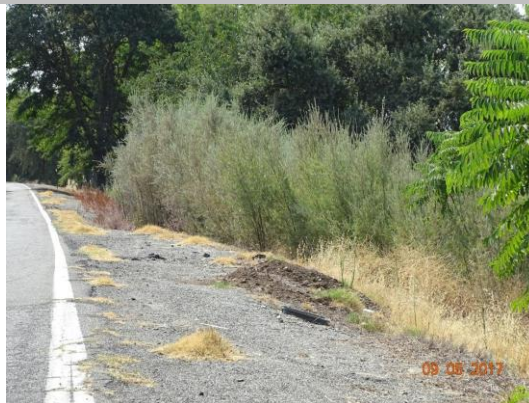
Photo 1 of 4 : SP_2018_RD0765_211_47_20180501_00096.jpg

Looking south at the landside slope (Fall 2017).

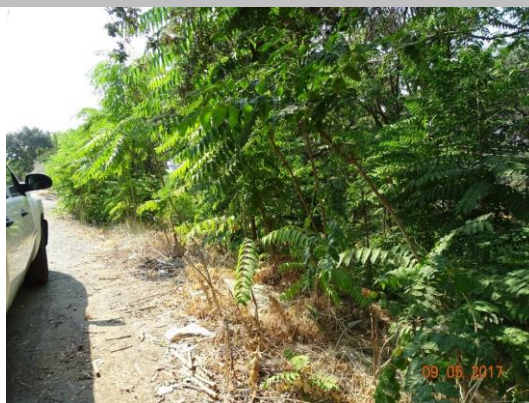
Photo 2 of 4 : SP_2018_RD0765_211_47_20180301_00050.jpg

Looking south at the landside slope (Fall 2017).

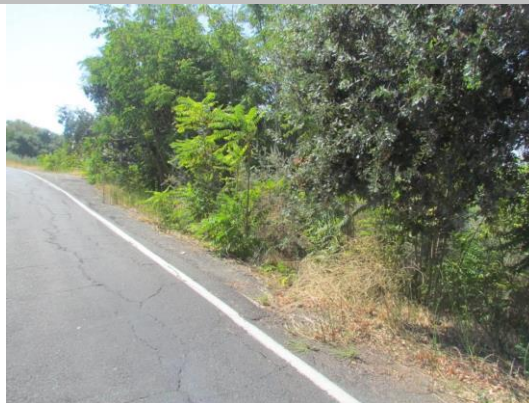
Photo 4 of 4 : SP_2018_RD0765_211_47_20180301_00052.jpg

Looking southwest at dense vegetation on landward shoulder and slope. (Fall 2016)

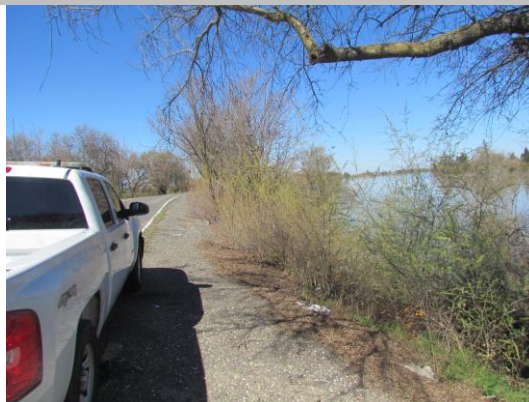
Photo 1 of 4 : SP_2018_RD0765_211_24_20180301_00025.jpg

LM Start	0.45	Rating **	U	Issue No.	24
LM End	0.47	Issue Type +	Ma	Location *	WS
Category	Earthen Levee			GPS Latitude/Longitude	
				Start	End
Item	Trim / Thin Trees			38.496534 °	38.496249 °
				-121.559880 °	-121.559760 °
DWR ID	DWR_RD0765_01_s_2012_24				
Comment Code					
T2 : Thin trees to allow visibility of the ground and room to flood fight.					
Inspector Comment					
Dense willows and untrimmed trees on waterside slope has been untrimmed for multiple inspection cycles.

Looking north at willows and other veg. on waterward slope. (Spring 2017)

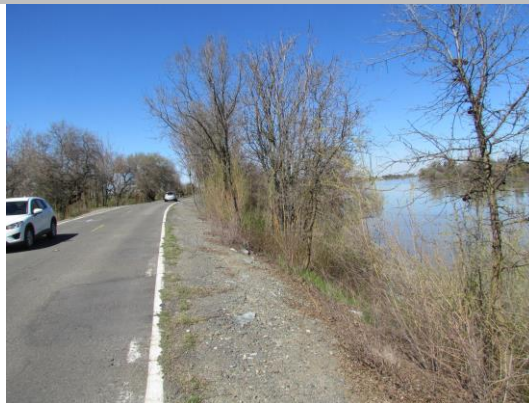
Photo 2 of 4 : SP_2018_RD0765_211_24_20180301_00026.jpg

Looking north at dense veg on waterward slope. (Spring 2017)

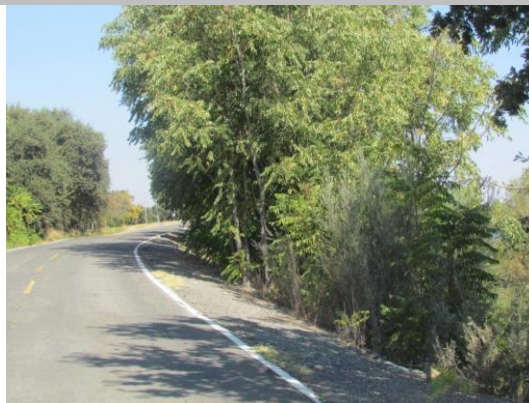
Photo 3 of 4 : SP_2018_RD0765_211_24_20180301_00027.jpg

Looking northeast at large cluster of trees on waterward slope. (Fall 2016)

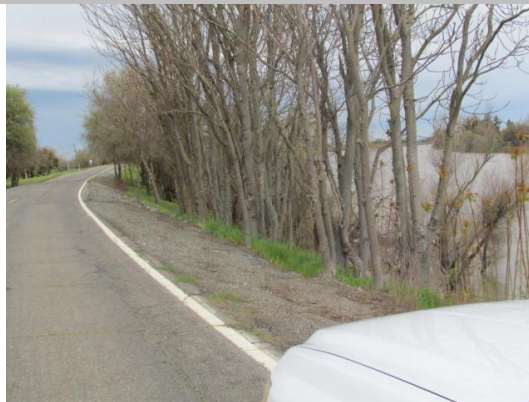
Photo 4 of 4 : SP_2018_RD0765_211_24_20180301_00028.jpg

Looking northeast at cluster of trees on waterward slope. (Spring 2016)

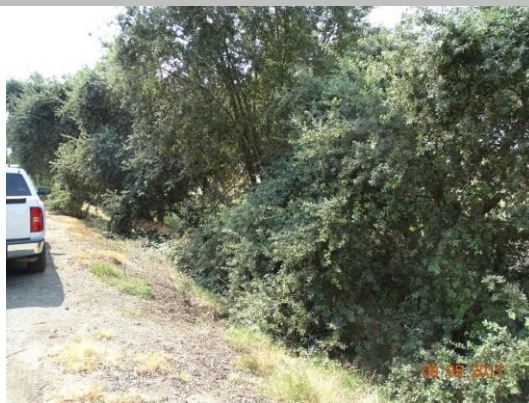
Photo 1 of 1 : SP_2018_RD0765_211_34_20180301_00043.jpg

Looking south at landside slope.

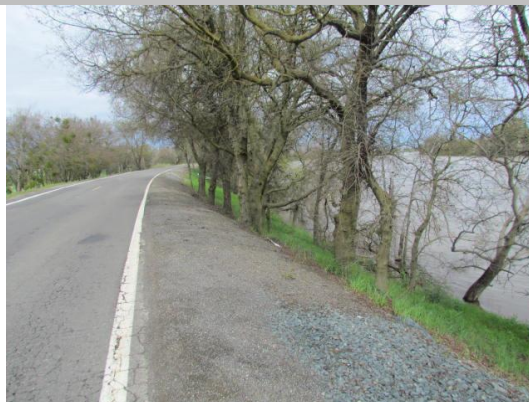
Photo 1 of 1 : SP_2018_RD0765_211_10_20180301_00014.jpg

LM Start	0.56	Rating **	M	Issue No.	10
LM End	0.59	Issue Type +	Ma	Location *	WS
Category	Earthen Levee			GPS Latitude/Longitude	
				Start	End
Item	Trim / Thin Trees			38.495035 °	38.494642 °
				-121.559027 °	-121.558697 °
DWR ID	DWR_RD0765_01_s_2016_10				
Comment Code					
T2 : Thin trees to allow visibility of the ground and room to flood fight.					
Inspector Comment

Looking northeast at trees on waterward slope.

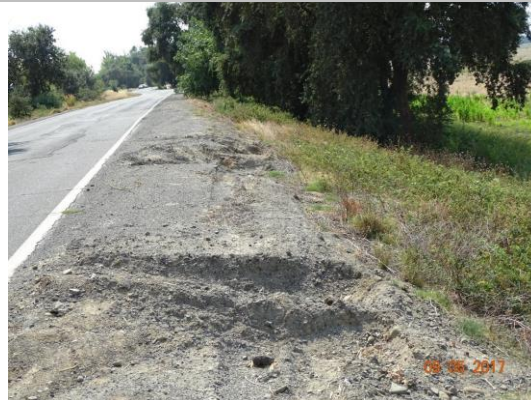
Photo 1 of 2 : SP_2018_RD0765_211_68_20180301_00078.jpg

LM Start	0.75	Rating **	M	Issue No.	68
LM End	0.75	Issue Type +	Ma	Location *	LS
Category	Earthen Levee			GPS Latitude/Longitude	
				Start	End
Item	Slope Stability			38.492705 °	38.492705 °
				-121.557193 °	-121.557193 °
DWR ID	DWR_RD0765_01_s_2017_68				
Comment Code					
S3 : Repair the levee slope damaged by vehicle traffic and prevent access where possible.					
Inspector Comment					
Damage caused by a truck.

Looking south on landside slope.

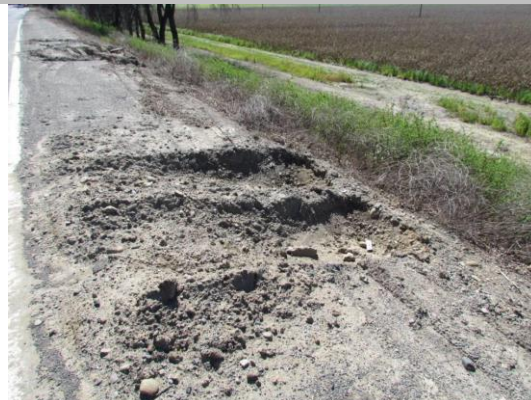
Photo 2 of 2 : SP_2018_RD0765_211_68_20180301_00079.jpg

Looking south at levee damage caused by vehicle traffic. (Spring 2017)

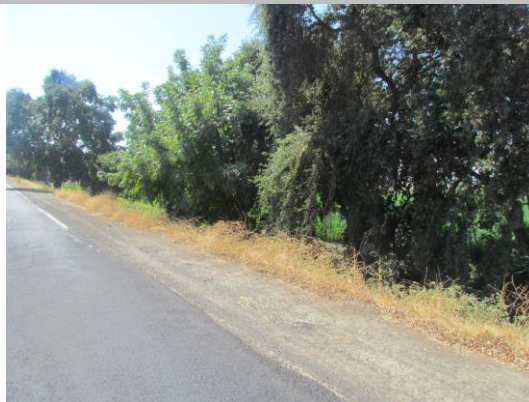
Photo 1 of 1 : SP_2018_RD0765_211_36_20180301_00044.jpg

Looking northwest at untrimmed trees on landward slope.

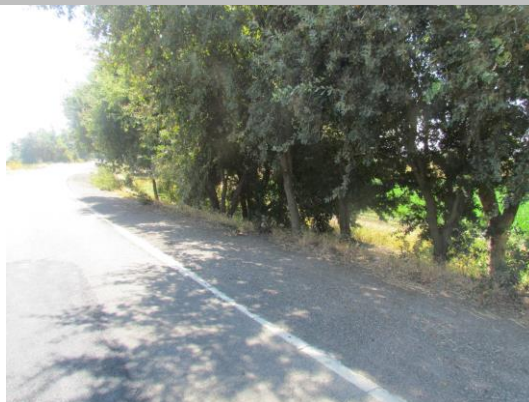
Photo 1 of 1 : SP_2018_RD0765_211_17_20180301_00021.jpg

Looking northwest at untrimmed trees on landward slope.

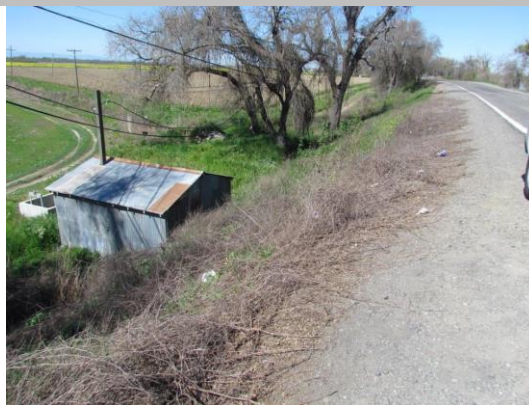
Photo 1 of 3 : SP_2018_RD0765_211_61_20180301_00072.jpg

Looking northwest at dense dead berryvines on landward slope. (Spring 2017)

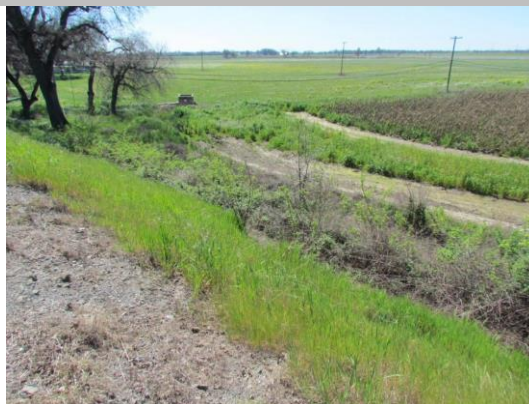
Photo 2 of 3 : SP_2018_RD0765_211_61_20180301_00073.jpg

Looking west at berryvine at bottom half of landward slope. (Spring 2017)

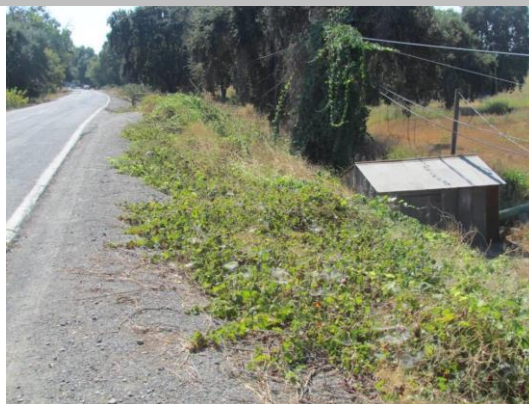
Photo 3 of 3 : SP_2018_RD0765_211_61_20180301_00074.jpg

Looking south at dense wildroses on landward slope. (Fall 2016)

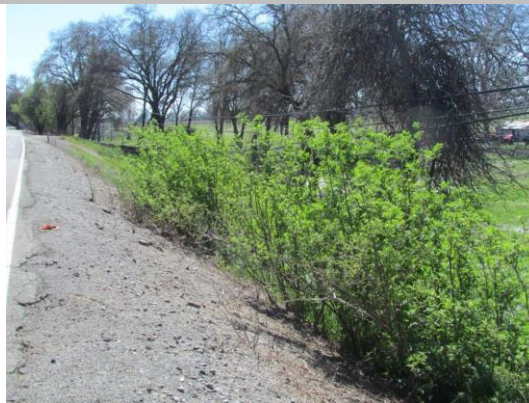
Photo 1 of 2 : SP_2018_RD0765_211_40_20180301_00047.jpg

Looking south at new growth on landward slope. (Spring 2017)

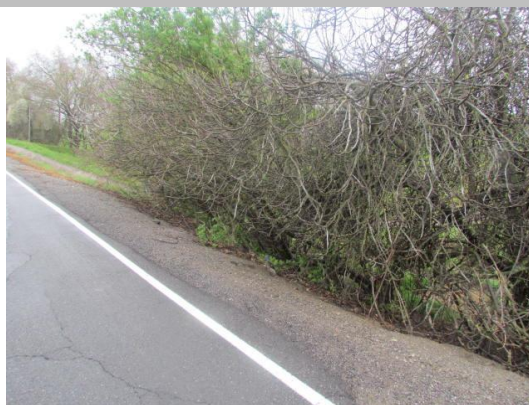
Photo 2 of 2 : SP_2018_RD0765_211_40_20180301_00048.jpg

Looking southwest at fig trees and other trees on landside slope and toe. (Fall 2016)

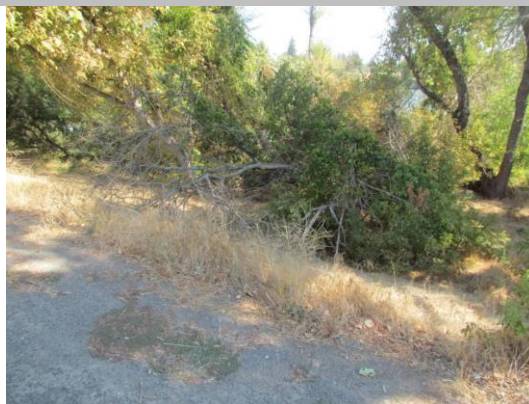
Photo 1 of 1 : SP_2018_RD0765_211_58_20180301_00067.jpg

Looking northeast at fallen tree on waterward slope.

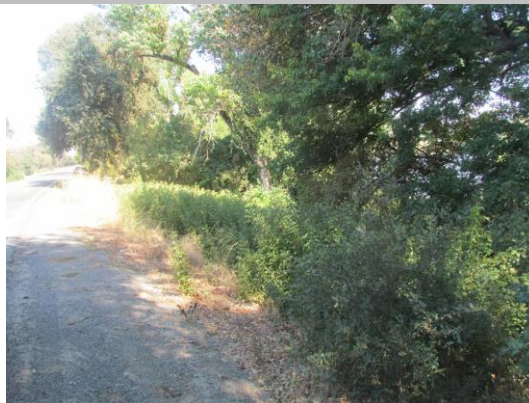
Photo 1 of 1 : SP_2018_RD0765_211_65_20180301_00076.jpg

Looking north at wildroses and untrimmed trees on waterward shoulder and slope.

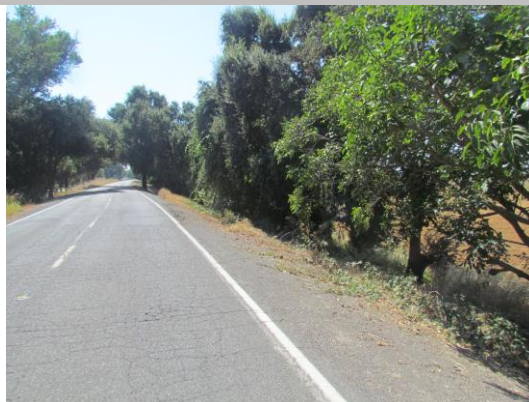
Photo 1 of 1 : SP_2018_RD0765_211_38_20180301_00045.jpg

Looking southwest at untrimmed trees on landward slope.

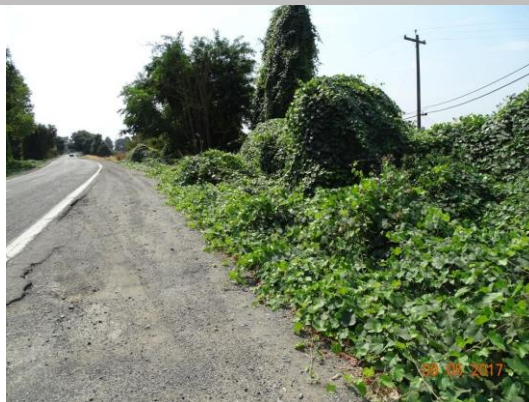
Photo 1 of 3 : SP_2018_RD0765_211_33_20180301_00040.jpg

Looking south at the landside slope.

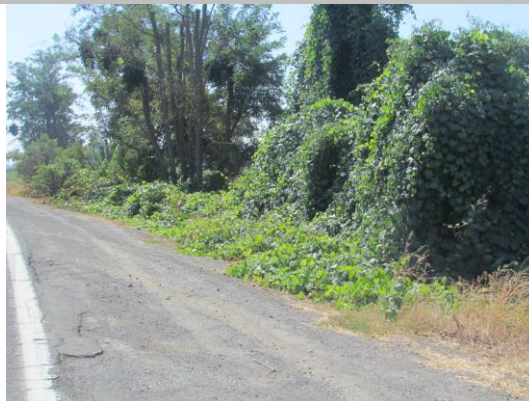
Photo 3 of 3 : SP_2018_RD0765_211_33_20180301_00042.jpg

Looking west at dense vegetation (grapevines) on landward slope. (Fall 2016)

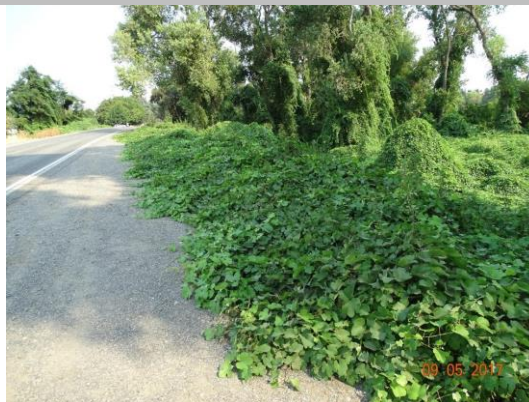
Photo 1 of 1 : SP_2018_RD0765_211_56_20180301_00066.jpg

Looking northwest at waterside slope.

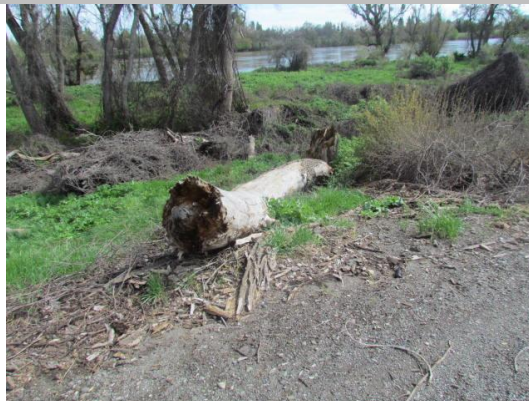
Photo 1 of 4 : SP_2018_RD0765_211_7_20180301_00010.jpg

Looking southeast at branch on waterward slope.

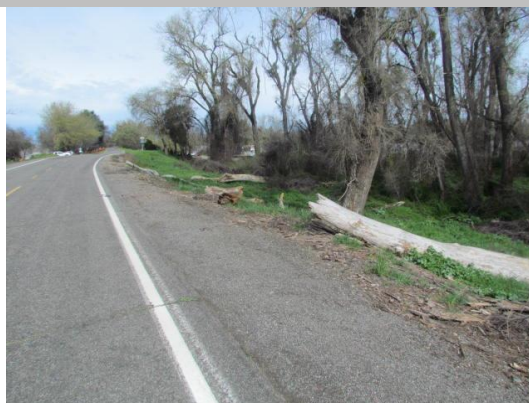
Photo 2 of 4 : SP_2018_RD0765_211_7_20180301_00011.jpg

Looking northeast at tree limbs on waterward slope.

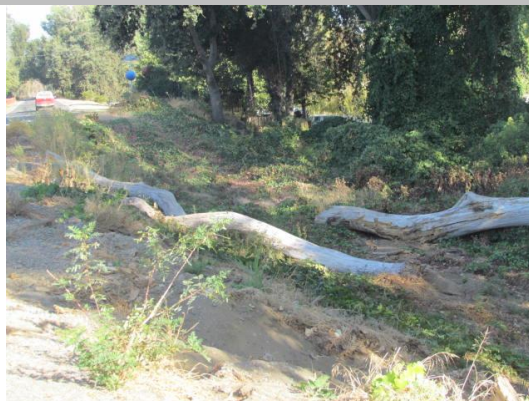
Photo 3 of 4 : SP_2018_RD0765_211_7_20180301_00012.jpg

Looking at several tree branches on waterward slope and berm.(2015)

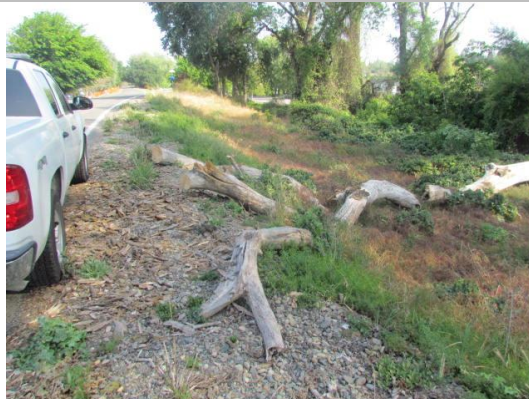
Photo 4 of 4 : SP_2018_RD0765_211_7_20180301_00013.jpg

Looking north at down tree across waterward slope.(2015)

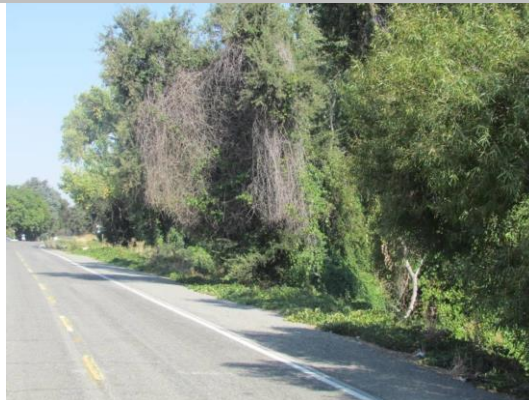
Photo 1 of 3 : SP_2018_RD0765_211_4_20180301_00006.jpg

Looking northeast at untrimmed trees and other vegetation on waterward slope. (Fall 2016)

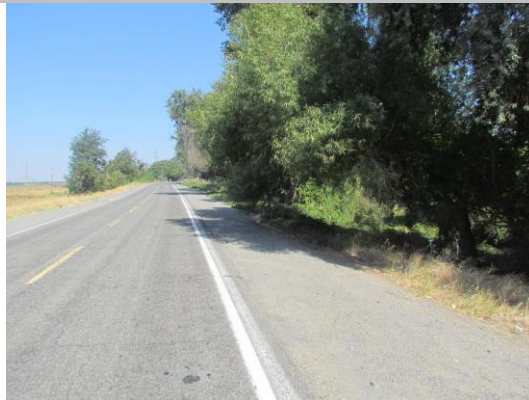
Photo 2 of 3 : SP_2018_RD0765_211_4_20180301_00007.jpg

Looking northeast at untrimmed trees on waterward slope. (Spring 2016)

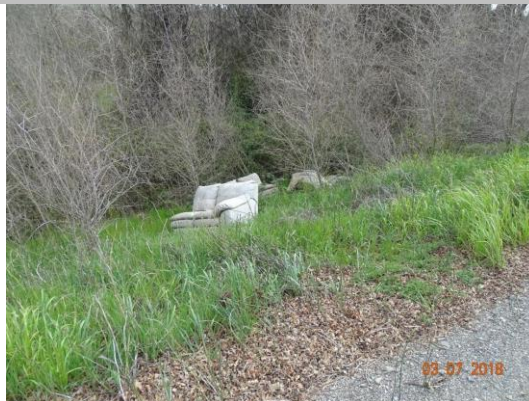
Photo 2 of 2 : SP_2018_RD0765_211_67_20180308_00094.jpg

Encroachment sofa waterside looking east.

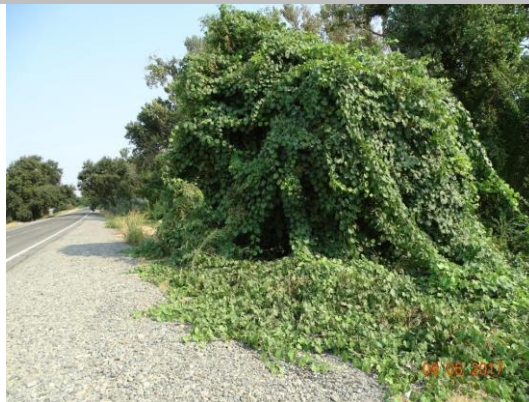
Photo 1 of 2 : SP_2018_RD0765_211_50_20180301_00057.jpg

Looking northwest on waterside slope.

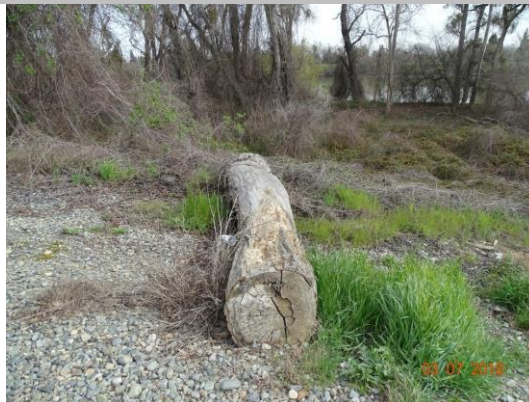
Photo 1 of 1 : SP_2018_RD0765_211_45_20180308_00093.jpg

Encroachment downed tree waterside used to control vehicle access looking northeast.

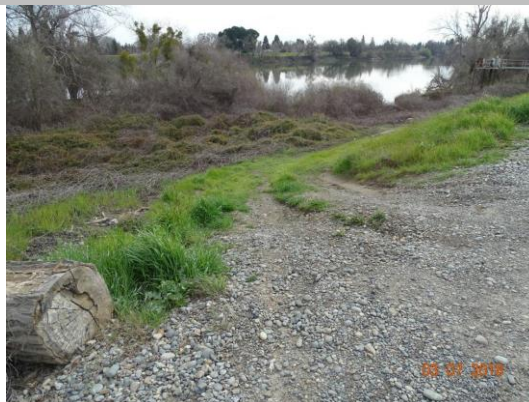
Photo 1 of 1 : SP_2018_RD0765_211_31_20180308_00092.jpg

LM Start	1.51	Rating **	M	Issue No.	31
LM End	1.51	Issue Type +	Ma	Location *	WS
Category	Earthen Levee			GPS Latitude/Longitude	
				Start	End
Item	Slope Stability			38.482788 °	38.482788 °
				-121.551048 °	-121.551048 °
DWR ID	DWR_RD0765_01_s_2018_31				
Comment Code					
S3 : Repair the levee slope damaged by vehicle traffic and prevent access where possible.					
Inspector Comment

Slope stability waterside looking southeast.

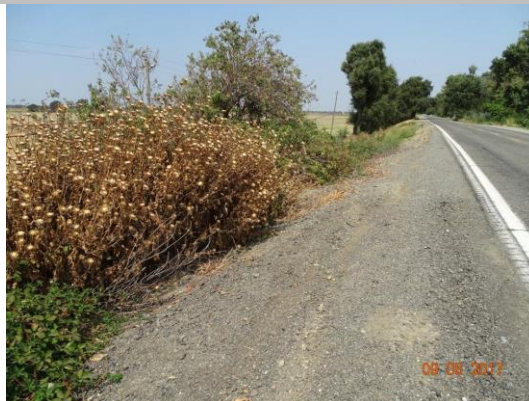
Photo 1 of 5 : SP_2018_RD0765_211_29_20180301_00033.jpg

Looking northwest at the landside slope.

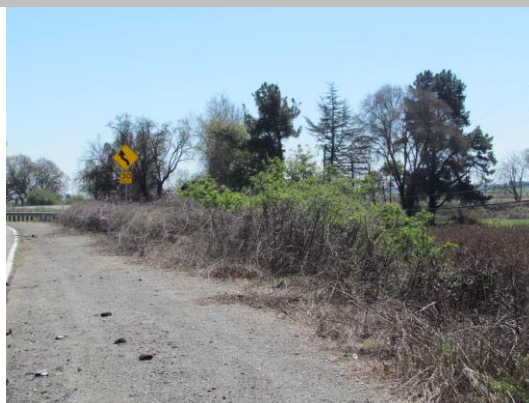
Photo 2 of 5 : SP_2018_RD0765_211_29_20180301_00034.jpg

Looking southwest at dead vines and other veg on landward slope.
(Spring 2017)

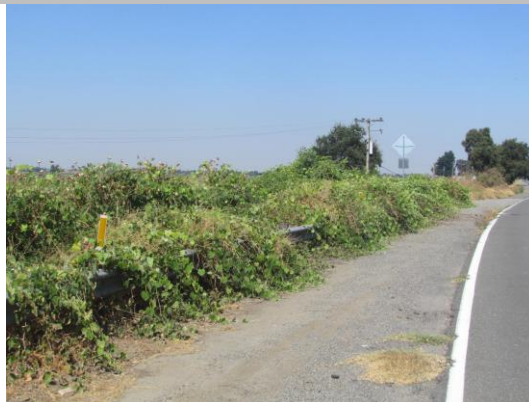
Photo 3 of 5 : SP_2018_RD0765_211_29_20180301_00035.jpg

Looking northwest at berryvines on landward slope and toe. (Fall 2016)

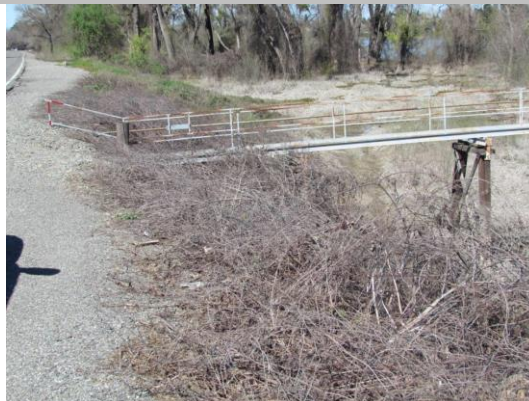
Photo 2 of 3 : SP_2018_RD0765_211_48_20180301_00054.jpg

Looking north at dead vines on waterward slope. (Spring 2017)

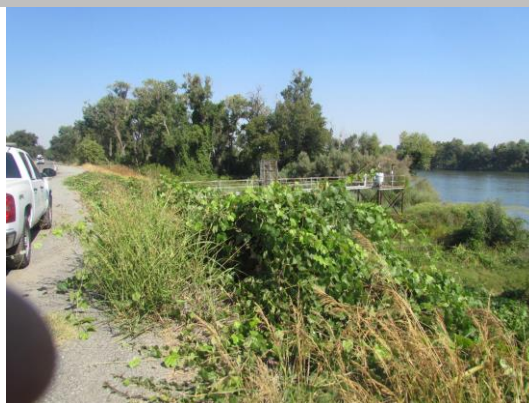
Photo 3 of 3 : SP_2018_RD0765_211_48_20180301_00055.jpg

Looking northeast at vines on waterward slope. (Fall 2016)

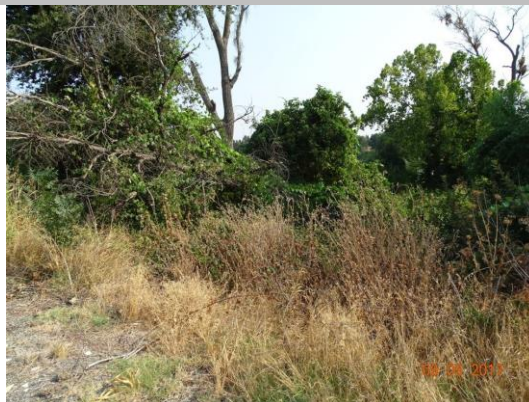
Photo 1 of 1 : SP_2018_RD0765_211_1_20180301_00001.jpg

Looking north at the downed tree.

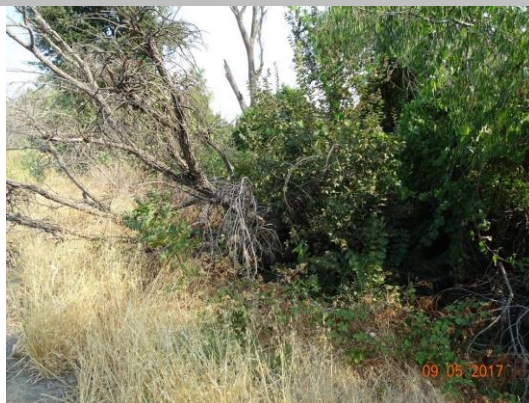
Photo 1 of 1 : SP_2018_RD0765_211_39_20180301_00046.jpg

Looking north at the waterside slope.

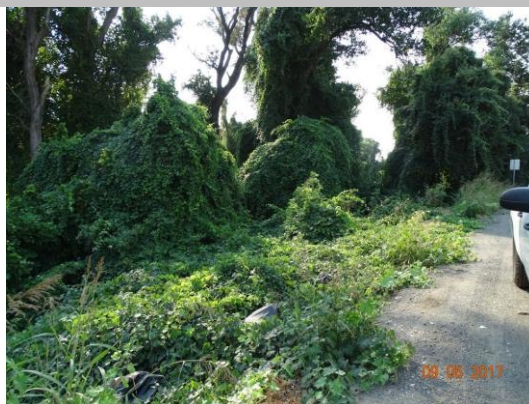
Photo 1 of 2 : SP_2018_RD0765_211_25_20180301_00029.jpg

Looking southeast at waterside slope.

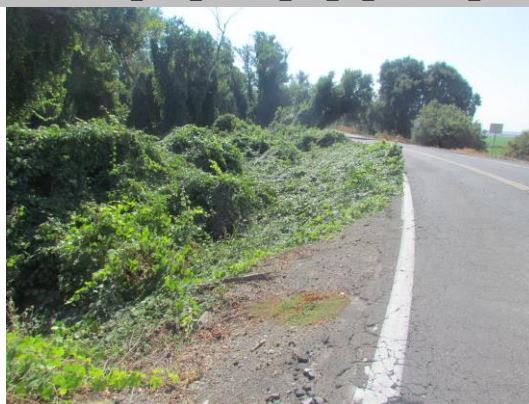
Photo 2 of 2 : SP_2018_RD0765_211_25_20180301_00030.jpg

Looking south on at dense berryvines on waterward slope.

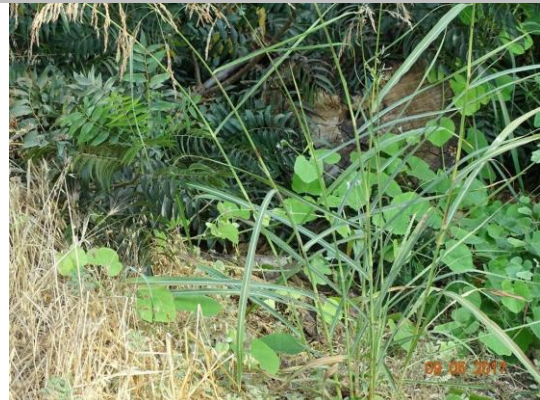
Photo 1 of 2 : SP_2018_RD0765_211_13_20180301_00017.jpg

Looking northwest at tree limb in vegetation on waterside slope.

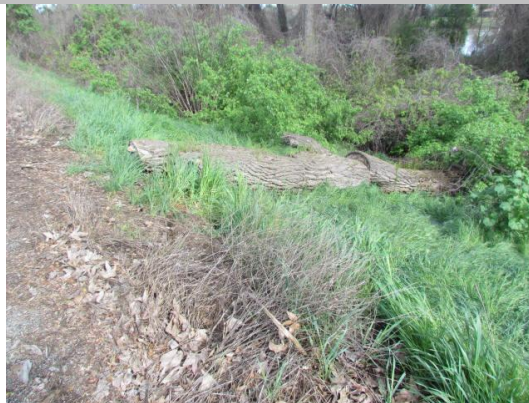
Photo 2 of 2 : SP_2018_RD0765_211_13_20180301_00018.jpg

Looking northwest at large tree limb on waterward slope.
