**Flood Control Project Maintenance
Levee Inspections**

Maintenance Issue Types Only, Levee Inspection Report By Mile - Spring 2019

Reclamation District No. 0765 Glide

Waterway	Bank	Unit Miles	Inspection Start/End	Inspector
Unit No. 01 Sacramento River	Right	1.72	04/10/2019 04/10/2019	Luz Dial

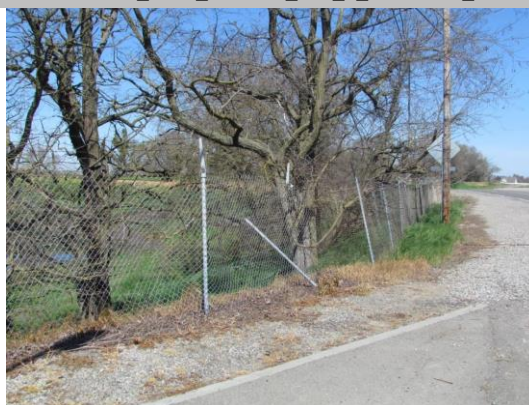
Photo 1 of 3 : SP_2019_RD0765_211_3_20190307_00003.jpg

LM Start	0.05	Rating **	M	Issue No.	3
LM End	0.05	Issue Type +	Ma	Location *	LS
Category	Earthen Levee			GPS Latitude/Longitude	
				Start	End
Item	Trim / Thin Trees			38.502253 °	38.502253 °
				-121.560192 °	-121.560192 °
DWR ID	DWR_RD0765_01_s_2012_3				
Comment Code					
T1 : Trim trees to at least five feet above ground level.					
Inspector Comment					
Trim trees that are blocking view of the landside slope.

Looking north at untrimmed trees along landward slope. (Spring 2017)

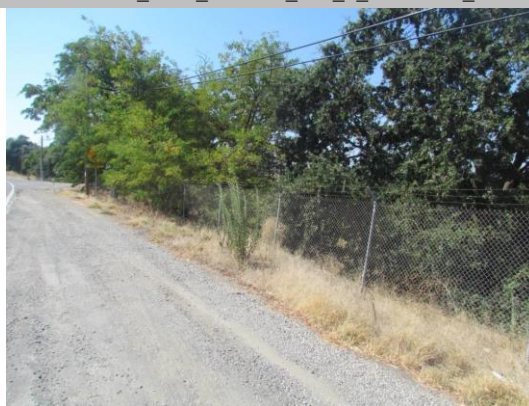
Photo 2 of 3 : SP_2019_RD0765_211_3_20190307_00004.jpg

Looking southwest at untrimmed trees on landward slope.(Fall 2016)

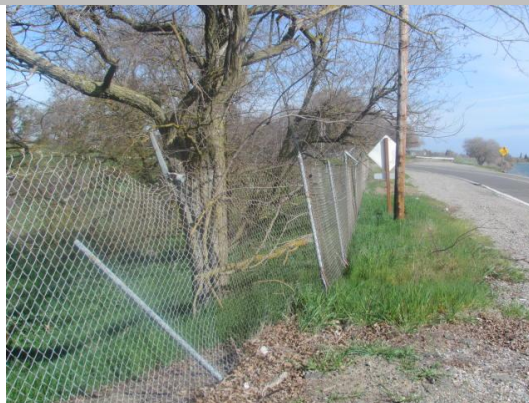
Photo 3 of 3 : SP_2019_RD0765_211_3_20190307_00005.jpg

LM Start	0.05	Rating **	M	Issue No.	3 (cont)	
LM End	0.05	Issue Type +	Ma	Location *	LS	
Category	Earthen Levee			GPS Latitude/Longitude		
				Start		End
Item	Trim / Thin Trees			38.502253 °		38.502253 °
				-121.560192 °		-121.560192 °
DWR ID	DWR_RD0765_01_s_2012_3					
Comment Code						
T1 : Trim trees to at least five feet above ground level.						
Inspector Comment						
Trim trees that are blocking view of the landside slope.

Looking north (upstream) at trees on landside slope. (Spring 2016)

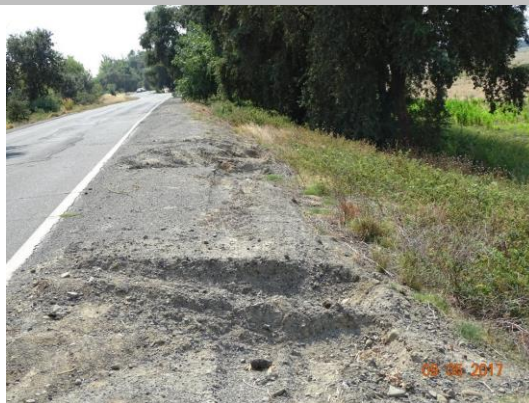
Photo 1 of 2 : SP_2019_RD0765_211_68_20190307_00041.jpg

LM Start	0.75	Rating **	M	Issue No.	68
LM End	0.75	Issue Type +	Ma	Location *	LS
Category	Earthen Levee			GPS Latitude/Longitude	
				Start	End
Item	Slope Stability			38.492705 °	38.492705 °
				-121.557193 °	-121.557193 °
DWR ID	DWR_RD0765_01_s_2017_68				
Comment Code					
S3 : Repair the levee slope damaged by vehicle traffic and prevent access where possible.					
Inspector Comment					
Repair slope damage likely caused by a truck.

Looking south on landside slope.

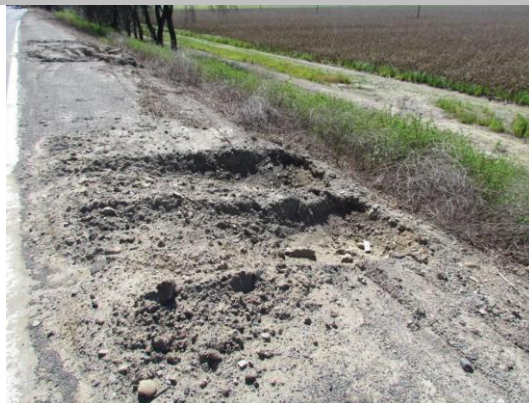
Photo 2 of 2 : SP_2019_RD0765_211_68_20190307_00042.jpg

LM Start	0.75	Rating **	M	Issue No.	68 (cont)	
LM End	0.75	Issue Type +	Ma	Location *	LS	
Category	Earthen Levee			GPS Latitude/Longitude		
				Start		End
Item	Slope Stability			38.492705 °		38.492705 °
				-121.557193 °		-121.557193 °
DWR ID	DWR_RD0765_01_s_2017_68					
Comment Code						
S3 : Repair the levee slope damaged by vehicle traffic and prevent access where possible.						
Inspector Comment						
Repair slope damage likely caused by a truck.

Looking south at levee damage caused by vehicle traffic. (Spring 2017)

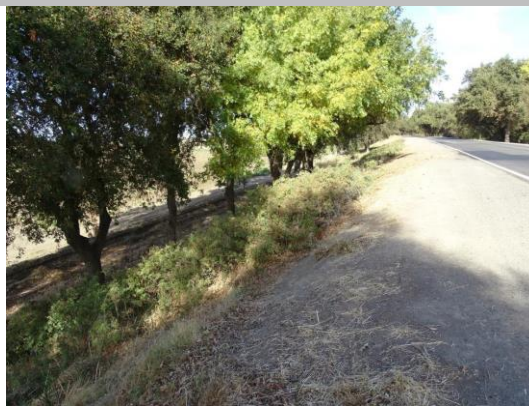
Photo 1 of 1 : SP_2019_RD0765_211_63_20190307_00039.jpg

LM Start	0.75	Rating **	M	Issue No.	63
LM End	0.79	Issue Type +	Ma	Location *	LS
Category	Earthen Levee			GPS Latitude/Longitude	
				Start	End
Item	Vegetation			38.492647 °	38.492145 °
				-121.557192 °	-121.556891 °
DWR ID	DWR_RD0765_01_s_2018_63				
Comment Code					
V2 : Remove the wild growth other than native grasses from the levee slopes.					
Inspector Comment

View of wild brush on levee slope. Fall 2018

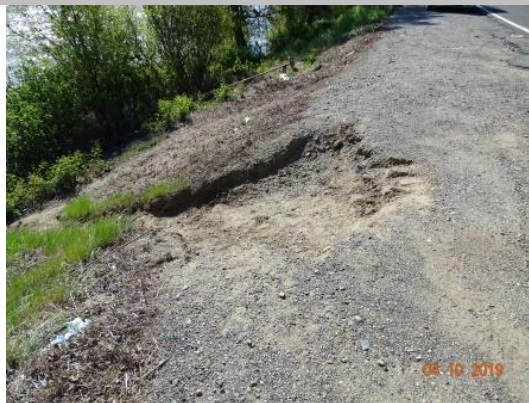
Photo 1 of 1 : SP_2019_RD0765_211_24_20190410_00060.jpg

LM Start	0.94	Rating **	M	Issue No.	24
LM End	0.94	Issue Type +	Ma	Location *	WS
Category	Earthen Levee			GPS Latitude/Longitude	
				Start	End
Item	Slope Stability			38.490265 °	38.490265 °
				-121.555617 °	-121.555617 °
DWR ID	DWR_RD0765_01_s_2019_24				
Comment Code					
S2 : Repair the levee slope damaged by foot traffic and prevent access where possible.					
Inspector Comment

View looking downstream at footpath that cuts into levee slope. Spring 2019

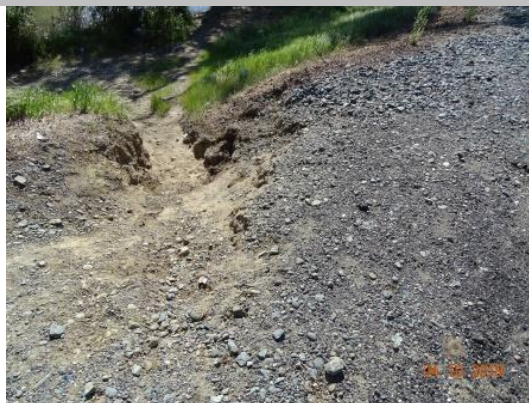
Photo 1 of 1 : SP_2019_RD0765_211_23_20190410_00059.jpg

LM Start	0.95	Rating **	M	Issue No.	23
LM End	0.95	Issue Type +	Ma	Location *	WS
Category	Earthen Levee			GPS Latitude/Longitude	
				Start	End
Item	Slope Stability			38.490067 °	38.490067 °
				-121.555530 °	-121.555530 °
DWR ID	DWR_RD0765_01_s_2019_23				
Comment Code					
S2 : Repair the levee slope damaged by foot traffic and prevent access where possible.					
Inspector Comment

View looking east at footpath that cuts into levee slope. Spring 2019

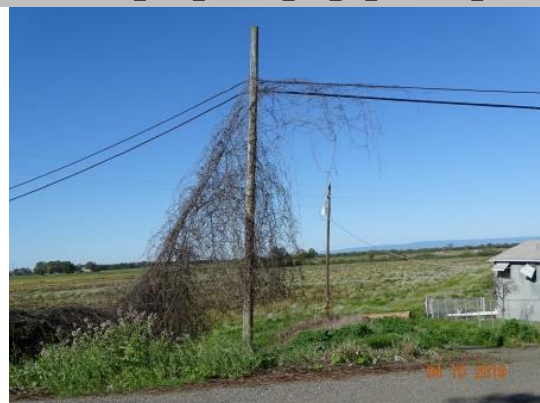
Photo 1 of 1 : SP_2019_RD0765_211_15_20190410_00057.jpg

LM Start	1.28	Rating **	U	Issue No.	15
LM End	1.32	Issue Type +	Ma	Location *	LS
Category	Earthen Levee			GPS Latitude/Longitude	
				Start	End
Item	Vegetation			38.485728 °	38.485210 °
				-121.553042 °	-121.552862 °
DWR ID	DWR_RD0765_01_s_2019_15				
Comment Code					
V2 : Remove the wild growth other than native grasses from the levee slopes.					
Inspector Comment					
Remove wild vines including the vines that have climbed up utility pole, which present a fire hazard.

View looking west at wild vines that have climbed up utility pole. Spring 2019

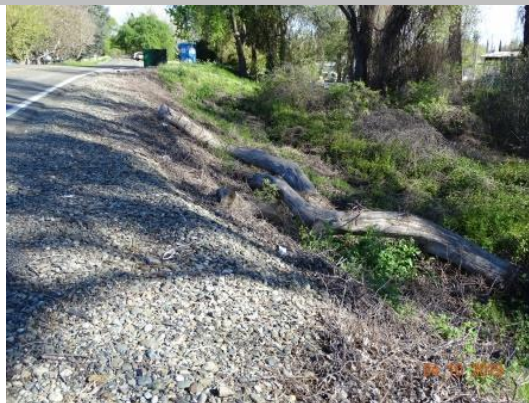
Photo 1 of 1 : SP_2019_RD0765_211_20_20190410_00056.jpg

LM Start	1.31	Rating **	M	Issue No.	20	
LM End	1.31	Issue Type +	Ma	Location *	WS	
Category	Earthen Levee			GPS Latitude/Longitude		
				Start	End	
Item	Encroachments			38.485382 °	38.485382 °	
				-121.552842 °	-121.552842 °	
DWR ID	DWR_RD0765_01_s_2019_20					
Comment Code						
TR : Tree or limb						
Inspector Comment						
Remove fallen tree from levee slope.

View looking upstream at fallen tree on levee slope. Spring 2019

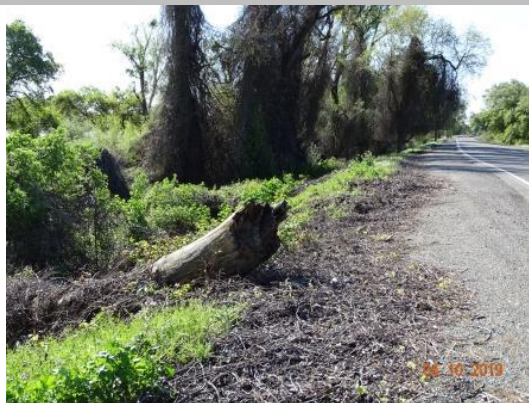
Photo 1 of 2 : SP_2019_RD0765_211_7_20190410_00061.jpg

LM Start	1.32	Rating **	M	Issue No.	7
LM End	1.34	Issue Type +	Ma	Location *	WS
Category	Earthen Levee			GPS Latitude/Longitude	
				Start	End
Item	Encroachments			38.485287 °	38.485014 °
				-121.552818 °	-121.552618 °
DWR ID	DWR_RD0765_01_s_2015_7				
Comment Code					
TR : Tree or limb					
Inspector Comment					
LMA removed some but not all tree logs.

View looking downstream at tree log on levee slope. Spring 2019

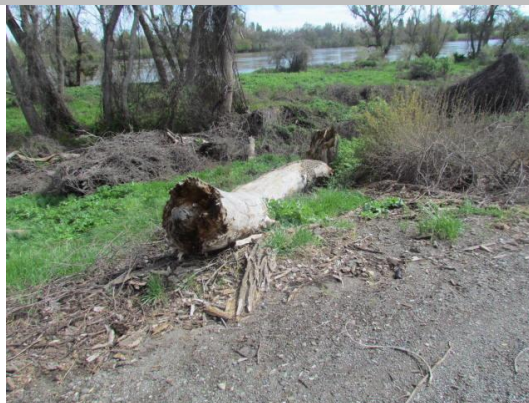
Photo 2 of 2 : SP_2019_RD0765_211_7_20190307_00009.jpg

LM Start	1.32	Rating **	M	Issue No.	7 (cont)	
LM End	1.34	Issue Type +	Ma	Location *	WS	
Category	Earthen Levee			GPS Latitude/Longitude		
				Start		End
Item	Encroachments			38.485287 °		38.485014 °
				-121.552818 °		-121.552618 °
DWR ID	DWR_RD0765_01_s_2015_7					
Comment Code						
TR : Tree or limb						
Inspector Comment						
LMA removed some but not all tree logs.

Looking southeast at branch on waterward slope.

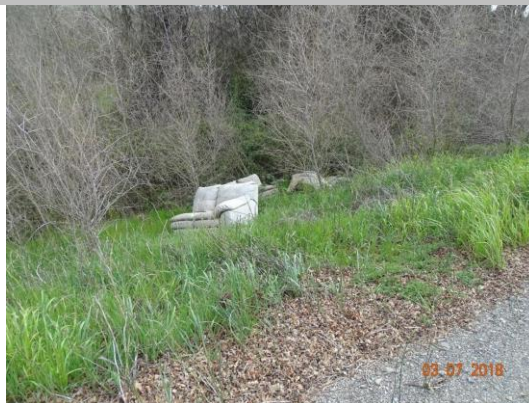
Photo 1 of 1 : SP_2019_RD0765_211_67_20190307_00040.jpg

LM Start	1.43	Rating **	M	Issue No.	67
LM End	1.43	Issue Type +	Ma	Location *	WS
Category	Earthen Levee			GPS Latitude/Longitude	
				Start	End
Item	Encroachments			38.483810 °	38.483810 °
				-121.551747 °	-121.551747 °
DWR ID	DWR_RD0765_01_s_2017_67				
Comment Code					
GA : Garbage					
Inspector Comment					
Remove sofa dumped on waterside slope.

View of sofa debris dumped on slope. Spring 2018

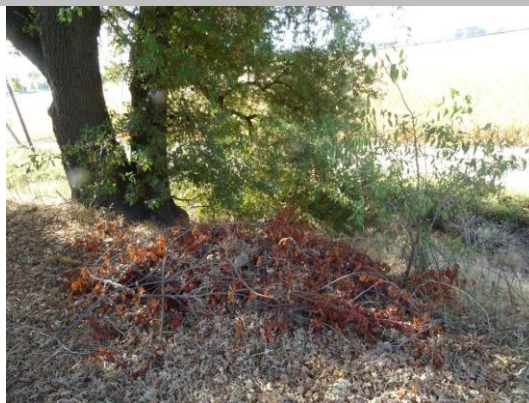
Photo 1 of 1 : SP_2019_RD0765_211_41_20190307_00021.jpg

LM Start	1.44	Rating **	M	Issue No.	41
LM End	1.44	Issue Type +	Ma	Location *	LS
Category	Earthen Levee			GPS Latitude/Longitude	
				Start	End
Item	Trim / Thin Trees			38.483640 °	38.483640 °
				-121.551727 °	-121.551727 °
DWR ID	DWR_RD0765_01_s_2012_41				
Comment Code					
T1 : Trim trees to at least five feet above ground level.					
Inspector Comment					
Trim trees to at least five feet above slope.

View of low branches and prunings on slope. Fall 2018

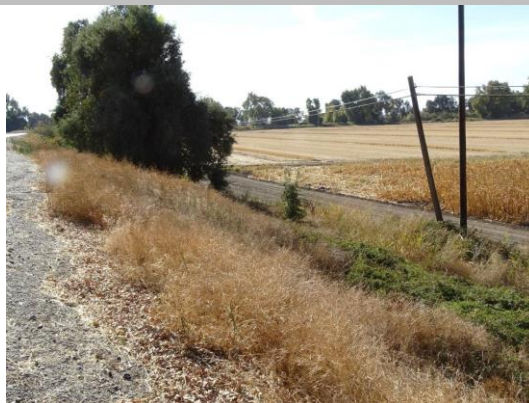
Photo 1 of 3 : SP_2019_RD0765_211_52_20190307_00030.jpg

LM Start	1.47	Rating **	M	Issue No.	52
LM End	1.70	Issue Type +	Ma	Location *	LS
Category	Earthen Levee			GPS Latitude/Longitude	
				Start	End
Item	Vegetation			38.483340 °	38.480345 °
				-121.551565 °	-121.549658 °
DWR ID	DWR_RD0765_01_f_2018_52				
Comment Code					
V2 : Remove the wild growth other than native grasses from the levee slopes.					
Inspector Comment					
Trim tall brush along slope.

View of tall brush on levee slope. Fall 2018

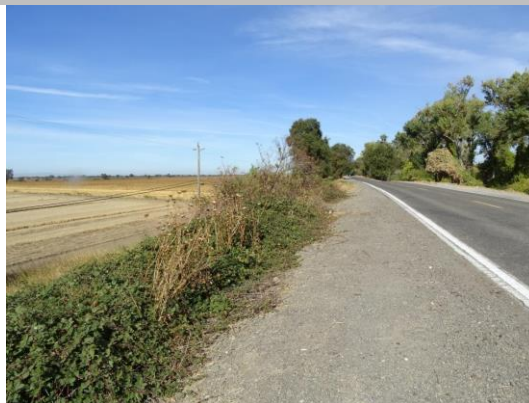
Photo 2 of 3 : SP_2019_RD0765_211_52_20190307_00031.jpg

LM Start	1.47	Rating **	M	Issue No.	52 (cont)	
LM End	1.70	Issue Type +	Ma	Location *	LS	
Category	Earthen Levee			GPS Latitude/Longitude		
				Start		End
Item	Vegetation			38.483340 °		38.480345 °
				-121.551565 °		-121.549658 °
DWR ID	DWR_RD0765_01_f_2018_52					
Comment Code						
V2 : Remove the wild growth other than native grasses from the levee slopes.						
Inspector Comment						
Trim tall brush along slope.

View of tall brush on levee slope. Fall 2018

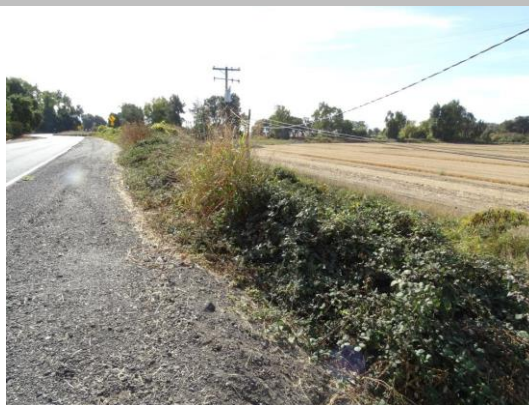
Photo 3 of 3 : SP_2019_RD0765_211_52_20190307_00032.jpg

View of tall brush on levee slope. Fall 2018

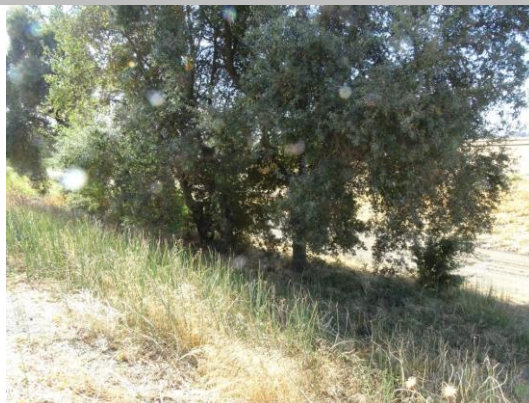
Photo 1 of 1 : SP_2019_RD0765_211_42_20190307_00022.jpg

LM Start	1.48	Rating **	M	Issue No.	42
LM End	1.50	Issue Type +	Ma	Location *	LS
Category	Earthen Levee			GPS Latitude/Longitude	
				Start	End
Item	Trim / Thin Trees			38.483170 °	38.482965 °
				-121.551367 °	-121.551265 °
DWR ID	DWR_RD0765_01_s_2012_42				
Comment Code					
T1 : Trim trees to at least five feet above ground level.					
Inspector Comment

View of low tree branches partially blocking visibility. Fall 2018

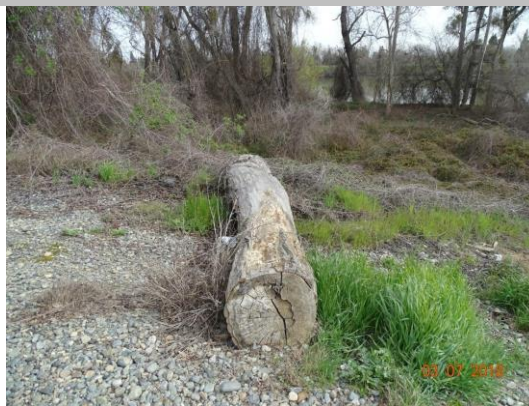
Photo 1 of 1 : SP_2019_RD0765_211_45_20190307_00024.jpg

LM Start	1.51	Rating **	A/W	Issue No.	45
LM End	1.51	Issue Type +	Ma	Location *	WS
Category	Earthen Levee			GPS Latitude/Longitude	
				Start	End
Item	Encroachments			38.482835 °	38.482835 °
				-121.551083 °	-121.551083 °
DWR ID	DWR_RD0765_01_s _ 2018_45				
Comment Code					
TR : Tree or limb					
Inspector Comment					
Tree log used to control vehicle traffic access to levee.

Tree log on waterside slope is used to control vehicle access. Spring 2018

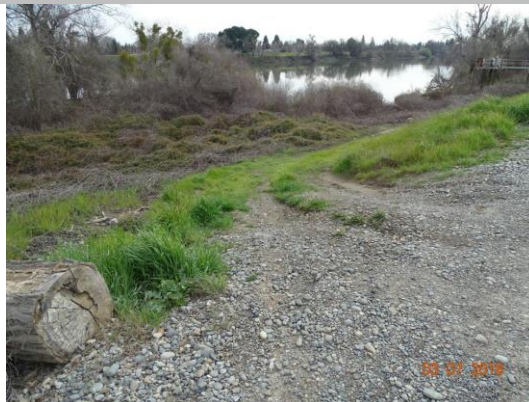
Photo 1 of 1 : SP_2019_RD0765_211_31_20190307_00018.jpg

LM Start	1.51	Rating **	M	Issue No.	31
LM End	1.51	Issue Type +	Ma	Location *	WS
Category	Earthen Levee			GPS Latitude/Longitude	
				Start	End
Item	Slope Stability			38.482788 °	38.482788 °
				-121.551048 °	-121.551048 °
DWR ID	DWR_RD0765_01_s _ 2018_31				
Comment Code					
S3 : Repair the levee slope damaged by vehicle traffic and prevent access where possible.					
Inspector Comment

View looking southeast at slope instability due to vehicle traffic. Spring 2018

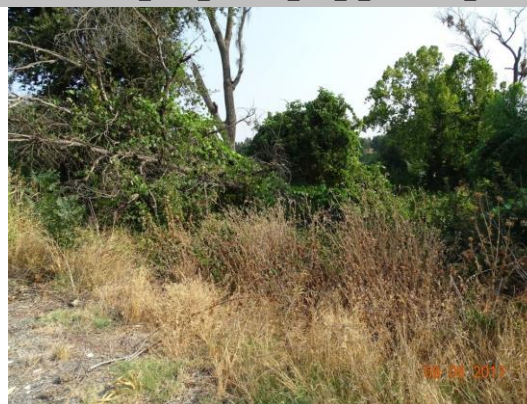
Photo 1 of 1 : SP_2019_RD0765_211_1_20190307_00001.jpg

LM Start	1.58	Rating **	M	Issue No.	1
LM End	1.58	Issue Type +	Ma	Location *	WS
Category	Earthen Levee			GPS Latitude/Longitude	
				Start	End
Item	Encroachments			38.481959 °	38.481959 °
				-121.550527 °	-121.550527 °
DWR ID	DWR_RD0765_01_f_2017_1				
Comment Code					
TR : Tree or limb					
Inspector Comment					
Remove fallen tree on waterside slope.

View looking north at the fallen tree. Fall 2017

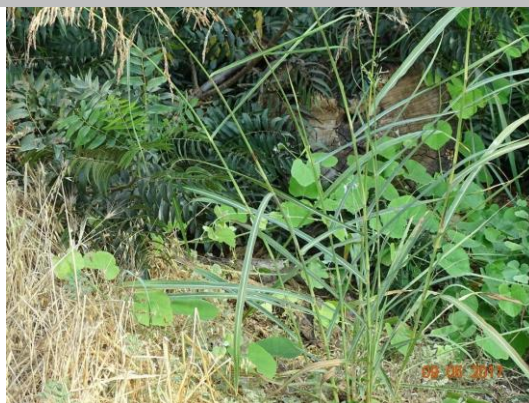
Photo 1 of 2 : SP_2019_RD0765_211_13_20190307_00014.jpg

LM Start	1.67	Rating **	M	Issue No.	13	
LM End	1.68	Issue Type +	Ma	Location *	WS	
Category	Earthen Levee			GPS Latitude/Longitude		
				Start		End
Item	Encroachments			38.480763 °	38.480632 °	
				-121.549581 °	-121.549543 °	
DWR ID	DWR_RD0765_01_s_2012_13					
Comment Code						
TR : Tree or limb						
Inspector Comment						
Remove large tree branch on waterside slope.

Looking northwest at tree limb in vegetation on waterside slope. Fall 2017

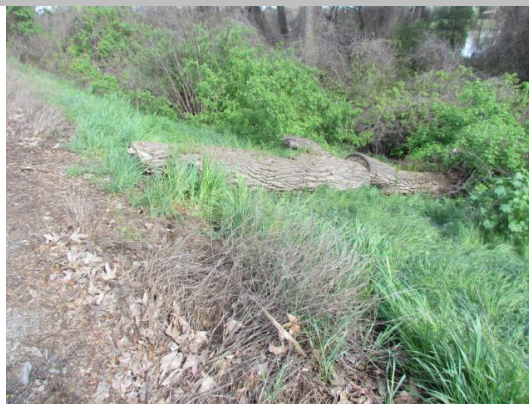
Photo 2 of 2 : SP_2019_RD0765_211_13_20190307_00015.jpg

Looking northwest at large tree limb on waterward slope.
