**Flood Control Project Maintenance
Levee Inspections**

Maintenance Issue Types Only, Levee Inspection Report By Mile - Spring 2020

Reclamation District No. 0765 Glide

Waterway	Bank	Unit Miles	Inspection Start/End	Inspector
Unit No. 01 Sacramento River	Right	1.72	03/03/2020 03/19/2020	Luz Dial

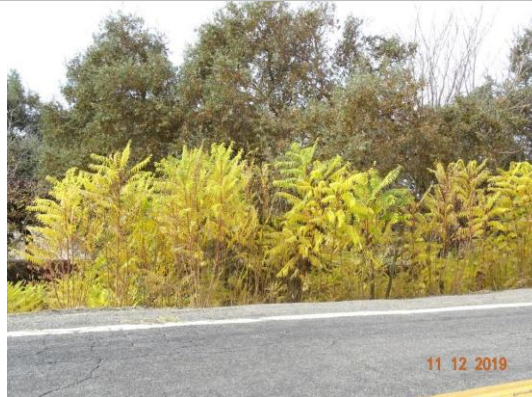
Photo 1 of 1 : SP_2020_RD0765_211_10_20200302_00005.jpg

LM Start	0.43	Rating **	M	Issue No.	10
LM End	0.50	Issue Type +	Ma	Location *	LS
Category	Earthen Levee		GPS Latitude/Longitude		
			Start	End	
Item	Vegetation		38.496717 °	38.495810 °	
			-121.560023 °	-121.559520 °	
DWR ID	DWR_RD0765_01_f_2019_10				
Comment Code					
V2 : Remove the wild growth other than native grasses from the levee slopes.					
Inspector Comment					
Remove wild growth of invasive plants.

View of invasive wild growth on the landside slope. Fall 2019

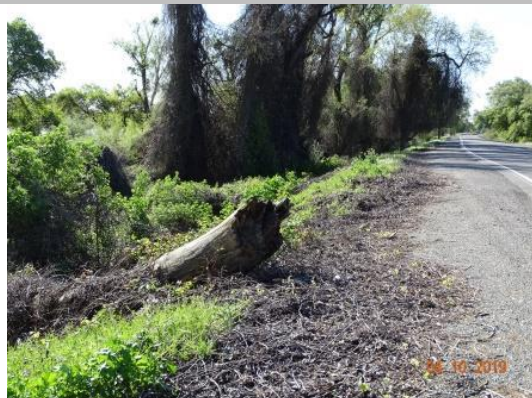
Photo 1 of 2 : SP_2020_RD0765_211_7_20200302_00003.jpg

LM Start	1.32	Rating **	M	Issue No.	7
LM End	1.34	Issue Type +	Ma	Location *	WS
Category	Earthen Levee			GPS Latitude/Longitude	
				Start	End
Item	Encroachments			38.485287 °	38.485014 °
				-121.552818 °	-121.552618 °
DWR ID	DWR_RD0765_01_s_2015_7				
Comment Code					
TR : Tree or limb					
Inspector Comment

View looking downstream at tree log on levee slope. Spring 2019

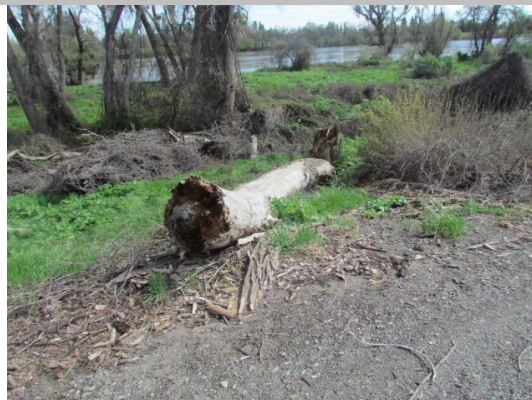
Photo 2 of 2 : SP_2020_RD0765_211_7_20200302_00004.jpg

Looking southeast at branch on waterward slope.

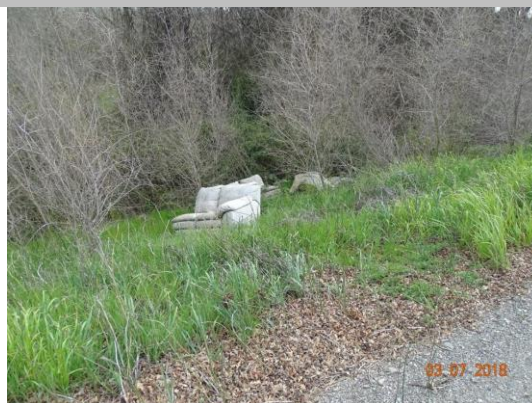
Photo 1 of 1 : SP_2020_RD0765_211_67_20200302_00030.jpg

LM Start	1.43	Rating **	M	Issue No.	67
LM End	1.43	Issue Type +	Ma	Location *	WS
Category	Earthen Levee			GPS Latitude/Longitude	
				Start	End
Item	Encroachments			38.483810 °	38.483810 °
				-121.551747 °	-121.551747 °
DWR ID	DWR_RD0765_01_s_2017_67				
Comment Code					
GA : Garbage					
Inspector Comment					
Remove sofa dumped on waterside slope.

View of sofa debris dumped on slope. Spring 2018

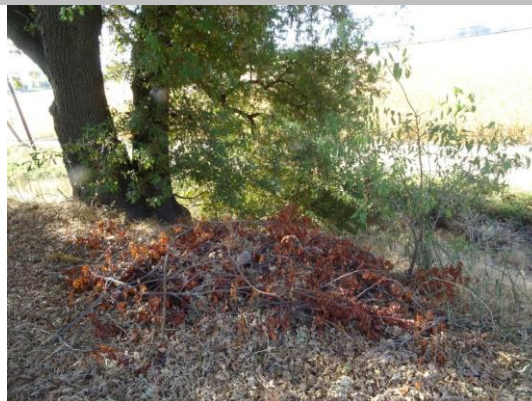
Photo 1 of 1 : SP_2020_RD0765_211_41_20200302_00015.jpg

LM Start	1.44	Rating **	M	Issue No.	41
LM End	1.45	Issue Type +	Ma	Location *	LS
Category	Earthen Levee			GPS Latitude/Longitude	
				Start	End
Item	Trim / Thin Trees			38.483640 °	38.483555 °
				-121.551727 °	-121.551648 °
DWR ID	DWR_RD0765_01_s_2012_41				
Comment Code					
T1 : Trim trees to at least five feet above ground level.					
Inspector Comment					
Trim trees to at least five feet above the slope.

View of low branches on slope. Fall 2018

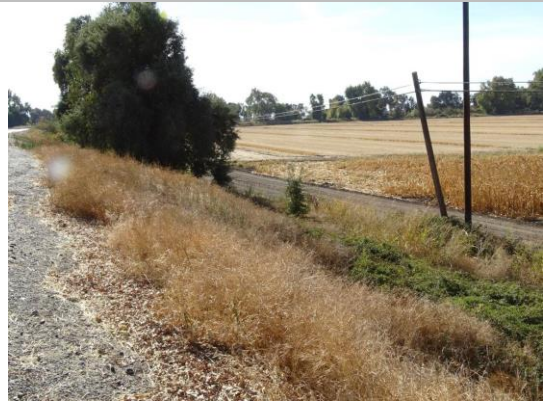
Photo 1 of 3 : SP_2020_RD0765_211_52_20200302_00021.jpg

LM Start	1.47	Rating **	M	Issue No.	52
LM End	1.70	Issue Type +	Ma	Location *	LS
Category	Earthen Levee			GPS Latitude/Longitude	
				Start	End
Item	Vegetation			38.483340 °	38.480345 °
				-121.551565 °	-121.549658 °
DWR ID	DWR_RD0765_01_f_2018_52				
Comment Code					
V2 : Remove the wild growth other than native grasses from the levee slopes.					
Inspector Comment					
Trim tall brush along the slope.

View of tall brush on levee slope. Fall 2018

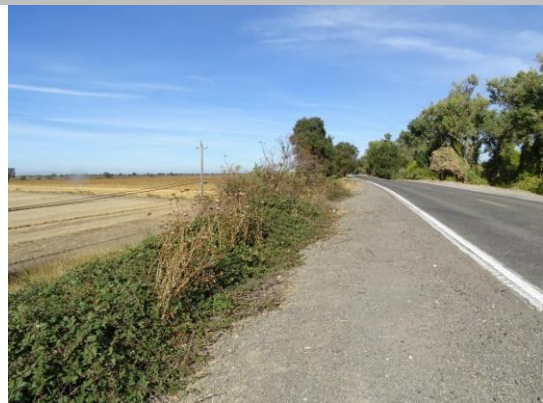
Photo 2 of 3 : SP_2020_RD0765_211_52_20200302_00022.jpg

View of tall brush on levee slope. Fall 2018

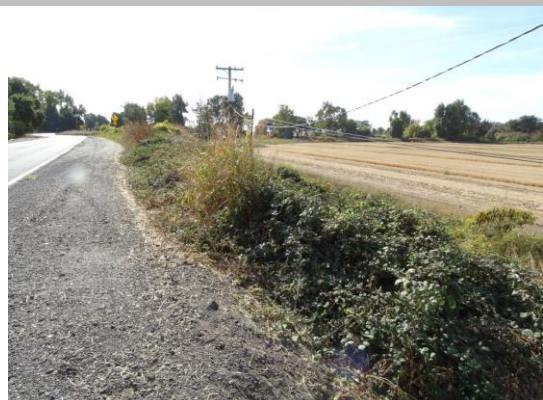
Photo 3 of 3 : SP_2020_RD0765_211_52_20200302_00023.jpg

View of tall brush on levee slope. Fall 2018

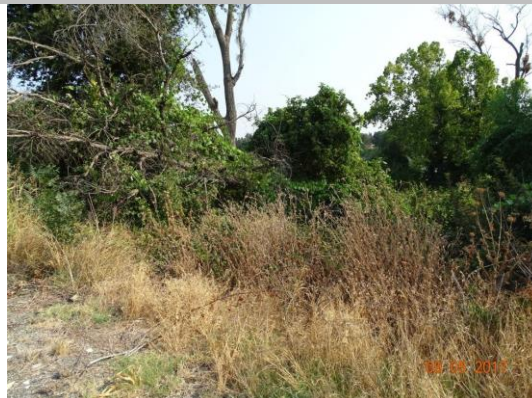
Photo 1 of 1 : SP_2020_RD0765_211_1_20200302_00001.jpg

LM Start	1.58	Rating **	M	Issue No.	1
LM End	1.58	Issue Type +	Ma	Location *	WS
Category	Earthen Levee			GPS Latitude/Longitude	
				Start	End
Item	Encroachments			38.481959 °	38.481959 °
				-121.550527 °	-121.550527 °
DWR ID	DWR_RD0765_01_f_2017_1				
Comment Code					
TR : Tree or limb					
Inspector Comment					
Remove a fallen tree on the waterside slope.

View looking north at the fallen tree. Fall 2017

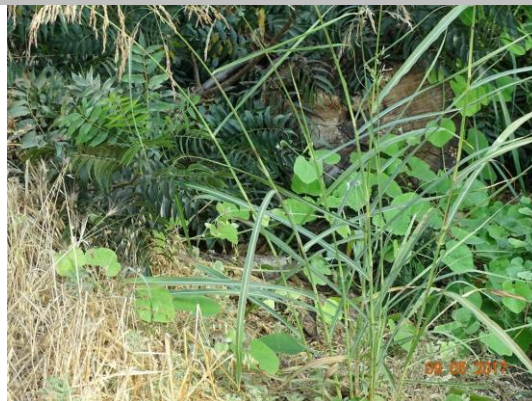
Photo 1 of 2 : SP_2020_RD0765_211_13_20200302_00007.jpg

LM Start	1.67	Rating **	M	Issue No.	13
LM End	1.68	Issue Type +	Ma	Location *	WS
Category	Earthen Levee			GPS Latitude/Longitude	
				Start	End
Item	Encroachments			38.480763 °	38.480632 °
				-121.549581 °	-121.549543 °
DWR ID	DWR_RD0765_01_s_2012_13				
Comment Code					
TR : Tree or limb					
Inspector Comment					
Remove a large tree branch on the waterside slope.

Looking northwest at tree limb in vegetation on waterside slope. Fall 2017

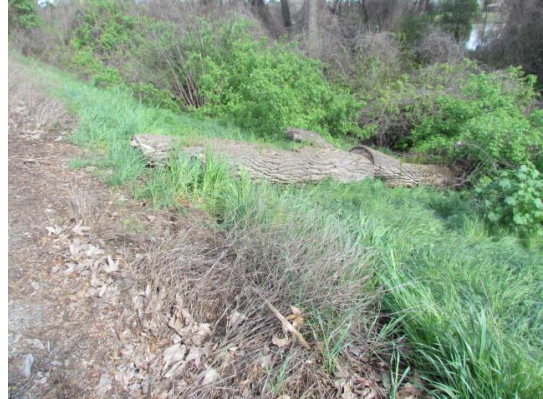
Photo 2 of 2 : SP_2020_RD0765_211_13_20200302_00008.jpg

Looking northwest at large tree limb on waterward slope.
