**Flood Control Project Maintenance
Levee Inspections**

Maintenance Issue Types Only, Levee Inspection Report By Mile - Spring 2021

Reclamation District No. 0765 Glide

Waterway	Bank	Unit Miles	Inspection Start/End	Inspector
Unit No. 01 Sacramento River	Right	1.72	04/01/2021 04/01/2021	Saskia Donovan

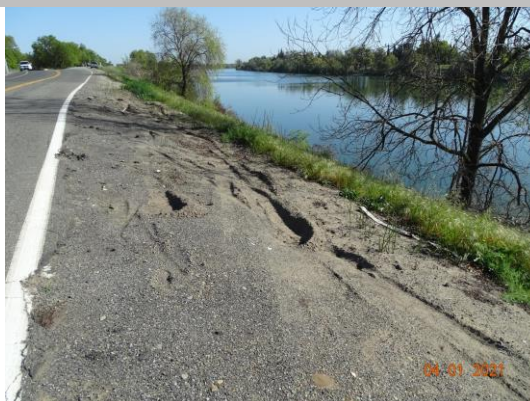
Photo 1 of 1 : SP_2021_RD0765_211_42_20210426_00053.jpg

LM Start	0.07	Rating **	M	Issue No.	42
LM End	0.07	Issue Type +	Ma	Location *	WS
Category	Earthen Levee			GPS Latitude/Longitude	
				Start	End
Item	Slope Stability			38.501920 °	38.501920 °
				-121.560368 °	-121.560368 °
DWR ID	DWR_RD0765_01_s_2021_42				
Comment Code					
S3 : Repair the levee slope damaged by vehicle traffic and prevent access where possible.					
Inspector Comment

View of the WS levee slope damaged by vehicle traffic. Spring 2021.

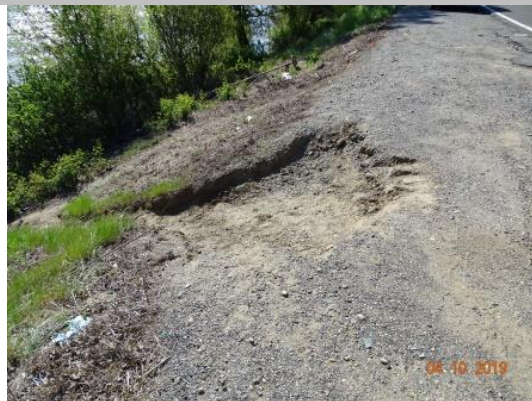
Photo 1 of 1 : SP_2021_RD0765_211_24_20210308_00010.jpg

LM Start	0.94	Rating **	M	Issue No.	24
LM End	0.94	Issue Type +	Ma	Location *	WS
Category	Earthen Levee			GPS Latitude/Longitude	
				Start	End
Item	Slope Stability			38.490265 °	38.490265 °
				-121.555617 °	-121.555617 °
DWR ID	DWR_RD0765_01_s _ 2019_24				
Comment Code					
S2 : Repair the levee slope damaged by foot traffic and prevent access where possible.					
Inspector Comment

View looking downstream at footpath that cuts into levee slope. Spring 2019

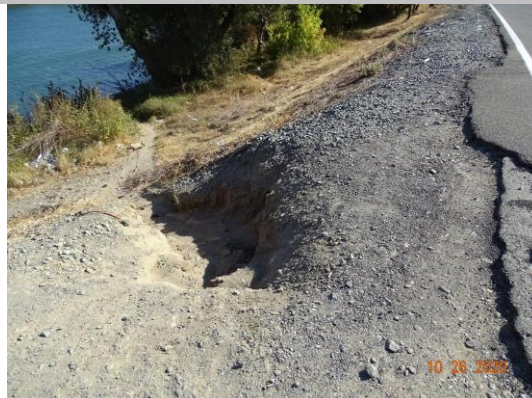
Photo 1 of 1 : SP_2021_RD0765_211_23_20210308_00009.jpg

LM Start	0.95	Rating **	M	Issue No.	23
LM End	0.95	Issue Type +	Ma	Location *	WS
Category	Earthen Levee			GPS Latitude/Longitude	
				Start	End
Item	Slope Stability			38.490067 °	38.490067 °
				-121.555530 °	-121.555530 °
DWR ID	DWR_RD0765_01_s_2019_23				
Comment Code					
S2 : Repair the levee slope damaged by foot traffic and prevent access where possible.					
Inspector Comment

View of footpath on the waterside slope. Fall 2020

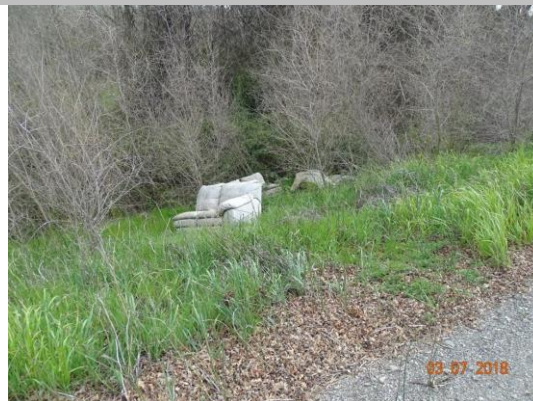
Photo 1 of 1 : SP_2021_RD0765_211_67_20210308_00022.jpg

LM Start	1.43	Rating **	M	Issue No.	67
LM End	1.43	Issue Type +	Ma	Location *	WS
Category	Earthen Levee			GPS Latitude/Longitude	
				Start	End
Item	Encroachments			38.483810 °	38.483810 °
				-121.551747 °	-121.551747 °
DWR ID	DWR_RD0765_01_s _ 2017_67				
Comment Code					
GA : Garbage					
Inspector Comment					
Remove sofa dumped on waterside slope.

View of sofa debris dumped on slope. Spring 2018

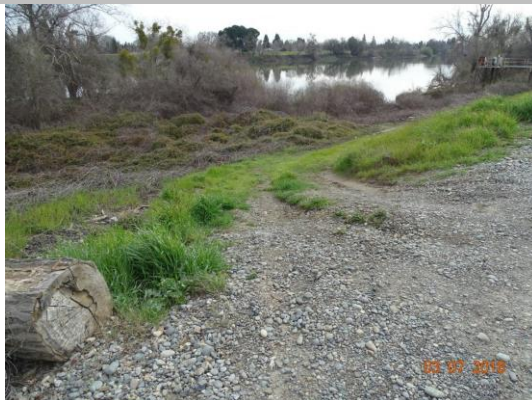
Photo 1 of 1 : SP_2021_RD0765_211_31_20210308_00012.jpg

LM Start	1.51	Rating **	M	Issue No.	31
LM End	1.51	Issue Type +	Ma	Location *	WS
Category	Earthen Levee			GPS Latitude/Longitude	
				Start	End
Item	Slope Stability			38.482788 °	38.482788 °
				-121.551048 °	-121.551048 °
DWR ID	DWR_RD0765_01_f_2019_31				
Comment Code					
S3 : Repair the levee slope damaged by vehicle traffic and prevent access where possible.					
Inspector Comment

View looking southeast at slope instability due to vehicle traffic. Spring 2018

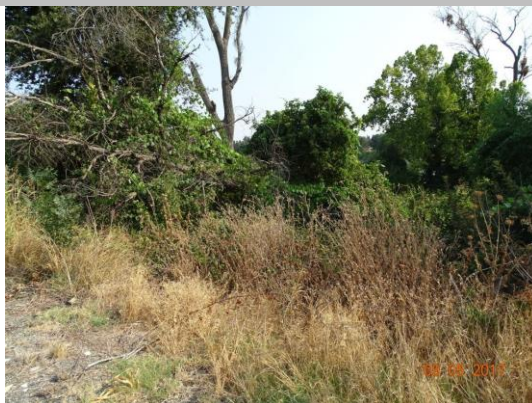
Photo 1 of 1 : SP_2021_RD0765_211_1_20210308_00001.jpg

LM Start	1.58	Rating **	M	Issue No.	1
LM End	1.58	Issue Type +	Ma	Location *	WS
Category	Earthen Levee			GPS Latitude/Longitude	
				Start	End
Item	Encroachments			38.481959 °	38.481959 °
				-121.550527 °	-121.550527 °
DWR ID	DWR_RD0765_01_f_2017_1				
Comment Code					
TR : Tree or limb					
Inspector Comment					
Remove a fallen tree on the waterside slope.

View looking north at the fallen tree. Fall 2017

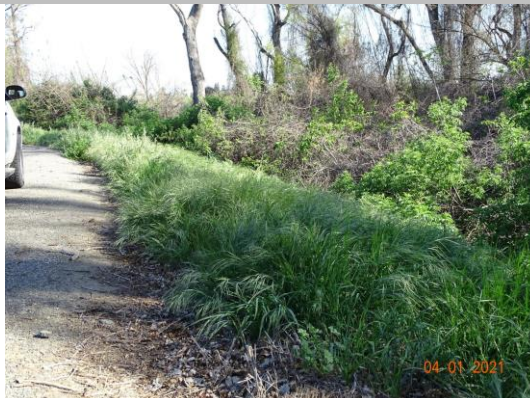
Photo 1 of 1 : SP_2021_RD0765_211_40_20210426_00051.jpg

LM Start	1.66	Rating **	M	Issue No.	40
LM End	1.68	Issue Type +	Ma	Location *	WS
Category	Earthen Levee			GPS Latitude/Longitude	
				Start	End
Item	Vegetation			38.480958 °	38.480673 °
				-121.549678 °	-121.549532 °
DWR ID	DWR_RD0765_01_s_2021_40				
Comment Code					
V1 : Control annual grass and weeds on the levee slopes and easements.					
Inspector Comment					
Annual vegetation on the WS levee slope is starting to get too tall. Spring 2021.

View of the annual vegetation on the WS levee slope. Spring 2021.

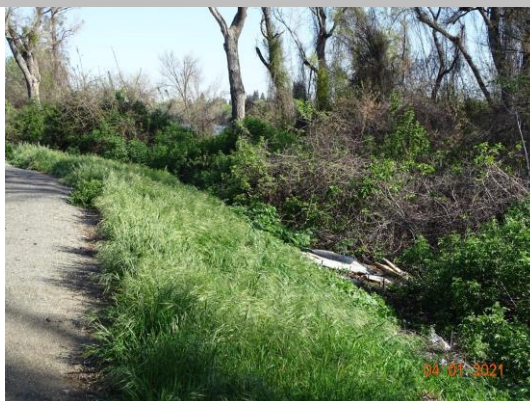
Photo 1 of 1 : SP_2021_RD0765_211_13_20210426_00050.jpg

LM Start	1.68	Rating **	M	Issue No.	13
LM End	1.68	Issue Type +	Ma	Location *	WS
Category	Earthen Levee			GPS Latitude/Longitude	
				Start	End
Item	Encroachments			38.480632 °	38.480632 °
				-121.549543 °	-121.549543 °
DWR ID	DWR_RD0765_01_s_2012_13				
Comment Code					
TR : Tree or limb					
Inspector Comment					
Remove a large tree branch on the waterside slope.

View of the tree limb on the WS levee slope. Spring 2021.
