**Flood Control Project Maintenance
Levee Inspections**

Maintenance Issue Types Only, Levee Inspection Report By Mile - Spring 2022

Reclamation District No. 0765 Glide

Waterway	Bank	Unit Miles	Inspection Start/End	Inspector
Unit No. 01 Sacramento River	Right	1.72	04/27/2022 04/27/2022	Marvin Marshall

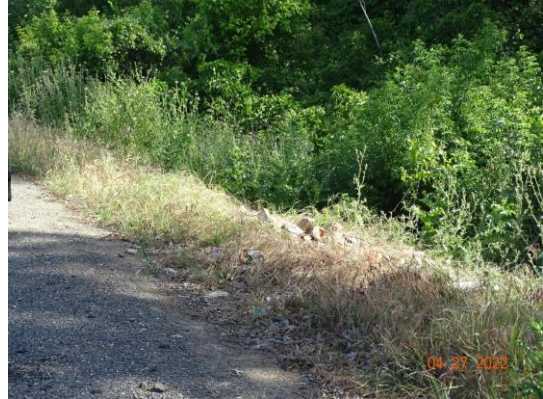
Photo 1 of 1 : SP_2022_RD0765_211_13_20220427_00046.jpg

LM Start	0.03	Rating **	M	Issue No.	13
LM End	1.69	Issue Type +	Ma	Location *	WS
Category	Earthen Levee			GPS Latitude/Longitude	
				Start	End
Item	Vegetation			38.502578 °	38.480521 °
				-121.560085 °	-121.549497 °
DWR ID	DWR_RD0765_01_s_2022_13				
Comment Code					
V1 : Control annual grass and weeds on the levee slopes and easements.					
Inspector Comment

Vegetation on the waterside slope. Spring 2022

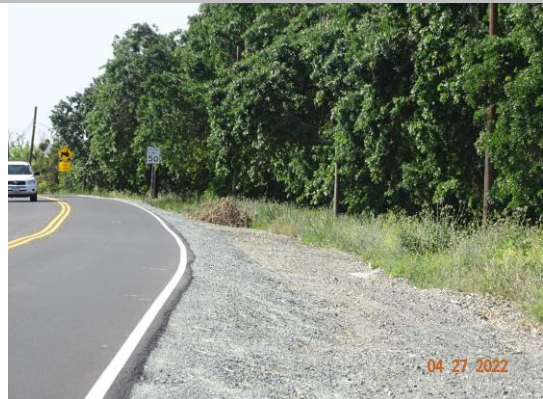
Photo 1 of 1 : SP_2022_RD0765_211_38_20220427_00047.jpg

LM Start	0.11	Rating **	M	Issue No.	38
LM End	1.71	Issue Type +	Ma	Location *	LS
Category	Earthen Levee			GPS Latitude/Longitude	
				Start	End
Item	Vegetation			38.501454 °	38.480267 °
				-121.560390 °	-121.549642 °
DWR ID	DWR_RD0765_01_s_2022_38				
Comment Code					
V1 : Control annual grass and weeds on the levee slopes and easements.					
Inspector Comment					
Maintain vegetation prior to Fall inspection.

Vegetation on the landside slope. Spring 2022

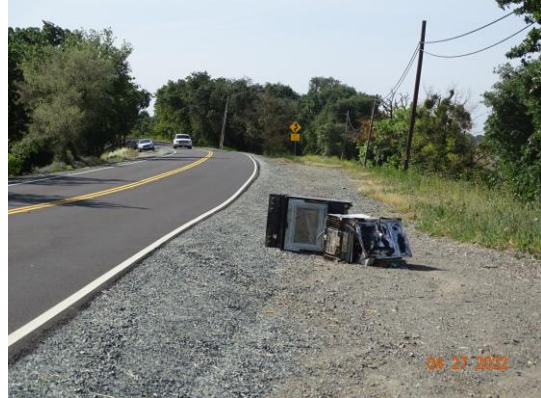
Photo 1 of 1 : SP_2022_RD0765_211_39_20220427_00048.jpg

LM Start	0.27	Rating **	M	Issue No.	39
LM End	0.27	Issue Type +	Ma	Location *	LS
Category	Earthen Levee			GPS Latitude/Longitude	
				Start	End
Item	Encroachments			38.499102 °	38.499102 °
				-121.560475 °	-121.560475 °
DWR ID	DWR_RD0765_01_s_2022_39				
Comment Code					
DE : Debris					
Inspector Comment					
Remove appliances from the landside shulder.

Appliances on the landside shulder. Spring 2022

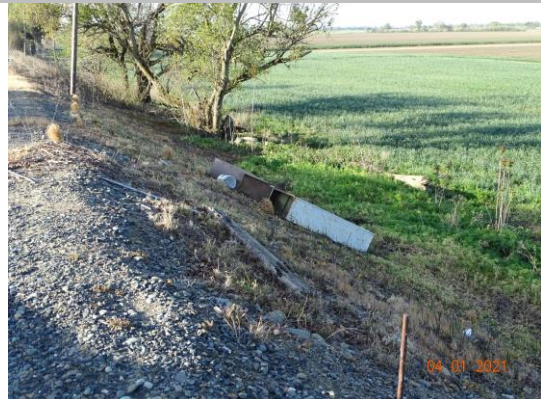
Photo 1 of 1 : SP_2022_RD0765_211_34_20220307_00023.jpg

LM Start	0.29	Rating **	M	Issue No.	34
LM End	0.29	Issue Type +	Ma	Location *	LS
Category	Earthen Levee			GPS Latitude/Longitude	
				Start	End
Item	Encroachments			38.498798 °	38.498798 °
				-121.560501 °	-121.560501 °
DWR ID	DWR_RD0765_01_f_2020_34				
Comment Code					
DE : Debris					
Inspector Comment					
Remove sofas (three) from the LS slope/toe.

View of the filing cabinets on the LS levee slope. Spring 2021.

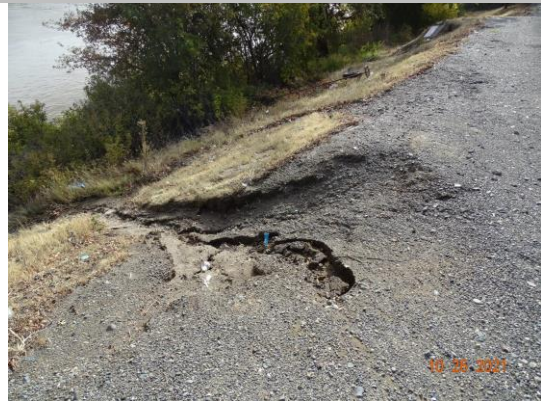
Photo 1 of 1 : SP_2022_RD0765_211_24_20220307_00015.jpg

LM Start	0.94	Rating **	U	Issue No.	24
LM End	0.94	Issue Type +	Ma	Location *	WS
Category	Earthen Levee			GPS Latitude/Longitude	
				Start	End
Item	Erosion / Foot Traffic			38.490265 °	38.490265 °
				-121.555617 °	-121.555617 °
DWR ID	DWR_RD0765_01_s_2019_24				
Comment Code					
E3 : Repair the levee slope damaged by foot traffic and prevent access where possible.					
Inspector Comment					
Erosion and footpath on the WS slope need to be repaired.

Erosion on the WS footpath. Fall 2021

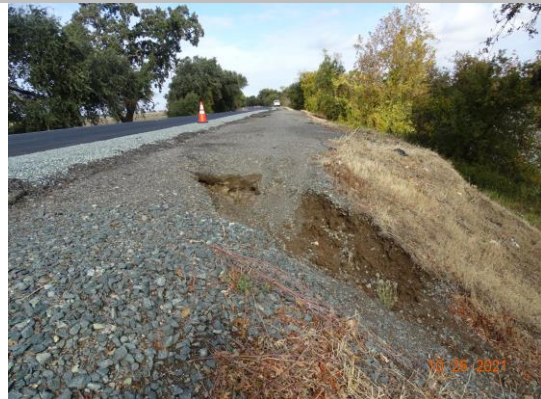
Photo 1 of 1 : SP_2022_RD0765_211_23_20220307_00014.jpg

LM Start	0.95	Rating **	U	Issue No.	23
LM End	0.95	Issue Type +	Ma	Location *	WS
Category	Earthen Levee			GPS Latitude/Longitude	
				Start	End
Item	Erosion / Foot Traffic			38.490067 °	38.490067 °
				-121.555530 °	-121.555530 °
DWR ID	DWR_RD0765_01_s_2019_23				
Comment Code					
E3 : Repair the levee slope damaged by foot traffic and prevent access where possible.					
Inspector Comment					
Repair the erosion at the footpath on the WS slope.

Erosion at the footpath on the WS slope. Fall 2021

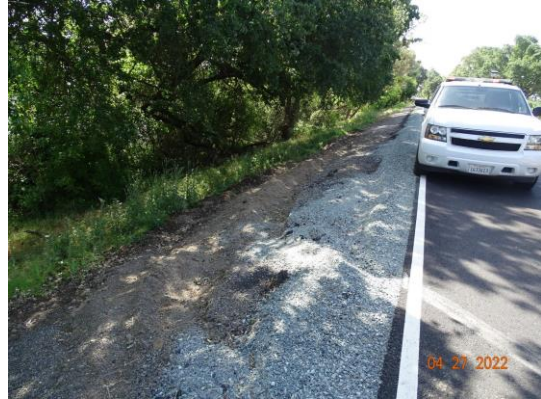
Photo 1 of 1 : SP_2022_RD0765_211_35_20220427_00052.jpg

LM Start	0.99	Rating **	M	Issue No.	35
LM End	0.99	Issue Type +	Ma	Location *	WS
Category	Earthen Levee			GPS Latitude/Longitude	
				Start	End
Item	Erosion / Vehicle Traffic			38.489574 °	38.489574 °
				-121.555308 °	-121.555308 °
DWR ID	DWR_RD0765_01_s_2022_35				
Comment Code					
E6 : Repair the levee slope damaged by vehicle traffic and prevent access where possible.					
Inspector Comment					
Repair rutting on the waterside shoulder.

Rutting on the waterside shoulder. Spring 2022

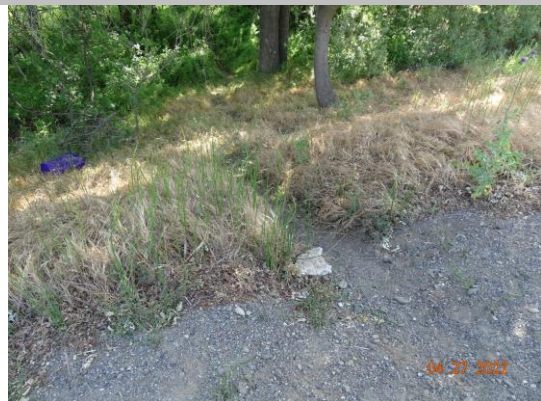
Photo 1 of 1 : SP_2022_RD0765_211_30_20220427_00054.jpg

LM Start	1.00	Rating **	A/W	Issue No.	30
LM End	1.00	Issue Type +	Ma	Location *	WS
Category	Earthen Levee			GPS Latitude/Longitude	
				Start	End
Item	Erosion / Foot Traffic			38.489503 °	38.489503 °
				-121.555272 °	-121.555272 °
DWR ID	DWR_RD0765_01_s_2022_30				
Comment Code					
E3 : Repair the levee slope damaged by foot traffic and prevent access where possible.					
Inspector Comment					
Monitor footpath for further erosion.

Footpath on the waterside slope. Spring 2022

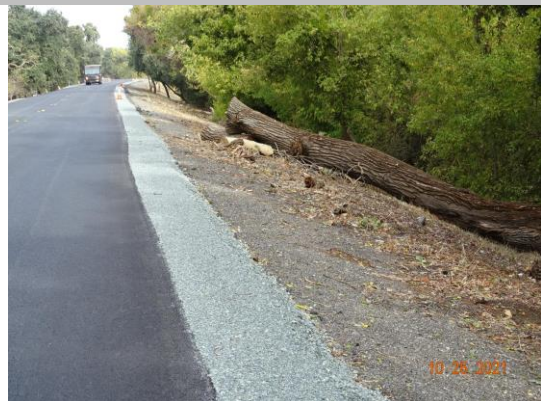
Photo 1 of 1 : SP_2022_RD0765_211_14_20220307_00007.jpg

LM Start	1.08	Rating **	M	Issue No.	14
LM End	1.08	Issue Type +	Ma	Location *	WS
Category	Earthen Levee			GPS Latitude/Longitude	
				Start	End
Item	Encroachments			38.488401 °	38.488401 °
				-121.554658 °	-121.554658 °
DWR ID	DWR_RD0765_01_f_2021_14				
Comment Code					
TR : Tree or limb					
Inspector Comment					
Remove fallen tree from with 20' of the crown.

Fallen tree log within 20 of the WS crown. Fall 2021

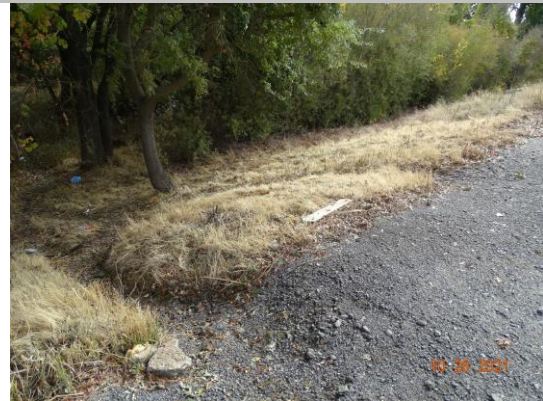
Photo 1 of 1 : SP_2022_RD0765_211_10_20220307_00004.jpg

LM Start	1.42	Rating **	A/W	Issue No.	10
LM End	1.42	Issue Type +	Ma	Location *	WS
Category	Earthen Levee			GPS Latitude/Longitude	
				Start	End
Item	Erosion / Foot Traffic			38.483973 °	38.483973 °
				-121.551855 °	-121.551855 °
DWR ID	DWR_RD0765_01_f_2021_10				
Comment Code					
E3 : Repair the levee slope damaged by foot traffic and prevent access where possible.					
Inspector Comment					
Monitor two footpaths for erosion.

Footpaths on the WS slope. Fall 2021

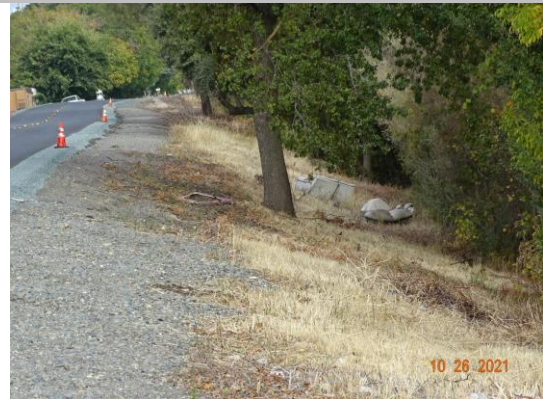
Photo 1 of 1 : SP_2022_RD0765_211_67_20220307_00032.jpg

LM Start	1.43	Rating **	M	Issue No.	67
LM End	1.43	Issue Type +	Ma	Location *	WS
Category	Earthen Levee			GPS Latitude/Longitude	
				Start	End
Item	Encroachments			38.483810 °	38.483810 °
				-121.551747 °	-121.551747 °
DWR ID	DWR_RD0765_01_s_2017_67				
Comment Code					
GA : Garbage					
Inspector Comment					
Remove sofas dumped on waterside slope.

Sofas on the WS slope. Fall 2021

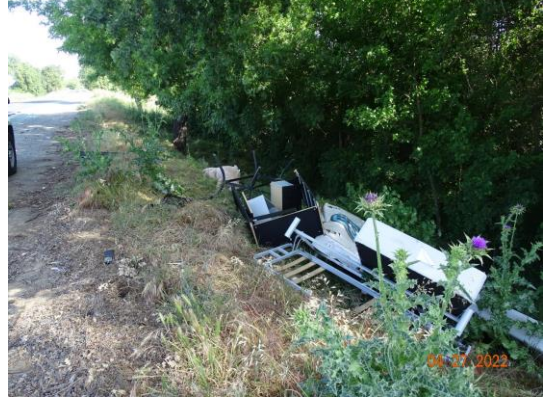
Photo 1 of 1 : SP_2022_RD0765_211_22_20220427_00056.jpg

LM Start	1.60	Rating **	M	Issue No.	22
LM End	1.60	Issue Type +	Ma	Location *	WS
Category	Earthen Levee			GPS Latitude/Longitude	
				Start	End
Item	Encroachments			38.481708 °	38.481708 °
				-121.550346 °	-121.550346 °
DWR ID	DWR_RD0765_01_s_2022_22				
Comment Code					
DE : Debris					
Inspector Comment					
Remove debris pile from waterside shoulder.

Debris pile on the waterside shoulder. Spring 2022
