**Flood Control Project Maintenance  
Levee Inspections**

**Maintenance Issue Types Only, Levee Inspection Report By Mile - Spring 2023**

**Reclamation District No. 0765 Glide**

Waterway	Bank	Unit Miles	Inspection Start/End	Inspector
Unit No. 01 Sacramento River	Right	1.72	04/14/2023 04/14/2023	Marvin Marshall

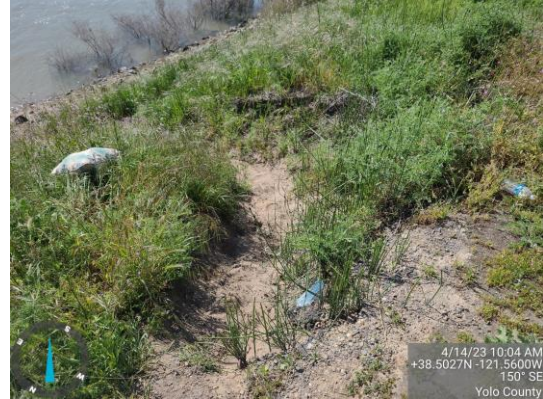
Photo 1 of 1 : SP\_2023\_RD0765\_211\_20\_20230418\_00025.jpg

LM Start	0.02	Rating **	U	Issue No.	20
LM End	0.02	Issue Type +	Ma	Location *	WS
Category	Earthen Levee			GPS Latitude/Longitude	
				Start	End
Item	Erosion / Foot Traffic			38.502711°	38.502711°
				-121.560019°	-121.560019°
DWR ID	DWR_RD0765_01_f _ 2022_20				
Comment Code					
E3 : Repair the levee slope damaged by foot traffic and prevent access where possible.					
Inspector Comment					
Repair erosion caused by foot traffic.

Footpath on the WS slope. Spring 2023

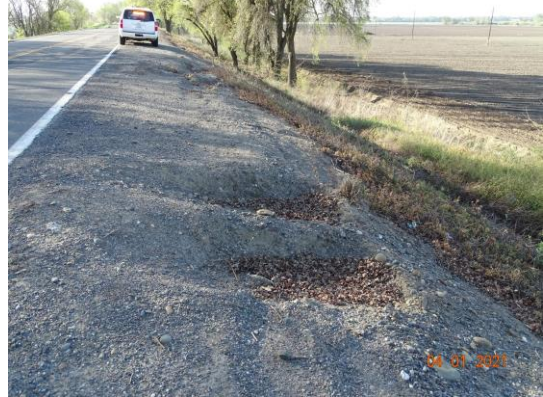
Photo 1 of 1 : SP\_2023\_RD0765\_211\_68\_20230306\_00024.jpg

LM Start	0.75	Rating **	M	Issue No.	68
LM End	0.75	Issue Type +	Ma	Location *	LS
Category	Earthen Levee			GPS Latitude/Longitude	
				Start	End
Item	Erosion / Vehicle Traffic			38.492705°	38.492705°
				-121.557193°	-121.557193°
DWR ID	DWR_RD0765_01_s_2017_68				
Comment Code					
E6 : Repair the levee slope damaged by vehicle traffic and prevent access where possible.					
Inspector Comment					
Repair tire rut damage on the LS shoulder.

View of the LS levee shoulder damaged by vehicle traffic. Spring 2021.

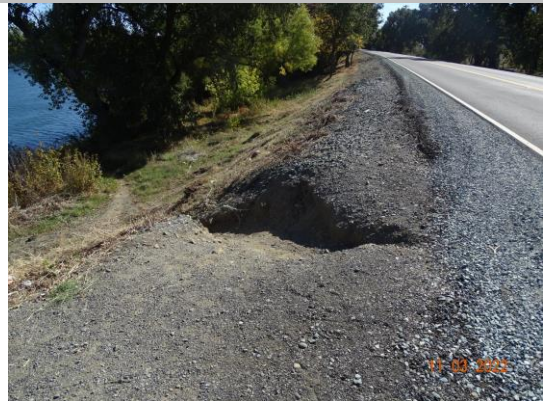
Photo 1 of 1 : SP\_2023\_RD0765\_211\_24\_20230306\_00011.jpg

LM Start	0.94	Rating **	U	Issue No.	24
LM End	0.94	Issue Type +	Ma	Location *	WS
Category	Earthen Levee			GPS Latitude/Longitude	
				Start	End
Item	Erosion / Foot Traffic			38.490265°	38.490265°
				-121.555617°	-121.555617°
DWR ID	DWR_RD0765_01_s_2019_24				
Comment Code					
E3 : Repair the levee slope damaged by foot traffic and prevent access where possible.					
Inspector Comment					
Erosion and footpath on the WS slope need to be repaired.

Erosion on the WS footpath. Fall 2022

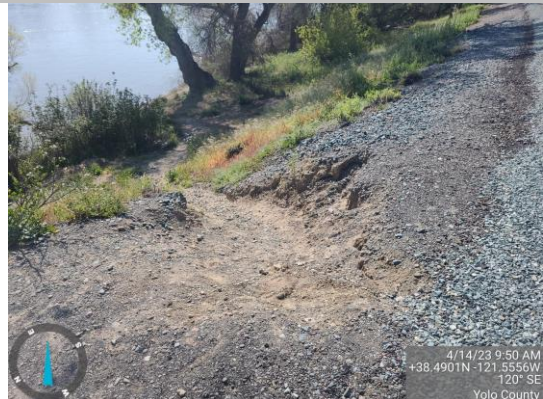
Photo 1 of 1 : SP\_2023\_RD0765\_211\_23\_20230418\_00026.jpg

LM Start	0.95	Rating **	U	Issue No.	23
LM End	0.95	Issue Type +	Ma	Location *	WS
Category	Earthen Levee			GPS Latitude/Longitude	
				Start	End
Item	Erosion / Foot Traffic			38.490067°	38.490067°
				-121.555530°	-121.555530°
DWR ID	DWR_RD0765_01_s_2019_23				
Comment Code					
E3 : Repair the levee slope damaged by foot traffic and prevent access where possible.					
Inspector Comment					
Repair the erosion at the footpath on the WS slope.

Erosion at the footpath on the WS slope. Spring 2023

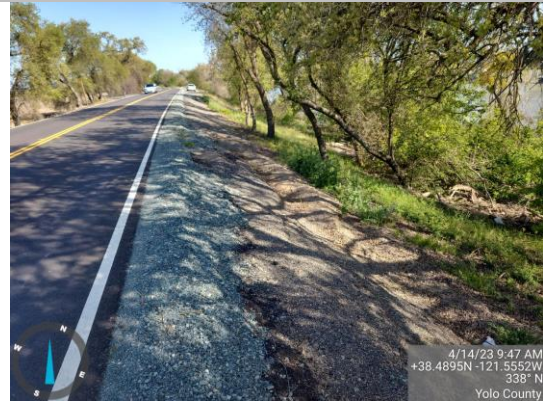
Photo 1 of 1 : SP\_2023\_RD0765\_211\_35\_20230418\_00027.jpg

LM Start	0.99	Rating **	M	Issue No.	35
LM End	0.99	Issue Type +	Ma	Location *	WS
Category	Earthen Levee			GPS Latitude/Longitude	
				Start	End
Item	Erosion / Vehicle Traffic			38.489574°	38.489574°
				-121.555308°	-121.555308°
DWR ID	DWR_RD0765_01_s_2022_35				
Comment Code					
E6 : Repair the levee slope damaged by vehicle traffic and prevent access where possible.					
Inspector Comment					
Repair rutting on the waterside shoulder.

Rutting on the waterside shoulder. Spring 2023

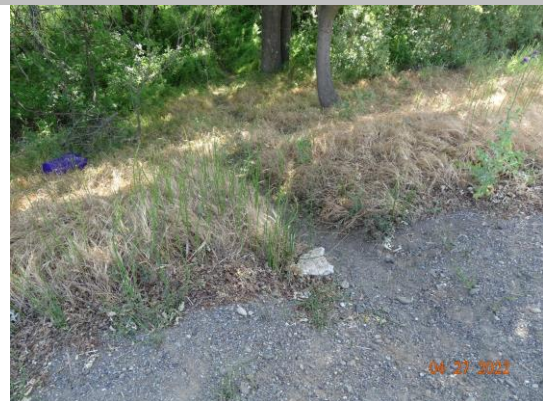
Photo 1 of 1 : SP\_2023\_RD0765\_211\_30\_20230306\_00013.jpg

LM Start	1.00	Rating **	A/W	Issue No.	30
LM End	1.00	Issue Type +	Ma	Location *	WS
Category	Earthen Levee			GPS Latitude/Longitude	
				Start	End
Item	Erosion / Foot Traffic			38.489503°	38.489503°
				-121.555272°	-121.555272°
DWR ID	DWR_RD0765_01_s_2022_30				
Comment Code					
E3 : Repair the levee slope damaged by foot traffic and prevent access where possible.					
Inspector Comment					
Monitor footpath for further erosion.

Footpath on the waterside slope. Spring 2022

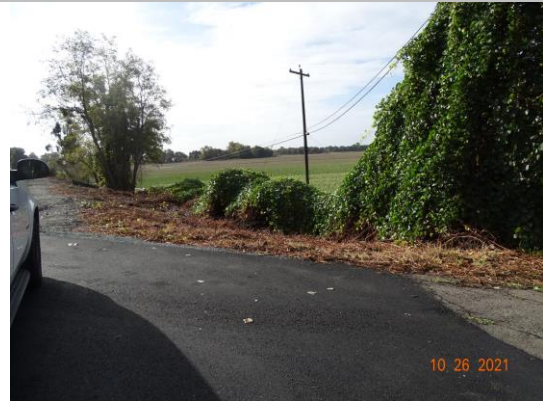
Photo 1 of 1 : SP\_2023\_RD0765\_211\_15\_20230306\_00006.jpg

LM Start	1.29	Rating **	U	Issue No.	15
LM End	1.30	Issue Type +	Ma	Location *	LS
Category	Earthen Levee			GPS Latitude/Longitude	
				Start	End
Item	Vegetation			38.485644°	38.485445°
				-121.553128°	-121.553014°
DWR ID	DWR_RD0765_01_s_2019_15				
Comment Code					
V2 : Remove the wild growth and woody vegetation other than native grasses from the levee slopes.					
Inspector Comment					
Remove wild vines and growth on the LS slope.

Ivy growth on the LS slope. Fall 2021

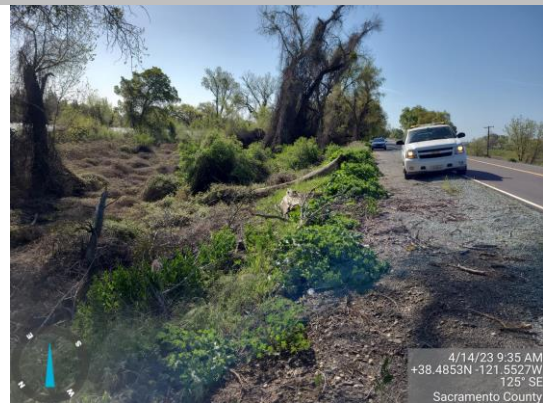
Photo 1 of 1 : SP\_2023\_RD0765\_211\_4\_20230418\_00031.jpg

LM Start	1.33	Rating **	U	Issue No.	4
LM End	1.33	Issue Type +	Ma	Location *	WS
Category	Earthen Levee			GPS Latitude/Longitude	
				Start	End
Item	Trim / Thin Trees			38.485062°	38.485062°
				-121.552635°	-121.552635°
DWR ID	DWR_RD0765_01_s_2023_4				
Comment Code					
T2 : Tree or limb.					
Inspector Comment					
Remove logs and limbs from WS slope within 20' of the crown.

Logs on the WS slope. Spring 2023

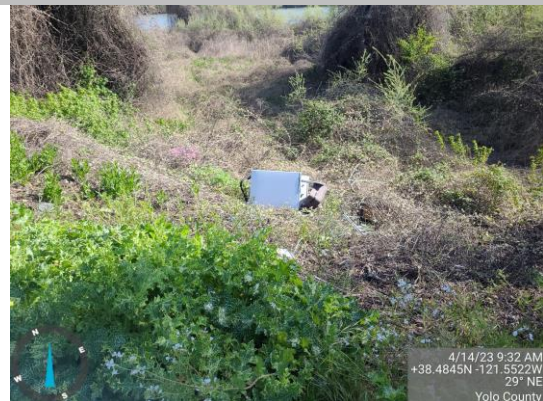
Photo 1 of 1 : SP\_2023\_RD0765\_211\_3\_20230418\_00032.jpg

LM Start	1.38	Rating **	M	Issue No.	3
LM End	1.38	Issue Type +	Ma	Location *	WS
Category	Earthen Levee			GPS Latitude/Longitude	
				Start	End
Item	Encroachments			38.484507°	38.484507°
				-121.552229°	-121.552229°
DWR ID	DWR_RD0765_01_s_2023_3				
Comment Code					
GA : Garbage					
Inspector Comment					
Remove appliance from WS slope.

Appliance on the WS slope. Spring 2023

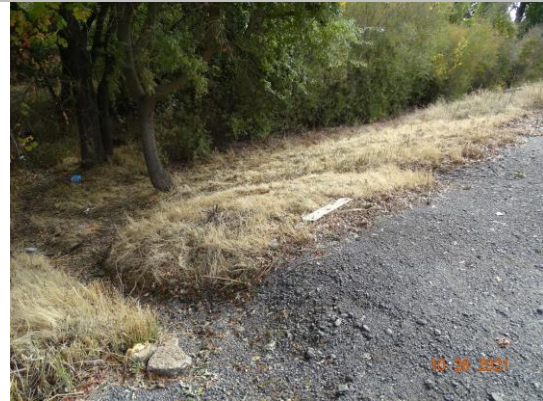
Photo 1 of 1 : SP\_2023\_RD0765\_211\_10\_20230306\_00002.jpg

LM Start	1.42	Rating **	A/W	Issue No.	10
LM End	1.42	Issue Type +	Ma	Location *	WS
Category	Earthen Levee			GPS Latitude/Longitude	
				Start	End
Item	Erosion / Foot Traffic			38.483973°	38.483973°
				-121.551855°	-121.551855°
DWR ID	DWR_RD0765_01_f_2021_10				
Comment Code					
E3 : Repair the levee slope damaged by foot traffic and prevent access where possible.					
Inspector Comment					
Monitor two footpaths for erosion.

Footpaths on the WS slope. Fall 2021

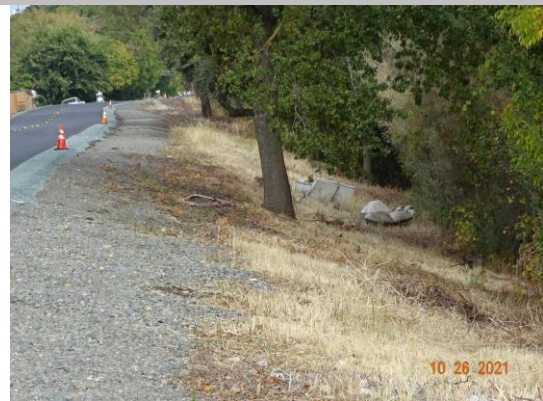
Photo 1 of 1 : SP\_2023\_RD0765\_211\_67\_20230306\_00023.jpg

LM Start	1.43	Rating **	M	Issue No.	67
LM End	1.43	Issue Type +	Ma	Location *	WS
Category	Earthen Levee			GPS Latitude/Longitude	
				Start	End
Item	Encroachments			38.483810°	38.483810°
				-121.551747°	-121.551747°
DWR ID	DWR_RD0765_01_s_2017_67				
Comment Code					
GA : Garbage					
Inspector Comment					
Remove sofas dumped on waterside slope.

Sofas on the WS slope. Fall 2021

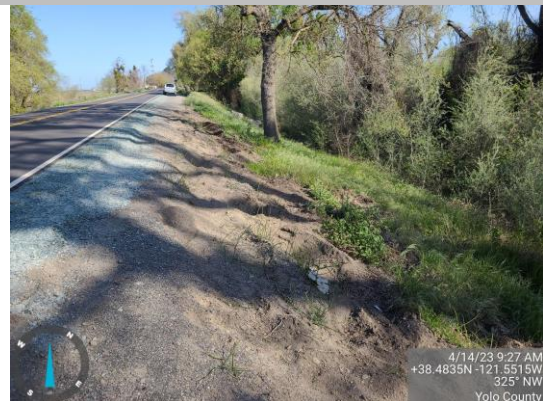
Photo 1 of 1 : SP\_2023\_RD0765\_211\_2\_20230418\_00033.jpg

LM Start	1.46	Rating **	M	Issue No.	2
LM End	1.46	Issue Type +	Ma	Location *	WS
Category	Earthen Levee			GPS Latitude/Longitude	
				Start	End
Item	Erosion / Vehicle Traffic			38.483414°	38.483414°
				-121.551472°	-121.551472°
DWR ID	DWR_RD0765_01_s_2023_2				
Comment Code					
E6 : Repair the levee slope damaged by vehicle traffic and prevent access where possible.					
Inspector Comment					
Repair rutting on the WS shoulder.

Rutting on the WS shoulder. Spring 2023

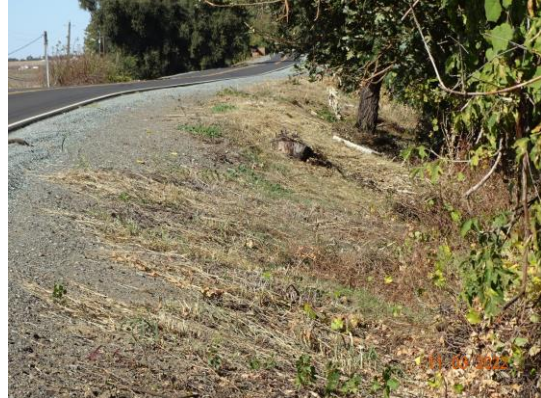
Photo 1 of 1 : SP\_2023\_RD0765\_211\_9\_20230306\_00001.jpg

LM Start	1.61	Rating **	N	Issue No.	9
LM End	1.61	Issue Type +	Ma	Location *	WS
Category	Earthen Levee			GPS Latitude/Longitude	
				Start	End
Item	Trim / Thin Trees			38.481560°	38.481560°
				-121.550295°	-121.550295°
DWR ID	DWR_RD0765_01_s_2020_9				
Comment Code					
T5 : Tree stumps.					
Inspector Comment					
Remove stump on the WS slope.

Tree stump on the WS slope. Fall 2022
