**Flood Control Project Maintenance
Levee Inspections**

Maintenance Issue Types Only, Levee Inspection Report By Mile - Spring 2024

Reclamation District No. 0765 Glide

Waterway	Bank	Unit Miles	Inspection Start/End	Inspector
Unit No. 01 Sacramento River	Right	1.72	03/19/2024 03/19/2024	Marvin Marshall

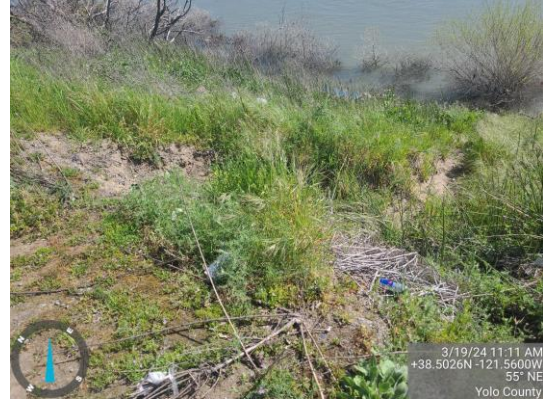
Photo 1 of 1 : SP_2024_RD0765_211_20_20240319_00021.jpg

LM Start	0.02	Rating **	U	Issue No.	20
LM End	0.02	Issue Type +	Ma	Location *	WS
Category	Earthen Levee			GPS Latitude/Longitude	
				Start	End
Item	Erosion / Foot Traffic			38.502711°	38.502711°
				-121.560019°	-121.560019°
DWR ID	DWR_RD0765_01_f _ 2023_20				
Comment Code					
E3 : Repair the levee slope damaged by foot traffic and prevent access where possible.					
Inspector Comment					
Repair erosion caused by foot traffic.

Footpath on the WS slope. Spring 2024

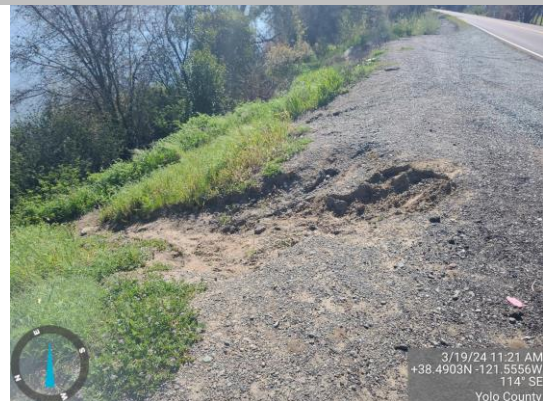
Photo 1 of 1 : SP_2024_RD0765_211_24_20240319_00022.jpg

LM Start	0.94	Rating **	U	Issue No.	24
LM End	0.94	Issue Type +	Ma	Location *	WS
Category	Earthen Levee			GPS Latitude/Longitude	
				Start	End
Item	Erosion / Foot Traffic			38.490265°	38.490265°
				-121.555617°	-121.555617°
DWR ID	DWR_RD0765_01_s_2019_24				
Comment Code					
E3 : Repair the levee slope damaged by foot traffic and prevent access where possible.					
Inspector Comment					
Erosion and footpath on the WS slope need to be repaired.

Erosion on the WS footpath. Spring 2024

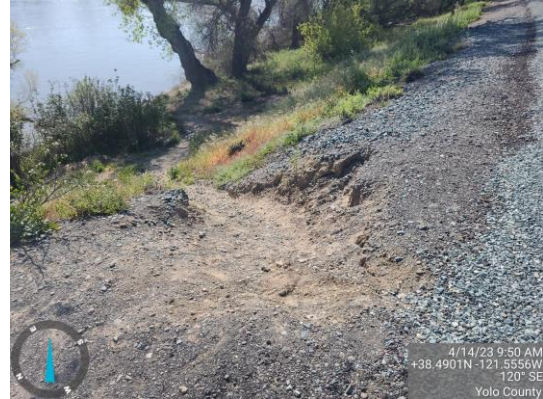
Photo 1 of 1 : SP_2024_RD0765_211_23_20240212_00012.jpg

LM Start	0.95	Rating **	U	Issue No.	23
LM End	0.95	Issue Type +	Ma	Location *	WS
Category	Earthen Levee			GPS Latitude/Longitude	
				Start	End
Item	Erosion / Foot Traffic			38.490067°	38.490067°
				-121.555530°	-121.555530°
DWR ID	DWR_RD0765_01_s_2019_23				
Comment Code					
E3 : Repair the levee slope damaged by foot traffic and prevent access where possible.					
Inspector Comment					
Repair the erosion at the footpath on the WS slope.

Erosion at the footpath on the WS slope. Spring 2023

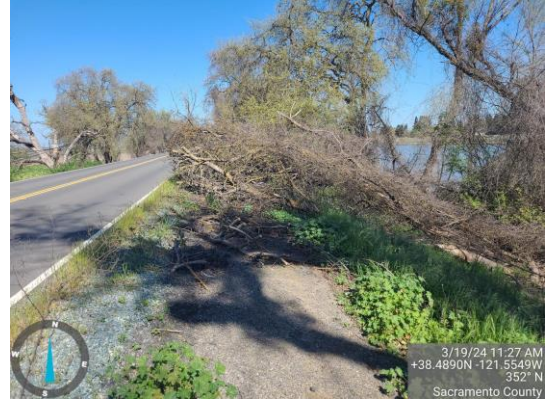
Photo 1 of 1 : SP_2024_RD0765_211_3_20240319_00019.jpg

LM Start	1.04	Rating **	U	Issue No.	3
LM End	1.04	Issue Type +	Ma	Location *	WS
Category	Earthen Levee			GPS Latitude/Longitude	
				Start	End
Item	Trim / Thin Trees			38.489000°	38.489000°
				-121.554900°	-121.554900°
DWR ID	DWR_RD0765_01_s_2024_3				
Comment Code					
T2 : Tree or limb.					
Inspector Comment					
Remove tree and limbs from WS slope.

Tree and limbs on WS slope. Spring 2024

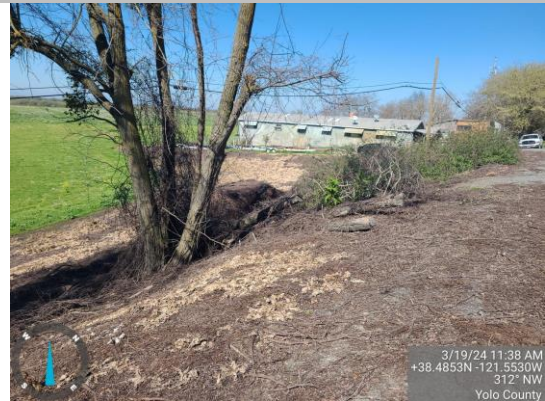
Photo 1 of 1 : SP_2024_RD0765_211_15_20240325_00024.jpg

LM Start	1.31	Rating **	M	Issue No.	15
LM End	1.31	Issue Type +	Ma	Location *	LS
Category	Earthen Levee			GPS Latitude/Longitude	
				Start	End
Item	Trim / Thin Trees			38.485300°	38.485300°
				-121.553000°	-121.553000°
DWR ID	DWR_RD0765_01_s_2019_15				
Comment Code					
T2 : Tree or limb.					
Inspector Comment					
Remove fallen limbs from levee slope.

Fellen tree on LS slope. Spring 2024

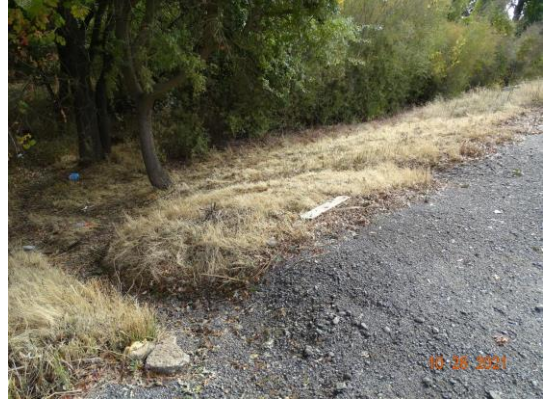
Photo 1 of 1 : SP_2024_RD0765_211_10_20240212_00005.jpg

LM Start	1.42	Rating **	A/W	Issue No.	10
LM End	1.42	Issue Type +	Ma	Location *	WS
Category	Earthen Levee			GPS Latitude/Longitude	
				Start	End
Item	Erosion / Foot Traffic			38.483973°	38.483973°
				-121.551855°	-121.551855°
DWR ID	DWR_RD0765_01_f _ 2021_10				
Comment Code					
E3 : Repair the levee slope damaged by foot traffic and prevent access where possible.					
Inspector Comment					
Monitor two footpaths for erosion.

Footpaths on the WS slope. Fall 2021

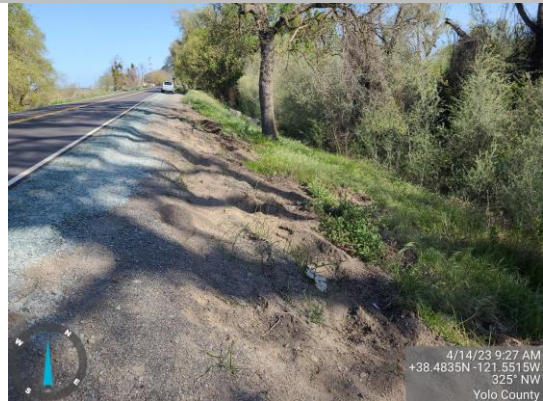
Photo 1 of 1 : SP_2024_RD0765_211_2_20240212_00002.jpg

LM Start	1.46	Rating **	M	Issue No.	2
LM End	1.46	Issue Type +	Ma	Location *	WS
Category	Earthen Levee			GPS Latitude/Longitude	
				Start	End
Item	Erosion / Vehicle Traffic			38.483414°	38.483414°
				-121.551472°	-121.551472°
DWR ID	DWR_RD0765_01_s_2023_2				
Comment Code					
E6 : Repair the levee slope damaged by vehicle traffic and prevent access where possible.					
Inspector Comment					
Repair rutting on the WS shoulder.

Rutting on the WS shoulder. Spring 2023

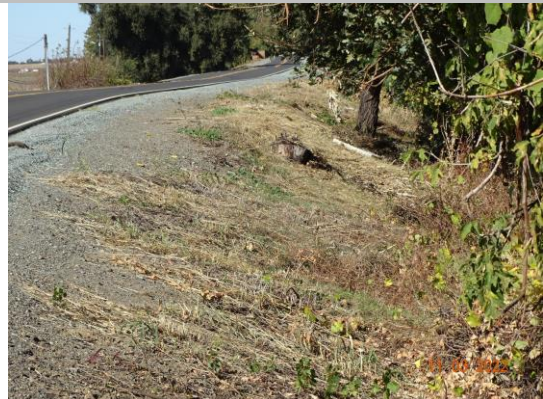
Photo 1 of 1 : SP_2024_RD0765_211_9_20240212_00004.jpg

LM Start	1.61	Rating **	N	Issue No.	9
LM End	1.61	Issue Type +	Ma	Location *	WS
Category	Earthen Levee			GPS Latitude/Longitude	
				Start	End
Item	Trim / Thin Trees			38.481560°	38.481560°
				-121.550295°	-121.550295°
DWR ID	DWR_RD0765_01_s_2020_9				
Comment Code					
T5 : Tree stumps.					
Inspector Comment					
Remove stump on the WS slope.

Tree stump on the WS slope. Fall 2022

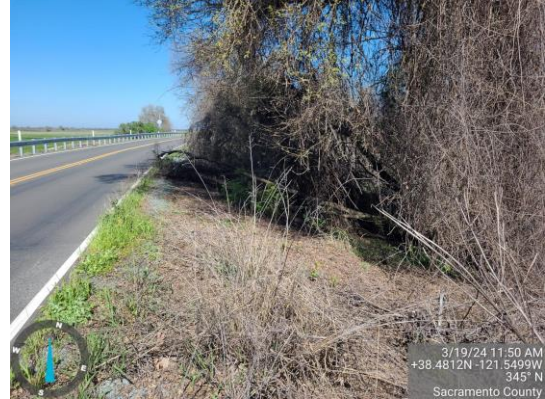
Photo 1 of 1 : SP_2024_RD0765_211_1_20240319_00023.jpg

LM Start	1.64	Rating **	M	Issue No.	1
LM End	1.64	Issue Type +	Ma	Location *	WS
Category	Earthen Levee			GPS Latitude/Longitude	
				Start	End
Item	Vegetation			38.481151°	38.481151°
				-121.549866°	-121.549866°
DWR ID	DWR_RD0765_01_s_2023_1				
Comment Code					
V2 : Remove the wild growth and woody vegetation other than native grasses from the levee slopes.					
Inspector Comment					
Remove woody vegetation from within 20' of the crown. Trim trees to 5' above grade.

Limbs and woody growth on the WS slope. Spring 2023
