**Flood Control Project Maintenance
Levee Inspections**

Fall 2011 Levee Maintenance Deficiency Summary Report

Reclamation District No. 0784 Plumas Lake

Levee Inspection Report By Mile - Fall 2011

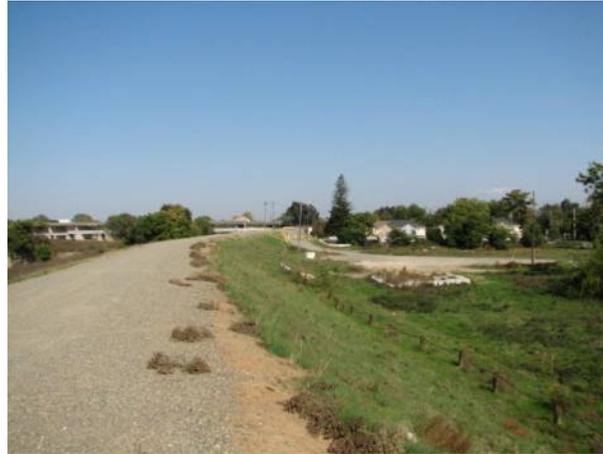
Levee Mile Report Line	1
Start Levee Mile	0.00
End Levee Mile	2.19
Location	Land Side
Category	Earthen Levee
Item	Vegetation

This photo shows the landside vegetation at levee mile 2.20.

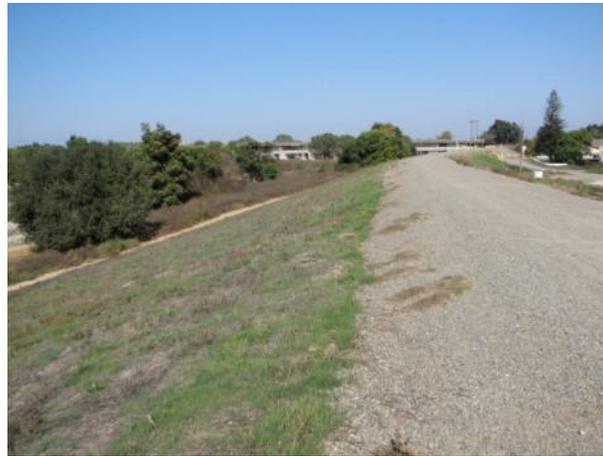
Levee Mile Report Line	2
Start Levee Mile	0.00
End Levee Mile	2.19
Location	Water Side
Category	Earthen Levee
Item	Vegetation

This photo shows the waterside vegetation at levee mile 2.20.

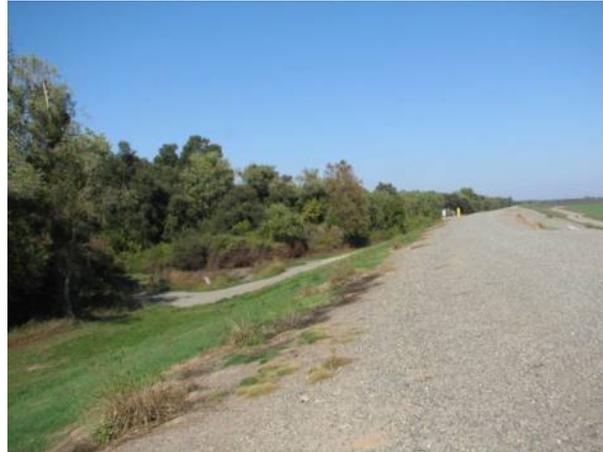
This photo shows the waterside vegetation at levee mile 12.77, looking upstream.

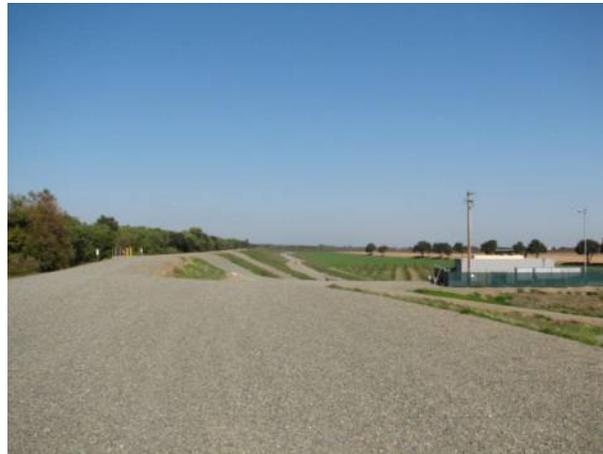
Levee Mile Report Line	2
Start Levee Mile	0.06
End Levee Mile	12.77
Location	Land Side
Category	Earthen Levee
Item	Vegetation

This photo shows the landside vegetation at levee mile 12.77, looking upstream.

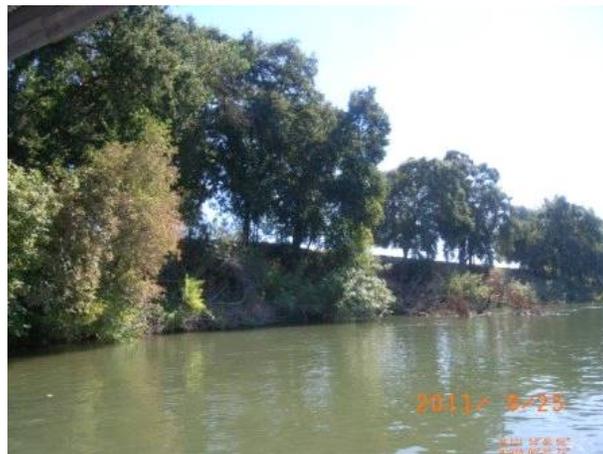
USACE 2011 Photo #1

Levee Mile Report Line	3
Start Levee Mile	8.90
End Levee Mile	9.23
Location	Water Side
Category	Supplemental
Item	USACE Erosion Survey

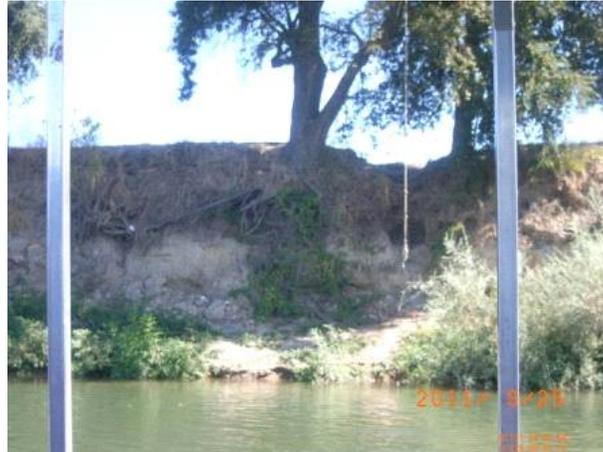
Levee Mile Report Line	3
Start Levee Mile	8.90
End Levee Mile	9.23
Location	Water Side
Category	Supplemental
Item	USACE Erosion Survey
USACE 2011 Photo #2	
USACE2011_FHR_17-8_L_2.jpg

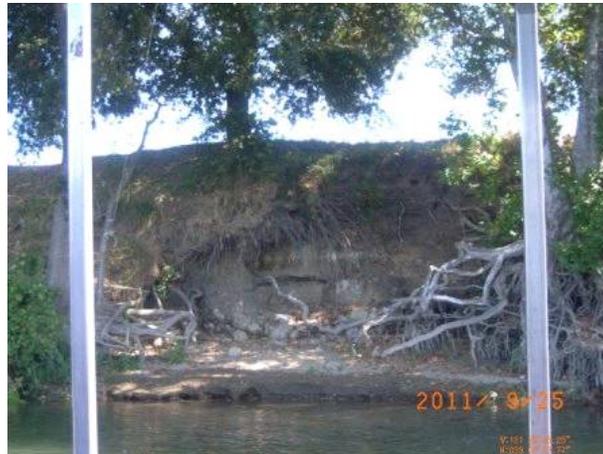
Levee Mile Report Line	3
Start Levee Mile	8.90
End Levee Mile	9.23
Location	Water Side
Category	Supplemental
Item	USACE Erosion Survey
USACE 2011 Photo #3	
USACE2011_FHR_17-8_L_3.jpg

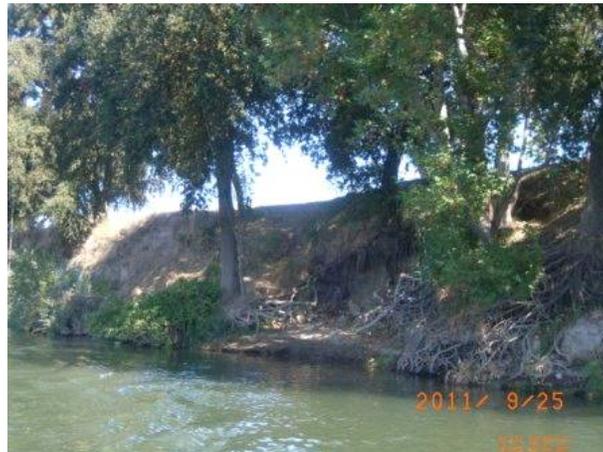
Levee Mile Report Line	3
Start Levee Mile	8.90
End Levee Mile	9.23
Location	Water Side
Category	Supplemental
Item	USACE Erosion Survey
USACE 2011 Photo #4	
USACE2011_FHR_17-8_L_4.jpg

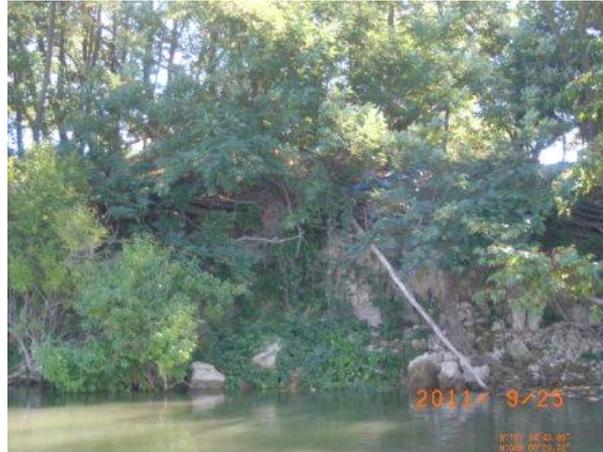
Levee Mile Report Line	3
Start Levee Mile	8.90
End Levee Mile	9.23
Location	Water Side
Category	Supplemental
Item	USACE Erosion Survey
USACE 2011 Photo #5	
USACE2011_FHR_17-8_L_5.jpg

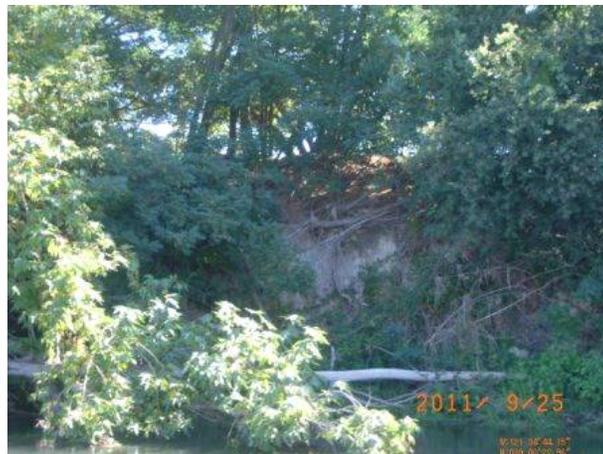
Levee Mile Report Line	3
Start Levee Mile	8.90
End Levee Mile	9.23
Location	Water Side
Category	Supplemental
Item	USACE Erosion Survey
USACE 2011 Photo #6	
USACE2011_FHR_17-8_L_6.jpg

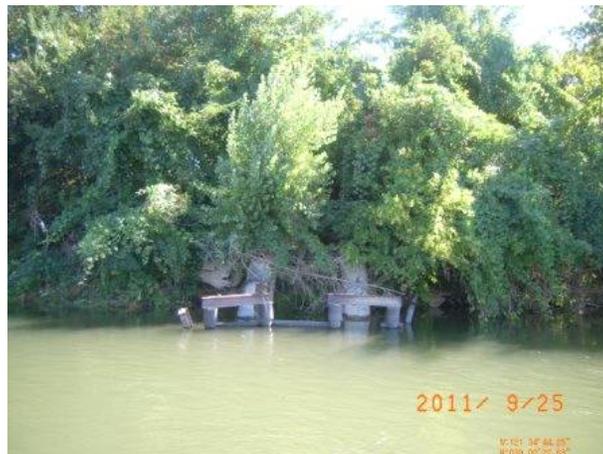
Levee Mile Report Line	3
Start Levee Mile	8.90
End Levee Mile	9.23
Location	Water Side
Category	Supplemental
Item	USACE Erosion Survey
USACE 2011 Photo #7	
USACE2011_FHR_17-8_L_7.jpg

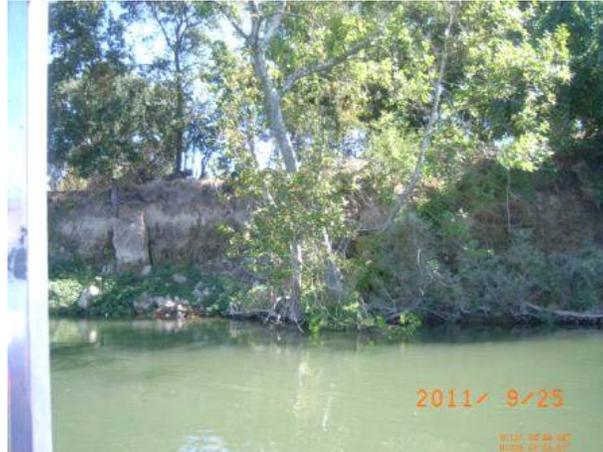
Levee Mile Report Line	3
Start Levee Mile	8.90
End Levee Mile	9.23
Location	Water Side
Category	Supplemental
Item	USACE Erosion Survey
USACE 2011 Photo #8	
USACE2011_FHR_17-8_L_8.jpg

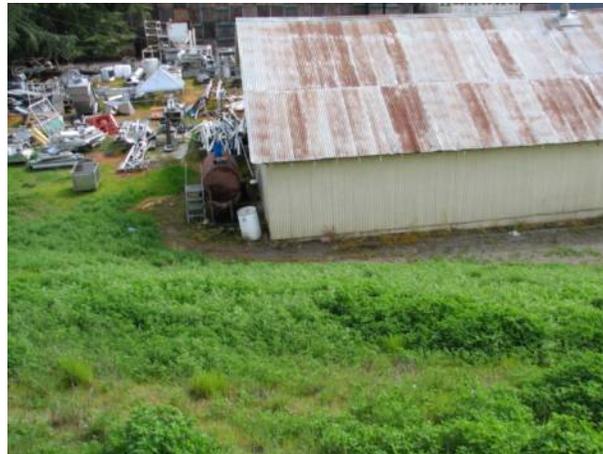
Levee Mile Report Line	4
Start Levee Mile	9.40
End Levee Mile	9.40
Location	Land Side
Category	Earthen Levee
Item	Encroachments
Levee mile 9.40, looking at a building that is encroaching on the levee toe.	
cathom_f_20110929_138.jpg

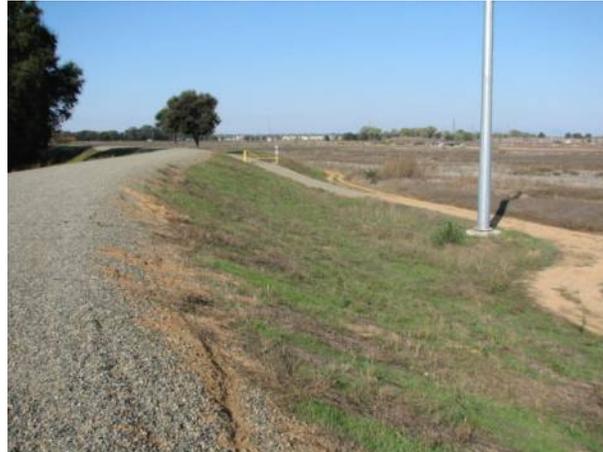
This photo shows the landside vegetation at levee mile 3.19, looking downstream.

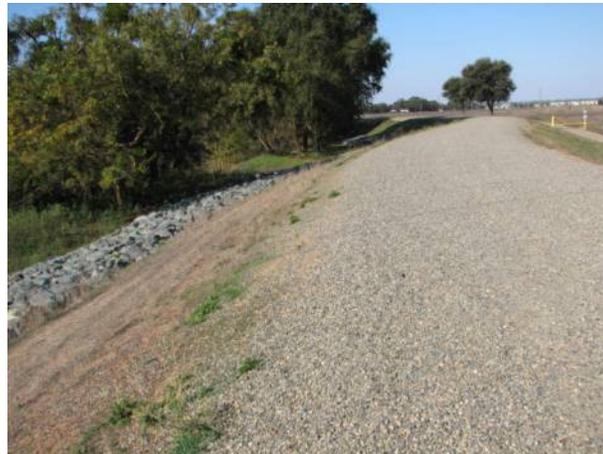
Levee Mile Report Line	2
Start Levee Mile	2.46
End Levee Mile	4.70
Location	Water Side
Category	Earthen Levee
Item	Vegetation

This photo shows the waterside vegetation at levee mile 3.19, looking downstream.

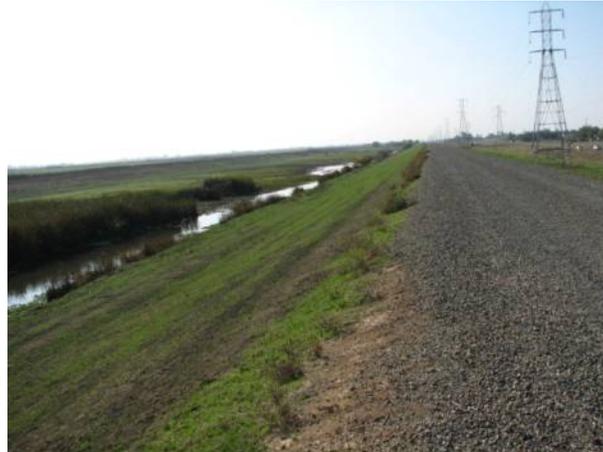
Levee Mile Report Line	1
Start Levee Mile	0.02
End Levee Mile	6.34
Location	Water Side
Category	Earthen Levee
Item	Vegetation
<p>This photo shows the waterside vegetation at levee mile 4.82, looking downstream.</p>	
<p>cathom_f_20111031_971.jpg</p>

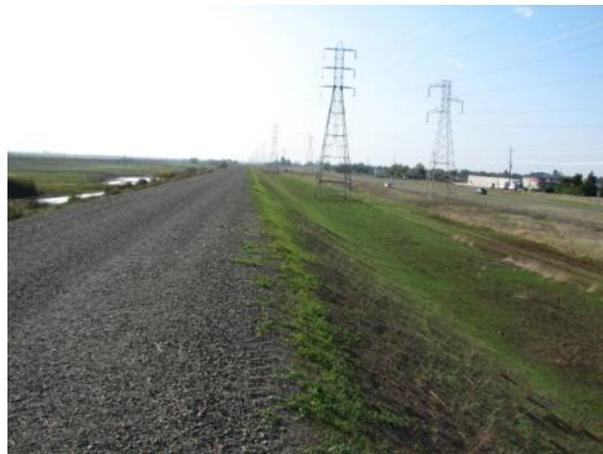
Levee Mile Report Line	2
Start Levee Mile	0.02
End Levee Mile	6.34
Location	Land Side
Category	Earthen Levee
Item	Vegetation
<p>This photo shows the landside vegetation at levee mile 4.82, looking downstream.</p>	
<p>cathom_f_20111031_970.jpg</p>

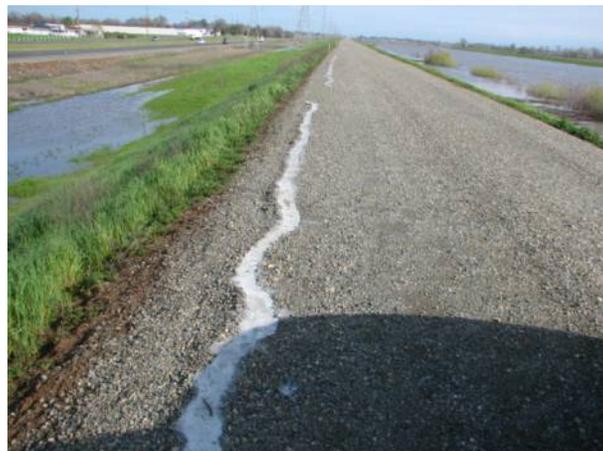
Levee Mile Report Line	3
Start Levee Mile	4.31
End Levee Mile	4.43
Location	Crown
Category	Earthen Levee
Item	Erosion / Bank Caving
<p>Levee mile 4.31, looking at a crack near the landside shoulder with a temporary repair.</p>	
<p>cathom_f_20110929_351.jpg</p>

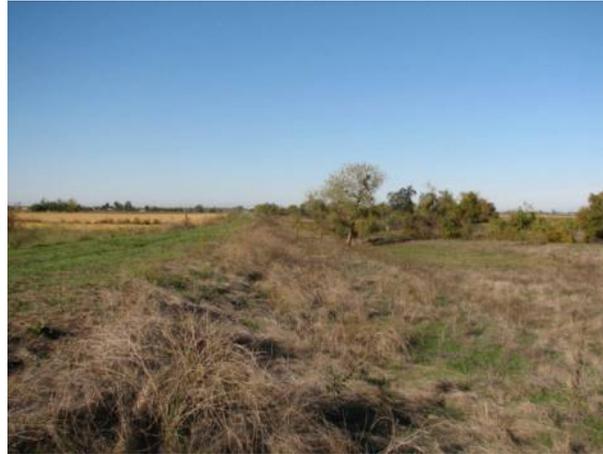
This photo shows the waterside vegetation at levee mile 4.20.

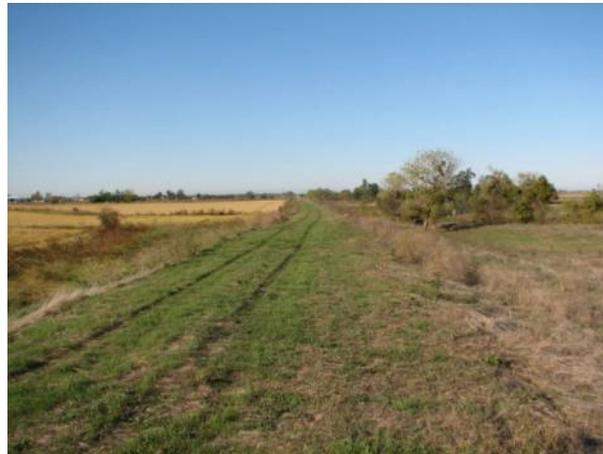
Levee Mile Report Line	6
Start Levee Mile	3.89
End Levee Mile	4.20
Location	Crown
Category	Earthen Levee
Item	Vegetation

This photo shows the crown vegetation at levee mile 4.20.

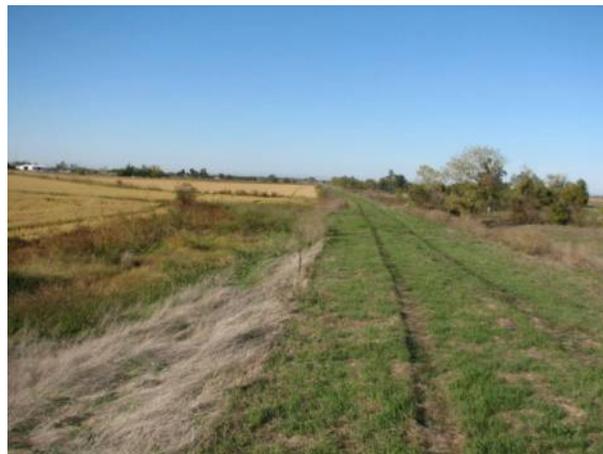
Levee Mile Report Line	7
Start Levee Mile	3.89
End Levee Mile	4.20
Location	Land Side
Category	Earthen Levee
Item	Vegetation

This photo shows the landside vegetation at levee mile 4.20.

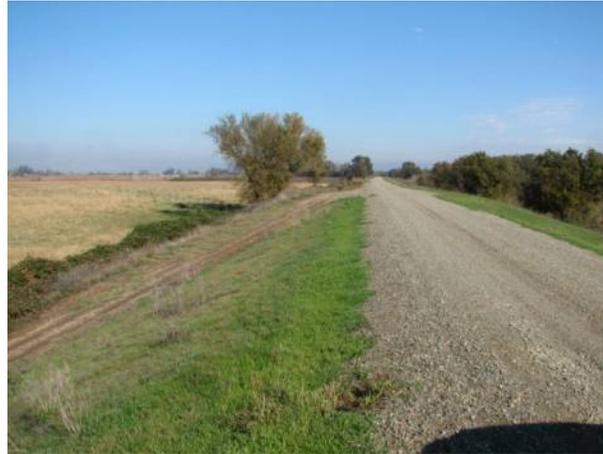
This photo shows the landside vegetation at levee mile 0.24.

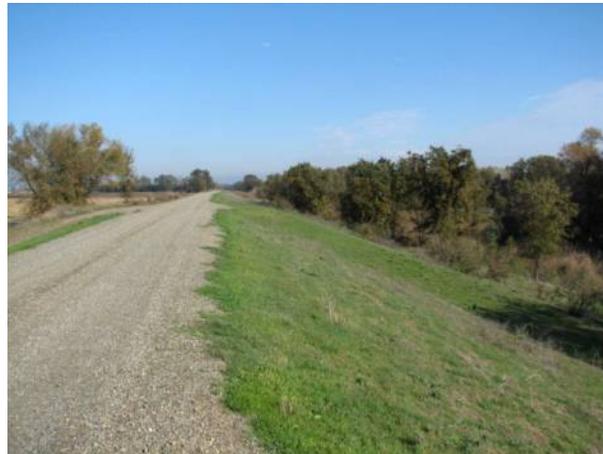
Levee Mile Report Line	2
Start Levee Mile	0.01
End Levee Mile	0.24
Location	Water Side
Category	Earthen Levee
Item	Vegetation

This photo shows the waterside vegetation at levee mile 0.24.

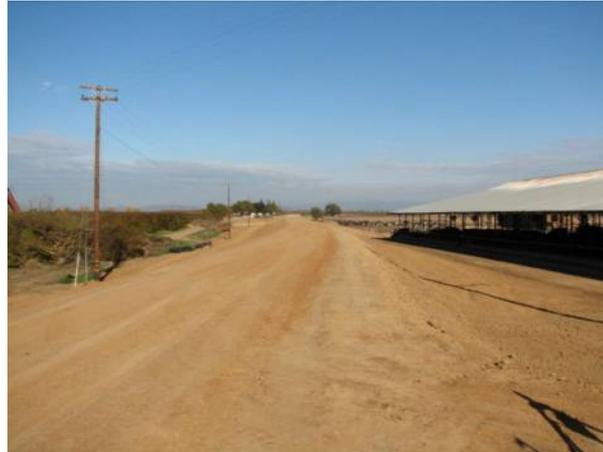
Levee Mile Report Line	1
Start Levee Mile	1.72
End Levee Mile	1.72
Location	Crown
Category	Earthen Levee
Item	Encroachments
This photo is looking upstream from levee mile 1.72.	
cathom_f_20111202_037.jpg

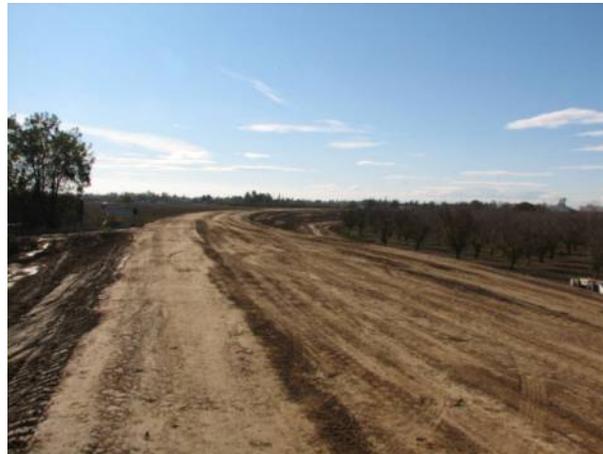
Levee Mile Report Line	1
Start Levee Mile	1.72
End Levee Mile	1.72
Location	Crown
Category	Earthen Levee
Item	Encroachments
This photo is looking downstream from levee mile 1.72.	
cathom_f_20111202_038.jpg

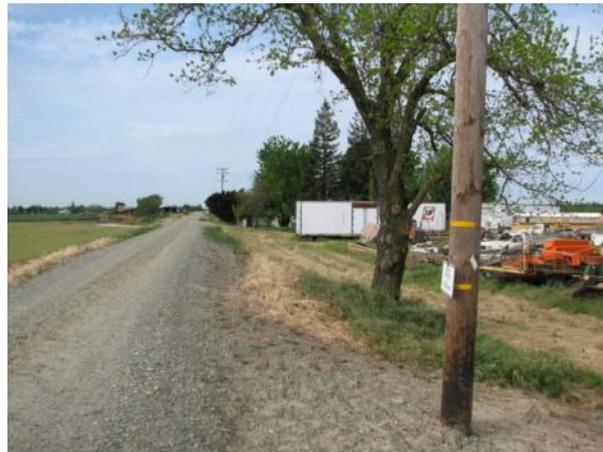
Levee Mile Report Line	2
Start Levee Mile	2.18
End Levee Mile	2.18
Location	Water Side
Category	Earthen Levee
Item	Encroachments
Water side buildings and equipment levee mile 2.18.	
cathom_f_20110929_679.jpg

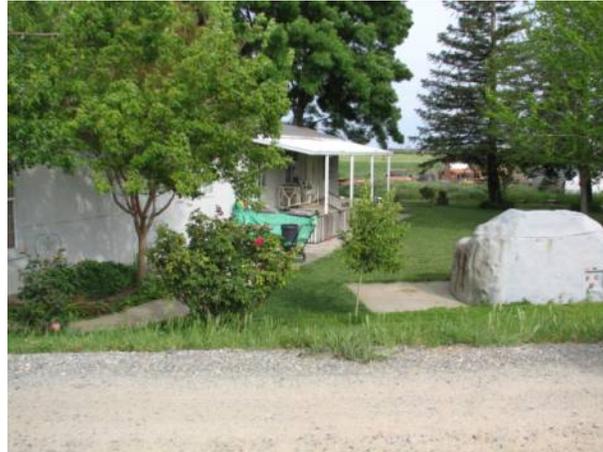
Levee Mile Report Line	2
Start Levee Mile	2.18
End Levee Mile	2.18
Location	Water Side
Category	Earthen Levee
Item	Encroachments
Water side buildings and equipment levee mile 2.18.	
cathom_f_20110929_680.jpg

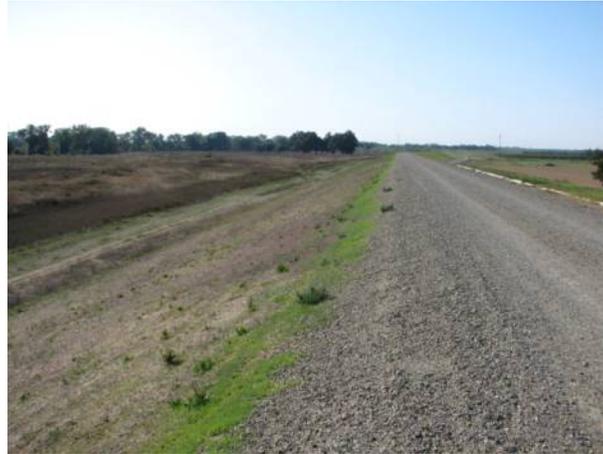
This photo shows the waterside vegetation at levee mile 1.85, looking downstream.

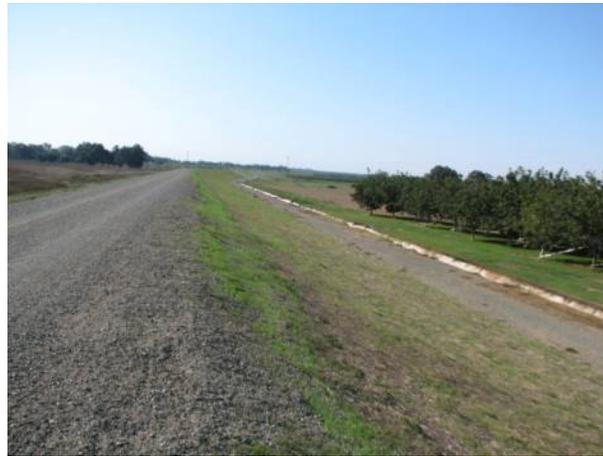
Levee Mile Report Line	2
Start Levee Mile	0.00
End Levee Mile	1.85
Location	Land Side
Category	Earthen Levee
Item	Vegetation

This photo shows the landside vegetation at levee mile 1.85, looking downstream.

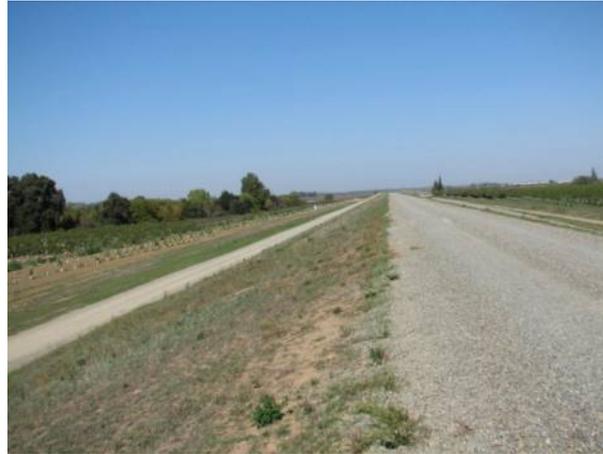
This photo shows the waterside vegetation at levee mile 4.00.

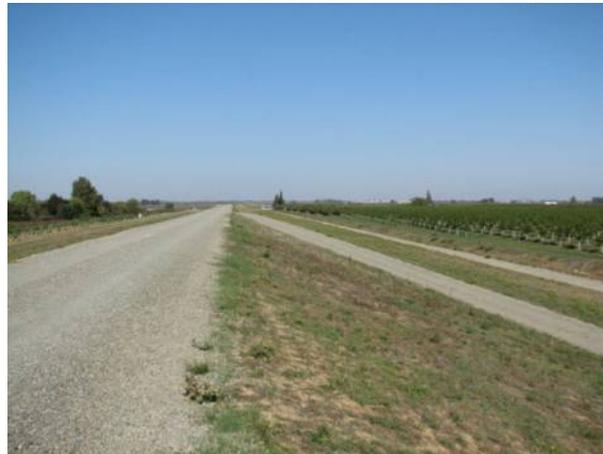
Levee Mile Report Line	2
Start Levee Mile	0.02
End Levee Mile	4.00
Location	Land Side
Category	Earthen Levee
Item	Vegetation

This photo shows the landside vegetation at levee mile 4.00.
