**Flood Control Project Maintenance  
Levee Inspections**

**Fall 2012 Levee Maintenance Deficiency Summary Report**

**Sacramento River Basin**

**Reclamation District No. 0784 Plumas Lake**

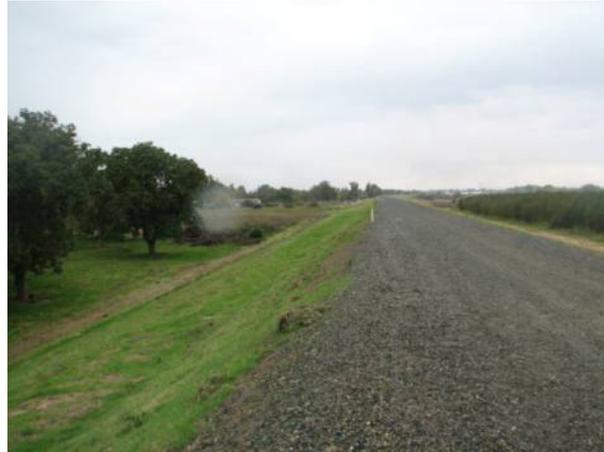
Levee Mile Report Line	4
Start Levee Mile	0.04
End Levee Mile	2.20
Location	Land Side
Category	Earthen Levee
Item	Vegetation
Levee mile 0.00, the landside levee slope.	
cathom_f_20121115_254.JPG

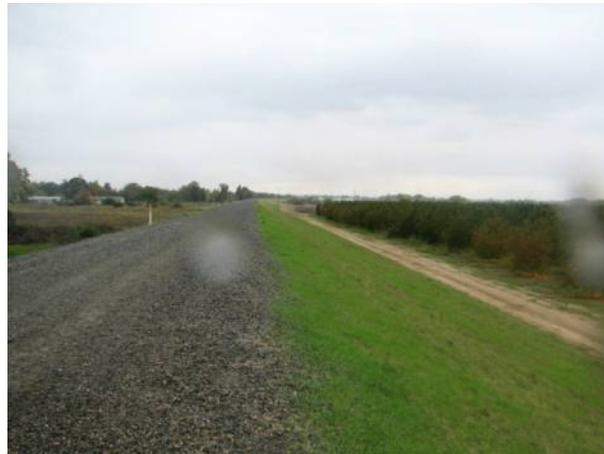
Levee Mile Report Line	5
Start Levee Mile	0.04
End Levee Mile	2.20
Location	Water Side
Category	Earthen Levee
Item	Vegetation
Levee mile 0.00, the waterside levee slope.	
cathom_f_20121115_255.JPG

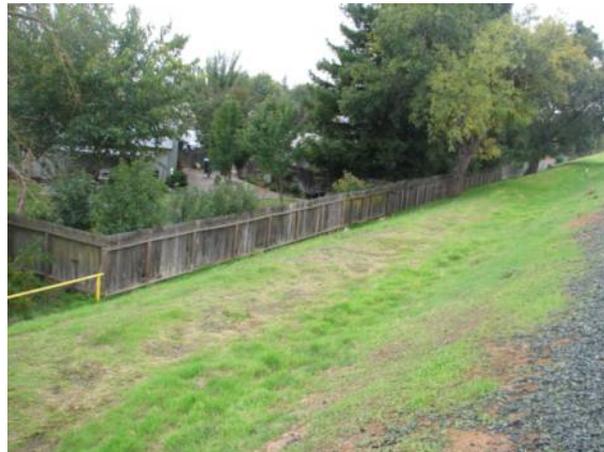
Levee Mile Report Line	7
Start Levee Mile	0.52
End Levee Mile	1.00
Location	Land Side
Category	Earthen Levee
Item	Encroachments
Levee mile 0.53-1.00, this photo shows the fences and other obstruction near the toe of the levee on the landside.	
cathom_f_20121115_256.JPG

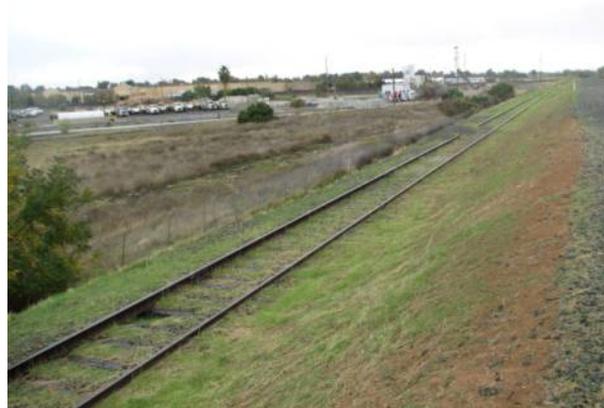
Levee Mile Report Line	8
Start Levee Mile	1.00
End Levee Mile	1.12
Location	Land Side
Category	Earthen Levee
Item	Encroachments
Levee mile 1.00-1.12, this photo shows a fence near the levee toe on the landside.	
cathom_f_20121115_257.JPG

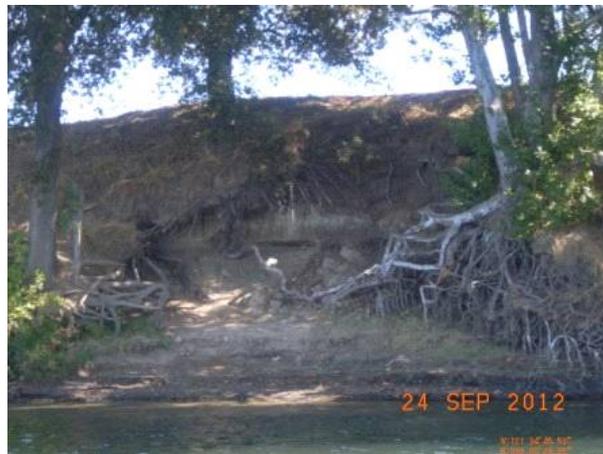
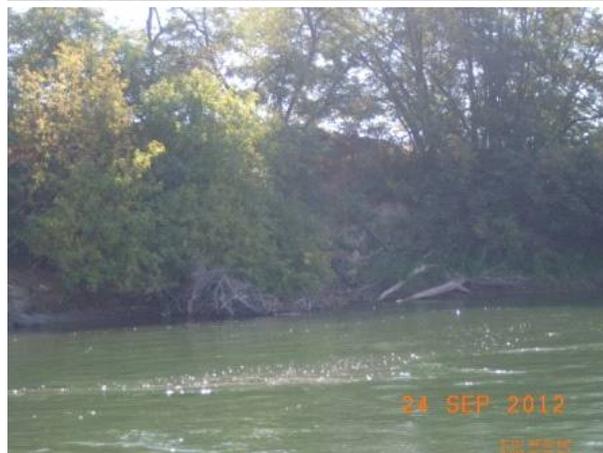
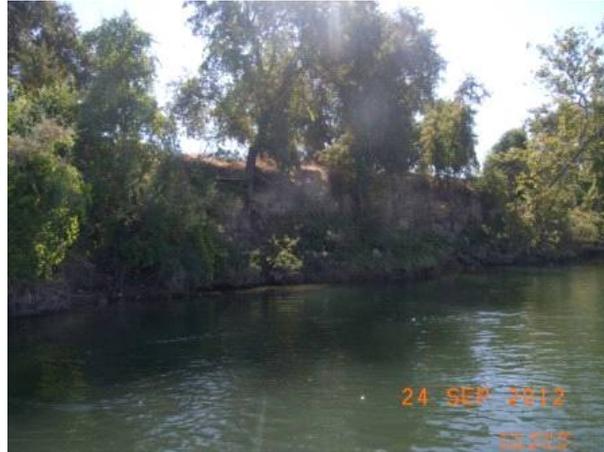
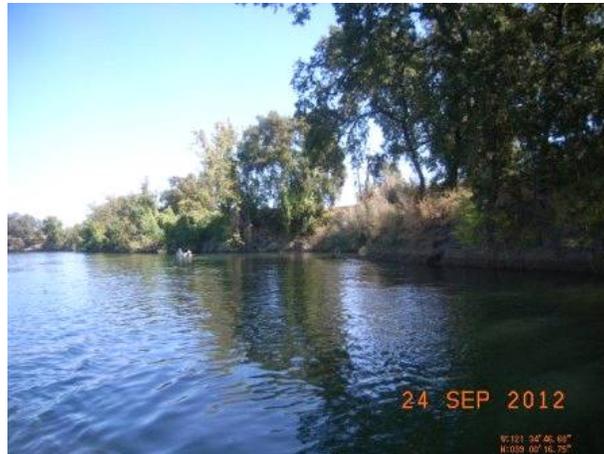
LMIR No.	Levee Mile		Category	Item	Location	Rating	Action/Comment	GPS Latitude/Longitude		Issue No. Photo
	Start	End						Start	End	
1	8.72	9.14	Supplemental	USACE Erosion Survey	WS	M Ma	Inspector Comments: 2003 - Bank is near vertical. Identified as a Potentially Critical site. 2004 - Eddy flow off downstream end of Modesto formation eroding the fluvial sediments. 2005 - Some new slumping. Actively eroding but berm width is greater than 50 ft. 2006 - Downgraded to regular erosion site. Still actively eroding. Large old rotational failures in high bank on the downstream end. 2008 - Removed from inventory due to wide berm width does not meet criteria for an erosion site. 2010 - Added back to the inventory after 10 ft of bank erosion in the winter 2009 storm. Steep vertical face. 2011 - Bank has retreated an additional 2.5 ft from last year. New tree popouts and erosion throughout the site. 2012: Site continues to worsen with new tree popouts and many areas of new erosion. [2012 Site ID: FHR_17-8_L]	39.009366 ° -121.579766 °	39.004549 ° -121.579143 °	2 Y

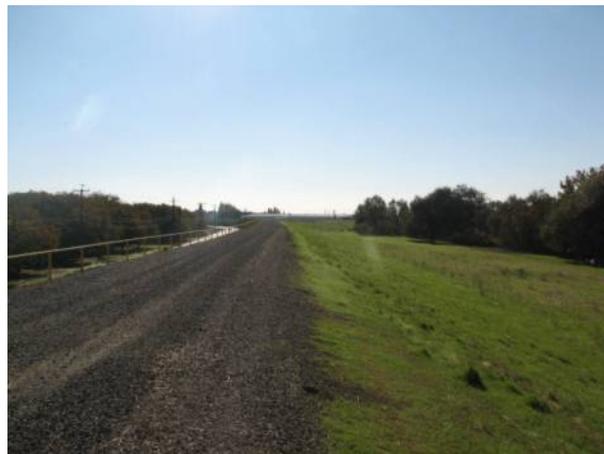
Levee Mile Report Line	2
Start Levee Mile	9.01
End Levee Mile	12.76
Location	Water Side
Category	Earthen Levee
Item	Vegetation
Levee mile 9.01, the waterside levee slope.	
cathom_f_20121115_258.JPG

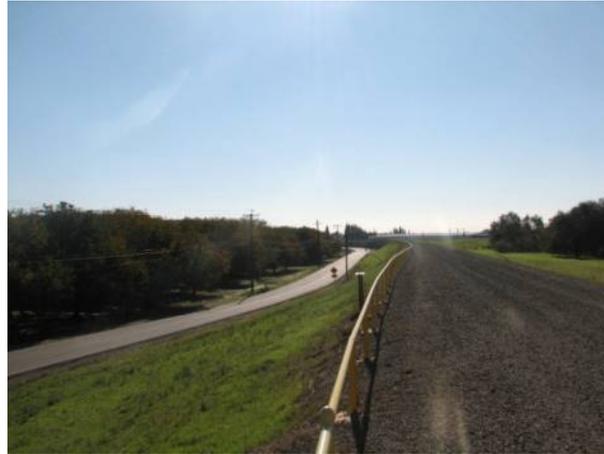
Levee mile 9.01, the landside levee slope.

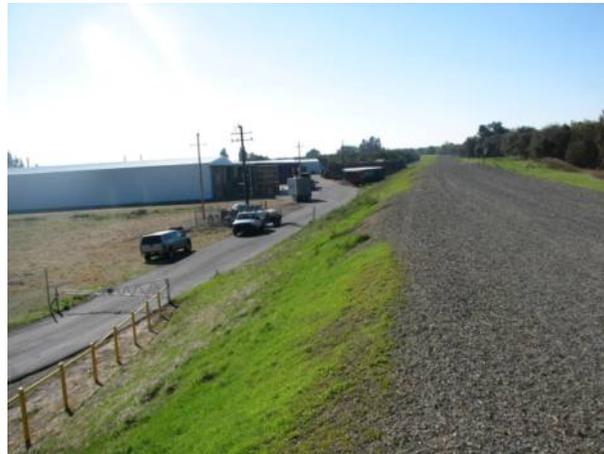
Levee Mile Report Line	4
Start Levee Mile	9.21
End Levee Mile	9.29
Location	Land Side
Category	Earthen Levee
Item	Encroachments

Levee mile 9.21, new paving near the levee toe, no permit found for this work.

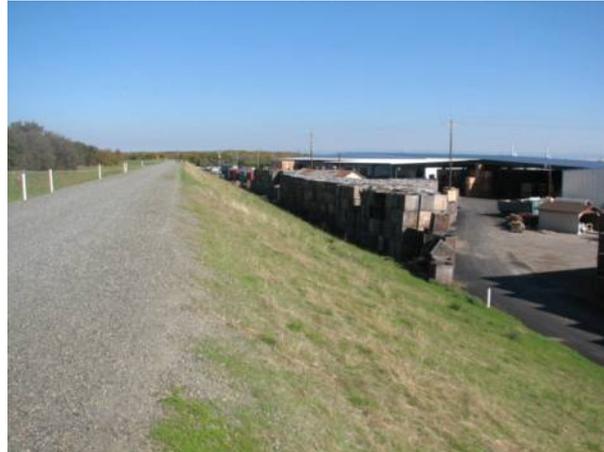
Levee Mile Report Line	5
Start Levee Mile	9.29
End Levee Mile	9.29
Location	Land Side
Category	Earthen Levee
Item	Encroachments
Levee mile 9.29, other material at or near the landside levee toe.	
cathom_f_20121115_262.JPG

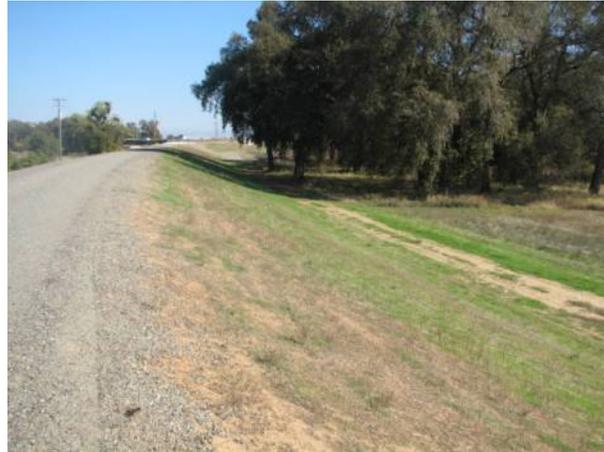
Levee Mile Report Line	1
Start Levee Mile	2.50
End Levee Mile	3.19
Location	Water Side
Category	Earthen Levee
Item	Vegetation
Levee mile 2.50, the waterside slope.	
cathom_f_20121115_263.JPG

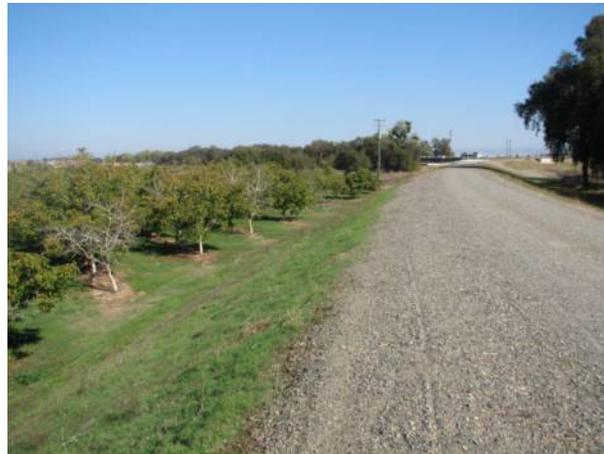
Levee Mile Report Line	2
Start Levee Mile	2.50
End Levee Mile	3.19
Location	Land Side
Category	Earthen Levee
Item	Vegetation
Levee mile 2.50, the landside levee slope.	
cathom_f_20121115_264.JPG

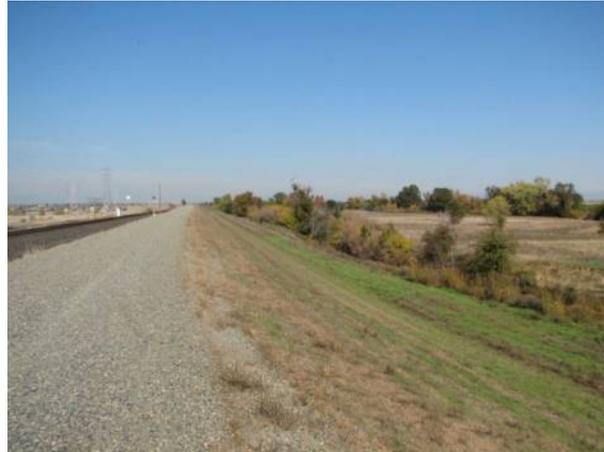
Levee Mile Report Line	1
Start Levee Mile	0.01
End Levee Mile	5.86
Location	Water Side
Category	Earthen Levee
Item	Vegetation
Levee mile 0.00, the waterside slope.	
cathom_f_20121115_265.JPG

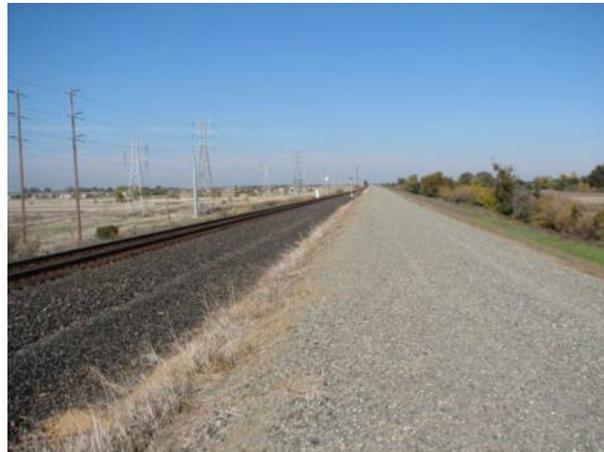
Levee Mile Report Line	2
Start Levee Mile	0.01
End Levee Mile	5.86
Location	Land Side
Category	Earthen Levee
Item	Vegetation
Levee mile 0.00, the landside slope.	
cathom_f_20121115_266.JPG

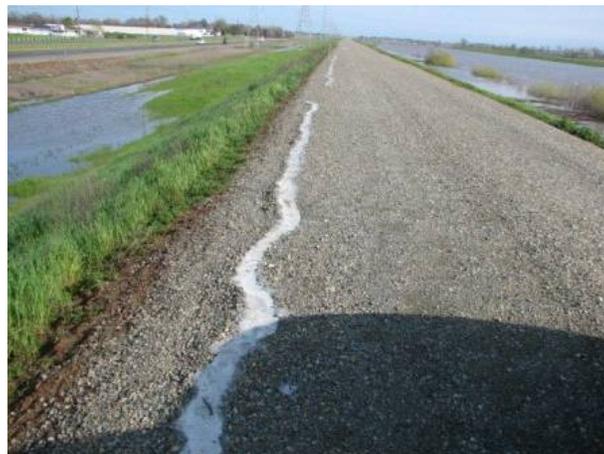
Levee Mile Report Line	3
Start Levee Mile	4.31
End Levee Mile	4.43
Location	Crown
Category	Earthen Levee
Item	Erosion / Bank Caving
Levee mile 4.31, looking at a crack near the landside shoulder with a temporary repair.	
cathom_f_20120912_054.jpg

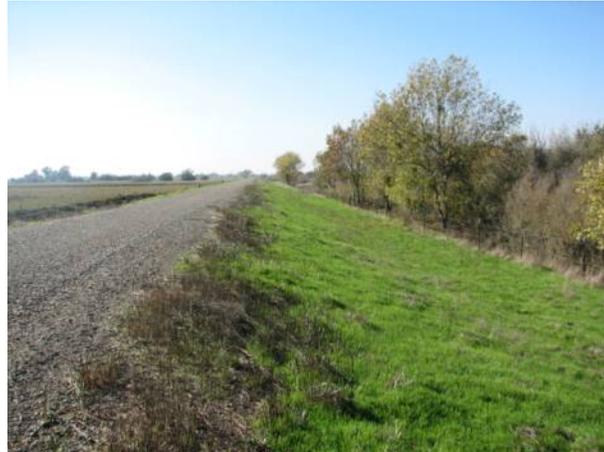
Levee Mile Report Line	1
Start Levee Mile	0.02
End Levee Mile	3.89
Location	Water Side
Category	Earthen Levee
Item	Vegetation
Levee mile 3.89, the waterside slope.	
cathom_f_20121115_267.JPG

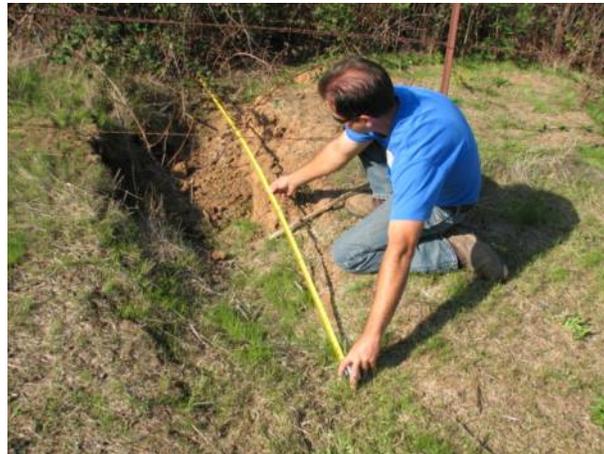
Levee Mile Report Line	6
Start Levee Mile	2.98
End Levee Mile	2.98
Location	Water Side
Category	Earthen Levee
Item	Erosion / Bank Caving
Levee mile 2.98, erosion near the waterside levee toe.	
cathom_f_20121115_268.JPG

DWR ID: DWR_RD0784_05_f_2012_7										
6	2.98	2.98	Earthen Levee	Erosion / Bank Caving	WS	M Ma	E2 : Schedule repair of erosion site prior to the next inspection.	39.014631 ° -121.529577 °	39.014631 ° -121.529577 °	3 Y
DWR ID: DWR_RD0784_05_f_2012_3										
7	3.89	4.20	Earthen Levee	Vegetation	WS	M Ma	V2 : Remove the wild growth other than native grasses from the levee slopes.	39.019567 ° -121.514560 °	39.020545 ° -121.509080 °	86 Y
DWR ID: DWR_RD0784_05_s_2012_86										
8	3.89	4.20	Earthen Levee	Vegetation	LS	M Ma	V2 : Remove the wild growth other than native grasses from the levee slopes.	39.019566 ° -121.514560 °	39.020545 ° -121.509078 °	83 Y
DWR ID: DWR_RD0784_05_s_2012_83

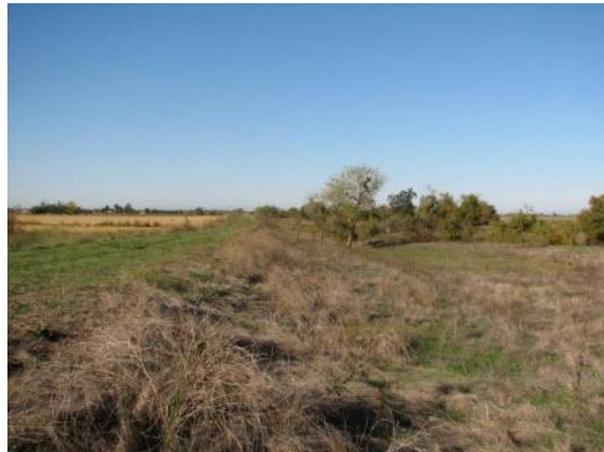
Levee Mile Report Line	7
Start Levee Mile	3.89
End Levee Mile	4.20
Location	Water Side
Category	Earthen Levee
Item	Vegetation
This photo shows the waterside vegetation at levee mile 4.20.	
cathom_f_20120912_058.jpg

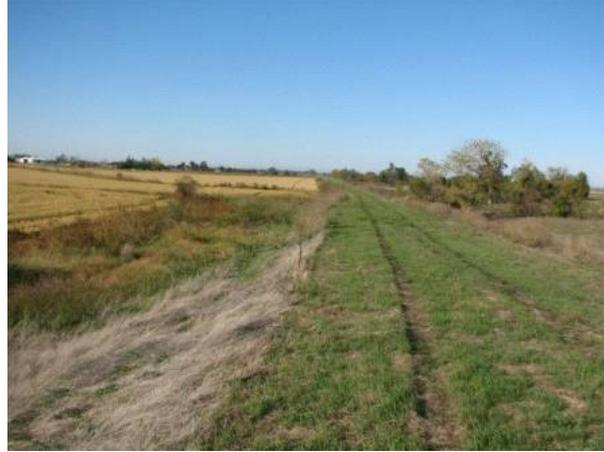
Levee Mile Report Line	8
Start Levee Mile	3.89
End Levee Mile	4.20
Location	Land Side
Category	Earthen Levee
Item	Vegetation
<p>This photo shows the landside vegetation at levee mile 4.20.</p>	
<p>cathom_f_20120912_057.jpg</p>

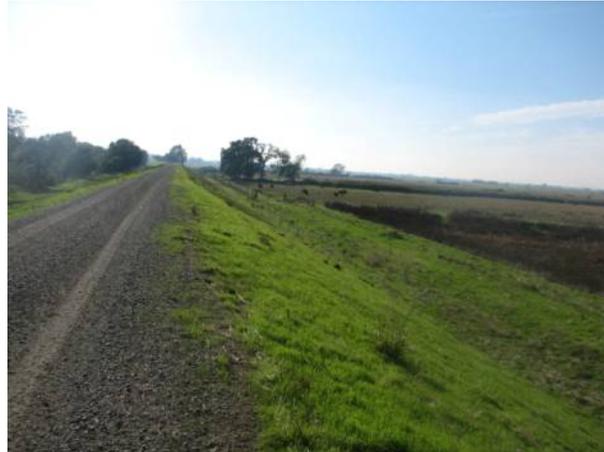
Levee Mile Report Line	1
Start Levee Mile	0.00
End Levee Mile	0.25
Location	Land Side
Category	Earthen Levee
Item	Vegetation
Levee mile 0.25 looking downstream at the landside slope.	
cathom_f_20121119_269.JPG

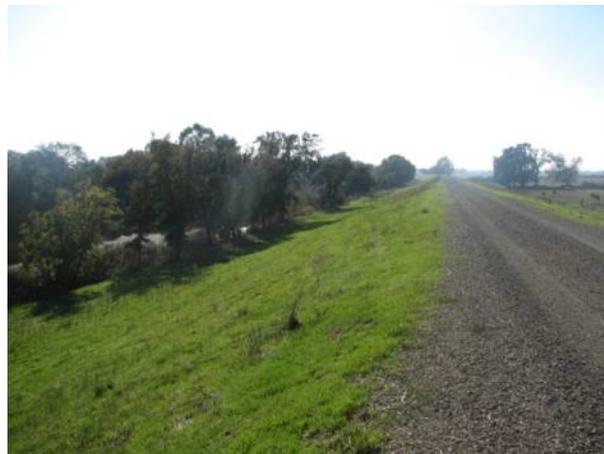
Levee Mile Report Line	2
Start Levee Mile	0.00
End Levee Mile	0.25
Location	Water Side
Category	Earthen Levee
Item	Vegetation
Levee mile 0.25 looking downstream at the waterside slope.	
cathom_f_20121119_270.JPG

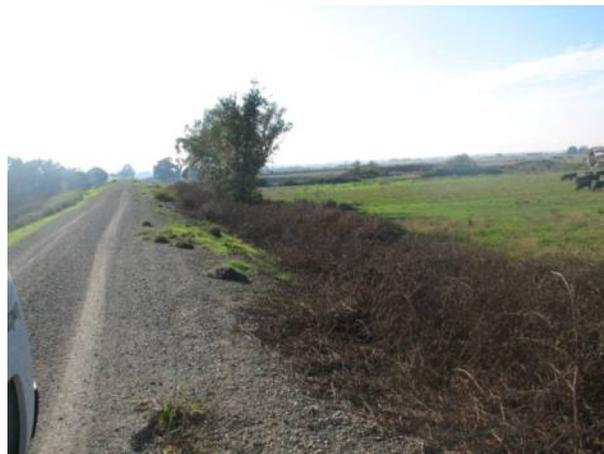
Levee Mile Report Line	5
Start Levee Mile	0.32
End Levee Mile	0.39
Location	Land Side
Category	Earthen Levee
Item	Vegetation
Levee mile 0.39 looking downstream at the vegetation on the slope. The slope is maintained by RD 817 in unit 3.	
cathom_f_20121119_271.JPG

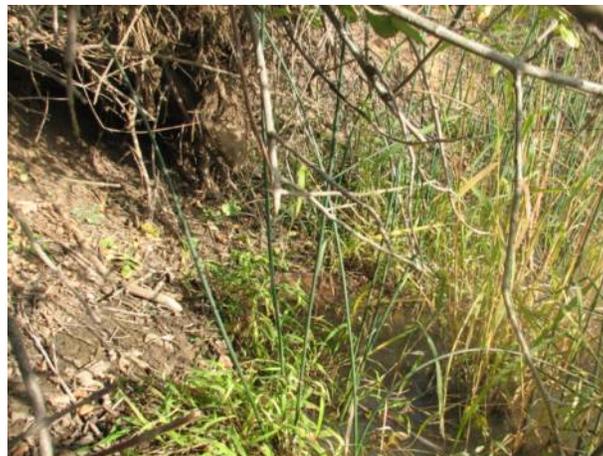
Levee Mile Report Line	8
Start Levee Mile	0.68
End Levee Mile	0.68
Location	Water Side
Category	Interior Drainage & Piping Systems
Item	Culverts: Breaks / Holes / Cracks
Levee mile 0.68, this is located near the low flow channel, the flap gate is lying on the ground, the end of the pipe was not located.	
cathom_f_20121119_273.JPG

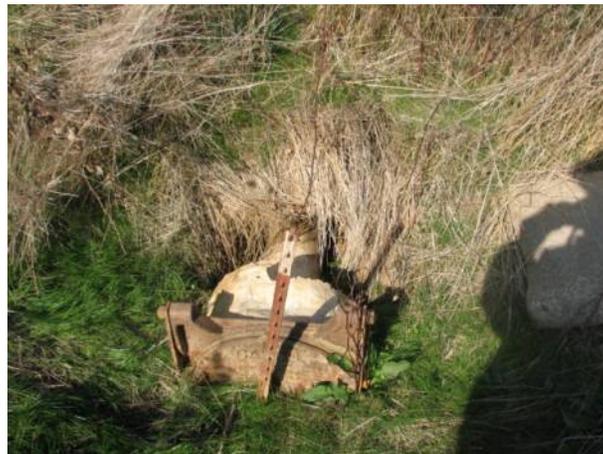
Levee Mile Report Line	10
Start Levee Mile	1.17
End Levee Mile	1.17
Location	Water Side
Category	Interior Drainage & Piping Systems
Item	Culverts: Breaks / Holes / Cracks
Levee mile 1.17 near the low flow channel, it appears a smaller pipe has been sleeved into the larger pipe, the flap gate does not make contact with the smaller pipe.	
cathom_f_20121119_274.JPG

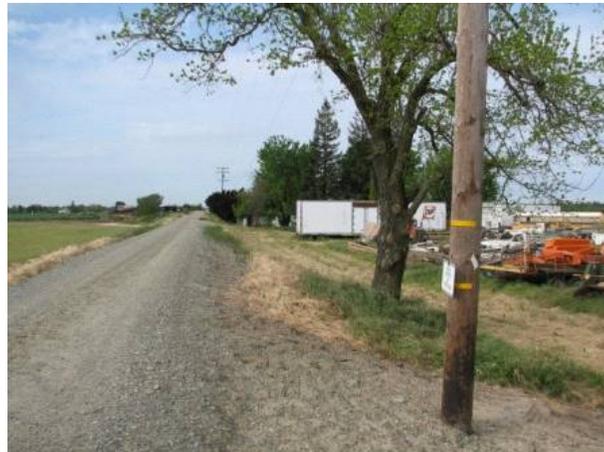
Levee Mile Report Line	3
Start Levee Mile	2.18
End Levee Mile	2.18
Location	Water Side
Category	Earthen Levee
Item	Encroachments
Water side buildings and equipment levee mile 2.18.	
cathom_f_20120912_060.jpg

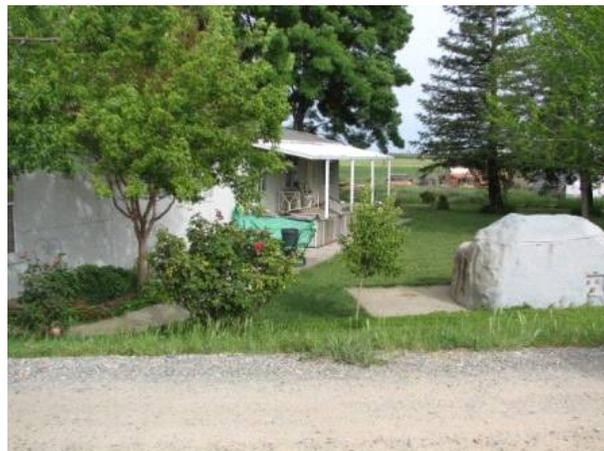
Levee Mile Report Line	3
Start Levee Mile	2.18
End Levee Mile	2.18
Location	Water Side
Category	Earthen Levee
Item	Encroachments
Water side buildings and equipment levee mile 2.18.	
cathom_f_20120912_061.jpg

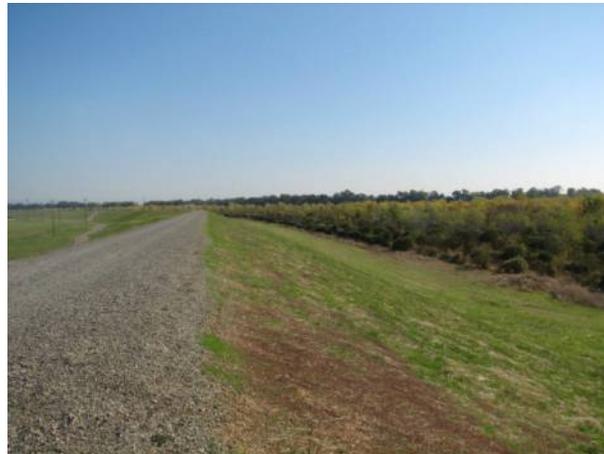
Levee Mile Report Line	2
Start Levee Mile	0.00
End Levee Mile	1.88
Location	Water Side
Category	Earthen Levee
Item	Vegetation
Levee mile 0.00, the waterside slope of the levee.	
cathom_f_20121119_280.JPG

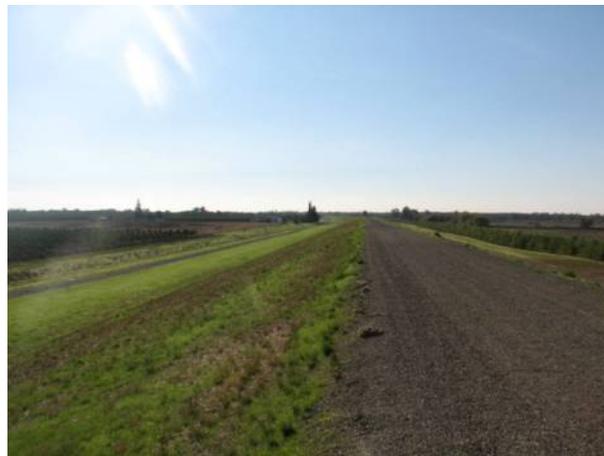
Levee Mile Report Line	2
Start Levee Mile	3.08
End Levee Mile	5.68
Location	Land Side
Category	Earthen Levee
Item	Vegetation
Levee mile 3.08, the landside levee slope.	
cathom_f_20121119_281.JPG
