**Flood Control Project Maintenance
Levee Inspections**

Fall 2013 Levee Maintenance Deficiency Summary Report

Sacramento River Basin

RD0784		Overall LMA Rating	Total LMA Miles						
Reclamation District No. 0784 Plumas Lake		M	34.79						
Rated Item	Maintenance Deficiency				Enforcement		Design & System Obsolescence		
	M Miles	U Miles	M + 4U Miles	Threshold %	M Miles	U Miles	M Miles	U Miles	
<i>Earthen Levee</i>									
Vegetation	0.27	0.96	4.11	11.81%					
Encroachments					2.01	1.54			
Erosion / Bank Caving	0.01		0.01	0.03%					
<i>Interior Drainage & Piping Systems</i>									
Culverts: Inlets / Outlets	0.07		0.07	0.20%					
Culverts: Breaks / Holes / Cracks		0.02	0.08	0.23%					
<i>Supplemental</i>									
USACE Erosion Survey	0.41		0.41	1.18%					
DWR UCIP Field Study					0.15	0.08			
<i>LMA Totals:</i>	0.76	0.98	4.68	13.45%	2.16	1.62	0.00	0.00

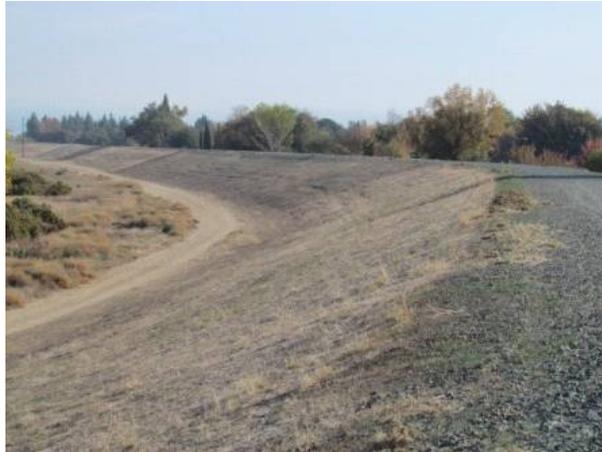
Levee Mile Report Line	5
Start Levee Mile	0.97
End Levee Mile	0.97
Location	Water Side
Category	Earthen Levee
Item	Vegetation
<p>This photo was taken from the levee crown facing east looking down the landward slope at acceptable vegetation control. Fall 2013.</p>	
<p>mhoffman_f_20131115_710.JPG</p>

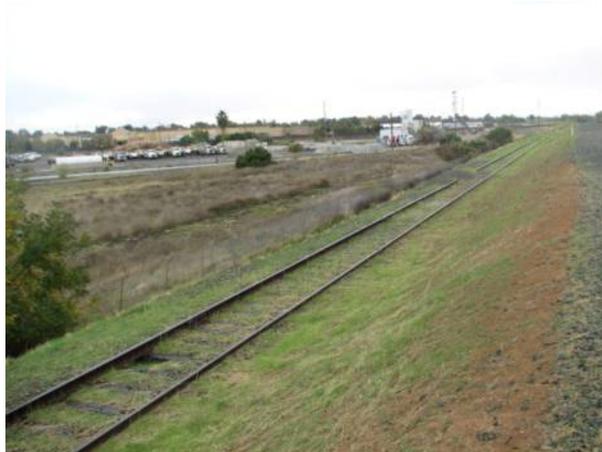
Levee Mile Report Line	6
Start Levee Mile	1.00
End Levee Mile	1.12
Location	Land Side
Category	Earthen Levee
Item	Encroachments
<p>Levee mile 1.00-1.12, this photo shows a fence near the levee toe on the landside.</p>	
<p>mhoffman_f_20130917_063.JPG</p>

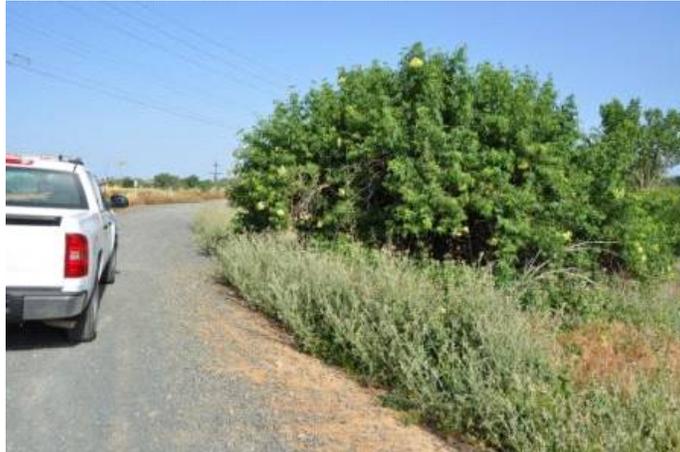
DWR ID: DWR_RD0784_01_f_2012_13		
7	1.28	1.28	Earthen Levee	Vegetation	WS	M Ma	V4 : Elderberries are blocking visibility and flood fight capability.	39.129783 ° -121.574384 °	39.129783 ° -121.574384 °	2 Y
								DWR ID: DWR_RD0784_01_s_2012_2		
8	1.32	1.32	Supplemental	DWR UCIP Field Study	WS	M En	Inspector Comments: FS_ID:9467 EP_NO: N/A Repair Type: Non-Urgent Crossing Status: Indicator Found UCIP Comments: No permit identified for this crossing. Need to determine if owner has permit. FIELD_STRUCT_DESC: Fiber Optic Communication lines cross levee. Diameter unknown. FS Date: 2/28/2013	39.129826 ° 39.129826 °	-121.574940 ° -121.574940 °	1 Y
								DWR ID: DWR_RD0784_01_f_2013_1

Levee Mile Report Line	7
Start Levee Mile	1.28
End Levee Mile	1.28
Location	Water Side
Category	Earthen Levee
Item	Vegetation
W/S slope vegetation, Elderberry.	
mhoffman_f_20130917_061.JPG

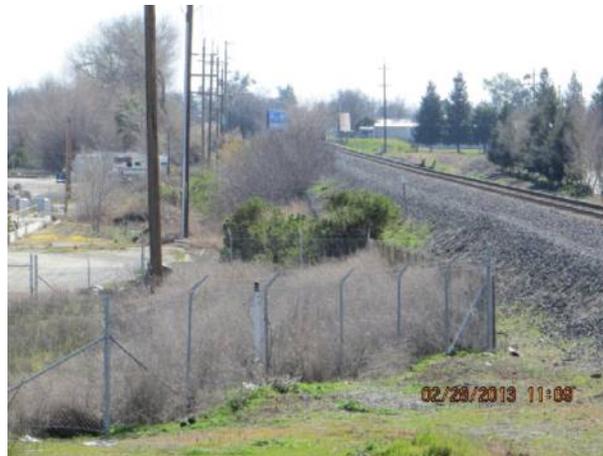
Levee Mile Report Line	8
Start Levee Mile	1.32
End Levee Mile	1.32
Location	Water Side
Category	Supplemental
Item	DWR UCIP Field Study
Marker on East side of Rail/LS of levee.	
UCIP_5684.jpg

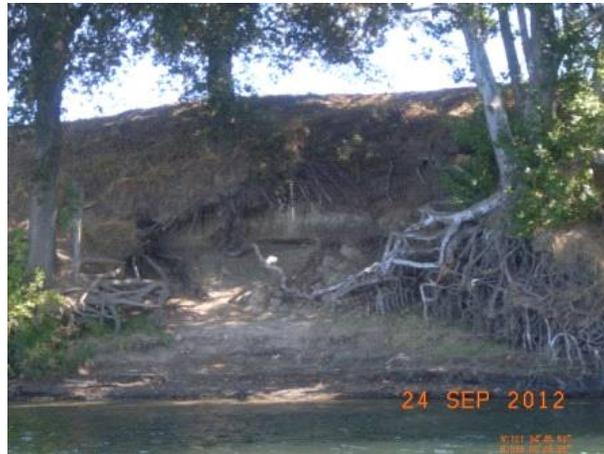
Levee Mile Report Line	1
Start Levee Mile	8.96
End Levee Mile	9.36
Location	Water Side
Category	Supplemental
Item	USACE Erosion Survey
USACE 2012 Photo #2	
USACE2013_FHR_17-8_L_2.jpg

1	8.96	9.36	Supplemental	USACE Erosion Survey	WS	M Ma	Inspector Comments: 2003 - Bank is near vertical. Identified as a Potentially Critical site. 2004 - Eddy flow off downstream end of Modesto formation eroding the fluvial sediments. 2005 - Some new slumping. Actively eroding but berm width is greater than 50 ft. 2006 - Downgraded to regular erosion site. Still actively eroding. Large old rotational failures in high bank on the downstream end. 2008 - Removed from inventory due to wide berm width does not meet criteria for an erosion site. 2010 - Added back to the inventory after 10 ft of bank erosion in the winter 2009 storm. Steep vertical face. 2011 - Bank has retreated an additional 2.5 ft from last year. New tree popouts and erosion throughout the site. 2012: Site continues to worsen with new tree popouts and many areas of new erosion. [2012 Site ID: FHR_17-8_L]	39.009366 ° -121.579766 °	39.004549 ° -121.579143 °	2 Y

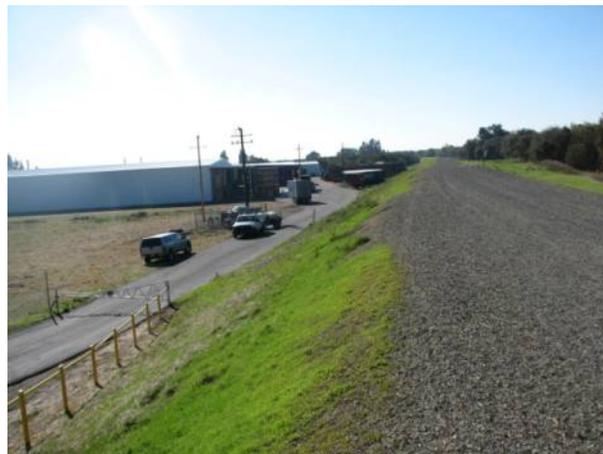
Levee Mile Report Line	2
Start Levee Mile	9.21
End Levee Mile	9.29
Location	Land Side
Category	Earthen Levee
Item	Encroachments
Levee mile 9.21, new paving near the levee toe, no permit found for this work.	
mhoffman_f_20130917_070.JPG

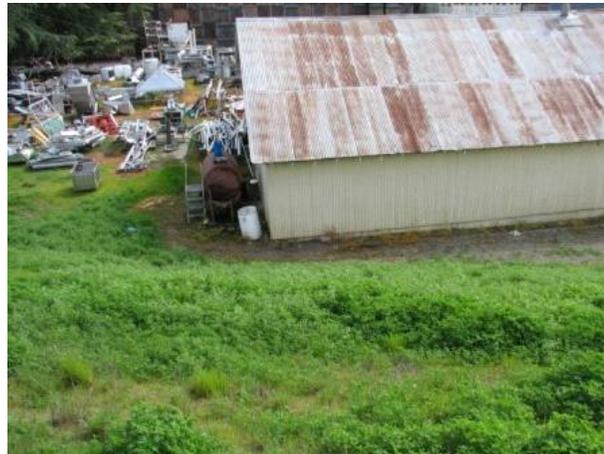
Levee Mile Report Line	6
Start Levee Mile	9.40
End Levee Mile	9.40
Location	Land Side
Category	Earthen Levee
Item	Encroachments
Levee mile 9.40, looking at a building that is encroaching on the levee toe.	
mhoffman_f_20130917_064.jpg

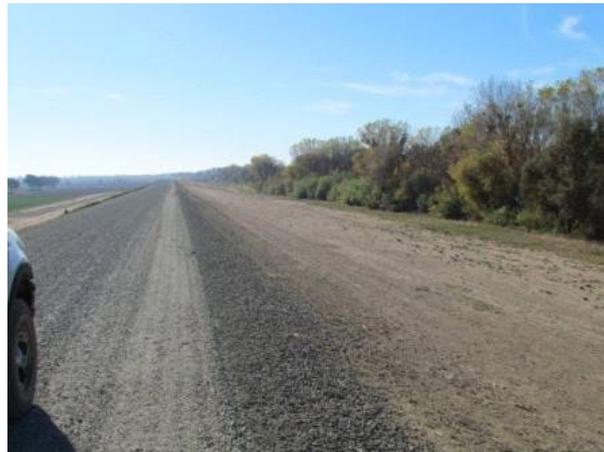
Levee Mile Report Line	8
Start Levee Mile	11.86
End Levee Mile	11.86
Location	Water Side
Category	Earthen Levee
Item	Vegetation
This photo was taken from the levee crown facing south looking down the waterward slope at acceptable vegetation control. Fall 2013.	
mhoffman_f_20131115_702.JPG

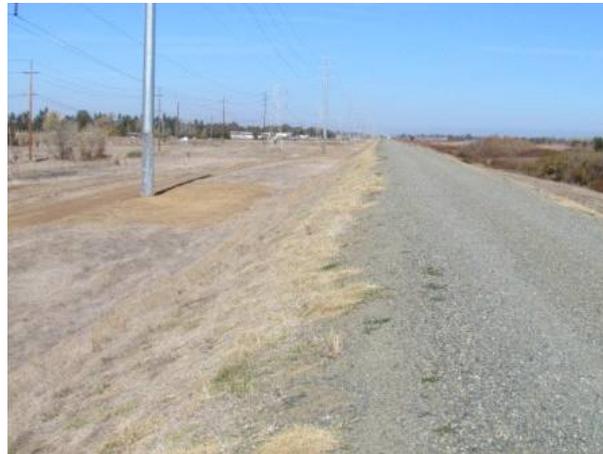
Levee Mile Report Line	2
Start Levee Mile	3.84
End Levee Mile	3.84
Location	Land Side
Category	Earthen Levee
Item	Vegetation
This photo was taken from the levee crown facing north looking down the landward slope at acceptable vegetation control. Fall 2013.	
mhoffman_f_20131115_705.JPG

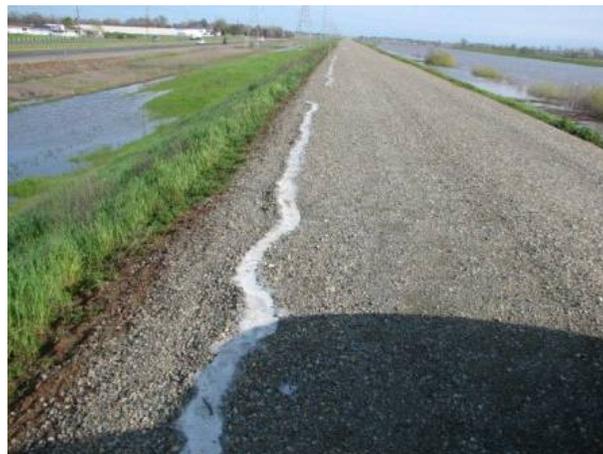
Levee Mile Report Line	3
Start Levee Mile	4.31
End Levee Mile	4.43
Location	Crown
Category	Earthen Levee
Item	Erosion / Bank Caving
Levee mile 4.31, looking at a crack near the landside shoulder with a temporary repair.	
mhoffman_f_20130917_075.jpg

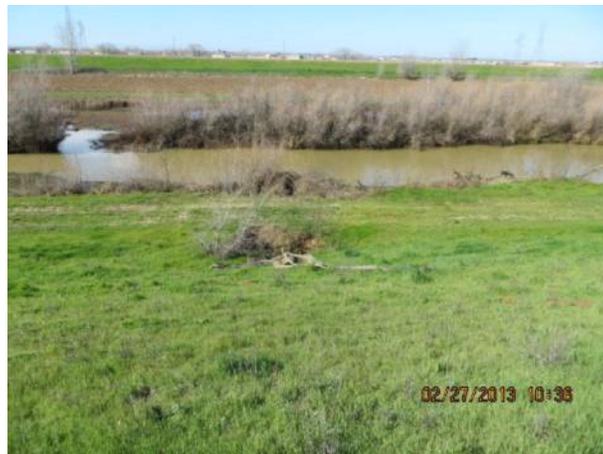
Levee Mile Report Line	5
Start Levee Mile	2.04
End Levee Mile	2.04
Location	Land Side
Category	Supplemental
Item	DWR UCIP Field Study
Concrete U-shaped outlet on WS toe.	
UCIP_5701.jpg

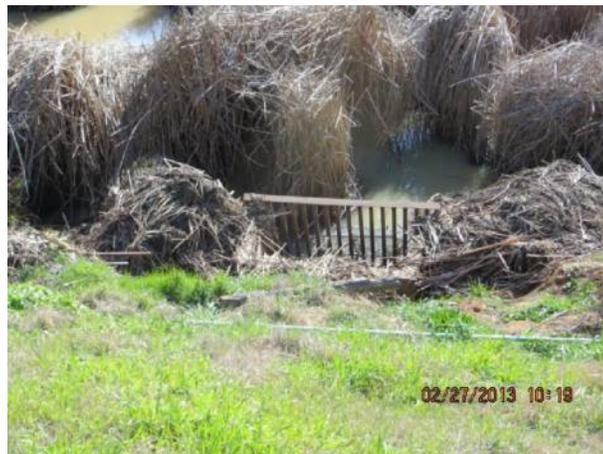
Levee Mile Report Line	8
Start Levee Mile	2.47
End Levee Mile	2.47
Location	Land Side
Category	Supplemental
Item	DWR UCIP Field Study
Inlet on LS.	
UCIP_5704.jpg

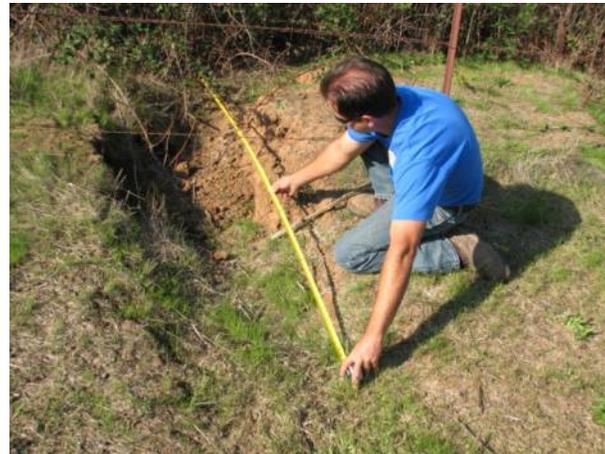
Levee Mile Report Line	10
Start Levee Mile	2.98
End Levee Mile	2.98
Location	Water Side
Category	Earthen Levee
Item	Erosion / Bank Caving
Levee mile 2.98, erosion near the waterside levee toe.	
mhoffman_f_20130917_077.JPG

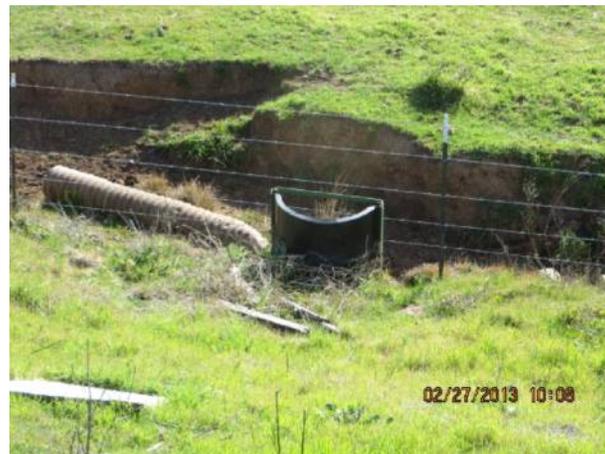
Levee Mile Report Line	11
Start Levee Mile	3.06
End Levee Mile	3.06
Location	Water Side
Category	Supplemental
Item	DWR UCIP Field Study
PVC weir on LS toe. Notice pipe debris from repair.	
UCIP_5713.jpg

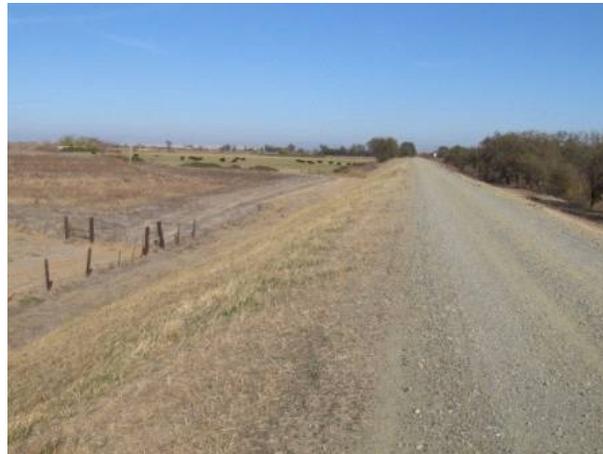
Levee Mile Report Line	2
Start Levee Mile	0.15
End Levee Mile	0.15
Location	Land Side
Category	Earthen Levee
Item	Vegetation
This photo was taken from the levee crown facing east looking down the landward slope at acceptable vegetation control. Fall 2013.	
mhoffman_f_20131115_708.JPG

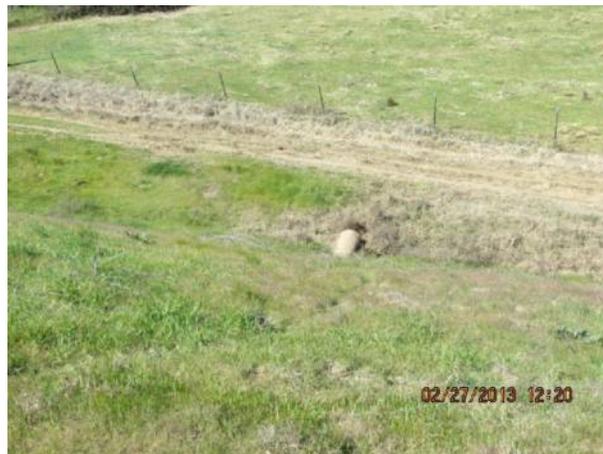
Levee Mile Report Line	5
Start Levee Mile	0.27
End Levee Mile	0.27
Location	Land Side
Category	Supplemental
Item	DWR UCIP Field Study
Pipe at LS toe	
UCIP_6345.jpg

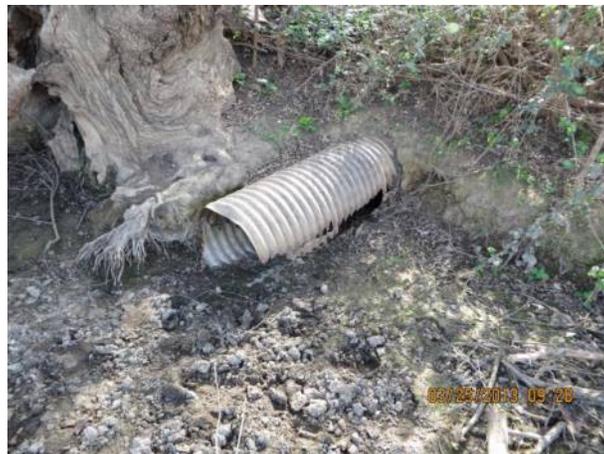
Levee Mile Report Line	7
Start Levee Mile	0.54
End Levee Mile	0.54
Location	Land Side
Category	Supplemental
Item	DWR UCIP Field Study
Pipe on LS toe corroded through.	
UCIP_6339.jpg

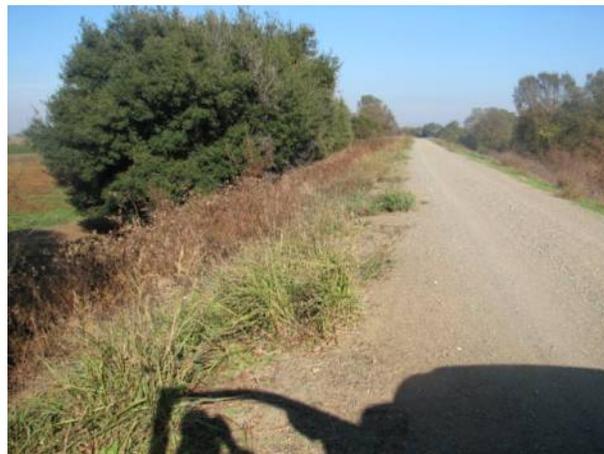
Levee Mile Report Line	8
Start Levee Mile	0.54
End Levee Mile	0.79
Location	Land Side
Category	Earthen Levee
Item	Vegetation
Levee mile 0.54, the landside slope.	
mhoffman_f_20130917_083.JPG

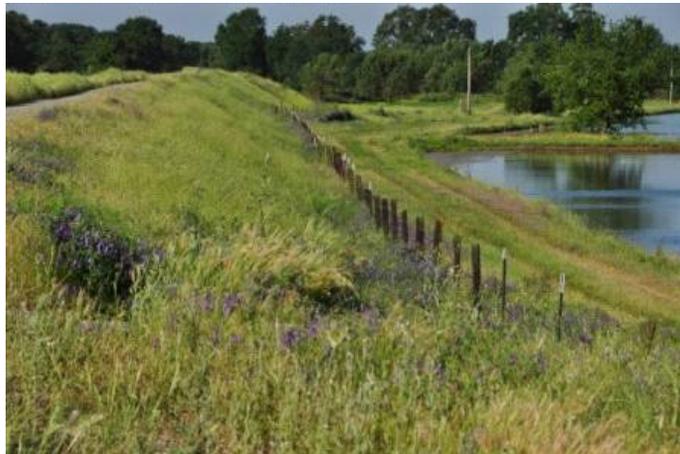
Levee Mile Report Line	14
Start Levee Mile	0.85
End Levee Mile	1.26
Location	Land Side
Category	Earthen Levee
Item	Encroachments
Wire fence along L/S toe.	
mhoffman_f_20130917_089.JPG

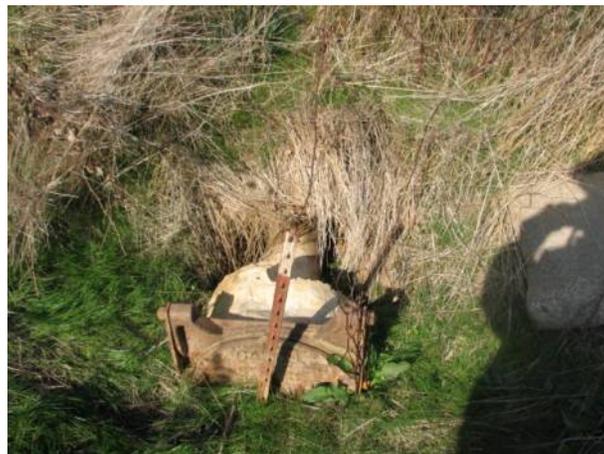
Levee Mile Report Line	16
Start Levee Mile	1.17
End Levee Mile	1.17
Location	Water Side
Category	Interior Drainage & Piping Systems
Item	Culverts: Breaks / Holes / Cracks
Levee mile 1.17 near the low flow channel, it appears a smaller pipe has been sleeved into the larger pipe, the flap gate does not make contact with the smaller pipe.	
mhoffman_f_20130917_084.JPG

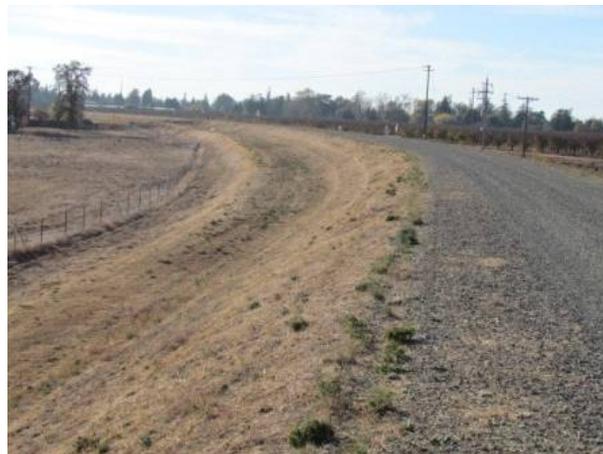
Levee Mile Report Line	2
Start Levee Mile	1.38
End Levee Mile	1.38
Location	Land Side
Category	Earthen Levee
Item	Vegetation
This photo was taken from the levee crown facing east looking down the landward slope at acceptable vegetation control. Fall 2013.	
mhoffman_f_20131115_709.JPG
