**Flood Control Project Maintenance  
Levee Inspections**

**Fall 2014 Levee Maintenance Deficiency Summary Report**

**Reclamation District No. 0784 Plumas Lake**

**Levee Inspection Report By Mile - Fall 2014**

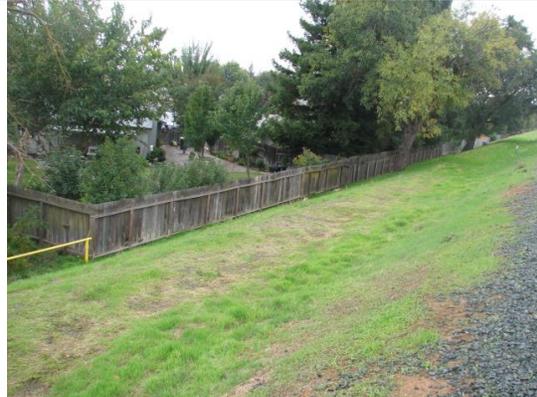
Photo 1 of 1 : FA\_2014\_RD0784\_178\_12\_20140929\_00002.jpg

LM Start	<b>0.51</b>	Rating **	U	Issue No.	<b>12</b>
LM End	<b>1.00</b>	Issue Type +	En	Location *	LS
Category	Earthen Levee		GPS Latitude/Longitude		
			Start	End	
Item	Encroachments		39.131558 °	39.129475 °	
			-121.560668 °	-121.569209 °	
DWR ID	DWR_RD0784_01_f_2012_12				
Action/Comments					
Urban

Levee mile 0.53-1.00, this photo shows the fences and other obstruction near the toe of the levee on the landside.

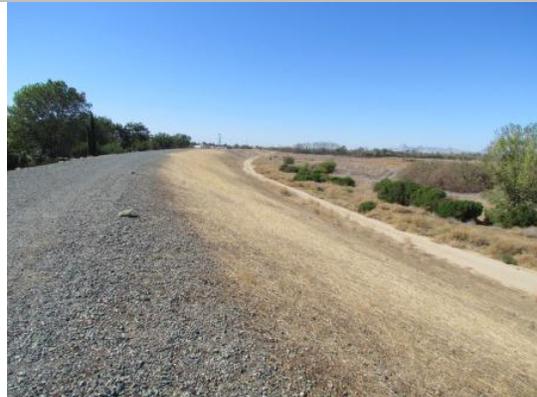
Photo 1 of 1 : FA\_2014\_RD0784\_178\_3\_20141003\_00005.jpg

LM Start	<b>0.83</b>	Rating **	A	Issue No.	<b>3</b>
LM End	<b>0.83</b>	Issue Type +	Ma	Location *	WS
Category	Earthen Levee		GPS Latitude/Longitude		
			Start	End	
Item	Vegetation		39.129794 °	39.129794 °	
			-121.566146 °	-121.566146 °	
DWR ID	DWR_RD0784_01_f_2014_3				
Action/Comments					
Control annual grass and weeds on the levee slopes and easements.

This photo was taken from the levee crown facing west looking down the waterward levee slope at acceptable vegetation maintenance.

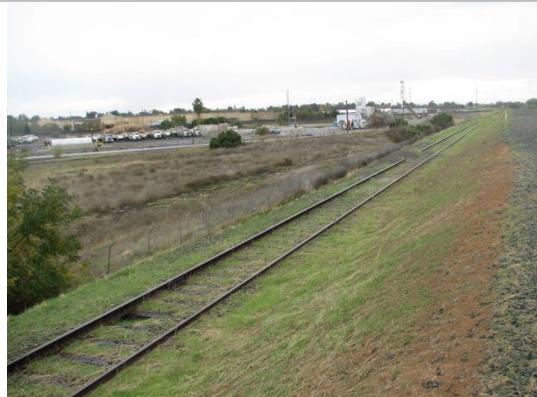
Photo 1 of 1 : FA\_2014\_RD0784\_178\_13\_20140929\_00003.jpg

LM Start	<b>1.00</b>	Rating **	U	Issue No.	<b>13</b>
LM End	<b>1.12</b>	Issue Type +	En	Location *	LS
Category	Earthen Levee		GPS Latitude/Longitude		
			Start	End	
Item	Encroachments		39.129475 °	39.129615 °	
			-121.569210 °	-121.571371 °	
DWR ID	DWR_RD0784_01_f_2012_13				
Action/Comments					
Fence

Levee mile 1.00-1.12, this photo shows a fence near the levee toe on the landside.

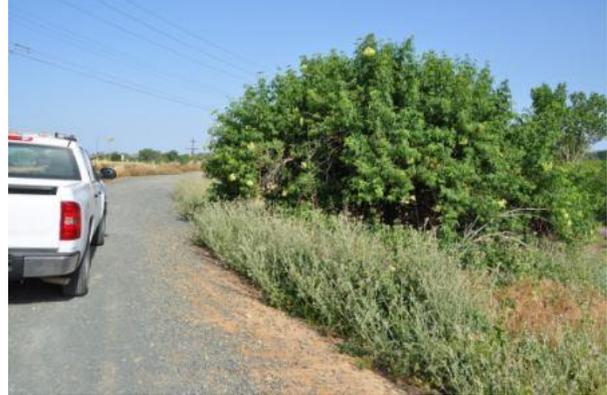
Photo 1 of 1 : FA\_2014\_RD0784\_178\_2\_20140929\_00001.jpg

LM Start	<b>1.28</b>	Rating **	M	Issue No.	<b>2</b>
LM End	<b>1.28</b>	Issue Type +	Ma	Location *	WS
Category	Earthen Levee			GPS Latitude/Longitude	
				Start	End
Item	Vegetation			39.129783 °	39.129783 °
				-121.574384 °	-121.574384 °
DWR ID	DWR_RD0784_01_s_2012_2				
Action/Comments					
Elderberries are blocking visibility and flood fight capability.

W/S slope vegetation, Elderberry.

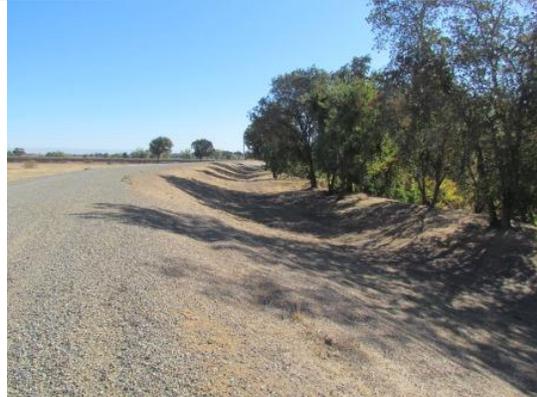
Photo 1 of 1 : FA\_2014\_RD0784\_533\_2\_20141003\_00002.jpg

LM Start	<b>3.19</b>	Rating **	A	Issue No.	<b>2</b>
LM End	<b>3.19</b>	Issue Type +	Ma	Location *	WS
Category	Earthen Levee		GPS Latitude/Longitude		
			Start	End	
Item	Vegetation		38.974679 °	38.974679 °	
			-121.535478 °	-121.535478 °	
DWR ID	DWR_RD0784_03A_f_2014_2				
Action/Comments					
Control annual grass and weeds on the levee slopes and easements.

This photo was taken from the levee crown facing east looking down the waterward levee slope at acceptable vegetation maintenance.

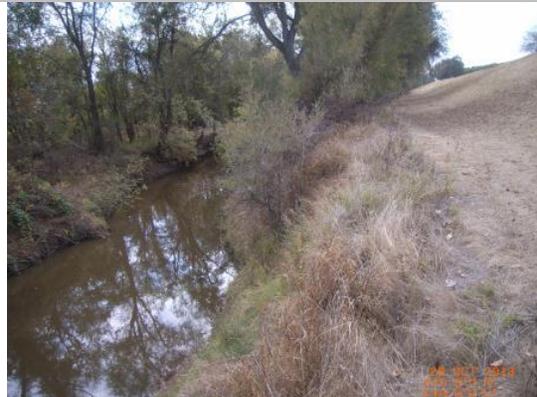
Photo 1 of 1 : FA\_2014\_RD0784\_533\_3\_20140929\_00001.jpg

LM Start	<b>4.31</b>	Rating **	M	Issue No.	<b>3</b>
LM End	<b>4.32</b>	Issue Type +	Ma	Location *	WS
Category	Supplemental		GPS Latitude/Longitude		
			Start	End	
Item	USACE Erosion Survey		38.981400 °	38.981271 °	
			-121.515848 °	-121.515999 °	
DWR ID	DWR_RD0784_03A_f_2014_3				
Action/Comments					
Inspector Comments: 2009 - Small site which could be repaired with maintenance. Erosion into the levee toe, rock has started to fail. 2013: No observed changes. [2013 Site ID: BER_4-9_R]

USACE 2013 Photo #1

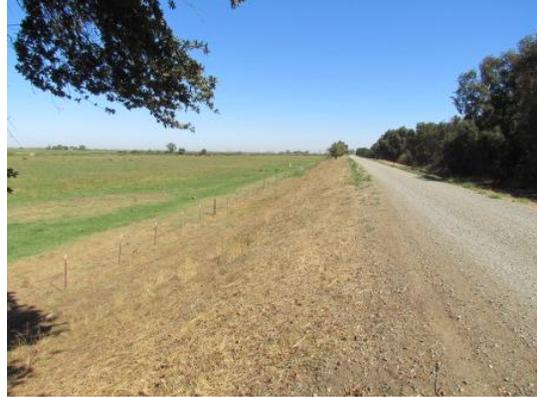
Photo 1 of 1 : FA\_2014\_RD0784\_534\_2\_20141003\_00002.jpg

LM Start	<b>4.12</b>	Rating **	A	Issue No.	<b>2</b>
LM End	<b>4.12</b>	Issue Type +	Ma	Location *	LS
Category	Earthen Levee		GPS Latitude/Longitude		
			Start	End	
Item	Vegetation		38.979542 °	38.979542 °	
			-121.518508 °	-121.518508 °	
DWR ID	DWR_RD0784_03B_f_2014_2				
Action/Comments					
Control annual grass and weeds on the levee slopes and easements.

This photo was taken from the levee crown facing east looking down the landward levee slope at acceptable vegetation maintenance.

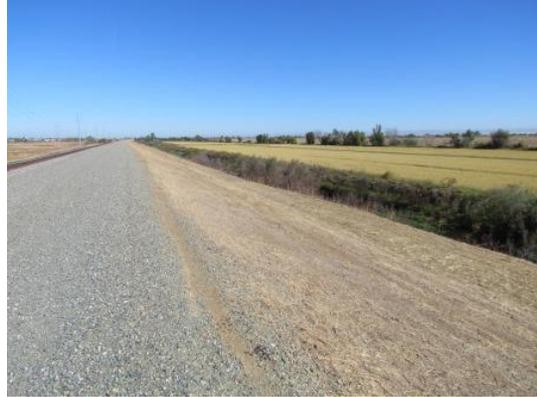
Photo 1 of 1 : FA\_2014\_RD0784\_181\_3\_20141003\_00004.jpg

LM Start	<b>1.55</b>	Rating **	A	Issue No.	<b>3</b>
LM End	<b>1.55</b>	Issue Type +	Ma	Location *	WS
Category	Earthen Levee			GPS Latitude/Longitude	
				Start	End
Item	Vegetation			38.997023 °	38.997023 °
				-121.539335 °	-121.539335 °
DWR ID	DWR_RD0784_04_f_2014_3				
Action/Comments					
Control annual grass and weeds on the levee slopes and easements.

This photo was taken from the levee crown facing north looking down the waterward levee slope at acceptable vegetation maintenance.

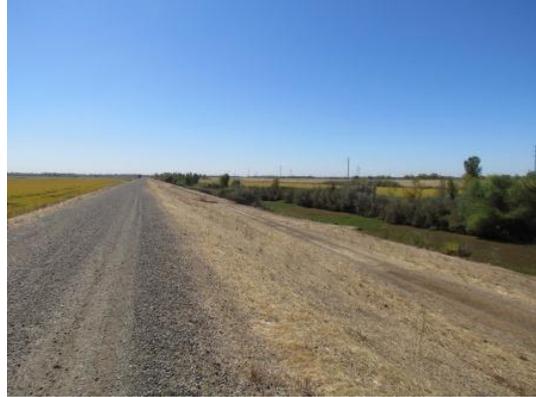
Photo 1 of 1 : FA\_2014\_RD0784\_182\_11\_20141003\_00009.jpg

LM Start	<b>2.10</b>	Rating **	A	Issue No.	<b>11</b>
LM End	<b>2.10</b>	Issue Type +	Ma	Location *	WS
Category	Earthen Levee			GPS Latitude/Longitude	
				Start	End
Item	Vegetation			39.004504 °	39.004504 °
				-121.538492 °	-121.538492 °
DWR ID	DWR_RD0784_05_f_2014_11				
Action/Comments					
Control annual grass and weeds on the levee slopes and easements.

This photo was taken from the levee crown facing west looking down the waterward levee slope at acceptable vegetation maintenance.

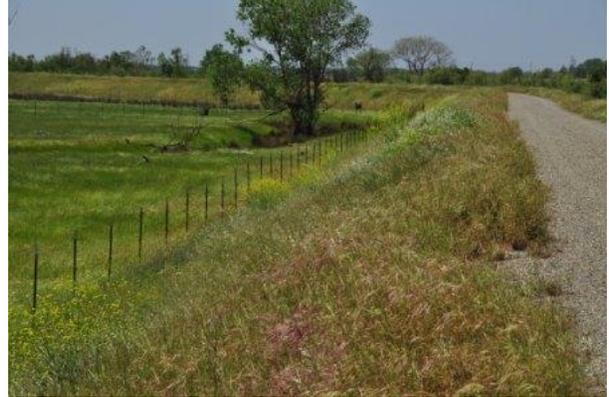
Photo 1 of 1 : FA\_2014\_RD0784\_182\_5\_20140929\_00001.jpg

LM Start	<b>2.51</b>	Rating **	U	Issue No.	<b>5</b>
LM End	<b>3.36</b>	Issue Type +	En	Location *	LS
Category	Earthen Levee			GPS Latitude/Longitude	
				Start	End
Item	Encroachments			39.009439 °	39.017779 °
				-121.535210 °	-121.524150 °
DWR ID	DWR_RD0784_05_s_2013_5				
Action/Comments					
Fence

Fence at L/S levee toe.

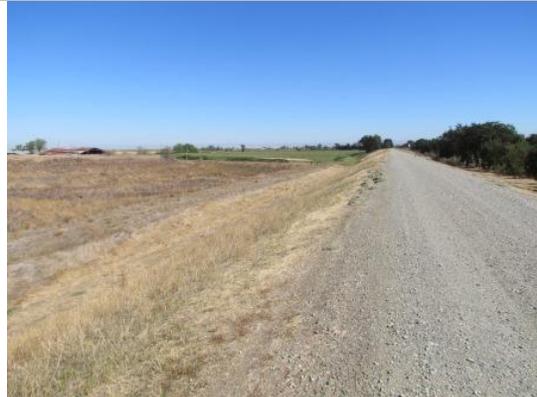
Photo 1 of 1 : FA\_2014\_RD0784\_183\_18\_20141003\_00016.jpg

LM Start	<b>0.18</b>	Rating **	A	Issue No.	<b>18</b>
LM End	<b>0.18</b>	Issue Type +	Ma	Location *	LS
Category	Earthen Levee			GPS Latitude/Longitude	
				Start	End
Item	Vegetation			38.986983 °	38.986983 °
				-121.507783 °	-121.507783 °
DWR ID	DWR_RD0784_06_f_2014_18				
Action/Comments					
Control annual grass and weeds on the levee slopes and easements.

This photo was taken from the levee crown facing east looking down the landward levee slope at acceptable vegetation maintenance.

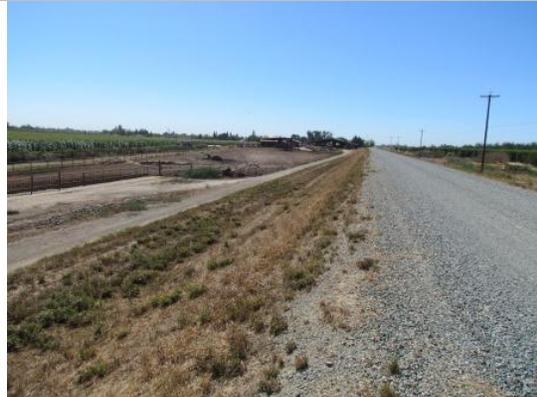
Photo 1 of 1 : FA\_2014\_RD0784\_184\_2\_20141003\_00003.jpg

LM Start	<b>1.97</b>	Rating **	A	Issue No.	<b>2</b>
LM End	<b>1.97</b>	Issue Type +	Ma	Location *	LS
Category	Earthen Levee			GPS Latitude/Longitude	
				Start	End
Item	Vegetation			39.147537 °	39.147537 °
				-121.520566 °	-121.520566 °
DWR ID	DWR_RD0784_07_f_2014_2				
Action/Comments					
Control annual grass and weeds on the levee slopes and easements.

This photo was taken from the levee crown facing west looking down the landward levee slope at acceptable vegetation maintenance.

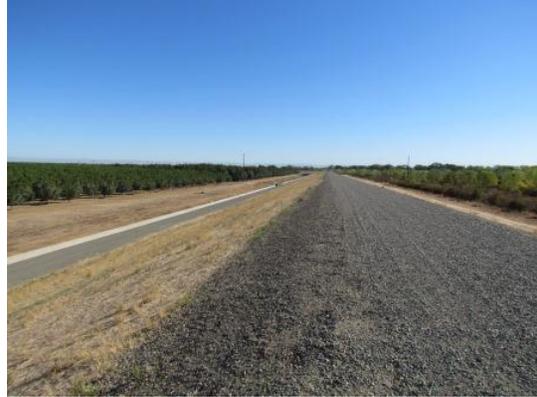
Photo 1 of 1 : FA\_2014\_RD0784\_437\_1\_20141013\_00002.jpg

LM Start	<b>0.61</b>	Rating **	A	Issue No.	<b>1</b>
LM End	<b>0.61</b>	Issue Type +	Ma	Location *	N/A
Category	Earthen Levee			GPS Latitude/Longitude	
				Start	End
Item	Vegetation			38.957281 °	38.957281 °
				-121.564089 °	-121.564089 °
DWR ID	DWR_RD0784_08_f_2014_1				
Action/Comments					
Control annual grass and weeds on the levee slopes and easements.

This photo was taken from the crown facing east looking down the landward levee slope at acceptable vegetation maintenance.
