**Flood Control Project Maintenance
Levee Inspections**

Fall 2015 Levee Maintenance Deficiency Summary Report

Sacramento River Basin

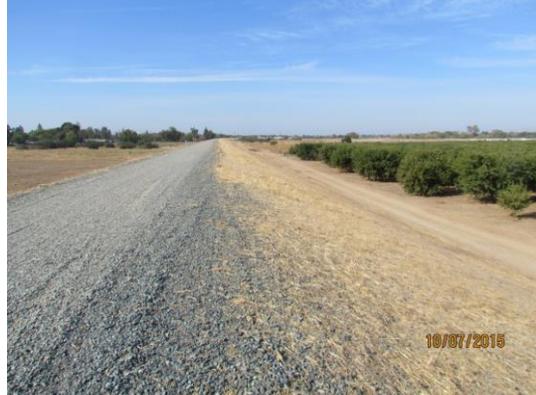
Photo 1 of 1 : FA_2015_RD0784_178_3_20151009_00004.jpg

View of the acceptable vegetation on the waterside slope of the levee looking downstream.

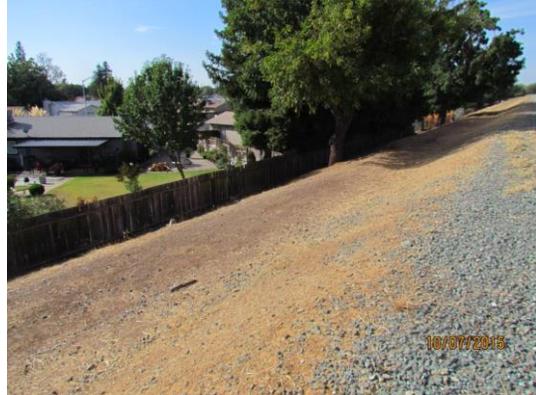
Photo 1 of 1 : FA_2015_RD0784_178_12_20151009_00005.jpg

LM Start	0.51	Rating **	M	Issue No.	12
LM End	1.00	Issue Type +	En	Location *	LS
Category	Earthen Levee		GPS Latitude/Longitude		
			Start	End	
Item	Encroachments		39.131558 °	39.129475 °	
			-121.560668 °	-121.569209 °	
DWR ID	DWR_RD0784_01_f_2012_12				
Action/Comments					
Fence Inspector Comments: Fences are found within the 10 feet of levee easement .

Fences were found on the landside toe of the levee looking downstream.

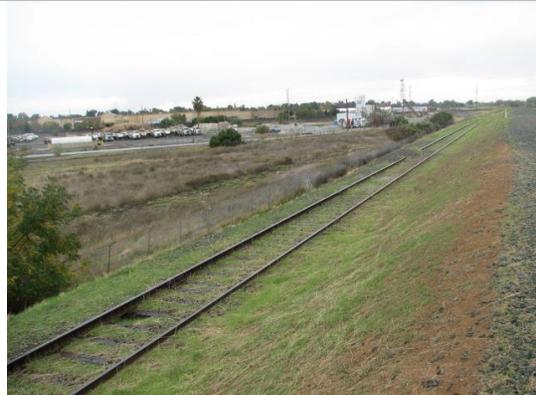
Photo 1 of 1 : FA_2015_RD0784_178_13_20150911_00003.jpg

LM Start	1.00	Rating **	M	Issue No.	13
LM End	1.12	Issue Type +	En	Location *	LS
Category	Earthen Levee		GPS Latitude/Longitude		
			Start	End	
Item	Encroachments		39.129475 °	39.129615 °	
			-121.569210 °	-121.571371 °	
DWR ID	DWR_RD0784_01_f_2012_13				
Action/Comments					
Fence

Levee mile 1.00-1.12, this photo shows a fence near the levee toe on the landside.

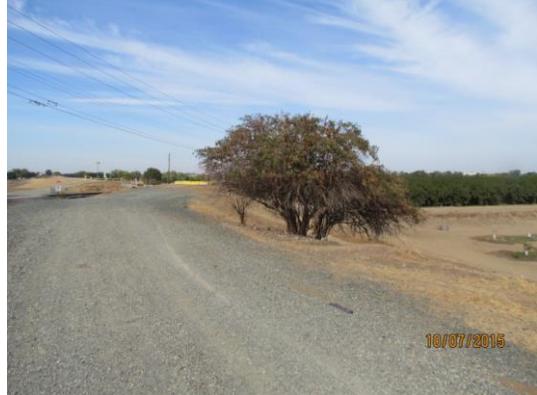
Photo 1 of 2 : FA_2015_RD0784_178_2_20151009_00006.jpg

View of the elderberry tree on the waterside of the levee looking downstream.

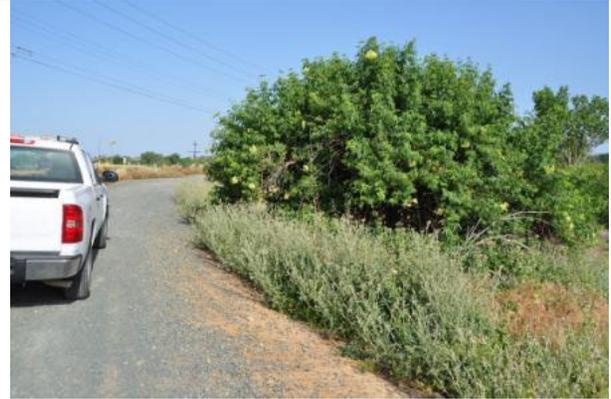
Photo 2 of 2 : FA_2015_RD0784_178_2_20150911_00001.jpg

LM Start	1.28	Rating **	A/W	Issue No.	2 (cont)
LM End	1.28	Issue Type +	Ma	Location *	WS

W/S slope vegetation, Elderberry.

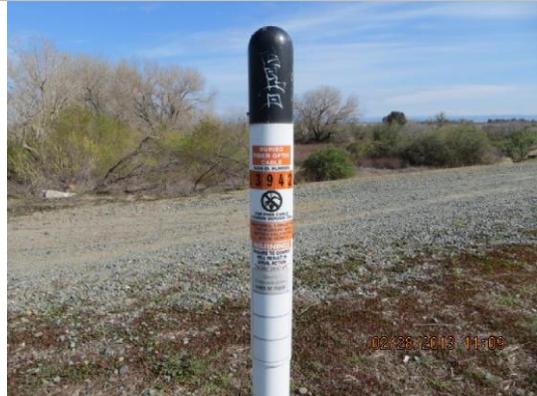
Photo 1 of 3 : UCIP_FA_2015_1204.jpg

LM Start	1.31	Rating **	M	Issue No.	14
LM End	1.31	Issue Type +	En	Location *	WS
Category	Supplemental		GPS Latitude/Longitude		
			Start	End	
Item	DWR UCIP Field Study		39.129826 °	39.129826 °	
			-121.574940 °	-121.574940 °	
DWR ID	DWR_RD0784_01_f_2015_14				
Action/Comments					
Inspector Comments: FS_ID:46778 DS_ID:18552 EP_NO: N/A FS_HLM: 1.315 Repair Type: Non-Urgent Crossing Status: Indicator Found

Marker on east side of Rail/WS of Levee.

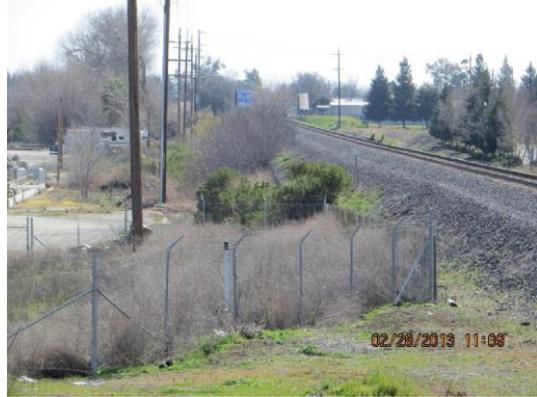
Photo 2 of 3 : UCIP_FA_2015_3041.jpg

LM Start	1.31	Rating **	M	Issue No.	14 (cont)
LM End	1.31	Issue Type +	En	Location *	WS
Category	Supplemental			GPS Latitude/Longitude	
				Start	End
Item	DWR UCIP Field Study			39.129826 °	39.129826 °
				-121.574940 °	-121.574940 °
DWR ID	DWR_RD0784_01_f_2015_14				
Action/Comments					
Inspector Comments: FS_ID:46778 DS_ID:18552 EP_NO: N/A FS_HLM: 1.315 Repair Type: Non-Urgent Crossing Status: Indicator Found UCIP Comments: 11-1-2015 - Letter requesting permit or to provide permit sent to owner Century Link, 700 W. Mineral Avenue, Rm D 27.34, Littleton, CO 80120 on 2/18/2014. Pending CVFPB enforcement on utility crossing owner. Requesting DWR inspector to change the status of this issue to "No Action Needed" (P. Meagher - RD784)No permit identified for this crossing. Need to determine if owner has permit. (W.Wylie UCIP Inspector). FIELD_STRUCT_DESC: Fiber Optic Communication lines cross levee. Diameter unknown. FS Date: 09/11/2015

Marker on East side of Rail/LS of levee.

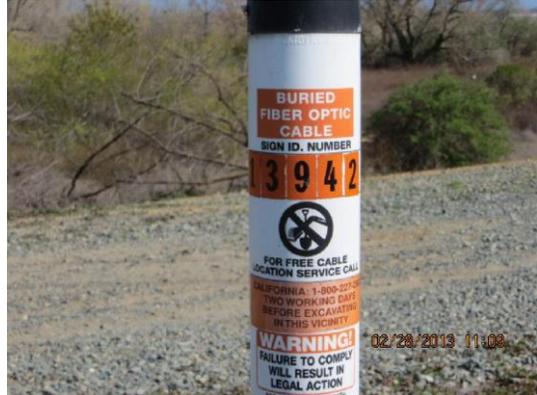
Photo 3 of 3 : UCIP_FA_2015_3042.jpg

Marker on east side of Rail/WS of Levee.

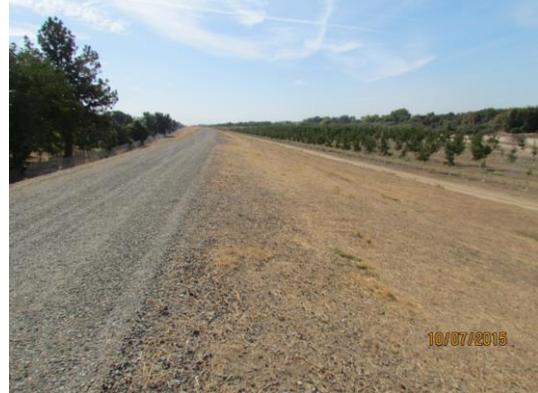
Photo 1 of 1 : FA_2015_RD0784_531_2_20151009_00001.jpg

View of the acceptable vegetation on the waterside of the levee looking downstream.

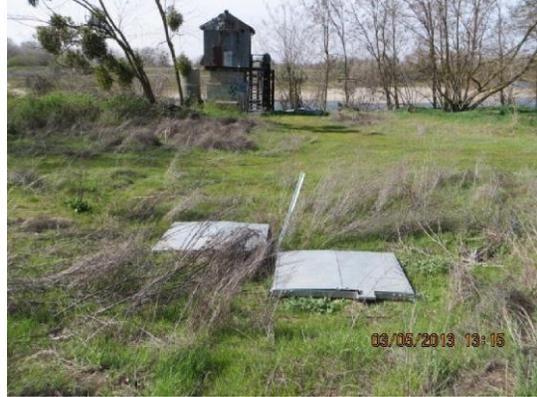
Photo 1 of 3 : UCIP_FA_2015_3435.jpg

LM Start	Rating **	M	Issue No.	8
LM End	Issue Type +	En	Location *	LS
Category	Supplemental	GPS Latitude/Longitude		
		Start	End	
Item	DWR UCIP Field Study	39.005970 °	39.005970 °	
		-121.578008 °	-121.578008 °	
DWR ID				
Action/Comments				
Inspector Comments: FS_ID:46784 DS_ID:18716 EP_NO: 18227 FS_HLM: 9.247 Repair Type: Non-Urgent Crossing Status: Indicator Found UCIP Comments: 11-1-2015 - Gate is locked (By owner) as of 9/11/2015 (P. Meagher - RD784) Gate on enclosure at LS toe is not locked. Vaults on WS toe are open and need to be secured. (W. Wylie - UCIP Inspector). FIELD_STRUCT_DESC: 1 of 3: 30-inch HDPE irrigation pipe through the levee 3-feet below the crown. Siphon breaker and air relief valve in vault on waterside shoulder. Pumps in pump house on the bank. Gate valves in concrete distribution box. Chain link enclosure at the landside toe. Discharges into concrete box on the landward side. (Permit No. 18227, 2007) FS Date: 08/01/2014

Pumphouse off WS toe at waters edge. Vaults with access to pipes in foreground.

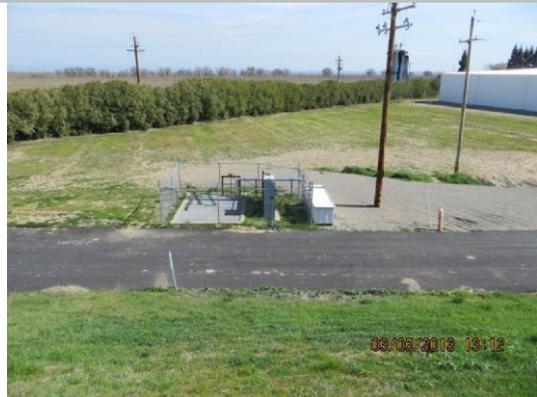
Photo 2 of 3 : UCIP_FA_2015_3442.jpg

Concrete distribution box with chain link enclosure on LS toe.

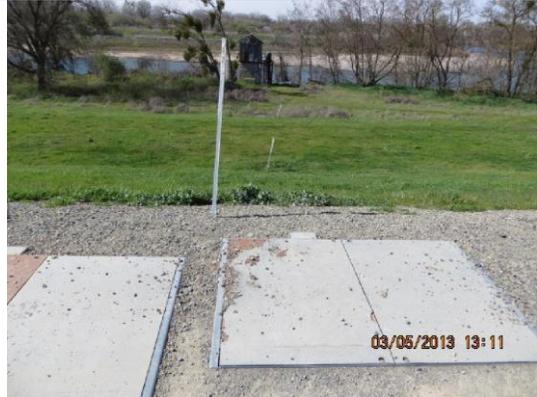
Photo 3 of 3 : UCIP_FA_2015_3443.jpg

LM Start	Rating **	M	Issue No.	8 (cont)	
LM End	Issue Type +	En	Location *	LS	
Category	Supplemental		GPS Latitude/Longitude		
			Start	End	
Item	DWR UCIP Field Study		39.005970 °	39.005970 °	
			-121.578008 °	-121.578008 °	
DWR ID					
Action/Comments					
Inspector Comments: FS_ID:46784 DS_ID:18716 EP_NO: 18227 FS_HLM: 9.247 Repair Type: Non-Urgent Crossing Status: Indicator Found

Vault on WS shoulder.

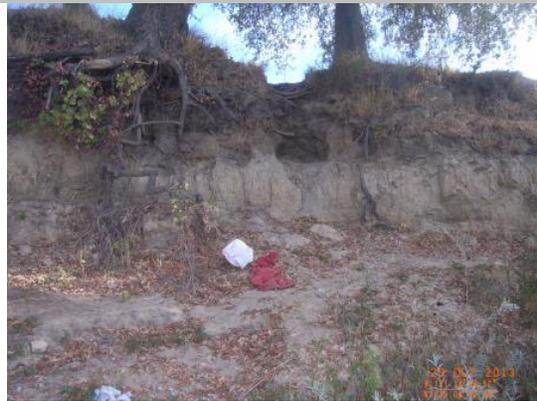
Photo 1 of 1 : USACE2013A_FHR_17-8_L_11.jpg

LM Start	8.96	Rating **	A/W	Issue No.	1
LM End	9.36	Issue Type +	Ma	Location *	WS
Category	Supplemental		GPS Latitude/Longitude		
			Start	End	
Item	2015 USACE Erosion Survey, DRAFT		39.009366 °	39.004549 °	
			-121.579766 °	-121.579143 °	
DWR ID	DWR_RD0784_02B_f_2015_1				
Action/Comments					
Inspector Comments: 2003 - Bank is near vertical. Identified as a Potentially Critical site. 2004 - Eddy flow off downstream end of Modesto formation eroding the fluvial sediments. 2005 - Some new slumping. Actively eroding but berm width is greater than 50 ft. 2006 - Downgraded to regular erosion site. Still actively eroding. Large old rotational failures in high bank on the downstream end. 2008 - Removed from inventory due to wide berm width does not meet criteria for an erosion site. 2010 - Added back to the inventory after 10 ft of bank erosion in the winter 2009 storm. Steep vertical face. 2011 - Bank has retreated an additional 2.5 ft from last year. New tree popouts and erosion throughout the site. 2012 - Site continues to worsen with new tree popouts and many sections of new erosion. 2015: Last observed in 2013. [2015 Site ID: FHR_17-8_L]

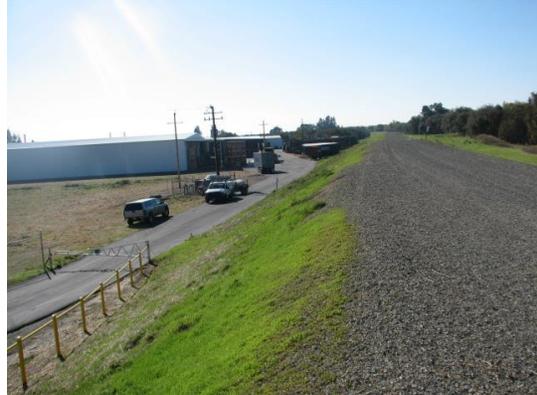
Photo 1 of 1 : FA_2015_RD0784_532_6_20150911_00001.jpg

Levee mile 9.21, new paving near the levee toe, no permit found for this work.

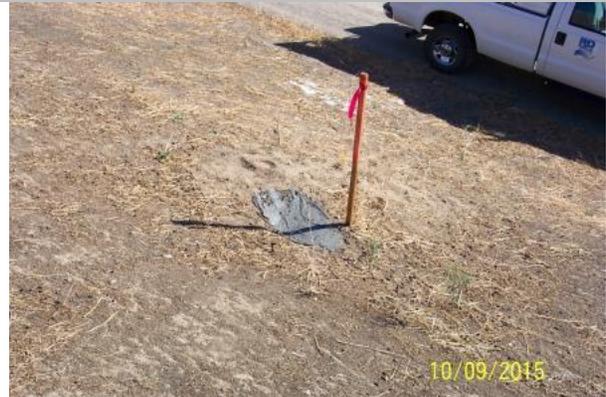
Photo 1 of 2 : FA_2015_RD0784_532_2_20151009_00004.jpg

LM Start	9.33	Rating **	A	Issue No.	2
LM End	9.33	Issue Type +	Ma	Location *	LS
Category	Earthen Levee		GPS Latitude/Longitude		
			Start	End	
Item	Animal Control		39.004951 °	39.004951 °	
			-121.578390 °	-121.578390 °	
DWR ID	DWR_RD0784_02B_f_2015_2				
Action/Comments					
No rodents visible, but rodent burrows visible; need to backfill and compact or grout burrows. Inspector Comments: LMA fixed the issue after the fall 2015 inspection.

LMA backfilled the rodent hole after the fall 2015 inspection.

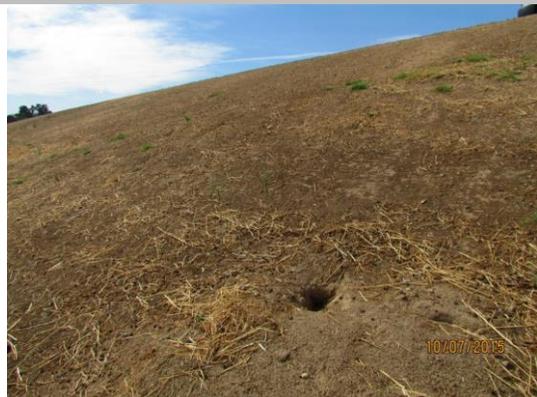
Photo 2 of 2 : FA_2015_RD0784_532_2_20151009_00003.jpg

Rodent hole was found on the landside toe of the levee looking downstream.

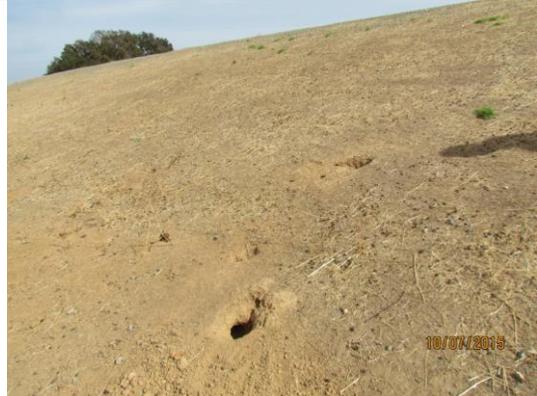
Photo 2 of 2 : FA_2015_RD0784_533_3_20151009_00001.jpg

A rodent hole was found on the landside toe of the levee looking upstream.

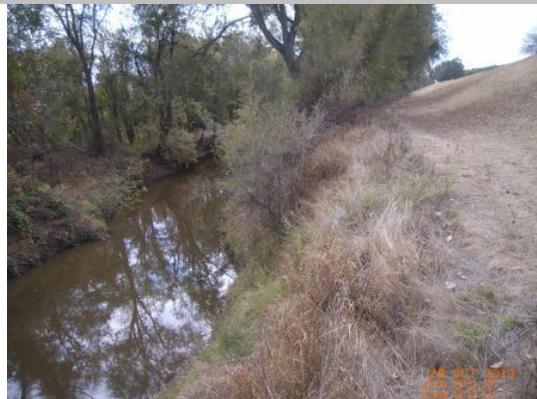
Photo 1 of 1 : USACE2013A_BER_4-9_R_4.jpg

LM Start	10.36	Rating **	M	Issue No.	2
LM End	10.40	Issue Type +	Ma	Location *	WS
Category	Supplemental		GPS Latitude/Longitude		
			Start	End	
Item	2015 USACE Erosion Survey, DRAFT		38.981400 °	38.981271 °	
			-121.515848 °	-121.515999 °	
DWR ID					
Action/Comments					
Inspector Comments: 2009 - Small site which could be repaired with maintenance. Erosion into the levee toe, rock has started to fail. 2015: Last observed in 2013. [2015 Site ID: BER_4-9_R]

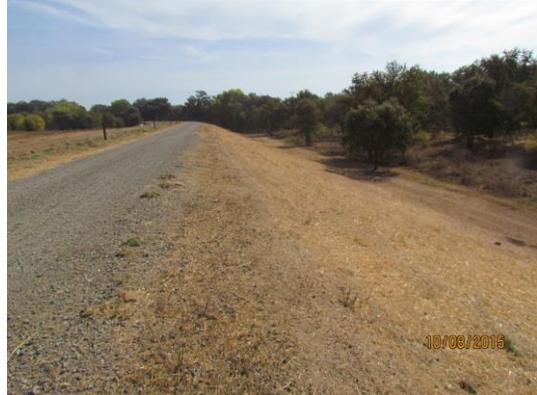
Photo 1 of 1 : FA_2015_RD0784_534_1_20151009_00001.jpg

View of acceptable vegetation on the waterside of the levee looking upstream.

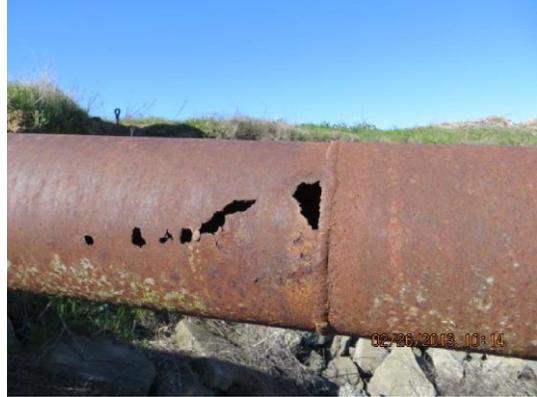
Photo 1 of 3 : UCIP_FA_2015_3430.jpg

Inspector Comments: FS_ID:46783
 DS_ID:18581
 EP_NO: 5384
 FS_HLM: 6.261
 Repair Type: Urgent
 Crossing Status: Found
 UCIP Comments: 11-1-2015 - Notification Letter Dated 1/10/2014 to fix the problem sent to property owner Vera Lyn Herrell at 18548 Ivan St., Rochester WA 98579. UPDATE: On June 11, 2014 the pipe owner accepted a blank CVFPB permit application to pursue repairs. Pending Correspondence. Requesting DWR to change the status of this issue to "No Further Action Needed by the LMA". Large animal burrough along pipe alignment on WS has undermined pipe for an unknown length. Pipe is corroded through on WS. Pipe should be properly abandoned. (W. Wylie - UCIP Inspector).
 FIELD_STRUCT_DESC: 8-inch pipe through the levee 2.6 feet below the crown. Vertical pump unit and service pole on the waterward side. Discharge into concrete riser on the landward side. (Permit No. 5384) 1966.
 FS Date: 09/11/2015

Corrosion holes through pipe on WS slope.

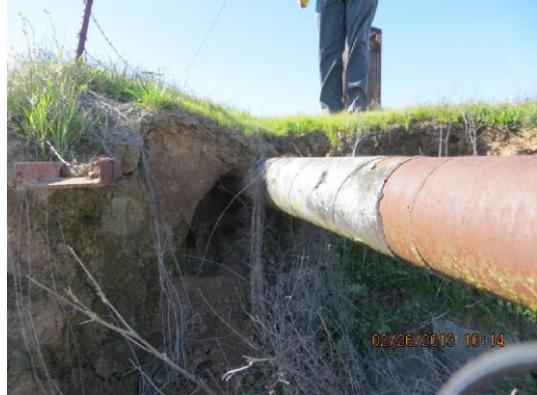
Photo 3 of 3 : UCIP_FA_2015_3432.jpg

LM Start	Rating **	U	Issue No.	4 (cont)	
LM End	Issue Type +	En	Location *	WS	
Category	Supplemental		GPS Latitude/Longitude		
			Start	End	
Item	DWR UCIP Field Study		39.058533 °	39.058533 °	
			-121.550485 °	-121.550485 °	
DWR ID					
Action/Comments					
Inspector Comments: FS_ID:46783 DS_ID:18581 EP_NO: 5384 FS_HLM: 6.261 Repair Type: Urgent Crossing Status: Found UCIP Comments: 11-1-2015 - Notification Letter Dated 1/10/2014 to fix the problem sent to property owner Vera Lyn Herrell at 18548 Ivan St., Rochester WA 98579. UPDATE: On June 11, 2014 the pipe owner accepted a blank CVFPB permit application to pursue repairs. Pending Correspondence. Requesting DWR to change the status of this issue to "No Further Action Needed by the LMA". Large animal burrough along pipe alignment on WS has undermined pipe for an unknown length. Pipe is corroded through on WS. Pipe should be properly abandoned. (W. Wylie - UCIP Inspector). FIELD_STRUCT_DESC: 8-inch pipe through the levee 2.6 feet below the crown. Vertical pump unit and service pole on the waterward side. Discharge into concrete riser on the landward side. (Permit No. 5384) 1966. FS Date: 09/11/2015

Animal burrough under pipe on WS slope.

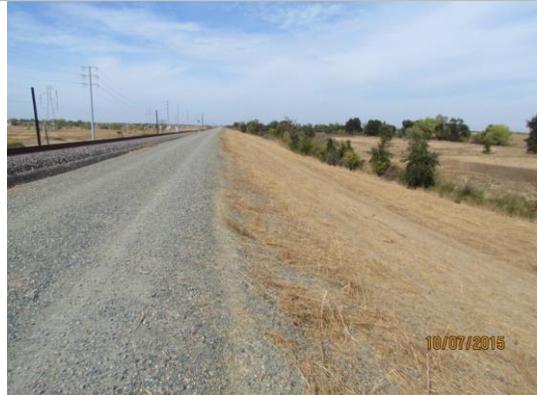
Photo 1 of 1 : FA_2015_RD0784_181_3_20151009_00001.jpg

LM Start	0.03	Rating **	A	Issue No.	3
LM End	0.03	Issue Type +	Ma	Location *	WS
Category	Earthen Levee		GPS Latitude/Longitude		
			Start	End	
Item	Vegetation		38.975170 °	38.975170 °	
			-121.535128 °	-121.535128 °	
DWR ID	DWR_RD0784_04_f_2015_3				
Action/Comments					
Control annual grass and weeds on the levee slopes and easements. Inspector Comments: Acceptable vegetation.

View of the acceptable vegetation on the waterside of the levee.

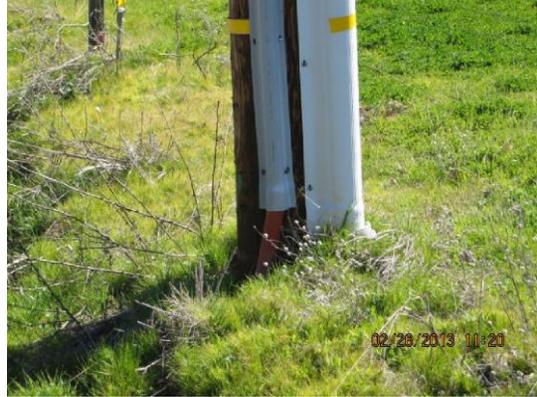
Photo 1 of 3 : UCIP_FA_2015_3444.jpg

LM Start	3.59	Rating **	M	Issue No.	5
LM End	3.59	Issue Type +	En	Location *	WS
Category	Supplemental			GPS Latitude/Longitude	
				Start	End
Item	DWR UCIP Field Study			39.026347 °	39.026347 °
				-121.542343 °	-121.542343 °
DWR ID					
Action/Comments					
Inspector Comments: FS_ID:46600 DS_ID:22686 EP_NO: N/A FS_HLM: 3.603 Repair Type: Non-Urgent Crossing Status: Found UCIP Comments: No permit identified for crossing. FIELD_STRUCT_DESC: Communication line through the levee at unknown depth on downstream side of bridge. FS Date: 09/11/2015

Communication line runs on south side of Plumas Arboga Road to JP approximately 400-feet West of levee crown.

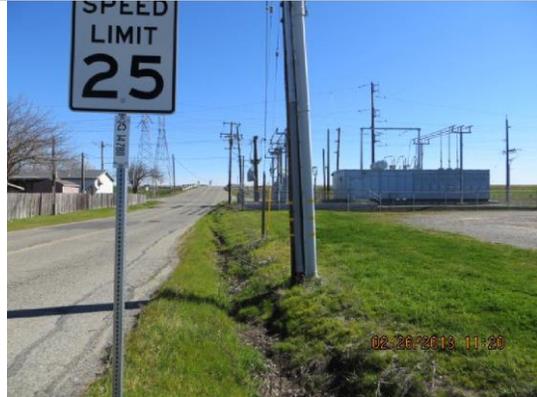
Photo 2 of 3 : UCIP_FA_2015_3445.jpg

Communication line runs on south side of Plumas Arboga Road to JP approximately 400-feet West of levee crown.

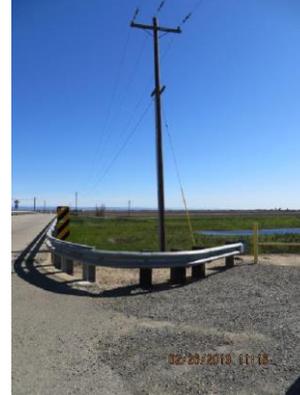
Photo 3 of 3 : UCIP_FA_2015_3446.jpg

LM Start	3.59	Rating **	M	Issue No.	5 (cont)
LM End	3.59	Issue Type +	En	Location *	WS
Category	Supplemental			GPS Latitude/Longitude	
				Start	End
Item	DWR UCIP Field Study			39.026347 °	39.026347 °
				-121.542343 °	-121.542343 °
DWR ID					
Action/Comments					
Inspector Comments: FS_ID:46600 DS_ID:22686 EP_NO: N/A FS_HLM: 3.603 Repair Type: Non-Urgent Crossing Status: Found

Communication line at base of JP on WS slope.

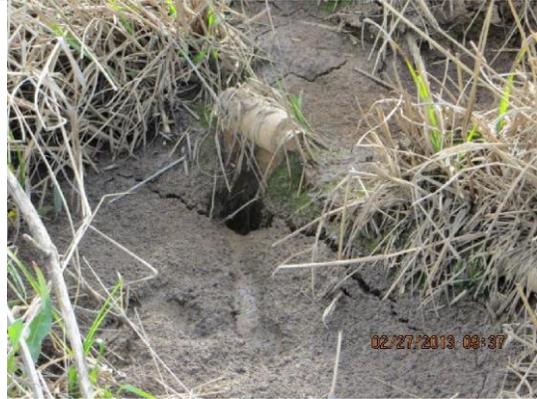
Photo 1 of 3 : UCIP_FA_2015_3282.jpg

LM Start	Rating **	M	Issue No.	12
LM End	Issue Type +	En	Location *	WS
Category	Supplemental	GPS Latitude/Longitude		
		Start	End	
Item	DWR UCIP Field Study	39.019787 °	39.019787 °	
		-121.513386 °	-121.513386 °	
DWR ID				
Action/Comments				
Inspector Comments: FS_ID:46781 DS_ID:18593 EP_NO: N/A FS_HLM: 3.96 Repair Type: Non-Urgent Crossing Status: Found UCIP Comments: 11-1-2015 - Waterside Flap Gate Uncovered. Photo sent to DWR Matt Hoffman on 3/3/2014. Fresh photo sent to DWR Pavel Kazi on 9/9/2015. Landside toe has never been able to be located. Requesting DWR inspector to change the status of this issue to "No Action Needed". (P.Meagher - RD784). Pipe buried on LS toe and flap gate is blocked by soil on WS toe. (W. Wylie - UCIP Inspector). FIELD_STRUCT_DESC: 18-inch CM pipe through the levee, 10.0 feet below the crown. Flap gate on the waterward end. Originally included in O+M manual (1955). FS Date: 10/09/2015

Flap gate buried in soil at outlet on WS toe.

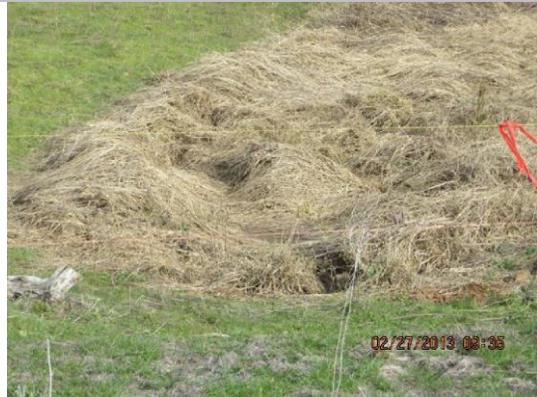
Photo 2 of 3 : UCIP_FA_2015_3283.jpg

Outlet on WS toe .

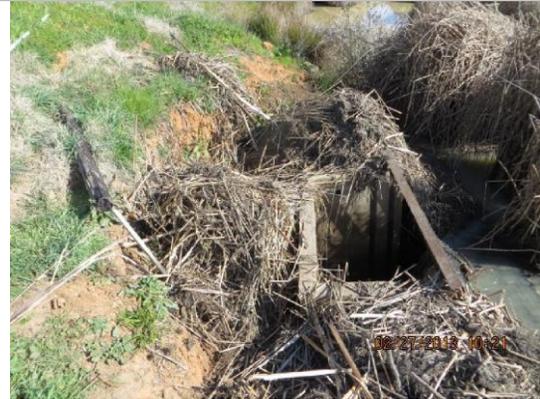
Photo 1 of 3 : UCIP_FA_2015_3455.jpg

LM Start	Rating **	M	Issue No.	13	
LM End	Issue Type +	En	Location *	WS	
Category	Supplemental		GPS Latitude/Longitude		
			Start	End	
Item	DWR UCIP Field Study		39.008994 °	39.008994 °	
			-121.535679 °	-121.535679 °	
DWR ID					
Action/Comments					
Inspector Comments: FS_ID:46780 DS_ID:18597 EP_NO: N/A FS_HLM: 2.468 Repair Type: Non-Urgent Crossing Status: Found UCIP Comments: 11-1-2015 The concrete box weir structure on the landside inlet has slumped off the end of the pipe. DWR Chief inspector George Willie inspected the site on 8/13/2015 with Steve Fordice, General Manager of RD784. (P.Meagher - RD784) Heavy erosion around inlet headwall due to beaver activity. (W. Wylie - UCIP Inspector) FIELD_STRUCT_DESC: 18-inch CM drain pipe through the levee, 15.5 feet below the crown. Flap gate on the waterward end. Concrete "U" headwall on the waterward side. Originally included in O+M manual (1955). Modifications made to this crossing under permit No. 9230, 1974. FS Date: 09/11/2015

Erosion and debris from Beaver activity.

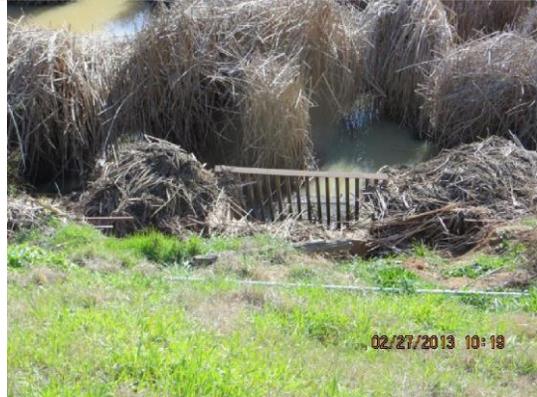
Photo 2 of 3 : UCIP_FA_2015_3456.jpg

Inlet on LS.

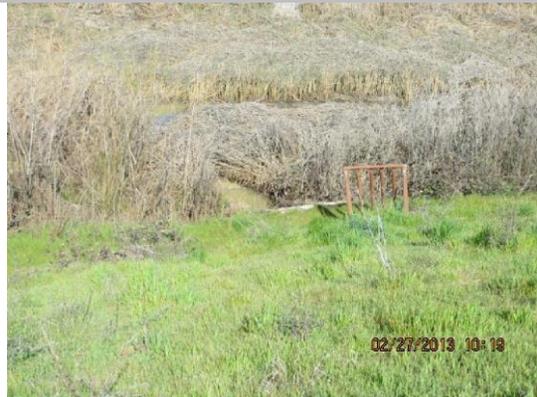
Photo 3 of 3 : UCIP_FA_2015_3457.jpg

Outlet on WS.

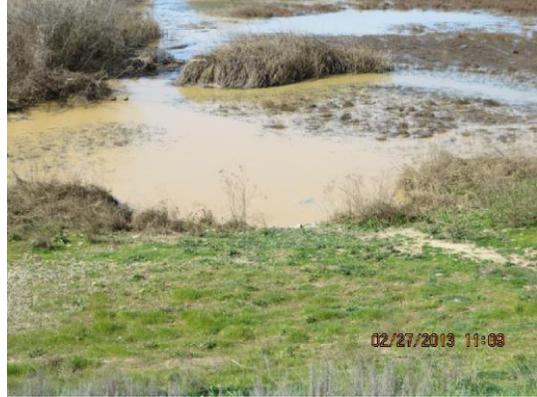
Photo 1 of 2 : UCIP_FA_2015_3447.jpg

LM Start	0.84	Rating **	M	Issue No.	14
LM End	0.84	Issue Type +	En	Location *	WS
Category	Supplemental			GPS Latitude/Longitude	
				Start	End
Item	DWR UCIP Field Study			38.986432 °	38.986432 °
				-121.534983 °	-121.534983 °
DWR ID					
Action/Comments					
Inspector Comments: FS_ID:46592 DS_ID:18591 EP_NO: N/A FS_HLM: 0.832 Repair Type: Non-Urgent Crossing Status: Found

Outlet with riprap on WS toe.

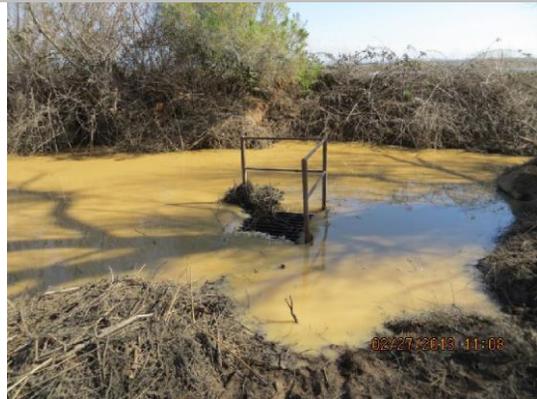
Photo 2 of 2 : UCIP_FA_2015_3448.jpg

Concrete drop-inlet at LS toe.

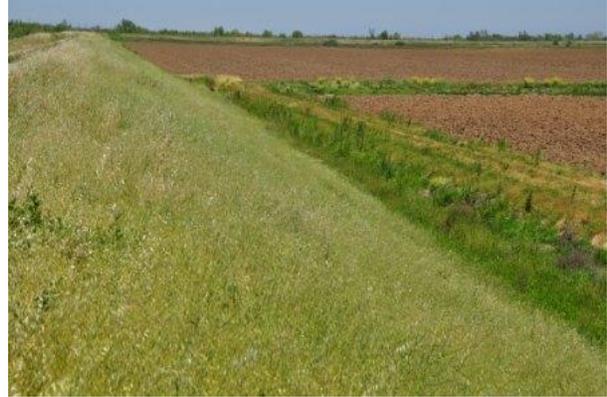
Photo 1 of 1 : FA_2015_RD0784_182_10_20150911_00002.jpg

Ditch at L/S toe.

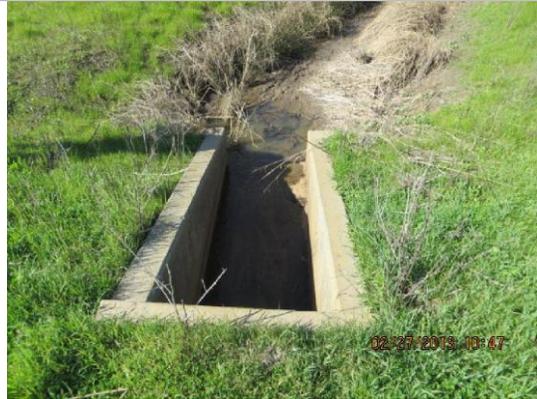
Photo 1 of 3 : UCIP_FA_2015_3449.jpg

Concrete U-shaped outlet and flap-gate on WS toe.

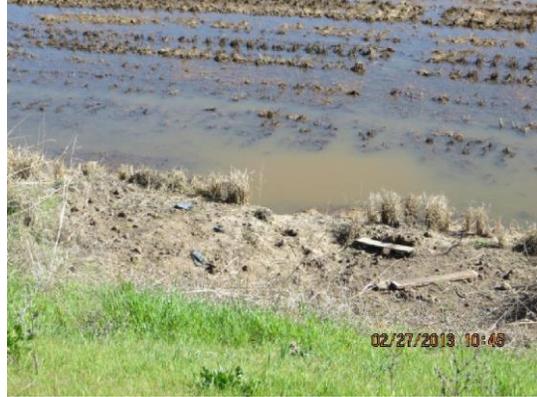
Photo 2 of 3 : UCIP_FA_2015_3450.jpg

Debris covered inlet on LS toe.

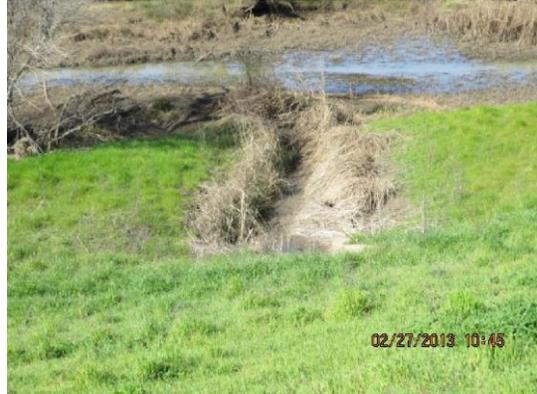
Photo 3 of 3 : UCIP_FA_2015_3451.jpg

Drainage outlet on WS toe.

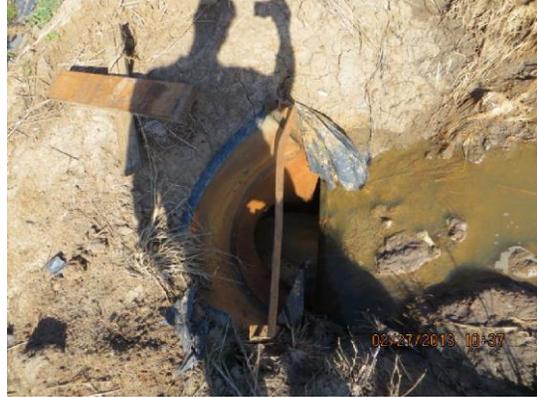
Photo 1 of 3 : UCIP_FA_2015_3452.jpg

Inlet with PVC weir on LS toe.

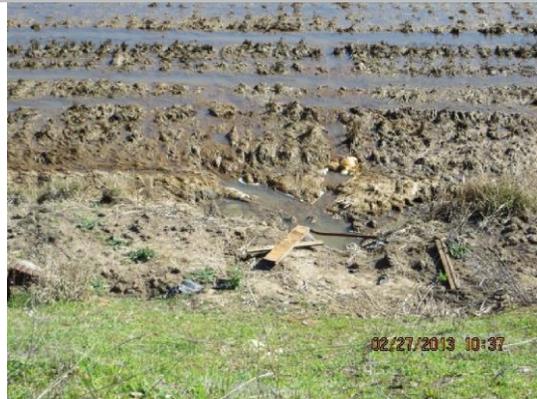
Photo 2 of 3 : UCIP_FA_2015_3453.jpg

Inlet with PVC weir on LS toe.

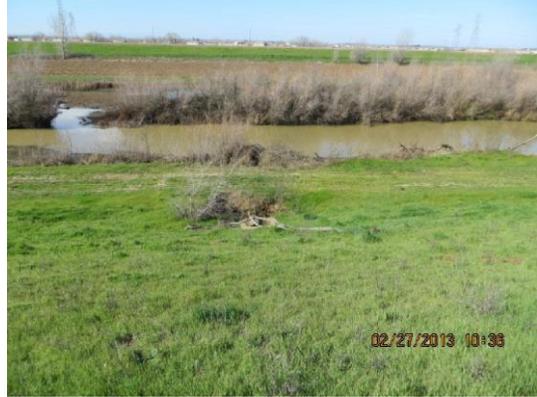
Photo 3 of 3 : UCIP_FA_2015_3454.jpg

Concrete U-shaped outlet on WS toe.

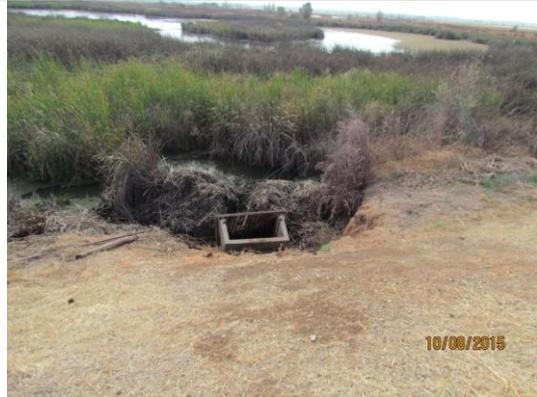
Photo 1 of 2 : FA_2015_RD0784_182_11_20151009_00004.jpg

View of the broken headwall on the landside of the levee.

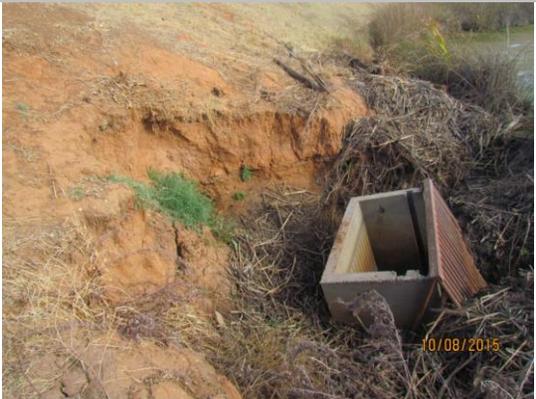
Photo 2 of 2 : FA_2015_RD0784_182_11_20151009_00006.jpg

View of the broken headwall and erosion on the landside toe of the levee looking upstream.

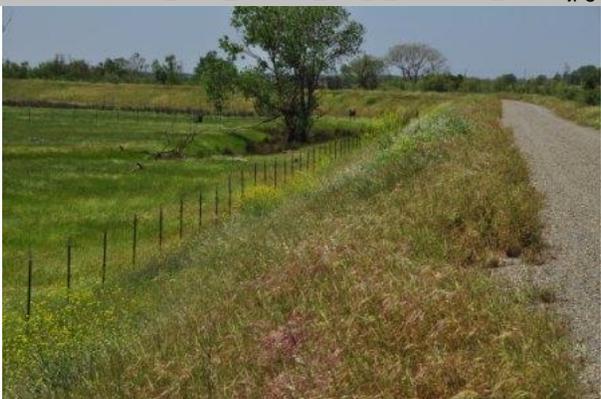
Photo 1 of 1 : FA_2015_RD0784_182_5_20150911_00001.jpg

Fence at L/S levee toe.

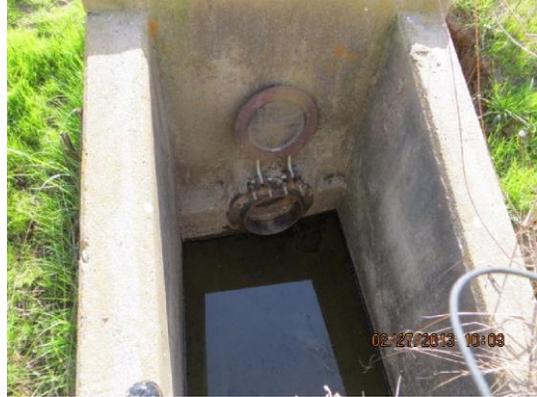
Photo 1 of 3 : UCIP_FA_2015_3475.jpg

Concrete U-shaped headwall and flap gate on WS toe.

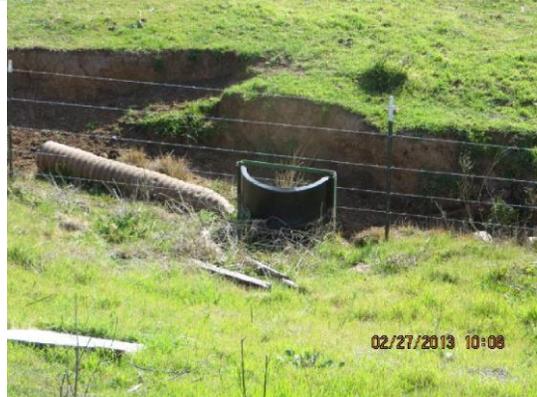
Photo 2 of 3 : UCIP_FA_2015_3476.jpg

PVC weir on LS toe. Notice pipe debris from repair.

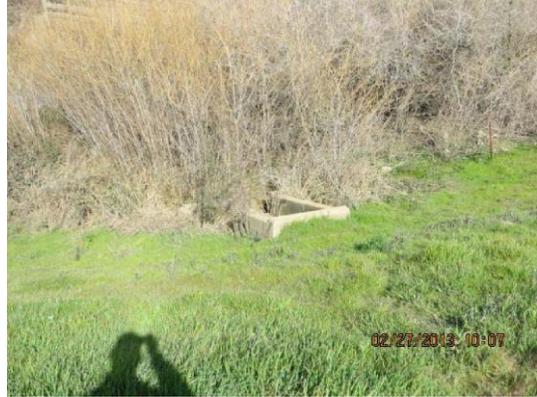
Photo 3 of 3 : UCIP_FA_2015_3477.jpg

Concrete U-shaped headwall on WS toe.

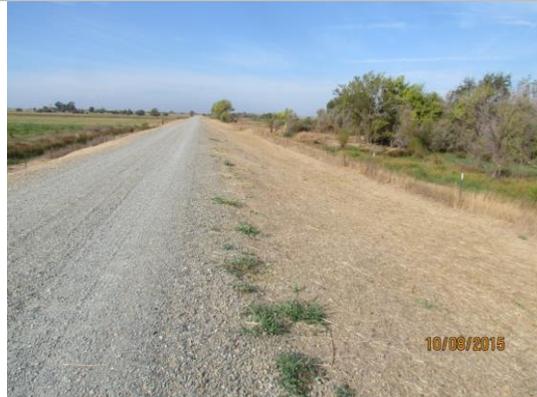
Photo 1 of 1 : FA_2015_RD0784_182_6_20151009_00003.jpg

View of acceptable vegetation on the waterside of the levee looking downstream.

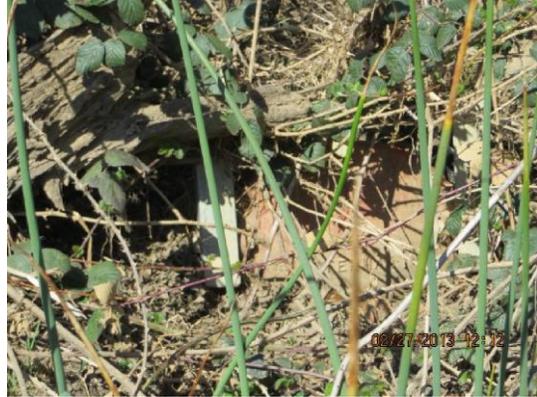
Photo 1 of 3 : UCIP_FA_2015_3478.jpg

Flap gate blocked by vegetation at WS.

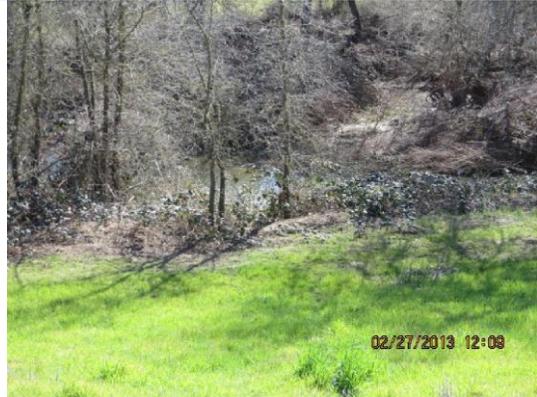
Photo 2 of 3 : UCIP_FA_2015_3479.jpg

Outlet at WS stream bank.

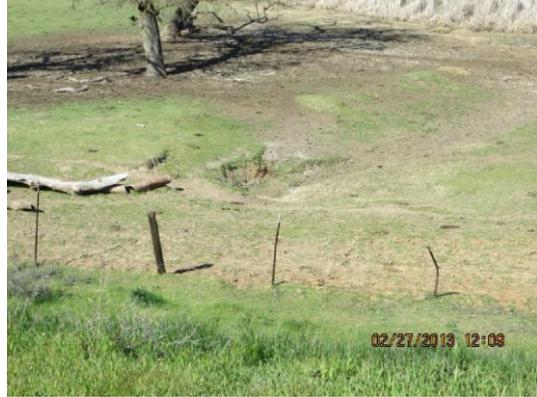
Photo 3 of 3 : UCIP_FA_2015_3480.jpg

INlet at LS toe.

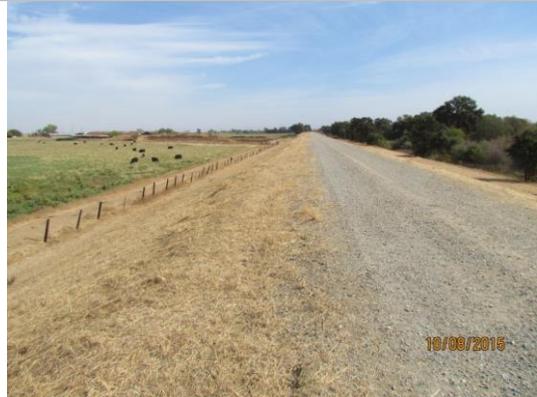
Photo 1 of 1 : FA_2015_RD0784_183_5_20151009_00004.jpg

View of acceptable vegetation on the landside of the levee looking upstream.

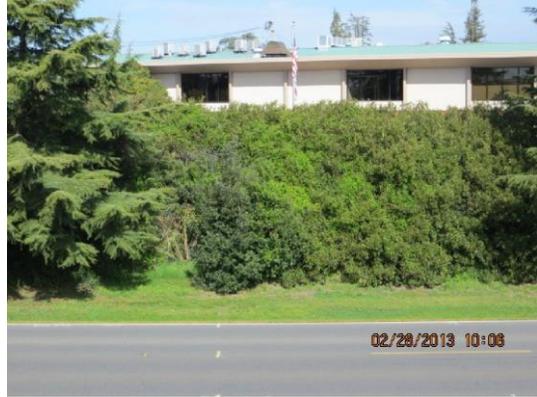
Photo 1 of 2 : UCIP_FA_2015_3433.jpg

Alignment of pipe is approximately in-line with the flag pole on LS building.

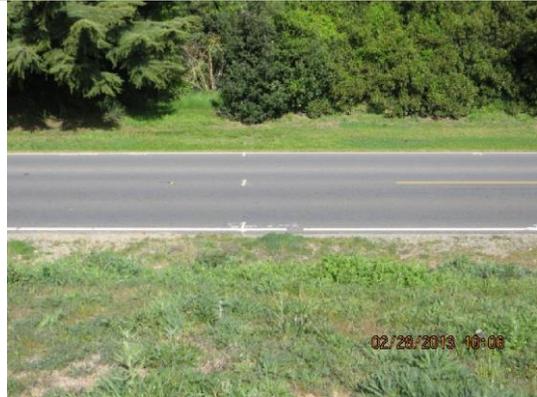
Photo 2 of 2 : UCIP_FA_2015_3434.jpg

Paint alignment marks on pavement, LS toe.

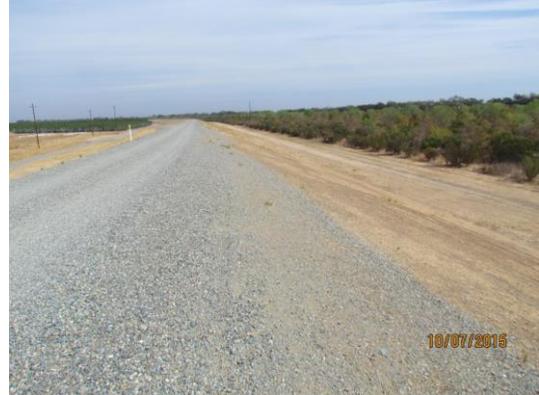
Photo 1 of 1 : FA_2015_RD0784_437_1_20151009_00001.jpg

View of the acceptable vegetation on the waterside of the levee.

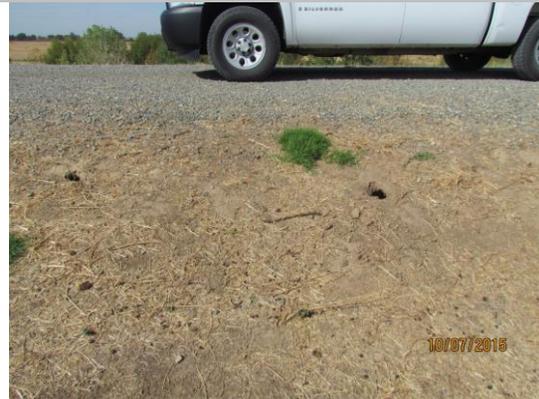
Photo 2 of 2 : FA_2015_RD0784_530_1_20151009_00003.jpg

Rodent holes were found on the landside of the levee.

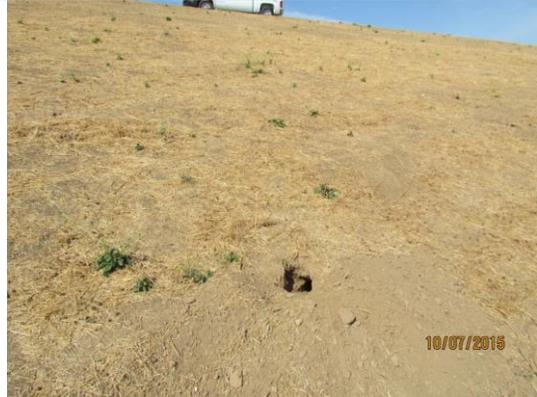
Photo 2 of 2 : FA_2015_RD0784_530_4_20151009_00004.jpg

An animal hole was found on the landside toe of the levee looking upstream.

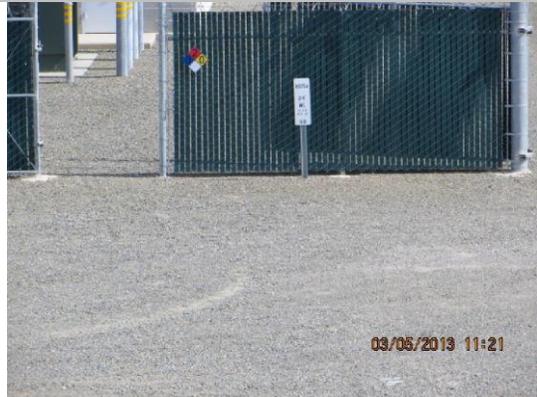
Photo 1 of 2 : UCIP_FA_2015_1427.jpg

Paddle marker on LS toe at pumping plant fence.

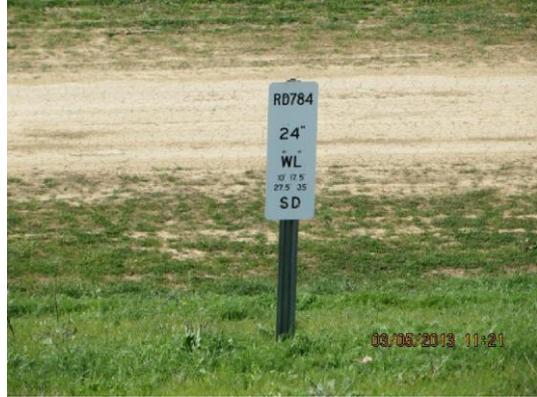
Photo 2 of 2 : UCIP_FA_2015_1428.jpg

Paddle marker on WS toe.

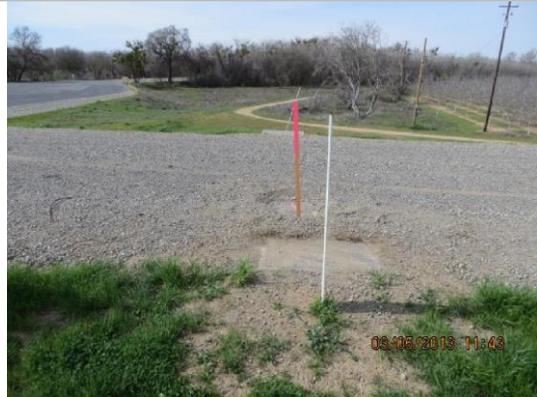
Photo 1 of 2 : UCIP_FA_2015_1425.jpg

Christy box on LS shoulder.
