**Flood Control Project Maintenance
Levee Inspections**
LMA District Cover Sheet
Spring 2012 Levee Inspection Results

Reclamation District No. 0784 Plumas Lake

Levee Inspection Report By Mile - Spring 2012

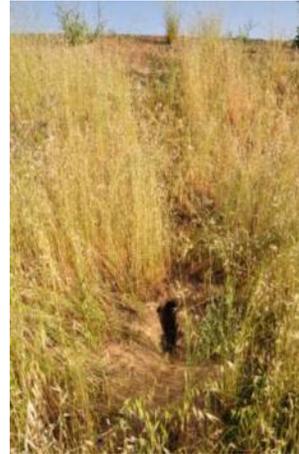
Levee Mile Report Line	4
Start Levee Mile	0.12
End Levee Mile	0.12
Location	Land Side
Category	Earthen Levee
Item	Animal Control
Rodent burrow on L/S slope.	
rburnett_s_20120521_373.JPG

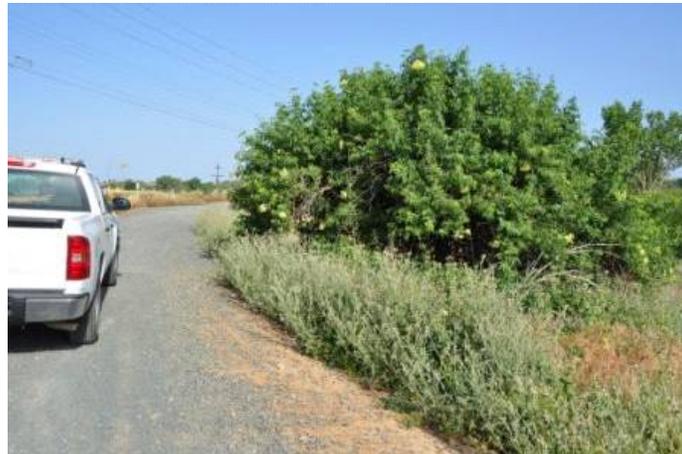
Levee Mile Report Line	5
Start Levee Mile	1.28
End Levee Mile	1.28
Location	Water Side
Category	Earthen Levee
Item	Vegetation
W/S slope vegetation, Elderberry.	
rburnett_s_20120521_374.JPG

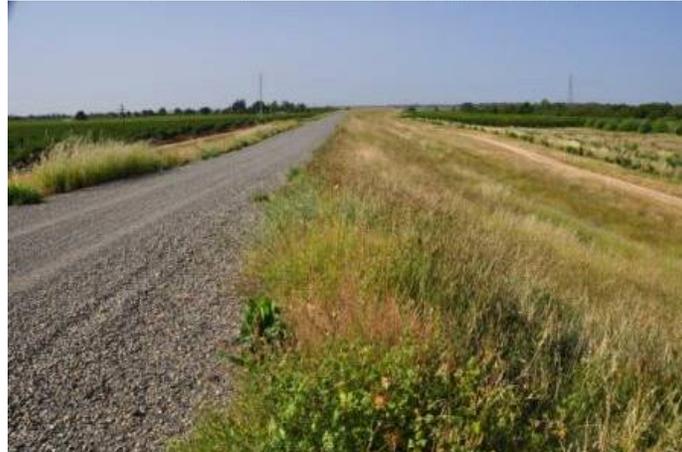
Levee Mile Report Line	1
Start Levee Mile	1.50
End Levee Mile	1.50
Location	Land Side
Category	Earthen Levee
Item	Vegetation
Typical W/S slope vegetation.	
dpesaven_s_20120601_376.JPG

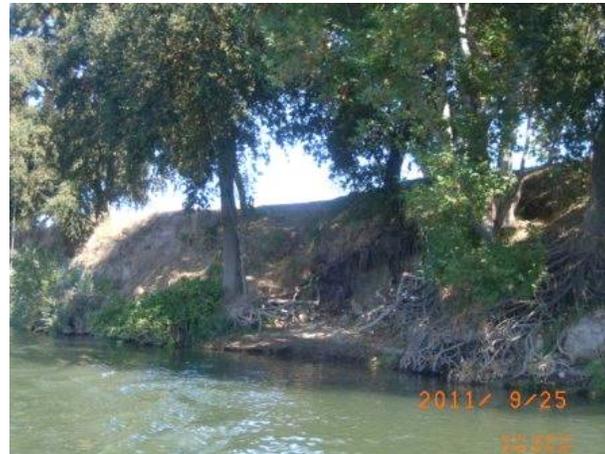
Levee Mile Report Line	2
Start Levee Mile	8.90
End Levee Mile	9.23
Location	Water Side
Category	Supplemental
Item	USACE Erosion Survey
USACE 2011 Photo #4	
rburnett_s_20120508_009.jpg

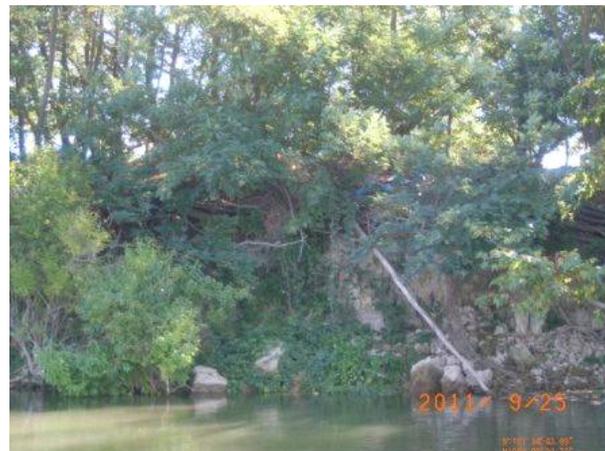
Levee Mile Report Line	2
Start Levee Mile	8.90
End Levee Mile	9.23
Location	Water Side
Category	Supplemental
Item	USACE Erosion Survey
USACE 2011 Photo #5	
rburnett_s_20120508_010.jpg

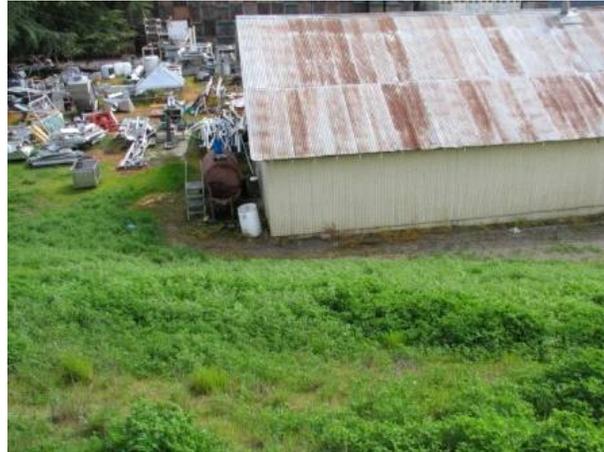
Levee Mile Report Line	3
Start Levee Mile	9.40
End Levee Mile	9.40
Location	Land Side
Category	Earthen Levee
Item	Encroachments

DWR ID: DWR_RD0784_02_s_2012_2										
3	9.40	9.40	Earthen Levee	Encroachments	LS	U En	BU : Buildings	39.003905 ° -121.578774 °	39.003905 ° -121.578774 °	1 Y
DWR ID: DWR_RD0784_02_s_2012_1										
4	10.08	10.08	Earthen Levee	Vegetation	LS	A Ma	V1 : Control annual grass and weeds on the levee slopes and easements.	38.994130 ° -121.580283 °	38.994130 ° -121.580283 °	3
DWR ID: DWR_RD0784_02_s_2012_3

Levee mile 9.40, looking at a building that is encroaching on the levee toe.

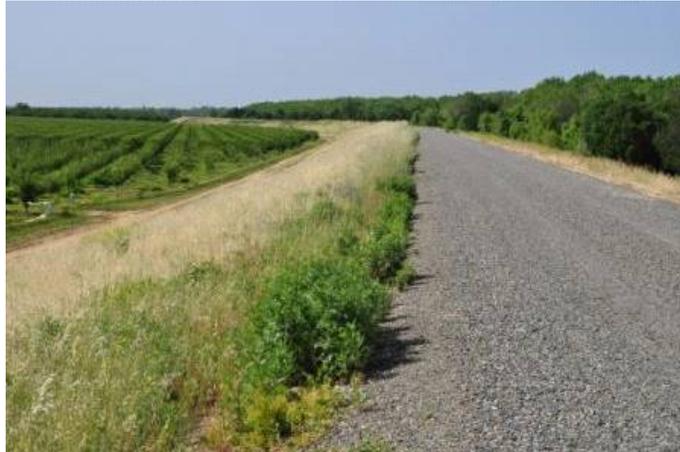
Levee Mile Report Line	1
Start Levee Mile	0.00
End Levee Mile	0.00
Location	Land Side
Category	Earthen Levee
Item	Vegetation

Typical view of vegetation.

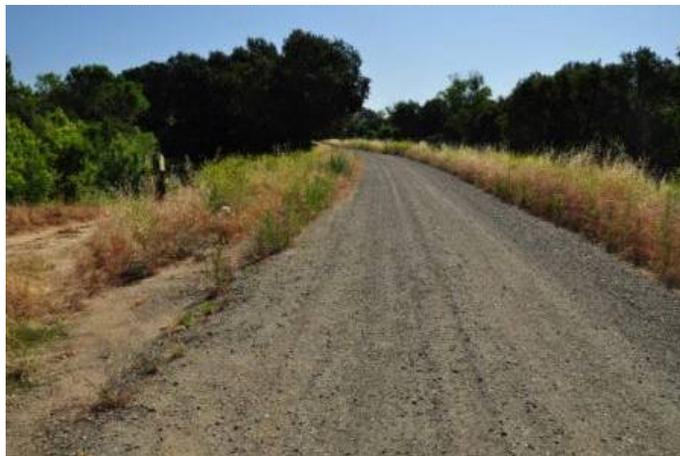
Levee Mile Report Line	4
Start Levee Mile	3.23
End Levee Mile	4.71
Location	Water Side
Category	Earthen Levee
Item	Vegetation

RD 784 Unit 3 - Vegetation

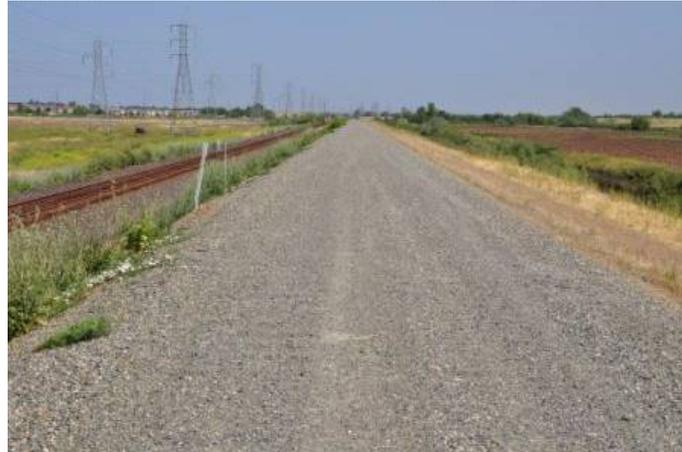
Typical vegetation throughout Unit 4.

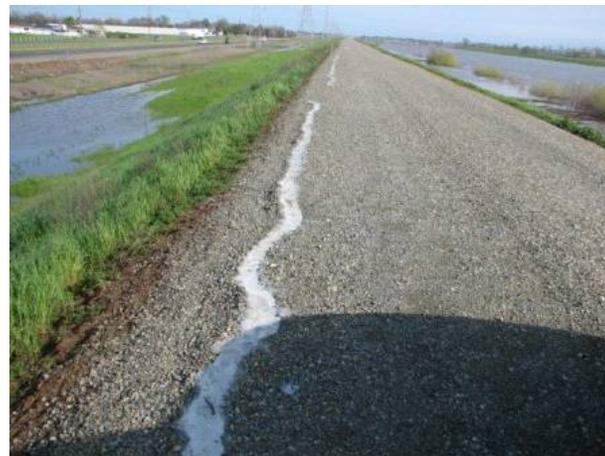
Levee Mile Report Line	3
Start Levee Mile	4.31
End Levee Mile	4.43
Location	Crown
Category	Earthen Levee
Item	Erosion / Bank Caving

Levee mile 4.31, looking at a crack near the landside shoulder with a temporary repair.

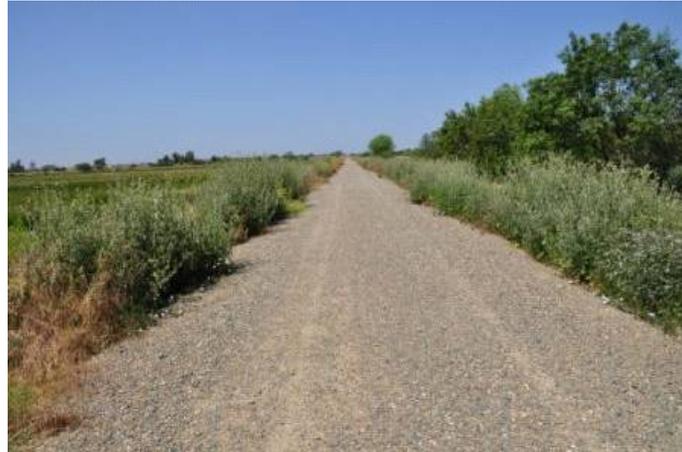
Typical vegetation throughout Unit 5.

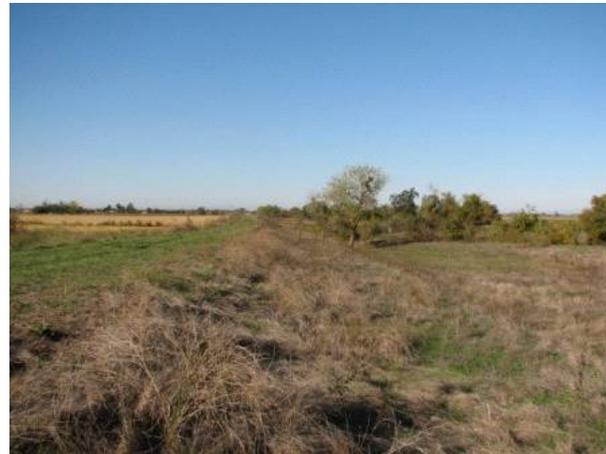
Levee Mile Report Line	6
Start Levee Mile	3.89
End Levee Mile	4.20
Location	Water Side
Category	Earthen Levee
Item	Vegetation

This photo shows the waterside vegetation at levee mile 4.20.

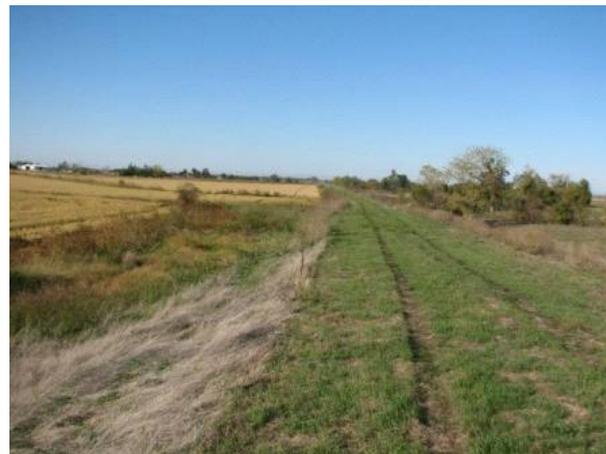
Levee Mile Report Line	8
Start Levee Mile	3.89
End Levee Mile	4.20
Location	Land Side
Category	Earthen Levee
Item	Vegetation

This photo shows the landside vegetation at levee mile 4.20.

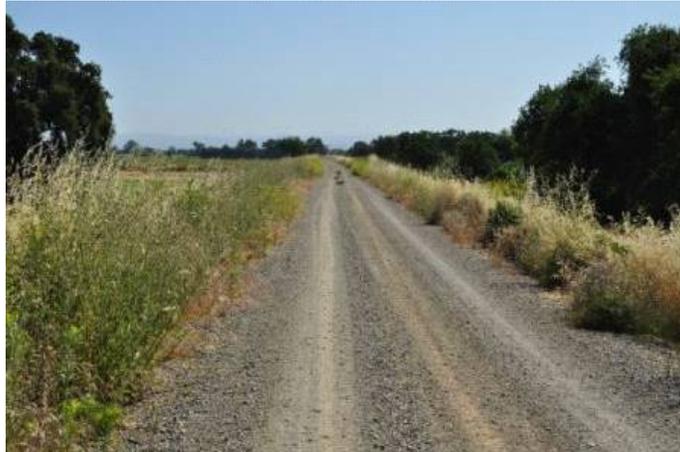
Levee Mile Report Line	1
Start Levee Mile	0.00
End Levee Mile	0.24
Location	Land Side
Category	Earthen Levee
Item	Vegetation
RD 784 Unit 6 - Vegetation	
rburnett_s_20120601_450.JPG

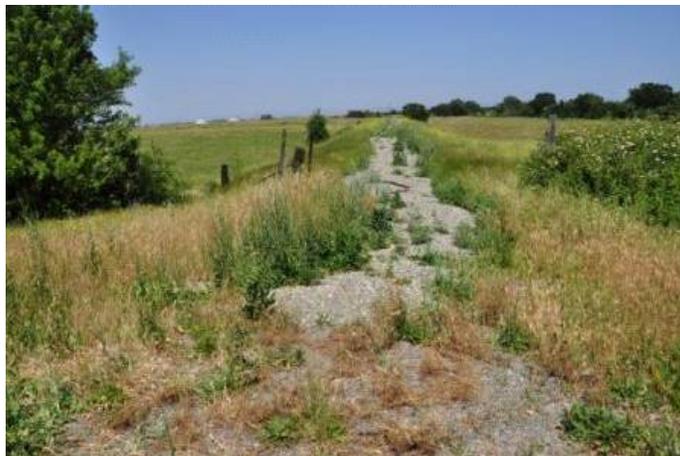
Levee Mile Report Line	4
Start Levee Mile	1.27
End Levee Mile	1.50
Location	Crown
Category	Earthen Levee
Item	Crown Surface / Depressions / Rutting
Spray crown roadway for vegetation. Control vegetation on both slopes. (Maintained by RD 817)	
rburnett_s_20120521_379.JPG

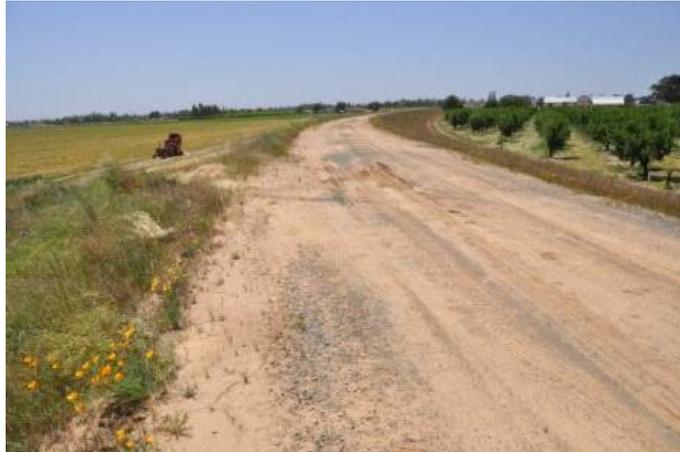
Levee Mile Report Line	1
Start Levee Mile	1.02
End Levee Mile	1.62
Location	Crown
Category	Earthen Levee
Item	Crown Surface / Depressions / Rutting
Crown roadway needs gravel. Looking west.	
rburnett_s_20120514_354.JPG

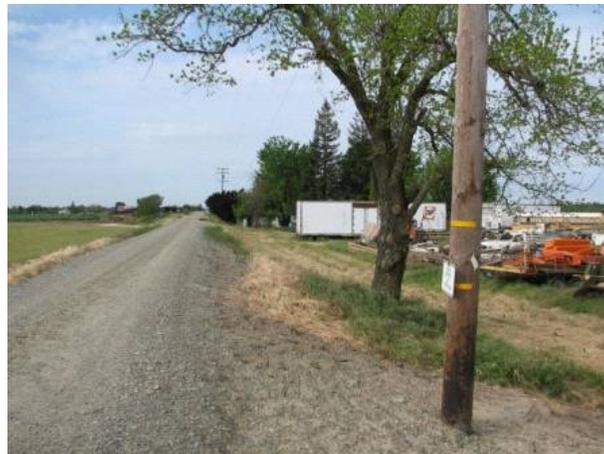
Levee Mile Report Line	2
Start Levee Mile	2.18
End Levee Mile	2.18
Location	Water Side
Category	Earthen Levee
Item	Encroachments
Water side buildings and equipment levee mile 2.18.	
rburnett_s_20120508_015.jpg

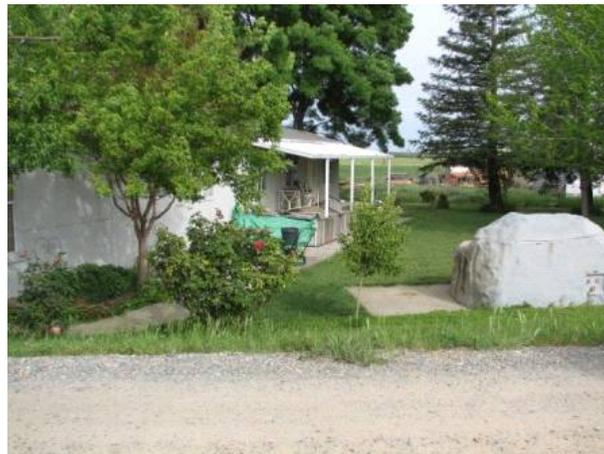
Levee Mile Report Line	2
Start Levee Mile	2.18
End Levee Mile	2.18
Location	Water Side
Category	Earthen Levee
Item	Encroachments
Water side buildings and equipment levee mile 2.18.	
rburnett_s_20120508_016.jpg

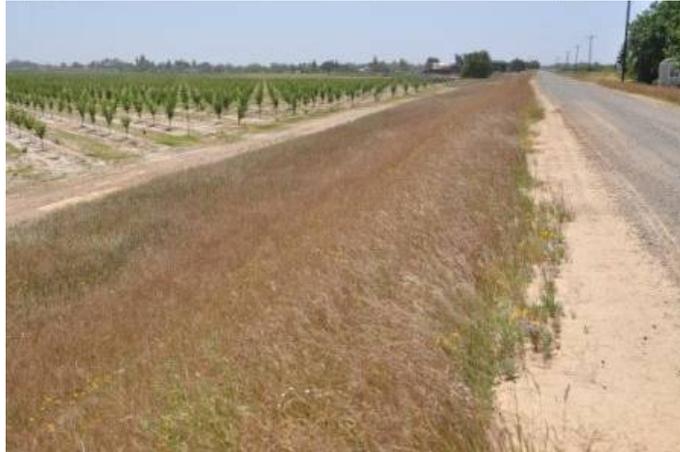
Levee Mile Report Line	3
Start Levee Mile	2.26
End Levee Mile	2.26
Location	Land Side
Category	Earthen Levee
Item	Vegetation
New levee, native grasses, typical.	
rburnett_s_20120514_353.JPG

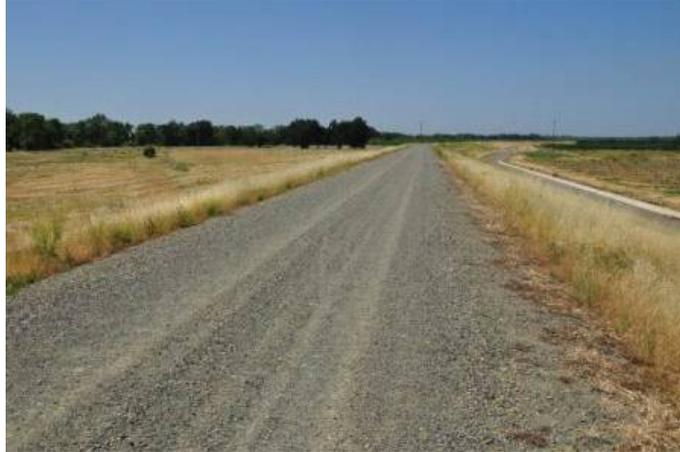
Levee Mile Report Line	1
Start Levee Mile	0.00
End Levee Mile	0.00
Location	Water Side
Category	Earthen Levee
Item	Vegetation
RD 784 Unit 8 - Vegetation	
rburnett_s_20120601_451.JPG

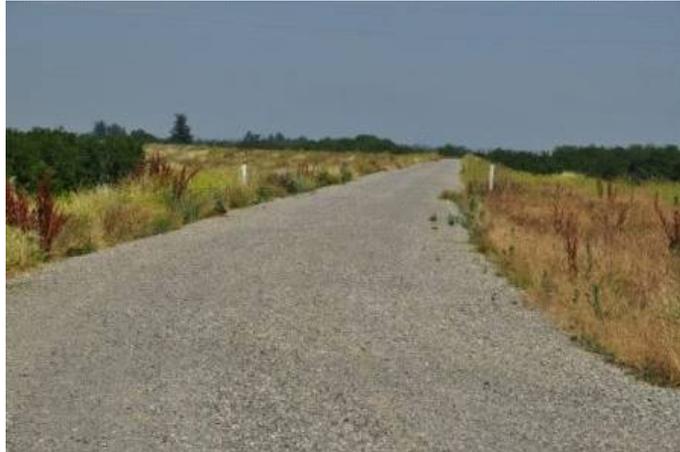
View of typical vegetation.
