**Flood Control Project Maintenance
Levee Inspections**
LMA District Cover Sheet
Spring 2013 Levee Inspection Results

Reclamation District No. 0784 Plumas Lake

Spring 2013 Levee Inspection Results

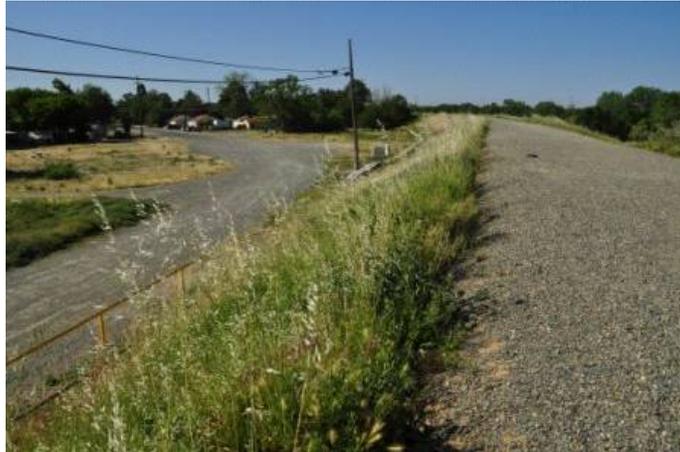
Levee Mile Report Line	4
Start Levee Mile	0.06
End Levee Mile	2.21
Location	Land Side
Category	
Item	Vegetation
Typical L/S vegetation.	
rburnett_s_20130424_263.JPG

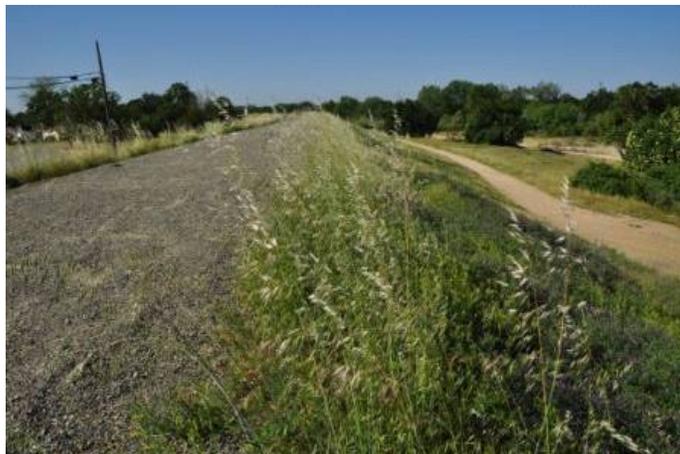
Levee Mile Report Line	5
Start Levee Mile	0.06
End Levee Mile	2.21
Location	Water Side
Category	
Item	Vegetation
Typical W/S vegetation.	
rburnett_s_20130424_262.JPG

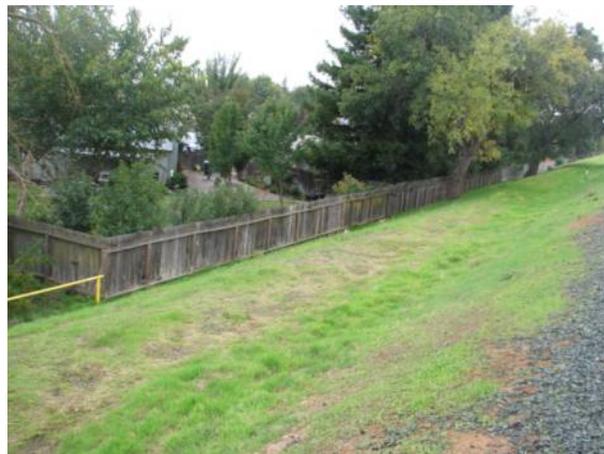
Levee Mile Report Line	6
Start Levee Mile	0.52
End Levee Mile	1.00
Location	Land Side
Category	
Item	Encroachments
Levee mile 0.53-1.00, this photo shows the fences and other obstruction near the toe of the levee on the landside.	
jhirabay_s_20130314_040.JPG

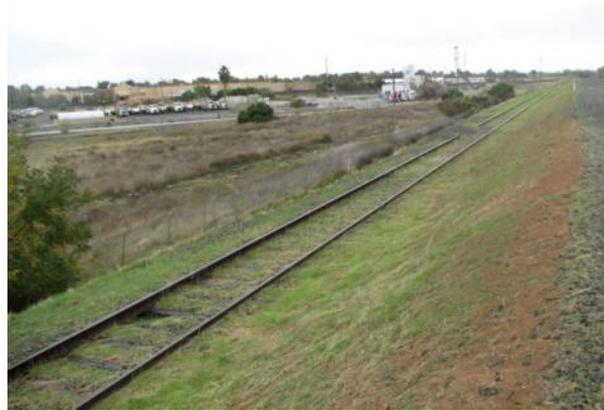
Levee Mile Report Line	7
Start Levee Mile	1.00
End Levee Mile	1.12
Location	Land Side
Category	
Item	Encroachments
Levee mile 1.00-1.12, this photo shows a fence near the levee toe on the landside.	
jhirabay_s_20130314_041.JPG

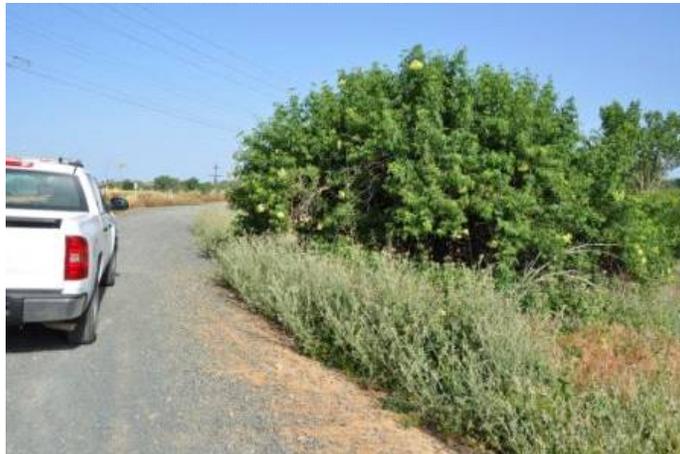
Levee Mile Report Line	8
Start Levee Mile	1.28
End Levee Mile	1.28
Location	Water Side
Category	
Item	Vegetation
W/S slope vegetation, Elderberry.	
jhirabay_s_20130314_039.JPG

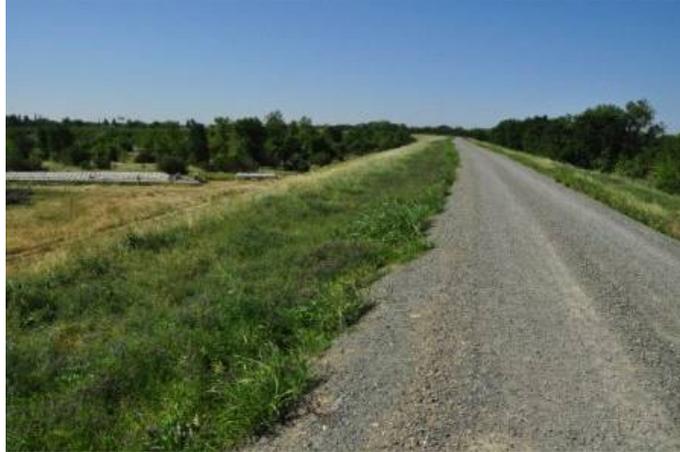
Levee Mile Report Line	1
Start Levee Mile	0.00
End Levee Mile	2.31
Location	Land Side
Category	
Item	Vegetation
Typical L/S vegetation.	
rburnett_s_20130424_264.JPG

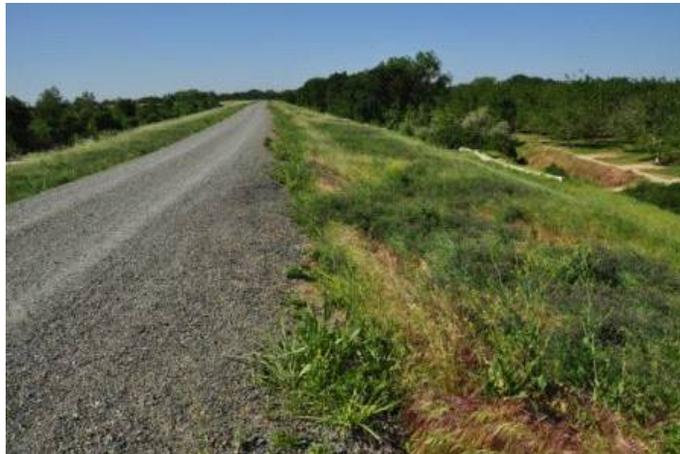
Levee Mile Report Line	2
Start Levee Mile	0.01
End Levee Mile	2.31
Location	Water Side
Category	
Item	Vegetation
Typical W/S vegetation.	
rburnett_s_20130424_265.JPG

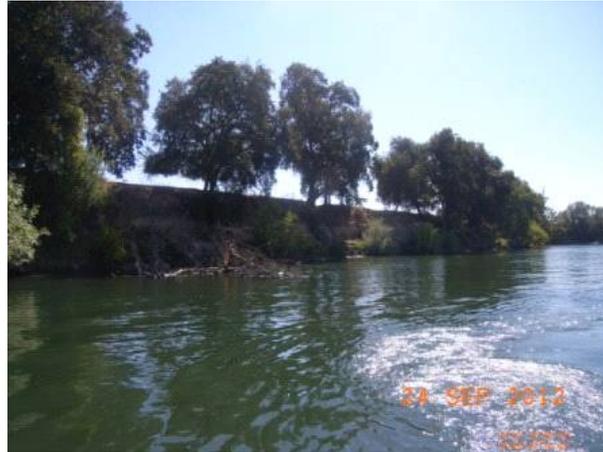
LMIR No.	Levee Mile		Category	Item	Location	Rating	Action/Comment	GPS Latitude/Longitude		Issue No. Photo
	Start	End						Start	End	
1	8.72	9.14	Supplemental	USACE Erosion Survey	WS	M Ma	Inspector Comments: 2003 - Bank is near vertical. Identified as a Potentially Critical site. 2004 - Eddy flow off downstream end of Modesto formation eroding the fluvial sediments. 2005 - Some new slumping. Actively eroding but berm width is greater than 50 ft. 2006 - Downgraded to regular erosion site. Still actively eroding. Large old rotational failures in high bank on the downstream end. 2008 - Removed from inventory due to wide berm width does not meet criteria for an erosion site. 2010 - Added back to the inventory after 10 ft of bank erosion in the winter 2009 storm. Steep vertical face. 2011 - Bank has retreated an additional 2.5 ft from last year. New tree popouts and erosion throughout the site. 2012: Site continues to worsen with new tree popouts and many areas of new erosion. [2012 Site ID: FHR_17-8_L]	39.009366 ° -121.579766 °	39.004549 ° -121.579143 °	2 Y

Levee Mile Report Line	1
Start Levee Mile	8.72
End Levee Mile	9.14
Location	Water Side
Category	Supplemental
Item	USACE Erosion Survey
USACE 2012 Photo #1	
jhirabay_s_20130314_043.jpg

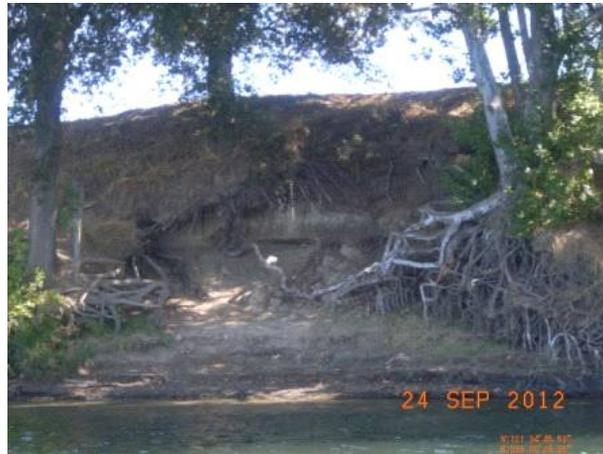
Levee Mile Report Line	1
Start Levee Mile	8.72
End Levee Mile	9.14
Location	Water Side
Category	Supplemental
Item	USACE Erosion Survey
USACE 2012 Photo #2	
jhirabay_s_20130314_044.jpg

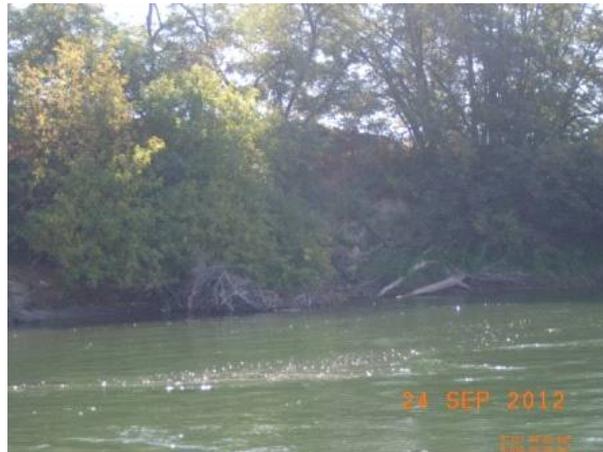
Levee Mile Report Line	1
Start Levee Mile	8.72
End Levee Mile	9.14
Location	Water Side
Category	Supplemental
Item	USACE Erosion Survey
USACE 2012 Photo #3	
jhirabay_s_20130314_045.jpg

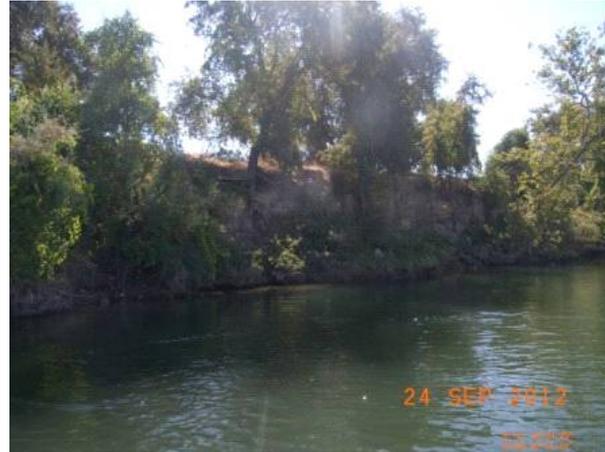
Levee Mile Report Line	1
Start Levee Mile	8.72
End Levee Mile	9.14
Location	Water Side
Category	Supplemental
Item	USACE Erosion Survey
USACE 2012 Photo #4	
jhirabay_s_20130314_046.jpg

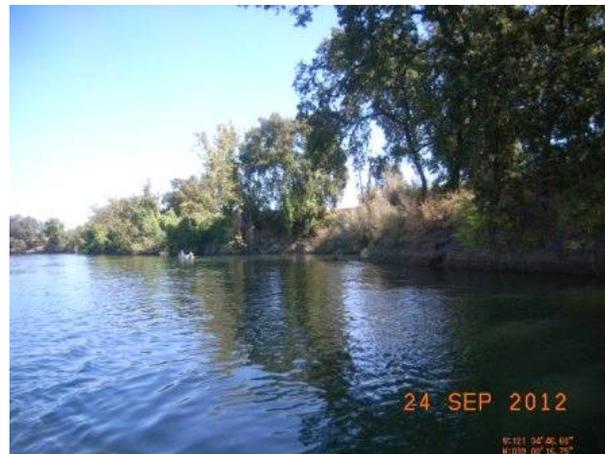
Levee Mile Report Line	1
Start Levee Mile	8.72
End Levee Mile	9.14
Location	Water Side
Category	Supplemental
Item	USACE Erosion Survey
USACE 2012 Photo #5	
jhirabay_s_20130314_047.jpg

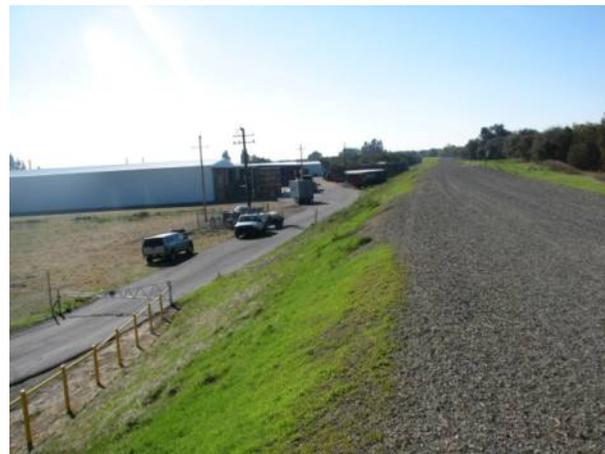
Levee Mile Report Line	4
Start Levee Mile	9.21
End Levee Mile	9.29
Location	Land Side
Category	
Item	Encroachments
Levee mile 9.21, new paving near the levee toe, no permit found for this work.	
jhirabay_s_20130314_048.JPG

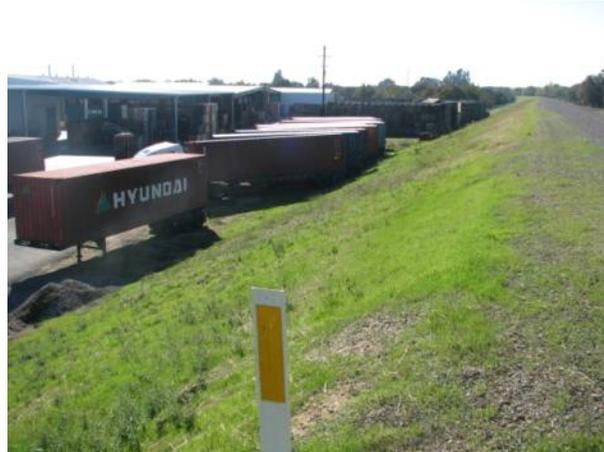
Levee Mile Report Line	5
Start Levee Mile	9.29
End Levee Mile	9.29
Location	Land Side
Category	
Item	Encroachments
Levee mile 9.29, truck trailers and other material near the landside levee toe.	
jhirabay_s_20130314_049.JPG

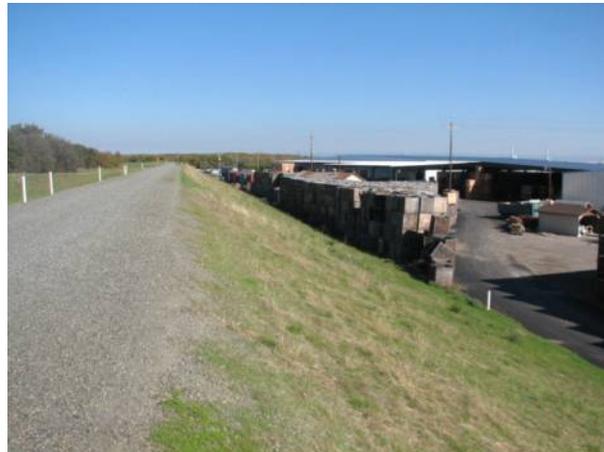
Levee Mile Report Line	5
Start Levee Mile	9.29
End Levee Mile	9.29
Location	Land Side
Category	
Item	Encroachments
Levee mile 9.29, other material at or near the landside levee toe.	
jhirabay_s_20130314_050.JPG

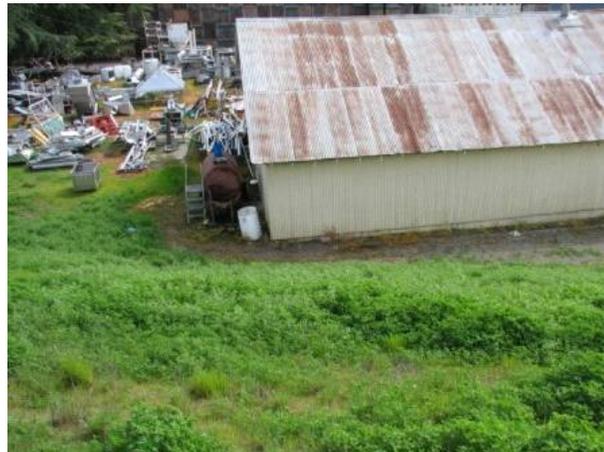
Levee Mile Report Line	6
Start Levee Mile	9.40
End Levee Mile	9.40
Location	Land Side
Category	
Item	Encroachments
Levee mile 9.40, looking at a building that is encroaching on the levee toe.	
jhirabay_s_20130314_042.jpg

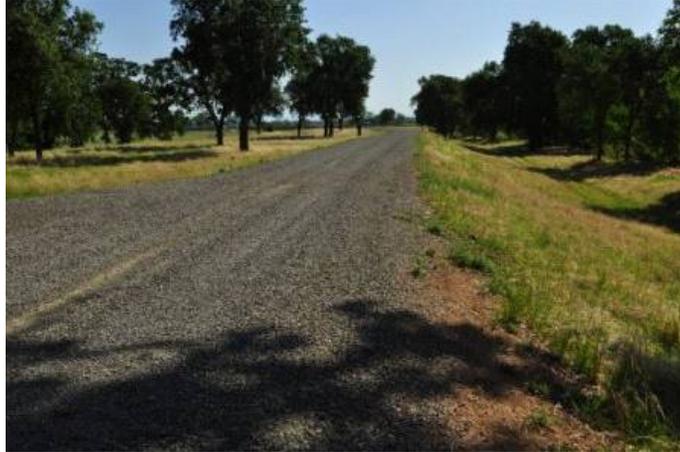
Levee Mile Report Line	1
Start Levee Mile	2.88
End Levee Mile	2.88
Location	Water Side
Category	
Item	Vegetation
Levee has been recently grazed.	
rburnett_s_20130425_285.JPG

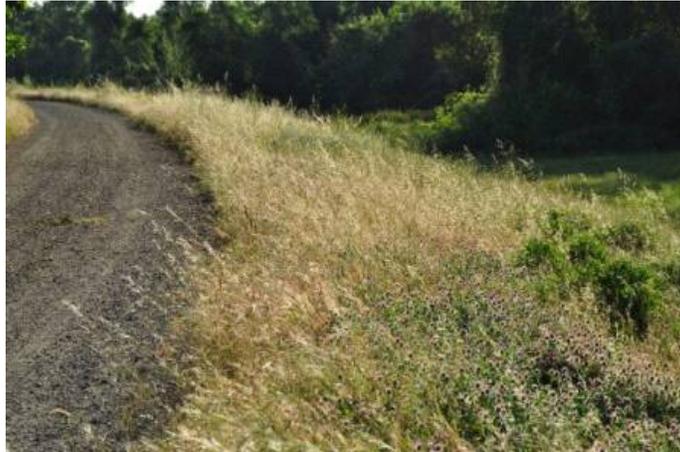
Levee Mile Report Line	1
Start Levee Mile	3.23
End Levee Mile	4.71
Location	Water Side
Category	
Item	Vegetation
Typical W/S vegetation.	
rburnett_s_20130425_279.JPG

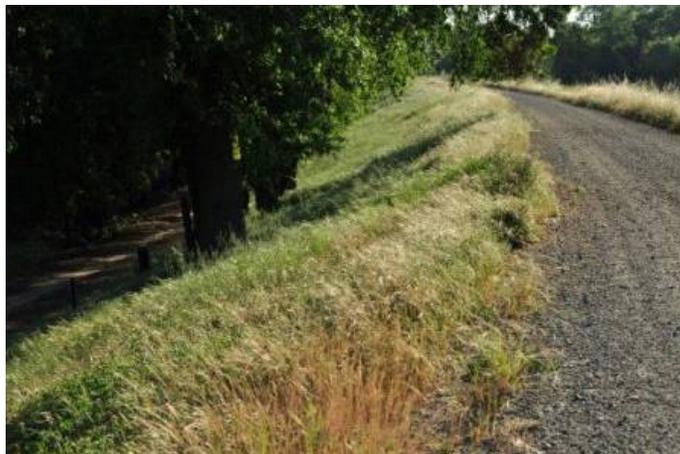
Levee Mile Report Line	2
Start Levee Mile	3.51
End Levee Mile	4.71
Location	Land Side
Category	
Item	Vegetation
Typical L/S vegetation.	
rburnett_s_20130425_278.JPG

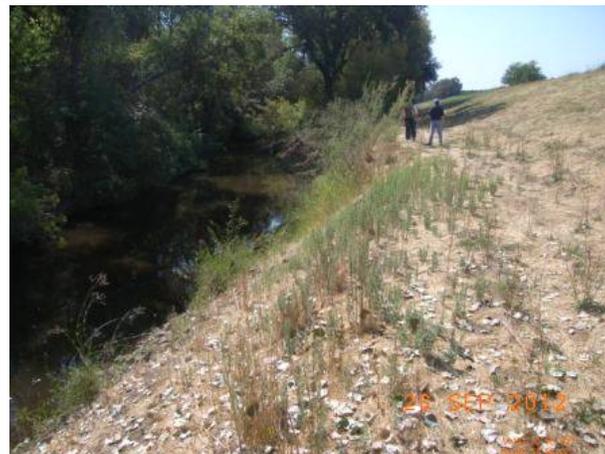
Levee Mile Report Line	3
Start Levee Mile	4.30
End Levee Mile	4.31
Location	Water Side
Category	Supplemental
Item	USACE Erosion Survey
USACE 2012 Photo #1	
jhirabay_s_20130314_051.jpg

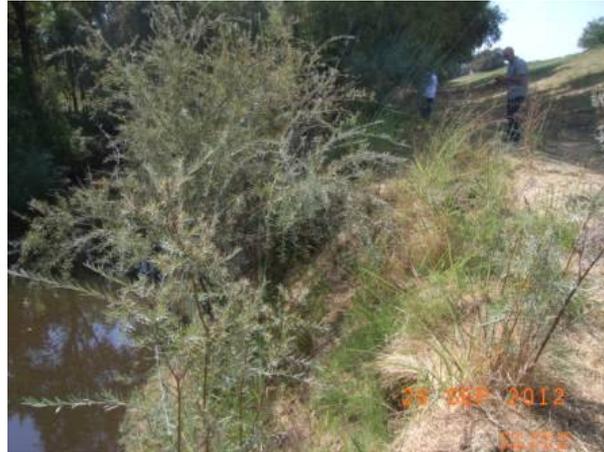
Levee Mile Report Line	3
Start Levee Mile	4.30
End Levee Mile	4.31
Location	Water Side
Category	Supplemental
Item	USACE Erosion Survey
USACE 2012 Photo #2	
jhirabay_s_20130314_052.jpg

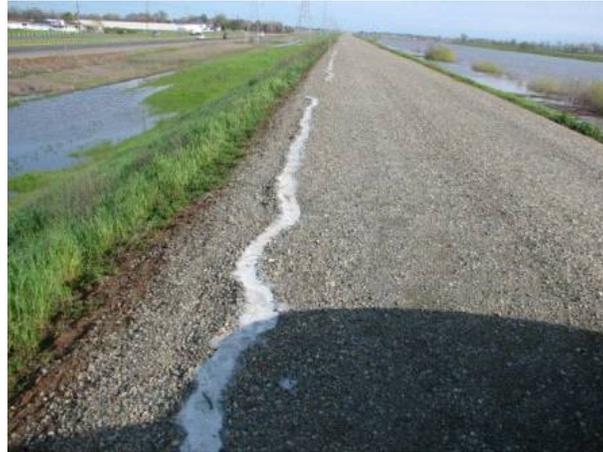
Levee Mile Report Line	1
Start Levee Mile	4.31
End Levee Mile	4.43
Location	Crown
Category	
Item	Erosion / Bank Caving
Levee mile 4.31, looking at a crack near the landside shoulder with a temporary repair.	
jhirabay_s_20130314_053.jpg

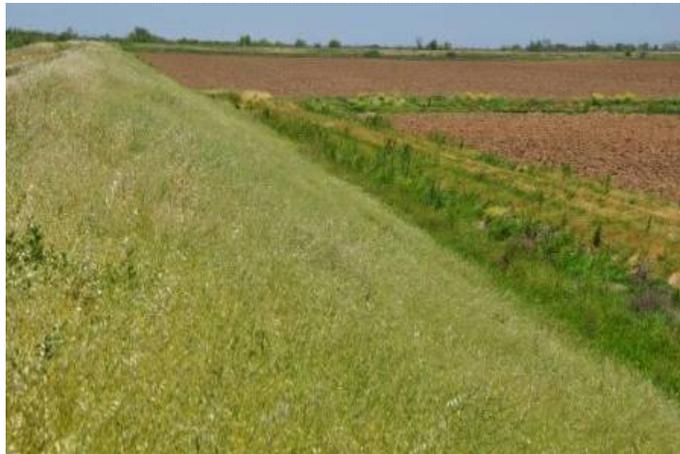
Levee Mile Report Line	3
Start Levee Mile	1.08
End Levee Mile	1.72
Location	Land Side
Category	
Item	Encroachments
Ditch at L/S toe.	
rburnett_s_20130424_277.JPG

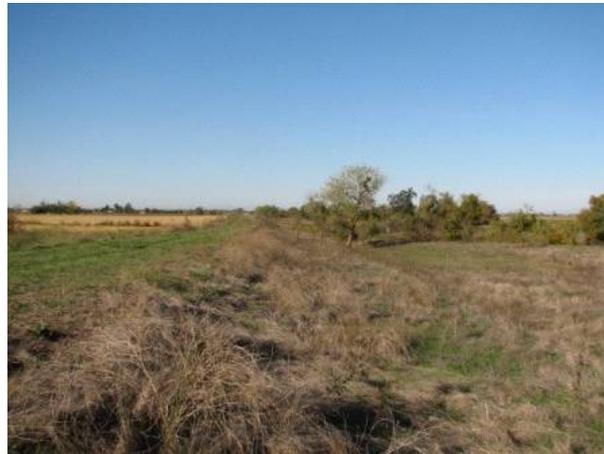
Levee Mile Report Line	9
Start Levee Mile	3.89
End Levee Mile	4.20
Location	Water Side
Category	
Item	Vegetation
This photo shows the waterside vegetation at levee mile 4.20.	
jhirabay_s_20130314_056.jpg

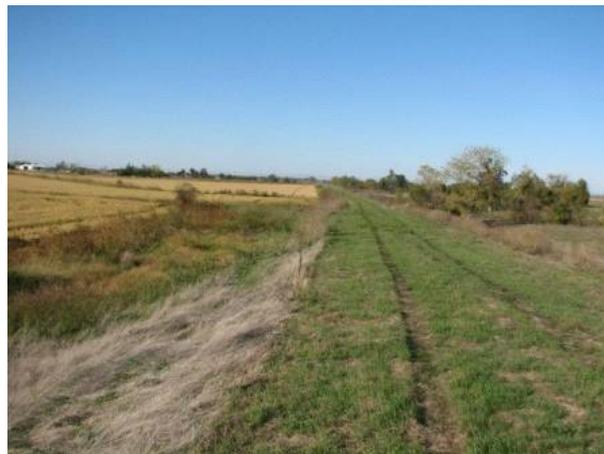
Levee Mile Report Line	10
Start Levee Mile	3.89
End Levee Mile	4.20
Location	Land Side
Category	
Item	Vegetation
This photo shows the landside vegetation at levee mile 4.20.	
jhirabay_s_20130314_055.jpg

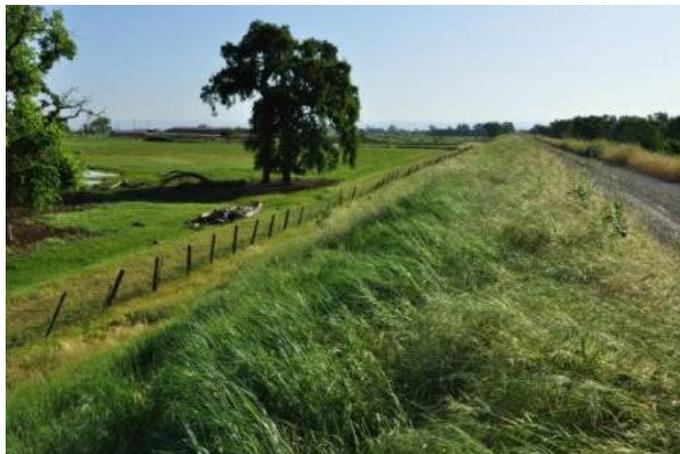
Levee Mile Report Line	2
Start Levee Mile	0.00
End Levee Mile	1.26
Location	Land Side
Category	
Item	Vegetation
Typical L/S vegetation.	
rburnett_s_20130425_281.JPG

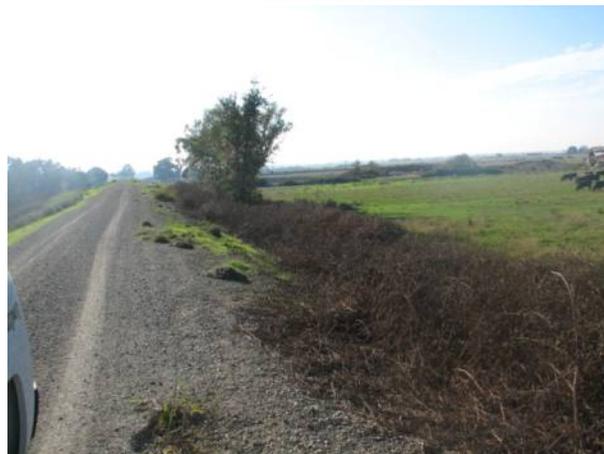
Levee Mile Report Line	5
Start Levee Mile	0.32
End Levee Mile	0.39
Location	Land Side
Category	
Item	Vegetation
Levee mile 0.39 looking downstream at the vegetation on the slope. The slope is maintained by RD 817 in unit 3.	
jhirabay_s_20130314_057.JPG

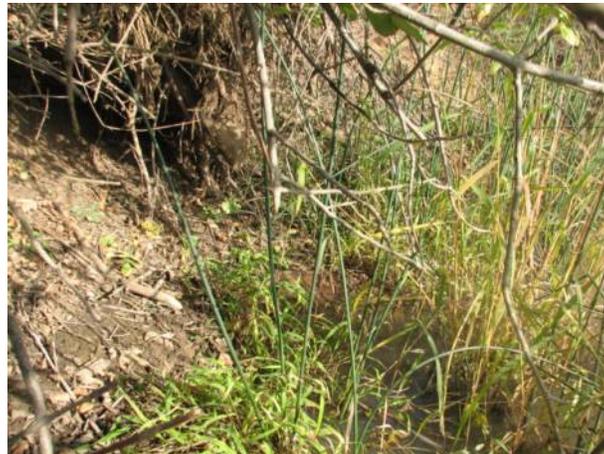
Levee Mile Report Line	8
Start Levee Mile	0.68
End Levee Mile	0.68
Location	Water Side
Category	Interior Drainage & Piping Systems
Item	Culverts: Breaks / Holes / Cracks
Levee mile 0.68, this is located near the low flow channel, the flap gate is lying on the ground, the end of the pipe was not located.	
jhirabay_s_20130314_060.JPG

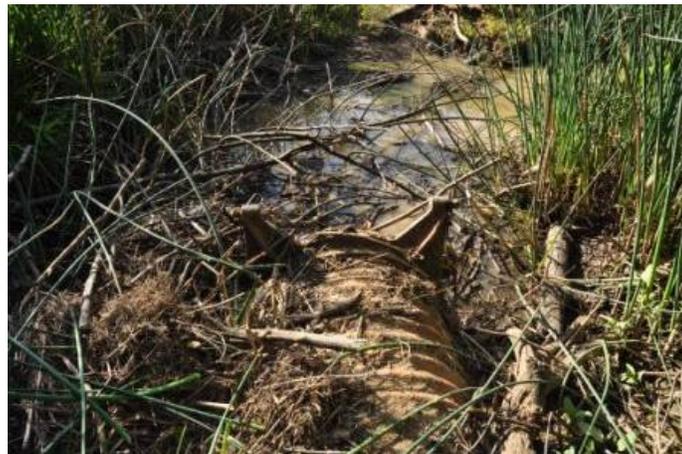
Levee Mile Report Line	8
Start Levee Mile	0.68
End Levee Mile	0.68
Location	Water Side
Category	Interior Drainage & Piping Systems
Item	Culverts: Breaks / Holes / Cracks
CMP is rusting and has numerous holes but flap gate is in place. 4/25/13 - Burnett	
rburnett_s_20130425_282.JPG

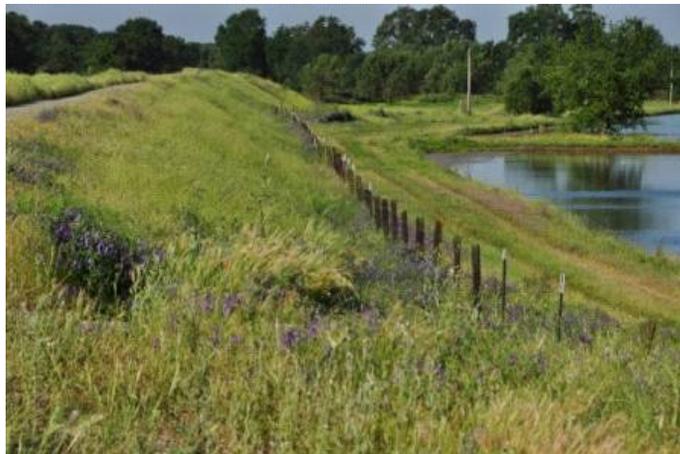
Levee Mile Report Line	9
Start Levee Mile	0.85
End Levee Mile	1.26
Location	Land Side
Category	
Item	Encroachments
Wire fence along L/S toe.	
rburnett_s_20130425_284.JPG

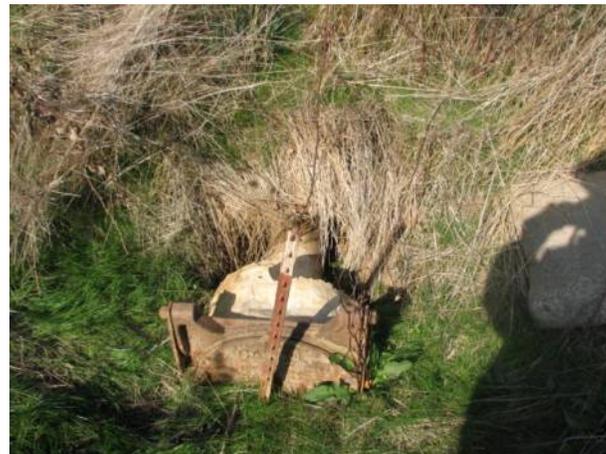
Levee Mile Report Line	11
Start Levee Mile	1.17
End Levee Mile	1.17
Location	Water Side
Category	Interior Drainage & Piping Systems
Item	Culverts: Breaks / Holes / Cracks
Levee mile 1.17 near the low flow channel, it appears a smaller pipe has been sleeved into the larger pipe, the flap gate does not make contact with the smaller pipe.	
jhirabay_s_20130314_059.JPG

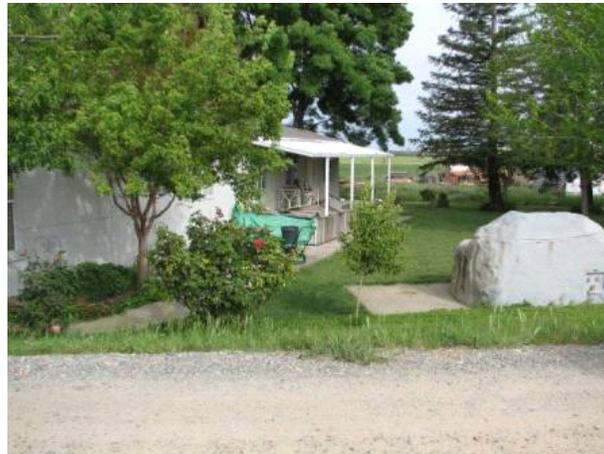
Levee Mile Report Line	1
Start Levee Mile	2.18
End Levee Mile	2.18
Location	Water Side
Category	
Item	Encroachments
Water side buildings and equipment levee mile 2.18.	
jhirabay_s_20130314_064.jpg

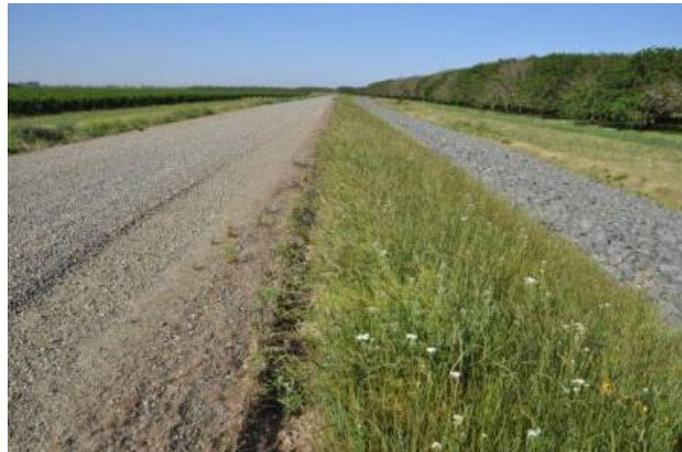
Levee Mile Report Line	2
Start Levee Mile	3.88
End Levee Mile	3.88
Location	Water Side
Category	
Item	Vegetation
Typical W/S seasonal vegetation.	
rburnett_s_20130424_261.JPG

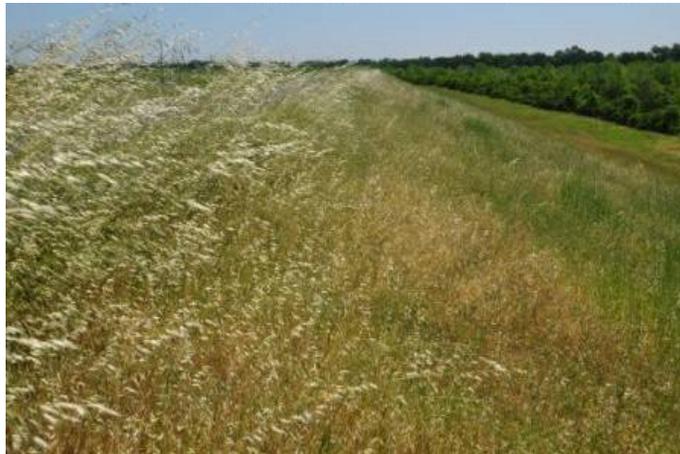
Levee Mile Report Line	2
Start Levee Mile	0.01
End Levee Mile	1.87
Location	Water Side
Category	
Item	Vegetation
Typical W/S vegetation.	
rburnett_s_20130424_271.JPG
