**Flood Control Project Maintenance
Levee Inspections**
LMA District Cover Sheet
Spring 2015 Levee Inspection Results

Reclamation District No. 0784 Plumas Lake

Levee Inspection Report By Mile - Spring 2015

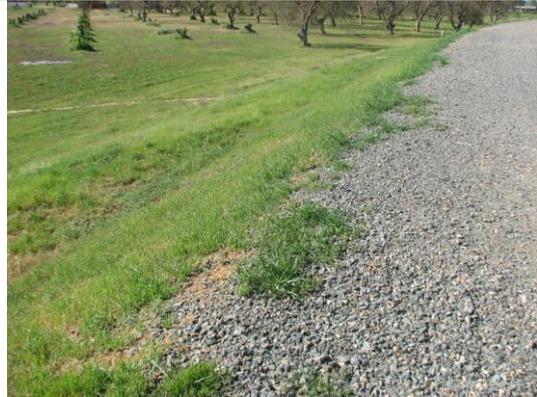
Photo 1 of 1 : SP_2015_RD0784_178_3_20150330_00004.jpg

LM Start	0.04	Rating **	A	Issue No.	3
LM End	0.05	Issue Type +	Ma	Location *	LS
Category	Earthen Levee			GPS Latitude/Longitude	
				Start	End
Item	Vegetation			39.134403 °	39.134340 °
				-121.552673 °	-121.552725 °
DWR ID	DWR_RD0784_01_s_2015_3				
Action/Comments					
Control annual grass and weeds on the levee slopes and easements.

Left bank landside, facing downstream.

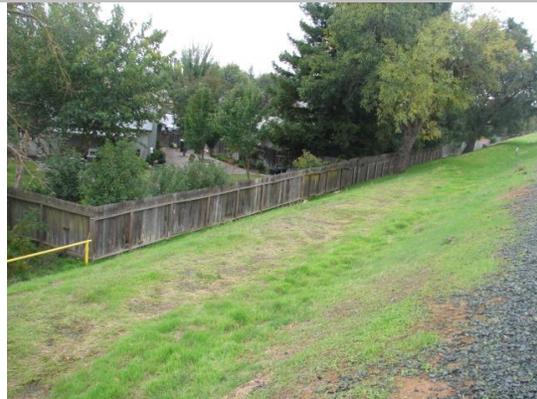
Photo 1 of 1 : SP_2015_RD0784_178_12_20150325_00002.jpg

LM Start	0.51	Rating **	U	Issue No.	12
LM End	1.00	Issue Type +	En	Location *	LS
Category	Earthen Levee			GPS Latitude/Longitude	
				Start	End
Item	Encroachments			39.131558 °	39.129475 °
				-121.560668 °	-121.569209 °
DWR ID	DWR_RD0784_01_f_2012_12				
Action/Comments					
Urban

Levee mile 0.53-1.00, this photo shows the fences and other obstruction near the toe of the levee on the landside.

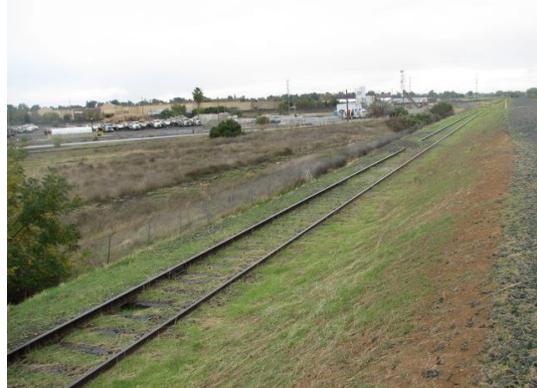
Photo 1 of 1 : SP_2015_RD0784_178_13_20150325_00003.jpg

LM Start	1.00	Rating **	U	Issue No.	13
LM End	1.12	Issue Type +	En	Location *	LS
Category	Earthen Levee		GPS Latitude/Longitude		
			Start	End	
Item	Encroachments		39.129475 °	39.129615 °	
			-121.569210 °	-121.571371 °	
DWR ID	DWR_RD0784_01_f_2012_13				
Action/Comments					
Fence

Levee mile 1.00-1.12, this photo shows a fence near the levee toe on the landside.

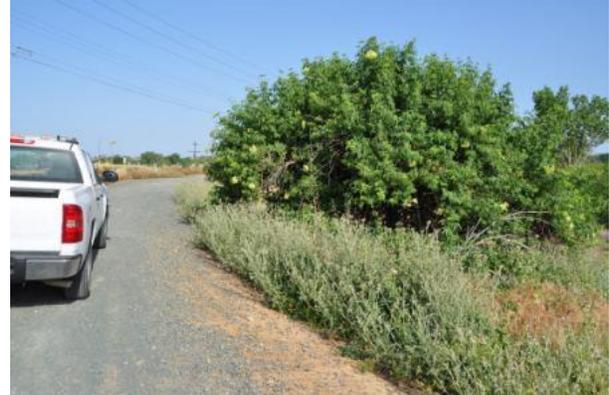
Photo 1 of 1 : SP_2015_RD0784_178_2_20150325_00001.jpg

LM Start	1.28	Rating **	M	Issue No.	2
LM End	1.28	Issue Type +	Ma	Location *	WS
Category	Earthen Levee		GPS Latitude/Longitude		
			Start	End	
Item	Vegetation		39.129783 °	39.129783 °	
			-121.574384 °	-121.574384 °	
DWR ID	DWR_RD0784_01_s_2012_2				
Action/Comments					
Elderberries are blocking visibility and flood fight capability.

W/S slope vegetation, Elderberry.

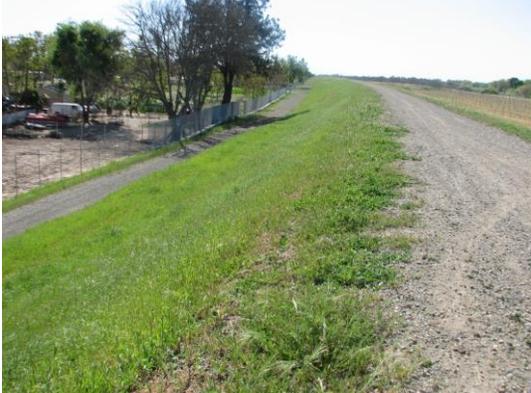
Photo 1 of 1 : SP_2015_RD0784_531_2_20150330_00002.jpg

LM Start	0.04	Rating **	A	Issue No.	2
LM End	0.04	Issue Type +	Ma	Location *	LS
Category	Earthen Levee		GPS Latitude/Longitude		
			Start	End	
Item	Vegetation		39.125198 °	39.125198 °	
			-121.588575 °	-121.588575 °	
DWR ID	DWR_RD0784_02A_s_2015_2				
Action/Comments					
Control annual grass and weeds on the levee slopes and easements.

Left bank land side, facing downstream.

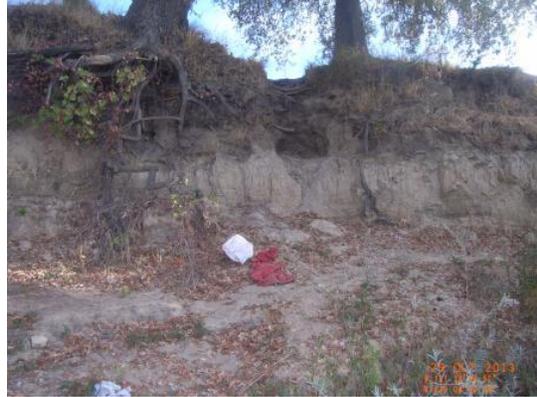
Photo 1 of 1 : SP_2015_RD0784_532_7_20150325_00003.jpg

LM Start	8.96	Rating **	M	Issue No.	7
LM End	9.36	Issue Type +	Ma	Location *	WS
Category	Supplemental			GPS Latitude/Longitude	
				Start	End
Item	USACE Erosion Survey			39.009366 °	39.004549 °
				-121.579766 °	-121.579143 °
DWR ID	DWR_RD0784_02A_f_2014_3				
Action/Comments					
Inspector Comments: 2003 - Bank is near vertical. Identified as a Potentially Critical site. 2004 - Eddy flow off downstream end of Modesto formation eroding the fluvial sediments. 2005 - Some new slumping. Actively eroding but berm width is greater than 50 ft. 2006 - Downgraded to regular erosion site. Still actively eroding. Large old rotational failures in high bank on the downstream end. 2008 - Removed from inventory due to wide berm width does not meet criteria for an erosion site. 2010 - Added back to the inventory after 10 ft of bank erosion in the winter 2009 storm. Steep vertical face. 2011 - Bank has retreated an additional 2.5 ft from last year. New tree popouts and erosion throughout the site. 2012 - Site continues to worsen with new tree popouts and many sections of new erosion. 2013: No observed changes. [2013 Site ID: FHR_17-8_L]

USACE 2013 Photo #1

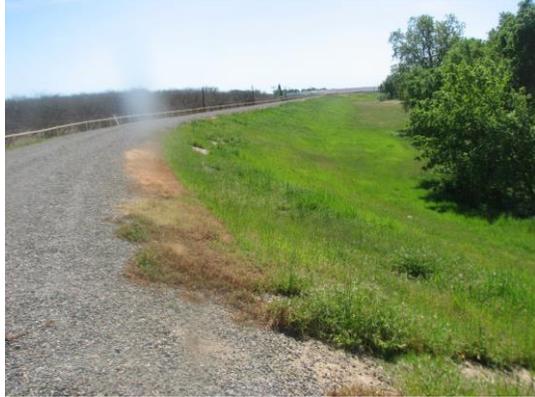
Photo 1 of 1 : SP_2015_RD0784_532_3_20150330_00002.jpg

LM Start	8.97	Rating **	M	Issue No.	3
LM End	8.97	Issue Type +	Ma	Location *	WS
Category	Earthen Levee		GPS Latitude/Longitude		
			Start	End	
Item	Vegetation		39.009813 °	39.009813 °	
			-121.579082 °	-121.579082 °	
DWR ID	DWR_RD0784_02B_s_2015_3				
Action/Comments					
Control annual grass and weeds on the levee slopes and easements.

Waterside facing downstream

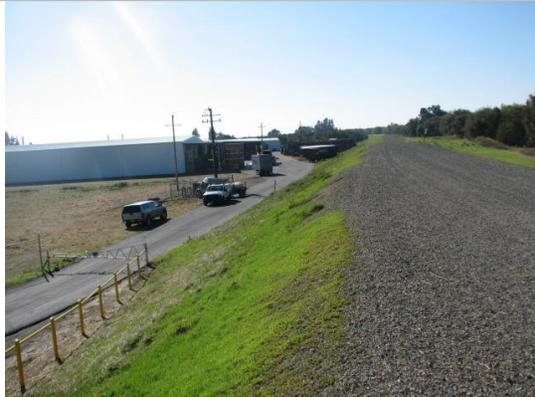
Photo 1 of 1 : SP_2015_RD0784_532_6_20150325_00001.jpg

LM Start	9.21	Rating **	M	Issue No.	6
LM End	9.31	Issue Type +	En	Location *	LS
Category	Earthen Levee		GPS Latitude/Longitude		
			Start	End	
Item	Encroachments		39.006523 °	39.005235 °	
			-121.577843 °	-121.578286 °	
DWR ID	DWR_RD0784_02_f_2012_6				
Action/Comments					
Material Inspector Comments: Paving at toe.

Levee mile 9.21, new paving near the levee toe, no permit found for this work.

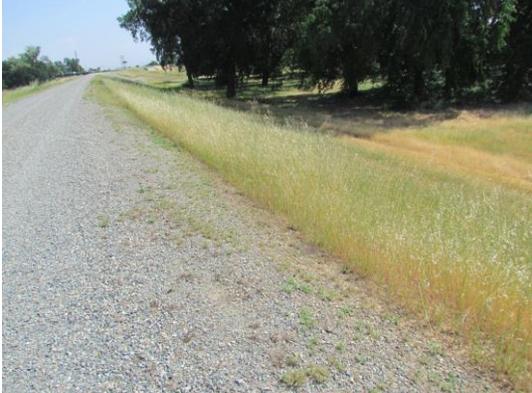
Photo 1 of 1 : SP_2015_RD0784_180_4_20150429_00002.jpg

LM Start	2.52	Rating **	A/W	Issue No.	4
LM End	2.52	Issue Type +	Ma	Location *	WS
Category	Earthen Levee		GPS Latitude/Longitude		
			Start	End	
Item	Vegetation		38.971682 °	38.971682 °	
			-121.546682 °	-121.546682 °	
DWR ID	DWR_RD0784_03_s_2015_4				
Action/Comments					
Control annual grass and weeds on the levee slopes and easements.

View of the vegetation on the waterside of the levee facing upstream.

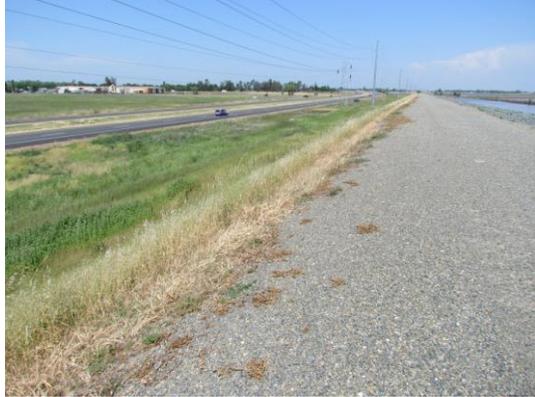
Photo 1 of 1 : SP_2015_RD0784_181_5_20150429_00004.jpg

LM Start	5.10	Rating **	A/W	Issue No.	5
LM End	5.57	Issue Type +	Ma	Location *	LS
Category	Earthen Levee		GPS Latitude/Longitude		
			Start	End	
Item	Vegetation		39.048223 °	39.048223 °	
			-121.542410 °	-121.542410 °	
DWR ID	DWR_RD0784_04_s_2015_5				
Action/Comments					
Control annual grass and weeds on the levee slopes and easements.

View of the vegetation on the landside of the levee facing upstream.

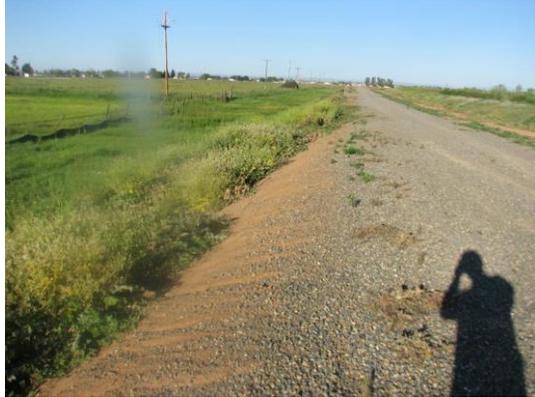
Photo 1 of 1 : SP_2015_RD0784_181_7_20150330_00003.jpg

LM Start	5.94	Rating **	M	Issue No.	7
LM End	6.23	Issue Type +	Ma	Location *	LS
Category	Earthen Levee		GPS Latitude/Longitude		
			Start	End	
Item	Vegetation		39.058635 °	39.058517 °	
			-121.544995 °	-121.550295 °	
DWR ID	DWR_RD0784_04_s_2015_7				
Action/Comments					
Control annual grass and weeds on the levee slopes and easements.

Landside facing upstream

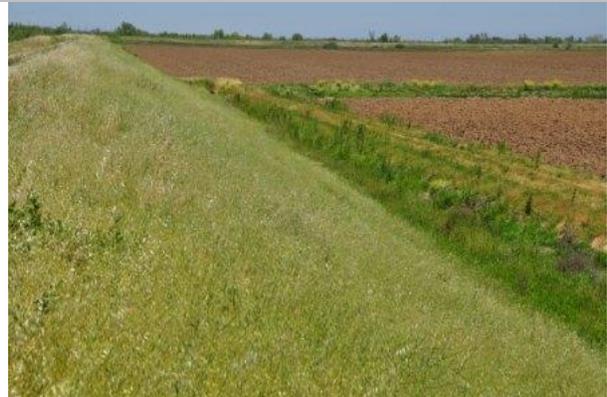
Photo 1 of 1 : SP_2015_RD0784_182_10_20150325_00002.jpg

LM Start	1.09	Rating **	M	Issue No.	10
LM End	1.72	Issue Type +	En	Location *	LS
Category	Earthen Levee			GPS Latitude/Longitude	
				Start	End
Item	Encroachments			38.989955 °	38.999068 °
				-121.535672 °	-121.537462 °
DWR ID	DWR_RD0784_05_s_2012_10				
Action/Comments					
Ditch

Ditch at L/S toe.

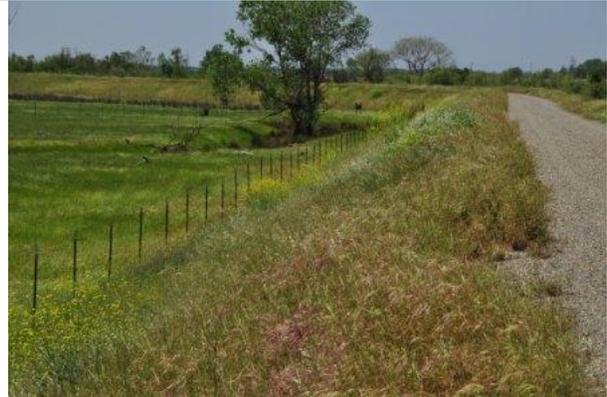
Photo 1 of 1 : SP_2015_RD0784_182_5_20150325_00001.jpg

LM Start	3.10	Rating **	U	Issue No.	5
LM End	3.86	Issue Type +	En	Location *	LS
Category	Earthen Levee			GPS Latitude/Longitude	
				Start	End
Item	Encroachments			39.015978 °	39.019465 °
				-121.528173 °	-121.515120 °
DWR ID	DWR_RD0784_05_s_2013_5				
Action/Comments					
Fence

Fence at L/S levee toe.

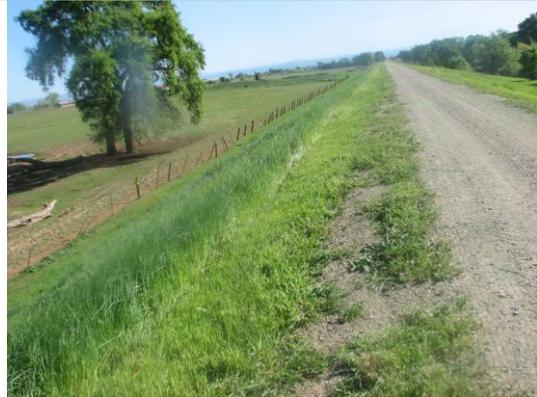
Photo 1 of 1 : SP_2015_RD0784_183_9_20150330_00004.jpg

LM Start	0.00	Rating **	M	Issue No.	9
LM End	0.25	Issue Type +	Ma	Location *	LS
Category	Earthen Levee		GPS Latitude/Longitude		
			Start	End	
Item	Vegetation		38.985647 °	38.987603 °	
			-121.510458 °	-121.506583 °	
DWR ID	DWR_RD0784_06_s_2015_9				
Action/Comments					
Control annual grass and weeds on the levee slopes and easements.

Landside facing upstream

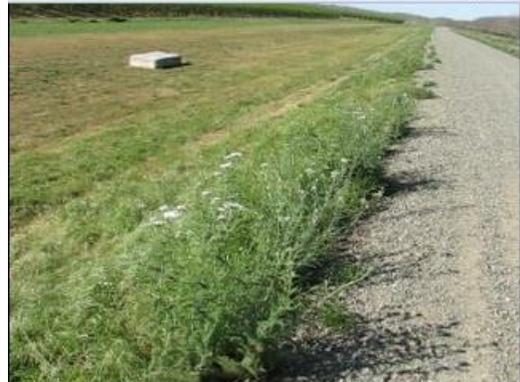
Photo 1 of 1 : SP_2015_RD0784_184_3_20150330_00002.jpg

LM Start	0.00	Rating **	A/W	Issue No.	3
LM End	3.73	Issue Type +	Ma	Location *	WS
Category	Earthen Levee		GPS Latitude/Longitude		
			Start	End	
Item	Vegetation		°	39.134403 °	
			°	-121.552673 °	
DWR ID	DWR_RD0784_07_s_2015_3				
Action/Comments					
Control annual grass and weeds on the levee slopes and easements.

Left bank waterside, facing upstream.

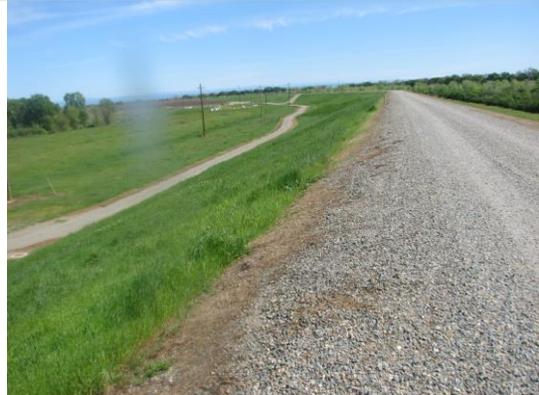
Photo 1 of 1 : SP_2015_RD0784_437_2_20150330_00002.jpg

LM Start	0.05	Rating **	A	Issue No.	2
LM End	0.05	Issue Type +	Ma	Location *	WS
Category	Earthen Levee			GPS Latitude/Longitude	
				Start	End
Item	Vegetation			38.955502 °	38.955502 °
				-121.574117 °	-121.574117 °
DWR ID	DWR_RD0784_08_s_2015_2				
Action/Comments					
Control annual grass and weeds on the levee slopes and easements.

Waterside facing downstream

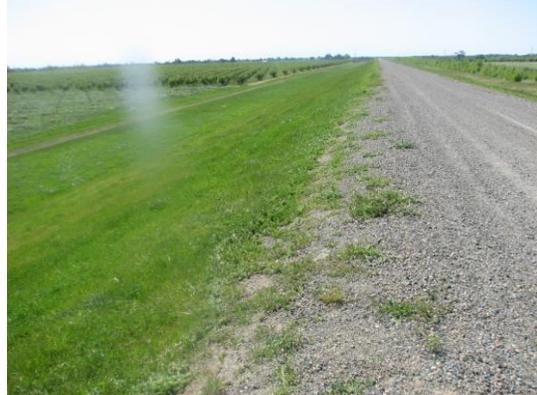
Photo 1 of 1 : SP_2015_RD0784_530_1_20150330_00002.jpg

LM Start	0.21	Rating **	A	Issue No.	1
LM End	0.21	Issue Type +	Ma	Location *	LS
Category	Earthen Levee			GPS Latitude/Longitude	
				Start	End
Item	Vegetation			39.087308 °	39.087308 °
				-121.585417 °	-121.585417 °
DWR ID	DWR_RD0784_09_s_2015_1				
Action/Comments					
Control annual grass and weeds on the levee slopes and easements.

Landside facing downstream
