**Flood Control Project Maintenance
Levee Inspections**

Maintenance Issue Types Only, Levee Inspection Report By Mile - Fall 2014

Reclamation District No. 0784 Plumas Lake

Waterway	Bank	Unit Miles	Inspection Start/End	Inspector
Unit No. 01 Yuba River	Left	2.21	10/01/2014 10/01/2014	Matthew Hoffman

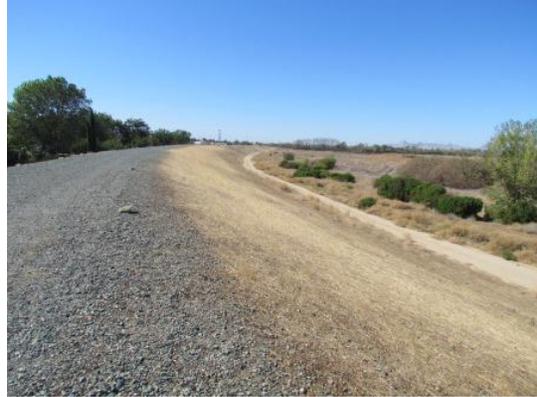
Photo 1 of 1 : FA_2014_RD0784_178_3_20141003_00005.jpg

LM Start	0.83	Rating **	A	Issue No.	3
LM End	0.83	Issue Type +	Ma	Location *	WS
Category	Earthen Levee		GPS Latitude/Longitude		
			Start	End	
Item	Vegetation		39.129794 °	39.129794 °	
			-121.566146 °	-121.566146 °	
DWR ID	DWR_RD0784_01_f_2014_3				
Action/Comments					
Control annual grass and weeds on the levee slopes and easements.

This photo was taken from the levee crown facing west looking down the waterward levee slope at acceptable vegetation maintenance.

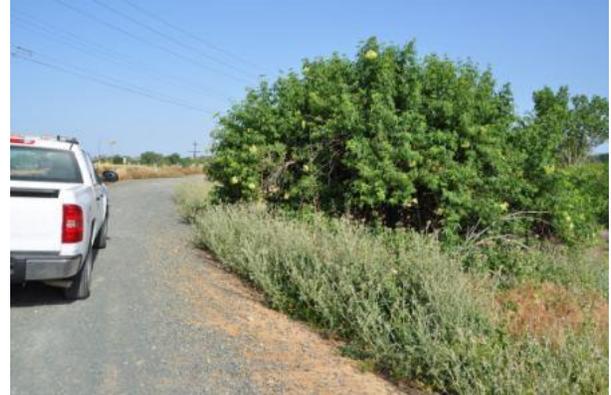
Photo 1 of 1 : FA_2014_RD0784_178_2_20140929_00001.jpg

LM Start	1.28	Rating **	M	Issue No.	2
LM End	1.28	Issue Type +	Ma	Location *	WS
Category	Earthen Levee		GPS Latitude/Longitude		
			Start	End	
Item	Vegetation		39.129783 °	39.129783 °	
			-121.574384 °	-121.574384 °	
DWR ID	DWR_RD0784_01_s_2012_2				
Action/Comments					
Elderberries are blocking visibility and flood fight capability.

W/S slope vegetation, Elderberry.

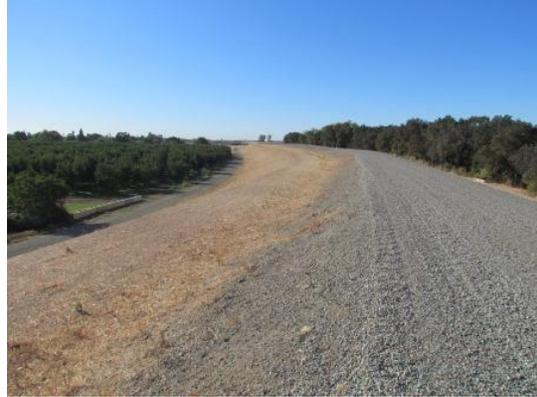
Photo 1 of 1 : FA_2014_RD0784_531_2_20141003_00002.jpg

LM Start	1.33	Rating **	A	Issue No.	2
LM End	1.33	Issue Type +	Ma	Location *	LS
Category	Earthen Levee		GPS Latitude/Longitude		
			Start	End	
Item	Vegetation		39.107673 °	39.107673 °	
			-121.586411 °	-121.586411 °	
DWR ID	DWR_RD0784_02A_f_2014_2				
Action/Comments					
Control annual grass and weeds on the levee slopes and easements.

This photo was taken from the levee crown facing south looking down the landward levee slope at acceptable vegetation maintenance.

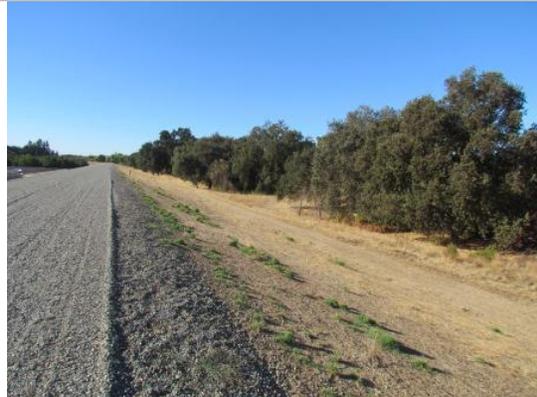
Photo 1 of 1 : FA_2014_RD0784_532_3_20141003_00004.jpg

LM Start	9.52	Rating **	A	Issue No.	3
LM End	9.52	Issue Type +	Ma	Location *	WS
Category	Earthen Levee			GPS Latitude/Longitude	
				Start	End
Item	Vegetation			39.002279 °	39.002279 °
				-121.579388 °	-121.579388 °
DWR ID	DWR_RD0784_02B_f_2014_3				
Action/Comments					
Control annual grass and weeds on the levee slopes and easements.

This photo was taken from the levee crown facing south looking down the waterward levee slope at acceptable vegetation maintenance.

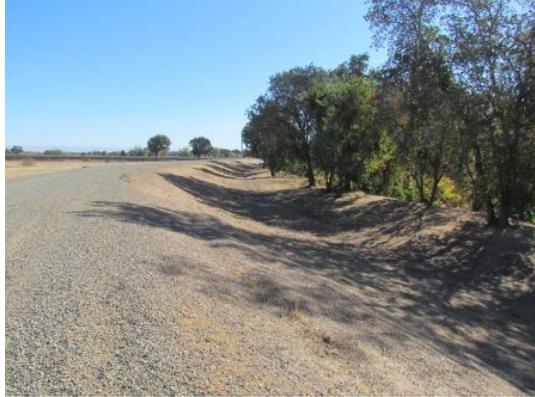
Photo 1 of 1 : FA_2014_RD0784_533_2_20141003_00002.jpg

LM Start	3.19	Rating **	A	Issue No.	2
LM End	3.19	Issue Type +	Ma	Location *	WS
Category	Earthen Levee		GPS Latitude/Longitude		
			Start	End	
Item	Vegetation		38.974679 °	38.974679 °	
			-121.535478 °	-121.535478 °	
DWR ID	DWR_RD0784_03A_f_2014_2				
Action/Comments					
Control annual grass and weeds on the levee slopes and easements.

This photo was taken from the levee crown facing east looking down the waterward levee slope at acceptable vegetation maintenance.

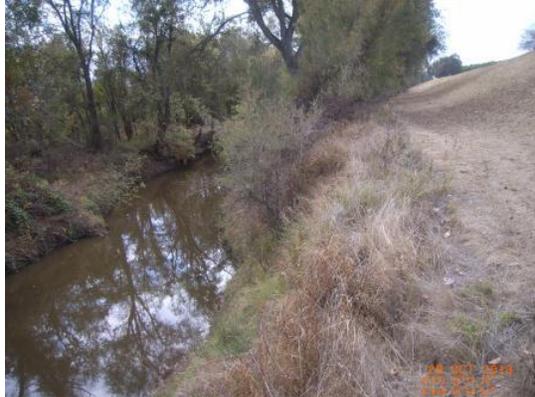
Photo 1 of 1 : FA_2014_RD0784_533_3_20140929_00001.jpg

LM Start	4.31	Rating **	M	Issue No.	3
LM End	4.32	Issue Type +	Ma	Location *	WS
Category	Supplemental		GPS Latitude/Longitude		
			Start	End	
Item	USACE Erosion Survey		38.981400 °	38.981271 °	
			-121.515848 °	-121.515999 °	
DWR ID	DWR_RD0784_03A_f_2014_3				
Action/Comments					
Inspector Comments: 2009 - Small site which could be repaired with maintenance. Erosion into the levee toe, rock has started to fail. 2013: No observed changes. [2013 Site ID: BER_4-9_R]

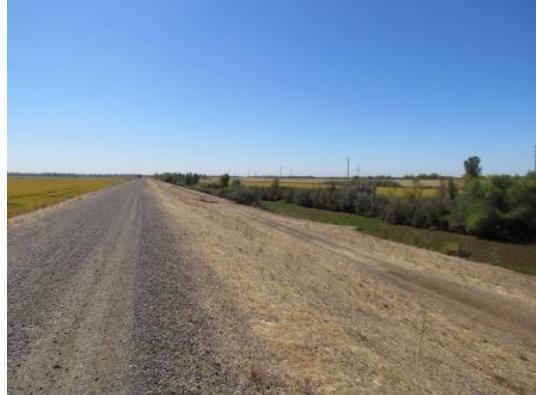
Photo 1 of 1 : FA_2014_RD0784_182_11_20141003_00009.jpg

LM Start	2.10	Rating **	A	Issue No.	11
LM End	2.10	Issue Type +	Ma	Location *	WS
Category	Earthen Levee		GPS Latitude/Longitude		
			Start	End	
Item	Vegetation		39.004504 °	39.004504 °	
			-121.538492 °	-121.538492 °	
DWR ID	DWR_RD0784_05_f_2014_11				
Action/Comments					
Control annual grass and weeds on the levee slopes and easements.

This photo was taken from the levee crown facing west looking down the waterward levee slope at acceptable vegetation maintenance.

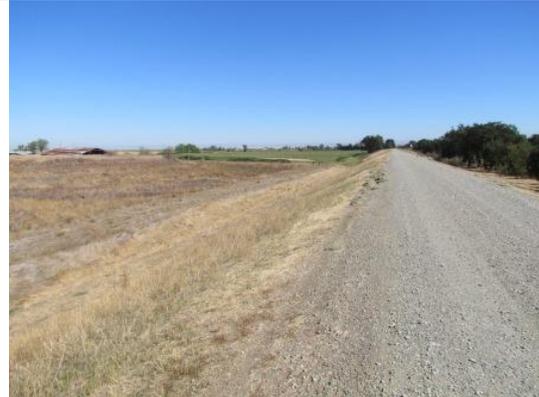
Photo 1 of 1 : FA_2014_RD0784_183_18_20141003_00016.jpg

LM Start	0.18	Rating **	A	Issue No.	18
LM End	0.18	Issue Type +	Ma	Location *	LS
Category	Earthen Levee		GPS Latitude/Longitude		
			Start	End	
Item	Vegetation		38.986983 °	38.986983 °	
			-121.507783 °	-121.507783 °	
DWR ID	DWR_RD0784_06_f_2014_18				
Action/Comments					
Control annual grass and weeds on the levee slopes and easements.

This photo was taken from the levee crown facing east looking down the landward levee slope at acceptable vegetation maintenance.

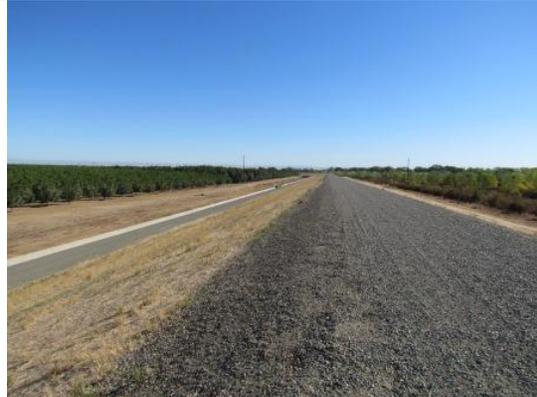
Photo 1 of 1 : FA_2014_RD0784_437_1_20141013_00002.jpg

LM Start	0.61	Rating **	A	Issue No.	1
LM End	0.61	Issue Type +	Ma	Location *	N/A
Category	Earthen Levee		GPS Latitude/Longitude		
			Start	End	
Item	Vegetation		38.957281 °	38.957281 °	
			-121.564089 °	-121.564089 °	
DWR ID	DWR_RD0784_08_f_2014_1				
Action/Comments					
Control annual grass and weeds on the levee slopes and easements.

This photo was taken from the crown facing east looking down the landward levee slope at acceptable vegetation maintenance.

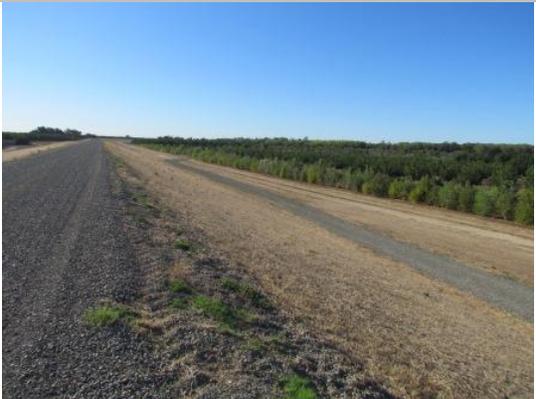
Photo 1 of 1 : FA_2014_RD0784_530_1_20141003_00002.jpg

LM Start	4.82	Rating **	A	Issue No.	1
LM End	4.82	Issue Type +	Ma	Location *	WS
Category	Earthen Levee		GPS Latitude/Longitude		
			Start	End	
Item	Vegetation		39.022142 °	39.022142 °	
			-121.584782 °	-121.584782 °	
DWR ID	DWR_RD0784_09_f_2014_1				
Action/Comments					
Control annual grass and weeds on the levee slopes and easements.

This photo was taken from the levee crown facing south looking down the waterward levee slope at acceptable vegetation maintenance.
