**Flood Control Project Maintenance
Levee Inspections**

Maintenance Issue Types Only, Levee Inspection Report By Mile - Fall 2015

Reclamation District No. 0784 Plumas Lake

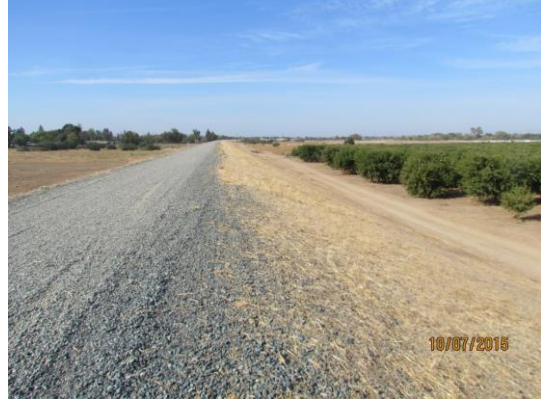
Photo 1 of 1 : FA_2015_RD0784_178_3_20151009_00004.jpg

| Inspector Comments: Acceptable vegetation. | | | | | |

View of the acceptable vegetation on the waterside slope of the levee looking downstream.

| Control annual grass and weeds on the levee slopes and easements. | | | | | |

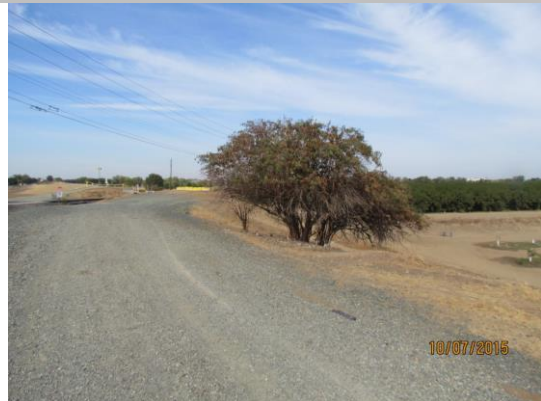
Photo 1 of 2 : FA_2015_RD0784_178_2_20151009_00006.jpg

| Elderberries are blocking visibility and flood fight capability. Inspector Comments: Elderberry tree is appeared to be dying on the waterside slope of the levee. | | | | | |

View of the elderberry tree on the waterside of the levee looking downstream.

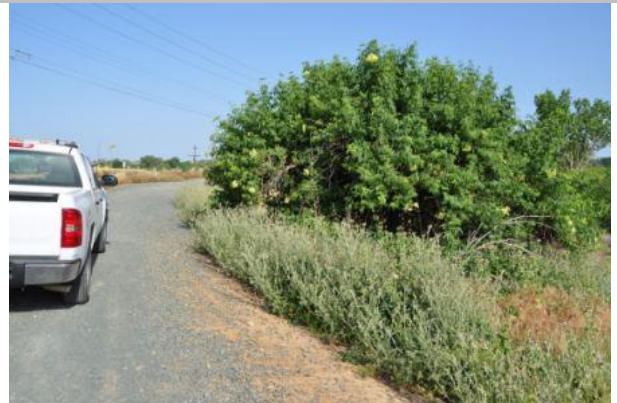
Photo 2 of 2 : FA_2015_RD0784_178_2_20150911_00001.jpg

W/S slope vegetation, Elderberry.

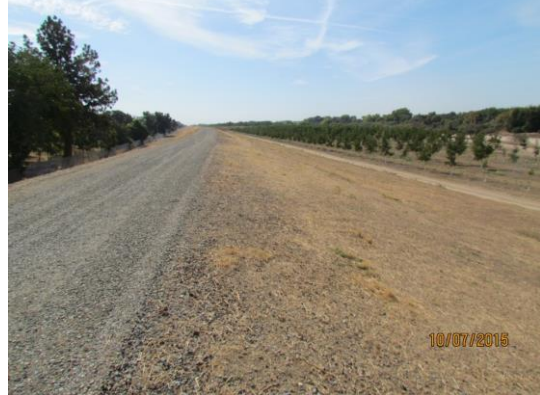
Photo 1 of 1 : FA_2015_RD0784_531_2_20151009_00001.jpg

| Inspector Comments: Acceptable vegetation | | | | | |

View of the acceptable vegetation on the waterside of the levee looking downstream.

| Control annual grass and weeds on the levee slopes and easements. | | | | | |

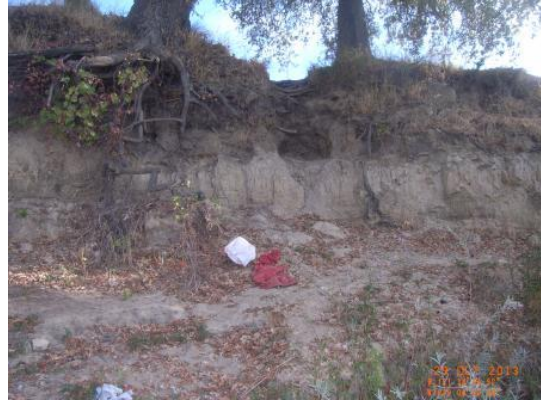
Photo 1 of 1 : USACE2013A_FHR_17-8_L_11.jpg

Inspector Comments: 2003 - Bank is near vertical. Identified as a Potentially Critical site. 2004 - Eddy flow off downstream end of Modesto formation eroding the fluvial sediments. 2005 - Some new slumping. Actively eroding but berm width is greater than 50 ft. 2006 - Downgraded to regular erosion site. Still actively eroding. Large old rotational failures in high bank on the downstream end. 2008 - Removed from inventory due to wide berm width does not meet criteria for an erosion site. 2010 - Added back to the inventory after 10 ft of bank erosion in the winter 2009 storm. Steep vertical face. 2011 - Bank has retreated an additional 2.5 ft from last year. New tree popouts and erosion throughout the site. 2012 - Site continues to worsen with new tree popouts and many sections of new erosion. 2015: Last observed in 2013. [2015 Site ID: FHR_17-8_L]

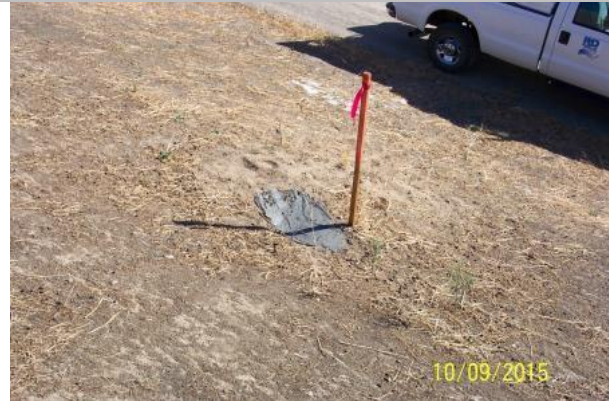
Photo 1 of 2 : FA_2015_RD0784_532_2_20151009_00004.jpg

LMA backfilled the rodent hole after the fall 2015 inspection.

No rodents visible, but rodent burrows visible; need to backfill and compact or grout burrows.
Inspector Comments: LMA fixed the issue after the fall 2015 inspection.

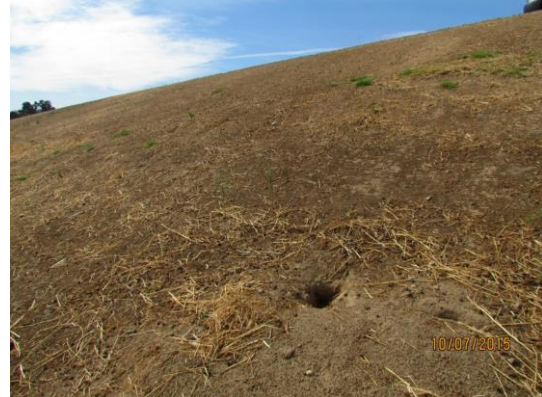
Photo 2 of 2 : FA_2015_RD0784_532_2_20151009_00003.jpg

| No rodents visible, but rodent burrows visible; need to backfill and compact or grout burrows. | | | | | | |

Rodent hole was found on the landside toe of the levee looking downstream.

| Inspector Comments: LMA fixed the issue after the fall 2015 inspection. | | | | | | |

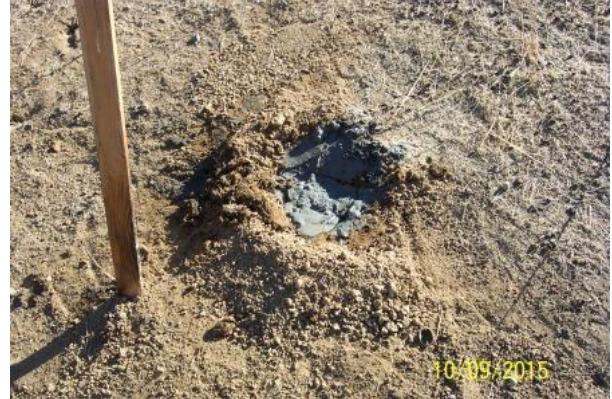
Photo 1 of 2 : FA_2015_RD0784_533_3_20151009_00002.jpg

LMA backfilled the rodent hole after completion of the fall 2015 inspection.

| No rodents visible, but rodent burrows visible; need to backfill and compact or grout burrows. Inspector Comments: LMA backfilled the rodent hole after the inspection. | | | | | |

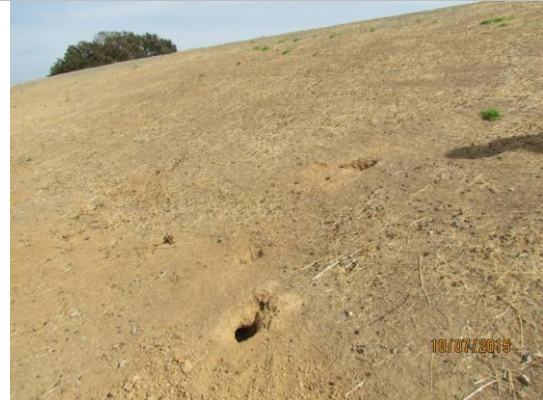
Photo 2 of 2 : FA_2015_RD0784_533_3_20151009_00001.jpg

A rodent hole was found on the landside toe of the levee looking upstream.

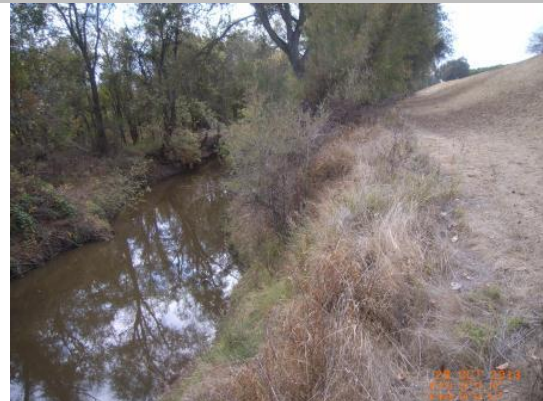
Photo 1 of 1 : USACE2013A_BER_4-9_R_4.jpg

| Inspector Comments: 2009 - Small site which could be repaired with maintenance. Erosion into the levee toe, rock has started to fail. 2015: Last observed in 2013. [2015 Site ID: BER_4-9_R] | | | | | |

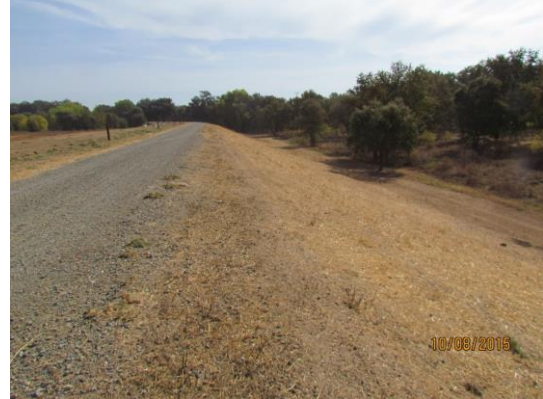
Photo 1 of 1 : FA_2015_RD0784_534_1_20151009_00001.jpg

| Control annual grass and weeds on the levee slopes and easements. Inspector Comments: Acceptable vegetation. | | | | | |

View of acceptable vegetation on the waterside of the levee looking upstream.

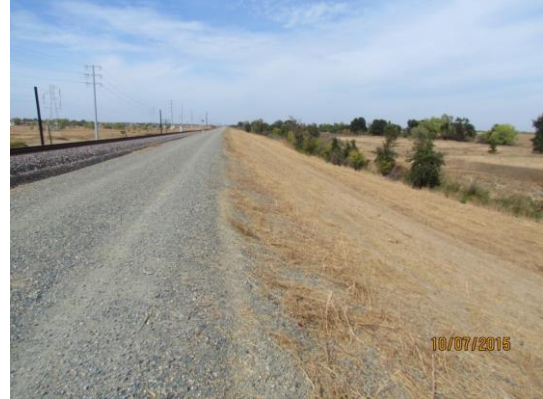
Photo 1 of 1 : FA_2015_RD0784_181_3_20151009_00001.jpg

| Control annual grass and weeds on the levee slopes and easements. Inspector Comments: Acceptable vegetation. | | | | | |

View of the acceptable vegetation on the waterside of the levee.

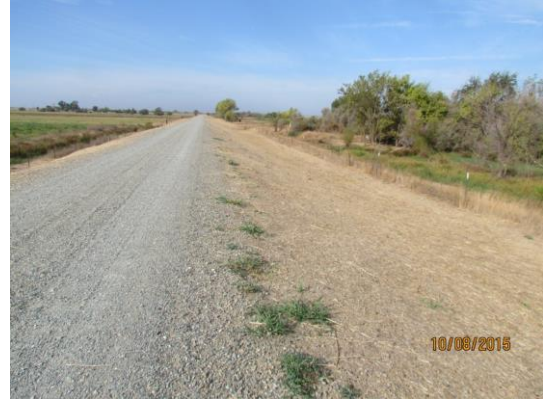
Photo 1 of 1 : FA_2015_RD0784_182_6_20151009_00003.jpg

| Control annual grass and weeds on the levee slopes and easements. Inspector Comments: Acceptable vegetation. | | | | | |

View of acceptable vegetation on the waterside of the levee looking downstream.

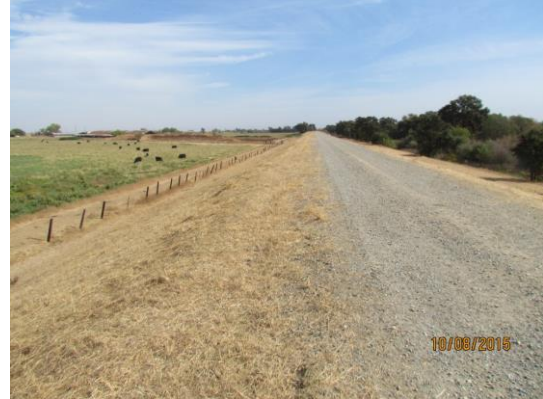
Photo 1 of 1 : FA_2015_RD0784_183_5_20151009_00004.jpg

| Control annual grass and weeds on the levee slopes and easements. Inspector Comments: Acceptable vegetation. | | | | | |

View of acceptable vegetation on the landside of the levee looking upstream.

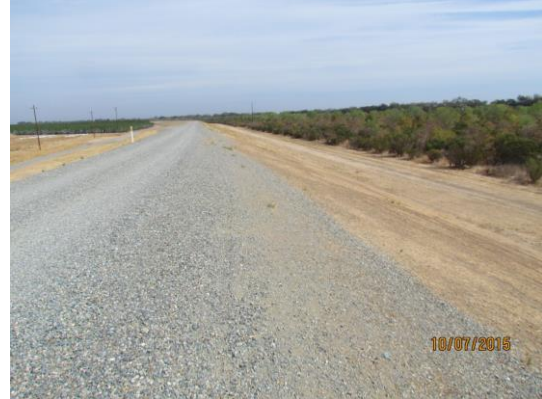
Photo 1 of 1 : FA_2015_RD0784_437_1_20151009_00001.jpg

| Control annual grass and weeds on the levee slopes and easements. Inspector Comments: Acceptable vegetation. | | | | | |

View of the acceptable vegetation on the waterside of the levee.

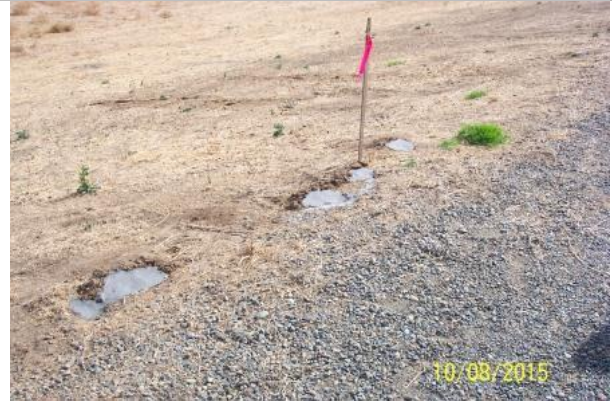
Photo 1 of 2 : FA_2015_RD0784_530_1_20151009_00005.jpg

LMA fixed the animal holes after the fall 2015 inspections.

| No rodents visible, but rodent burrows visible; need to backfill and compact or grout burrows. Inspector Comments: LMA repaired the animal hole. | | | | | |

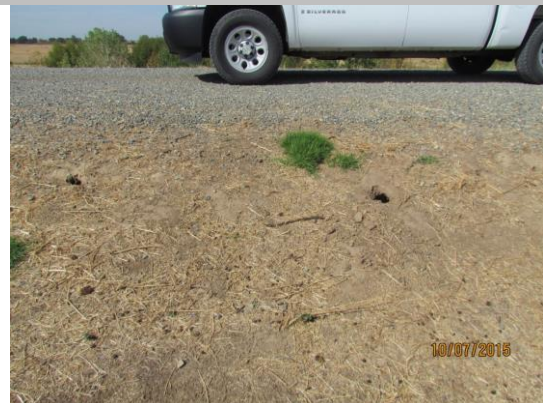
Photo 2 of 2 : FA_2015_RD0784_530_1_20151009_00003.jpg

Rodent holes were found on the landside of the levee.

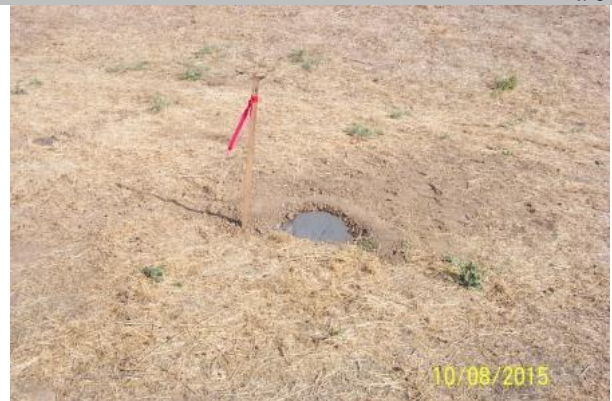
Photo 1 of 2 : FA_2015_RD0784_530_4_20151009_00006.jpg

LMA repaired the issue after completion of the fall 2015 inspection.

| No rodents visible, but rodent burrows visible; need to backfill and compact or grout burrows. Inspector Comments: LMA repaired the issue. | | | | | |

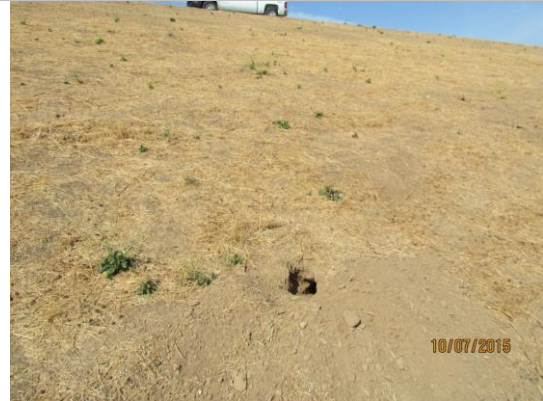
Photo 2 of 2 : FA_2015_RD0784_530_4_20151009_00004.jpg

| No rodents visible, but rodent burrows visible; need to backfill and compact or grout burrows. Inspector Comments: LMA repaired the issue. | | | | | | |

An animal hole was found on the landside toe of the levee looking upstream.
