**Flood Control Project Maintenance
Levee Inspections**

Maintenance Issue Types Only, Levee Inspection Report By Mile - Fall 2016

Reclamation District No. 0784 Plumas Lake

Waterway	Bank	Unit Miles	Inspection Start/End	Inspector
Unit No. 01 Yuba River	Left	2.21	11/01/2016 11/01/2016	Sterling York

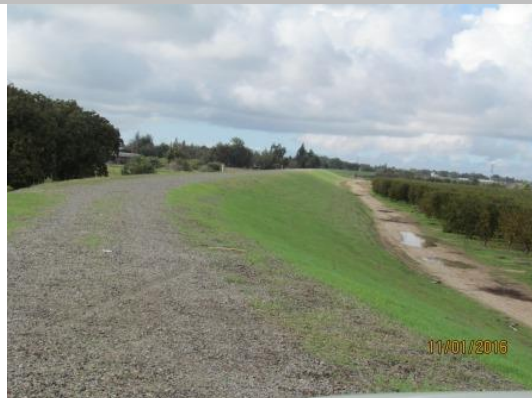
Photo 1 of 1 : FA_2016_RD0784_178_2_20161103_00006.jpg

LM Start	0.04	Rating **	A	Issue No.	2
LM End	2.20	Issue Type +	Ma	Location *	WS
Category	Earthen Levee			GPS Latitude/Longitude	
				Start	End
Item	Vegetation			39.134450 °	39.125874 °
				-121.552671 °	-121.588644 °
DWR ID	DWR_RD0784_01_f_2016_2				
Comment Code					
V1 : Control annual grass and weeds on the levee slopes and easements.					
Inspector Comment					
Well maintained annual vegetation. Fall 2016.

View of waterside looking downstream of well maintained annual vegetation. Fall 2016.

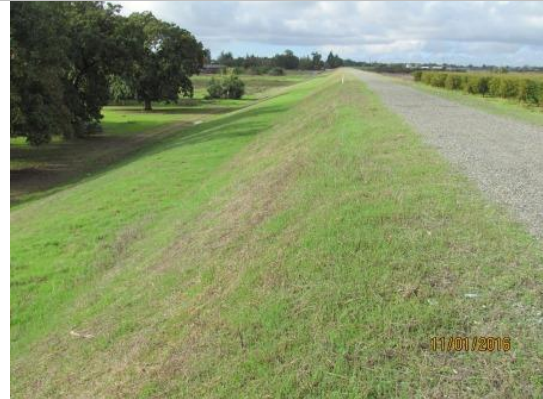
Photo 1 of 1 : FA_2016_RD0784_178_3_20161103_00007.jpg

LM Start	0.04	Rating **	A	Issue No.	3
LM End	2.20	Issue Type +	Ma	Location *	LS
Category	Earthen Levee			GPS Latitude/Longitude	
				Start	End
Item	Vegetation			39.134450°	39.125874°
				-121.552672°	-121.588644°
DWR ID	DWR_RD0784_01_f _ 2016_3				
Comment Code					
V1 : Control annual grass and weeds on the levee slopes and easements.					
Inspector Comment					
Well maintained annual vegetation. Fall 2016.

View of landside looking downstream of well maintained annual vegetation. Fall 2016.

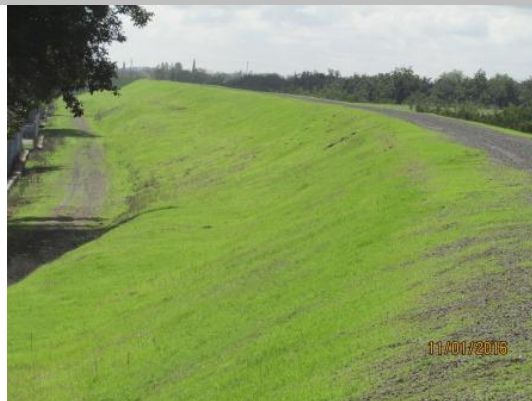
Photo 1 of 2 : FA_2016_RD0784_531_1_20161103_00005.jpg

LM Start	0.01	Rating **	A	Issue No.	1
LM End	2.53	Issue Type +	Ma	Location *	LS
Category	Earthen Levee			GPS Latitude/Longitude	
				Start	End
Item	Vegetation			39.125763 °	39.090425 °
				-121.588667 °	-121.584694 °
DWR ID	DWR_RD0784_02A_f_2016_1				
Comment Code					
V1 : Control annual grass and weeds on the levee slopes and easements.					
Inspector Comment					
Well maintained annual vegetation. Fall 2016.

First view looking downstream of landside well maintained annual vegetation. Fall 2016.

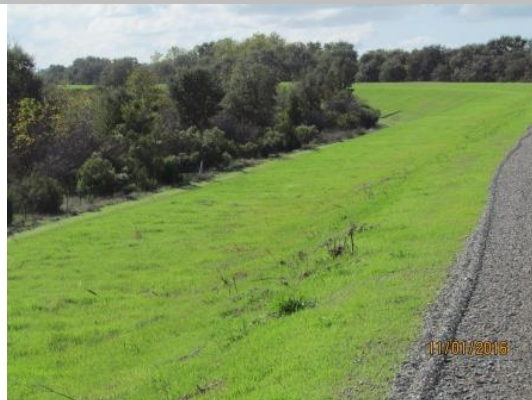
Photo 2 of 2 : FA_2016_RD0784_531_1_20161117_00007.jpg

Second view looking downstream on waterside of well maintained annual vegetation. Fall 2016.

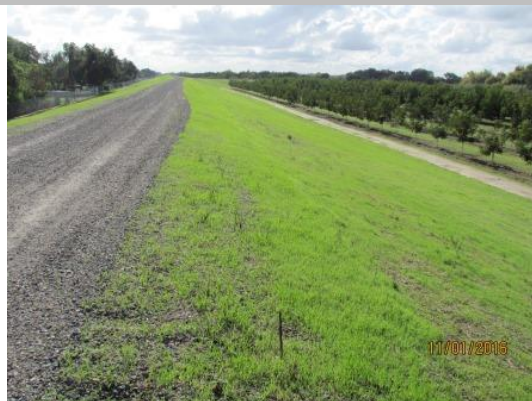
Photo 1 of 2 : FA_2016_RD0784_531_2_20161103_00003.jpg

LM Start	0.01	Rating **	A	Issue No.	2
LM End	2.53	Issue Type +	Ma	Location *	WS
Category	Earthen Levee			GPS Latitude/Longitude	
				Start	End
Item	Vegetation			39.125763 °	39.090425 °
				-121.588667 °	-121.584695 °
DWR ID	DWR_RD0784_02A_f_2016_2				
Comment Code					
V1 : Control annual grass and weeds on the levee slopes and easements.					
Inspector Comment					
Well maintained annual vegetation. Fall 2016.

First view of waterside looking downstream of well maintained annual vegetation. Fall 2016.

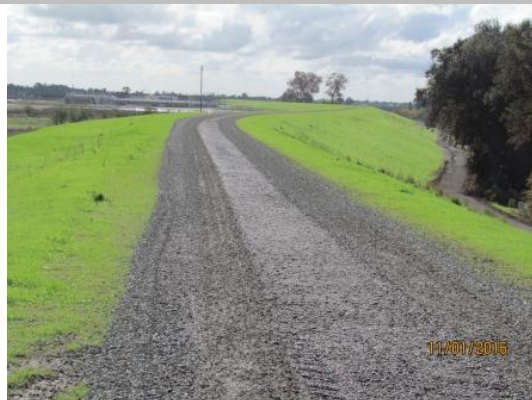
Photo 2 of 2 : FA_2016_RD0784_531_2_20161103_00004.jpg

Second view of waterside looking downstream of well maintained annual vegetation. Fall 2016.

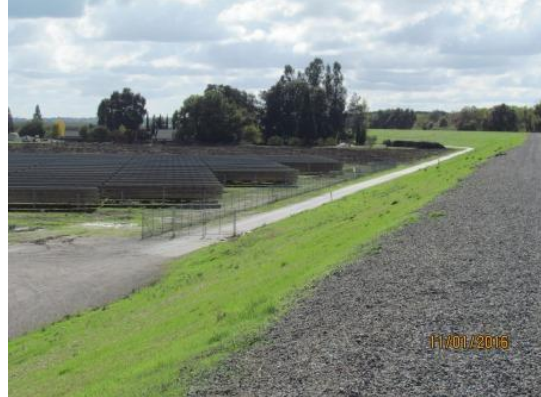
Photo 1 of 1 : FA_2016_RD0784_532_3_20161103_00007.jpg

LM Start	9.00	Rating **	A	Issue No.	3
LM End	12.80	Issue Type +	Ma	Location *	LS
Category	Earthen Levee			GPS Latitude/Longitude	
				Start	End
Item	Vegetation			39.009547 °	38.955539 °
				-121.578825 °	-121.574623 °
DWR ID	DWR_RD0784_02B_f _ 2016_3				
Comment Code					
V1 : Control annual grass and weeds on the levee slopes and easements.					
Inspector Comment					
Well maintained annual vegetation. Fall 2016.

View of landside looking downstream of landside well maintained annual vegetation. Fall 2016.

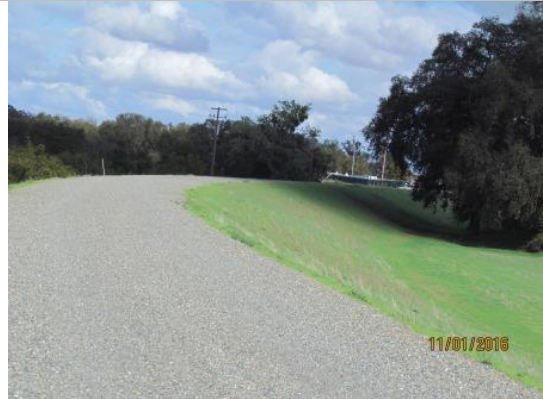
Photo 1 of 1 : FA_2016_RD0784_533_3_20161103_00002.jpg

LM Start	2.43	Rating **	A	Issue No.	3
LM End	3.20	Issue Type +	Ma	Location *	WS
Category	Earthen Levee			GPS Latitude/Longitude	
				Start	End
Item	Vegetation			38.970576 °	38.974682 °
				-121.547586 °	-121.535308 °
DWR ID	DWR_RD0784_03A_f _ 2016_3				
Comment Code					
V1 : Control annual grass and weeds on the levee slopes and easements.					
Inspector Comment					
Well maintained annual vegetation. Fall 2016.

View of waterside looking upstream at well maintained annual vegetation. Fall 2016.

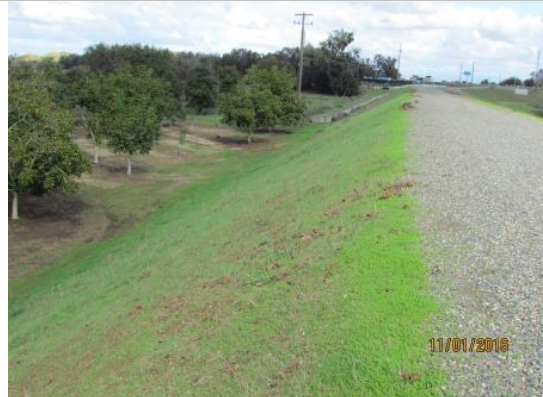
Photo 1 of 1 : FA_2016_RD0784_533_1_20161103_00003.jpg

LM Start	2.43	Rating **	A	Issue No.	1
LM End	3.20	Issue Type +	Ma	Location *	LS
Category	Earthen Levee			GPS Latitude/Longitude	
				Start	End
Item	Vegetation			38.970576 °	38.974682 °
				-121.547585 °	-121.535308 °
DWR ID	DWR_RD0784_03A_f _ 2016_1				
Comment Code					
V1 : Control annual grass and weeds on the levee slopes and easements.					
Inspector Comment					
Well maintained annual vegetation. Fall 2016.

View of landside looking upstream of landside well maintained annual vegetation. Fall 2016.

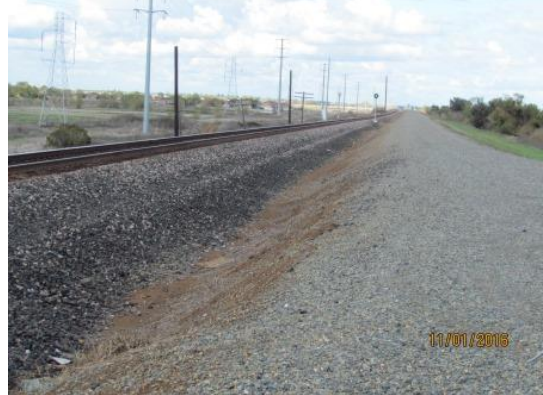
Photo 1 of 1 : FA_2016_RD0784_181_3_20161103_00007.jpg

LM Start	0.00	Rating **	A	Issue No.	3
LM End	6.31	Issue Type +	Ma	Location *	LS
Category	Earthen Levee			GPS Latitude/Longitude	
				Start	End
Item	Vegetation			38.974774 °	39.059304 °
				-121.535090 °	-121.551040 °
DWR ID	DWR_RD0784_04_f _ 2016_3				
Comment Code					
V1 : Control annual grass and weeds on the levee slopes and easements.					
Inspector Comment					
Well maintained annual vegetation. Fall 2016.

View of landside looking upstream of landside well maintained annual vegetation. Fall 2016.

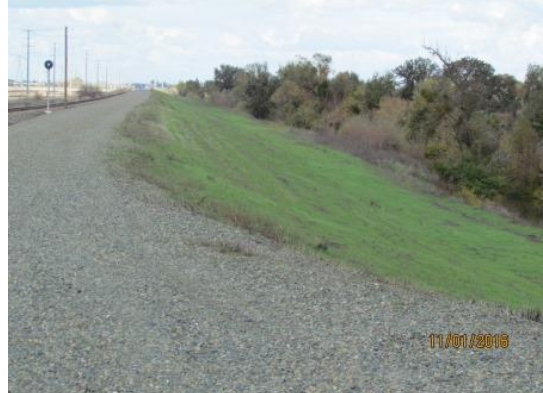
Photo 1 of 1 : FA_2016_RD0784_181_4_20161103_00008.jpg

LM Start	0.00	Rating **	A	Issue No.	4
LM End	6.31	Issue Type +	Ma	Location *	WS
Category	Earthen Levee			GPS Latitude/Longitude	
				Start	End
Item	Vegetation			38.974774 °	39.059304 °
				-121.535089 °	-121.551040 °
DWR ID	DWR_RD0784_04_f_2016_4				
Comment Code					
V1 : Control annual grass and weeds on the levee slopes and easements.					
Inspector Comment					
Well maintained annual vegetation. Fall 2016.

View of waterside looking upstream at well maintained annual vegetation. Fall 2016.

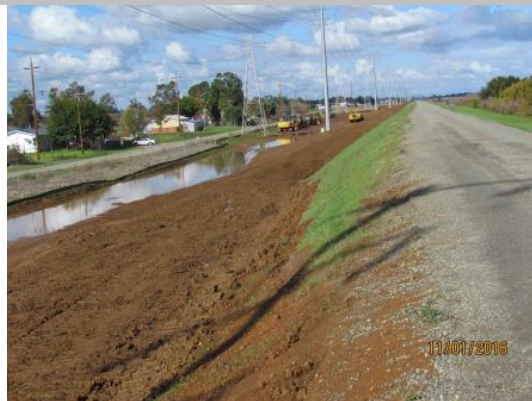
Photo 1 of 2 : FA_2016_RD0784_181_5_20161103_00009.jpg

LM Start	3.60	Rating **	A	Issue No.	5
LM End	5.84	Issue Type +	Ma	Location *	LS
Category	Earthen Levee			GPS Latitude/Longitude	
				Start	End
Item	Slope Stability			39.026503 °	39.058462 °
				-121.542349 °	-121.543125 °
DWR ID	DWR_RD0784_04_f _ 2016_5				
Comment Code					
S1 : Repair slope instability.					
Inspector Comment					
This section of levee on the landside is under construction with Permit Number 19020-1 to construct a stability berm and all weather access road. Fall 2016.

View of landside looking upstream. This section of levee on the landside is under construction with Permit Number 19020-1 to construct a stability berm and all weather access road. Fall 2016.

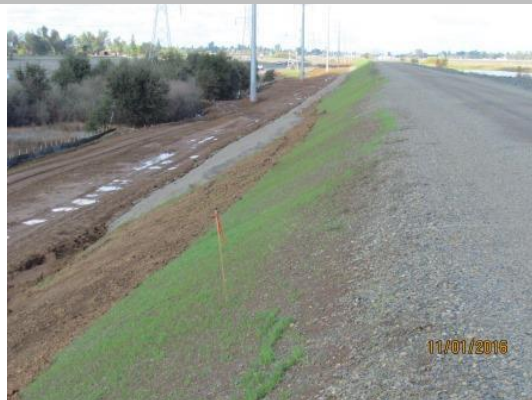
Photo 2 of 2 : FA_2016_RD0784_181_5_20161103_00010.jpg

Second view of landside looking upstream. This section of levee on the landside is under construction with Permit Number 19020-1 to construct a stability berm and all weather access road. Fall 2016.

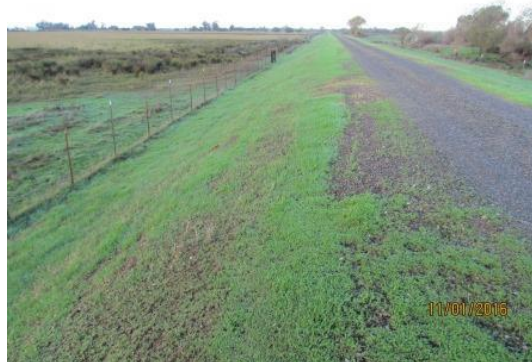
Photo 1 of 1 : FA_2016_RD0784_182_8_20161103_00023.jpg

LM Start	0.01	Rating **	A	Issue No.	8
LM End	4.19	Issue Type +	Ma	Location *	LS
Category	Earthen Levee			GPS Latitude/Longitude	
				Start	End
Item	Vegetation			38.974573 °	39.020574 °
				-121.532567 °	-121.509096 °
DWR ID	DWR_RD0784_05_f_2016_8				
Comment Code					
V1 : Control annual grass and weeds on the levee slopes and easements.					
Inspector Comment					
Well maintained annual vegetation. Fall 2016.

View of landside looking downstream of landside well maintained annual vegetation. Fall 2016.

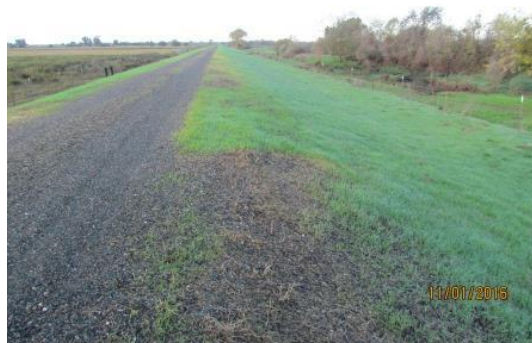
Photo 1 of 1 : FA_2016_RD0784_182_12_20161103_00022.jpg

LM Start	0.01	Rating **	A	Issue No.	12
LM End	4.19	Issue Type +	Ma	Location *	WS
Category	Earthen Levee			GPS Latitude/Longitude	
				Start	End
Item	Vegetation			38.974573 °	39.020574 °
				-121.532567 °	-121.509096 °
DWR ID	DWR_RD0784_05_f_2016_12				
Comment Code					
V1 : Control annual grass and weeds on the levee slopes and easements.					
Inspector Comment					
Well maintained annual vegetation. Fall 2016.

View of waterside looking downstream at well maintained annual vegetation. Fall 2016.

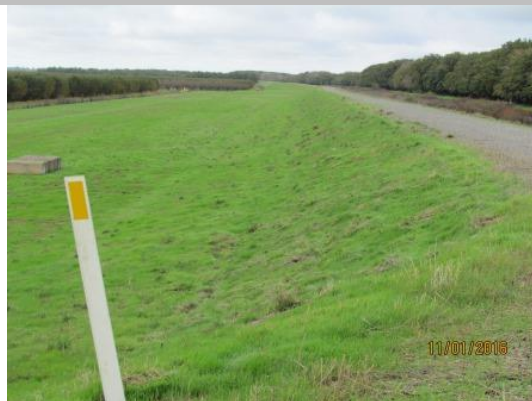
Photo 1 of 1 : FA_2016_RD0784_184_2_20161103_00005.jpg

LM Start	0.12	Rating **	A	Issue No.	2
LM End	3.81	Issue Type +	Ma	Location *	LS
Category	Earthen Levee			GPS Latitude/Longitude	
				Start	End
Item	Vegetation			39.135137°	39.165505°
				-121.550129°	-121.495615°
DWR ID	DWR_RD0784_07_f_2016_2				
Comment Code					
V1 : Control annual grass and weeds on the levee slopes and easements.					
Inspector Comment					
Well maintained annual vegetation. Fall 2016.

View of landside looking downstream of landside well maintained annual vegetation. Fall 2016.

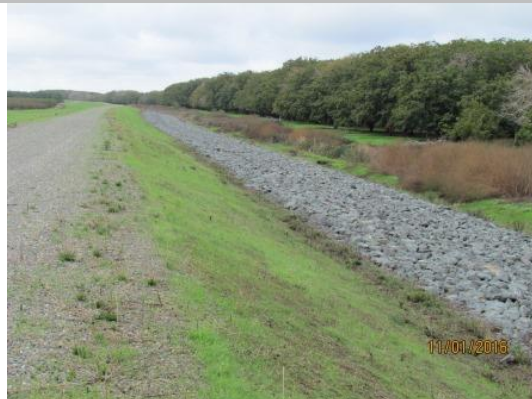
Photo 1 of 1 : FA_2016_RD0784_184_3_20161103_00004.jpg

LM Start	0.12	Rating **	A	Issue No.	3
LM End	3.81	Issue Type +	Ma	Location *	WS
Category	Earthen Levee			GPS Latitude/Longitude	
				Start	End
Item	Vegetation			39.135138°	39.165505°
				-121.550129°	-121.495615°
DWR ID	DWR_RD0784_07_f_2016_3				
Comment Code					
V1 : Control annual grass and weeds on the levee slopes and easements.					
Inspector Comment					
Well maintained annual vegetation. Fall 2016.

View of waterside looking downstream at well maintained annual vegetation. Fall 2016.

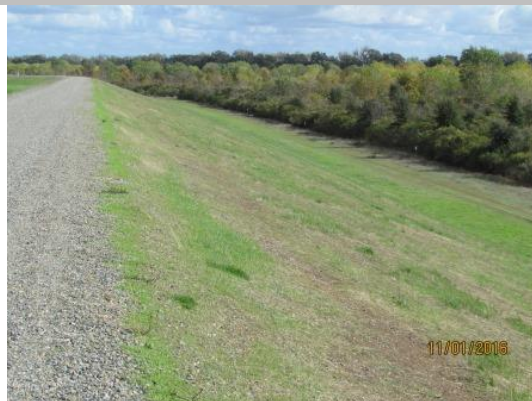
Photo 1 of 1 : FA_2016_RD0784_437_2_20161103_00002.jpg

LM Start	0.02	Rating **	A	Issue No.	2
LM End	1.93	Issue Type +	Ma	Location *	WS
Category	Earthen Levee			GPS Latitude/Longitude	
				Start	End
Item	Vegetation			38.955540°	38.970544°
				-121.574624°	-121.547607°
DWR ID	DWR_RD0784_08_f_2016_2				
Comment Code					
V1 : Control annual grass and weeds on the levee slopes and easements.					
Inspector Comment					
Well maintained annual vegetation. Fall 2016.

View of waterside looking upstream at well maintained annual vegetation. Fall 2016.

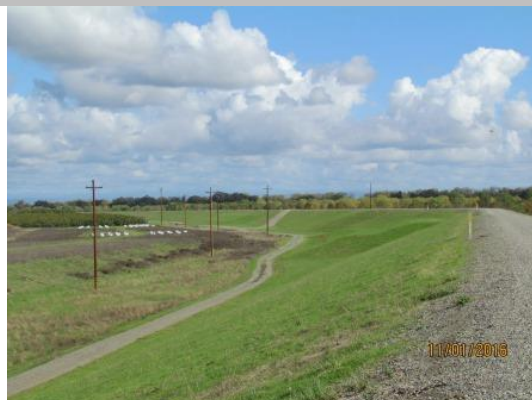
Photo 1 of 1 : FA_2016_RD0784_437_1_20161103_00001.jpg

LM Start	0.02	Rating **	A	Issue No.	1
LM End	1.93	Issue Type +	Ma	Location *	LS
Category	Earthen Levee			GPS Latitude/Longitude	
				Start	End
Item	Vegetation			38.955539 °	38.970544 °
				-121.574623 °	-121.547607 °
DWR ID	DWR_RD0784_08_f_2016_1				
Comment Code					
V1 : Control annual grass and weeds on the levee slopes and easements.					
Inspector Comment					
Well maintained annual vegetation. Fall 2016.

View of landside looking upstream of landside well maintained annual vegetation. Fall 2016.
