**Flood Control Project Maintenance
Levee Inspections**

Maintenance Issue Types Only, Levee Inspection Report By Mile - Fall 2017

Reclamation District No. 0784 Plumas Lake

Waterway	Bank	Unit Miles	Inspection Start/End	Inspector
Unit No. 01 Yuba River	Left	2.21	10/31/2017 10/31/2017	Sterling York

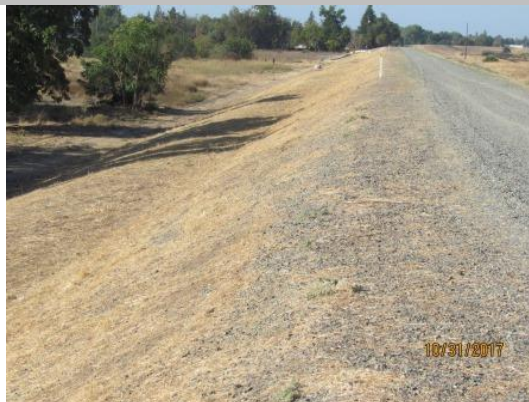
Photo 1 of 1 : FA_2017_RD0784_178_2_20171102_00006.jpg

LM Start	0.01	Rating **	A	Issue No.	2
LM End	2.20	Issue Type +	Ma	Location *	LS
Category	Earthen Levee			GPS Latitude/Longitude	
				Start	End
Item	Vegetation			39.134844 °	39.125884 °
				-121.552385 °	-121.588621 °
DWR ID	DWR_RD0784_01_f_2017_2				
Comment Code					
V1 : Control annual grass and weeds on the levee slopes and easements.					
Inspector Comment					
Well maintained annual vegetation, Fall 2017.

View looking downstream landside of well maintained vegetation, Fall 2017.

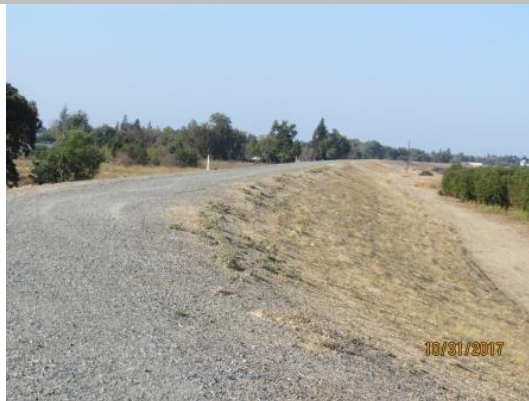
Photo 1 of 1 : FA_2017_RD0784_178_3_20171102_00007.jpg

View looking downstream waterside of well maintained annual vegetation, Fall2017.

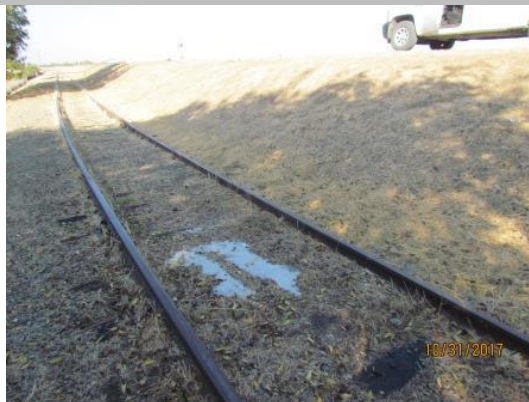
Photo 1 of 1 : FA_2017_RD0784_178_7_20171102_00009.jpg

LM Start	0.97	Rating **	A	Issue No.	7
LM End	0.97	Issue Type +	Ma	Location *	LS
Category	Earthen Levee			GPS Latitude/Longitude	
				Start	End
Item	Animal Control			39.129471 °	39.129471 °
				-121.568720 °	-121.568720 °
DWR ID	DWR_RD0784_01_f_2017_7				
Comment Code					
A1 : Exterminate rodents and backfill and compact or grout burrows.					
Inspector Comment					
No sign of Rodent activity and holes have been grouted, Fall 2017.

View looking downstream landside, no sign of Rodent activity and holes have been grouted, Fall 2017.

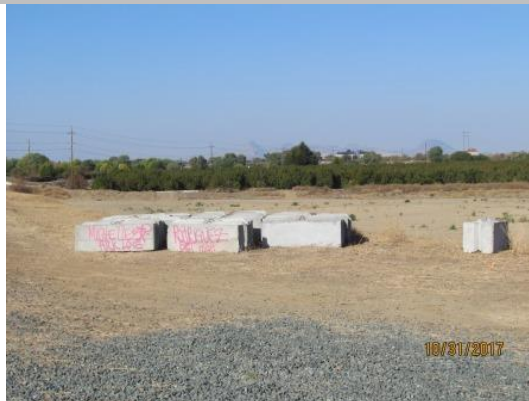
Photo 1 of 1 : FA_2017_RD0784_178_8_20171102_00013.jpg

LM Start	1.17	Rating **	A	Issue No.	8
LM End	1.17	Issue Type +	Ma	Location *	WS
Category	Earthen Levee			GPS Latitude/Longitude	
				Start	End
Item	Slope Stability			39.129690 °	39.129690 °
				-121.572334 °	-121.572334 °
DWR ID	DWR_RD0784_01_f_2017_8				
Comment Code					
S3 : Repair the levee slope damaged by vehicle traffic and prevent access where possible.					
Inspector Comment					
Blocks are being placed to prevent motor vehicle, Fall 2017.

View of waterside crown where blocks are staged prior to being placed at levee toe to prevent vehicles from driving up levee slope, Fall 2017.

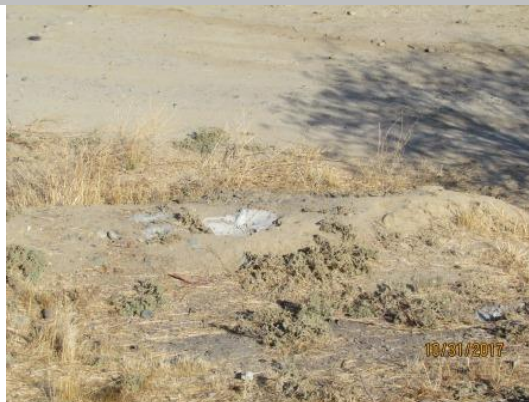
Photo 1 of 2 : FA_2017_RD0784_178_9_20171102_00011.jpg

LM Start	1.27	Rating **	A	Issue No.	9
LM End	1.27	Issue Type +	Ma	Location *	WS
Category	Earthen Levee			GPS Latitude/Longitude	
				Start	End
Item	Animal Control			39.129713 °	39.129713 °
				-121.574321 °	-121.574321 °
DWR ID	DWR_RD0784_01_f_2017_9				
Comment Code					
A1 : Exterminate rodents and backfill and compact or grout burrows.					
Inspector Comment					
No sign of Rodent activity and holes have been grouted, Fall 2017.

View looking downstream waterside, no sign of Rodent activity and holes have been grouted, Fall 2017.

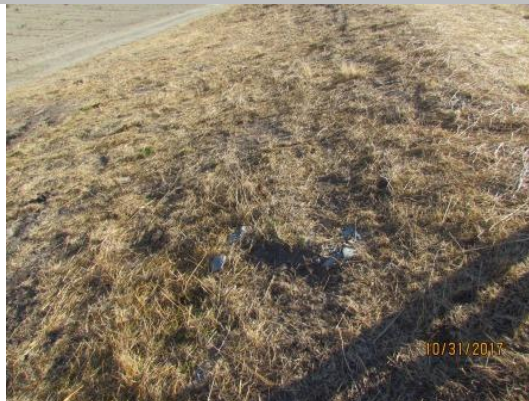
Photo 2 of 2 : FA_2017_RD0784_178_9_20171102_00010.jpg

View looking downstream waterside, no sign of Rodent activity and holes have been grouted, Fall 2017.

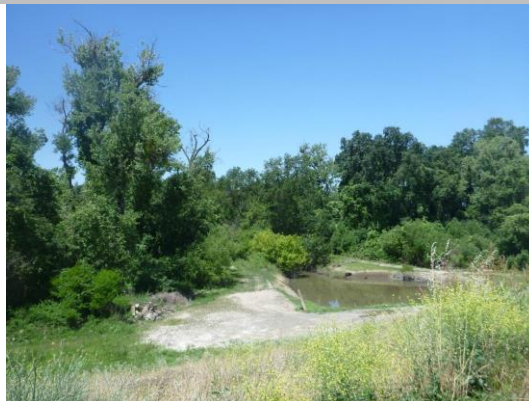
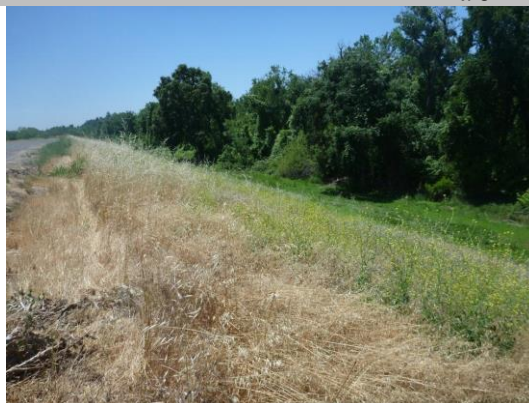
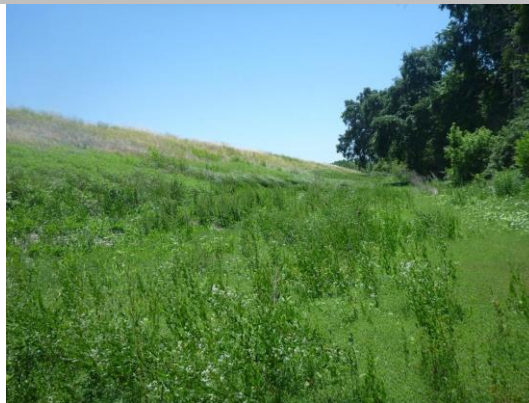
LM Start		Rating **	A/W	Issue No.	1	
LM End		Issue Type +	Ma	Location *		
Category	Supplemental			GPS Latitude/Longitude		
				Start	End	
Item	2017 Storm Damage			38.956165 °		
				-121.577400 °		
DWR ID	DWR_RD0784_02A_f_2017_1					
Comment Code						
Inspector Comment						
Levee Evaluation Comments						
Description:						
Site ID No:221						
Site Designation:LMA-28						
Repair Type: Erosion						
Rating:Area of Concern						
Field Date:6/6/2017						
Notes: LMA not aware of erosion, and no levee erosion found. About 400' into channel there is some erosion at the inlet and outlet of a culvert.

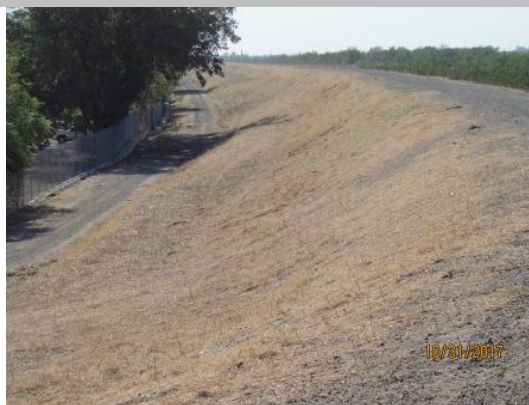
Photo 1 of 2 : FA_2017_RD0784_531_2_20171102_00004.jpg

LM Start	0.00	Rating **	A	Issue No.	2
LM End	2.54	Issue Type +	Ma	Location *	LS
Category	Earthen Levee			GPS Latitude/Longitude	
				Start	End
Item	Vegetation			39.125803 °	39.090355 °
				-121.588647 °	-121.584683 °
DWR ID	DWR_RD0784_02A_f_2017_2				
Comment Code					
V1 : Control annual grass and weeds on the levee slopes and easements.					
Inspector Comment					
Annual vegetation is well maintained, Fall 2017.

View looking downstream landside of well maintained annual vegetation, Fall 2017.

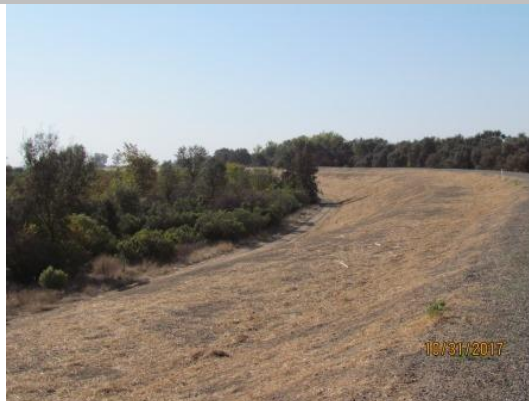
Photo 2 of 2 : FA_2017_RD0784_531_2_20171102_00005.jpg

Another view looking downstream landside of well maintained annual vegetation, Fall 2017.

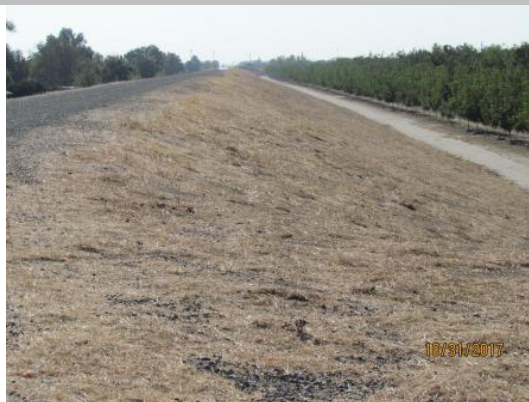
Photo 1 of 2 : FA_2017_RD0784_531_3_20171102_00006.jpg

LM Start	0.00	Rating **	A	Issue No.	3
LM End	2.54	Issue Type +	Ma	Location *	WS
Category	Earthen Levee			GPS Latitude/Longitude	
				Start	End
Item	Vegetation			39.125803 °	39.090355 °
				-121.588647 °	-121.584683 °
DWR ID	DWR_RD0784_02A_f_2017_3				
Comment Code					
V1 : Control annual grass and weeds on the levee slopes and easements.					
Inspector Comment					
Annual vegetation is well maintained, Fall 2017.

View looking downstream waterside of well maintained annual vegetation, Fall 2017.

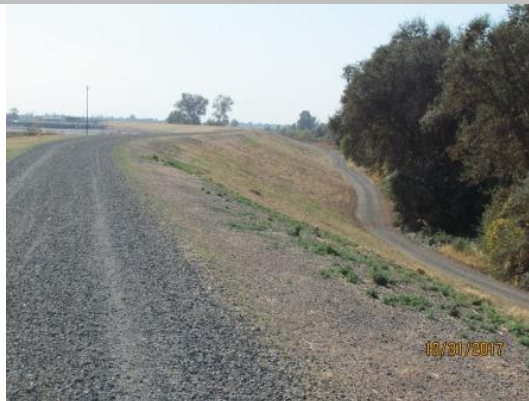
Photo 2 of 2 : FA_2017_RD0784_531_3_20171102_00007.jpg

Another view looking downstream waterside of well maintained annual vegetation, Fall 2017.

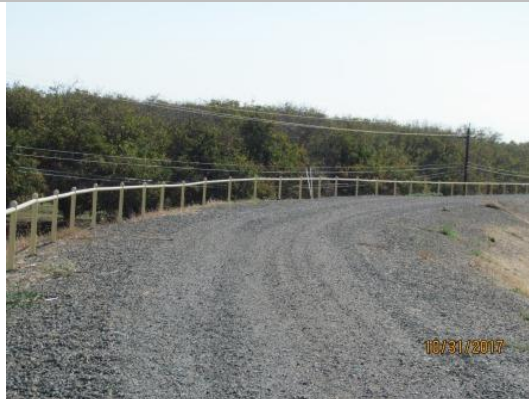
Photo 1 of 1 : FA_2017_RD0784_532_4_20171102_00003.jpg

LM Start	8.95	Rating **	A	Issue No.	4
LM End	9.21	Issue Type +	Ma	Location *	CR
Category	Earthen Levee			GPS Latitude/Longitude	
				Start	End
Item	Slope Stability			39.010040 °	39.006547 °
				-121.579332 °	-121.577836 °
DWR ID	DWR_RD0784_02B_f_2017_4				
Comment Code					
S1 : Repair slope instability.					
Inspector Comment					
Pipe fence to prevent vehicles from driving up levee slope, Fall 2017.

View looking downstream at the crown where pipe fence has been installed to prevent vehicles from rutting up the levee slope. This is a very high traffic area, Fall 2017.

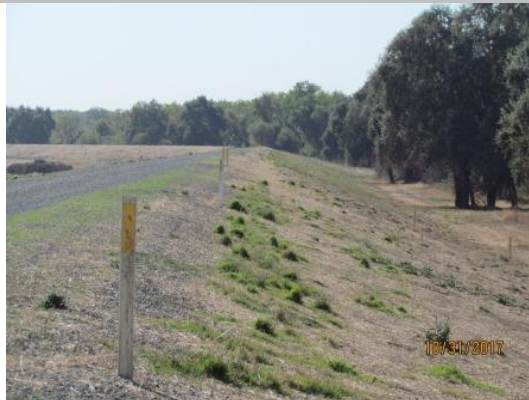
Photo 1 of 2 : FA_2017_RD0784_532_3_20171102_00007.jpg

View looking downstream waterside of well maintained annual vegetation, Fall 2017.

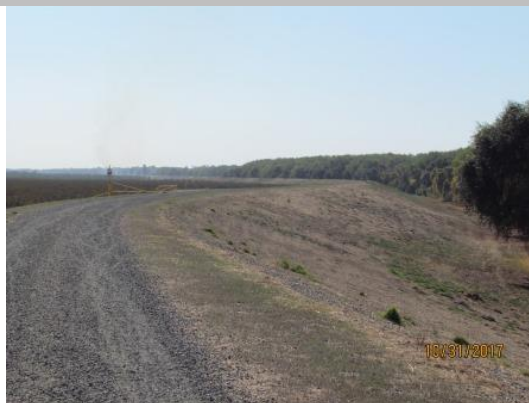
Photo 2 of 2 : FA_2017_RD0784_532_3_20171102_00008.jpg

Another view looking downstream waterside of the well maintained annual vegetation, Fall 2017.

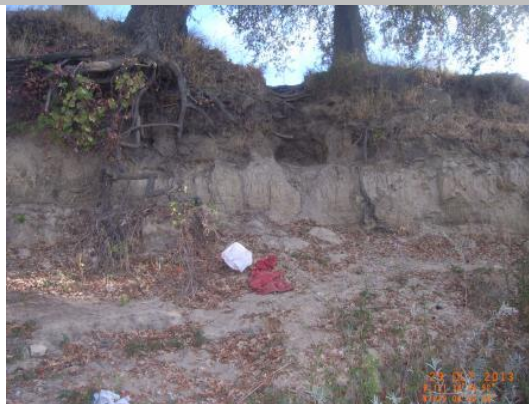
Photo 1 of 1 : FA_2017_RD0784_532_1_20170911_00001.jpg

Comment Code					
Inspector Comment					
2003 - Bank is near vertical. Identified as a Potentially Critical site. 2004 - Eddy flow off downstream end of Modesto formation eroding the fluvial sediments. 2005 - Some new slumping. Actively eroding but berm width is greater than 50 ft. 2006 - Downgraded to regular erosion site. Still actively eroding. Large old rotational failures in high bank on the downstream end. 2008 - Removed from inventory due to wide berm width does not meet criteria for an erosion site. 2010 - Added back to the inventory after 10 ft of bank erosion in the winter 2009 storm. Steep vertical face. 2011 - Bank has retreated an additional 2.5 ft from last year. New tree popouts and erosion throughout the site. 2012 - Site continues to worsen with new tree popouts and many sections of new erosion. 2015: Last observed in 2013. [2015 Site ID: FHR_17-8_L]

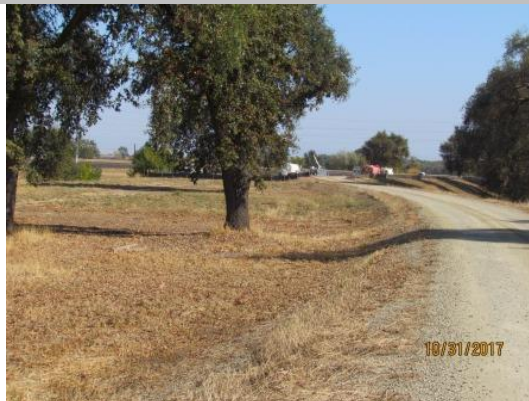
Photo 1 of 2 : FA_2017_RD0784_533_1_20171102_00002.jpg

View looking upstream landside of well maintained annual vegetation, Fall 2017.

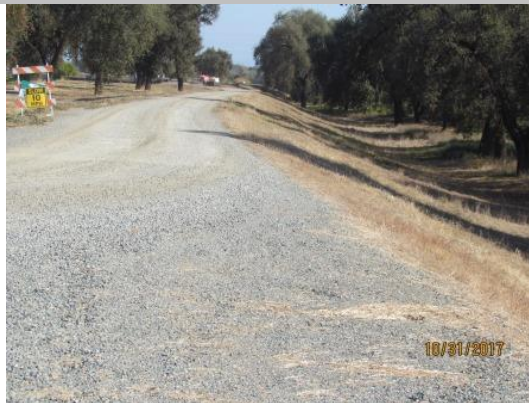
Photo 1 of 1 : FA_2017_RD0784_533_3_20171102_00001.jpg

View looking upstream waterside of well maintained annual vegetation, Fall 2017.

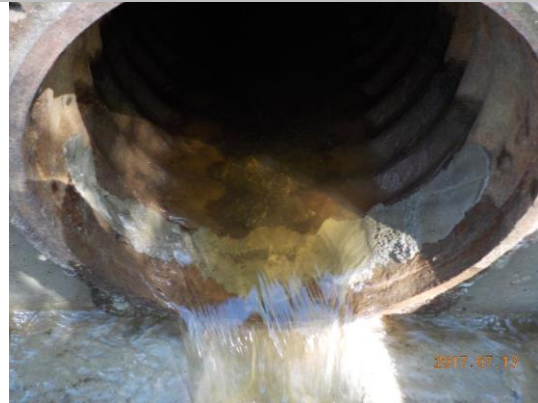
Photo 1 of 3 : UCIP_FA_2017_52571_77114.jpg

FS_ID:52571
DS_ID:18627
EP_NO: N/A
Repair Type: Urgent
Crossing Status: Found
UCIP Comments: 11/30/2017 Crossing remains Urgent due to uncertainty of pipe condition through levee -- recommend an internal inspection of the pipe through the levee as a precaution measure to determine integrity of pipe. Repair of the rusted out collar (void) found at the WS pipe outlet has been repaired by the LMA. Received additional photos from DWR levee inspector, S. York, of the WS concrete headwall installed and vegetation cleared from WS. (O. Magana - DWR UCIP)07/13/2017 - The rusted out collar at the bottom of the waterside flap gate has been sealed with concrete. Internal pipe inspections still pending. (P.Meagher-RD784).04/13/2017 - Spoke to LMA representative, P. Meagher, regarding the status of this crossing. The report has been updated to indicate vegetation has been cleared from WS outlet and LS inlet. The crossing remains Urgent--WS pipe collar is rusted out on the bottom. Recommend internal pipe inspection to determine pipe integrity through the levee. Owner will need to coordinate with the CVFPB to address issue. (O. Magana - DWR UCIP)

01/16/2017 - Landowner who utilizes this pipe reported to RD784 staff on 1/11/2017 that he suspected this pipe at the waterside flap gate ring area was rusted out at the bottom. After investigating, we could see what was reported is correct. Sandbags have been temporarily placed around the 2" +/- gapped area underneath the flap gate ring. A permanent solution is anticipated to be completed in the next 3 to 6 months. The plan is to pour a concrete ring / headwall around the open corroded pipe end. Photos attached. (P. Meagher - RD784).11/04/2016 - Flap gate on waterside has been cleared again as of 10/17/2016. The LS inlet area has been cleared as of 9/21/2016. See updated photos attached. (P.Meagher - RD784)09/22/2016 - vegetation at inlet of pipe has been cleared by owner. photos added showing pipe inlet. (T. Hatch - DWR UCIP)08/09/2016 - vegetation partially obscuring outlet on WS. Heavy vegetation on landside (LS) limiting inspection of inlet. Owner asked by RD0784 to clear vegetation and debris. (T. Hatch - DWR UCIP)11/1/2015 - Flap Gate has been cleared as of 12/9/2014 and again during summer of 2015 (P. Meagher/RD0784)2/27/2013 - Flap gate blocked by vegetation on WS toe. Unable to locate inlet. (W. Wylie - DWR UCIP)

Close up photo of concrete seal where the rusted out void used to be. Farmer irrigation was currently flowing at the time the photo was taken.

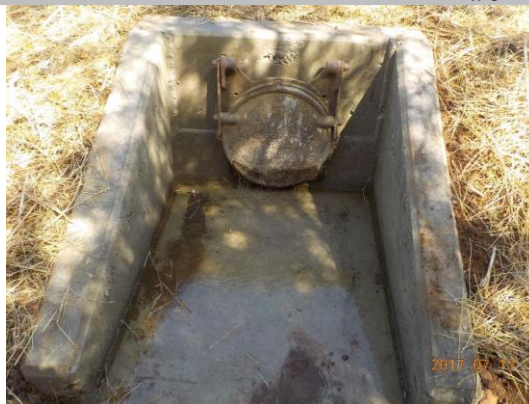
Photo 2 of 3 : UCIP_FA_2017_52571_77115.jpg

Concrete collar completed around the waterside exterior flap gate section.

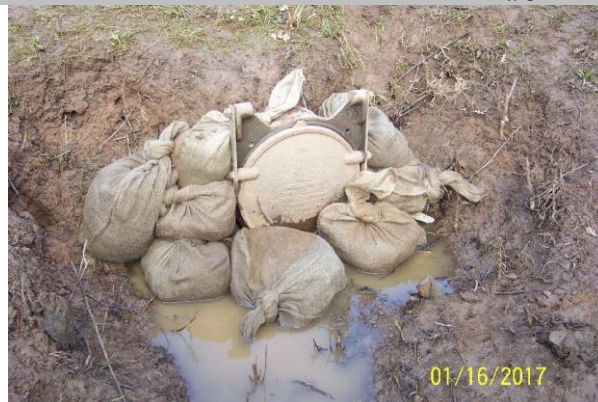
Photo 3 of 3 : UCIP_FA_2017_52571_76618.jpg

Sandbags temporarily placed in front of flapgate.

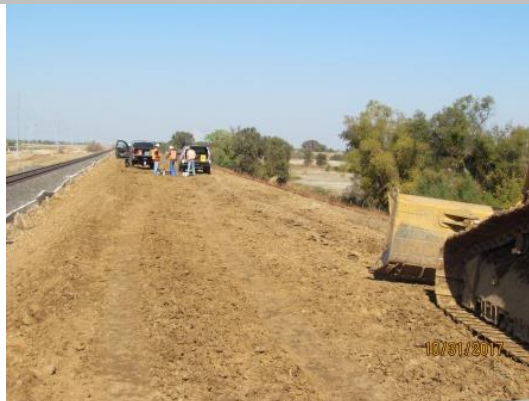
Photo 1 of 3 : FA_2017_RD0784_181_4_20171102_00006.jpg

View looking upstream startpoint where the levee is under construction, Fall 2017.

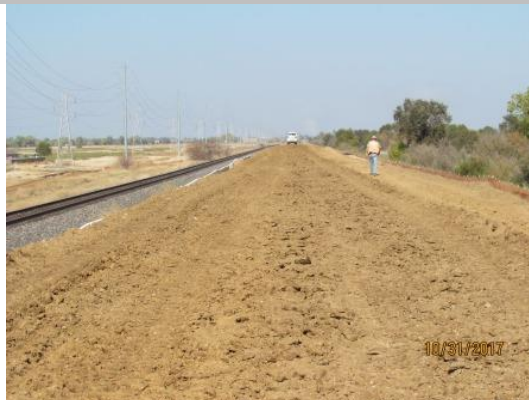
Photo 2 of 3 : FA_2017_RD0784_181_4_20171102_00007.jpg

View looking upstream midpoint where the levee is under construction, Fall 2017.

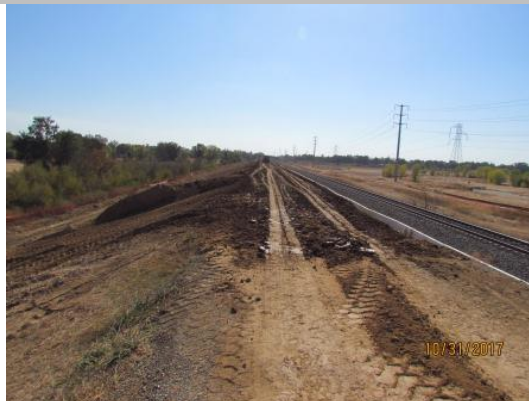
Photo 3 of 3 : FA_2017_RD0784_181_4_20171102_00008.jpg

View looking upstream endpoint where the levee is under construction, Fall 2017.

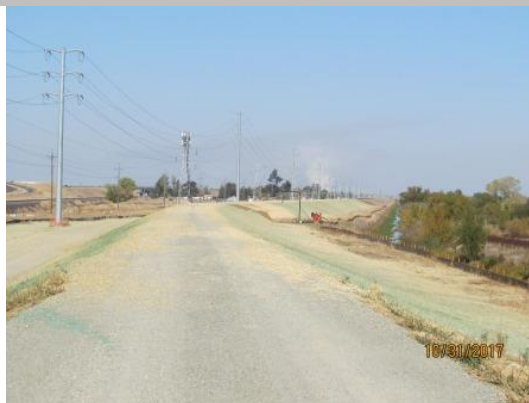
Photo 2 of 2 : FA_2017_RD0784_181_7_20171106_00012.jpg

View looking upstream midpoint where the levee is under construction, Fall 2017.

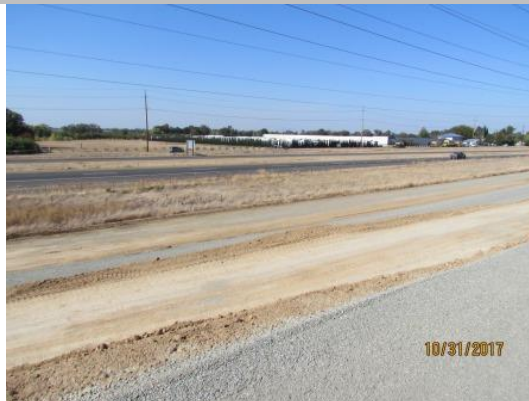
Photo 2 of 2 : FA_2017_RD0784_181_10_20171106_00016.jpg

Another view looking upstream where the levee is under construction, Fall 2017.

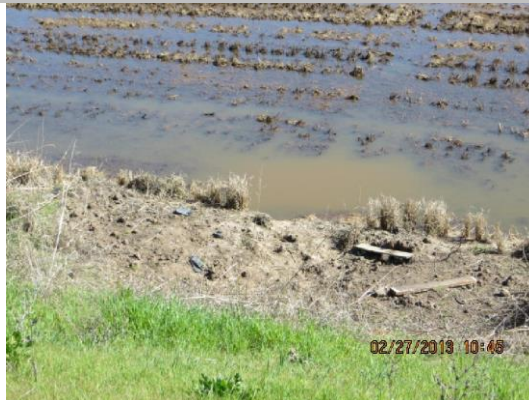
Photo 2 of 3 : UCIP_FA_2017_51719_54248.jpg

Debris covered inlet on LS toe.

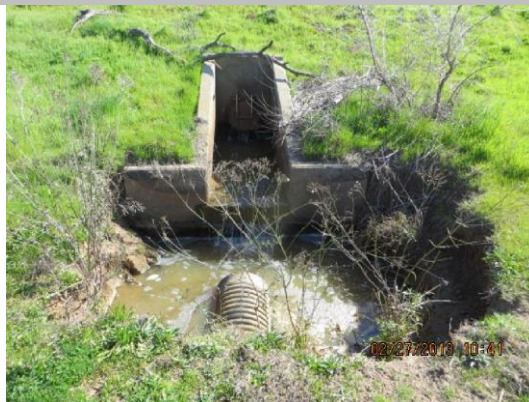
Photo 2 of 3 : UCIP_FA_2017_51707_54253.jpg

Concrete U-shaped headwall on WS toe with Flap gate showing erosion at outlet.

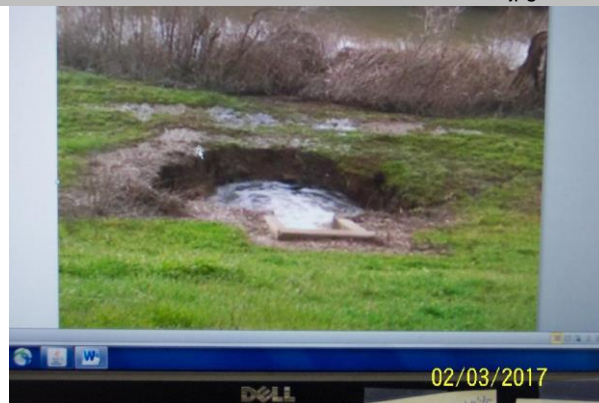
Photo 3 of 3 : UCIP_FA_2017_51707_76774.jpg

After photo after excess pipe was cut off. Actual photo date was 1/31/2017

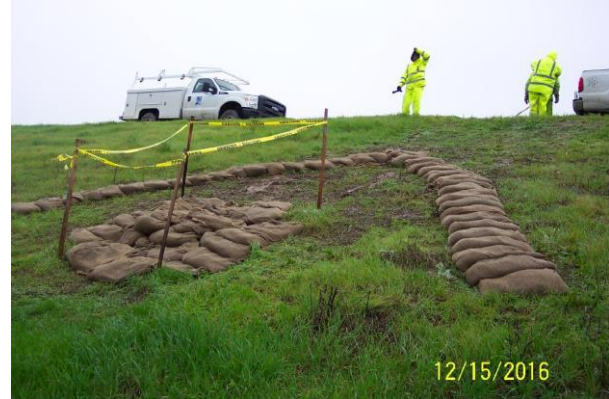
Photo 2 of 3 : UCIP_FA_2017_52570_76309.jpg

WS view: Sink hole filled in with sandbags and "V" shaped diversion dam built to help divert rainwater.

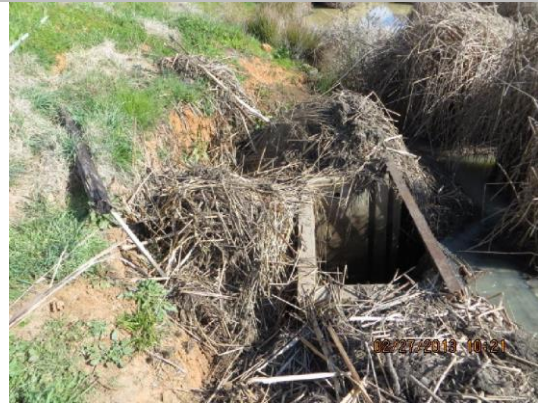
Photo 3 of 3 : UCIP_FA_2017_52570_54254.jpg

Erosion and debris from Beaver activity.

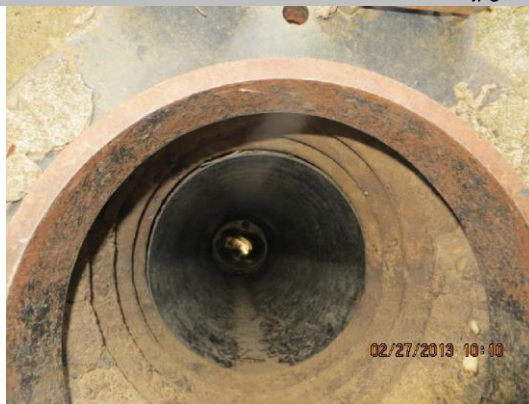
Photo 2 of 3 : UCIP_FA_2017_51714_54262.jpg

Pipe showing sliplied PVC insert. some erosion of PV at outlet and it may be disjointed internally.

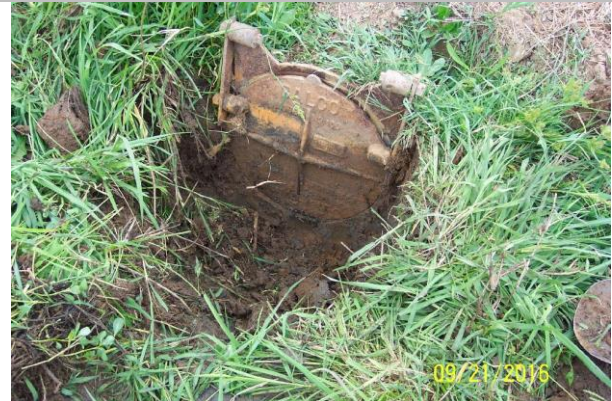
Photo 1 of 3 : UCIP_FA_2017_51712_76147.jpg

Flap gate on the WS toe is exposed

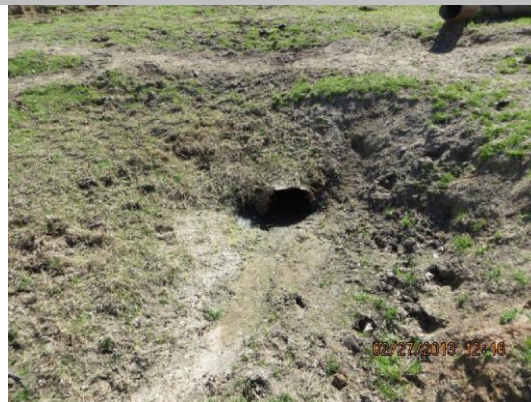
Photo 2 of 3 : UCIP_FA_2017_51716_54268.jpg

Partially clogged inlet pipe at LS toe.

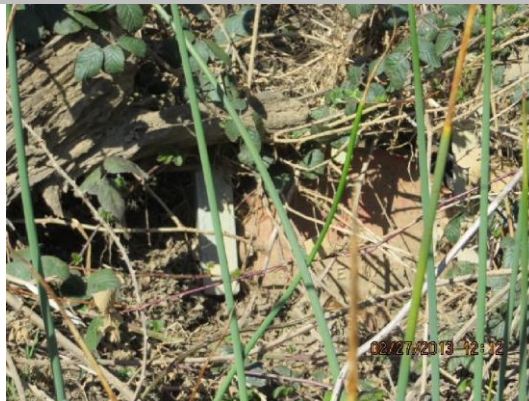
Photo 3 of 3 : UCIP_FA_2017_51716_54265.jpg

Flap gate blocked by vegetation at WS.
