**Flood Control Project Maintenance  
Levee Inspections**

**Maintenance Issue Types Only, Levee Inspection Report By Mile - Fall 2018**

**Reclamation District No. 0784 Plumas Lake**

Waterway	Bank	Unit Miles	Inspection Start/End	Inspector
Unit No. 01 Yuba River	Left	2.21	10/25/2018 10/25/2018	Sterling York

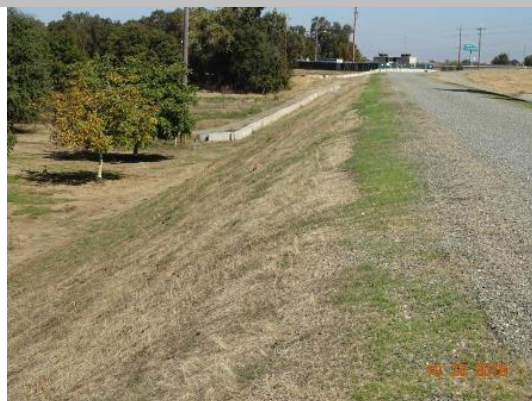
Photo 1 of 1 : FA\_2018\_RD0784\_533\_1\_20181106\_00002.jpg

View looking downstream landside of the well maintained annual Vegetation, Fall 2018.

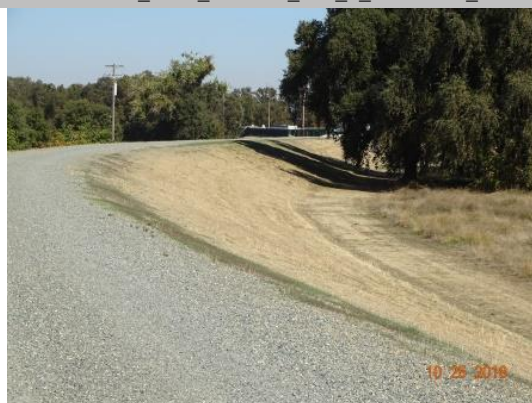
Photo 1 of 1 : FA\_2018\_RD0784\_533\_2\_20181106\_00001.jpg

LM Start	2.43	Rating **	A	Issue No.	2
LM End	3.20	Issue Type +	Ma	Location *	WS
Category	Earthen Levee			GPS Latitude/Longitude	
				Start	End
Item	Vegetation			38.970603 °	38.974686 °
				-121.547558 °	-121.535306 °
DWR ID	DWR_RD0784_03A_f_2018_2				
Comment Code					
V1 : Control annual grass and weeds on the levee slopes and easements.					
Inspector Comment					
The annual vegetation is well maintained, Fall 2018.

View looking downstream waterside of the well maintained annual Vegetation, Fall 2018.

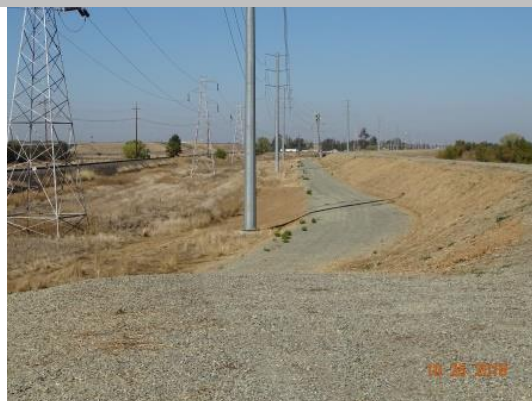
Photo 1 of 1 : FA\_2018\_RD0784\_181\_2\_20181106\_00005.jpg

View looking upstream landside of the well maintained annual Vegetation, Fall 2018.

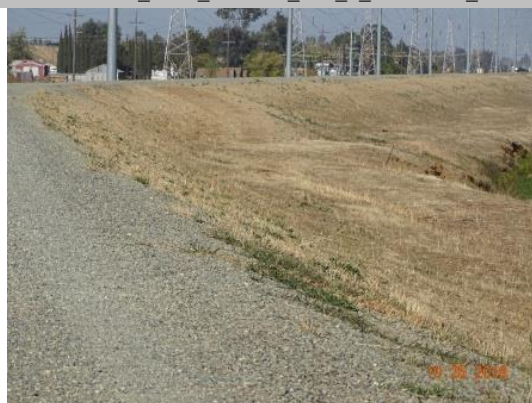
Photo 1 of 1 : FA\_2018\_RD0784\_181\_3\_20181106\_00004.jpg

LM Start	0.00	Rating **	A	Issue No.	3
LM End	6.25	Issue Type +	Ma	Location *	WS
Category	Earthen Levee			GPS Latitude/Longitude	
				Start	End
Item	Vegetation			38.974781 °	39.058447 °
				-121.535086 °	-121.550701 °
DWR ID	DWR_RD0784_04_f_2018_3				
Comment Code					
V1 : Control annual grass and weeds on the levee slopes and easements.					
Inspector Comment					
The annual vegetation is well maintained, Fall 2018.

View looking upstream waterside of the well maintained annual Vegetation, Fall 2018.

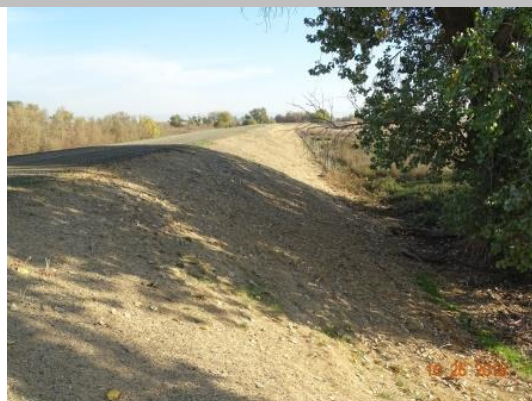
Photo 1 of 1 : FA\_2018\_RD0784\_182\_14\_20181106\_00035.jpg

View looking upstream landside of the well maintained annual Vegetation, Fall 2018.

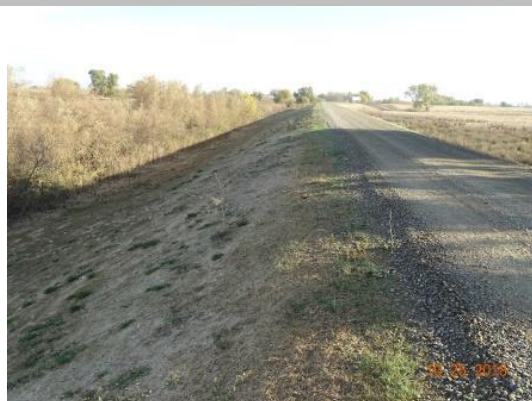
Photo 1 of 1 : FA\_2018\_RD0784\_182\_15\_20181106\_00036.jpg

LM Start	0.01	Rating **	A	Issue No.	15
LM End	4.20	Issue Type +	Ma	Location *	WS
Category	Earthen Levee			GPS Latitude/Longitude	
				Start	End
Item	Vegetation			38.974498 °	39.020574 °
				-121.532531 °	-121.508986 °
DWR ID	DWR_RD0784_05_f_2018_15				
Comment Code					
V1 : Control annual grass and weeds on the levee slopes and easements.					
Inspector Comment					
The annual vegetation is well maintained, Fall 2018.

View looking upstream waterside of the well maintained annual Vegetation, Fall 2018.

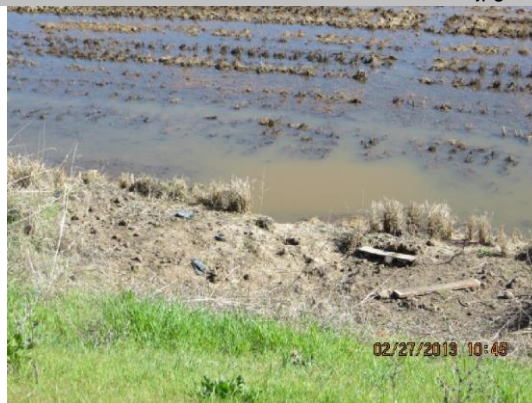
Photo 2 of 3 : UCIP\_FA\_2018\_51719\_54248.jpg

Debris covered inlet on LS toe.

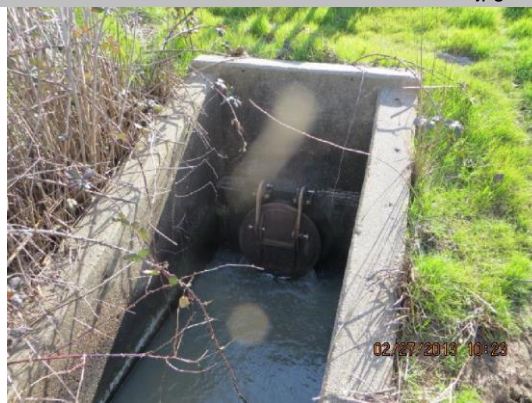
Photo 1 of 3 : UCIP\_FA\_2018\_53070\_54258.jpg

UCIP Comments: 10/16/2018 - Pipe remains Urgent due to internal pipe failure. Diversion dam on the WS slope is still present. Mr. Meagher is monitoring the progress of the erosion on the LS. Flag markers have been added just above the erosion site on the LS to monitor the progress of the slope failure. LMA is working with the District Engineer on proposed repair and CVFPB to obtain approval for a pipe replacement. Crossing is listed as DMP Phase 1 eligible crossing. (O. Magana - DWR UCIP) 11/30/2017 - same as previous inspection - crossing remains Urgent. Received updated photos from DWR levee inspector, S. York, showing current condition of levee LS and WS. (O. Magana - DWR UCIP) 12/15/2016 - Coordination email was received from RD0784 this afternoon. Patrick Meagher with Reclamation District is closely monitoring the eroded pipe area at the Horseshoe Levee due to periodic rainstorms and unpredictable water flow elevations. To avoid further damage at this location, Mr. Meagher has coordinated with LMA Consultant Sean Minard at MHM Engineering and DWR Levee Inspector Sterling York to address further deterioration at site. As a proactive measure by RD784, sandbags were used to fill in the sink hole on the WS. A "V" shape diversion dam was also built of sandbags above the sinkhole area to help divert running rainwater coming down the slope around the fill area. RD0784 used approximately 100 sandbags at the site to fill in sink hole and create the "V" shaped diversion dam. (O. Magana - DWR UCIP) 07/29/2016 - Erosion scarp on LS cut into levee shoulder starting at inlet headwall. Cavity failure on WS shoulder approximately 2-feet in diameter and several feet in depth. (T. Hatch/UCIP) 11/01/2015 - The concrete box weir structure on the landside inlet has slumped off the end of the pipe. DWR Chief inspector George Wilie inspected the site on 8/13/2015 with Steve Fordice, General Manager of RD784. (P. Meagher - RD784)

Concrete U-shaped headwall and flap gate on WS toe.

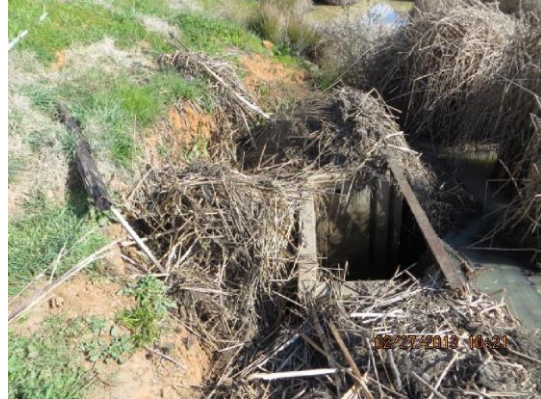
Photo 3 of 3 : UCIP\_FA\_2018\_53070\_54254.jpg

Comment Code					
Inspector Comment					
FS_ID:53070 DS_ID:18597 EP_NO: N/A Repair Type: Urgent Crossing Status: Found UCIP Comments: 10/16/2018 - Pipe remains Urgent due to internal pipe failure. Diversion dam on the WS slope is still present. Mr. Meagher is monitoring the progress of the erosion on the LS. Flag markers have been added just above the erosion site on the LS to monitor the progress of the slope failure. LMA is working with the District Engineer on proposed repair and CVFPB to obtain approval for a pipe replacement. Crossing is listed as DMP Phase 1 eligible crossing. (O. Magana - DWR UCIP) 11/30/2017 - same as previous inspection - crossing remains Urgent. Received updated photos from DWR levee inspector, S. York, showing current condition of levee LS and WS. (O. Magana - DWR UCIP) 12/15/2016 - Coordination email was received from RD0784 this afternoon. Patrick Meagher with Reclamation District is closely moritoning the eroded pipe area at the Horseshoe Levee due to periodic rainstorms and unpredictable water flow elevations. To avoid further damage at this location, Mr. Meagher has coordinated with LMA Consultant Sean Minard at MHM Engineering and DWR Levee Inspector Sterling York to address further deterioration at site. As a proactive measure by RD784, sandbags were used to fill in the sink hole on the WS. A "V" shape diversion dam was also built of sandbags above the sinkhole area to help divert running rainwater coming down the slope around the fill area. RD0784 used approximately 100 sandbags at the site to fill in sink hole and create the "V" shaped diversion dam. (O. Magana - DWR UCIP) 07/29/2016 - Erosion scarp on LS cut into levee shoulder starting at inlet headwall. Cavity failure on WS shoulder approximately 2-feet in diameter and several feet in depth. (T. Hatch/UCIP) 11/01/2015 - The concrete box weir structure on the landside inlet has slumped off the end of the pipe. DWR Chief inspector George Wilie inspected the site on 8/13/2015 with Steve Fordice, General Manager of RD784. (P. Meagher - RD784)  2/27/2013 - Heavy erosion around inlet headwall due to beaver activity. (W. Wylie/UCIP) FIELD_STRUCT_DESC: 18-inch corrugated metal drainage pipe through the levee, 15.5 feet below the crown. Flap gate on the waterside (WS) toe. Concrete U-shaped headwall on the WS toe. (Removable standpipe and bulkheads approved under Permit No. 9230, 1974 - Frach, Inc.). [Additional Reference(s): DWR Levee Log, 2005. USACE Sacramento O&M Manual 145, August 1955 (Station 13+72). USACE As-Built Drawing No. 2-4-106, Sheet 6, July 1944 (Station 13+72)]. FS Date: 10/16/2018 1:06:00 PM

Erosion and debris from Beaver activity.

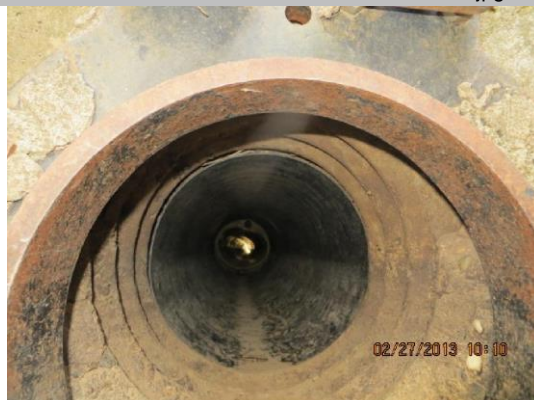
Photo 2 of 3 : UCIP\_FA\_2018\_51714\_54262.jpg

Comment Code						
Inspector Comment						
FS_ID:51714						
DS_ID:18596						
EP_NO: N/A						
Repair Type: Non-Urgent						
Crossing Status: Found						
UCIP Comments: 02/27/2013 Pipe has been sliplined with PVC, but the liner appears to be eroding at outlet and may be disjointed internal to the levee. See pic. Good candidate for video inspection. (W. Wylie - DWR UCIP)						
FIELD_STRUCT_DESC: 12-inch corrugated metal drainage pipe through the levee, 12 feet below the crown. Flap gate and concrete U-shaped headwall on the waterside (WS). Polyvinyl chloride weir on inlet at the landside (LS) toe. [Additional Reference(s): DWR Levee Log, 2005. USACE Sacramento O&M Manual 145, August 1955 (Station 44+96)].						
FS Date: 9/11/2015 9:26:00 AM

Pipe showing sliplined PVC insert. some erosion of PV at outlet and it may be disjointed internally.

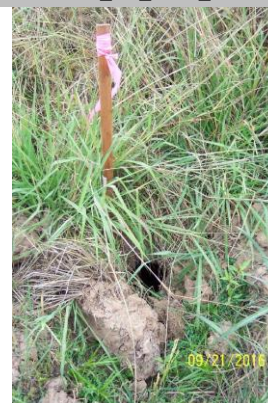
Photo 2 of 3 : UCIP\_FA\_2018\_51712\_76148.jpg

Possible location of the inlet on the LS toe

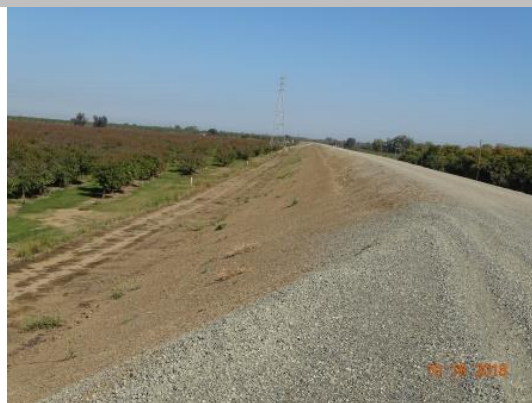
Photo 1 of 1 : FA\_2018\_RD0784\_183\_2\_20181106\_00006.jpg

View looking upstream landside of the well maintained annual Vegetation, Fall 2018.

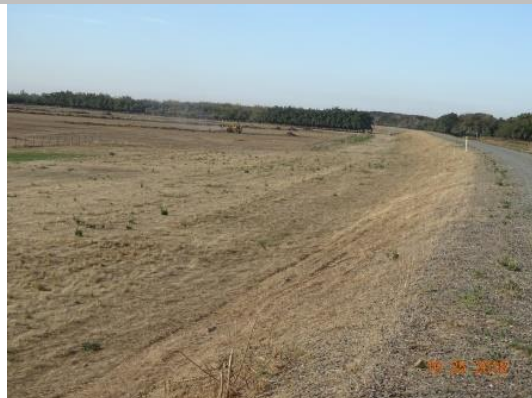
Photo 1 of 1 : FA\_2018\_RD0784\_184\_1\_20181106\_00001.jpg

View looking downstream landside of the well maintained annual Vegetation, Fall 2018.

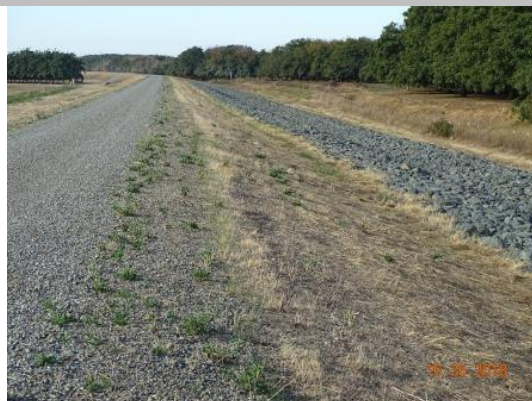
Photo 1 of 1 : FA\_2018\_RD0784\_184\_2\_20181106\_00002.jpg

View looking downstream waterside of the well maintained annual Vegetation, Fall 2018.
