**Flood Control Project Maintenance
Levee Inspections**

Maintenance Issue Types Only, Levee Inspection Report By Mile - Fall 2019

Reclamation District No. 0784 Plumas Lake

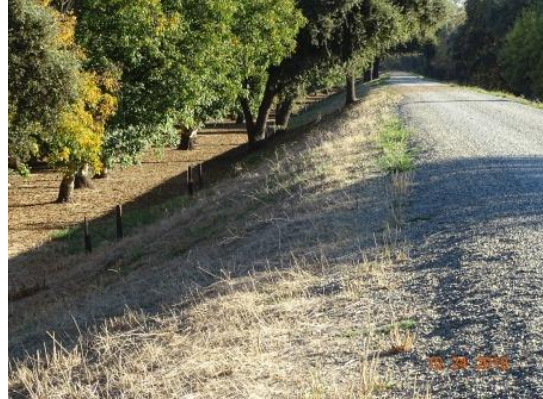
Photo 1 of 1 : FA_2019_RD0784_534_4_20191029_00005.jpg

View looking downstream landside at the well maintained annual vegetation, Fall 2019.

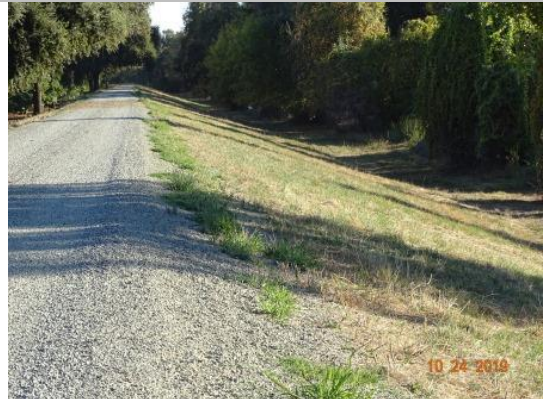
Photo 1 of 1 : FA_2019_RD0784_534_5_20191029_00006.jpg

LM Start	3.21	Rating **	A	Issue No.	5
LM End	4.68	Issue Type +	Ma	Location *	WS
Category	Earthen Levee			GPS Latitude/Longitude	
				Start	End
Item	Vegetation			38.974450 °	38.985442 °
				-121.532432 °	-121.510728 °
DWR ID	DWR_RD0784_03B_f_2019_5				
Comment Code					
V1 : Control annual grass and weeds on the levee slopes and easements.					
Inspector Comment					
The annual vegetation is well maintained, Fall 2019.

View looking downstream waterside at the well maintained annual vegetation, Fall 2019.

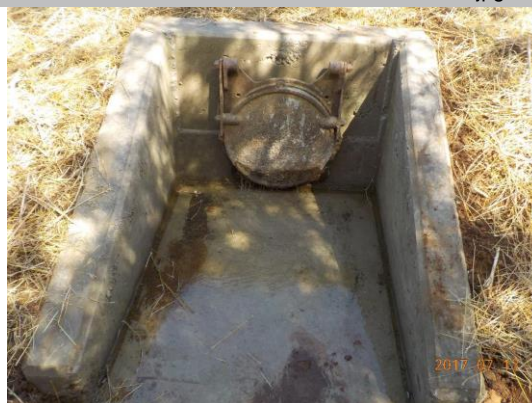
Photo 2 of 3 : UCIP_FA_2019_53072_77115.jpg

Concrete collar completed around the waterside exterior flap gate section.

07/13/2017 - The rusted out collar at the bottom of the waterside flap gate has been sealed with concrete. Internal pipe inspections still pending. (P.Meagher-RD784).

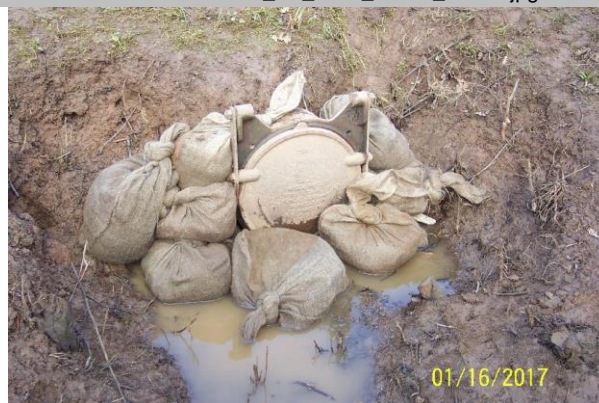
Photo 3 of 3 : UCIP_FA_2019_53072_76618.jpg

Sandbags temporarily placed in front of flapgate.

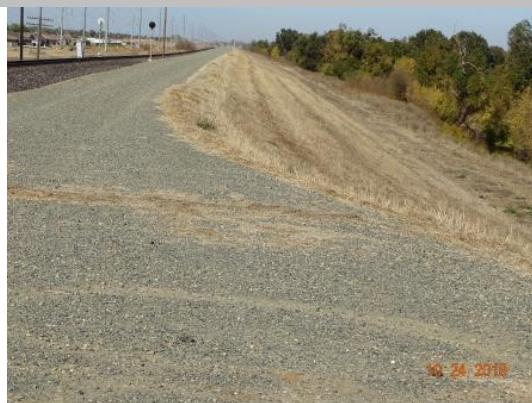
Photo 1 of 1 : FA_2019_RD0784_181_3_20191029_00007.jpg

View looking downstream waterside at the well maintained annual vegetation, Fall 2019.

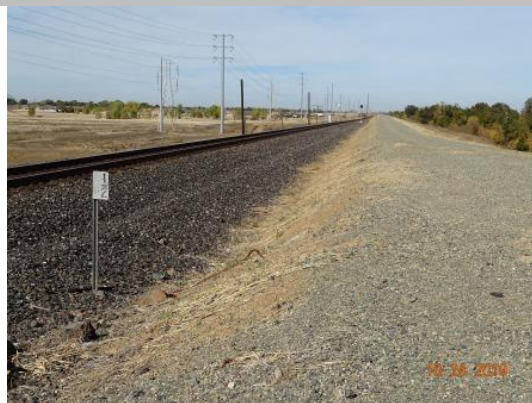
Photo 1 of 1 : FA_2019_RD0784_181_2_20191029_00006.jpg

LM Start	0.00	Rating **	A	Issue No.	2
LM End	6.31	Issue Type +	Ma	Location *	LS
Category	Earthen Levee			GPS Latitude/Longitude	
				Start	End
Item	Vegetation			38.974774 °	39.059299 °
				-121.535087 °	-121.551062 °
DWR ID	DWR_RD0784_04_f_2019_2				
Comment Code					
V1 : Control annual grass and weeds on the levee slopes and easements.					
Inspector Comment					
The annual vegetation is well maintained, Fall 2019.

View looking downstream landside at the well maintained annual vegetation, Fall 2019.

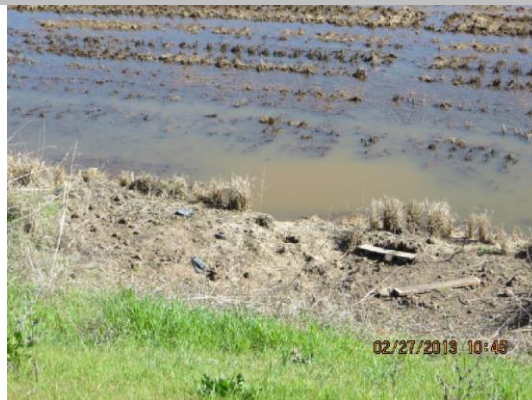
Photo 2 of 3 : UCIP_FA_2019_53548_54248.jpg

Debris covered inlet on LS toe.

Comment Code						
Inspector Comment						
DS_ID:18588 FS_ID:53548 EP_NO: N/A Repair Type: Non-Urgent Crossing Status: Found UCIP Comments: 2-1-2019 - Pipe crossing was video inspected on 8/14/2018. (P. Meagher)09/11/2015 Inlet burried. Good candidate for video inspection as pipe is corroded. (G. Wylie - FPIIB) FIELD_STRUCT_DESC: 18-inch corrugated metal drainage pipe through the levee, 14.5 feet below the crown. Flap gate on the waterside (WS) end. Concrete U-shaped headwall on the WS. [Additional Reference(s): DWR Levee Log, 2005. USACE Sacramento O&M Manual 145, August 1955 (Station 116+78)]. FS Date: 9/11/2015 9:36:00 AM

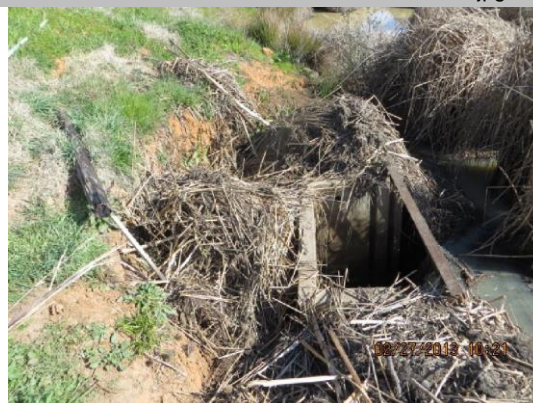
Photo 3 of 3 : UCIP_FA_2019_56031_54254.jpg

Erosion and debris from Beaver activity.

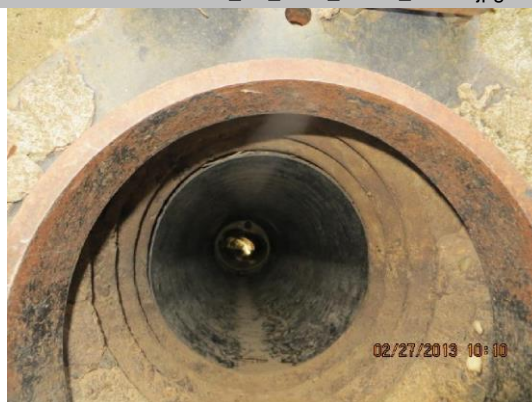
Photo 2 of 3 : UCIP_FA_2019_53553_54262.jpg

Comment Code						
Inspector Comment						
DS_ID:18596 FS_ID:53553 EP_NO: N/A Repair Type: Non-Urgent Crossing Status: Found UCIP Comments: 2-1-2019 - Pipe crossing was video inspected on 8/15/2018. (P. Meagher)02/27/2013 Pipe has been sliplined with PVC, but the liner appears to be eroding at outlet and may be disjointed internal to the levee. See pic. Good candidate for video inspection. (W. Wylie - DWR UCIP) FIELD_STRUCT_DESC: 12-inch corrugated metal drainage pipe through the levee, 12 feet below the crown. Flap gate and concrete U-shaped headwall on the waterside (WS). Polyvinyl chloride weir on inlet at the landside (LS) toe. [Additional Reference(s): DWR Levee Log, 2005. USACE Sacramento O&M Manual 145, August 1955 (Station 44+96)]. FS Date: 9/11/2015 9:26:00 AM

Pipe showing sliplined PVC insert. some erosion of PV at outlet and it may be disjointed internally.

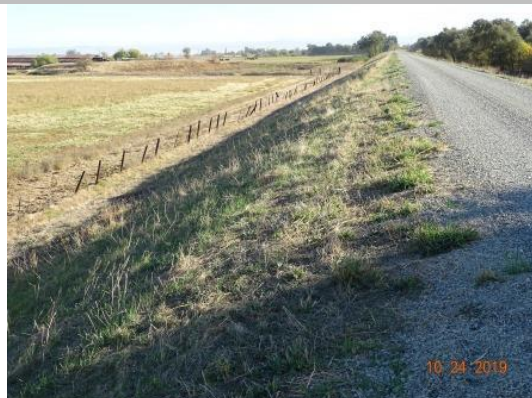
Photo 1 of 1 : FA_2019_RD0784_183_2_20191029_00005.jpg

View looking downstream landside at the well maintained annual vegetation, Fall 2019.

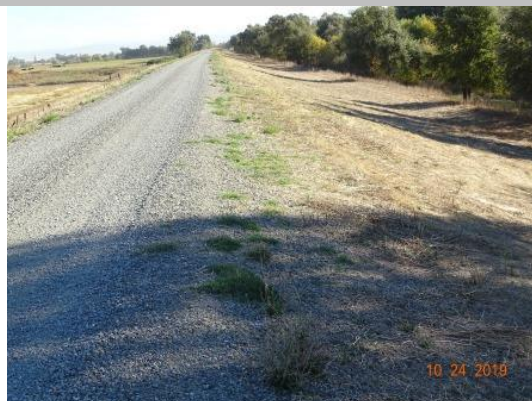
Photo 1 of 1 : FA_2019_RD0784_183_3_20191029_00004.jpg

View looking downstream waterside at the well maintained annual vegetation, Fall 2019.

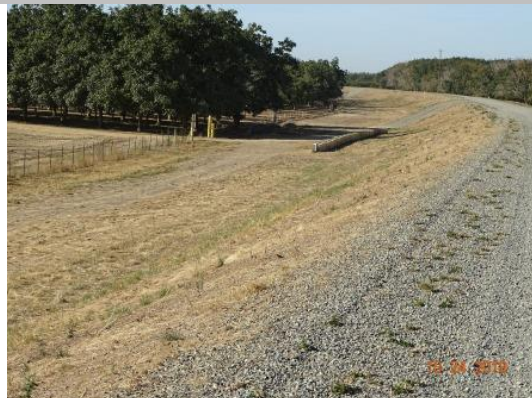
Photo 1 of 1 : FA_2019_RD0784_184_1_20191029_00003.jpg

View looking downstream landside at the well maintained annual vegetation, Fall 2019.

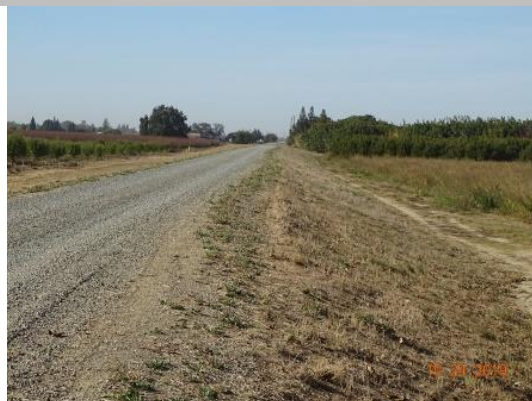
Photo 1 of 1 : FA_2019_RD0784_184_2_20191029_00002.jpg

View looking downstream waterside at the well maintained annual vegetation, Fall 2019.
