**Flood Control Project Maintenance
Levee Inspections**

Maintenance Issue Types Only, Levee Inspection Report By Mile - Fall 2020

Reclamation District No. 0784 Plumas Lake

Waterway	Bank	Unit Miles	Inspection Start/End	Inspector
Unit No. 01 Yuba River	Left	2.21	10/27/2020 10/27/2020	Brooks Weisser

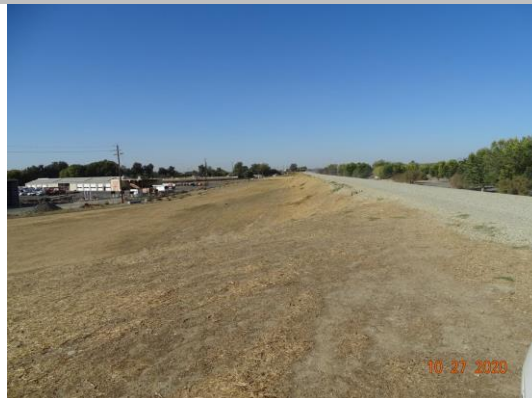
Photo 1 of 1 : FA_2020_RD0784_178_3_20201028_00011.jpg

LM Start	0.05	Rating **	A	Issue No.	3
LM End	2.20	Issue Type +	Ma	Location *	LS
Category	Earthen Levee			GPS Latitude/Longitude	
				Start	End
Item	Vegetation			39.134361 °	39.125902 °
				-121.552808 °	-121.588644 °
DWR ID	DWR_RD0784_01_f_2020_3				
Comment Code					
V1 : Control annual grass and weeds on the levee slopes and easements.					
Inspector Comment					
Annual vegetation is well maintained, Fall 2020.

View of landside annual vegetation that is well maintained, Fall 2020.

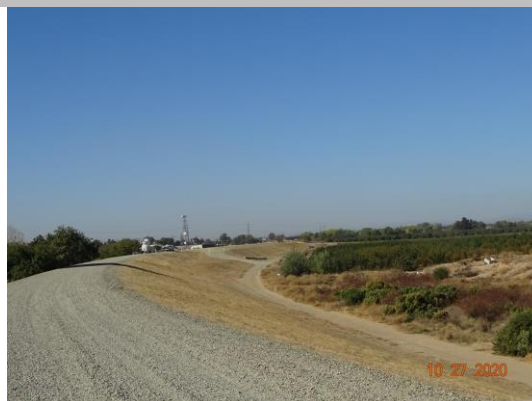
Photo 1 of 1 : FA_2020_RD0784_178_7_20201028_00010.jpg

LM Start	0.05	Rating **	A	Issue No.	7
LM End	2.20	Issue Type +	Ma	Location *	WS
Category	Earthen Levee			GPS Latitude/Longitude	
				Start	End
Item	Vegetation			39.134360 °	39.125929 °
				-121.552811 °	-121.588635 °
DWR ID	DWR_RD0784_01_f_2020_7				
Comment Code					
V1 : Control annual grass and weeds on the levee slopes and easements.					
Inspector Comment					
Annual vegetation is well maintained, Fall 2020.

View of waterside annual vegetation that is well maintained, Fall 2020.

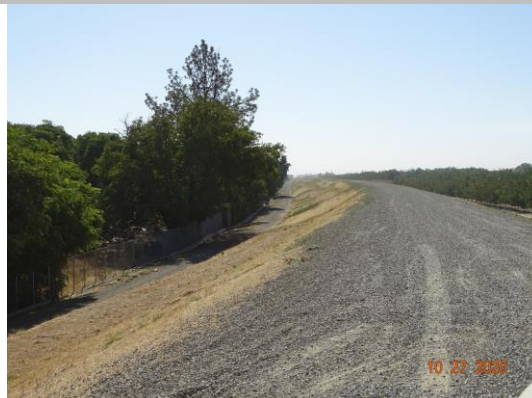
Photo 1 of 1 : FA_2020_RD0784_531_1_20201028_00001.jpg

LM Start	0.00	Rating **	A	Issue No.	1
LM End	2.51	Issue Type +	Ma	Location *	LS
Category	Earthen Levee			GPS Latitude/Longitude	
				Start	End
Item	Vegetation			39.125828 °	39.090732 °
				-121.588666 °	-121.584629 °
DWR ID	DWR_RD0784_02A_f_2020_1				
Comment Code					
V1 : Control annual grass and weeds on the levee slopes and easements.					
Inspector Comment					
Annual vegetation is well maintained, Fall 2020.

View of annual vegetation on landside slope, Fall 2020.

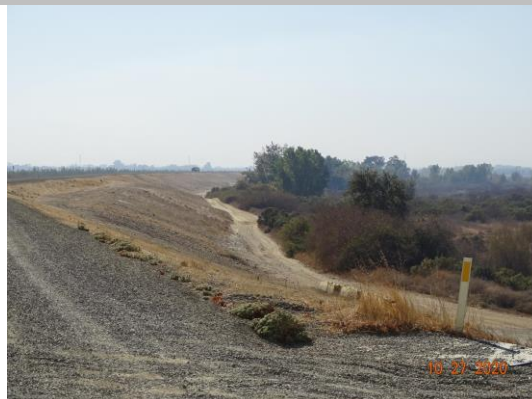
Photo 1 of 1 : FA_2020_RD0784_531_2_20201028_00002.jpg

LM Start	0.02	Rating **	A	Issue No.	2
LM End	2.51	Issue Type +	Ma	Location *	WS
Category	Earthen Levee			GPS Latitude/Longitude	
				Start	End
Item	Vegetation			39.125581 °	39.090754 °
				-121.588673 °	-121.584624 °
DWR ID	DWR_RD0784_02A_f_2020_2				
Comment Code					
V1 : Control annual grass and weeds on the levee slopes and easements.					
Inspector Comment					
Annual vegetation is well maintained, Fall 2020.

View of annual vegetation on waterside slope, Fall 2020.

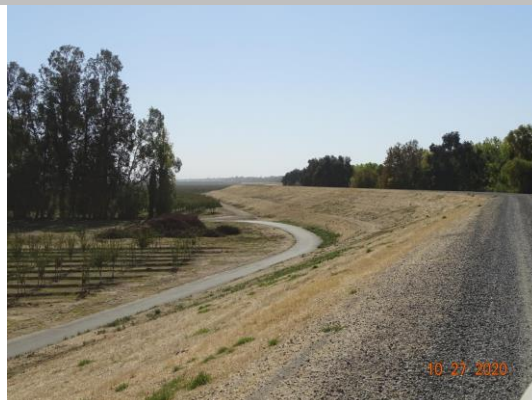
Photo 1 of 1 : FA_2020_RD0784_532_2_20201028_00005.jpg

LM Start	8.98	Rating **	A	Issue No.	2
LM End	12.80	Issue Type +	Ma	Location *	LS
Category	Earthen Levee			GPS Latitude/Longitude	
				Start	End
Item	Vegetation			39.009700 °	38.955555 °
				-121.578969 °	-121.574835 °
DWR ID	DWR_RD0784_02B_f_2020_2				
Comment Code					
V1 : Control annual grass and weeds on the levee slopes and easements.					
Inspector Comment					
Annual vegetation is well maintained, Fall 2020.

View of annual vegetation on landside slope, Fall 2020.

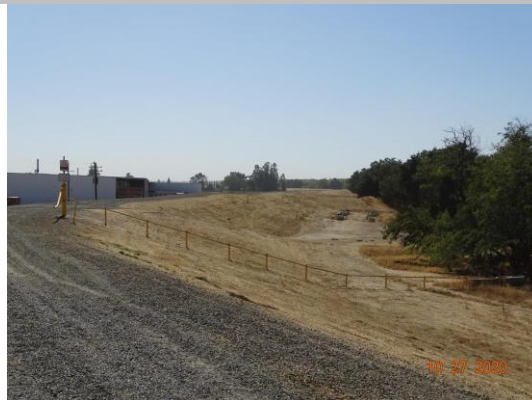
Photo 1 of 1 : FA_2020_RD0784_532_3_20201028_00006.jpg

LM Start	8.99	Rating **	A	Issue No.	3
LM End	12.80	Issue Type +	Ma	Location *	WS
Category	Earthen Levee			GPS Latitude/Longitude	
				Start	End
Item	Vegetation			39.009602 °	38.955556 °
				-121.578882 °	-121.574835 °
DWR ID	DWR_RD0784_02B_f_2020_3				
Comment Code					
V1 : Control annual grass and weeds on the levee slopes and easements.					
Inspector Comment					
Annual vegetation is well maintained, Fall 2020.

View of annual vegetation on waterside slope, Fall 2020.

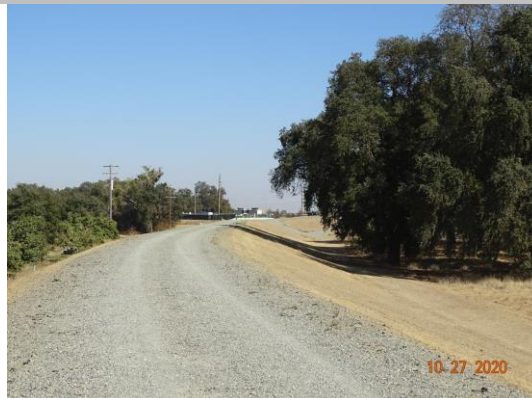
Photo 1 of 1 : FA_2020_RD0784_533_1_20201028_00001.jpg

LM Start	2.43	Rating **	A	Issue No.	1
LM End	3.20	Issue Type +	Ma	Location *	LS
Category	Earthen Levee			GPS Latitude/Longitude	
				Start	End
Item	Vegetation			38.970579 °	38.974705 °
				-121.547582 °	-121.535278 °
DWR ID	DWR_RD0784_03A_f_2020_1				
Comment Code					
V1 : Control annual grass and weeds on the levee slopes and easements.					
Inspector Comment					
Annual vegetation is well maintained, Fall 2020.

View of annual vegetation on landside slope, Fall 2020.

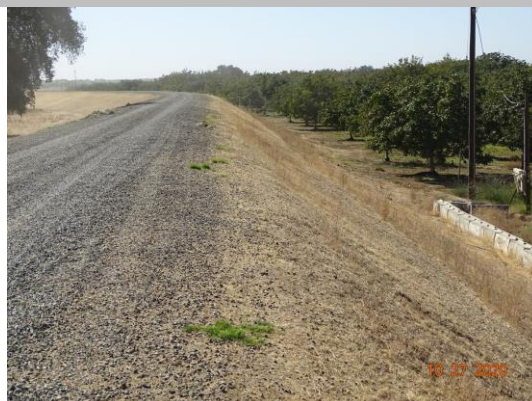
Photo 1 of 1 : FA_2020_RD0784_533_2_20201028_00002.jpg

LM Start	2.43	Rating **	A	Issue No.	2
LM End	3.20	Issue Type +	Ma	Location *	WS
Category	Earthen Levee			GPS Latitude/Longitude	
				Start	End
Item	Vegetation			38.970581 °	38.974704 °
				-121.547580 °	-121.535275 °
DWR ID	DWR_RD0784_03A_f_2020_2				
Comment Code					
V1 : Control annual grass and weeds on the levee slopes and easements.					
Inspector Comment					
Annual vegetation is well maintained, Fall 2020.

View of annual vegetation on waterside slope, Fall 2020.

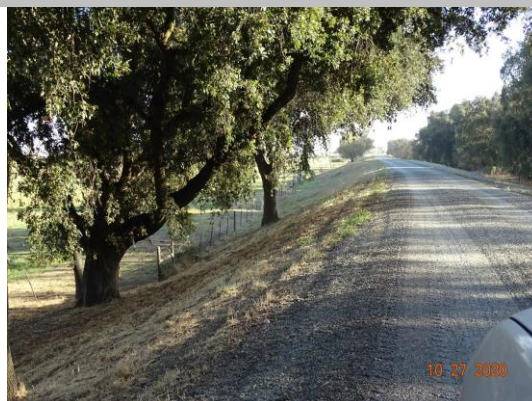
Photo 1 of 1 : FA_2020_RD0784_534_4_20201028_00005.jpg

LM Start	3.25	Rating **	A	Issue No.	4
LM End	4.59	Issue Type +	Ma	Location *	LS
Category	Earthen Levee			GPS Latitude/Longitude	
				Start	End
Item	Vegetation			38.974282 °	38.984655 °
				-121.531791 °	-121.512126 °
DWR ID	DWR_RD0784_03B_f_2020_4				
Comment Code					
V1 : Control annual grass and weeds on the levee slopes and easements.					
Inspector Comment					
Annual vegetation is well maintained, Fall 2020.

View of annual vegetation on landside slope, Fall 2020.

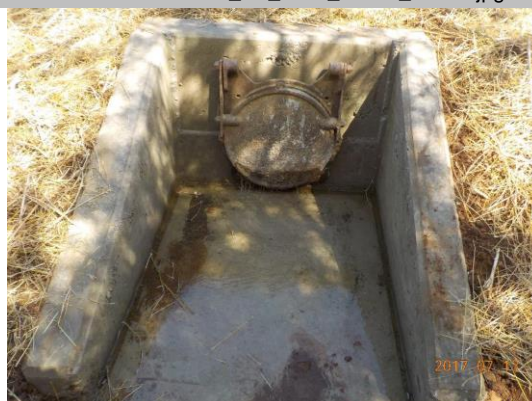
Photo 2 of 3 : UCIP_FA_2020_61742_77115.jpg

Concrete collar completed around the waterside exterior flap gate section.

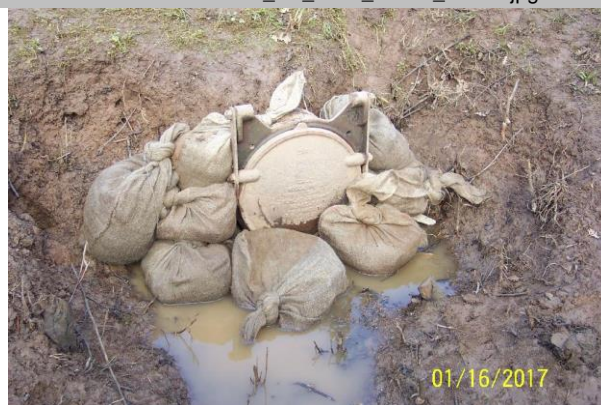
Photo 3 of 3 : UCIP_FA_2020_61742_76618.jpg

Sandbags temporarily placed in front of flapgate.

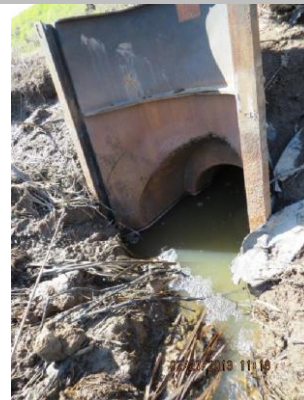
Photo 1 of 3 : UCIP_FA_2020_61747_16552.jpg

Comment Code						
Inspector Comment						
DS_ID:18592 FS_ID:61747 EP_NO: N/A Repair Type: No Action Needed EVAL Issue: Crossing Status: Found UCIP Comments: 12/16/2019 - Pipe crossing was hydroflushed and video inspected (again) in October 2019. Pending final review by RD784 Engineer and DWR. (P. Meagher - RD784)02/01/2019 - Pipe crossing was video inspected on 8/13/2018. (P. Meagher - RD784)02/26/2013 Good candidate for video inspection. (W. Wylie - DWR UCIP) FIELD_STRUCT_DESC: 18-inch corrugated metal drainage pipe through the levee, 18 feet below the crown. Flap gate on the waterside (WS) end. Concrete U-shaped headwall on the WS end. Polyvinyl chloride weir inlet on landside (LS) toe. [Additional Reference(s): DWR Levee Log, 2005 (HLM 0.10), listed as an 18-inch CMP. USACE Sacramento O&M Manual, Unit No. 145, August 1955, Revised 6 Aug 2019, (Station 25+28)]. FS Date: 2/26/2013

inlet control structure on LS toe.

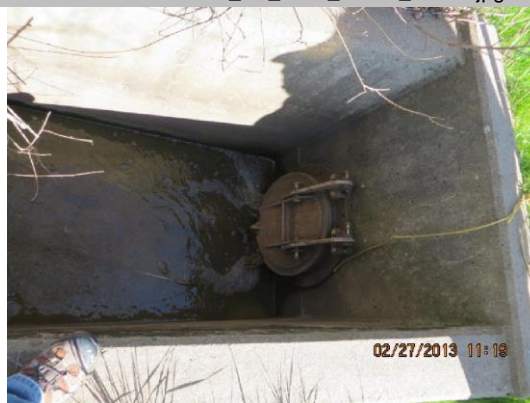
Photo 2 of 3 : UCIP_FA_2020_61747_16555.jpg

Concrete U-shaped outlet with flap gate on WS toe.

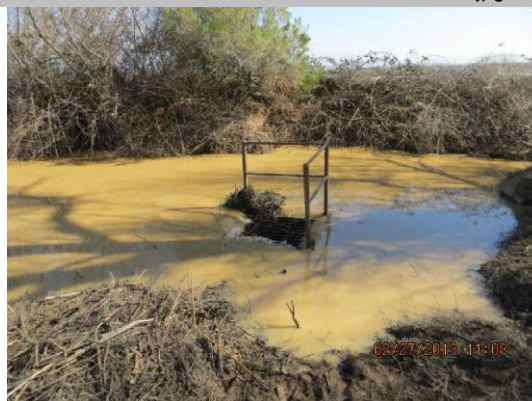
Photo 1 of 2 : UCIP_FA_2020_61748_54246.jpg

DS_ID:18591
FS_ID:61748
EP_NO: N/A
Repair Type: Non-Urgent
EVAL Issue:
Crossing Status: Found
UCIP Comments: 12/16/2019 - Pipe crossing was hydroflushed and video inspected (again) in October 2019. Pending final review by RD784 Engineer and DWR. (P.Meagher - RD784)02/01/2019 - Pipe crossing was video inspected on 8/14/2018. (P. Meagher)02/26/2013 - No handle or access to slide gate on LS toe. (W. Wylie - DWR UCIP)
FIELD_STRUCT_DESC: 30-inch corrugated metal drainage pipe through the levee, 23.7 feet below the crown. Flap gate on the waterside (WS) end. Slide gate inside a concrete drop inlet on the landside (LS). [Additional Reference(s): DWR Levee Log, 2005 (HLM 0.82), listed as a 30-inch CMP. USACE Sacramento O&M Manual, Unit No. 145, August 1955, Revised 6 Aug 2019, (Station 63+00)].
FS Date: 9/11/2015 9:05:00 AM

Concrete drop-inlet at LS toe.

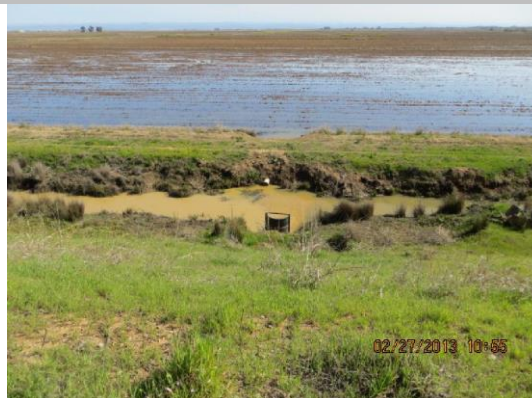
Photo 2 of 3 : UCIP_FA_2020_61749_16563.jpg

Pvc weir on inlet at LS toe.

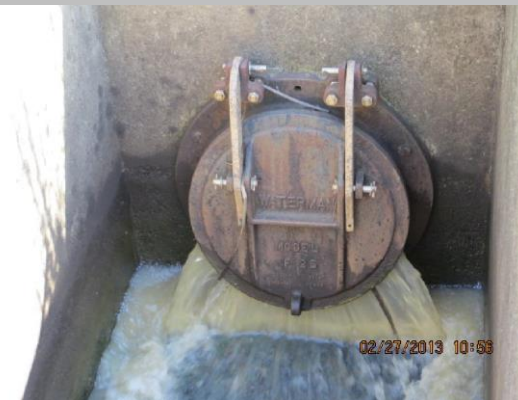
Photo 3 of 3 : UCIP_FA_2020_61749_16562.jpg

Concrete U-shaped headwall and flap gate on WS toe.

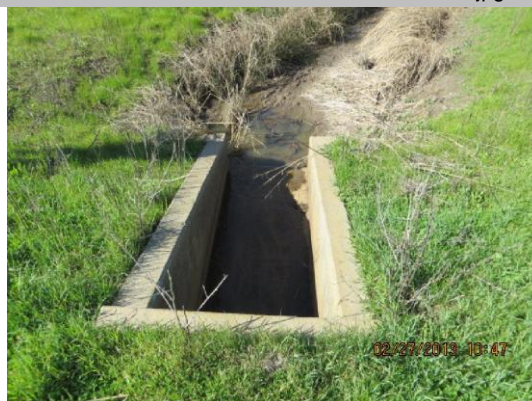
Photo 1 of 3 : UCIP_FA_2020_61750_54247.jpg

Comment Code						
Inspector Comment						
DS_ID:18588 FS_ID:61750 EP_NO: N/A Repair Type: Non-Urgent EVAL Issue: Crossing Status: Found UCIP Comments: 12/16/2019 - Pipe crossing was hydroflushed and video inspected in October 2019. Pending final review by RD784 District Engineer and DWR. (P. Meagher - RD784)02/01/2019 - Pipe crossing was video inspected on 8-14-2018. (P. Meagher - RD784)09/11/2015 - Inlet burried. Good candidate for video inspection as pipe is corroded. (W. Wylie - DWR UCIP) FIELD_STRUCT_DESC: 18-inch corrugated metal drainage pipe through the levee, 14.5 feet below the crown. Flap gate on the waterside (WS) end. Concrete U-shaped headwall on the WS. [Additional Reference(s): DWR Levee Log, 2005 (HLM 1.86), listed as an 18-inch CMP. USACE Sacramento O&M Manual, Unit No. 145, August 1955, Revised 6 Aug 2019, (Station 116+78)]. FS Date: 9/11/2015 9:36:00 AM

Concrete U-shaped outlet and flap-gate on WS toe.

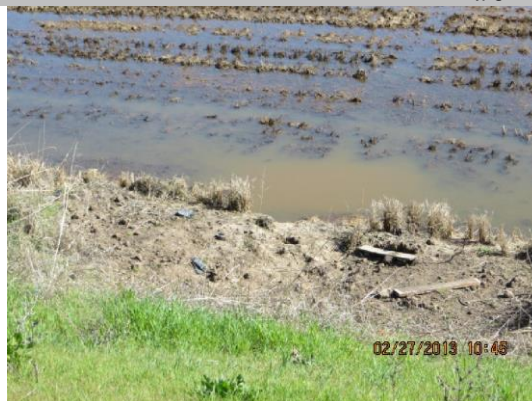
Photo 2 of 3 : UCIP_FA_2020_61750_54248.jpg

Debris covered inlet on LS toe.

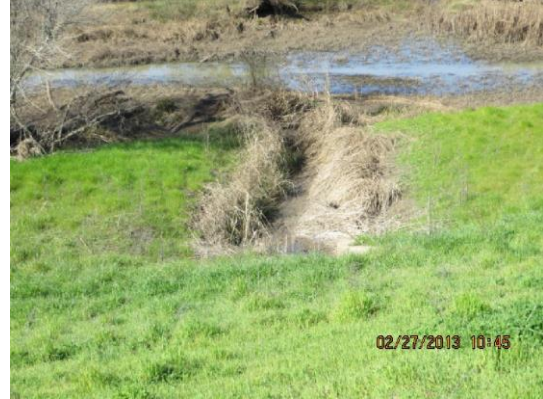
Photo 3 of 3 : UCIP_FA_2020_61750_54249.jpg

Drainage outlet on WS toe.

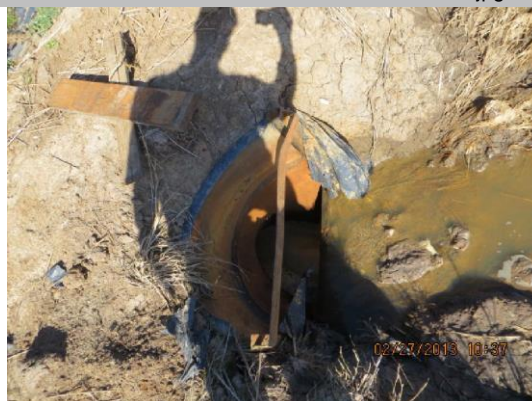
Photo 1 of 3 : UCIP_FA_2020_61751_54250.jpg

DS_ID:18587
FS_ID:61751
EP_NO: N/A
Repair Type: Non-Urgent
EVAL Issue:
Crossing Status: Found
UCIP Comments: 08/18/2020 - Letter of Authorization Received from the CVFPB to proceed with total pipe replacement (CVFPB Project No. WA2020067) (P. Meagher - RD784)12/16/2019 - This pipe crossing was hydroflushed and video inspected (again) in October 2019. Pending final review by RD784 District engineers and DWR. (P. Meagher - RD784)02/01/2019 - The pipe crossing was video inspected on 8-14-2018. New photos of the landside toe added. In August 2017 a sinkhole was noticed at the bottom of the landside toe shelf area. The sinkhole developed as a result of the landowner who extended the existing pipe in order to complete a new unauthorized concrete flashboard structure replacement. The pipe owner was mailed a letter from RD784 with a Cc to CVFPB and DWR dated 10-23-2017 acknowledging the owner's completion of an attempted repair. The sinkhole has since returned. (P. Meagher - RD784)02/03/2017 - On 1-31-2017 The waterside excess pipe end was discovered to be floating to the surface due to landside water runoff through the pipe. Because of the floating pipe, the water was not draining all the way through the pipe. Instead, the water was overtopping the levee shelf area. In order to resolve this issue, the excess portion of the pipe was cut off. After doing so, the water immediately started draining properly again. (P. Meagher - RD784). 02/26/2013 - Erosion at outlet may or may not be an issue. (W. Wylie - DWR UCIP)

Inlet with PVC weir on LS toe.

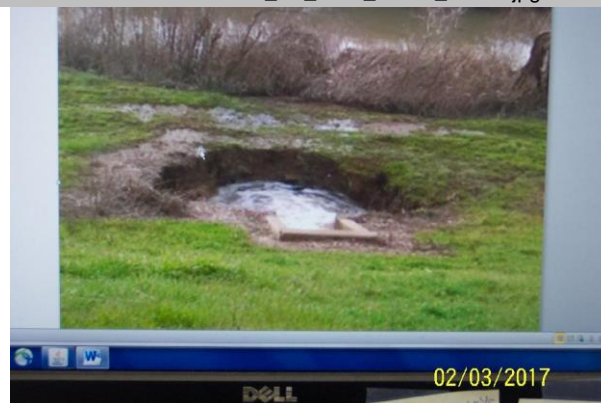
Photo 3 of 3 : UCIP_FA_2020_61751_76774.jpg

After photo after excess pipe was cut off. Actual photo date was 1/31/2017

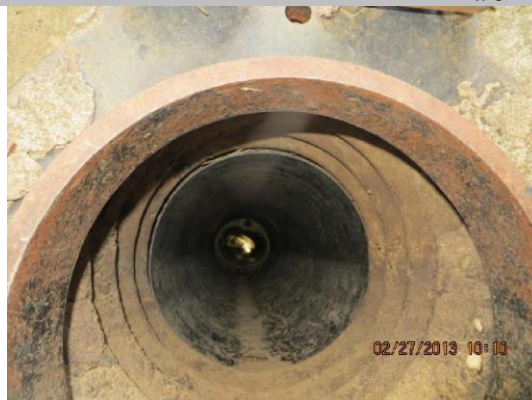
Photo 2 of 3 : UCIP_FA_2020_61754_54262.jpg

Pipe showing sliplined PVC insert. some erosion of PV at outlet and it may be disjointed internally.

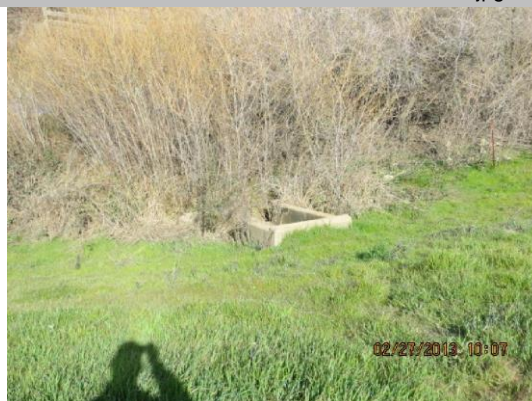
Photo 3 of 3 : UCIP_FA_2020_61754_54261.jpg

Concrete U-shaped headwall on WS toe.

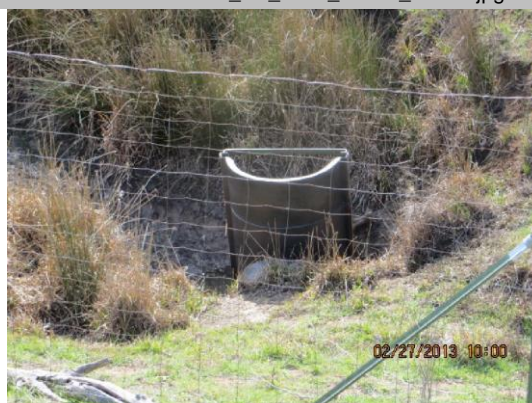
Photo 1 of 2 : UCIP_FA_2020_61755_16594.jpg

DS_ID:18595
 FS_ID:61755
 EP_NO: N/A
 Repair Type: No Action Needed
 EVAL Issue:
 Crossing Status: Found
 UCIP Comments: 12/16/2019 - Pipe crossing was hydroflushed and video inspected in October 2019. Pending final review by RD784 District Engineer and DWR. (P. Meagher - RD784)02/01/2019 - Pipe crossing was video inspected on 8-15-2018 (P. Meagher - RD784)02/27/2013 - Good candidate for video inspection. (W. Wylie - DWR UCIP)
 FIELD_STRUCT_DESC: 18-inch corrugated metal drainage pipe through the levee, 15.8 feet below the crown. Flap gate on the waterside (WS) end. Polyvinyl chloride weir on inlet at the landside (LS) toe. [Additional Reference(s): DWR Levee Log, 2005 (HLM 3.24), listed as an 18-inch pipe. USACE Sacramento O&M Manual, Unit No. 145, August 1955, Revised 6 Aug 2019, Drawing No. 2-4-106, Sheet 6 (Station 53+86)].
 FS Date: 2/27/2013

PVC weir inlet on LS toe.

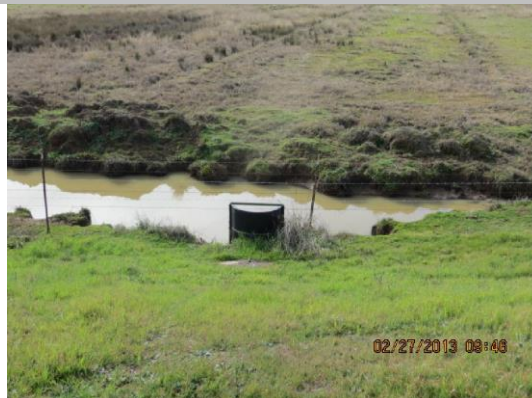
Photo 2 of 3 : UCIP_FA_2020_61756_16591.jpg

PVC weir at inlet on LS toe.

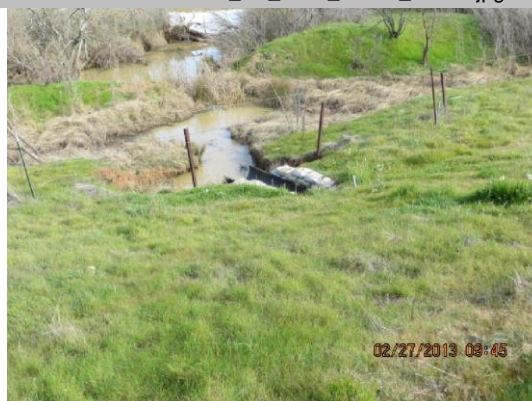
Photo 3 of 3 : UCIP_FA_2020_61756_16592.jpg

Concrete outlet on WS toe.

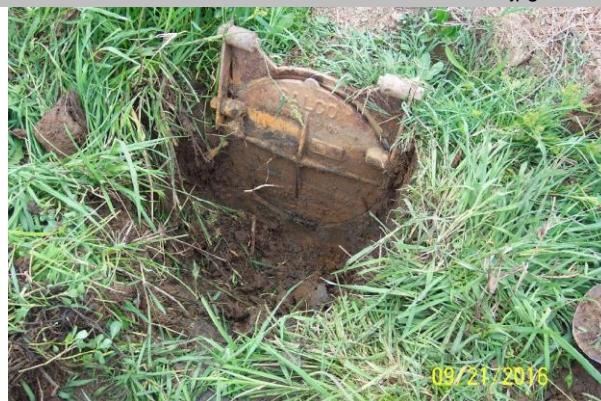
Photo 1 of 3 : UCIP_FA_2020_61757_76147.jpg

Comment Code						
Inspector Comment						
DS_ID:18593 FS_ID:61757 EP_NO: N/A Repair Type: Non-Urgent EVAL Issue: Crossing Status: Found UCIP Comments: 02/01/2019 - An attempt was made to video inspect this pipe crossing on 8-15-2018 but conditions were too muddy inside the pipe. (P. Meagher - RD784)11/14/2016 - Photos added of exposed flap gate on WS and possible inlet location on LS. Condition remains as Non-Urgent because of inlet not being fully operable. Unknown if pipe will operate as designed during high water or if it is full of sediment. (P. Meagher - RD784)11/01/2015 - Waterside Flap Gate Uncovered. Photo sent to DWR Matt Hoffman on 3-3-2014. Fresh photo sent to DWR Pavel Kazi on 9-9-2015. Landside toe has never been able to be located. Requesting DWR inspector to change the status of this issue to "No Action Needed". (P. Meagher - RD784).02/26/2013 - Pipe buried on LS toe and flap gate is blocked by soil on WS toe. (W. Wylie - DWR UCIP). FIELD_STRUCT_DESC: 18-inch corrugated metal drainage pipe through the levee, 10 feet below the crown. Flap gate on the waterside (WS) end. [Additional Reference(s): DWR Levee Log, 2005 (HLM 3.98), listed as an 18-inch pipe. USACE Sacramento O&M Manual, Unit No. 145, August 1955, Revised 6 Aug 2019, (Station 91+50)]. FS Date: 10/9/2015

Flap gate on the WS toe is exposed

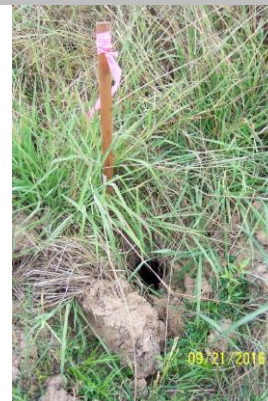
Photo 2 of 3 : UCIP_FA_2020_61757_76148.jpg

Possible location of the inlet on the LS toe

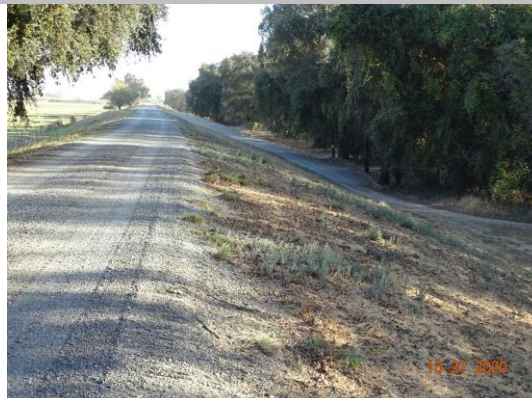
Photo 1 of 1 : FA_2020_RD0784_183_3_20201029_00004.jpg

View of annual vegetation on waterside slope, Fall 2020.

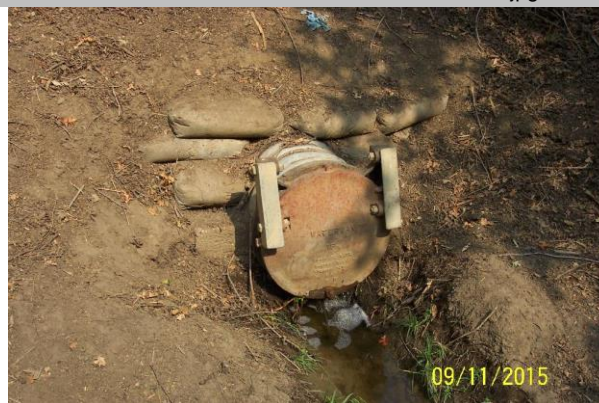
Photo 1 of 3 : UCIP_FA_2020_61758_74682.jpg

Comment Code						
Inspector Comment						
DS_ID:18626 FS_ID:61758 EP_NO: N/A Repair Type: Non-Urgent EVAL Issue: Crossing Status: Found UCIP Comments: 12/16/2019 Pipe was hydroflushed and video inspected (again) in October 2019. Pending final review by RD784 District Engineer and DWR. (P. Meagher - RD784)02/01/2019 - Pipe was video inspected on 8-13-2018. (P. Meagher - RD784)10/30/2015 - Waterside flap gate was cleared in December 2014 and again in September 2015 No LMA access available on Landside. (P. Meagher - RD784)02/26/2013 - Pipe partially blocked on LS and flap gate blocked on WS (W. Wylie - DWR UCIP) FIELD_STRUCT_DESC: 18-inch corrugated metal storm drainage pipe through the levee, 19 feet below the crown. Gate valve on the waterside (WS). [Additional Reference(s): USACE Drawing No. 2-4-106, Sheet 2]. FS Date: 9/11/2015

Flap Gate is clear as of 9/11/15.

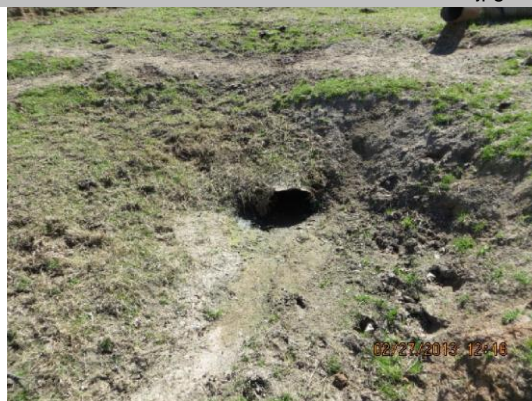
Photo 2 of 3 : UCIP_FA_2020_61758_54268.jpg

Partially clogged inlet pipe at LS toe.

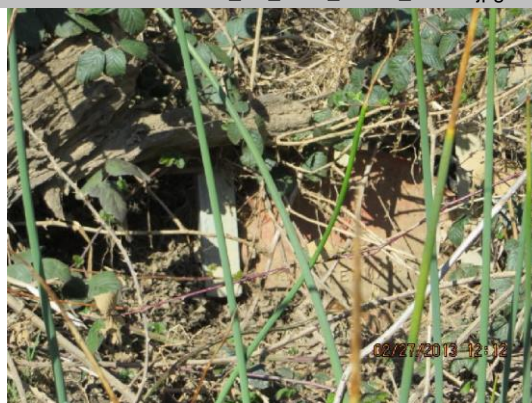
Photo 3 of 3 : UCIP_FA_2020_61758_54265.jpg

Flap gate blocked by vegetation at WS.

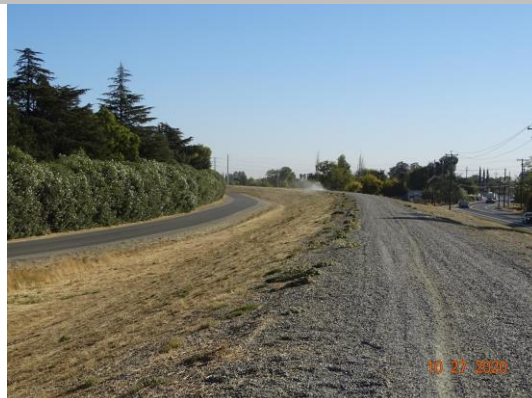
Photo 1 of 1 : FA_2020_RD0784_184_1_20201028_00004.jpg

View of annual vegetation on landside slope, Fall 2020.

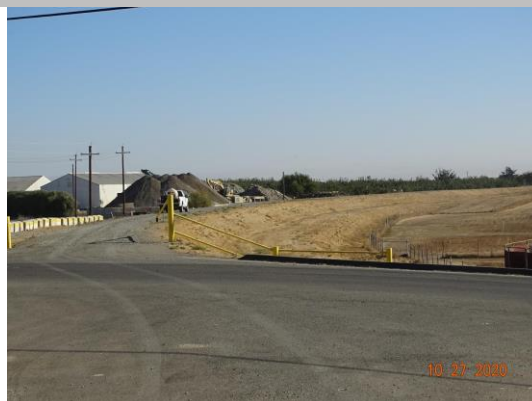
Photo 1 of 1 : FA_2020_RD0784_184_2_20201028_00003.jpg

View of annual vegetation on waterside slope, Fall 2020.

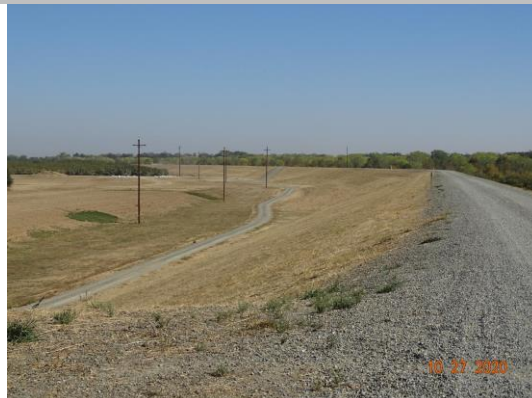
Photo 1 of 1 : FA_2020_RD0784_437_1_20201028_00001.jpg

View of annual vegetation on landside slope, Fall 2020.

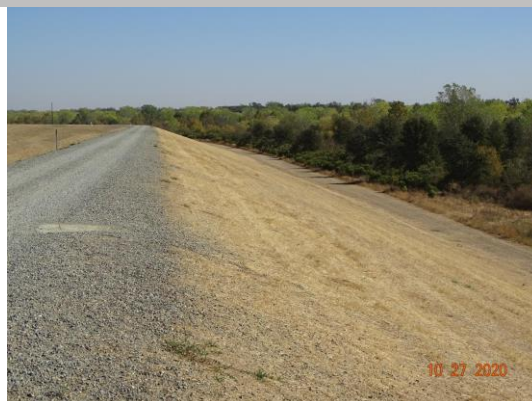
Photo 1 of 1 : FA_2020_RD0784_437_2_20201028_00002.jpg

View of annual vegetation on waterside slope, Fall 2020.

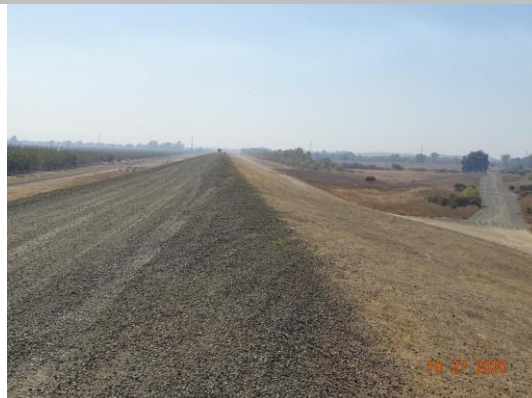
Photo 1 of 1 : FA_2020_RD0784_530_1_20201028_00002.jpg

View of annual vegetation on waterside slope, Fall 2020.

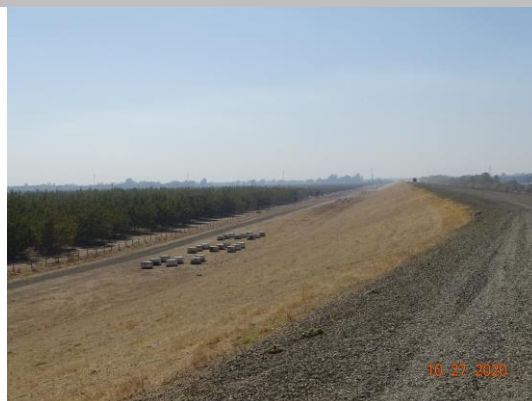
Photo 1 of 1 : FA_2020_RD0784_530_2_20201028_00001.jpg

View of annual vegetation on landside slope, Fall 2020.
