**Flood Control Project Maintenance
Levee Inspections**

Maintenance Issue Types Only, Levee Inspection Report By Mile - Fall 2021

Reclamation District No. 0784 Plumas Lake

Waterway	Bank	Unit Miles	Inspection Start/End	Inspector
Unit No. 01 Yuba River	Left	2.21	10/26/2021 10/26/2021	Sterling York

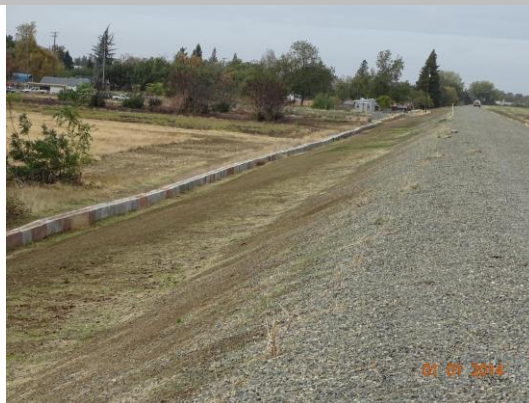
Photo 1 of 1 : FA_2021_RD0784_178_23_20211026_00029.jpg

LM Start	0.04	Rating **	A	Issue No.	23
LM End	2.21	Issue Type +	Ma	Location *	LS
Category	Earthen Levee			GPS Latitude/Longitude	
				Start	End
Item	Vegetation			39.134442 °	39.125837 °
				-121.552686 °	-121.588674 °
DWR ID	DWR_RD0784_01_f_2021_23				
Comment Code					
V1 : Control annual grass and weeds on the levee slopes and easements.					
Inspector Comment					
The annual vegetation is well maintained, Fall 2021.

View of the well maintained annual vegetation, Fall 2021.

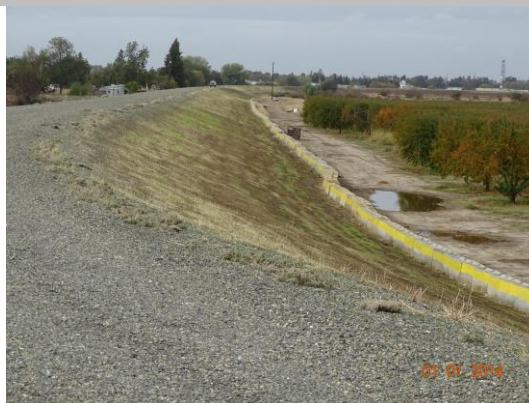
Photo 1 of 1 : FA_2021_RD0784_178_24_20211026_00030.jpg

LM Start	0.04	Rating **	A	Issue No.	24
LM End	2.21	Issue Type +	Ma	Location *	WS
Category	Earthen Levee			GPS Latitude/Longitude	
				Start	End
Item	Vegetation			39.134440 °	39.125846 °
				-121.552688 °	-121.588674 °
DWR ID	DWR_RD0784_01_f_2021_24				
Comment Code					
V1 : Control annual grass and weeds on the levee slopes and easements.					
Inspector Comment					
The annual vegetation is well maintained, Fall 2021.

View of the well maintained annual vegetation, Fall 2021.

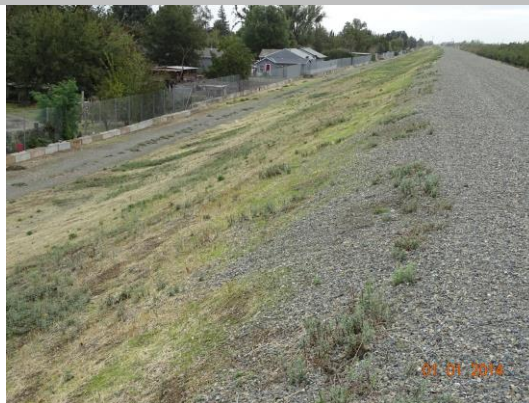
Photo 1 of 1 : FA_2021_RD0784_531_2_20211026_00004.jpg

View of the well maintained annual vegetation, Fall 2021.

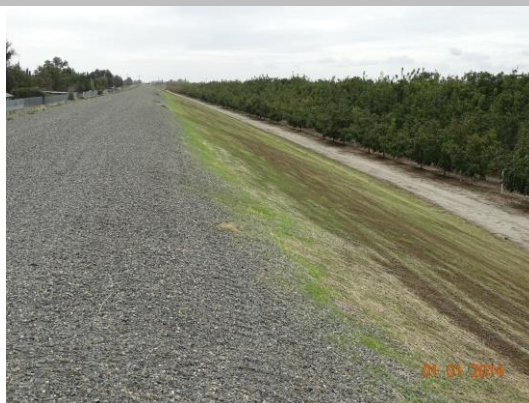
Photo 1 of 1 : FA_2021_RD0784_531_3_20211026_00005.jpg

LM Start	0.00	Rating **	A	Issue No.	3
LM End	2.51	Issue Type +	Ma	Location *	WS
Category	Earthen Levee			GPS Latitude/Longitude	
				Start	End
Item	Vegetation			39.125783 °	39.090682 °
				-121.588687 °	-121.584647 °
DWR ID	DWR_RD0784_02A_f_2021_3				
Comment Code					
V1 : Control annual grass and weeds on the levee slopes and easements.					
Inspector Comment					
The annual vegetation is well maintained, Fall 2021.

View of the well maintained annual vegetation, Fall 2021.

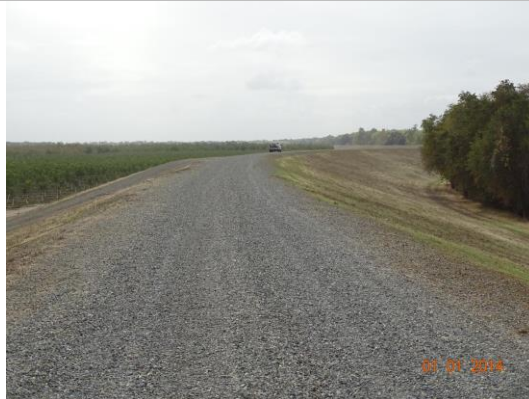
Photo 1 of 1 : FA_2021_RD0784_532_3_20211026_00003.jpg

View of the well maintained annual vegetation, Fall 2021.

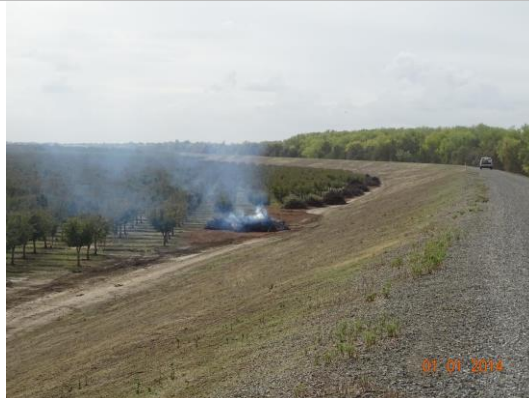
Photo 1 of 1 : FA_2021_RD0784_532_2_20211026_00004.jpg

LM Start	8.97	Rating **	A	Issue No.	2
LM End	12.81	Issue Type +	Ma	Location *	LS
Category	Earthen Levee			GPS Latitude/Longitude	
				Start	End
Item	Vegetation			39.009850 °	38.955361 °
				-121.579113 °	-121.574960 °
DWR ID	DWR_RD0784_02B_f_2021_2				
Comment Code					
V1 : Control annual grass and weeds on the levee slopes and easements.					
Inspector Comment					
The annual vegetation is well maintained, Fall 2021.

View of the well maintained annual vegetation, Fall 2021.

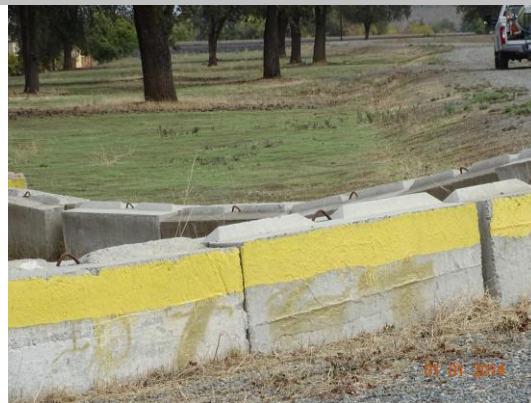
Photo 1 of 1 : FA_2021_RD0784_533_3_20211026_00007.jpg

View of the well maintained annual vegetation, Fall 2021.

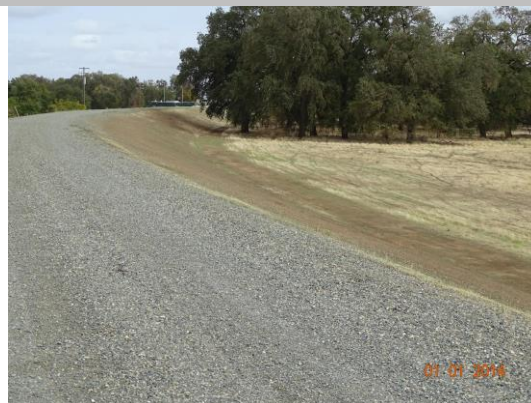
Photo 1 of 1 : FA_2021_RD0784_533_4_20211026_00008.jpg

LM Start	2.44	Rating **	A	Issue No.	4
LM End	3.20	Issue Type +	Ma	Location *	WS
Category	Earthen Levee			GPS Latitude/Longitude	
				Start	End
Item	Vegetation			38.970676 °	38.974675 °
				-121.547512 °	-121.535293 °
DWR ID	DWR_RD0784_03A_f_2021_4				
Comment Code					
V1 : Control annual grass and weeds on the levee slopes and easements.					
Inspector Comment					
The annual vegetation is well maintained, Fall 2021.

View of the well maintained annual vegetation, Fall 2021.

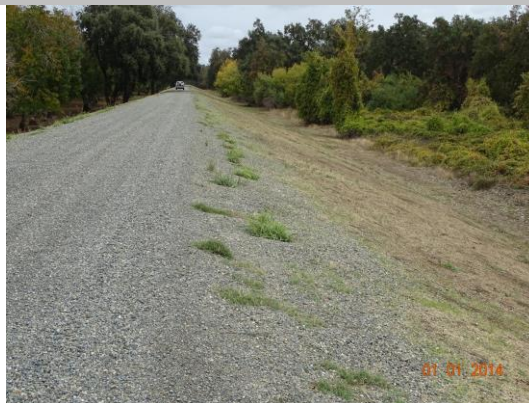
Photo 1 of 1 : FA_2021_RD0784_534_6_20211026_00008.jpg

View of the well maintained annual vegetation, Fall 2021.

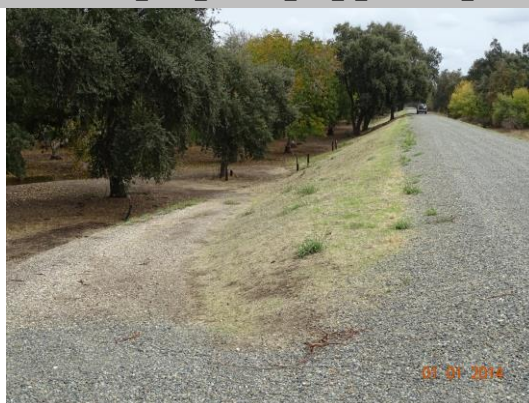
Photo 1 of 1 : FA_2021_RD0784_534_5_20211026_00009.jpg

LM Start	3.23	Rating **	A	Issue No.	5
LM End	4.64	Issue Type +	Ma	Location *	LS
Category	Earthen Levee			GPS Latitude/Longitude	
				Start	End
Item	Vegetation			38.974329 °	38.985084 °
				-121.532088 °	-121.511378 °
DWR ID	DWR_RD0784_03B_f_2021_5				
Comment Code					
V1 : Control annual grass and weeds on the levee slopes and easements.					
Inspector Comment					
The annual vegetation is well maintained, Fall 2021.

View of the well maintained annual vegetation, Fall 2021.

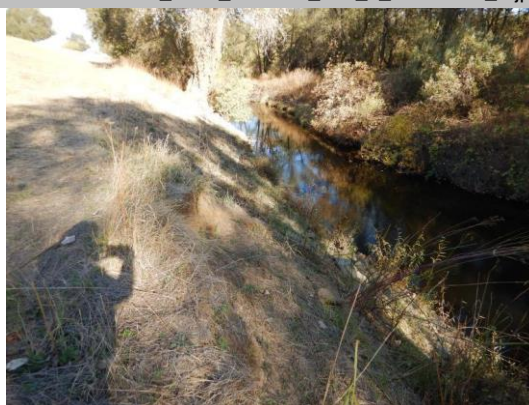
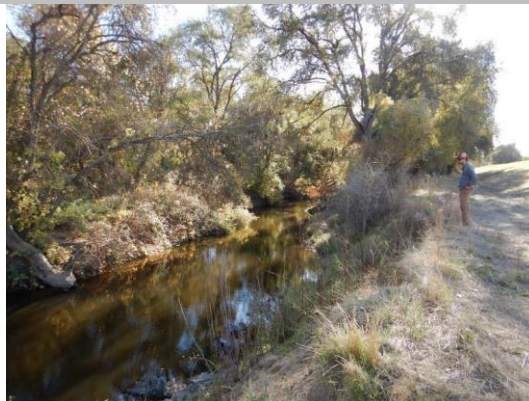
2018 Site ID: BER 4.9 R
Status: Eroding
2018 Field Notes: No observed change.
Site History: 2009 - Small site which could be repaired with maintenance. Erosion into the levee toe, rock has started to fail.

USACE 2018 Erosion Photo #1

USACE 2018 Erosion Photo #2

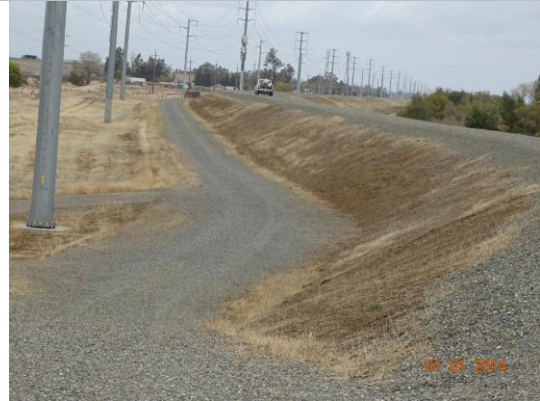
Photo 1 of 1 : FA_2021_RD0784_181_9_20211026_00015.jpg

View of the well maintained annual vegetation, Fall 2021.

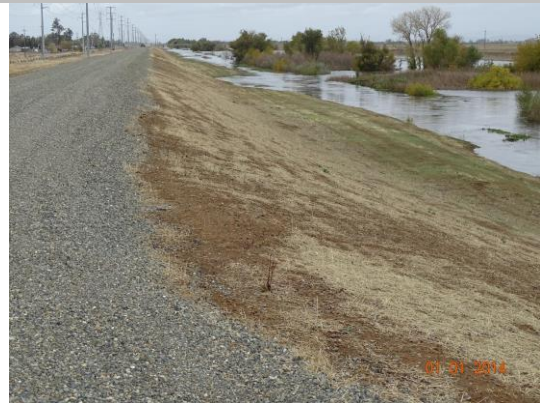
Photo 1 of 1 : FA_2021_RD0784_181_8_20211026_00016.jpg

LM Start	0.00	Rating **	A	Issue No.	8
LM End	6.33	Issue Type +	Ma	Location *	WS
Category	Earthen Levee			GPS Latitude/Longitude	
				Start	End
Item	Vegetation			38.974775 °	39.059285 °
				-121.535079 °	-121.551343 °
DWR ID	DWR_RD0784_04_f_2021_8				
Comment Code					
V1 : Control annual grass and weeds on the levee slopes and easements.					
Inspector Comment					
The annual vegetation is well maintained, Fall 2021.

View of the well maintained annual vegetation, Fall 2021.

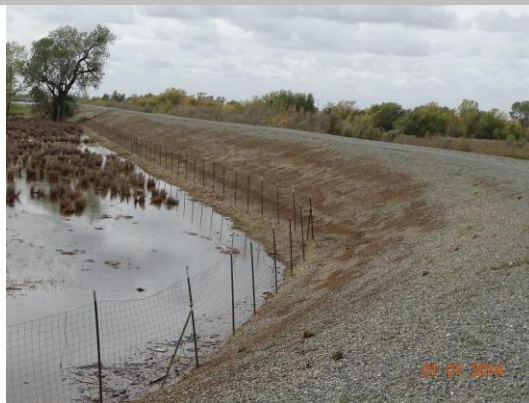
Photo 1 of 1 : FA_2021_RD0784_182_14_20211026_00028.jpg

View of the well maintained annual vegetation, Fall 2021.

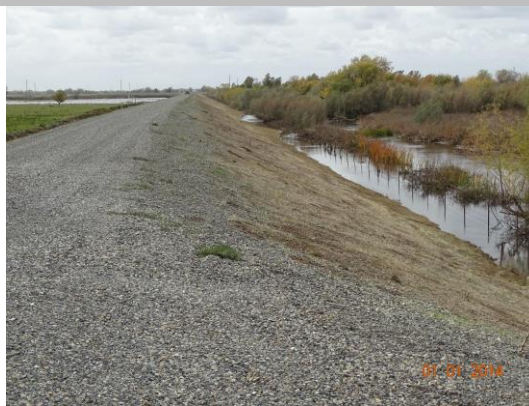
Photo 1 of 1 : FA_2021_RD0784_182_13_20211026_00029.jpg

LM Start	0.03	Rating **	A	Issue No.	13
LM End	3.86	Issue Type +	Ma	Location *	LS
Category	Earthen Levee			GPS Latitude/Longitude	
				Start	End
Item	Vegetation			38.974762 °	39.019480 °
				-121.532721 °	-121.515067 °
DWR ID	DWR_RD0784_05_f_2021_13				
Comment Code					
V1 : Control annual grass and weeds on the levee slopes and easements.					
Inspector Comment					
The annual vegetation is well maintained, Fall 2021.

View of the well maintained annual vegetation, Fall 2021.

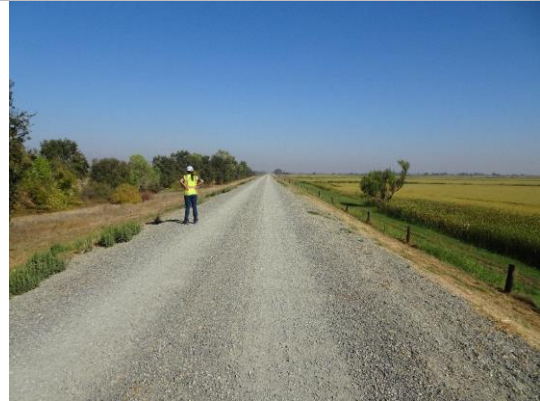
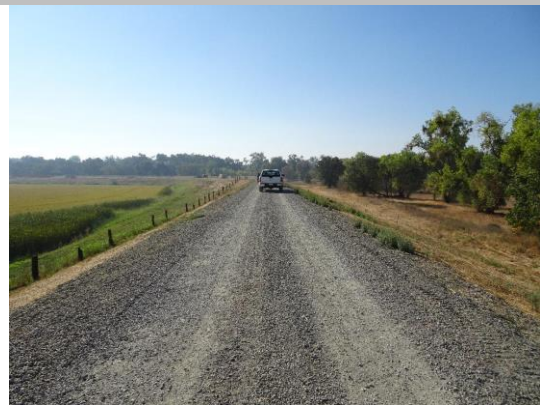
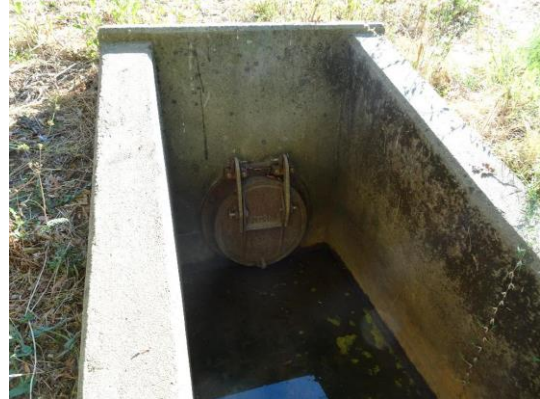
Comment Code						
Inspector Comment						
DS_ID:18592 FS_ID:70298 EP_NO: N/A Repair Type: Urgent EVAL Issue: Pipe Integrity Crossing Status: Found UCIP Comments: 10/05/2020 - Record has been updated from No Action Needed to Urgent. DWR DMP has found integrity issues, LOF between 5 and 6. Recommend monitoring crossing until funding becomes available to address. No permit was found authorizing this encroachment. CVFPB will need to review crossing to determine owner. (O. Magana - DWR UCIP)12/16/2019 - Pipe crossing was hydroflushed and video inspected (again) in October 2019. Pending final review by RD784 Engineer and DWR. (P. Meagher - RD784)02/01/2019 - Pipe crossing was video inspected on 8/13/2018. (P. Meagher - RD784)02/26/2013 Good candidate for video inspection. (W. Wylie - DWR UCIP) FIELD_STRUCT_DESC: 18-inch corrugated metal (CM) drainage pipe through the levee, 18.0 feet below the crown. Flap gate on the waterside (WS) end. Concrete U-shaped headwall on the WS end. Polyvinyl chloride (PVC) weir inlet on the landside (LS) toe. (No permit found authorizing this pipe. Owner unknown). [Additional Reference(s): DWR Levee Log, 2005, (HLM 0.10). USACE Sacramento O&M Manual, Unit No. 145, August 1955, Revised 6 August 2019, (Station 25+28). USACE As-Built Drawing No. 2-4-106, Sheet No. 106/5, July 1944, (Station 25+28)]. FS Date: 10/5/2020

Overview of Levee: Looking upstream from crown.

Overview of Levee: Looking downstream from crown.

Water-Side: Outlet structure with flap gate at waterside toe.

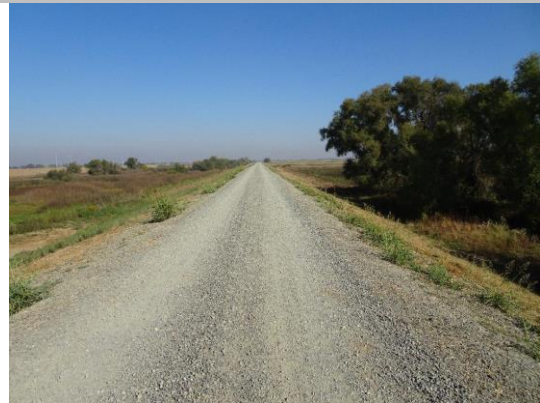
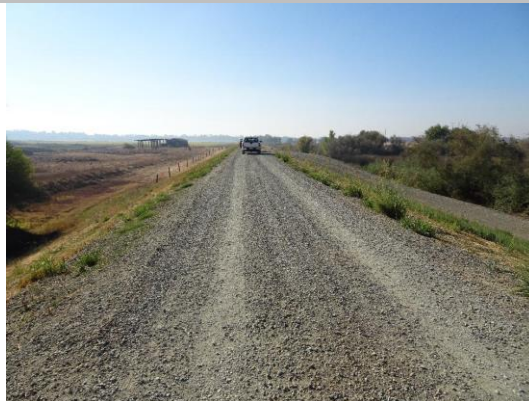
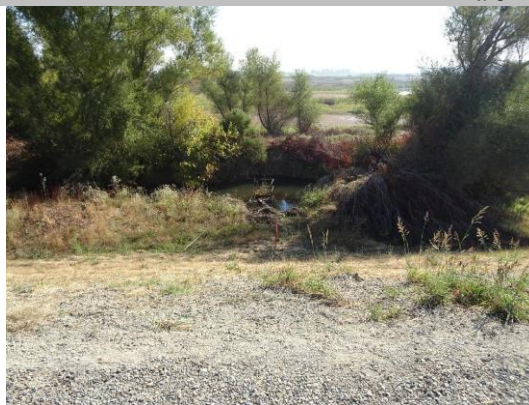
DS_ID:18591
FS_ID:70299
EP_NO: N/A
Repair Type: Urgent
EVAL Issue: Pipe Integrity
Crossing Status: Found
UCIP Comments: 10/05/2020 - Record has been updated from Non-Urgent to Urgent. DWR DMP has found integrity issues, LOF between 5 and 6. Recommend monitoring crossing until funding becomes available to address. Pipe was underwater during site inspection. No permit was found authorizing this encroachment. CVFPB will need to review crossing to determine owner. (O. Magana - DWR UCIP)12/16/2019 - Pipe crossing was hydroflushed and video inspected (again) in October 2019. Pending final review by RD784 Engineer and DWR. (P. Meagher - RD784)02/01/2019 - Pipe crossing was video inspected on 8/14/2018. (P. Meagher)02/26/2013 - No handle or access to slide gate on LS toe. (W. Wylie - DWR UCIP) FIELD_STRUCT_DESC: 30-inch corrugated metal (CM) drainage pipe through the levee, 23.7 feet below the crown. Flap gate on the waterside (WS) end. Slide gate inside a concrete drop inlet on the landside (LS). (No permit found authorizing this pipe. Owner unknown). [Additional Reference(s): DWR Levee Log, 2005, (HLM 0.82). USACE Sacramento O&M Manual, Unit No. 145, August 1955, Revised 6 August 2019, (Station 63+00). USACE As-Built Drawing No. 2-4-106, Sheet No. 106/5, July 1944, (Station 63+00)].

Overview of Levee: Looking upstream from crown.

Overview of Levee: Looking downstream from crown.

Land-Side: Drop inlet at landside toe.

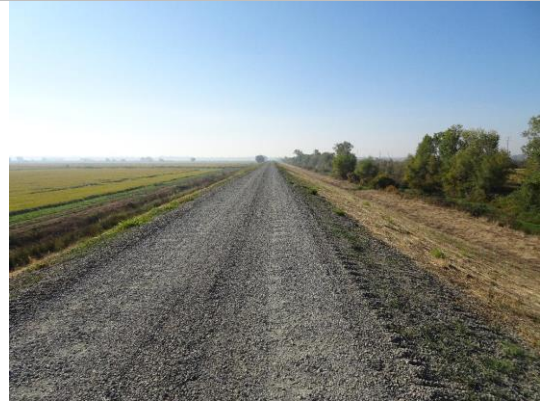
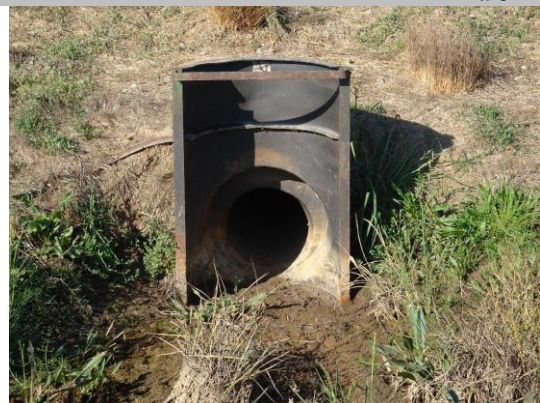
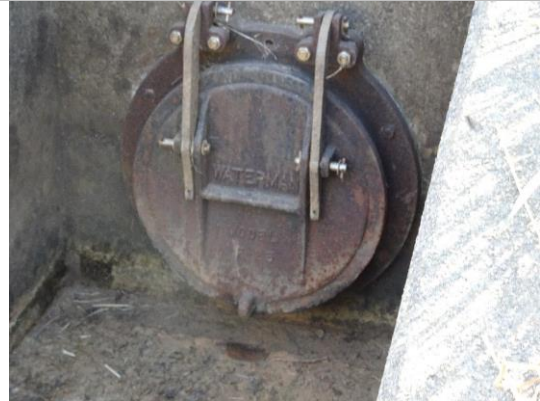
DS_ID:18590
FS_ID:70300
EP_NO: N/A
Repair Type: Urgent
EVAL Issue: Pipe Integrity
Crossing Status: Found
UCIP Comments: 10/06/2020 - Record has been updated from No Action Needed to Urgent. DWR DMP has found integrity issues, LOF between 5 and 6. Recommend monitoring crossing until funding becomes available to address. No permit was found authorizing this encroachment. CVFPB will need to review crossing to determine owner. (O. Magana - DWR UCIP)12/16/2019 - Pipe crossing was hydroflushed and video inspected in October 2019. Pending final review by RD784 District Engineer and DWR. (P. Meagher - RD784)02/01/2019 - Pipe crossing was video inspected on 8-14-2018. (P. Meagher)02/26/2013 - Good candidate for video inspection. (W. Wylie - DWR UCIP)
FIELD_STRUCT_DESC: 18-inch corrugated metal (CM) drainage pipe through the levee, 14.5 feet below the crown. Flap gate on the waterside (WS) end. Concrete U-shaped headwall on the WS. Polyvinyl chloride (PVC) weir on inlet. (No permit found authorizing this pipe. Owner unknown). [Additional Reference(s): DWR Levee Log, 2005, (HLM 1.60). USACE Sacramento O&M Manual, Unit No. 145, August 1955, Revised 6 August 2019, (Station 103+23). USACE As-Built Drawing No. 2-4-106, Sheet No. 106/5, July 1944, (Station 103+23)].

Overview of Levee: Looking downstream from crown.

Land-Side: Inlet at landside toe.

Water-Side: Outlet structure with flap gate at waterside toe.

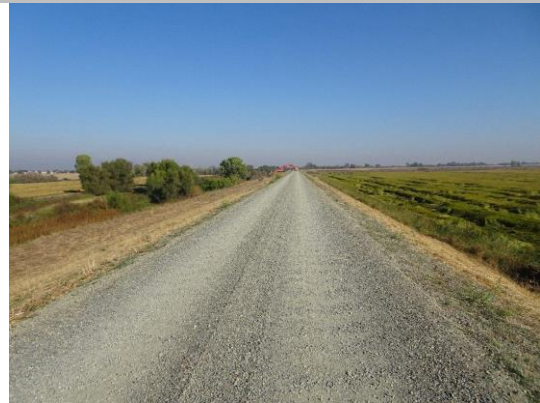
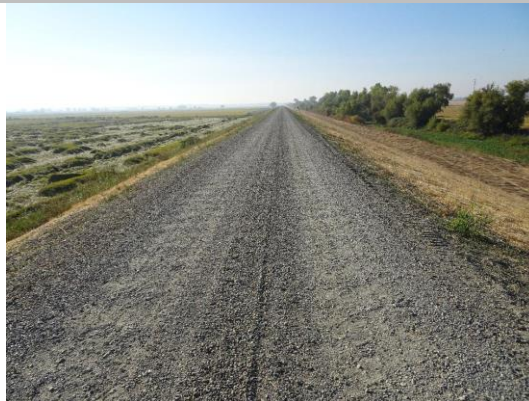
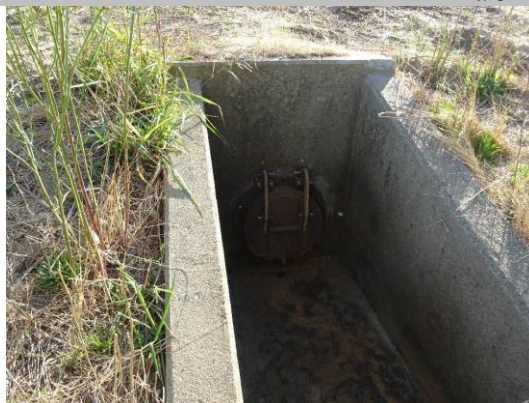
DS_ID:18588
FS_ID:70301
EP_NO: N/A
Repair Type: Urgent
EVAL Issue: Pipe Integrity
Crossing Status: Found
UCIP Comments: 10/05/2020 - Record has been updated from Non-Urgent to Urgent. DWR DMP has found integrity issues, LOF between 5 and 6. Recommend monitoring crossing until funding becomes available to address. No permit was found authorizing this encroachment. CVFPB will need to review crossing to determine owner. (O. Magana - DWR UCIP)12/16/2019 - Pipe crossing was hydroflushed and video inspected in October 2019. Pending final review by RD784 District Engineer and DWR. (P. Meagher - RD784)02/01/2019 - Pipe crossing was video inspected on 8-14-2018. (P. Meagher - RD784)09/11/2015 - Inlet buried. Good candidate for video inspection as pipe is corroded. (W. Wylie - DWR UCIP)
FIELD_STRUCT_DESC: 18-inch corrugated metal (CM) drainage pipe through the levee, 14.5 feet below the crown. Flap gate on the waterside (WS) end. Concrete U-shaped headwall on the WS.

Overview of Levee: Looking upstream from crown.

Overview of Levee: Looking downstream from crown.

Water-Side: Outlet structure with flap gate at waterside toe.

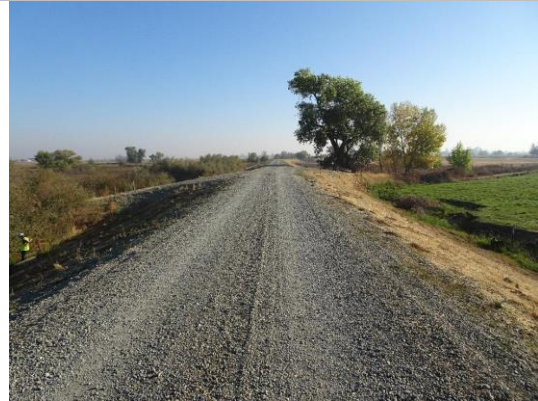
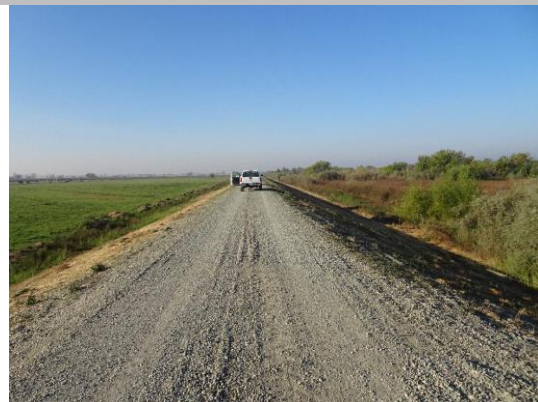
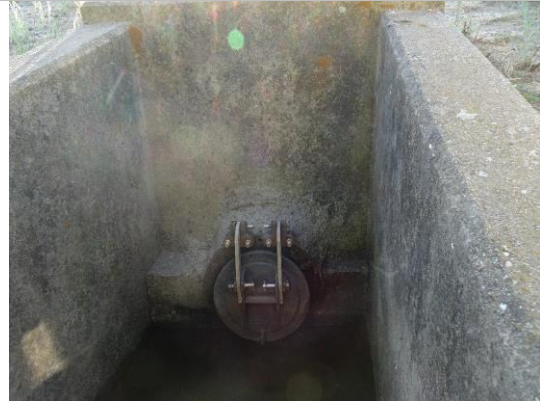
DS_ID:18596
FS_ID:70306
EP_NO: N/A
Repair Type: Urgent
EVAL Issue: Pipe Integrity
Crossing Status: Found
UCIP Comments: 10/05/2020 - Record has been updated from Non-Urgent to Urgent. DWR DMP has found integrity issues, LOF between 5 and 6. Recommend monitoring crossing until funding becomes available to address. No permit was found authorizing this encroachment. CVFPB will need to review crossing to determine owner. (O. Magana - DWR UCIP)12/16/2019 - Pipe crossing was hydroflushed and video inspected in October 2019. Pending final review by RD784 Engineer and DWR. (P. Meagher - RD784)02/01/2019 - Pipe crossing was video inspected on 8-15-2018. (P. Meagher - RD784)02/27/2013 - Pipe has been sliplined with PVC, but the liner appears to be eroding at outlet and may be disjointed internal to the levee. See pic. Good candidate for video inspection. (W. Wylie - DWR UCIP)
FIELD_STRUCT_DESC: 12-inch corrugated metal (CM) drainage pipe through the levee, 12.0 feet below the crown. Flap gate and concrete U-shaped headwall on the waterside (WS). Polyvinyl chloride (PVC) weir on inlet at the landside (LS) toe. [Additional Reference(s): DWR Levee Log, 2005, (HLM 3.08). USACE Sacramento O&M Manual, Unit No. 145, August 1955, Revised 6 August 2019, (Station 44+96). USACE As-Built Drawing No. 2-4-106, Sheet No. 106/6, July 1944, (Station 44+96)].

Overview of Levee: Looking upstream from crown.

Overview of Levee: Looking downstream from crown.

Water-Side: Outlet structure with flap gate at waterside toe.

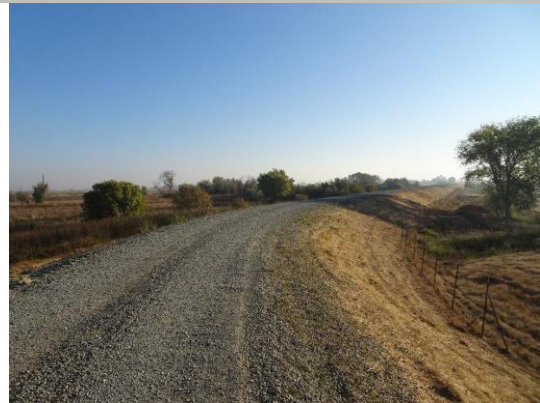
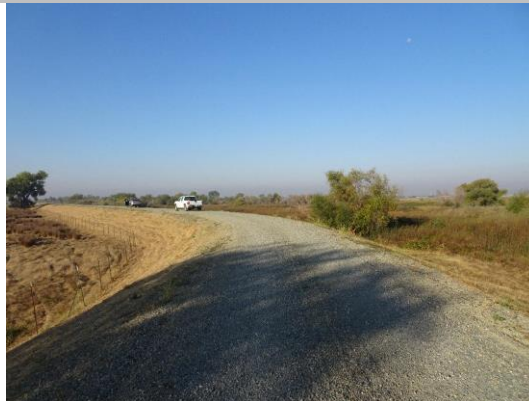
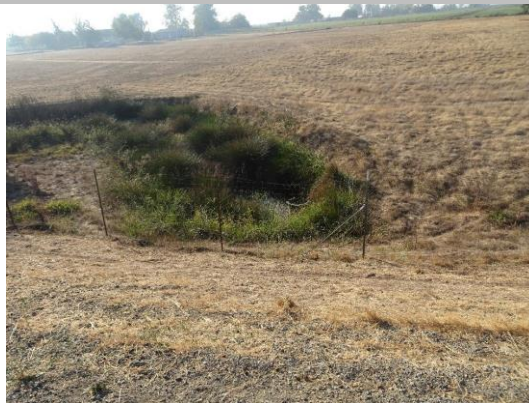
DS_ID:18595
FS_ID:70307
EP_NO: N/A
Repair Type: Urgent
EVAL Issue: Pipe Integrity
Crossing Status: Found
UCIP Comments: 10/05/2020 Record has been updated from No Action Needed to Urgent. DWR DMP has found integrity issues, LOF between 5 and 6. Recommend monitoring crossing until funding becomes available to address. No permit was found authorizing this encroachment. CVFPB will need to review crossing to determine owner. (O. Magana - DWR UCIP)12/16/2019 - Pipe crossing was hydroflushed and video inspected in October 2019. Pending final review by RD784 District Engineer and DWR. (P. Meagher - RD784)02/01/2019 - Pipe crossing was video inspected on 8-15-2018 (P. Meagher - RD784)02/27/2013 - Good candidate for video inspection. (W. Wylie - DWR UCIP)
FIELD_STRUCT_DESC: 18-inch corrugated metal (CM) drainage pipe through the levee, 15.8 feet below the crown. Flap gate on the waterside (WS) end. Polyvinyl chloride (PVC) weir on inlet at the landside (LS) toe. [Additional Reference(s): DWR Levee Log, 2005, (HLM 3.24). USACE Sacramento O&M Manual, Unit No. 145, August 1955, Revised 6 August 2019, (Station 53+86). USACE As-Built Drawing No. 2-4-106, Sheet No. 106/6, July 1944, (Station 53+86)].

Overview of Levee: Looking upstream from crown.

Overview of Levee: Looking downstream from crown.

Land-Side: Inlet structure at landside toe.

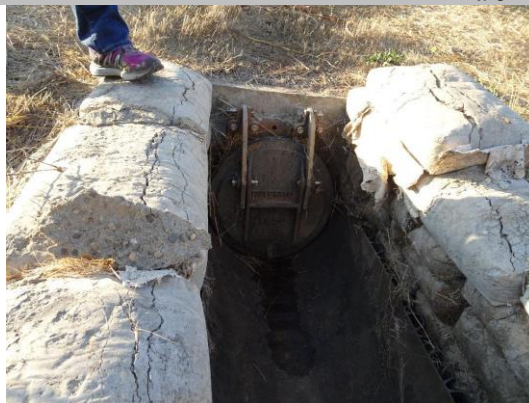
Photo 3 of 3 : UCIP_FA_2021_70308_100948.jpg

Water-Side: Outlet structure with flap gate at waterside toe.

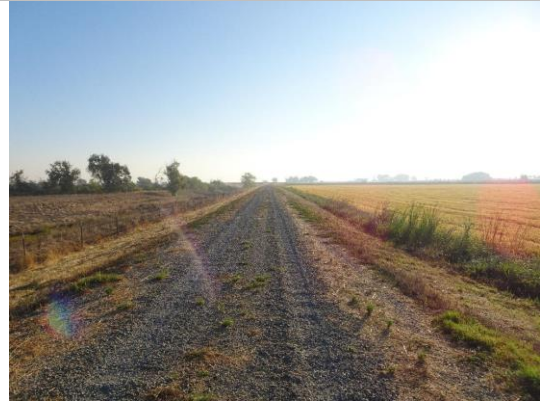
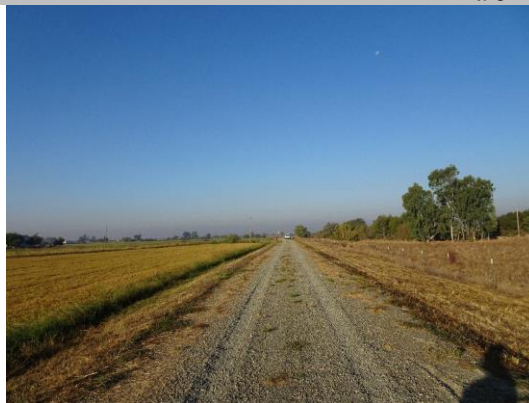
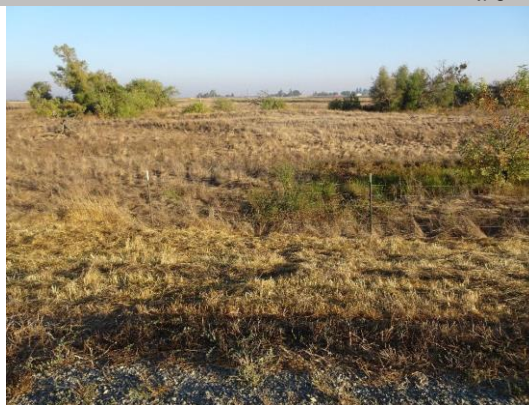
Comment Code						
Inspector Comment						
DS_ID:18593 FS_ID:70309 EP_NO: N/A Repair Type: Non-Urgent EVAL Issue: Unauthorized Encroachment, installed decades prior Crossing Status: Found UCIP Comments: 10/05/2020 - Record remains Non-Urgent. No permit was found authorizing this encroachment. CVFPB will need to review crossing to determine owner. No DWR DMP internal inspection has been completed yet. This crossing appears to be abandoned: buried inlet at landside toe. No access for internal video inspection. DWR DMP will complete assessment to determine final recommendation. (O. Magana - DWR UCIP) 02/01/2019 - An attempt was made to video inspect this pipe crossing on 8-15-2018 but conditions were too muddy inside the pipe. (P. Meagher - RD784)11/14/2016 - Photos added of exposed flap gate on WS and possible inlet location on LS. Condition remains as Non-Urgent because of inlet not being fully operable. Unknown if pipe will operate as designed during high water or if it is full of sediment. (P. Meagher - RD784)11/01/2015 - Waterside Flap Gate Uncovered. Photo sent to DWR Matt Hoffman on 3-3-2014. Fresh photo sent to DWR Pavel Kazi on 9-9-2015. Landside toe has never been able to be located. Requesting DWR inspector to change the status of this issue to "No Action Needed". (P. Meagher - RD784).02/26/2013 - Pipe buried on LS toe and flap gate is blocked by soil on WS toe. (W. Wylie - DWR UCIP). FIELD_STRUCT_DESC: 18-inch corrugated metal (CM) drainage pipe through the levee, 10.0 feet below the crown. Flap gate on the waterside (WS) end. [Additional Reference(s): DWR Levee Log, 2005, (HLM 3.98). USACE Sacramento O&M Manual, Unit No. 145, August 1955, Revised 6 August 2019, (Station 91+50). USACE As-Built Drawing No. 2-4-106, Sheet No. 106/6, July 1944, (Station 91+50)]. FS Date: 10/5/2020

Overview of Levee: Looking upstream from crown.

Overview of Levee: Looking downstream from crown.

Water-Side: View from crown. Outlet not visible.

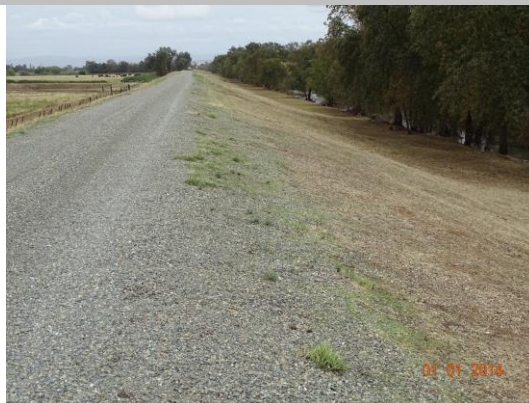
Photo 1 of 1 : FA_2021_RD0784_183_3_20211026_00004.jpg

View of the well maintained annual vegetation, Fall 2021.

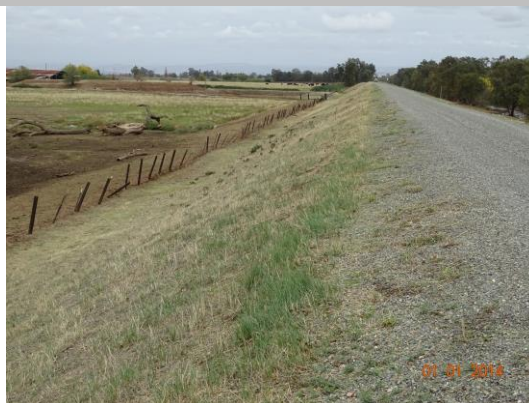
Photo 1 of 1 : FA_2021_RD0784_183_2_20211026_00005.jpg

View of the well maintained annual vegetation, Fall 2021.

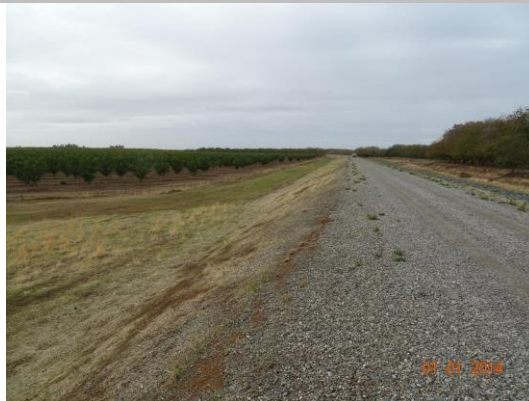
Photo 1 of 1 : FA_2021_RD0784_184_9_20211026_00024.jpg

View of the well maintained annual vegetation, Fall 2021.

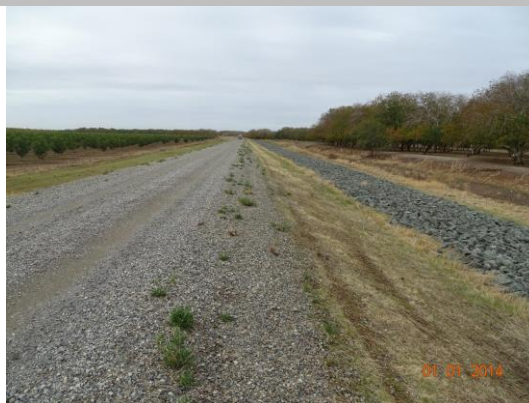
Photo 1 of 1 : FA_2021_RD0784_184_10_20211026_00023.jpg

View of the well maintained annual vegetation, Fall 2021.

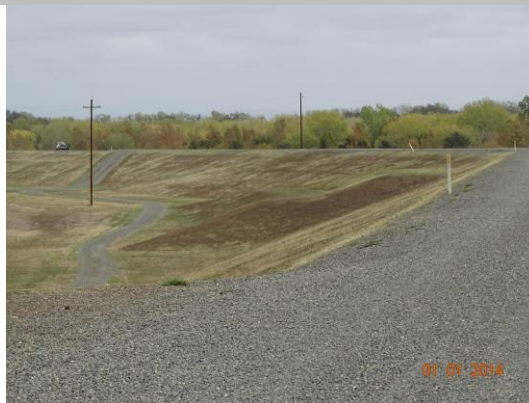
Photo 1 of 1 : FA_2021_RD0784_437_1_20211026_00001.jpg

View of the well maintained annual vegetation, Fall 2021.

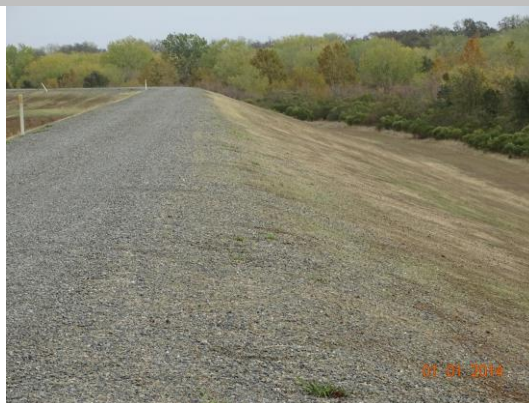
Photo 1 of 1 : FA_2021_RD0784_437_2_20211026_00002.jpg

View of the well maintained annual vegetation, Fall 2021.

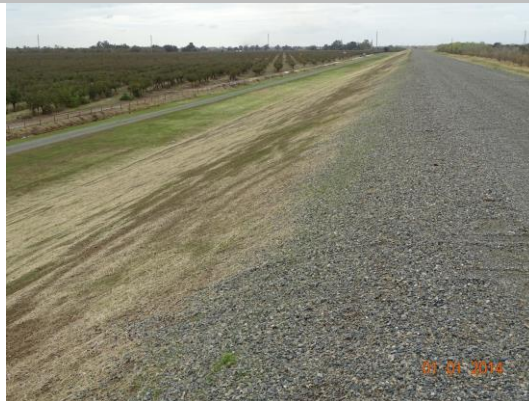
Photo 1 of 1 : FA_2021_RD0784_530_1_20211026_00001.jpg

View of the well maintained annual vegetation, Fall 2021.

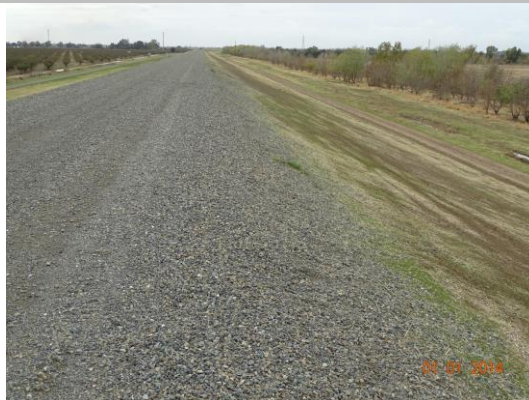
Photo 1 of 1 : FA_2021_RD0784_530_2_20211026_00002.jpg

View of the well maintained annual vegetation, Fall 2021.
