**Flood Control Project Maintenance  
Levee Inspections**

**Maintenance Issue Types Only, Levee Inspection Report By Mile - Fall 2022**

**Reclamation District No. 0784 Plumas Lake**

Waterway	Bank	Unit Miles	Inspection Start/End	Inspector
Unit No. 01 Yuba River	Left	2.21	10/25/2022 10/25/2022	Brooks Weisser

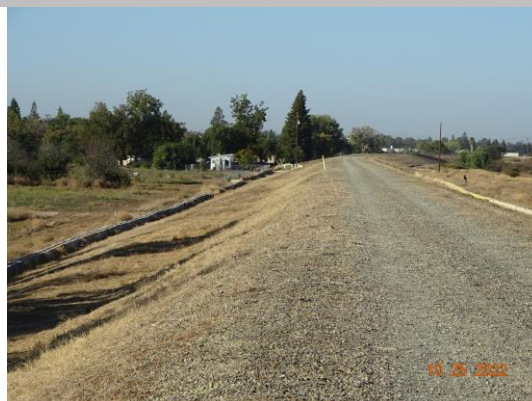
Photo 1 of 1 : FA\_2022\_RD0784\_178\_23\_20221028\_00030.jpg

LM Start	0.04	Rating **	A	Issue No.	23
LM End	2.21	Issue Type +	Ma	Location *	LS
Category	Earthen Levee			GPS Latitude/Longitude	
				Start	End
Item	Vegetation			39.134435 °	39.125782 °
				-121.552687 °	-121.588664 °
DWR ID	DWR_RD0784_01_f_2022_23				
Comment Code					
V1 : Control annual grass and weeds on the levee slopes and easements.					
Inspector Comment					
Annual vegetation is well maintained, Fall 2022.

View of annual vegetation on landside slope, Fall 2022.

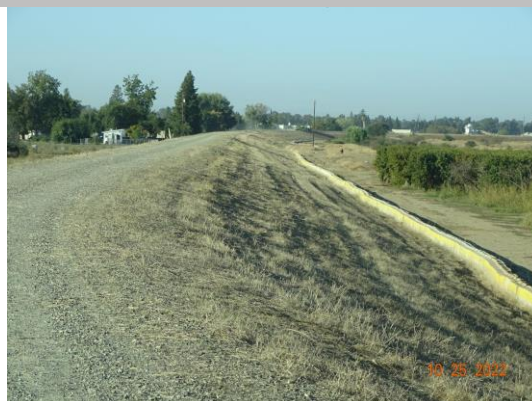
Photo 1 of 1 : FA\_2022\_RD0784\_178\_24\_20221028\_00031.jpg

LM Start	0.04	Rating **	A	Issue No.	24
LM End	2.21	Issue Type +	Ma	Location *	WS
Category	Earthen Levee			GPS Latitude/Longitude	
				Start	End
Item	Vegetation			39.134435 °	39.125782 °
				-121.552688 °	-121.588661 °
DWR ID	DWR_RD0784_01_f_2022_24				
Comment Code					
V1 : Control annual grass and weeds on the levee slopes and easements.					
Inspector Comment					
Annual vegetation is well maintained, Fall 2022.

View of annual vegetation on waterside slope, Fall 2022.

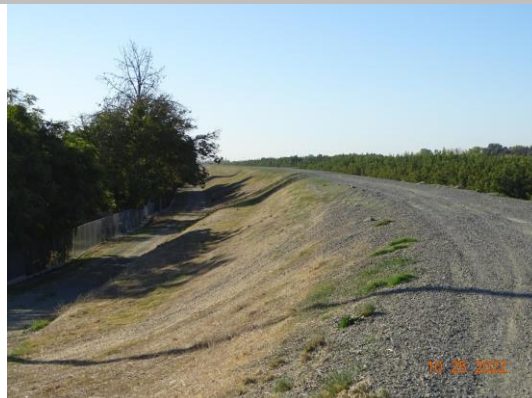
Photo 1 of 1 : FA\_2022\_RD0784\_531\_2\_20221028\_00004.jpg

Annual vegetation is well maintained, Fall 2022.

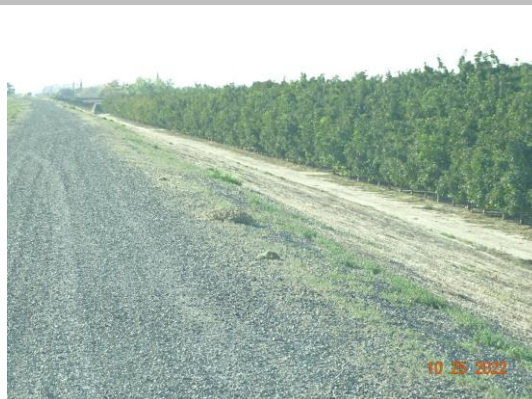
Photo 1 of 1 : FA\_2022\_RD0784\_531\_3\_20221028\_00005.jpg

LM Start	0.01	Rating **	A	Issue No.	3
LM End	2.54	Issue Type +	Ma	Location *	WS
Category	Earthen Levee			GPS Latitude/Longitude	
				Start	End
Item	Vegetation			39.125761 °	39.090358 °
				-121.588662 °	-121.584718 °
DWR ID	DWR_RD0784_02A_f_2022_3				
Comment Code					
V1 : Control annual grass and weeds on the levee slopes and easements.					
Inspector Comment					
Annual vegetation is well maintained, Fall 2022.

Annual vegetation is well maintained, Fall 2022.

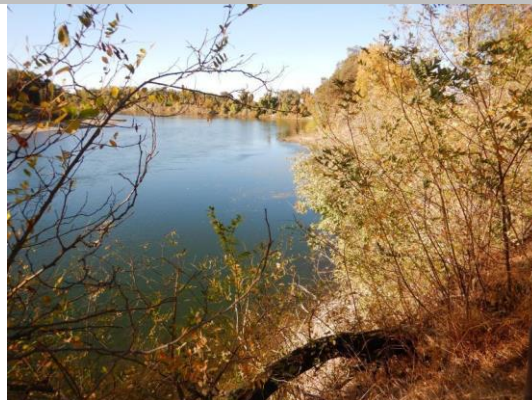
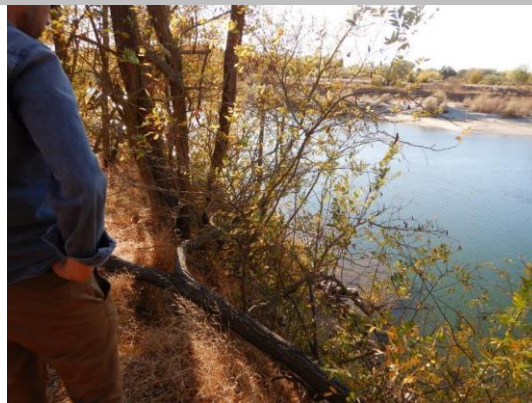
2018 Site ID: FHR 17.8 L  
 Status: Eroding  
 2018 Field Notes: Site continues to erode.  
 Site History: 2003 - Bank is near vertical. Identified as a Potentially Critical site. 2004 - Eddy flow off downstream end of Modesto formation eroding the fluvial sediments. 2005 - Some new slumping. Actively eroding but berm width is greater than 50 ft. 2006 - Downgraded to regular erosion site. Still actively eroding. Large old rotational failures in high bank on the downstream end. 2008 - Removed from inventory due to wide berm width does not meet criteria for an erosion site. 2010 - Added back to the inventory after 10 ft of bank erosion in the winter 2009 storm. Steep vertical face. 2011 - Bank has retreated an additional 2.5 ft from last year. New tree popouts and erosion throughout the site. 2012 - Site continues to worsen with new tree popouts and many sections of new erosion. 2017 - Large sandbag on opposite bank, thalweg is moving closer to the levee.

USACE 2018 Erosion Photo #1

USACE 2018 Erosion Photo #2

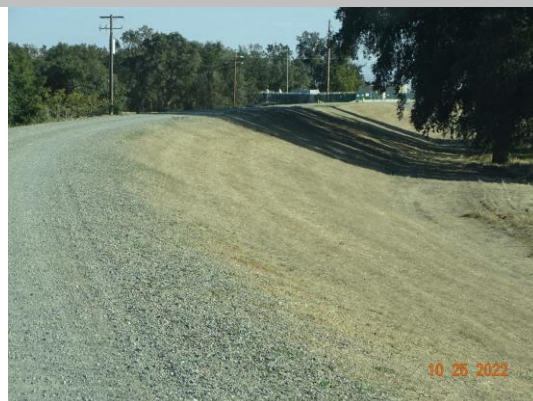
Photo 1 of 1 : FA\_2022\_RD0784\_533\_4\_20221028\_00008.jpg

Annual vegetation is well maintained, Fall 2022.

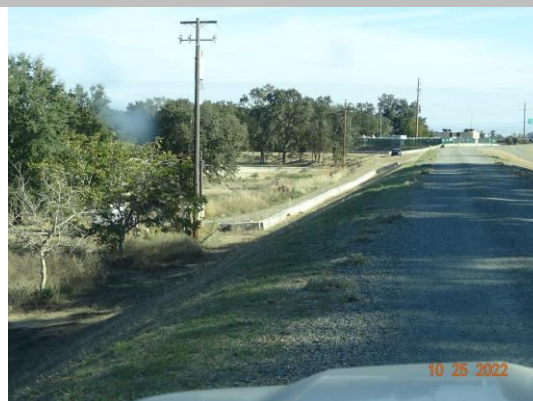
Photo 1 of 1 : FA\_2022\_RD0784\_533\_3\_20221028\_00007.jpg

LM Start	2.45	Rating **	A	Issue No.	3
LM End	3.18	Issue Type +	Ma	Location *	LS
Category	Earthen Levee			GPS Latitude/Longitude	
				Start	End
Item	Vegetation			38.970889 °	38.974737 °
				-121.547369 °	-121.535761 °
DWR ID	DWR_RD0784_03A_f_2022_3				
Comment Code					
V1 : Control annual grass and weeds on the levee slopes and easements.					
Inspector Comment					
Annual vegetation is well maintained, Fall 2022.

Annual vegetation is well maintained, Fall 2022.

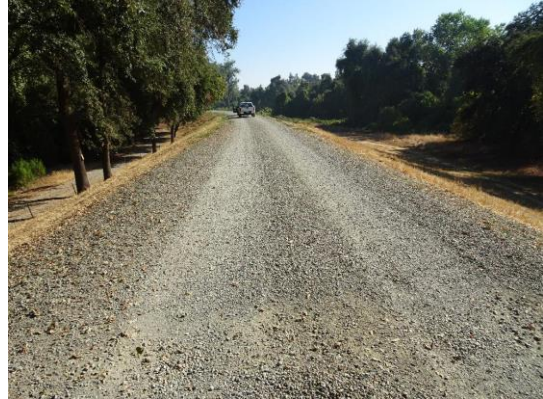
Photo 1 of 3 : UCIP\_FA\_2022\_69907\_101266.jpg

Comment Code					
Inspector Comment					
DS_ID:18580 FS_ID:69907 EP_NO: N/A Repair Type: Urgent EVAL Issue: 1, Pipe Integrity Crossing Status: Found UCIP Comments: 10/05/2020 - Record has been updated from No Action Needed to Urgent. DWR DMP has found integrity issues, LOF between 5 and 6. Recommend monitoring crossing until funding becomes available to address. No permit was found authorizing this encroachment. CVFPB will need to review crossing to determine owner. (O. Magana - DWR UCIP)12/16/2019 - Pipe crossing was hydroflushed and video inspected in October 2019. Pending final review by RD784 District Engineer and DWR. (P. Meagher - RD784)02/01/2019 - Pipe crossing was video inspected on 8-14-2018. (P. Meagher - RD784) FIELD_STRUCT_DESC: 30-inch corrugated metal (CM) drainage pipe through the levee, 19.0 feet below the crown. Flap gate on the waterside (WS) end. Concrete headwall at the WS toe. (No permit found for this crossing. Owner unknown). [Additional Reference(s): DWR Levee Log, 2005, (HLM 3.56). USACE Sacramento O&M Manual, Unit No. 145, August 1955, Revised 6 August 2019, (Station 92+88)]. FS Date: 10/5/2020

Overview of Levee: Looking upstream from crown.

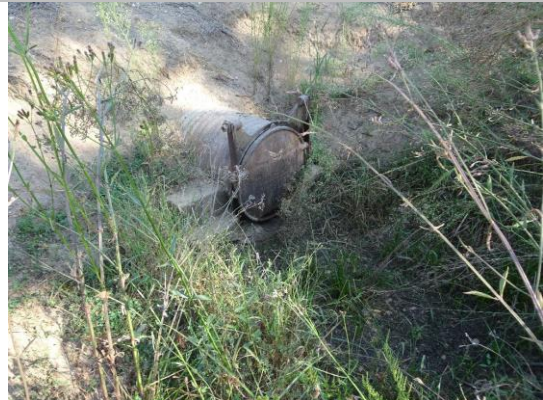
Photo 2 of 3 : UCIP\_FA\_2022\_69907\_101269.jpg

Water-Side: Pipe outlet and flap gate at waterside toe.

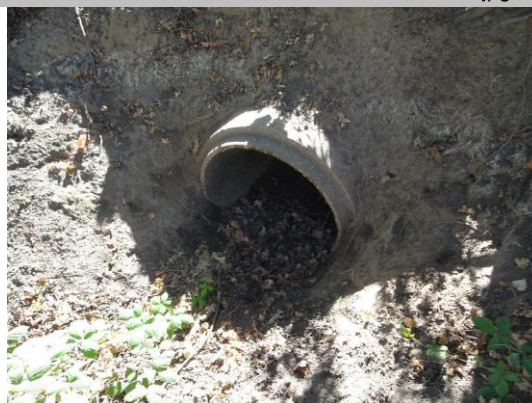
Photo 3 of 3 : UCIP\_FA\_2022\_69907\_101270.jpg

Land-Side: Pipe inlet beyond landside toe.

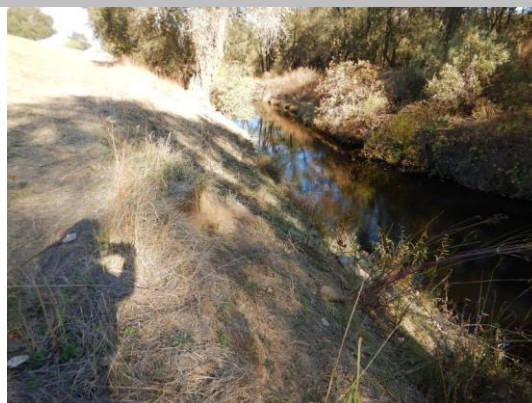
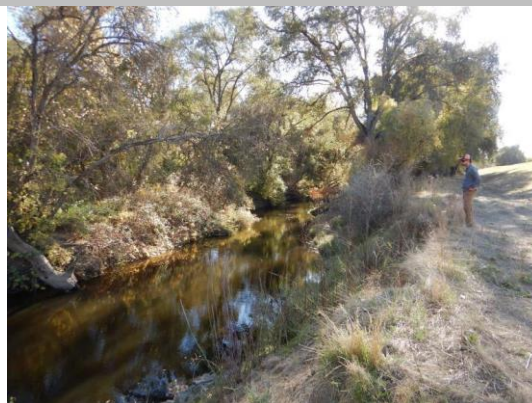
2018 Site ID: BER 4.9 R  
Status: Eroding  
2018 Field Notes: No observed change.  
Site History: 2009 - Small site which could be repaired with maintenance. Erosion into the levee toe, rock has started to fail.

USACE 2018 Erosion Photo #1

USACE 2018 Erosion Photo #2

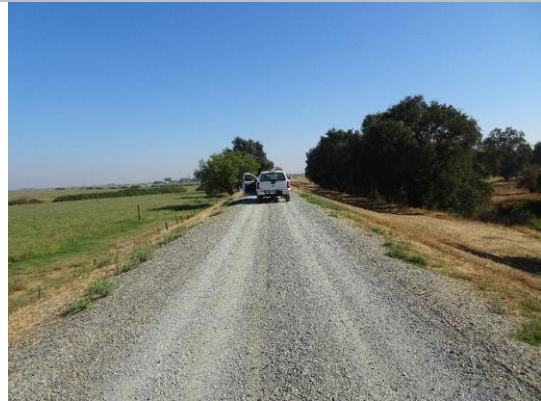
Photo 1 of 3 : UCIP\_FA\_2022\_69908\_101278.jpg

Comment Code						
Inspector Comment						
DS_ID:18579 FS_ID:69908 EP_NO: N/A Repair Type: Non-Urgent EVAL Issue: Crossing Status: Not Found UCIP Comments: 10/05/2020 Record has been updated from No Action Needed to Non-Urgent. DWR DMP geophysical study found no positive signal of pipe at latitude, longitude 38.983363, -121.513775. No signs or evidence of pipe were found during site inspection. No permit was found authorizing this encroachment. CVFPB will need to review crossing to determine owner. Record will remain in UCIP's database and will remain active until a levee improvement project can confirm that this crossing has been removed from the levee. (O. Magana - DWR UCIP) FIELD_STRUCT_DESC: 18-inch corrugated metal (CM) drainage pipe through the levee, 17.5 feet below the crown. Flap gate on the waterside (WS) end. (No permit found for this crossing. Owner unknown). [Additional Reference(s): DWR Levee Log, 2005, (HLM 4.52). USACE Sacramento O&M Manual, Unit No. 145, August 1955, Revised 6 August 2019, (Station 143+15)]. FS Date: 10/5/2020

Overview of Levee: Looking upstream from crown.

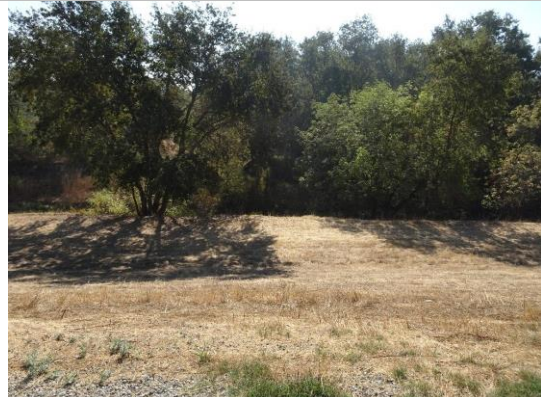
Photo 2 of 3 : UCIP\_FA\_2022\_69908\_101280.jpg

Water-Side: View of waterside looking from crown.

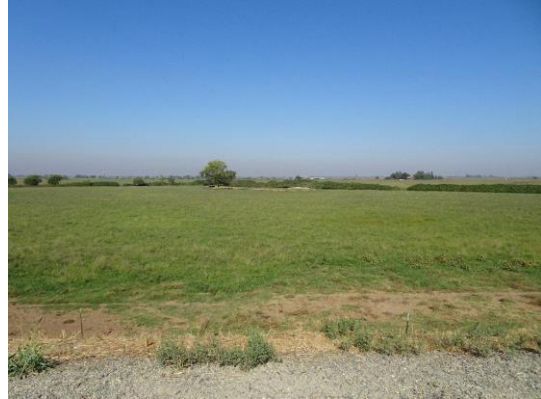
Photo 3 of 3 : UCIP\_FA\_2022\_69908\_101281.jpg

Land-Side: View of landside looking from crown.

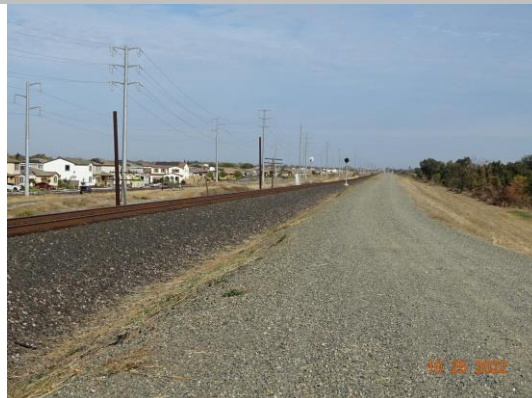
Photo 1 of 1 : FA\_2022\_RD0784\_181\_5\_20221028\_00013.jpg

Annual vegetation is well maintained, Fall 2022.

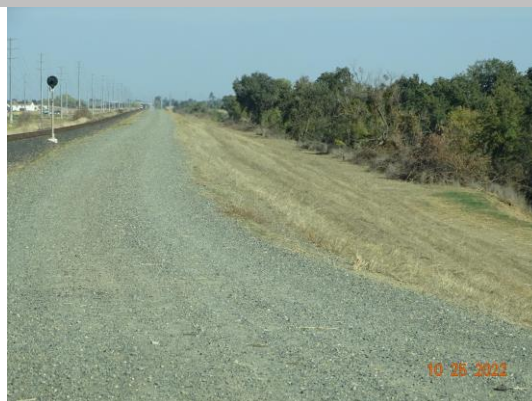
Photo 1 of 1 : FA\_2022\_RD0784\_181\_6\_20221028\_00014.jpg

LM Start	0.01	Rating **	A	Issue No.	6
LM End	5.78	Issue Type +	Ma	Location *	WS
Category	Earthen Levee			GPS Latitude/Longitude	
				Start	End
Item	Vegetation			38.974942 °	39.058106 °
				-121.535104 °	-121.542501 °
DWR ID	DWR_RD0784_04_f_2022_6				
Comment Code					
V1 : Control annual grass and weeds on the levee slopes and easements.					
Inspector Comment					
Annual vegetation is well maintained, Fall 2022.

Annual vegetation is well maintained, Fall 2022.

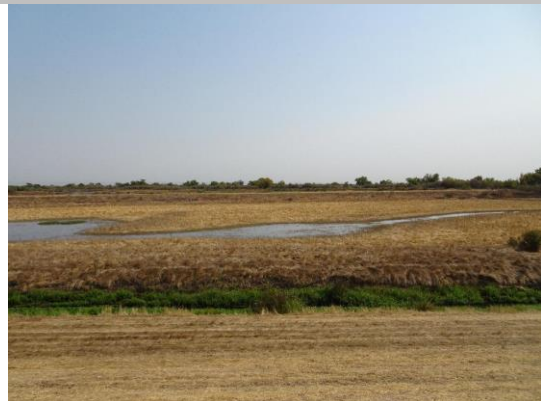
Photo 2 of 3 : UCIP\_FA\_2022\_70203\_100694.jpg

View of waterside from crown, no indicator of pipe.

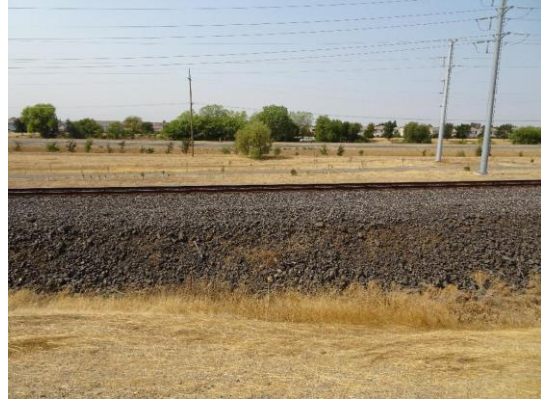
Photo 3 of 3 : UCIP\_FA\_2022\_70203\_100695.jpg

View of landside from crown, no indicator of pipe.

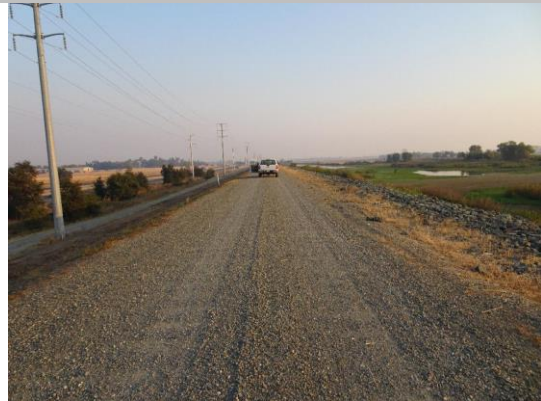
Photo 1 of 3 : UCIP\_FA\_2022\_70205\_100723.jpg

DS\_ID:18628  
 FS\_ID:70205  
 EP\_NO: N/A  
 Repair Type: Non-Urgent  
 EVAL Issue:  
 Crossing Status: Not Found  
 UCIP Comments: 09/29/2020 Record has been updated from No Action Needed to Non-Urgent. DWR DMP geophysical study found no positive signal of pipe at latitude, longitude 38.046633, -121.542399. No signs or evidence of pipe were found during the site inspection. No permit was found authorizing this encroachment. CVFPB will need to review crossing to determine owner. Record will remain in UCIP's database and will remain active until a levee improvement project can confirm that this crossing has been removed from the levee. (O. Magana - DWR UCIP) 02/26/2013 Unable to locate. Likely abandoned with levee improvements. (W. Wylie - DWR UCIP)  
 FIELD\_STRUCT\_DESC: 24-inch corrugated metal drainage pipe through the levee, 21.0 feet below the crown. [Additional Reference(s): USACE Sacramento O&M Manual, Unit No. 145, August 1955, Revised 6 August 2019, (Station 264+60). USACE As-Built Drawing No. 2-4-84-1, Sheet 84-1/3, (Station 264+60), September 1941].

Overview of Levee: looking upstream from crown.

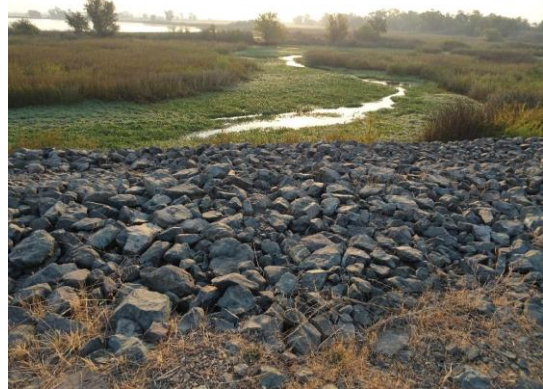
Photo 2 of 3 : UCIP\_FA\_2022\_70205\_100725.jpg

Waterside view from crown. Riprap on slope.

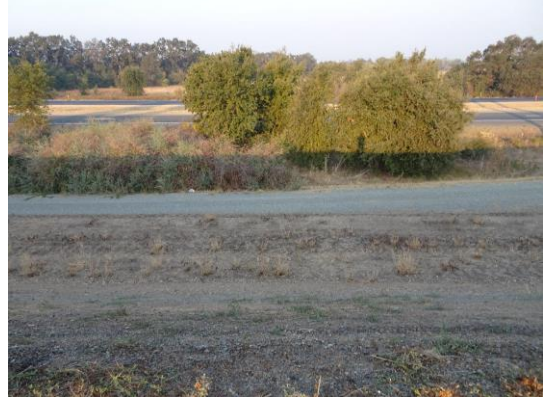
Photo 3 of 3 : UCIP\_FA\_2022\_70205\_100726.jpg

Landside view from crown.

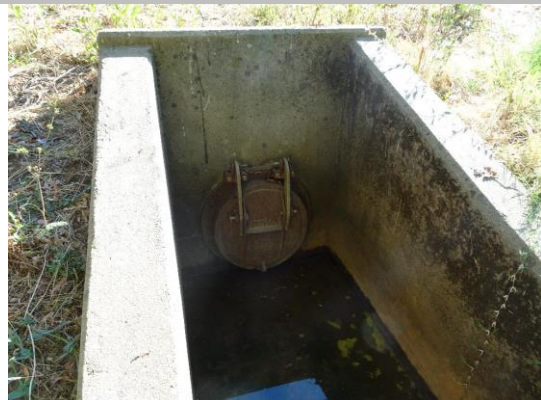
Photo 2 of 3 : UCIP\_FA\_2022\_70298\_100866.jpg

Water-Side: Outlet structure with flap gate at waterside toe.

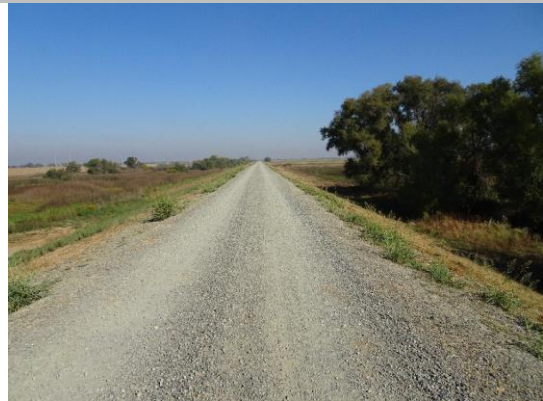
Photo 1 of 3 : UCIP\_FA\_2022\_70299\_100890.jpg

DS\_ID:18591  
 FS\_ID:70299  
 EP\_NO: N/A  
 Repair Type: Urgent  
 EVAL Issue: 1, Pipe Integrity  
 Crossing Status: Found  
 UCIP Comments: 10/05/2020 - Record has been updated from Non-Urgent to Urgent. DWR DMP has found integrity issues, LOF between 5 and 6. Recommend monitoring crossing until funding becomes available to address. Pipe was underwater during site inspection. No permit was found authorizing this encroachment. CVFPB will need to review crossing to determine owner. (O. Magana - DWR UCIP)12/16/2019 - Pipe crossing was hydroflushed and video inspected (again) in October 2019. Pending final review by RD784 Engineer and DWR. (P. Meagher - RD784)02/01/2019 - Pipe crossing was video inspected on 8/14/2018. (P. Meagher)02/26/2013 - No handle or access to slide gate on LS toe. (W. Wylie - DWR UCIP) FIELD\_STRUCT\_DESC: 30-inch corrugated metal (CM) drainage pipe through the levee, 23.7 feet below the crown. Flap gate on the waterside (WS) end. Slide gate inside a concrete drop inlet on the landside (LS). (No permit found authorizing this pipe. Owner unknown). [Additional Reference(s): DWR Levee Log, 2005, (HLM 0.82). USACE Sacramento O&M Manual, Unit No. 145, August 1955, Revised 6 August 2019, (Station 63+00). USACE As-Built Drawing No. 2-4-106, Sheet No. 106/5, July 1944, (Station 63+00)].

Overview of Levee: Looking upstream from crown.

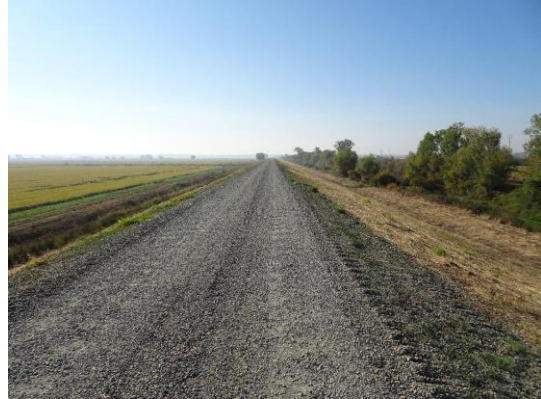
Photo 1 of 3 : UCIP\_FA\_2022\_73051\_100920.jpg

Comment Code					
Inspector Comment					
DS_ID:18590 FS_ID:73051 EP_NO: N/A Repair Type: No Action Needed EVAL Issue: Crossing Status: Not Found UCIP Comments: 08/02/2021 - The CVFPB has coordinated with the LMA to remove and replace this existing 18-inch pipe under Permit No. 19593. Retire this DSID. (D. Sanoski - DWR UCIP)10/06/2020 - Record has been updated from No Action Needed to Urgent. DWR DMP has found integrity issues, LOF between 5 and 6. Recommend monitoring crossing until funding becomes available to address. No permit was found authorizing this encroachment. CVFPB will need to review crossing to determine owner. (O. Magana - DWR UCIP)12/16/2019 - Pipe crossing was hydroflushed and video inspected in October 2019. Pending final review by RD784 District Engineer and DWR. (P. Meagher - RD784)02/01/2019 - Pipe crossing was video inspected on 8-14-2018. (P. Meagher)02/26/2013 - Good candidate for video inspection. (W. Wylie - DWR UCIP) FIELD_STRUCT_DESC: 18-inch corrugated metal (CM) drainage pipe through the levee, 14.5 feet below the crown. Flap gate on the waterside (WS) end. Concrete U-shaped headwall on the WS. Polyvinyl chloride (PVC) weir on inlet. (No permit found authorizing this pipe. Owner unknown). [Additional Reference(s): DWR Levee Log, 2005, (HLM 1.60). USACE Sacramento O&M Manual, Unit No. 145, August 1955, Revised 6 August 2019, (Station 103+23). USACE As-Built Drawing No. 2-4-106, Sheet No. 106/5, July 1944, (Station 103+23)]. FS Date: 10/5/2020

Overview of Levee: Looking downstream from crown.

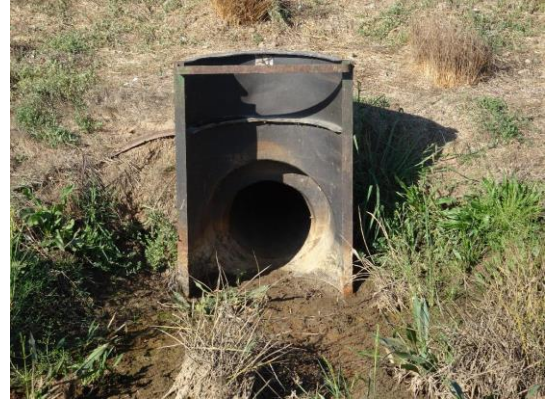
Photo 2 of 3 : UCIP\_FA\_2022\_73051\_100907.jpg

Land-Side: Inlet at landside toe.

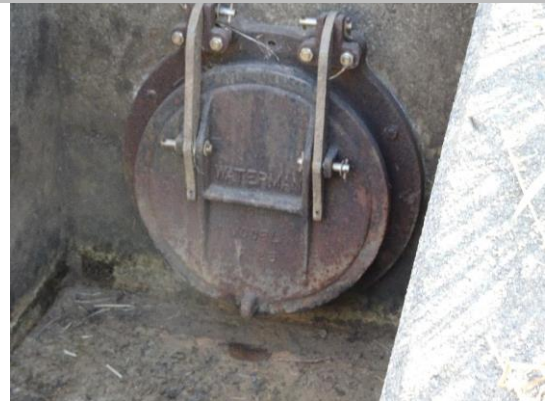
Photo 3 of 3 : UCIP\_FA\_2022\_73051\_100921.jpg

Water-Side: Outlet structure with flap gate at waterside toe.

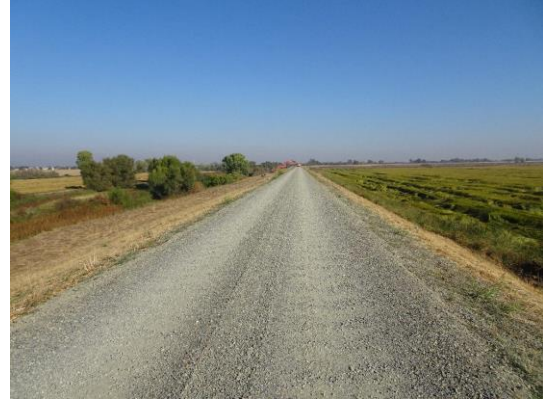
Photo 1 of 3 : UCIP\_FA\_2022\_70301\_100930.jpg

Comment Code						
Inspector Comment						
DS_ID:18588 FS_ID:70301 EP_NO: N/A Repair Type: Urgent EVAL Issue: 1, Pipe Integrity Crossing Status: Found UCIP Comments: 10/05/2020 - Record has been updated from Non-Urgent to Urgent. DWR DMP has found integrity issues, LOF between 5 and 6. Recommend monitoring crossing until funding becomes available to address. No permit was found authorizing this encroachment. CVFPB will need to review crossing to determine owner. (O. Magana - DWR UCIP)12/16/2019 - Pipe crossing was hydroflushed and video inspected in October 2019. Pending final review by RD784 District Engineer and DWR. (P. Meagher - RD784)02/01/2019 - Pipe crossing was video inspected on 8-14-2018. (P. Meagher - RD784)09/11/2015 - Inlet burried. Good candidate for video inspection as pipe is corroded. (W. Wylie - DWR UCIP) FIELD_STRUCT_DESC: 18-inch corrugated metal (CM) drainage pipe through the levee, 14.5 feet below the crown. Flap gate on the waterside (WS) end. Concrete U-shaped headwall on the WS. [Additional Reference(s): DWR Levee Log, 2005, (HLM 1.86). USACE Sacramento O&M Manual, Unit No. 145, August 1955, Revised 6 August 2019, (Station 116+78). USACE As-Built Drawing No. 2-4-106, Sheet No. 106/5, July 1944, (Station 116+78)]. FS Date: 10/5/2020

Overview of Levee: Looking upstream from crown.

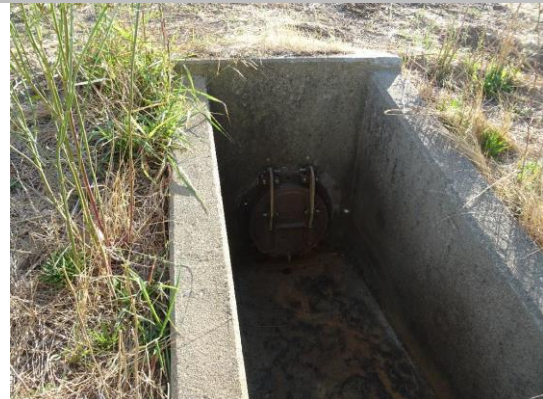
Photo 2 of 3 : UCIP\_FA\_2022\_70301\_100932.jpg

Water-Side: Outlet structure with flap gate at waterside toe.

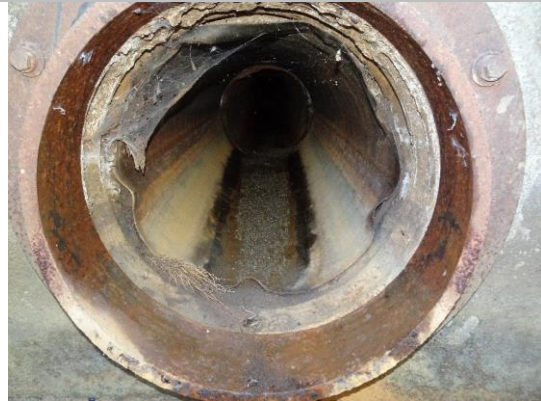
Photo 3 of 3 : UCIP\_FA\_2022\_70301\_100933.jpg

Water-Side: View of pipe lining material.

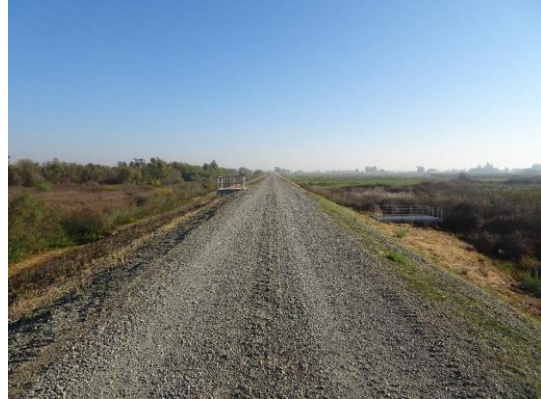
Photo 1 of 3 : UCIP\_FA\_2022\_70305\_100934.jpg

Comment Code					
Inspector Comment					
DS_ID:25591 FS_ID:70305 EP_NO: 12871-1 Repair Type: No Action Needed EVAL Issue: Crossing Status: Found UCIP Comments: 10/05/2020 - Record remains No Action Needed. No issues were found during site inspection. (O. Magana - DWR UCIP)01/10/2020 - Pipe replaces previous 18-inch pipe logged under UCIP dsid 18597. DSID 18597 has been retired. Construction photos of new pipe, courtesy of P. Meagher, have been uploaded to this record. This record will be used to log the maintenance and condition of new 18-inch pipe. Need photos of completed installation. (O. Magana - DWR UCIP) FIELD_STRUCT_DESC: 18-inch corrosion-proof steel storm drain gravity pipe through the levee, 15.5 feet below the crown. Improvements include a new inlet structure with trash rack, outfall structure with an 18-inch diameter automatic drainage gate, riprap apron, and facility markers. (18-inch pipe authorized under Permit No. 12817-1, 2019 - Reclamation District No. 784 [RD0784]. Proposed removal of 18-inch pipe under Permit No. 12817, 1983 - RD0784 withdrawn due to no funding available). [Additional Reference(s): DWR Levee Log, 2005, (HLM 2.47), listed as an 18-inch CMP. USACE Sacramento O&M Manual, Unit No. 145, August 1955, Revised 6 August 2019, (Station 13+72), listed as an 18-inch CMP. USACE As-Built Drawing No. 2-4-106, Sheet No. 106/6, July 1944, (Station 13+72), listed as an 18-inch CMP. Previous 18-inch pipe removed under Permit No. 12817-1 in 2019 (logged under UCIP DSID 18597)]. FS Date: 10/5/2020

Overview of Levee: Looking upstream from crown.

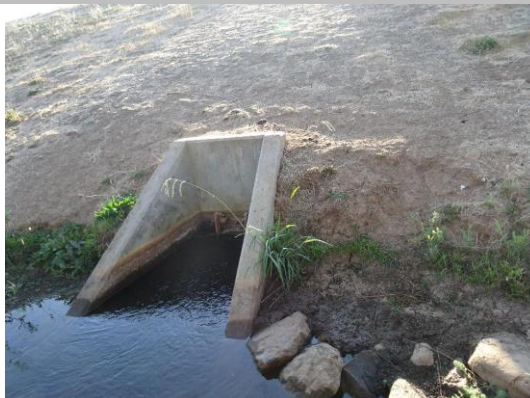
Photo 2 of 3 : UCIP\_FA\_2022\_70305\_100936.jpg

Water-Side: Outlet structure with flap gate at waterside toe.

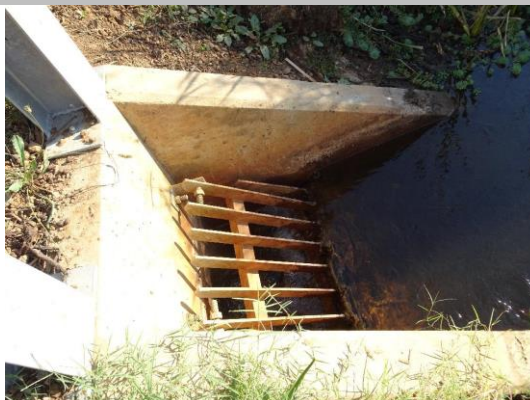
Photo 3 of 3 : UCIP\_FA\_2022\_70305\_100938.jpg

Land-Side: Inlet structure with grate at landside toe.

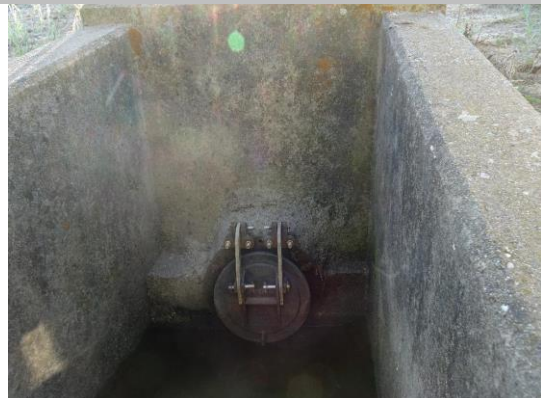
Photo 2 of 3 : UCIP\_FA\_2022\_70306\_100941.jpg

Water-Side: Outlet structure with flap gate at waterside toe.

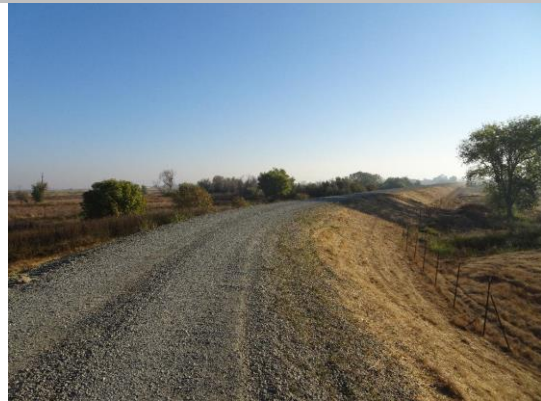
Photo 1 of 3 : UCIP\_FA\_2022\_70307\_100943.jpg

Overview of Levee: Looking upstream from crown.

Comment Code					
Inspector Comment					
DS_ID:18595 FS_ID:70307 EP_NO: N/A Repair Type: Urgent EVAL Issue: 1, Pipe Integrity Crossing Status: Found UCIP Comments: 10/05/2020 Record has been updated from No Action Needed to Urgent. DWR DMP has found integrity issues, LOF between 5 and 6. Recommend monitoring crossing until funding becomes available to address. No permit was found authorizing this encroachment. CVFPB will need to review crossing to determine owner. (O. Magana - DWR UCIP)12/16/2019 - Pipe crossing was hydroflushed and video inspected in October 2019. Pending final review by RD784 District Engineer and DWR. (P. Meagher - RD784)02/01/2019 - Pipe crossing was video inspected on 8-15-2018 (P. Meagher - RD784)02/27/2013 - Good candidate for video inspection. (W. Wylie - DWR UCIP) FIELD_STRUCT_DESC: 18-inch corrugated metal (CM) drainage pipe through the levee, 15.8 feet below the crown. Flap gate on the waterside (WS) end. Polyvinyl chloride (PVC) weir on inlet at the landside (LS) toe. [Additional Reference(s): DWR Levee Log, 2005, (HLM 3.24). USACE Sacramento O&M Manual, Unit No. 145, August 1955, Revised 6 August 2019, (Station 53+86). USACE As-Built Drawing No. 2-4-106, Sheet No. 106/6, July 1944, (Station 53+86)]. FS Date: 10/5/2020

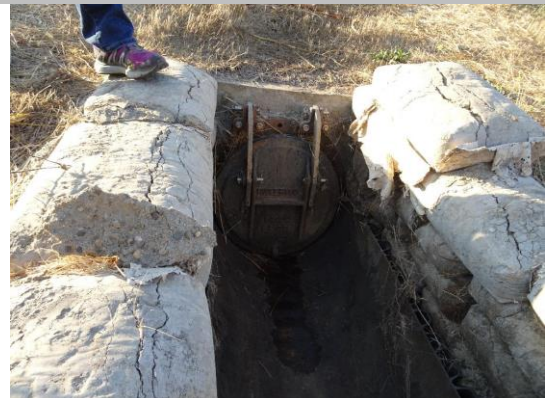
Photo 2 of 3 : UCIP\_FA\_2022\_70308\_100948.jpg

Water-Side: Outlet structure with flap gate at waterside toe.

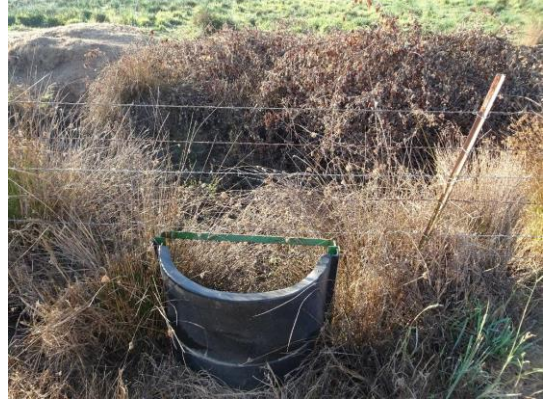
Photo 3 of 3 : UCIP\_FA\_2022\_70308\_100950.jpg

Land-Side: Inlet structure at landside toe.

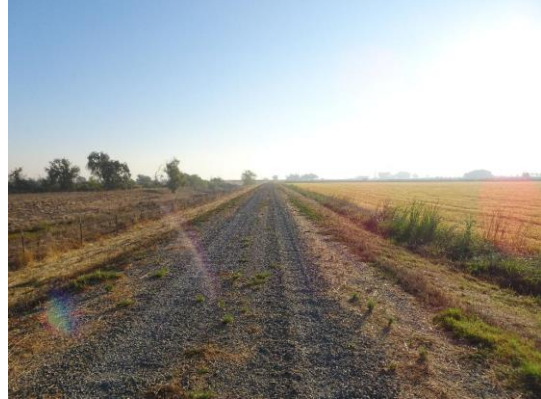
Photo 1 of 3 : UCIP\_FA\_2022\_70309\_100951.jpg

Overview of Levee: Looking upstream from crown.

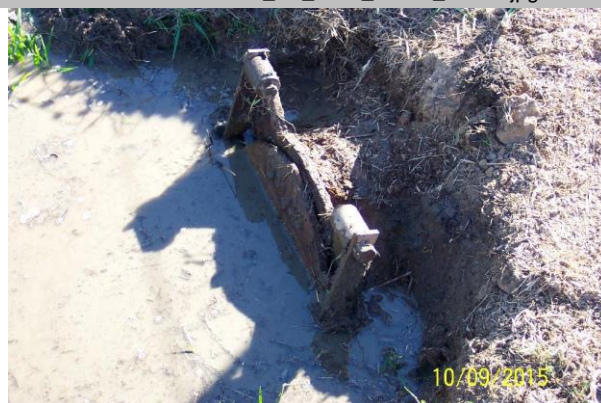
Photo 3 of 3 : UCIP\_FA\_2022\_70309\_74710.jpg

Flap gate at waterside toe partially under water

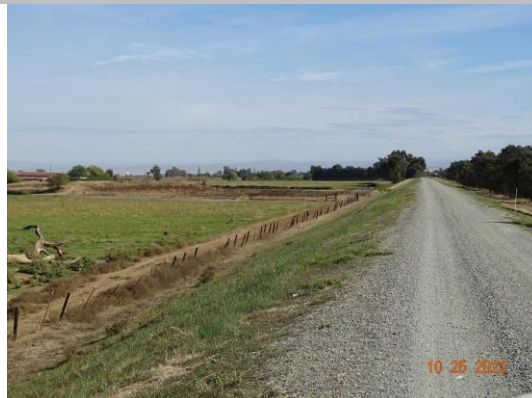
Photo 1 of 1 : FA\_2022\_RD0784\_183\_2\_20221028\_00004.jpg

Annual vegetation is well maintained, Fall 2022.

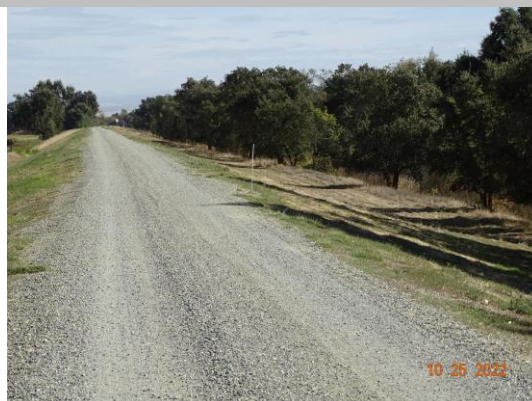
Photo 1 of 1 : FA\_2022\_RD0784\_183\_3\_20221028\_00005.jpg

Annual vegetation is well maintained, Fall 2022.

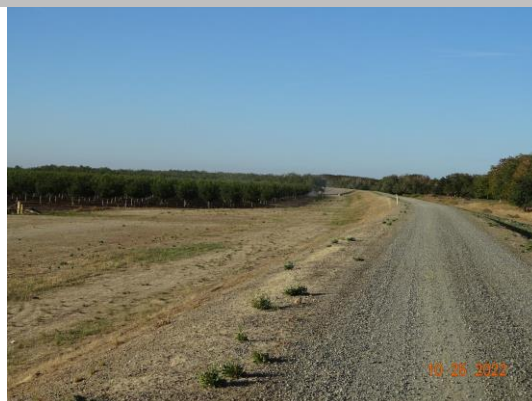
Photo 1 of 1 : FA\_2022\_RD0784\_184\_9\_20221028\_00023.jpg

Annual vegetation is well maintained, Fall 2022.

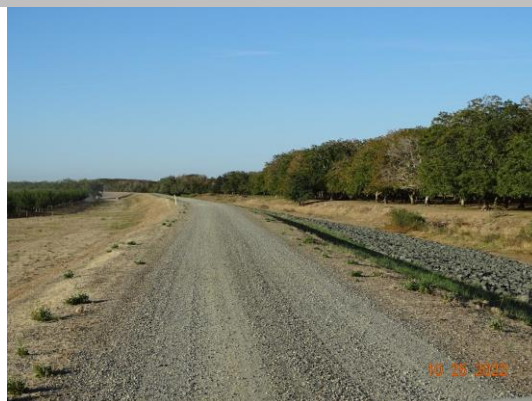
Photo 1 of 1 : FA\_2022\_RD0784\_184\_10\_20221028\_00024.jpg

Annual vegetation is well maintained, Fall 2022.

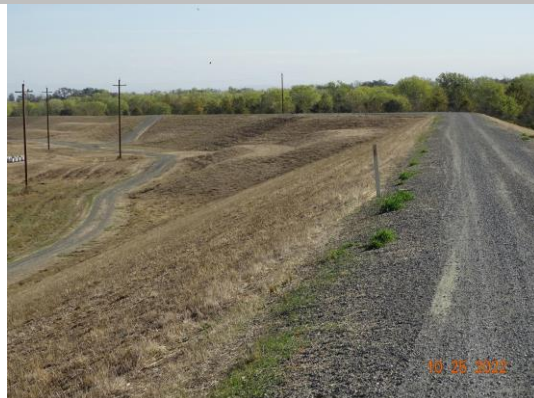
Photo 1 of 1 : FA\_2022\_RD0784\_437\_1\_20221028\_00001.jpg

Annual vegetation is well maintained, Fall 2022.

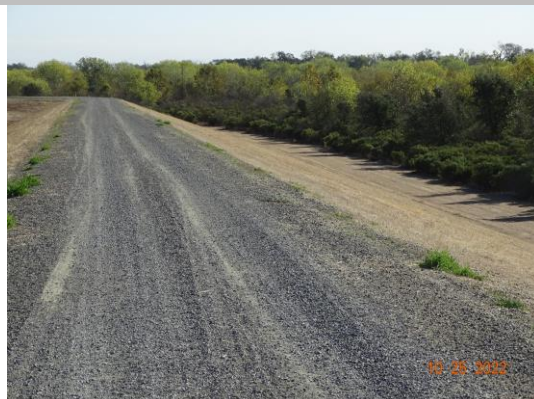
Photo 1 of 1 : FA\_2022\_RD0784\_437\_2\_20221028\_00002.jpg

Annual vegetation is well maintained, Fall 2022.

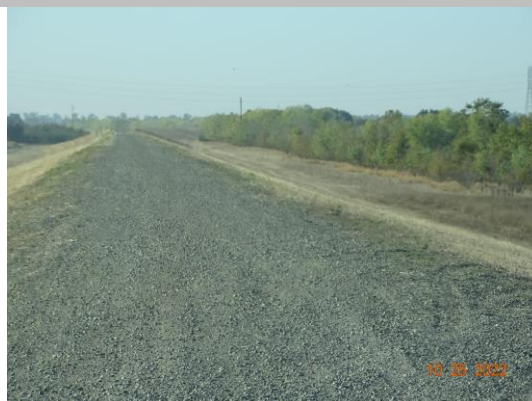
Photo 1 of 1 : FA\_2022\_RD0784\_530\_2\_20221028\_00002.jpg

Annual vegetation is well maintained, Fall 2022.

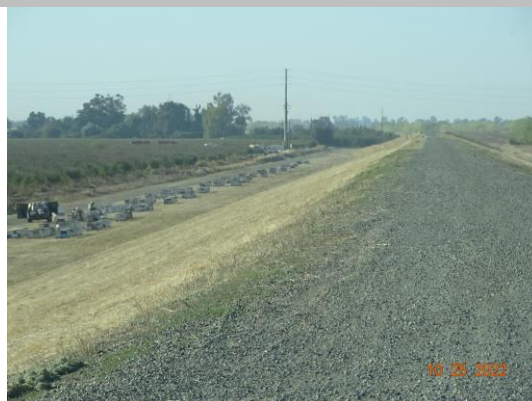
Photo 1 of 1 : FA\_2022\_RD0784\_530\_1\_20221028\_00001.jpg

Annual vegetation is well maintained, Fall 2022.
