**Flood Control Project Maintenance
Levee Inspections**

Maintenance Issue Types Only, Levee Inspection Report By Mile - Fall 2023

Reclamation District No. 0784 Plumas Lake

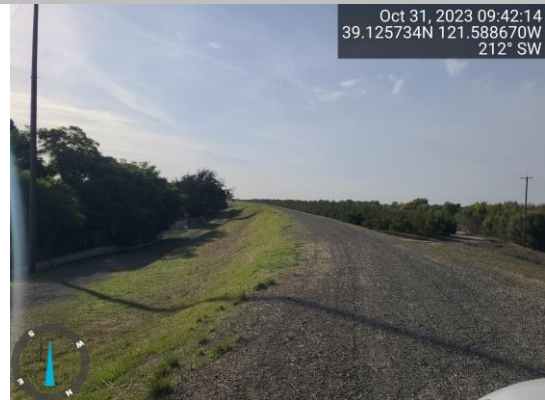
Photo 1 of 1 : FA_2023_RD0784_531_2_20231101_00001.jpg

LM Start	0.01	Rating **	A	Issue No.	2
LM End	2.54	Issue Type +	Ma	Location *	WS
Category	Earthen Levee			GPS Latitude/Longitude	
				Start	End
Item	Vegetation			39.125743°	39.090284°
				-121.588689°	-121.584652°
DWR ID	DWR_RD0784_02A_f_2023_2				
Comment Code					
V1 : Control annual grass and weeds on the levee slopes and easements.					
Inspector Comment					
Annual vegetation is well maintained, Fall 2023.

View of annual vegetation on the landside slope, Fall 2023.

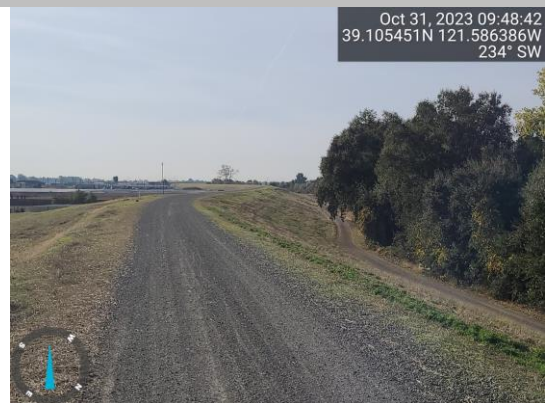
Photo 1 of 1 : FA_2023_RD0784_531_1_20231101_00002.jpg

LM Start	0.01	Rating **	A	Issue No.	1
LM End	2.54	Issue Type +	Ma	Location *	LS
Category	Earthen Levee			GPS Latitude/Longitude	
				Start	End
Item	Vegetation			39.125742°	39.090282°
				-121.588685°	-121.584651°
DWR ID	DWR_RD0784_02A_f_2023_1				
Comment Code					
V1 : Control annual grass and weeds on the levee slopes and easements.					
Inspector Comment					
Annual vegetation is well maintained, Fall 2023.

View of annual vegetation on the waterside slope, Fall 2023.

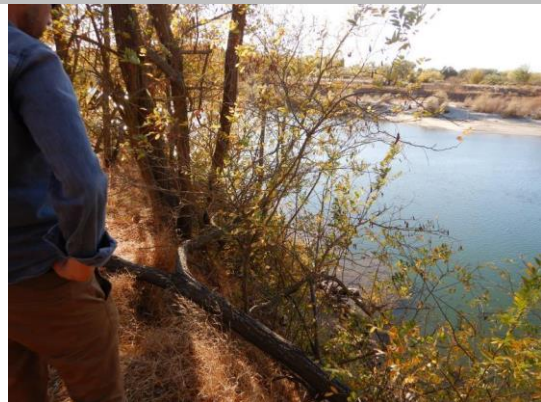
Photo 2 of 2 : FA_2023_RD0784_532_1_20230913_00002.jpg

Comment Code					
Inspector Comment					
2018 Site ID: FHR 17.8 L Status: Eroding 2018 Field Notes: Site continues to erode. Site History: 2003 - Bank is near vertical. Identified as a Potentially Critical site. 2004 - Eddy flow off downstream end of Modesto formation eroding the fluvial sediments. 2005 - Some new slumping. Actively eroding but berm width is greater than 50 ft. 2006 - Downgraded to regular erosion site. Still actively eroding. Large old rotational failures in high bank on the downstream end. 2008 - Removed from inventory due to wide berm width does not meet criteria for an erosion site. 2010 - Added back to the inventory after 10 ft of bank erosion in the winter 2009 storm. Steep vertical face. 2011 - Bank has retreated an additional 2.5 ft from last year. New tree popouts and erosion throughout the site. 2012 - Site continues to worsen with new tree popouts and many sections of new erosion. 2017 - Large sandbag on opposite bank, thalweg is moving closer to the levee.

USACE 2018 Erosion Photo #2

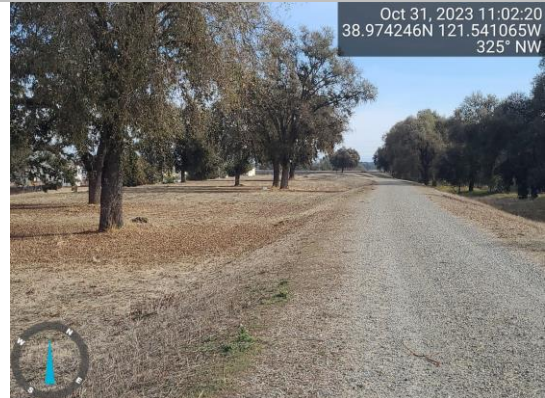
Photo 1 of 1 : FA_2023_RD0784_533_3_20231101_00008.jpg

LM Start	2.43	Rating **	A	Issue No.	3
LM End	3.19	Issue Type +	Ma	Location *	LS
Category	Earthen Levee			GPS Latitude/Longitude	
				Start	End
Item	Vegetation			38.970575°	38.974697°
				-121.547578°	-121.535570°
DWR ID	DWR_RD0784_03A_f_2023_3				
Comment Code					
V1 : Control annual grass and weeds on the levee slopes and easements.					
Inspector Comment					
Annual vegetation is well maintained, Fall 2023.

View of annual vegetation on the landside slope, Fall 2023.

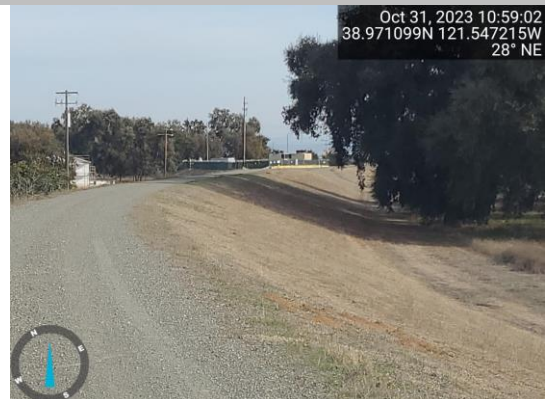
Photo 1 of 1 : FA_2023_RD0784_533_4_20231101_00009.jpg

LM Start	2.43	Rating **	A	Issue No.	4
LM End	3.18	Issue Type +	Ma	Location *	WS
Category	Earthen Levee			GPS Latitude/Longitude	
				Start	End
Item	Vegetation			38.970584°	38.974704°
				-121.547572°	-121.535621°
DWR ID	DWR_RD0784_03A_f_2023_4				
Comment Code					
V1 : Control annual grass and weeds on the levee slopes and easements.					
Inspector Comment					
Annual vegetation is well maintained, Fall 2023.

View of annual vegetation in the waterside slope, Fall 2023.

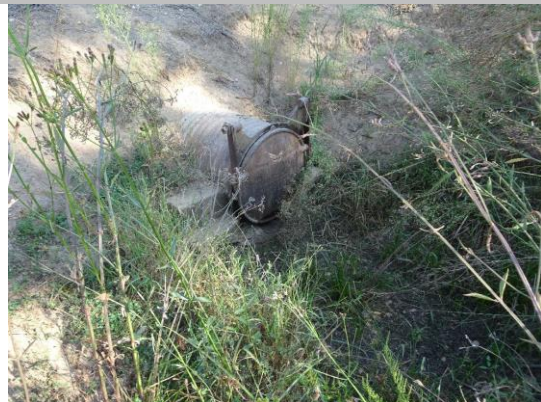
Photo 2 of 3 : UCIP_FA_2023_69907_101269.jpg

Comment Code					
Inspector Comment					
DS_ID:18580 FS_ID:69907 EP_NO: N/A Repair Type: Urgent EVAL Issue: 1, Pipe Integrity Crossing Status: Found UCIP Comments: 10/05/2020 - Record has been updated from No Action Needed to Urgent. DWR DMP has found integrity issues, LOF between 5 and 6. Recommend monitoring crossing until funding becomes available to address. No permit was found authorizing this encroachment. CVFPB will need to review crossing to determine owner. (O. Magana - DWR UCIP)12/16/2019 - Pipe crossing was hydroflushed and video inspected in October 2019. Pending final review by RD784 District Engineer and DWR. (P. Meagher - RD784)02/01/2019 - Pipe crossing was video inspected on 8-14-2018. (P. Meagher - RD784) FIELD_STRUCT_DESC: 30-inch corrugated metal (CM) drainage pipe through the levee, 19.0 feet below the crown. Flap gate on the waterside (WS) end. Concrete headwall at the WS toe. (No permit found for this crossing. Owner unknown). [Additional Reference(s): DWR Levee Log, 2005, (HLM 3.56). USACE Sacramento O&M Manual, Unit No. 145, August 1955, Revised 6 August 2019, (Station 92+88)]. FS Date: 10/5/2020

Water-Side: Pipe outlet and flap gate at waterside toe.

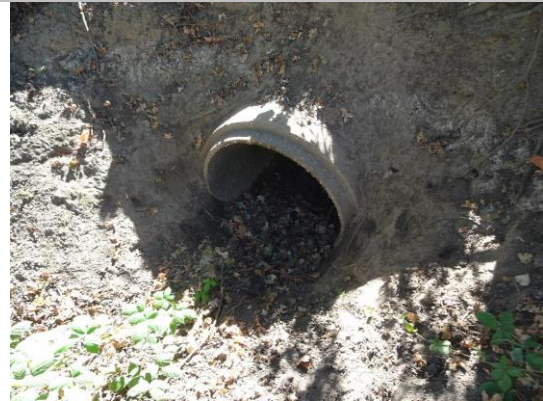
Photo 3 of 3 : UCIP_FA_2023_69907_101270.jpg

Land-Side: Pipe inlet beyond landside toe.

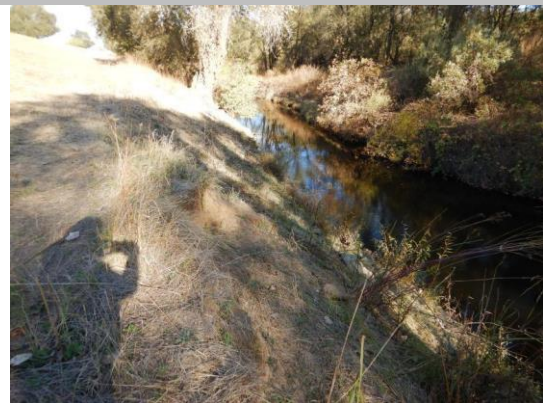
Photo 1 of 2 : FA_2023_RD0784_534_3_20230913_00001.jpg

2018 Site ID: BER 4.9 R
Status: Eroding
2018 Field Notes: No observed change.
Site History: 2009 - Small site which could be repaired with maintenance. Erosion into the levee toe, rock has started to fail.

USACE 2018 Erosion Photo #1

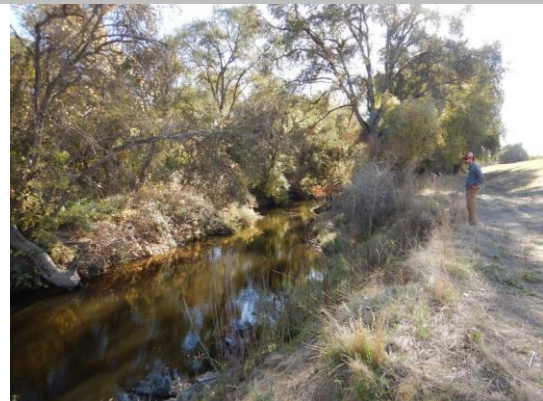
Photo 2 of 2 : FA_2023_RD0784_534_3_20230913_00002.jpg

USACE 2018 Erosion Photo #2

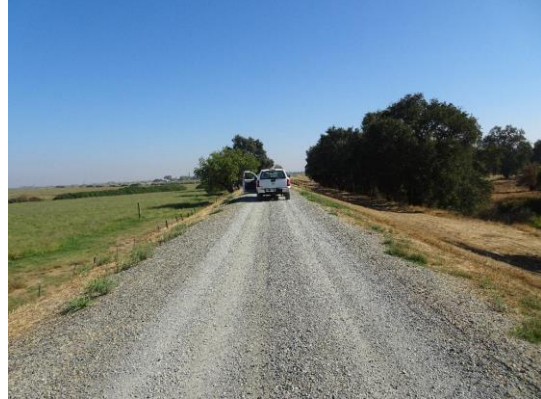
Photo 1 of 3 : UCIP_FA_2023_69908_101278.jpg

Comment Code						
Inspector Comment						
DS_ID:18579 FS_ID:69908 EP_NO: N/A Repair Type: Non-Urgent EVAL Issue: Crossing Status: Not Found UCIP Comments: 10/05/2020 Record has been updated from No Action Needed to Non-Urgent. DWR DMP geophysical study found no positive signal of pipe at latitude, longitude 38.983363, -121.513775. No signs or evidence of pipe were found during site inspection. No permit was found authorizing this encroachment. CVFPB will need to review crossing to determine owner. Record will remain in UCIP's database and will remain active until a levee improvement project can confirm that this crossing has been removed from the levee. (O. Magana - DWR UCIP) FIELD_STRUCT_DESC: 18-inch corrugated metal (CM) drainage pipe through the levee, 17.5 feet below the crown. Flap gate on the waterside (WS) end. (No permit found for this crossing. Owner unknown). [Additional Reference(s): DWR Levee Log, 2005, (HLM 4.52). USACE Sacramento O&M Manual, Unit No. 145, August 1955, Revised 6 August 2019, (Station 143+15)]. FS Date: 10/5/2020

Overview of Levee: Looking upstream from crown.

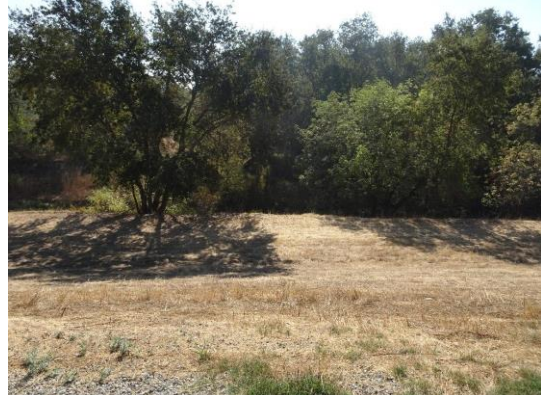
Photo 2 of 3 : UCIP_FA_2023_69908_101280.jpg

Water-Side: View of waterside looking from crown.

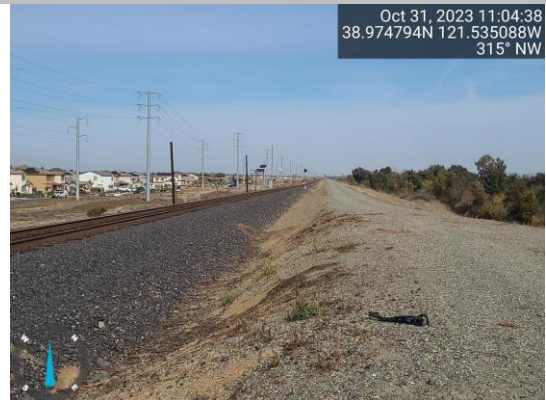
Photo 1 of 1 : FA_2023_RD0784_181_3_20231101_00007.jpg

View of annual vegetation on the landside slope, Fall 2023.

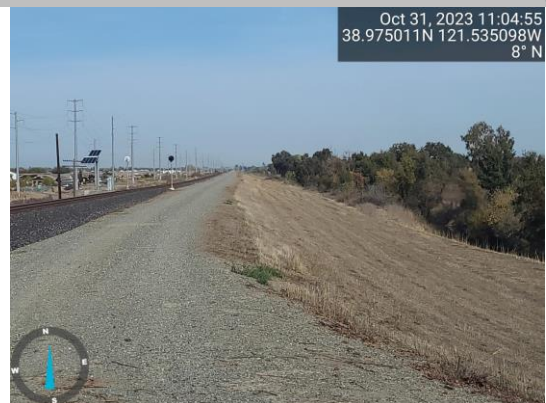
Photo 1 of 1 : FA_2023_RD0784_181_4_20231101_00008.jpg

LM Start	0.00	Rating **	A	Issue No.	4
LM End	5.84	Issue Type +	Ma	Location *	WS
Category	Earthen Levee			GPS Latitude/Longitude	
				Start	End
Item	Vegetation			38.974758°	39.058511°
				-121.535094°	-121.543096°
DWR ID	DWR_RD0784_04_f_2023_4				
Comment Code					
V1 : Control annual grass and weeds on the levee slopes and easements.					
Inspector Comment					
Annual vegetation is well maintained, Fall 2023.

View of annual vegetation on the waterside slope, Fall 2023.

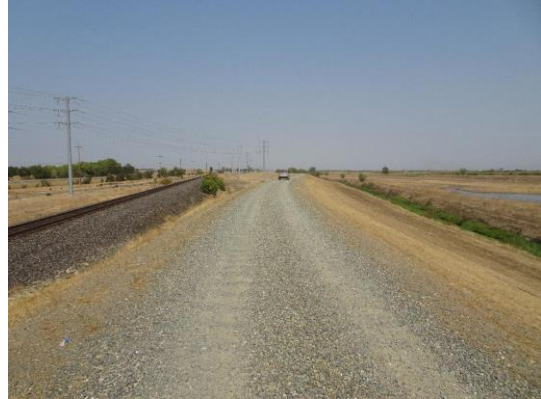
Photo 1 of 3 : UCIP_FA_2023_70203_100693.jpg

Comment Code						
Inspector Comment						
DS_ID:18629 FS_ID:70203 EP_NO: N/A Repair Type: No Action Needed EVAL Issue: Crossing Status: Not Found UCIP Comments: 09/29/2020 Pipe has been abandoned under Permit No. 17782. Pipe was backfilled with concrete slurry and left in place. (O. Magana - DWR UCIP) FIELD_STRUCT_DESC: 18-inch galvanized iron drainage pipe through the levee, 16.0 feet below the crown. (Pipe backfilled with concrete slurry and left in place under Permit No. 17782, 2006 - Three Rivers Levee Improvement Authority). (As-built shows abandonment). [Additional Reference(s): USACE Sacramento O&M Manual, Unit No. 145, August 1955, Revised 6 August 2019, (Station 132+40). USACE As-Built Drawing No. 2-4-84-1, Sheet 84-1/2, (Station 132+40), September 1941]. FS Date: 9/29/2020

Overview of Levee: looking upstream from the crown.

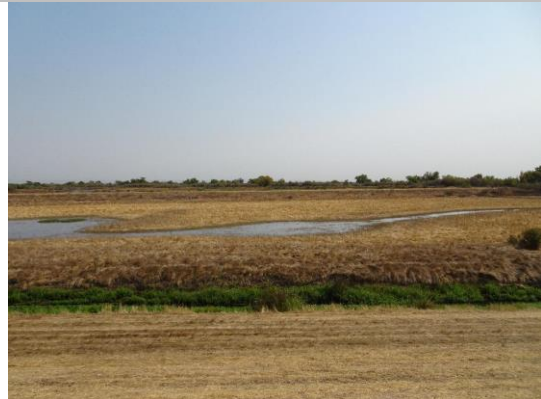
Photo 2 of 3 : UCIP_FA_2023_70203_100694.jpg

View of waterside from crown, no indicator of pipe.

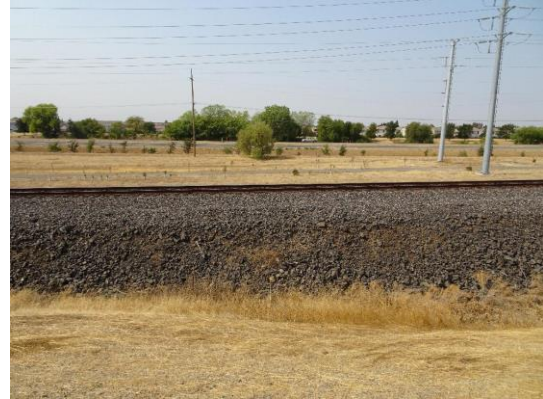
Photo 3 of 3 : UCIP_FA_2023_70203_100695.jpg

View of landside from crown, no indicator of pipe.

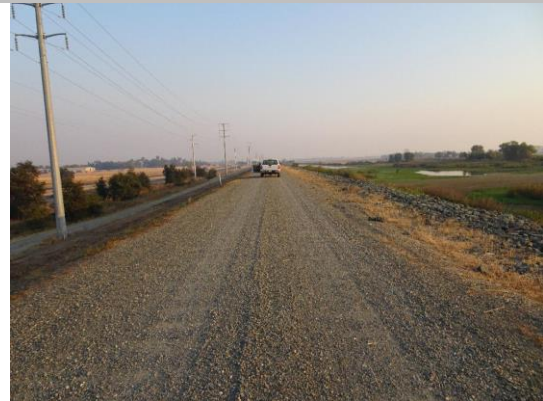
Photo 1 of 3 : UCIP_FA_2023_70205_100723.jpg

DS_ID:18628
FS_ID:70205
EP_NO: N/A
Repair Type: Non-Urgent
EVAL Issue:
Crossing Status: Not Found
UCIP Comments: 09/29/2020 Record has been updated from No Action Needed to Non-Urgent. DWR DMP geophysical study found no positive signal of pipe at latitude, longitude 38.046633, -121.542399. No signs or evidence of pipe were found during the site inspection. No permit was found authorizing this encroachment. CVFPB will need to review crossing to determine owner. Record will remain in UCIP's database and will remain active until a levee improvement project can confirm that this crossing has been removed from the levee. (O. Magana - DWR UCIP) 02/26/2013 Unable to locate. Likely abandoned with levee improvements. (W. Wylie - DWR UCIP)
FIELD_STRUCT_DESC: 24-inch corrugated metal drainage pipe through the levee, 21.0 feet below the crown. [Additional Reference(s): USACE Sacramento O&M Manual, Unit No. 145, August 1955, Revised 6 August 2019, (Station 264+60). USACE As-Built Drawing No. 2-4-84-1, Sheet 84-1/3, (Station 264+60), September 1941].

Overview of Levee: looking upstream from crown.

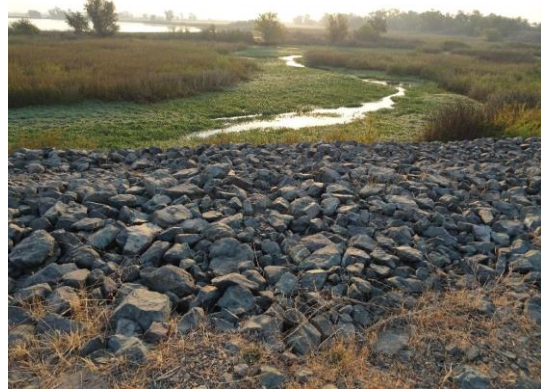
Photo 2 of 3 : UCIP_FA_2023_70205_100725.jpg

Waterside view from crown. Riprap on slope.

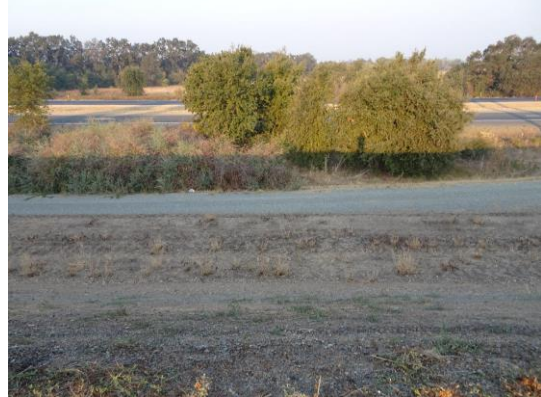
Photo 3 of 3 : UCIP_FA_2023_70205_100726.jpg

Landside view from crown.

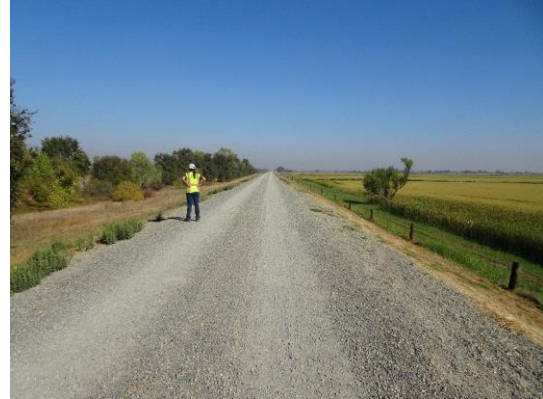
Photo 1 of 3 : UCIP_FA_2023_70298_100864.jpg

Comment Code						
Inspector Comment						
DS_ID:18592 FS_ID:70298 EP_NO: N/A Repair Type: Urgent EVAL Issue: 1, Pipe Integrity Crossing Status: Found UCIP Comments: 10/05/2020 - Record has been updated from No Action Needed to Urgent. DWR DMP has found integrity issues, LOF between 5 and 6. Recommend monitoring crossing until funding becomes available to address. No permit was found authorizing this encroachment. CVFPB will need to review crossing to determine owner. (O. Magana - DWR UCIP)12/16/2019 - Pipe crossing was hydroflushed and video inspected (again) in October 2019. Pending final review by RD784 Engineer and DWR. (P. Meagher - RD784)02/01/2019 - Pipe crossing was video inspected on 8/13/2018. (P. Meagher - RD784)02/26/2013 Good candidate for video inspection. (W. Wylie - DWR UCIP) FIELD_STRUCT_DESC: 18-inch corrugated metal (CM) drainage pipe through the levee, 18.0 feet below the crown. Flap gate on the waterside (WS) end. Concrete U-shaped headwall on the WS end. Polyvinyl chloride (PVC) weir inlet on the landside (LS) toe. (No permit found authorizing this pipe. Owner unknown). [Additional Reference(s): DWR Levee Log, 2005, (HLM 0.10). USACE Sacramento O&M Manual, Unit No. 145, August 1955, Revised 6 August 2019, (Station 25+28). USACE As-Built Drawing No. 2-4-106, Sheet No. 106/5, July 1944, (Station 25+28)]. FS Date: 10/5/2020

Overview of Levee: Looking upstream from crown.

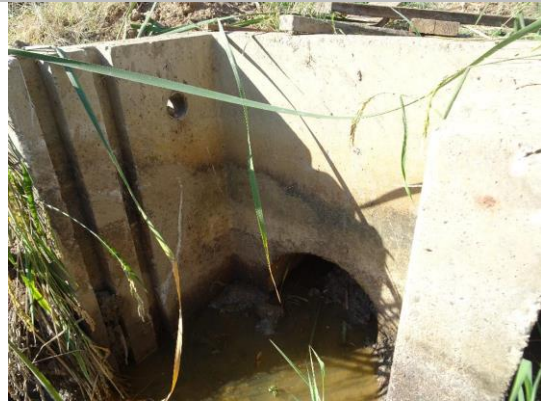
Photo 3 of 3 : UCIP_FA_2023_70298_100867.jpg

Land-Side: Inlet structure with open pipe at landside toe.

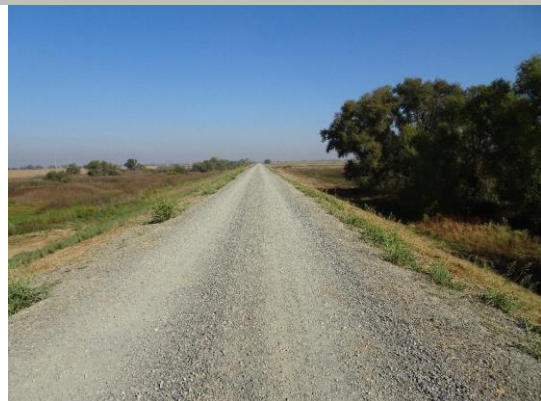
Photo 1 of 3 : UCIP_FA_2023_70299_100890.jpg

Overview of Levee: Looking upstream from crown.

DS_ID:18591
 FS_ID:70299
 EP_NO: N/A
 Repair Type: Urgent
 EVAL Issue: 1, Pipe Integrity
 Crossing Status: Found
 UCIP Comments: 10/05/2020 - Record has been updated from Non-Urgent to Urgent. DWR DMP has found integrity issues, LOF between 5 and 6. Recommend monitoring crossing until funding becomes available to address. Pipe was underwater during site inspection. No permit was found authorizing this encroachment. CVFPB will need to review crossing to determine owner. (O. Magana - DWR UCIP)12/16/2019 - Pipe crossing was hydroflushed and video inspected (again) in October 2019. Pending final review by RD784 Engineer and DWR. (P. Meagher - RD784)02/01/2019 - Pipe crossing was video inspected on 8/14/2018. (P. Meagher)02/26/2013 - No handle or access to slide gate on LS toe. (W. Wylie - DWR UCIP) FIELD_STRUCT_DESC: 30-inch corrugated metal (CM) drainage pipe through the levee, 23.7 feet below the crown. Flap gate on the waterside (WS) end. Slide gate inside a concrete drop inlet on the landside (LS). (No permit found authorizing this pipe. Owner unknown). [Additional Reference(s): DWR Levee Log, 2005, (HLM 0.82). USACE Sacramento O&M Manual, Unit No. 145, August 1955, Revised 6 August 2019, (Station 63+00). USACE As-Built Drawing No. 2-4-106, Sheet No. 106/5, July 1944, (Station 63+00)].

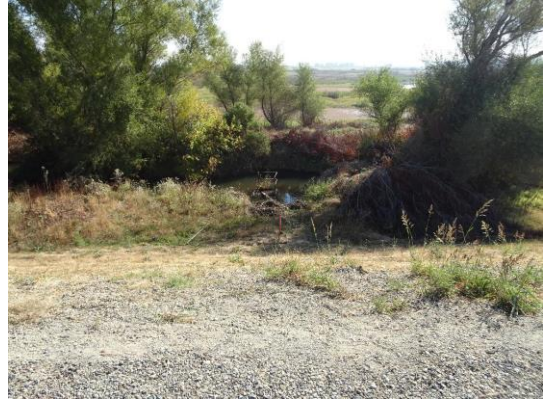
Photo 2 of 3 : UCIP_FA_2023_70299_100892.jpg

Land-Side: Drop inlet at landside toe.

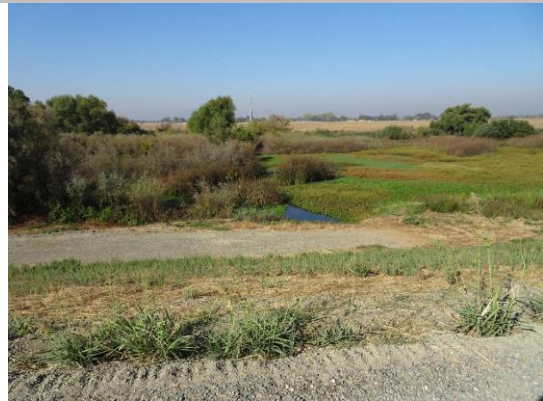
Photo 3 of 3 : UCIP_FA_2023_70299_100893.jpg

Water-Side: Outlet underwater at waterside toe.

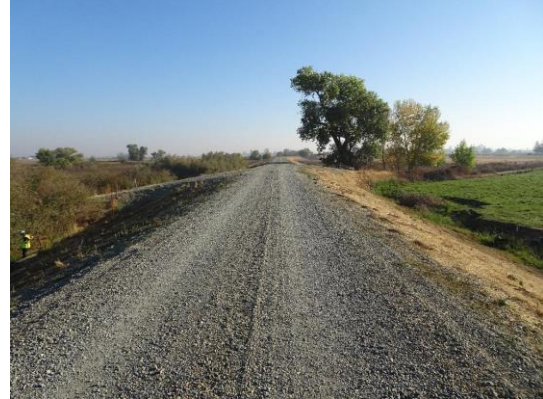
Photo 1 of 3 : UCIP_FA_2023_70306_100939.jpg

DS_ID:18596
FS_ID:70306
EP_NO: N/A
Repair Type: Urgent
EVAL Issue: 1, Pipe Integrity
Crossing Status: Found
UCIP Comments: 10/05/2020 - Record has been updated from Non-Urgent to Urgent. DWR DMP has found integrity issues, LOF between 5 and 6. Recommend monitoring crossing until funding becomes available to address. No permit was found authorizing this encroachment. CVFPB will need to review crossing to determine owner. (O. Magana - DWR UCIP)12/16/2019 - Pipe crossing was hydroflushed and video inspected in October 2019. Pending final review by RD784 Engineer and DWR. (P. Meagher - RD784)02/01/2019 - Pipe crossing was video inspected on 8-15-2018. (P. Meagher - RD784)02/27/2013 - Pipe has been sliplined with PVC, but the liner appears to be eroding at outlet and may be disjointed internal to the levee. See pic. Good candidate for video inspection. (W. Wylie - DWR UCIP)
FIELD_STRUCT_DESC: 12-inch corrugated metal (CM) drainage pipe through the levee, 12.0 feet below the crown. Flap gate and concrete U-shaped headwall on the waterside (WS). Polyvinyl chloride (PVC) weir on inlet at the landside (LS) toe. [Additional Reference(s): DWR Levee Log, 2005, (HLM 3.08). USACE Sacramento O&M Manual, Unit No. 145, August 1955, Revised 6 August 2019, (Station 44+96). USACE As-Built Drawing No. 2-4-106, Sheet No. 106/6, July 1944, (Station 44+96)]. FS Date: 10/5/2020

Overview of Levee: Looking upstream from crown.

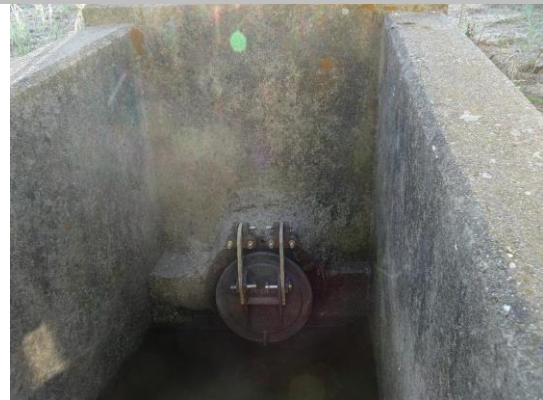
Photo 2 of 3 : UCIP_FA_2023_70306_100941.jpg

Water-Side: Outlet structure with flap gate at waterside toe.

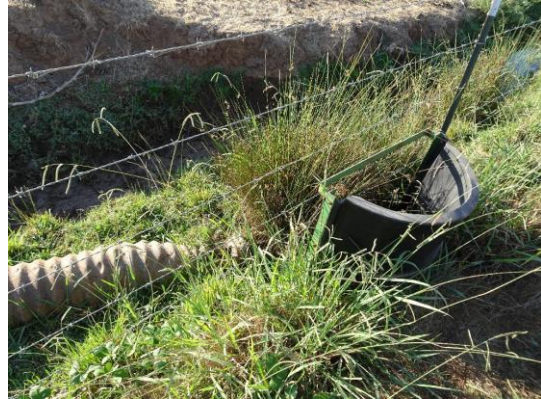
Photo 3 of 3 : UCIP_FA_2023_70306_100942.jpg

Land-Side: Inlet structure at landside toe.

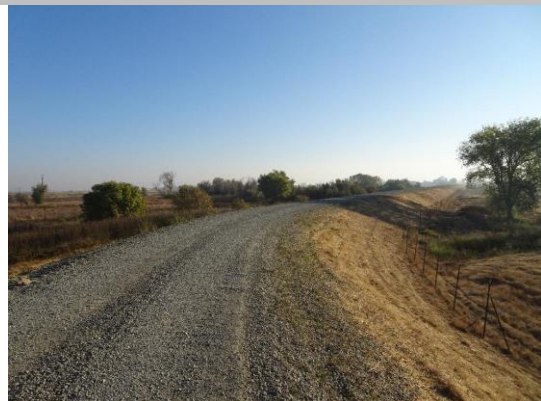
Photo 1 of 3 : UCIP_FA_2023_70307_100943.jpg

DS_ID:18595
 FS_ID:70307
 EP_NO: N/A
 Repair Type: Urgent
 EVAL Issue: 1, Pipe Integrity
 Crossing Status: Found
 UCIP Comments: 10/05/2020 Record has been updated from No Action Needed to Urgent. DWR DMP has found integrity issues, LOF between 5 and 6. Recommend monitoring crossing until funding becomes available to address. No permit was found authorizing this encroachment. CVFPB will need to review crossing to determine owner. (O. Magana - DWR UCIP)12/16/2019 - Pipe crossing was hydroflushed and video inspected in October 2019. Pending final review by RD784 District Engineer and DWR. (P. Meagher - RD784)02/01/2019 - Pipe crossing was video inspected on 8-15-2019 (P. Meagher - RD784)02/27/2013 - Good candidate for video inspection. (W. Wylie - DWR UCIP)
 FIELD_STRUCT_DESC: 18-inch corrugated metal (CM) drainage pipe through the levee, 15.8 feet below the crown. Flap gate on the waterside (WS) end. Polyvinyl chloride (PVC) weir on inlet at the landside (LS) toe. [Additional Reference(s): DWR Levee Log, 2005, (HLM 3.24). USACE Sacramento O&M Manual, Unit No. 145, August 1955, Revised 6 August 2019, (Station 53+86). USACE As-Built Drawing No. 2-4-106, Sheet No. 106/6, July 1944, (Station 53+86)].

Overview of Levee: Looking upstream from crown.

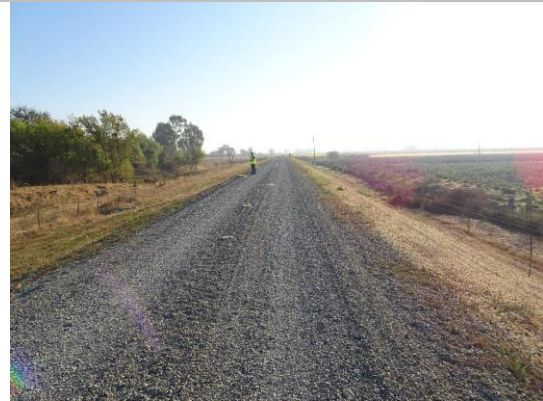
Photo 1 of 3 : UCIP_FA_2023_70308_100946.jpg

Comment Code					
Inspector Comment					
DS_ID:18594 FS_ID:70308 EP_NO: N/A Repair Type: Non-Urgent EVAL Issue: Crossing Status: Found UCIP Comments: 10/05/2020 - Record has been updated from No Action Needed to Non-Urgent. No permit was found authorizing this encroachment. CVFPB will need to review crossing to determine owner. DWR DMP has not found internal issues, LOF between 1 and 2. Recommend inspection in 5 years. (O. Magana - DWR UCIP)12/16/2019 - Pipe crossing was video inspected in October 2019. Pending final review by RD784 Engineer and DWR. (P. Meagher - RD784)02/01/2019 - Pipe crossing was video inspected on 8-15-2018. (P. Meagher - RD784) FIELD_STRUCT_DESC: 18-inch corrugated metal (CM) drainage pipe through the levee, 8.8 feet below the crown. Flap gate and headwall on the waterside (WS) end. [Additional Reference(s): DWR Levee Log, 2005, (HLM 3.81). USACE Sacramento O&M Manual, Unit No. 145, August 1955, Revised 6 August 2019, (Station 83+39). USACE As-Built Drawing No. 2-4-106, Sheet No. 106/6, July 1944, (Station 83+39)]. FS Date: 10/5/2020

Overview of Levee: Looking upstream from crown.

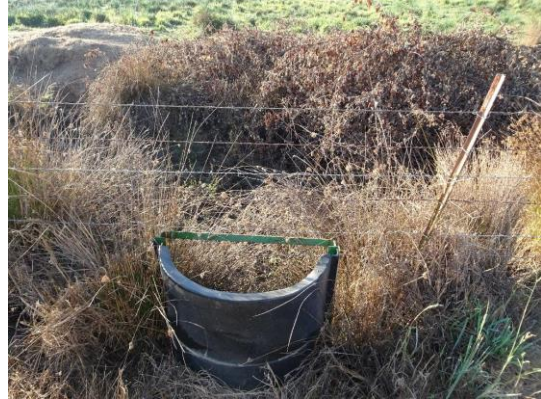
Photo 3 of 3 : UCIP_FA_2023_70308_100950.jpg

Land-Side: Inlet structure at landside toe.

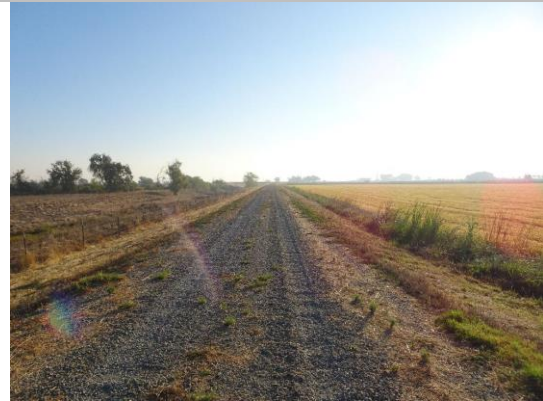
Photo 1 of 3 : UCIP_FA_2023_70309_100951.jpg

Comment Code						
Inspector Comment						
DS_ID:18593 FS_ID:70309 EP_NO: N/A Repair Type: Non-Urgent EVAL Issue: Crossing Status: Found UCIP Comments: 10/05/2020 - Record remains Non-Urgent. No permit was found authorizing this encroachment. CVFPB will need to review crossing to determine owner. No DWR DMP internal inspection has been completed yet. This crossing appears to be abandoned: buried inlet at landside toe. No access for internal video inspection. DWR DMP will complete assessment to determine final recommendation. (O. Magana - DWR UCIP) 02/01/2019 - An attempt was made to video inspect this pipe crossing on 8-15-2018 but conditions were too muddy inside the pipe. (P. Meagher - RD784) 11/14/2016 - Photos added of exposed flap gate on WS and possible inlet location on LS. Condition remains as Non-Urgent because of inlet not being fully operable. Unknown if pipe will operate as designed during high water or if it is full of sediment. (P. Meagher - RD784) 11/01/2015 - Waterside Flap Gate Uncovered. Photo sent to DWR Matt Hoffman on 3-3-2014. Fresh photo sent to DWR Pavel Kazi on 9-9-2015. Landside toe has never been able to be located. Requesting DWR inspector to change the status of this issue to "No Action Needed". (P. Meagher - RD784) 02/26/2013 - Pipe buried on LS toe and flap gate is blocked by soil on WS toe. (W. Wylie - DWR UCIP). FIELD_STRUCT_DESC: 18-inch corrugated metal (CM) drainage pipe through the levee, 10.0 feet below the crown. Flap gate on the waterside (WS) end. [Additional Reference(s): DWR Levee Log, 2005, (HLM 3.98). USACE Sacramento O&M Manual, Unit No. 145, August 1955, Revised 6 August 2019, (Station 91+50). USACE As-Built Drawing No. 2-4-106, Sheet No. 106/6, July 1944, (Station 91+50)]. FS Date: 10/5/2020

Overview of Levee: Looking upstream from crown.

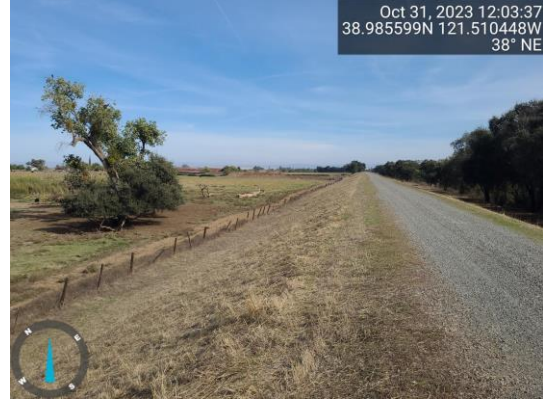
Photo 1 of 1 : FA_2023_RD0784_183_2_20231101_00004.jpg

View of annual vegetation on the landside slope, Fall 2023.

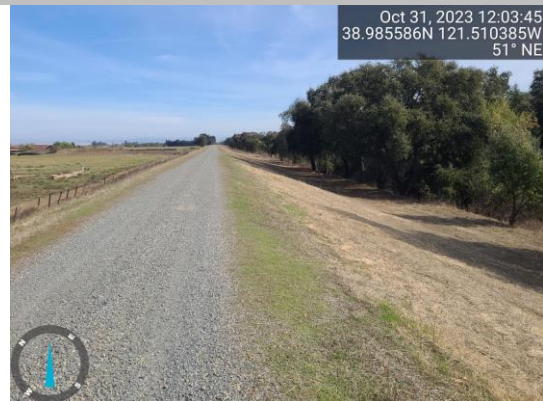
Photo 1 of 1 : FA_2023_RD0784_183_3_20231101_00005.jpg

View of annual vegetation on the waterside slope, Fall 2023.

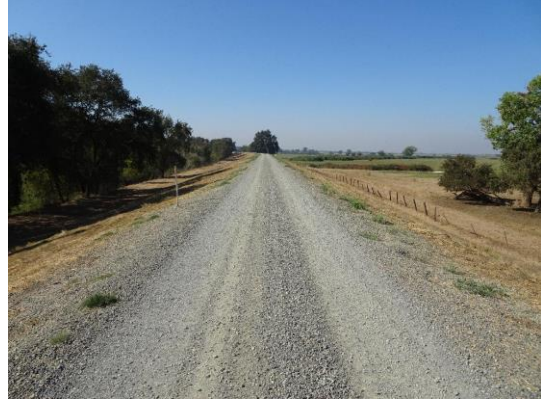
Photo 1 of 3 : UCIP_FA_2023_70311_100956.jpg

Comment Code					
Inspector Comment					
DS_ID:18626 FS_ID:70311 EP_NO: N/A Repair Type: Urgent EVAL Issue: 1, Pipe Integrity Crossing Status: Found UCIP Comments: 10/05/2020 Record has been updated from Non-Urgent to Urgent. DWR DMP has found integrity issues, LOF between 5 and 6. Recommend monitoring crossing until funding becomes available to address. No permit was found authorizing this encroachment. CVFPB will need to review crossing to determine owner. (O. Magana - DWR UCIP)12/16/2019 Pipe was hydroflushed and video inspected (again) in October 2019. Pending final review by RD784 District Engineer and DWR. (P. Meagher - RD784)02/01/2019 - Pipe was video inspected on 8-13-2018. (P. Meagher - RD784)10/30/2015 - Waterside flap gate was cleared in December 2014 and again in September 2015 No LMA access available on Landside. (P. Meagher - RD784)02/26/2013 - Pipe partially blocked on LS and flap gate blocked on WS (W. Wylie - DWR UCIP) FIELD_STRUCT_DESC: 18-inch corrugated metal (CM) storm drainage pipe through the levee, 19.0 feet below the crown. Gate valve on the waterside (WS). (No permit found authorizing this pipe. Owner unknown). [Additional Reference(s): USACE Sacramento O&M Manual, Unit No. 145, August 1955, Revised 6 August 2019, (Station 9+85). USACE As-Built Drawing No. 2-4-106, Sheet No. 106/2, July 1944, (Station 9+85)]. FS Date: 10/5/2020

Overview of Levee: Looking downstream from crown.

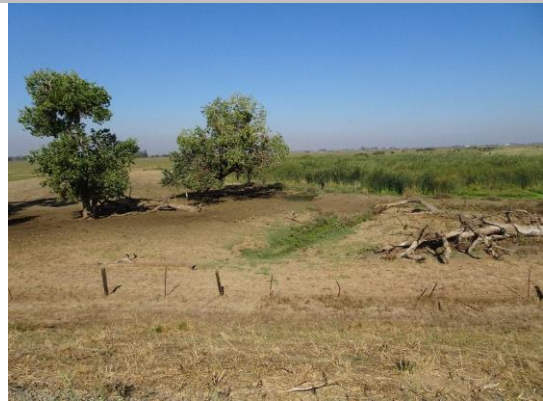
Photo 3 of 3 : UCIP_FA_2023_70311_100958.jpg

Land-Side: Inlet channel and pipe debris on landside.

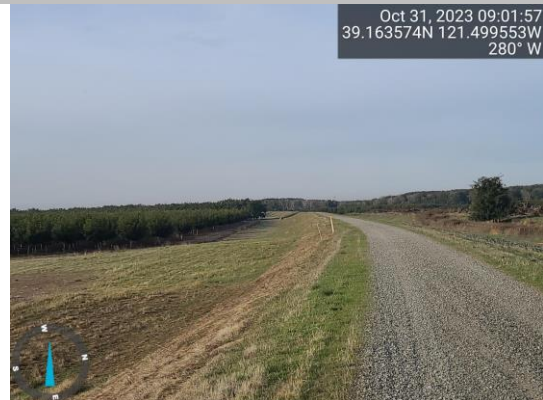
Photo 1 of 1 : FA_2023_RD0784_184_1_20231101_00001.jpg

View of annual vegetation on the landside slope, Fall 2023.

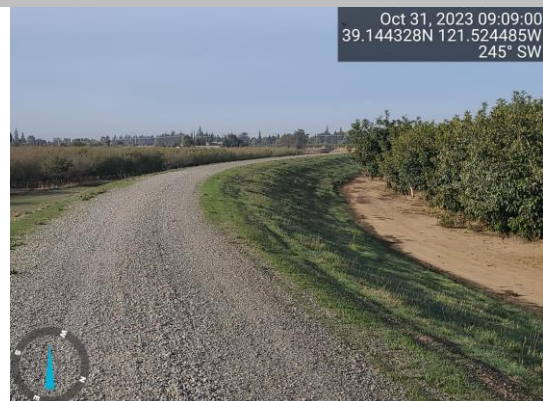
Photo 1 of 1 : FA_2023_RD0784_184_2_20231101_00002.jpg

View of annual vegetation on the waterside slope, Fall 2023.

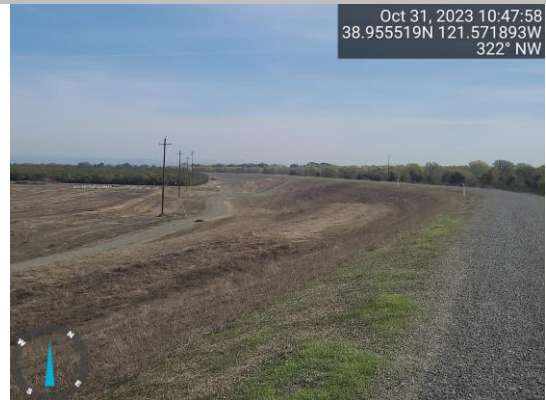
Photo 1 of 1 : FA_2023_RD0784_437_1_20231101_00001.jpg

View of annual vegetation on the landside slope, Fall 2023.

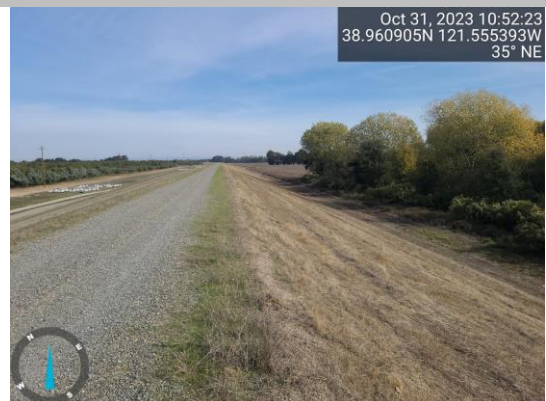
Photo 1 of 1 : FA_2023_RD0784_437_2_20231101_00002.jpg

View of annual vegetation on the waterside slope, Fall 2023.

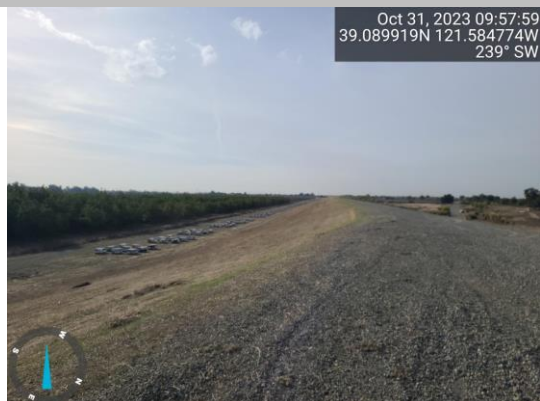
Photo 1 of 1 : FA_2023_RD0784_530_2_20231101_00001.jpg

View of vegetation on the landside slope, Fall 2023.

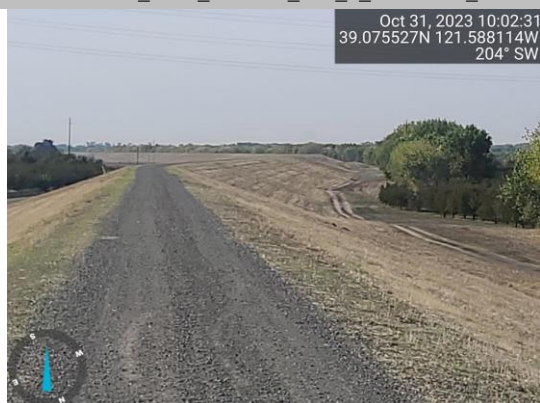
Photo 1 of 1 : FA_2023_RD0784_530_1_20231101_00002.jpg

View of annual vegetation on the waterside slope, Fall 2023.
