**Flood Control Project Maintenance  
Levee Inspections**

## Maintenance Issue Types Only, Levee Inspection Report By Mile - Fall 2024

### Reclamation District No. 0784 Plumas Lake

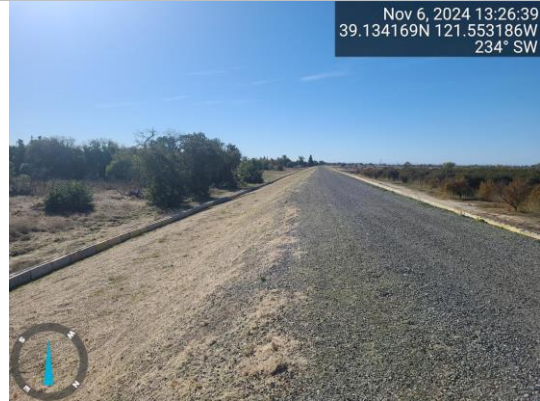
Photo 1 of 1 : FA\_2024\_RD0784\_178\_1\_20241106\_00003.jpg

LM Start	0.01	Rating **	A	Issue No.	1
LM End	2.20	Issue Type +	Ma	Location *	LS
Category	Earthen Levee			GPS Latitude/Longitude	
				Start	End
Item	Vegetation			39.134804°	39.125920°
				-121.552407°	-121.588599°
DWR ID	DWR_RD0784_01_f_2024_1				
Comment Code					
V1 : Control annual grass and weeds on the levee slopes and easements.					
Inspector Comment					
Vegetation is well maintained, Fall 2024.

View of annual vegetation on the landside slope, Fall 2024.

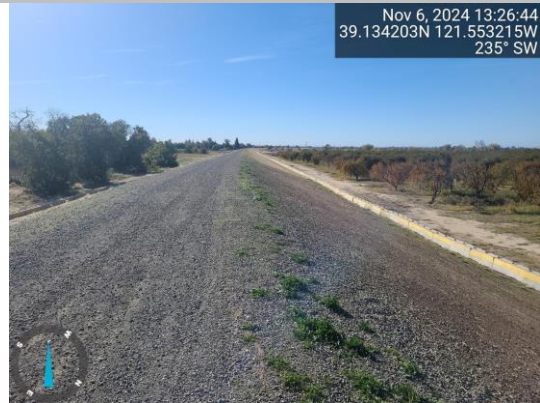
Photo 1 of 1 : FA\_2024\_RD0784\_178\_5\_20241106\_00004.jpg

LM Start	0.01	Rating **	A	Issue No.	5
LM End	2.20	Issue Type +	Ma	Location *	WS
Category	Earthen Levee			GPS Latitude/Longitude	
				Start	End
Item	Vegetation			39.134804°	39.125920°
				-121.552407°	-121.588599°
DWR ID	DWR_RD0784_01_f_2024_5				
Comment Code					
V1 : Control annual grass and weeds on the levee slopes and easements.					
Inspector Comment					
Annual vegetation is well maintained, Fall 2024.

View of annual vegetation on the waterside slope, Fall 2024.

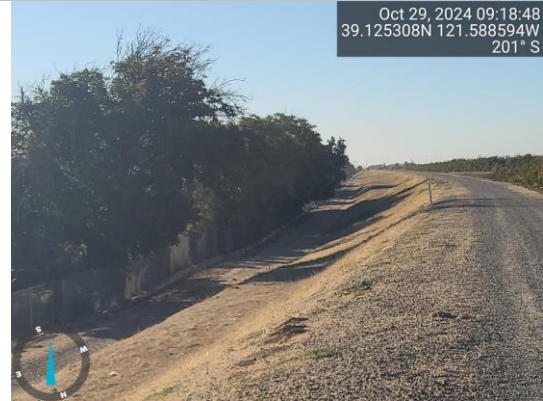
Photo 1 of 1 : FA\_2024\_RD0784\_531\_1\_20241031\_00001.jpg

View of maintained vegetation on the landside slope, Fall 2024.

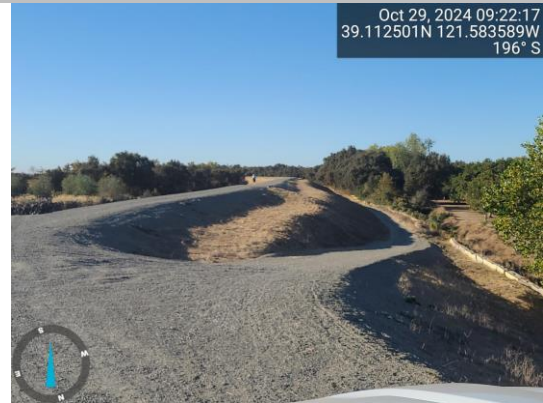
Photo 1 of 1 : FA\_2024\_RD0784\_531\_2\_20241031\_00002.jpg

LM Start	0.04	Rating **	A	Issue No.	2
LM End	2.53	Issue Type +	Ma	Location *	WS
Category	Earthen Levee			GPS Latitude/Longitude	
				Start	End
Item	Vegetation			39.125327°	39.090439°
				-121.588633°	-121.584734°
DWR ID	DWR_RD0784_02A_f_2024_2				
Comment Code					
V1 : Control annual grass and weeds on the levee slopes and easements.					
Inspector Comment					
Annual vegetation is well maintained, Fall 2024.

View of maintained vegetation on the waterside slope, Fall 2024.

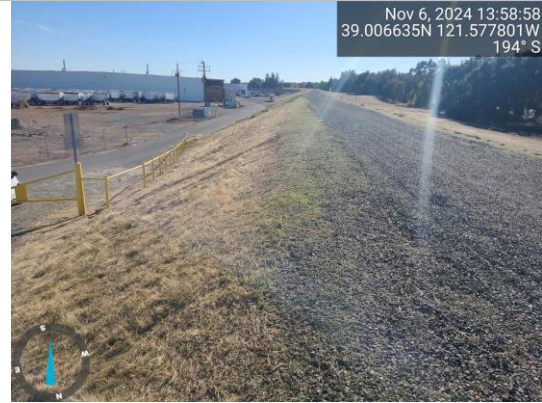
Photo 1 of 1 : FA\_2024\_RD0784\_532\_8\_20241106\_00020.jpg

View of annual vegetation on the landside slope, Fall 2024.

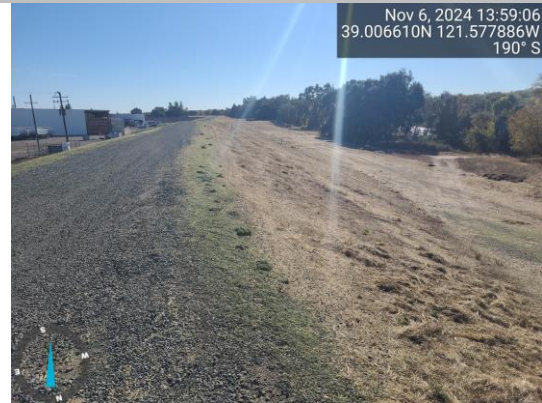
Photo 1 of 1 : FA\_2024\_RD0784\_532\_9\_20241106\_00021.jpg

LM Start	8.96	Rating **	A	Issue No.	9
LM End	12.76	Issue Type +	Ma	Location *	WS
Category	Earthen Levee			GPS Latitude/Longitude	
				Start	End
Item	Vegetation			39.009946°	38.956027°
				-121.579247°	-121.575178°
DWR ID	DWR_RD0784_02B_f_2024_9				
Comment Code					
V1 : Control annual grass and weeds on the levee slopes and easements.					
Inspector Comment					
Annual vegetation is well maintained, Fall 2024.

View of annual vegetation on the waterside slope, Fall 2024.

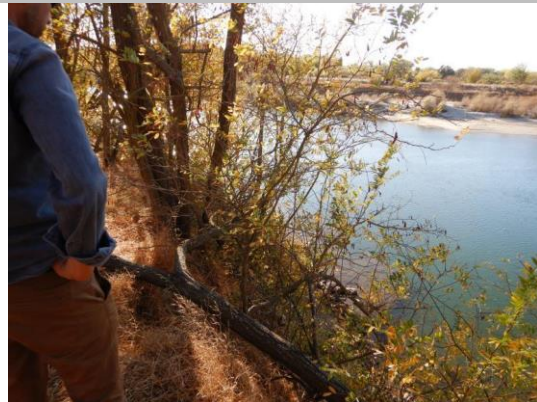
Photo 2 of 2 : FA\_2024\_RD0784\_532\_1\_20240829\_00002.jpg

2018 Site ID: FHR 17.8 L  
Status: Eroding  
2018 Field Notes: Site continues to erode.  
Site History: 2003 - Bank is near vertical. Identified as a Potentially Critical site. 2004 - Eddy flow off downstream end of Modesto formation eroding the fluvial sediments. 2005 - Some new slumping. Actively eroding but berm width is greater than 50 ft. 2006 - Downgraded to regular erosion site. Still actively eroding. Large old rotational failures in high bank on the downstream end. 2008 - Removed from inventory due to wide berm width does not meet criteria for an erosion site. 2010 - Added back to the inventory after 10 ft of bank erosion in the winter 2009 storm. Steep vertical face. 2011 - Bank has retreated an additional 2.5 ft from last year. New tree popouts and erosion throughout the site. 2012 - Site continues to worsen with new tree popouts and many sections of new erosion. 2017 - Large sandbag on opposite bank, thalweg is moving closer to the levee.

USACE 2018 Erosion Photo #2

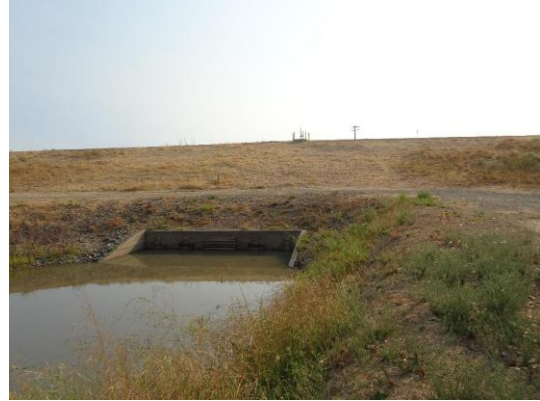
Photo 1 of 3 : UCIP\_FA\_2024\_69858\_101115.jpg

Water-Side: Outlet structure with five openings beyond waterside toe.

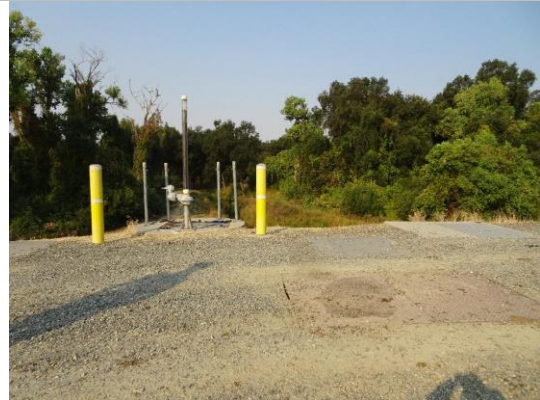
Photo 2 of 3 : UCIP\_FA\_2024\_69858\_101116.jpg

Water-Side: Vaults and screw gate at waterside shoulder.

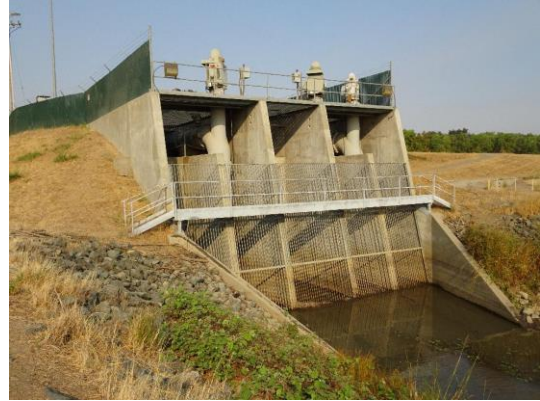
Photo 3 of 3 : UCIP\_FA\_2024\_69858\_101118.jpg

Land-Side: Inlet structure with pumps beyond landside toe.

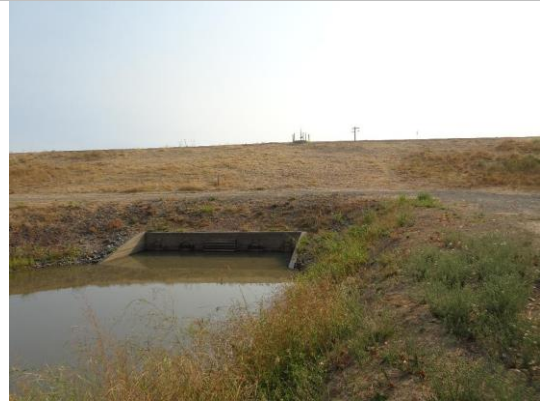
Photo 1 of 3 : UCIP\_FA\_2024\_69859\_101132.jpg

Water-Side: Outlet structure with five openings beyond waterside toe.

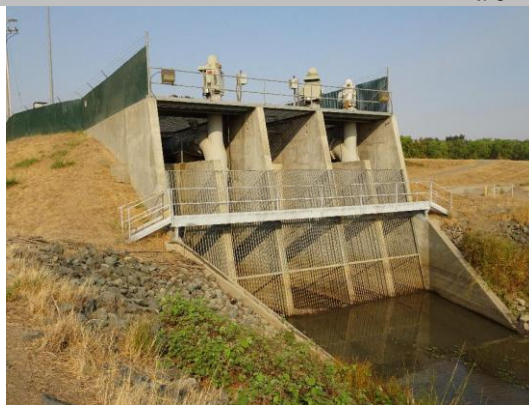
Photo 3 of 3 : UCIP\_FA\_2024\_69859\_101135.jpg

Land-Side: Inlet structure with pumps beyond landside toe.

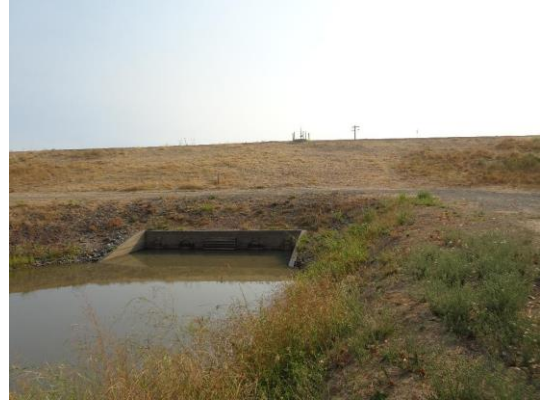
Photo 1 of 3 : UCIP\_FA\_2024\_69854\_101142.jpg

Water-Side: Outlet structure with five openings beyond waterside toe.

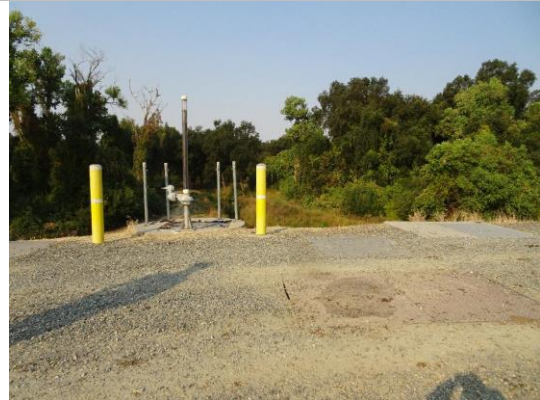
Photo 2 of 3 : UCIP\_FA\_2024\_69854\_101143.jpg

Water-Side: Vaults and screw gate at waterside shoulder.

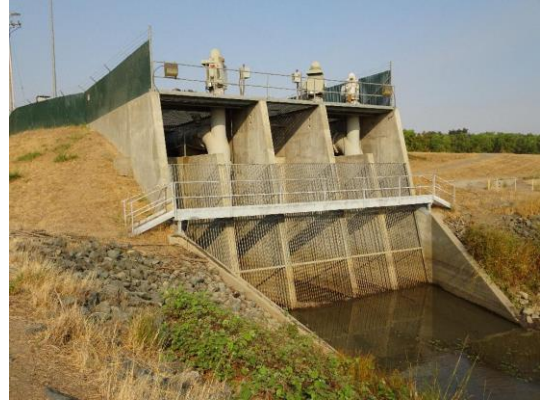
Photo 3 of 3 : UCIP\_FA\_2024\_69854\_101145.jpg

Land-Side: Inlet structure with pumps beyond landside toe.

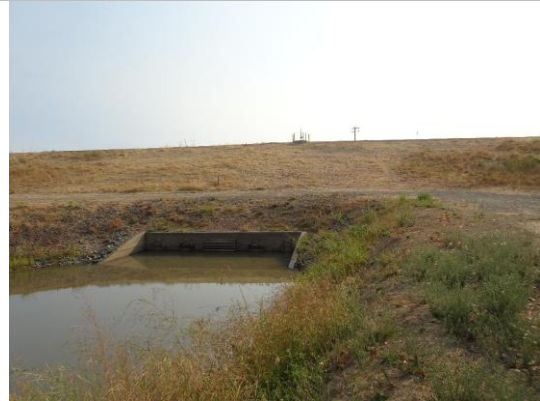
Photo 1 of 3 : UCIP\_FA\_2024\_69855\_101165.jpg

Water-Side: Outlet structure with five openings beyond waterside toe.

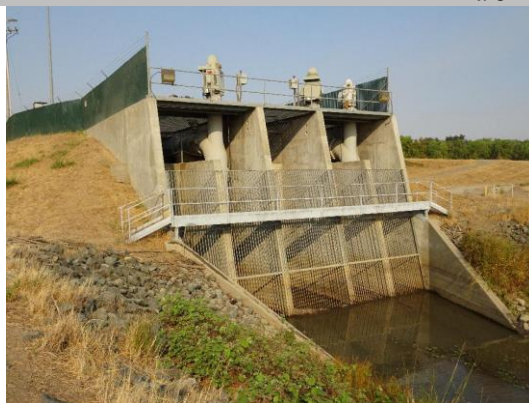
Photo 3 of 3 : UCIP\_FA\_2024\_69855\_101158.jpg

Land-Side: Inlet structure with pumps beyond landside toe.

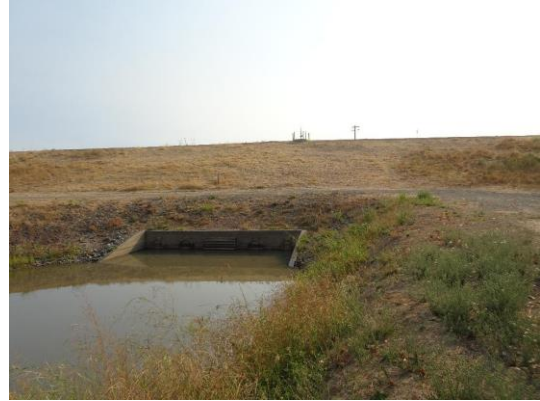
Photo 1 of 3 : UCIP\_FA\_2024\_69856\_101173.jpg

Water-Side: Outlet structure with five openings beyond waterside toe.

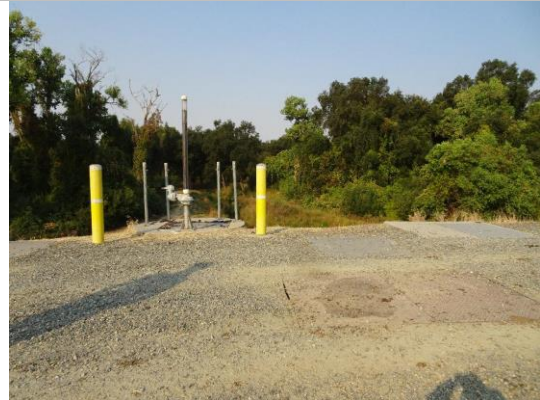
Photo 2 of 3 : UCIP\_FA\_2024\_69856\_101174.jpg

Water-Side: Vaults and screw gate at waterside shoulder.

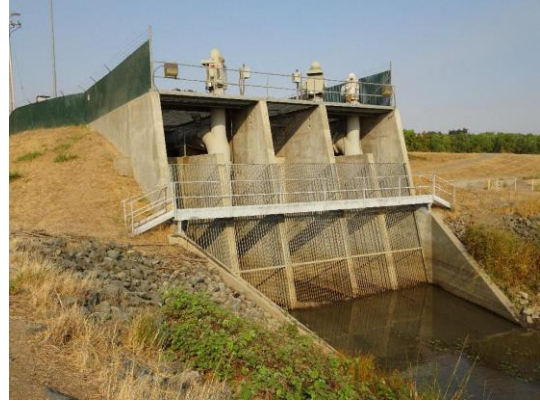
Photo 3 of 3 : UCIP\_FA\_2024\_69856\_101176.jpg

Land-Side: Inlet structure with pumps beyond landside toe.

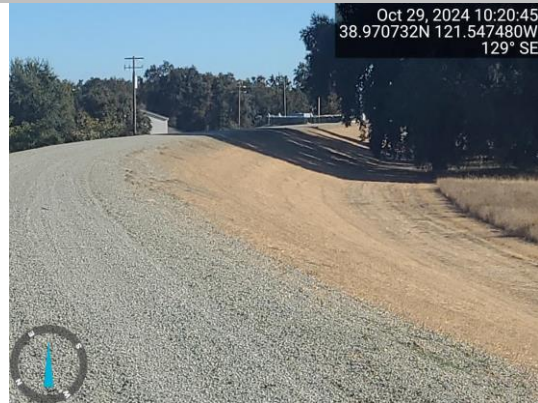
Photo 1 of 1 : FA\_2024\_RD0784\_533\_9\_20241031\_00023.jpg

View of maintained vegetation on the waterside slope, Fall 2024.

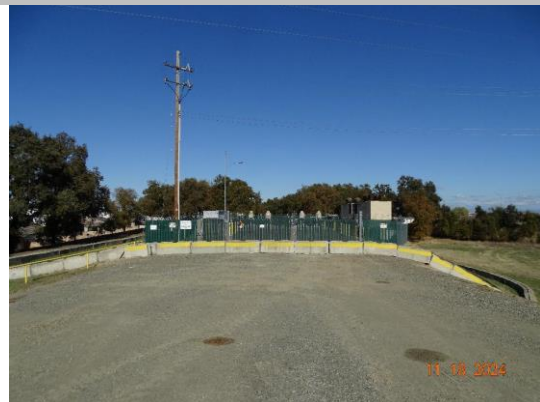
Photo 2 of 3 : UCIP\_FA\_2024\_85290\_126524.jpg

LS view: Pump station located approximately 100 feet from levee centerline.

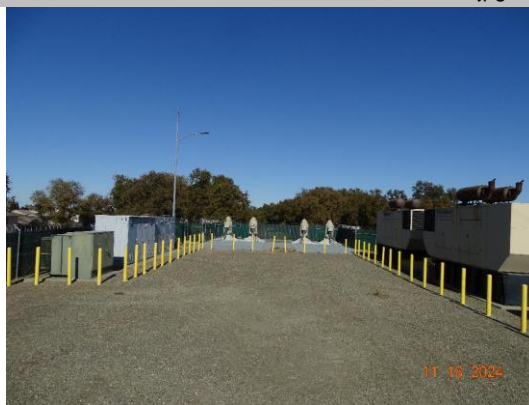
Photo 3 of 3 : UCIP\_FA\_2024\_85294\_126539.jpg

LS view: Pump station located approximately 100 feet from levee centerline; looking over fence.

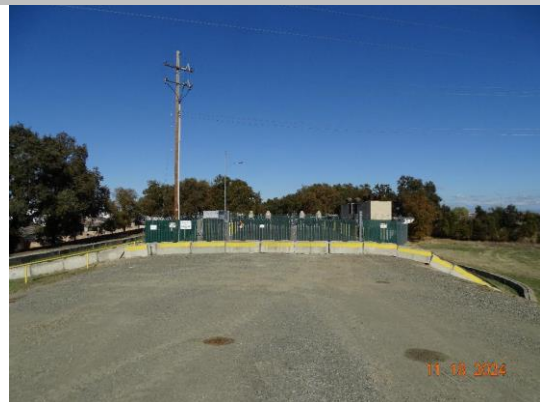
Photo 2 of 3 : UCIP\_FA\_2024\_85295\_126545.jpg

LS view: Pump station located approximately 100 feet from levee centerline.

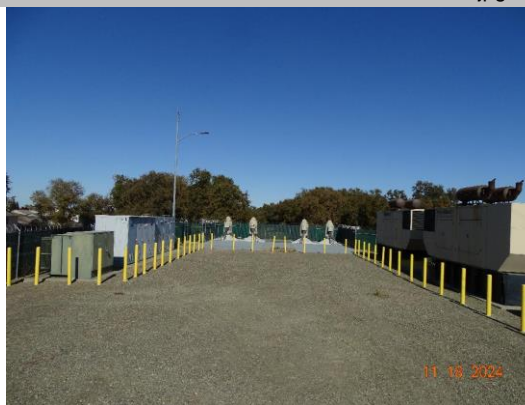
Photo 3 of 3 : UCIP\_FA\_2024\_85296\_126552.jpg

LS view: Pump station located approximately 100 feet from levee centerline; looking over fence.

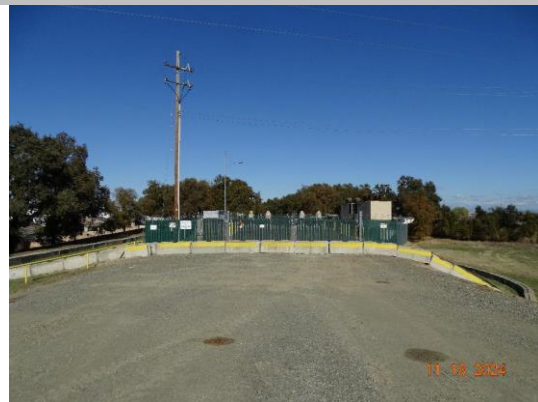
Photo 2 of 3 : UCIP\_FA\_2024\_85297\_126557.jpg

LS view: Pump station located approximately 100 feet from levee centerline.

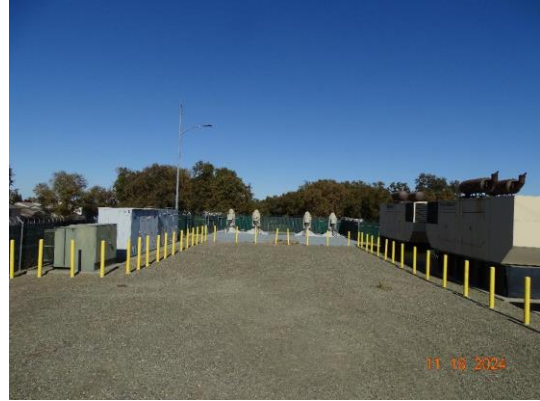
Photo 3 of 3 : UCIP\_FA\_2024\_85297\_126558.jpg

LS view: Pump station located approximately 100 feet from levee centerline; looking over fence.

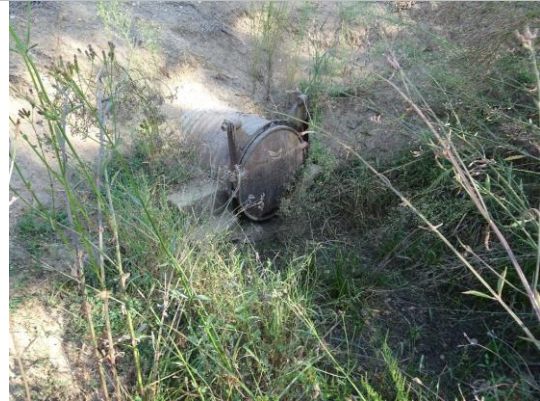
Photo 2 of 3 : UCIP\_FA\_2024\_85176\_101269.jpg

DS\_ID:18580  
FS\_ID:85176  
EP\_NO: N/A  
Repair Type: Non-Urgent  
EVAL Issue: 11, Maintenance Compliance Issue  
Crossing Status: Found  
UCIP Comments: 11/05/2024 Record updated from Urgent to Non-Urgent. RD784 has received approval from CVFPB for pipe replacement authorized under WA2024155 and plans to go out to bid and award a contract in time for the 2025 construction season. This section of the levee is in the process of becoming a state maintenance area. UCIP will update the pipe rating back to ?URGENT? if pipe is not replaced by the end of 2025. (M. Thao - DWR UCIP 10/05/2020 - Record has been updated from No Action Needed to Urgent. DWR DMP has found integrity issues, LOF between 5 and 6. Recommend monitoring crossing until funding becomes available to address. No permit was found authorizing this encroachment. CVFPB will need to review crossing to determine owner. (O. Magana - DWR UCIP 12/16/2019 - Pipe crossing was hydroflushed and video inspected in October 2019. Pending final review by RD784 District Engineer and DWR. (P. Meagher - RD784 01/01/2019 - Pipe crossing was video inspected on 8-14-2018. (P. Meagher - RD784)

Water-Side: Pipe outlet and flap gate at waterside toe.

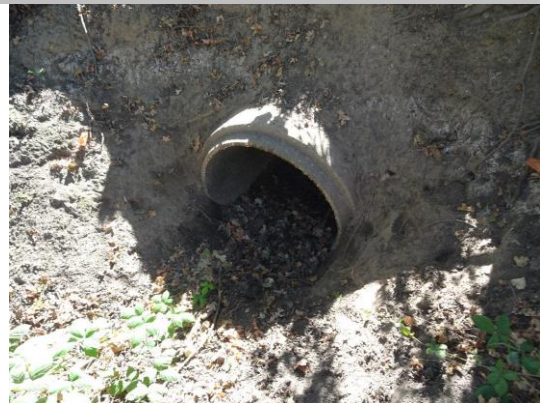
Photo 3 of 3 : UCIP\_FA\_2024\_85176\_101270.jpg

Land-Side: Pipe inlet beyond landside toe.

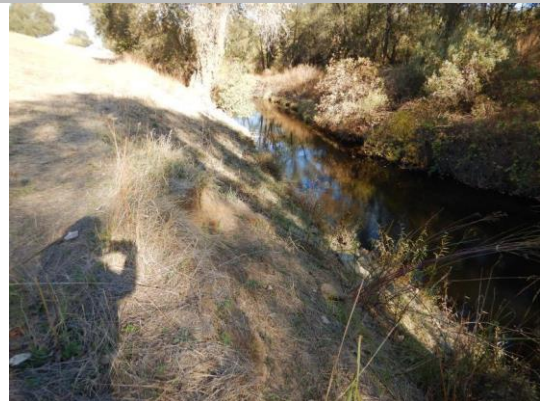
Photo 1 of 2 : FA\_2024\_RD0784\_534\_3\_20240829\_00001.jpg

LM Start	4.28	Rating **	A/W	Issue No.	3
LM End	4.29	Issue Type +	Ma	Location *	WS
Category	Supplemental			GPS Latitude/Longitude	
				Start	End
Item	2018 USACE Erosion Survey			38.981271°	38.981400°
				-121.515999°	-121.515848°
DWR ID	DWR_RD0784_03B_s _ 2022_3				
Comment Code					
Inspector Comment					
2018 Site ID: BER 4.9 R					
Status: Eroding					
2018 Field Notes: No observed change.					
Site History: 2009 - Small site which could be repaired with maintenance. Erosion into the levee toe, rock has started to fail.

USACE 2018 Erosion Photo #1

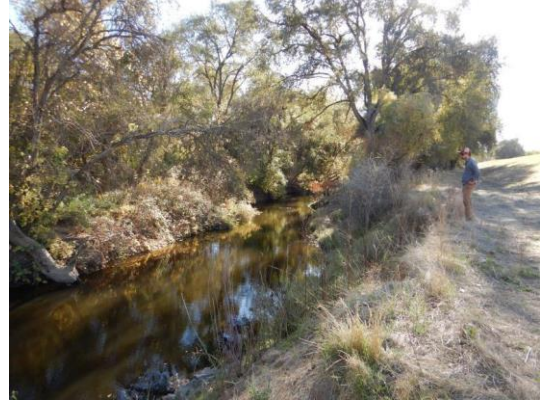
Photo 2 of 2 : FA\_2024\_RD0784\_534\_3\_20240829\_00002.jpg

USACE 2018 Erosion Photo #2

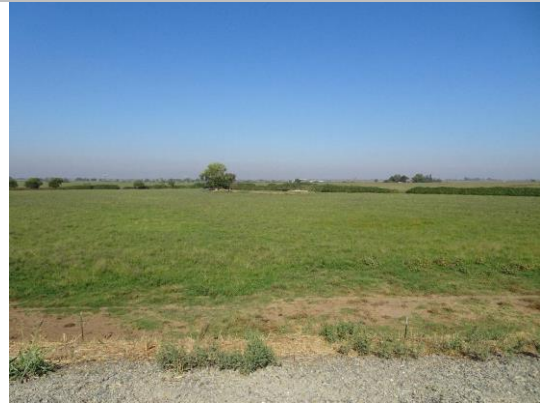
Photo 3 of 3 : UCIP\_FA\_2024\_69908\_101281.jpg

Land-Side: View of landside looking from crown.

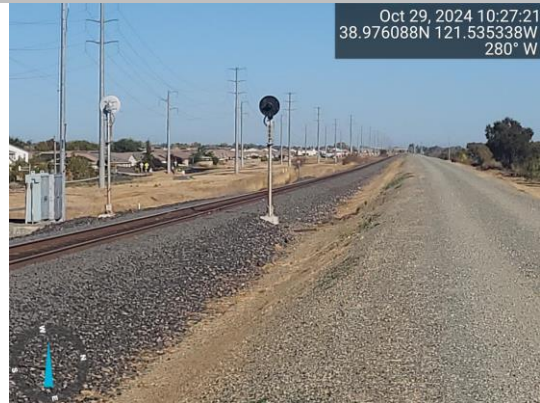
Photo 1 of 1 : FA\_2024\_RD0784\_181\_3\_20241031\_00007.jpg

View of maintained vegetation on the landside slope, Fall 2024.

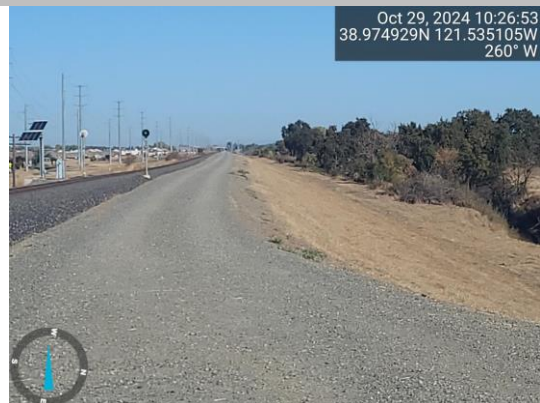
Photo 1 of 1 : FA\_2024\_RD0784\_181\_4\_20241031\_00008.jpg

View of maintained vegetation on the waterside slope, Fall 2024.

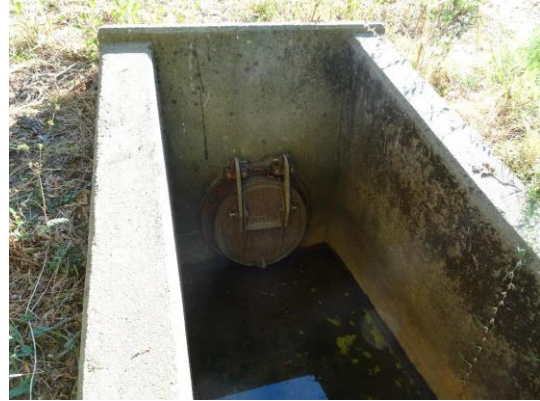
Photo 2 of 3 : UCIP\_FA\_2024\_85177\_100866.jpg

Water-Side: Outlet structure with flap gate at waterside toe.

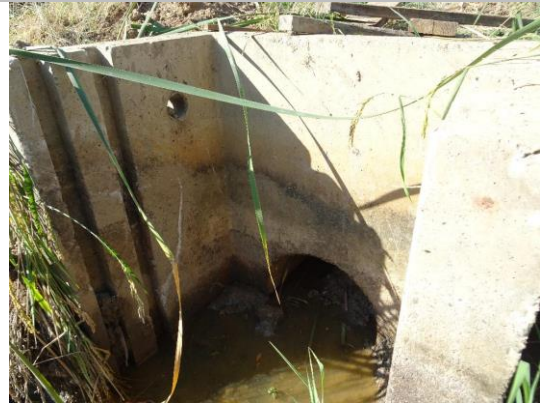
Photo 3 of 3 : UCIP\_FA\_2024\_85177\_100867.jpg

Land-Side: Inlet structure with open pipe at landside toe.

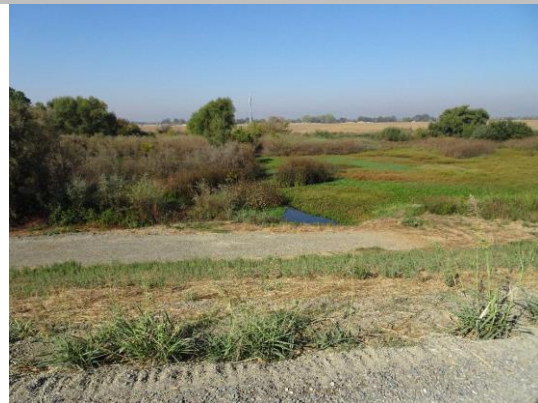
Photo 3 of 3 : UCIP\_FA\_2024\_85178\_100893.jpg

Water-Side: Outlet underwater at waterside toe.

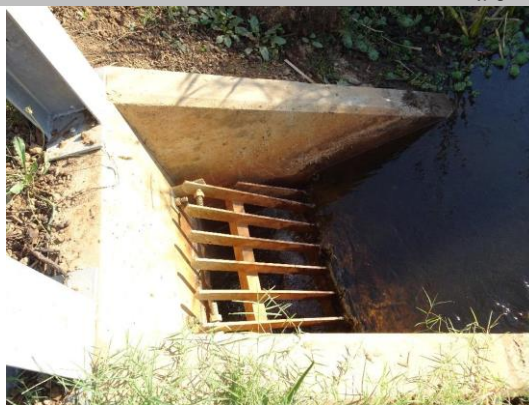
Photo 3 of 3 : UCIP\_FA\_2024\_82831\_100938.jpg

Land-Side: Inlet structure with grate at landside toe.

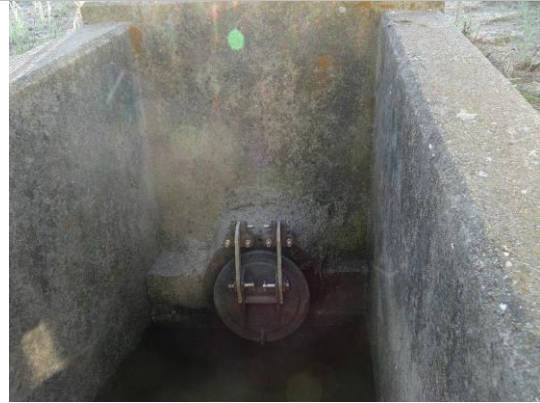
Photo 2 of 3 : UCIP\_FA\_2024\_85179\_100941.jpg

Water-Side: Outlet structure with flap gate at waterside toe.

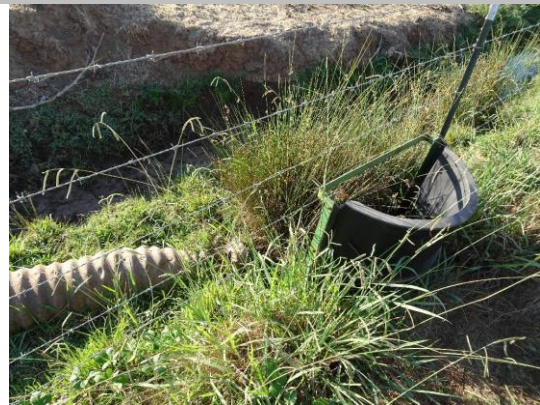
Photo 3 of 3 : UCIP\_FA\_2024\_85179\_100942.jpg

Land-Side: Inlet structure at landside toe.

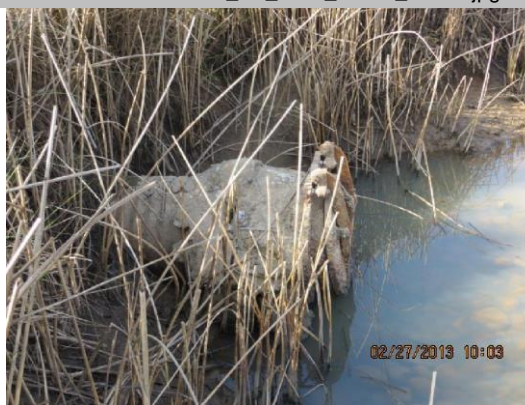
Photo 3 of 3 : UCIP\_FA\_2024\_85180\_16593.jpg

Flap gate at WS toe.

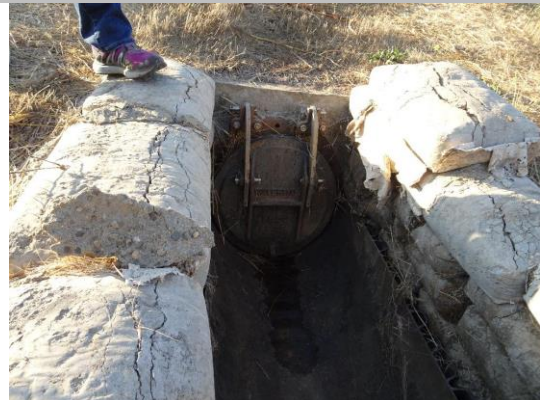
Photo 2 of 3 : UCIP\_FA\_2024\_70308\_100948.jpg

Water-Side: Outlet structure with flap gate at waterside toe.

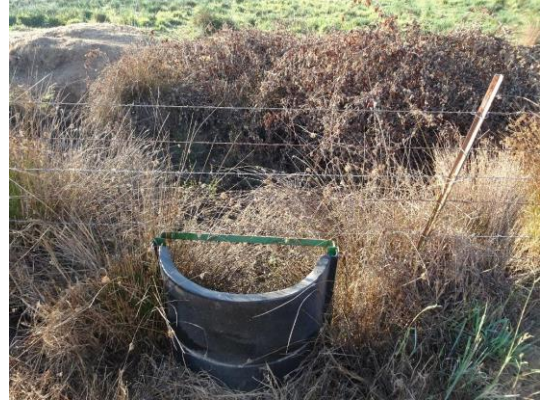
Photo 3 of 3 : UCIP\_FA\_2024\_70308\_100950.jpg

Land-Side: Inlet structure at landside toe.

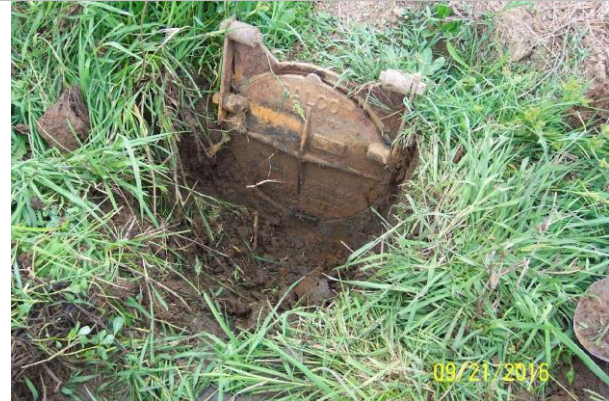
Photo 2 of 3 : UCIP\_FA\_2024\_70309\_76147.jpg

Flap gate on the WS toe is exposed

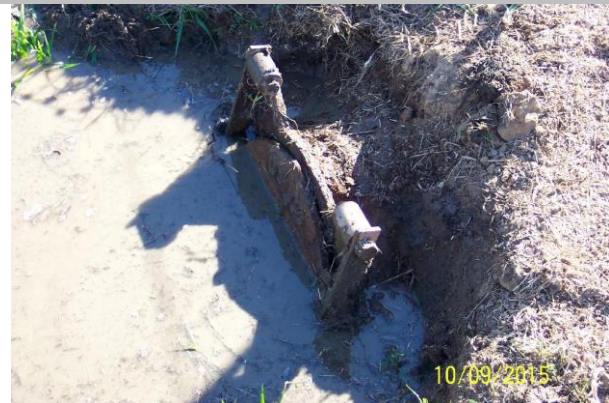
Photo 3 of 3 : UCIP\_FA\_2024\_70309\_74710.jpg

Flap gate at waterside toe partially under water

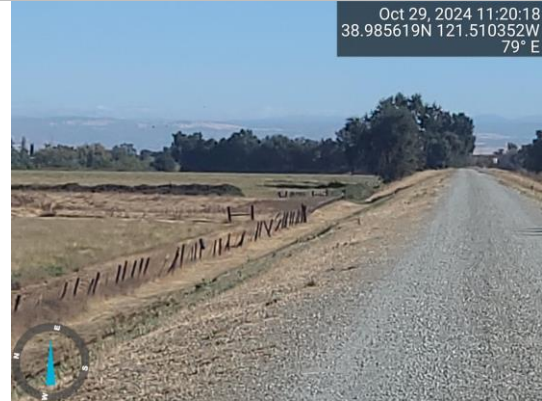
Photo 1 of 1 : FA\_2024\_RD0784\_183\_2\_20241031\_00004.jpg

View of maintained vegetation on the landside slope, Fall 2024.

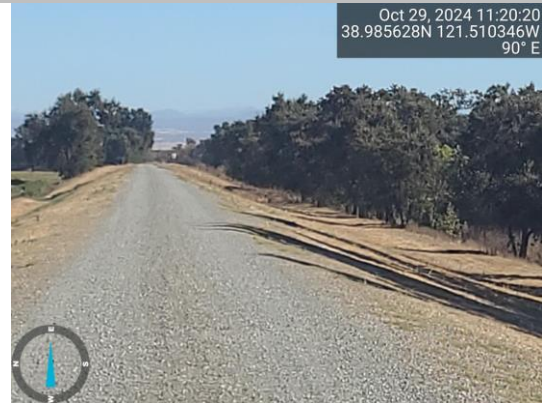
Photo 1 of 1 : FA\_2024\_RD0784\_183\_3\_20241031\_00005.jpg

View of maintained vegetation on the waterside slope, Fall 2024.

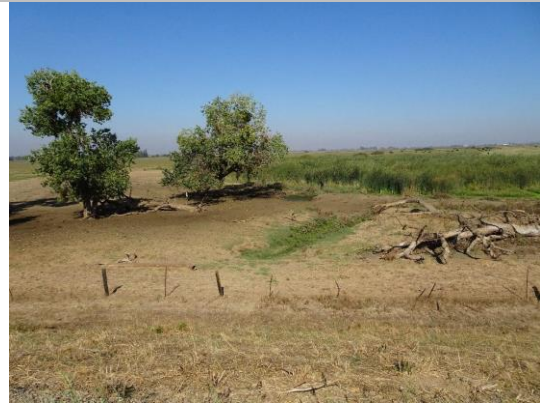
Photo 3 of 3 : UCIP\_FA\_2024\_85181\_100958.jpg

Land-Side: Inlet channel and pipe debris on landside.

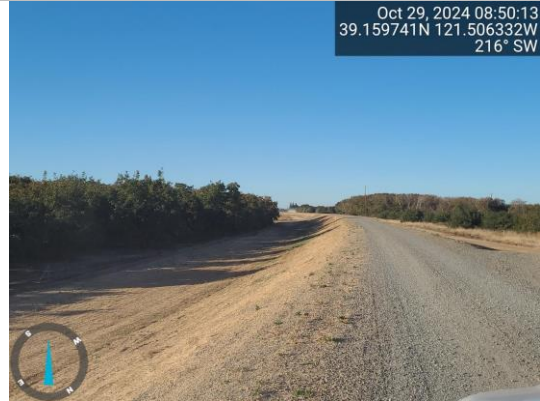
Photo 1 of 1 : FA\_2024\_RD0784\_184\_1\_20241031\_00001.jpg

View of maintained vegetation on the landside slope, Fall 2024.

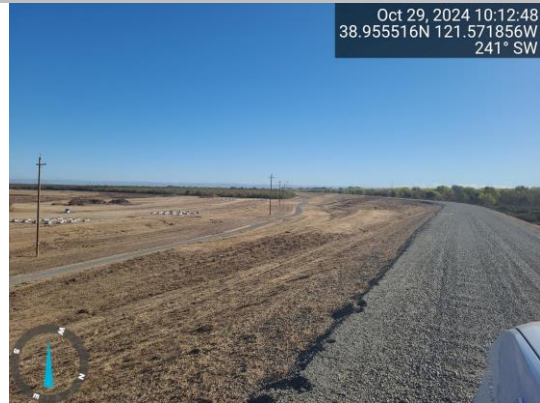
Photo 1 of 1 : FA\_2024\_RD0784\_437\_1\_20241031\_00001.jpg

View of maintained vegetation on the landside slope, Fall 2024.

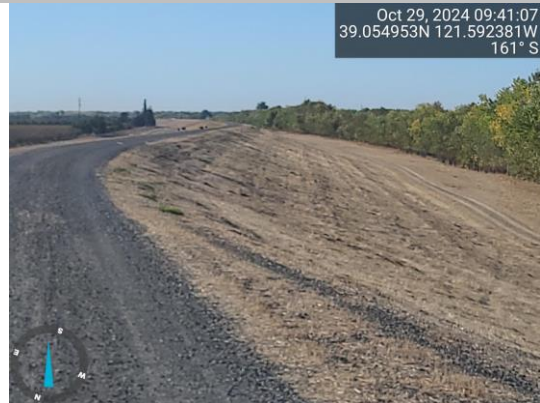
Photo 1 of 1 : FA\_2024\_RD0784\_530\_2\_20241031\_00002.jpg

View of maintained vegetation on the waterside slope, Fall 2024.
