**Flood Control Project Maintenance
Levee Inspections**

Maintenance Issue Types Only, Levee Inspection Report By Mile - Spring 2015

Reclamation District No. 0784 Plumas Lake

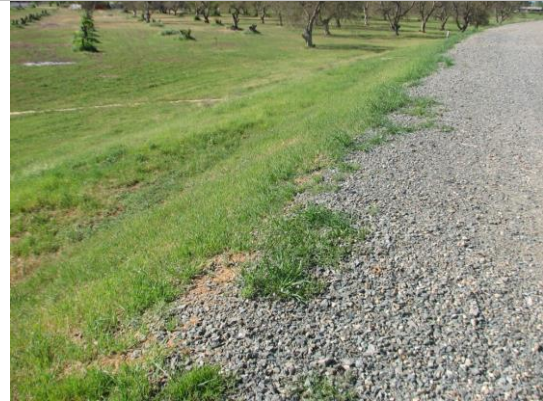
Photo 1 of 1 : SP_2015_RD0784_178_3_20150330_00004.jpg

Left bank landside, facing downstream.

| Control annual grass and weeds on the levee slopes and easements. | | | | | |

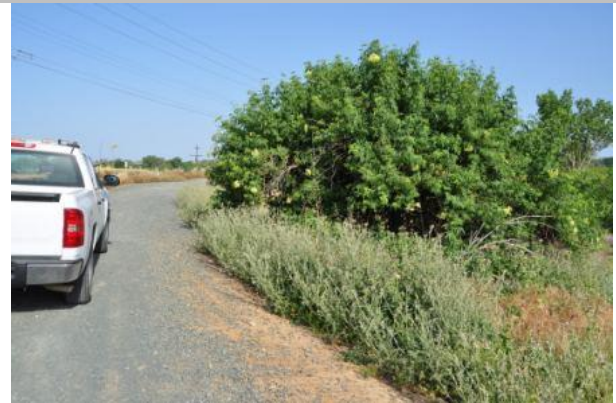
Photo 1 of 1 : SP_2015_RD0784_178_2_20150325_00001.jpg

| Elderberries are blocking visibility and flood fight capability. | | | | | |

W/S slope vegetation, Elderberry.

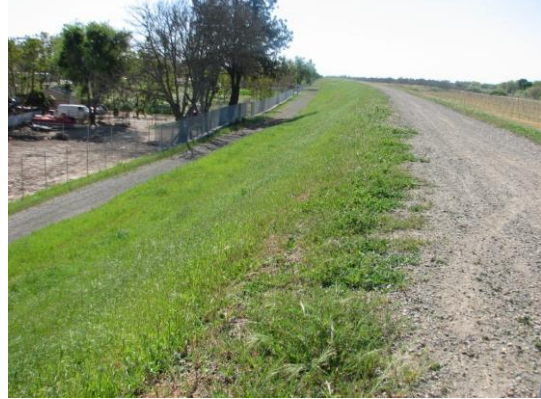
Photo 1 of 1 : SP_2015_RD0784_531_2_20150330_00002.jpg

Left bank land side, facing downstream.

| Control annual grass and weeds on the levee slopes and easements. | | | | | |

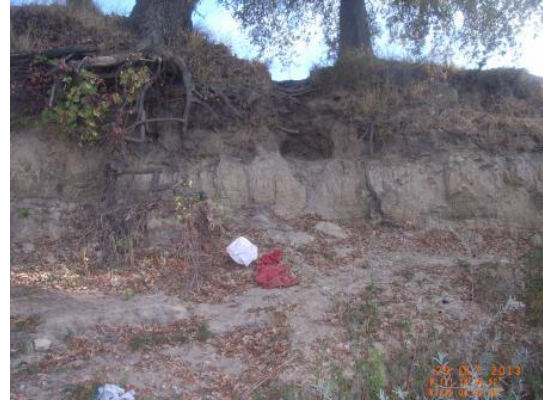
Photo 1 of 1 : SP_2015_RD0784_532_7_20150325_00003.jpg

Inspector Comments: 2003 - Bank is near vertical. Identified as a Potentially Critical site. 2004 - Eddy flow off downstream end of Modesto formation eroding the fluvial sediments. 2005 - Some new slumping. Actively eroding but berm width is greater than 50 ft. 2006 - Downgraded to regular erosion site. Still actively eroding. Large old rotational failures in high bank on the downstream end. 2008 - Removed from inventory due to wide berm width does not meet criteria for an erosion site. 2010 - Added back to the inventory after 10 ft of bank erosion in the winter 2009 storm. Steep vertical face. 2011 - Bank has retreated an additional 2.5 ft from last year. New tree popouts and erosion throughout the site. 2012 - Site continues to worsen with new tree popouts and many sections of new erosion. 2013: No observed changes. [2013 Site ID: FHR_17-8_L]

USACE 2013 Photo #1

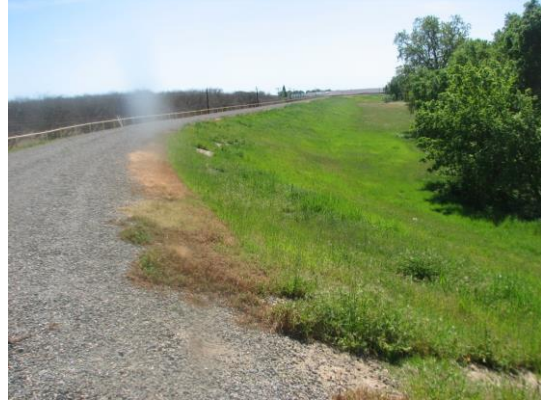
Photo 1 of 1 : SP_2015_RD0784_532_3_20150330_00002.jpg

Waterside facing downstream

| Control annual grass and weeds on the levee slopes and easements. | | | | | |

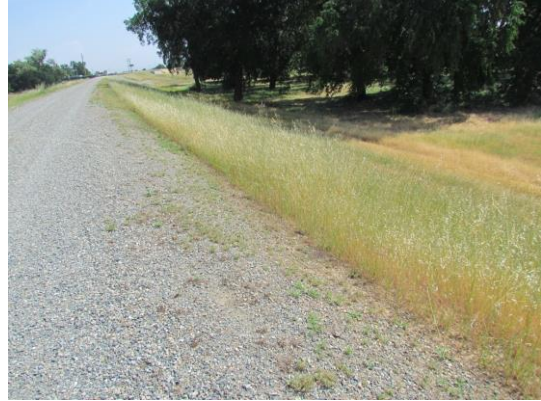
Photo 1 of 1 : SP_2015_RD0784_180_4_20150429_00002.jpg

View of the vegetation on the waterside of the levee facing upstream.

| Control annual grass and weeds on the levee slopes and easements. | | | | | |

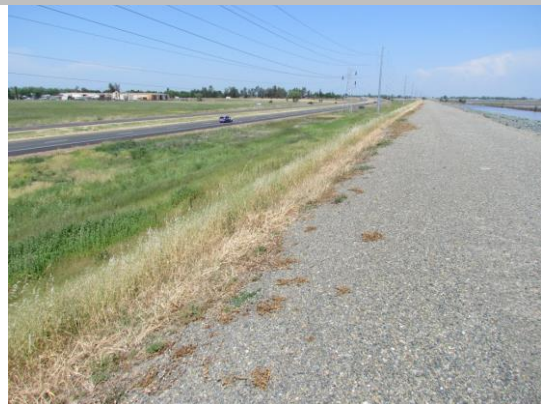
Photo 1 of 1 : SP_2015_RD0784_181_5_20150429_00004.jpg

View of the vegetation on the landside of the levee facing upstream.

| Control annual grass and weeds on the levee slopes and easements. | | | | | |

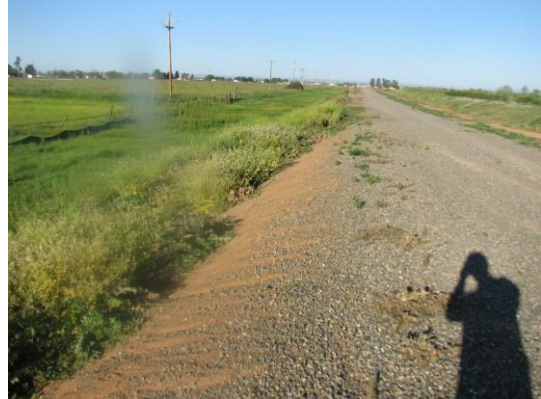
Photo 1 of 1 : SP_2015_RD0784_181_7_20150330_00003.jpg

Landside facing upstream

| Control annual grass and weeds on the levee slopes and easements. | | | | | |

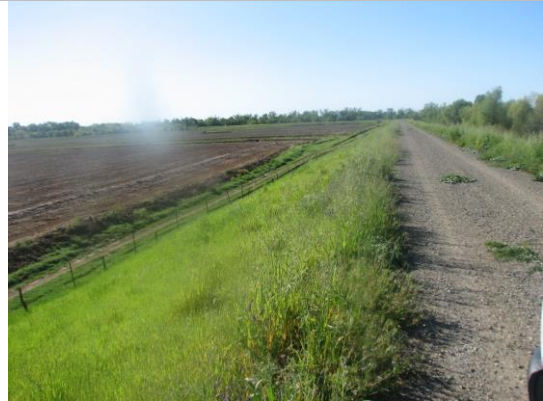
Photo 1 of 1 : SP_2015_RD0784_182_13_20150330_00004.jpg

Landside facing downstream

| Control annual grass and weeds on the levee slopes and easements. | | | | | |

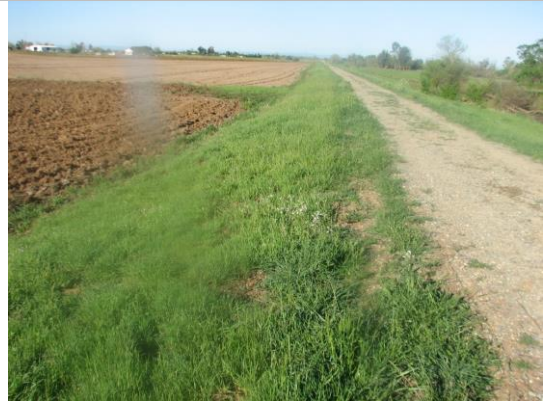
Photo 1 of 1 : SP_2015_RD0784_182_11_20150330_00003.jpg

Landside facing downstream

| Control annual grass and weeds on the levee slopes and easements. | | | | | |

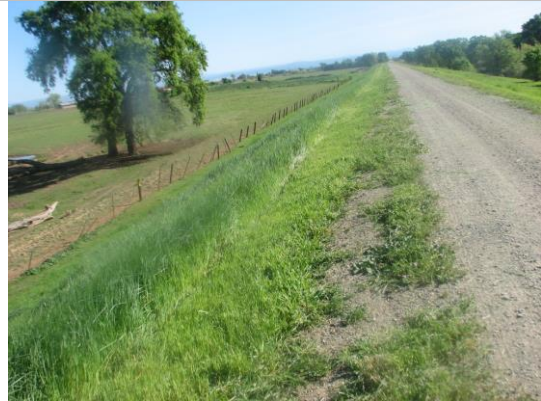
Photo 1 of 1 : SP_2015_RD0784_183_9_20150330_00004.jpg

Landside facing upstream

| Control annual grass and weeds on the levee slopes and easements. | | | | | |

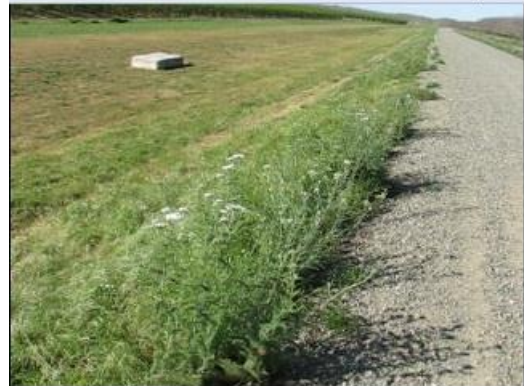
Photo 1 of 1 : SP_2015_RD0784_184_3_20150330_00002.jpg

Left bank waterside, facing upstream.

| Control annual grass and weeds on the levee slopes and easements. | | | | | |

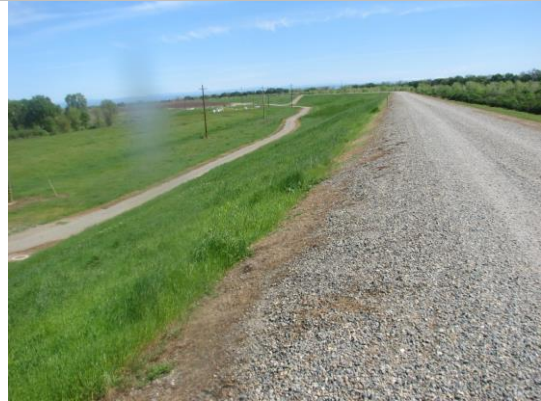
Photo 1 of 1 : SP_2015_RD0784_437_2_20150330_00002.jpg

Waterside facing downstream

| Control annual grass and weeds on the levee slopes and easements. | | | | | |

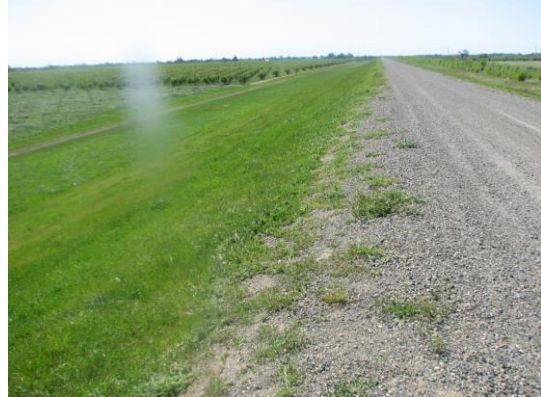
Photo 1 of 1 : SP_2015_RD0784_530_1_20150330_00002.jpg

Landside facing downstream

| Control annual grass and weeds on the levee slopes and easements. | | | | | |
