**Flood Control Project Maintenance  
Levee Inspections**

## Maintenance Issue Types Only, Levee Inspection Report By Mile - Spring 2016

### Reclamation District No. 0784 Plumas Lake

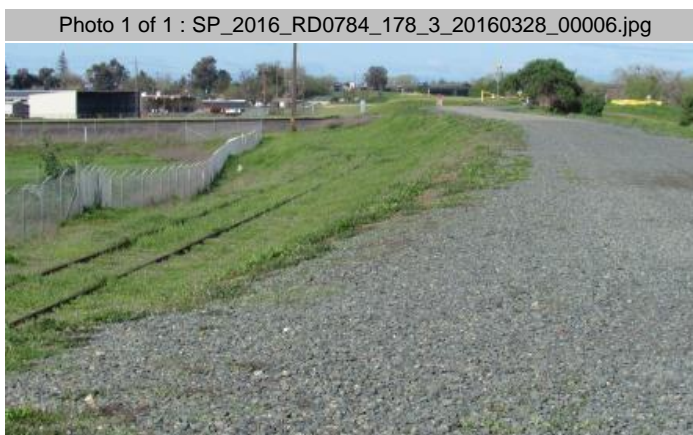
LM Start	1.15	Rating **	A	Issue No.	3
LM End	1.15	Issue Type +	Ma	Location *	LS
Category	Earthen Levee			GPS Latitude/Longitude	
				Start	End
Item	Vegetation			39.129622 °	39.129622 °
				-121.571981 °	-121.571981 °
DWR ID	DWR_RD0784_01_s_2016_3				
Comment Code					
V1 : Control annual grass and weeds on the levee slopes and easements.					
Inspector Comment

View of acceptable landside vegetation looking downstream. Spring 2016.

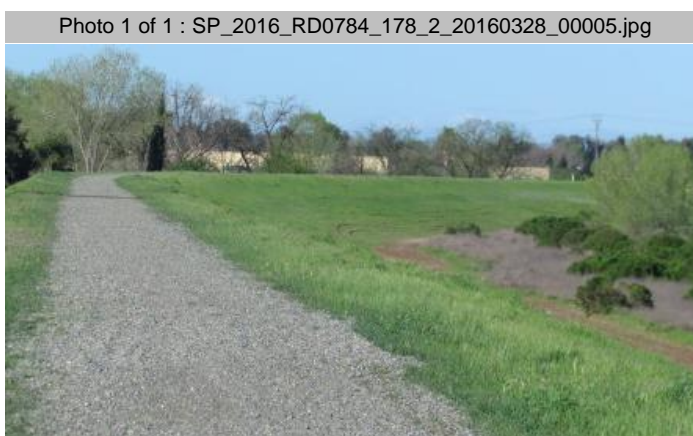
LM Start	1.28	Rating **	A	Issue No.	2
LM End	1.28	Issue Type +	Ma	Location *	WS
Category	Earthen Levee			GPS Latitude/Longitude	
				Start	End
Item	Vegetation			39.129783 °	39.129783 °
				-121.574384 °	-121.574384 °
DWR ID	DWR_RD0784_01_s_2012_2				
Comment Code					
V1 : Control annual grass and weeds on the levee slopes and easements.					
Inspector Comment

View of acceptable waterside vegetation looking downstream. Spring 2016.

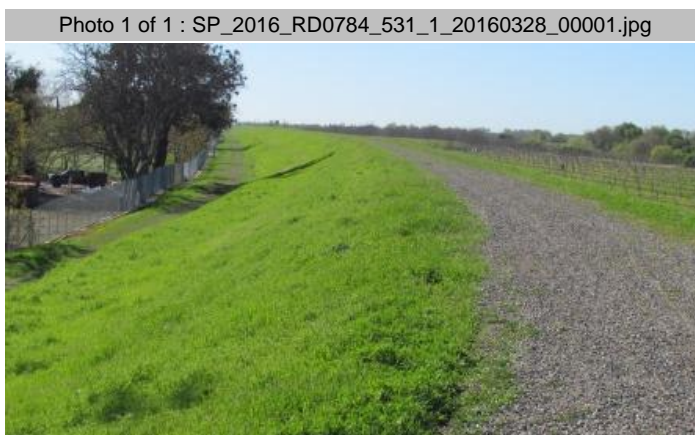
LM Start	0.01	Rating **	A	Issue No.	1
LM End	0.01	Issue Type +	Ma	Location *	LS
Category	Earthen Levee			GPS Latitude/Longitude	
				Start	End
Item	Vegetation			39.125724 °	39.125724 °
				-121.588665 °	-121.588665 °
DWR ID	DWR_RD0784_02A_s_2016_1				
Comment Code					
V1 : Control annual grass and weeds on the levee slopes and easements.					
Inspector Comment

View of acceptable landside vegetation looking downstream. Spring 2016.

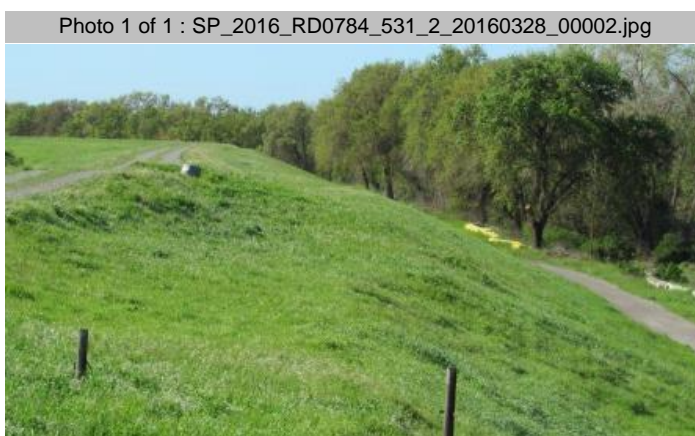
LM Start	0.97	Rating **	A	Issue No.	2
LM End	0.97	Issue Type +	Ma	Location *	WS
Category	Earthen Levee			GPS Latitude/Longitude	
				Start	End
Item	Vegetation			39.112386 °	39.112386 °
				-121.583602 °	-121.583602 °
DWR ID	DWR_RD0784_02A_s_2016_2				
Comment Code					
V1 : Control annual grass and weeds on the levee slopes and easements.					
Inspector Comment

View of acceptable waterside vegetation looking downstream. Spring 2016.

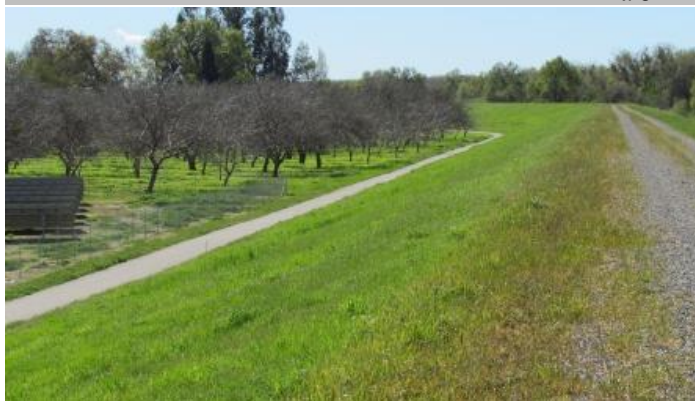
Photo 1 of 1 : SP\_2016\_RD0784\_532\_3\_20160328\_00006.jpg

LM Start	9.50	Rating **	A	Issue No.	3
LM End	9.50	Issue Type +	Ma	Location *	LS
Category	Earthen Levee			GPS Latitude/Longitude	
				Start	End
Item	Vegetation			39.002566 °	39.002566 °
				-121.579263 °	-121.579263 °
DWR ID	DWR_RD0784_02B_s_2016_3				
Comment Code					
V1 : Control annual grass and weeds on the levee slopes and easements.					
Inspector Comment

View of acceptable landside vegetation looking downstream. Spring 2016.

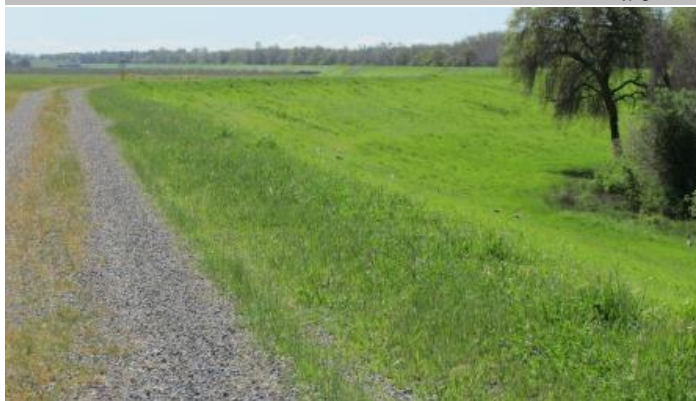
Photo 1 of 1 : SP\_2016\_RD0784\_532\_4\_20160328\_00007.jpg

LM Start	9.92	Rating **	A	Issue No.	4
LM End	9.92	Issue Type +	Ma	Location *	WS
Category	Earthen Levee			GPS Latitude/Longitude	
				Start	End
Item	Vegetation			38.996544 °	38.996544 °
				-121.580271 °	-121.580271 °
DWR ID	DWR_RD0784_02B_s_2016_4				
Comment Code					
V1 : Control annual grass and weeds on the levee slopes and easements.					
Inspector Comment

View of acceptable waterside vegetation looking downstream. Spring 2016.

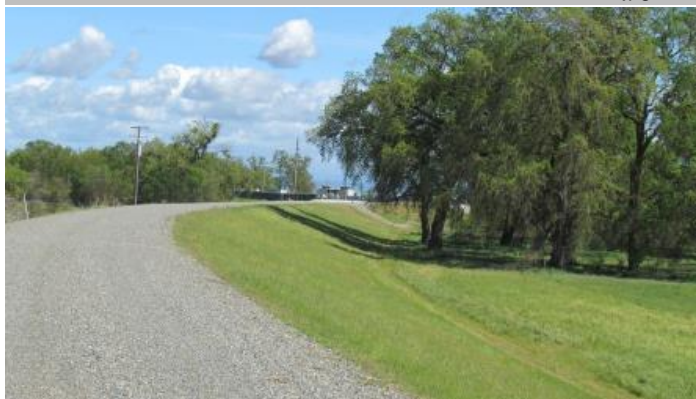
Photo 1 of 1 : SP\_2016\_RD0784\_533\_1\_20160328\_00002.jpg

LM Start	2.45	Rating **	A	Issue No.	1
LM End	2.45	Issue Type +	Ma	Location *	WS
Category	Earthen Levee			GPS Latitude/Longitude	
				Start	End
Item	Vegetation			38.970899 °	38.970899 °
				-121.547358 °	-121.547358 °
DWR ID	DWR_RD0784_03A_s_2016_1				
Comment Code					
V1 : Control annual grass and weeds on the levee slopes and easements.					
Inspector Comment

View of acceptable waterside vegetation looking upstream. Spring 2016.

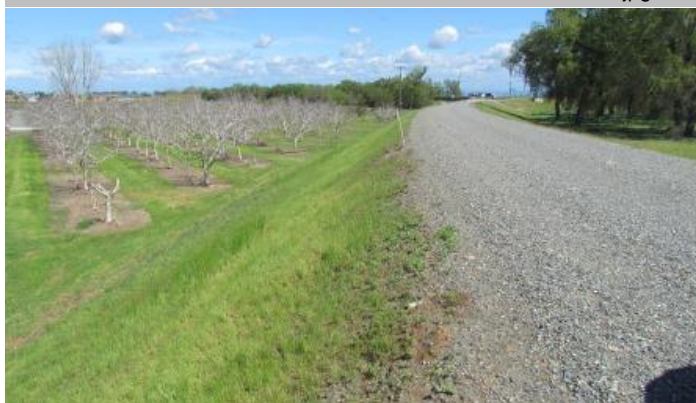
Photo 1 of 1 : SP\_2016\_RD0784\_533\_3\_20160328\_00003.jpg

LM Start	2.49	Rating **	A	Issue No.	3
LM End	2.49	Issue Type +	Ma	Location *	LS
Category	Earthen Levee			GPS Latitude/Longitude	
				Start	End
Item	Vegetation			38.971308 °	38.971308 °
				-121.547059 °	-121.547059 °
DWR ID	DWR_RD0784_03A_s_2016_3				
Comment Code					
V1 : Control annual grass and weeds on the levee slopes and easements.					
Inspector Comment

View of acceptable vegetation on the landside looking upstream. Spring 2016.

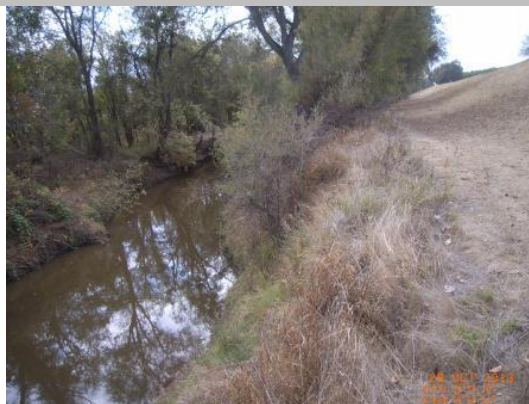
Photo 1 of 1 : SP\_2016\_RD0784\_533\_2\_20160307\_00001.jpg

LM Start	10.36	Rating **	M	Issue No.	2
LM End	10.40	Issue Type +	Ma	Location *	WS
Category	Supplemental			GPS Latitude/Longitude	
				Start	End
Item	2015 USACE Erosion Survey, DRAFT			38.981400 °	38.981271 °
				-121.515848 °	-121.515999 °
DWR ID	DWR_RD0784_03A_s_2016_2				
Comment Code					
Inspector Comment					
2009 - Small site which could be repaired with maintenance. Erosion into the levee toe, rock has started to fail. 2015: Last observed in 2013. [2015 Site ID: BER_4-9_R]

USACE 2013 Photo #1

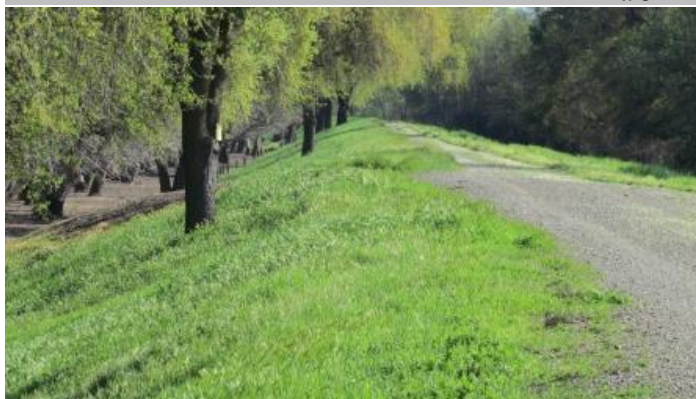
Photo 1 of 1 : SP\_2016\_RD0784\_534\_2\_20160328\_00004.jpg

LM Start	3.58	Rating **	A	Issue No.	2
LM End	3.58	Issue Type +	Ma	Location *	LS
Category	Earthen Levee			GPS Latitude/Longitude	
				Start	End
Item	Vegetation			38.974674 °	38.974674 °
				-121.525965 °	-121.525965 °
DWR ID	DWR_RD0784_03B_s_2016_2				
Comment Code					
V1 : Control annual grass and weeds on the levee slopes and easements.					
Inspector Comment

View of acceptable landside vegetation looking upstream. Spring 2016.

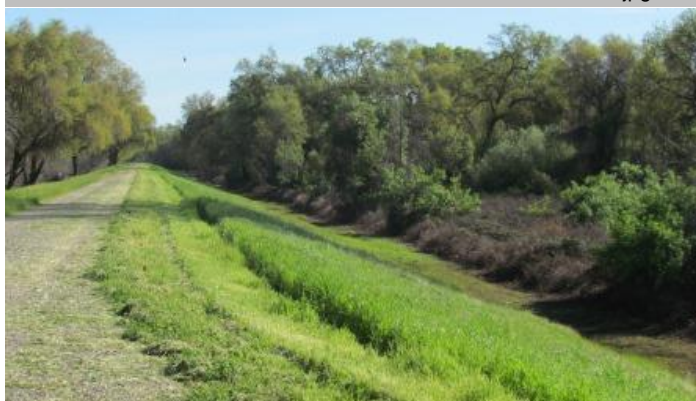
Photo 1 of 1 : SP\_2016\_RD0784\_534\_3\_20160328\_00005.jpg

LM Start	3.65	Rating **	A	Issue No.	3
LM End	3.65	Issue Type +	Ma	Location *	WS
Category	Earthen Levee			GPS Latitude/Longitude	
				Start	End
Item	Vegetation			38.975295 °	38.975295 °
				-121.524920 °	-121.524920 °
DWR ID	DWR_RD0784_03B_s_2016_3				
Comment Code					
V1 : Control annual grass and weeds on the levee slopes and easements.					
Inspector Comment

View of acceptable waterside vegetation looking upstream. Spring 2016.

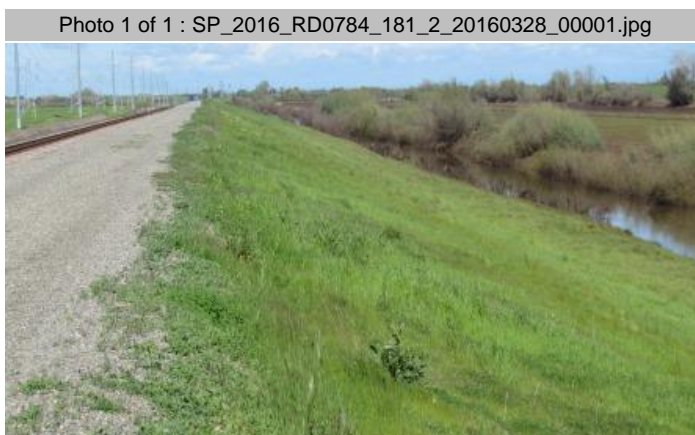
LM Start	1.08	Rating **	A	Issue No.	2
LM End	1.08	Issue Type +	Ma	Location *	WS
Category	Earthen Levee			GPS Latitude/Longitude	
				Start	End
Item	Vegetation			38.990188 °	38.990188 °
				-121.538020 °	-121.538020 °
DWR ID	DWR_RD0784_04_s_2016_2				
Comment Code					
V1 : Control annual grass and weeds on the levee slopes and easements.					
Inspector Comment

View of acceptable waterside vegetation looking upstream. Spring 2016.

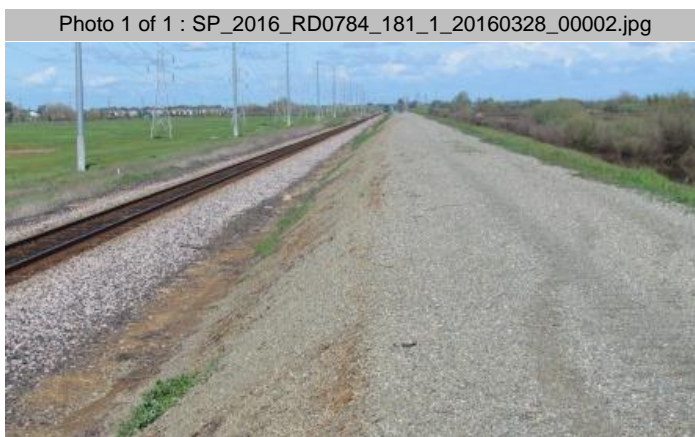
LM Start	1.08	Rating **	A	Issue No.	1
LM End	1.08	Issue Type +	Ma	Location *	LS
Category	Earthen Levee			GPS Latitude/Longitude	
				Start	End
Item	Vegetation			38.990188 °	38.990188 °
				-121.538021 °	-121.538021 °
DWR ID	DWR_RD0784_04_s_2016_1				
Comment Code					
V1 : Control annual grass and weeds on the levee slopes and easements.					
Inspector Comment

View of acceptable vegetation on the landside looking upstream. Spring 2016.

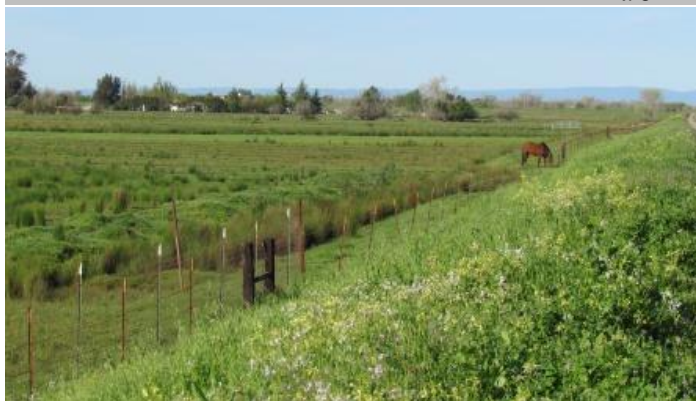
Photo 1 of 1 : SP\_2016\_RD0784\_182\_8\_20160328\_00022.jpg

LM Start	0.02	Rating **	M	Issue No.	8
LM End	3.86	Issue Type +	Ma	Location *	LS
Category	Earthen Levee			GPS Latitude/Longitude	
				Start	End
Item	Vegetation			38.974617 °	39.019460 °
				-121.532619 °	-121.515089 °
DWR ID	DWR_RD0784_05_s_2016_8				
Comment Code					
V1 : Control annual grass and weeds on the levee slopes and easements.					
Inspector Comment

View of landside vegetation looking downstream. Spring 2016.

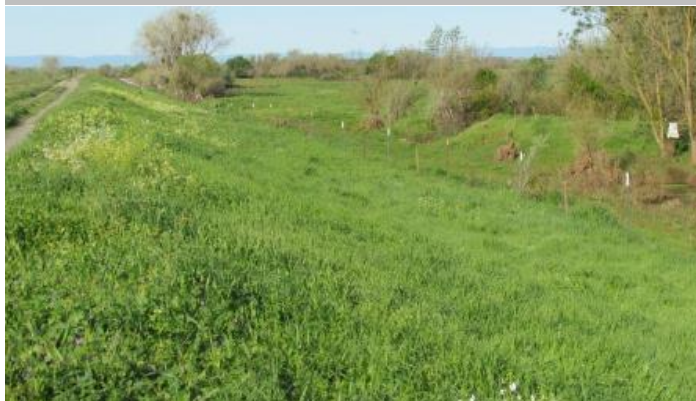
Photo 1 of 1 : SP\_2016\_RD0784\_182\_12\_20160328\_00023.jpg

LM Start	0.02	Rating **	M	Issue No.	12
LM End	3.86	Issue Type +	Ma	Location *	WS
Category	Earthen Levee			GPS Latitude/Longitude	
				Start	End
Item	Vegetation			38.974617 °	39.019460 °
				-121.532620 °	-121.515088 °
DWR ID	DWR_RD0784_05_s_2016_12				
Comment Code					
V1 : Control annual grass and weeds on the levee slopes and easements.					
Inspector Comment

View of waterside vegetation looking downstream. Spring 2016.

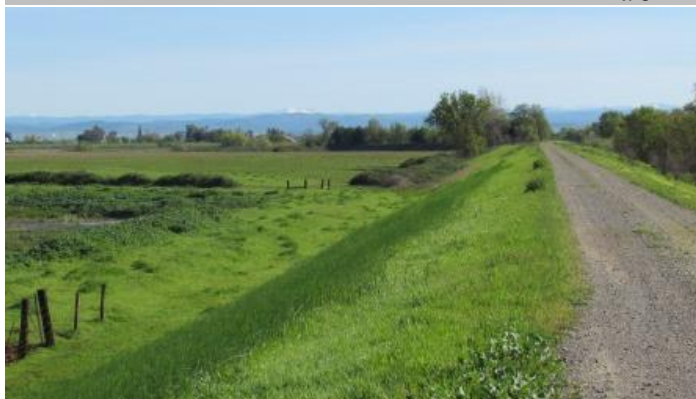
Photo 1 of 1 : SP\_2016\_RD0784\_183\_2\_20160328\_00004.jpg

LM Start	0.14	Rating **	A	Issue No.	2	
LM End	0.14	Issue Type +	Ma	Location *	LS	
Category	Earthen Levee			GPS Latitude/Longitude		
				Start		End
Item	Vegetation			38.986729 °		38.986729 °
				-121.508283 °		-121.508283 °
DWR ID	DWR_RD0784_06_s_2016_2					
Comment Code						
V1 : Control annual grass and weeds on the levee slopes and easements.						
Inspector Comment

View of acceptable landside vegetation looking upstream. Spring 2016.

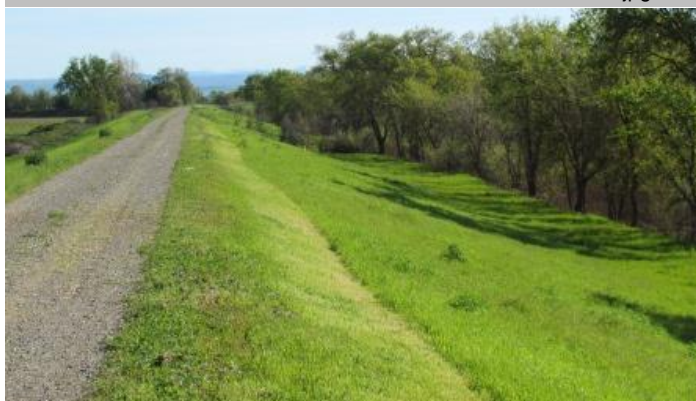
Photo 1 of 1 : SP\_2016\_RD0784\_183\_3\_20160328\_00005.jpg

LM Start	0.14	Rating **	A	Issue No.	3
LM End	0.14	Issue Type +	Ma	Location *	WS
Category	Earthen Levee			GPS Latitude/Longitude	
				Start	End
Item	Vegetation			38.986729 °	38.986729 °
				-121.508283 °	-121.508283 °
DWR ID	DWR_RD0784_06_s_2016_3				
Comment Code					
V1 : Control annual grass and weeds on the levee slopes and easements.					
Inspector Comment

View of acceptable waterside vegetation looking upstream. Spring 2016.

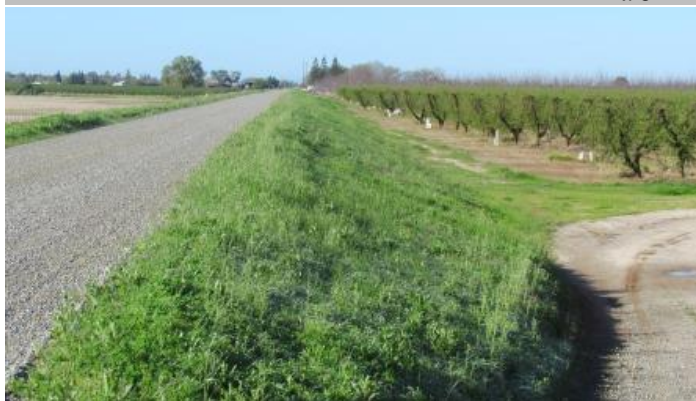
Photo 1 of 1 : SP\_2016\_RD0784\_184\_4\_20160328\_00006.jpg

LM Start	0.68	Rating **	M	Issue No.	4
LM End	0.85	Issue Type +	Ma	Location *	WS
Category	Earthen Levee			GPS Latitude/Longitude	
				Start	End
Item	Vegetation			39.138322 °	39.139637 °
				-121.540631 °	-121.537829 °
DWR ID	DWR_RD0784_07_s_2016_4				
Comment Code					
V1 : Control annual grass and weeds on the levee slopes and easements.					
Inspector Comment

View of waterside vegetation looking downstream. Spring 2016.

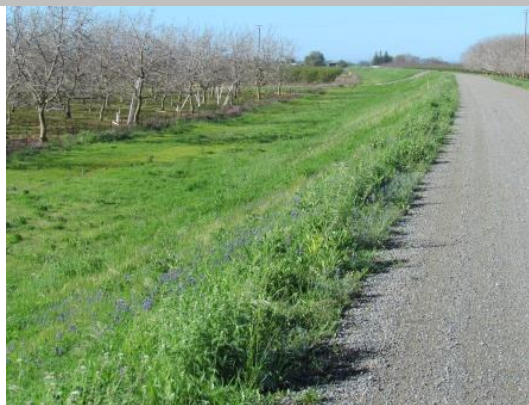
Photo 1 of 1 : SP\_2016\_RD0784\_184\_2\_20160328\_00004.jpg

LM Start	2.80	Rating **	M	Issue No.	2
LM End	3.07	Issue Type +	Ma	Location *	LS
Category	Earthen Levee			GPS Latitude/Longitude	
				Start	End
Item	Vegetation			39.156702 °	39.159398 °
				-121.510387 °	-121.506853 °
DWR ID	DWR_RD0784_07_s_2016_2				
Comment Code					
V1 : Control annual grass and weeds on the levee slopes and easements.					
Inspector Comment

View of landside vegetation looking downstream. Spring 2016.

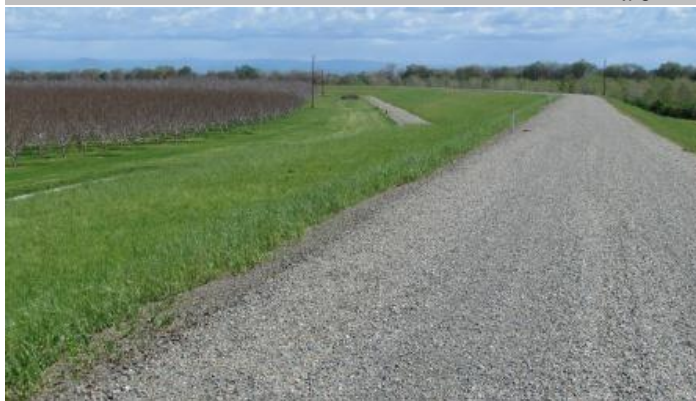
Photo 1 of 1 : SP\_2016\_RD0784\_437\_1\_20160328\_00001.jpg

LM Start	0.39	Rating **	A	Issue No.	1
LM End	0.39	Issue Type +	Ma	Location *	LS
Category	Earthen Levee			GPS Latitude/Longitude	
				Start	End
Item	Vegetation			38.956304 °	38.956304 °
				-121.567820 °	-121.567820 °
DWR ID	DWR_RD0784_08_s_2016_1				
Comment Code					
V1 : Control annual grass and weeds on the levee slopes and easements.					
Inspector Comment

View of acceptable landside vegetation looking upstream. Spring 2016.

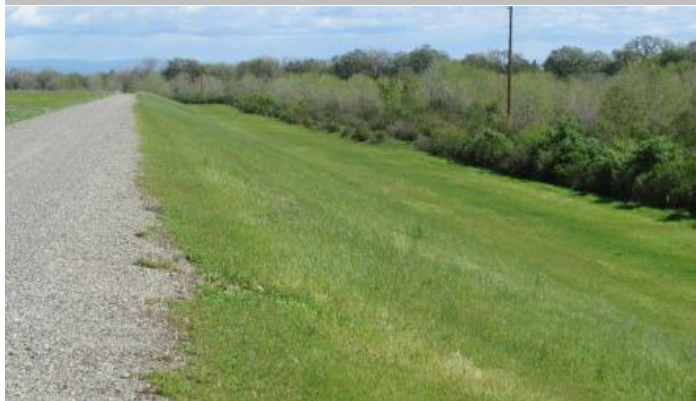
Photo 1 of 1 : SP\_2016\_RD0784\_437\_2\_20160328\_00002.jpg

LM Start	0.61	Rating **	A	Issue No.	2
LM End	0.61	Issue Type +	Ma	Location *	WS
Category	Earthen Levee			GPS Latitude/Longitude	
				Start	End
Item	Vegetation			38.957313 °	38.957313 °
				-121.563988 °	-121.563988 °
DWR ID	DWR_RD0784_08_s_2016_2				
Comment Code					
V1 : Control annual grass and weeds on the levee slopes and easements.					
Inspector Comment

View of acceptable vegetation on the waterside looking upstream. Spring 2016.

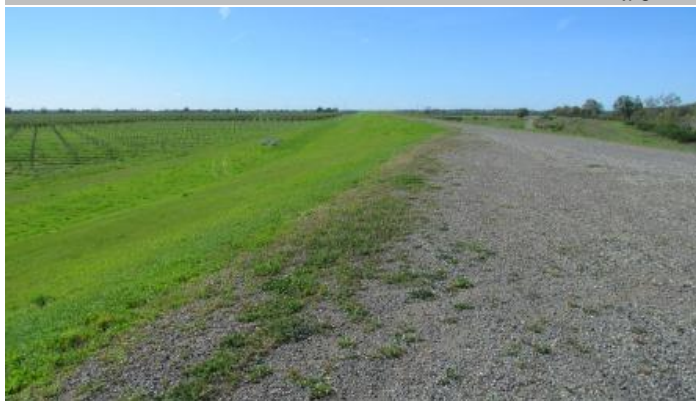
Photo 1 of 1 : SP\_2016\_RD0784\_530\_5\_20160328\_00007.jpg

LM Start	0.01	Rating **	A	Issue No.	5
LM End	0.01	Issue Type +	Ma	Location *	LS
Category	Earthen Levee			GPS Latitude/Longitude	
				Start	End
Item	Vegetation			39.090153 °	39.090153 °
				-121.584764 °	-121.584764 °
DWR ID	DWR_RD0784_09_s_2016_5				
Comment Code					
V1 : Control annual grass and weeds on the levee slopes and easements.					
Inspector Comment

View of acceptable landside vegetation looking downstream. Spring 2016.

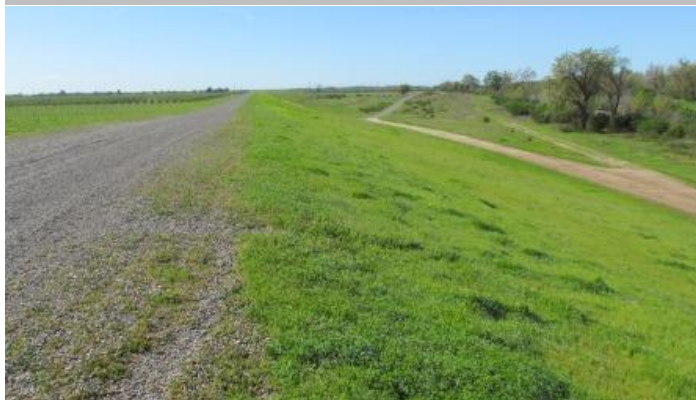
Photo 1 of 1 : SP\_2016\_RD0784\_530\_6\_20160328\_00008.jpg

LM Start	0.01	Rating **	A	Issue No.	6
LM End	0.01	Issue Type +	Ma	Location *	WS
Category	Earthen Levee			GPS Latitude/Longitude	
				Start	End
Item	Vegetation			39.090153 °	39.090153 °
				-121.584764 °	-121.584764 °
DWR ID	DWR_RD0784_09_s_2016_6				
Comment Code					
V1 : Control annual grass and weeds on the levee slopes and easements.					
Inspector Comment

View of acceptable waterside vegetation looking downstream. Spring 2016.
