**Flood Control Project Maintenance
Levee Inspections**

Maintenance Issue Types Only, Levee Inspection Report By Mile - Spring 2017

Reclamation District No. 0784 Plumas Lake

Waterway	Bank	Unit Miles	Inspection Start/End	Inspector
Unit No. 01 Yuba River	Left	2.21	04/05/2017 04/05/2017	Sterling York

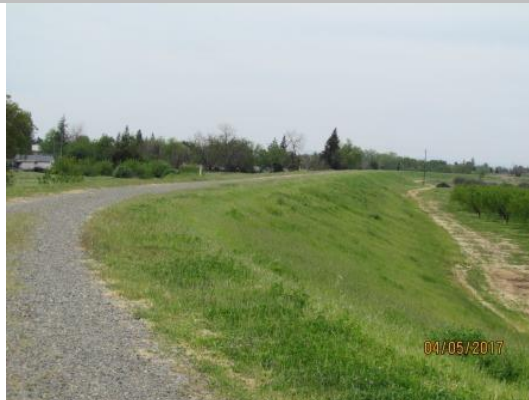
Photo 1 of 1 : SP_2017_RD0784_178_3_20170410_00006.jpg

LM Start	0.04	Rating **	M	Issue No.	3
LM End	2.20	Issue Type +	Ma	Location *	WS
Category	Earthen Levee			GPS Latitude/Longitude	
				Start	End
Item	Vegetation			39.134450 °	39.125940 °
				-121.552667 °	-121.588626 °
DWR ID	DWR_RD0784_01_s_2017_3				
Comment Code					
V1 : Control annual grass and weeds on the levee slopes and easements.					
Inspector Comment					
Maintain annual grasses, Spring 2017.

View looking downstream of annual grasses, Spring 2017.

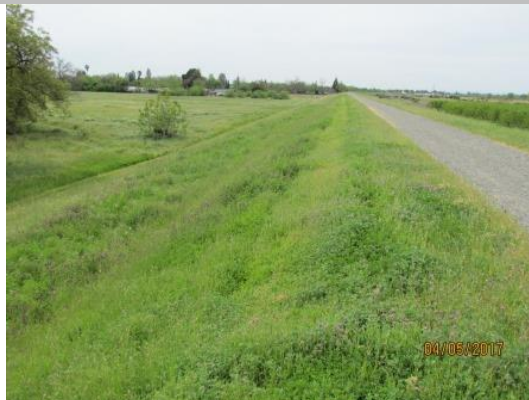
Photo 1 of 1 : SP_2017_RD0784_178_2_20170410_00007.jpg

LM Start	0.04	Rating **	M	Issue No.	2
LM End	2.20	Issue Type +	Ma	Location *	LS
Category	Earthen Levee			GPS Latitude/Longitude	
				Start	End
Item	Vegetation			39.134450 °	39.125942 °
				-121.552668 °	-121.588627 °
DWR ID	DWR_RD0784_01_s_2017_2				
Comment Code					
V1 : Control annual grass and weeds on the levee slopes and easements.					
Inspector Comment					
Maintain annual grasses, Spring 2017.

View looking downstream of annual grasses, Spring 2017.

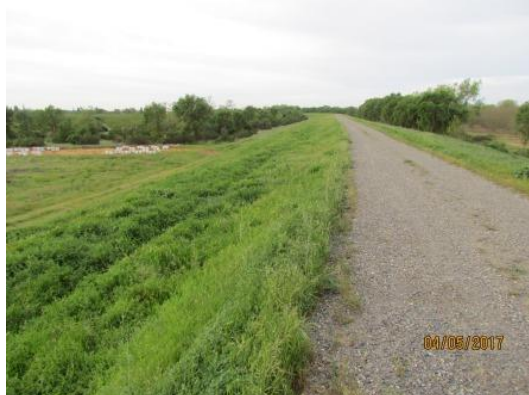
Photo 1 of 1 : SP_2017_RD0784_531_1_20170410_00002.jpg

View looking downstream of annual grasses, Spring 2017.

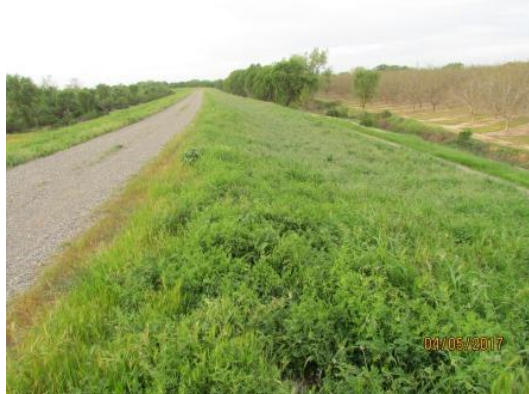
Photo 1 of 1 : SP_2017_RD0784_531_2_20170410_00001.jpg

LM Start	0.04	Rating **	M	Issue No.	2
LM End	2.54	Issue Type +	Ma	Location *	WS
Category	Earthen Levee			GPS Latitude/Longitude	
				Start	End
Item	Vegetation			39.125324 °	39.090307 °
				-121.588604 °	-121.584686 °
DWR ID	DWR_RD0784_02A_s_2017_2				
Comment Code					
V1 : Control annual grass and weeds on the levee slopes and easements.					
Inspector Comment					
Maintain annual grasses, Spring 2017.

View looking downstream of annual grasses, Spring 2017.

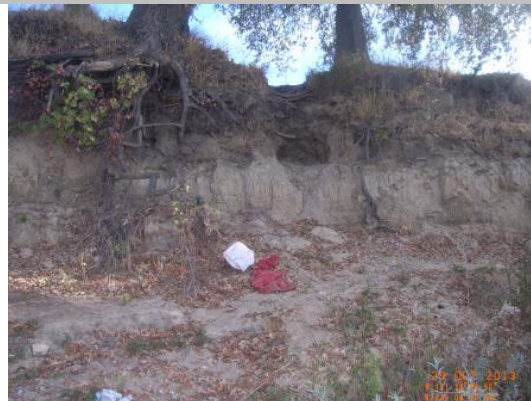
Photo 1 of 1 : SP_2017_RD0784_532_1_20170316_00001.jpg

Comment Code					
Inspector Comment					
2003 - Bank is near vertical. Identified as a Potentially Critical site. 2004 - Eddy flow off downstream end of Modesto formation eroding the fluvial sediments. 2005 - Some new slumping. Actively eroding but berm width is greater than 50 ft. 2006 - Downgraded to regular erosion site. Still actively eroding. Large old rotational failures in high bank on the downstream end. 2008 - Removed from inventory due to wide berm width does not meet criteria for an erosion site. 2010 - Added back to the inventory after 10 ft of bank erosion in the winter 2009 storm. Steep vertical face. 2011 - Bank has retreated an additional 2.5 ft from last year. New tree popouts and erosion throughout the site. 2012 - Site continues to worsen with new tree popouts and many sections of new erosion. 2015: Last observed in 2013. [2015 Site ID: FHR_17-8_L]

USACE 2013 Photo #1

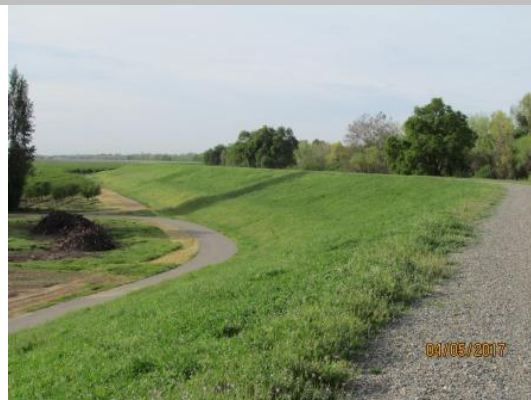
Photo 1 of 1 : SP_2017_RD0784_532_2_20170410_00003.jpg

LM Start	9.19	Rating **	A/W	Issue No.	2
LM End	12.86	Issue Type +	Ma	Location *	LS
Category	Earthen Levee			GPS Latitude/Longitude	
				Start	End
Item	Vegetation			39.006792 °	38.954616 °
				-121.577790 °	-121.574700 °
DWR ID	DWR_RD0784_02B_s_2017_2				
Comment Code					
V1 : Control annual grass and weeds on the levee slopes and easements.					
Inspector Comment					
Annual grasses are less than 6" tall at time of inspection, Spring 2017.

View looking downstream of annual grasses, Spring 2017.

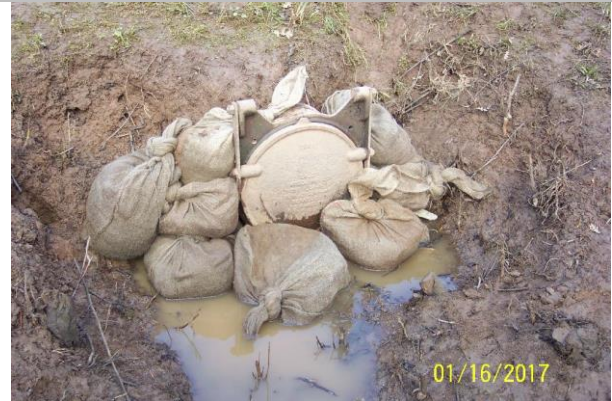
Photo 1 of 3 : UCIP_SP_2017_51717_76618.jpg

FS_ID:51717
DS_ID:18627
EP_NO: N/A
Repair Type: Urgent
Crossing Status: Found
UCIP Comments: 04/13/2017 - Spoke to LMA representative, P. Meagher, regarding the status of this crossing. The report has been updated to indicate vegetation has been cleared from WS outlet and LS inlet. The crossing remains Urgent--WS pipe collar is rusted out on the bottom. Recommend internal pipe inspection to determine pipe integrity through the levee. Owner will need to coordinate with the CVFPB to address issue. (O. Magana - DWR UCIP) 01/16/2017 - Landowner who utilizes this pipe reported to RD784 staff on 1/11/2017 that he suspected this pipe at the waterside flap gate ring area was rusted out at the bottom. After investigating, we could see what was reported is correct. Sandbags have been temporarily placed around the 2" +/- gapped area underneath the flap gate ring. A permanent solution is anticipated to be completed in the next 3 to 6 months. The plan is to pour a concrete ring / headwall around the open corroded pipe end. Photos attached. (P. Meagher - RD784) 11/04/2016 - Flap gate on waterside has been cleared again as of 10/17/2016. The LS inlet area has been cleared as of 9/21/2016. See updated photos attached. (P.Meagher - RD784) 09/22/2016 - vegetation at inlet of pipe has been cleared by owner. photos added showing pipe inlet. (T. Hatch - DWR UCIP) 08/09/2016 - vegetation partially obscuring outlet on WS. Heavy vegetation on landside (LS) limiting inspection of inlet. Owner asked by RD0784 to clear vegetation and debris. (T. Hatch - DWR UCIP) 11/1/2015 - Flap Gate has been cleared as of 12/9/2014 and again during summer of 2015 (P. Meagher/RD0784) 2/27/2013 - Flap gate blocked by vegetation on WS toe. Unable to locate inlet. (W. Wylie - DWR UCIP)

Sandbags temporarily placed in front of flapgate.

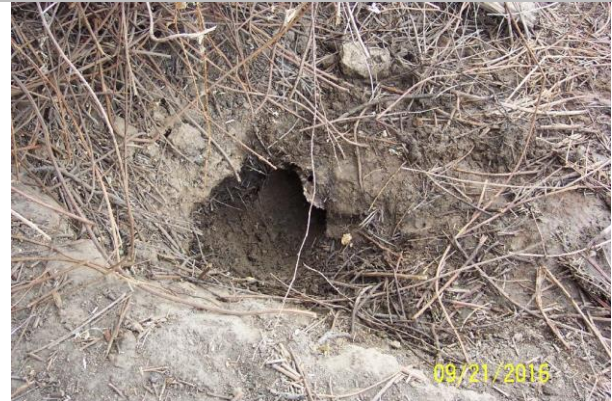
Photo 2 of 3 : UCIP_SP_2017_51717_75974.jpg

View of the inlet of the pipe on the LS after vegetation was removed

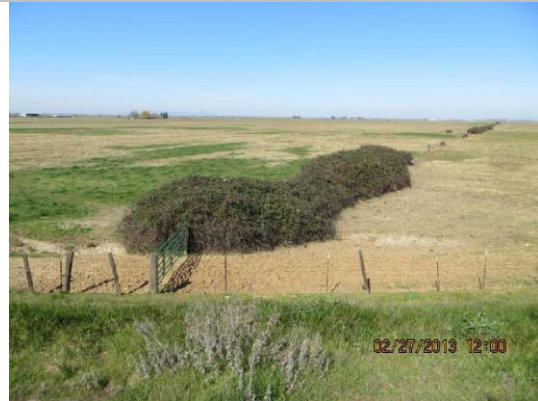
Photo 3 of 3 : UCIP_SP_2017_51717_54223.jpg

Unable to locate inlet due to blackberry overgrowth on LS toe.

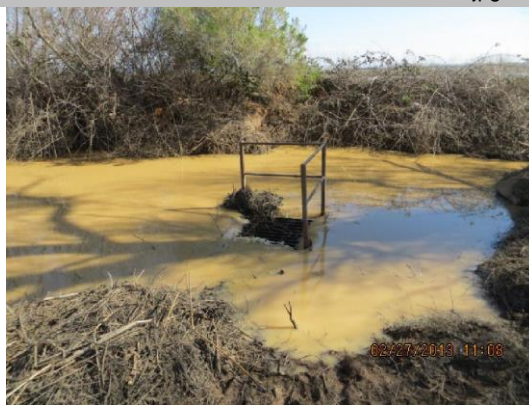
Photo 1 of 2 : UCIP_SP_2017_51710_54246.jpg

LM Start	0.84	Rating **	M	Issue No.	17
LM End	0.84	Issue Type +	Ma	Location *	WS
Category	Supplemental			GPS Latitude/Longitude	
				Start	End
Item	DWR UCIP LMA Responsibility			38.986432 °	38.986432 °
				-121.534983 °	-121.534983 °
DWR ID					
Comment Code					
Inspector Comment					
FS_ID:51710 DS_ID:18591 EP_NO: N/A Repair Type: Non-Urgent Crossing Status: Found UCIP Comments: No handle or access to slide gate on LS toe. FIELD_STRUCT_DESC: 30-inch CM pipe through the levee 23.7 feet below the crown. Flap gate on the waterward end. Slide gate in concrete drop inlet on the landward side. Originally included in O+M manual (1955). FS Date: 9/11/2015 9:05:00 AM

Concrete drop-inlet at LS toe.

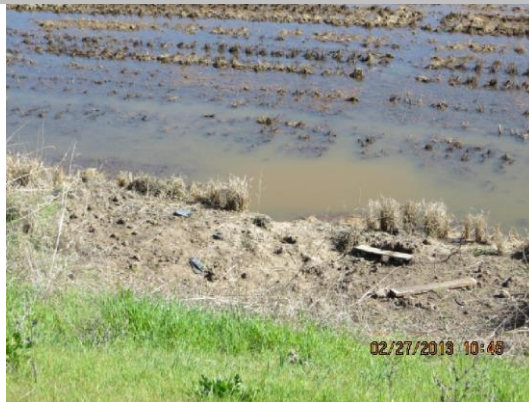
Photo 2 of 3 : UCIP_SP_2017_51719_54248.jpg

FS_ID:51719
DS_ID:18588
EP_NO: N/A
Repair Type: Non-Urgent
Crossing Status: Found
UCIP Comments: 09/11/2015 Inlet buried. Good candidate for video inspection as pipe is corroded. (G. Wylie - FPIIB)
FIELD_STRUCT_DESC: 18-inch CM drain pipe through the levee, 14.5 feet below the crown. Flap gate on the waterward end. Concrete "U" headwall on the waterward side. Originally included in O+M manual (1955).
FS Date: 9/11/2015 9:36:00 AM

Debris covered inlet on LS toe.

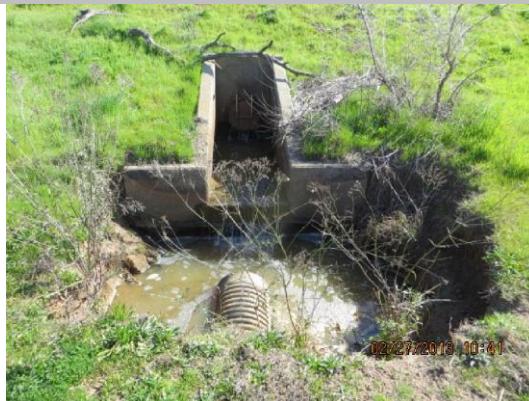
Photo 2 of 3 : UCIP_SP_2017_51707_54253.jpg

Comment Code					
Inspector Comment					
FS_ID:51707 DS_ID:18587 EP_NO: N/A Repair Type: Non-Urgent Crossing Status: Found UCIP Comments: On 1/31/2017 The waterside excess pipe end was discovered to be floating to the surface due to landside water runoff through the pipe. Because of the floating pipe, the water was not draining all the way through the pipe. Instead, the water was overtopping the levee shelf area. In order to resolve this issue, the excess portion of the pipe was cut off. After doing so, the water immediately started draining properly again. (P. Meagher, RD784 2/3/2017). Erosion at outlet may or may not be an issue. FIELD_STRUCT_DESC: 18-inch CM drain pipe through the levee, 14.5 feet below the crown. Flap gate on the waterward end. Concrete "U" headwall on the waterward side. PVC weir on inlet. Originally included in O+M manual (1955). FS Date: 2/3/2017

Concrete U-shaped headwall on WS toe with Flap gate showing erosion at outlet.

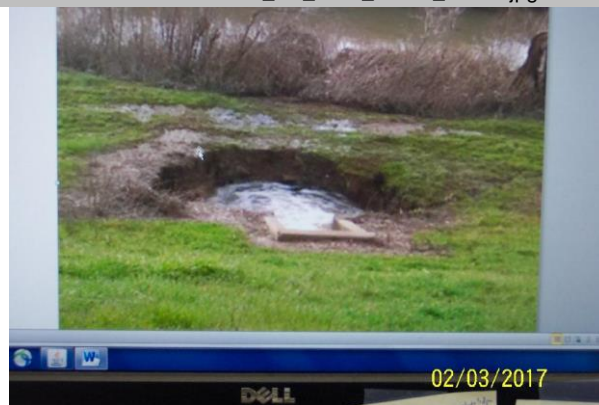
Photo 3 of 3 : UCIP_SP_2017_51707_76774.jpg

After photo after excess pipe was cut off. Actual photo date was 1/31/2017

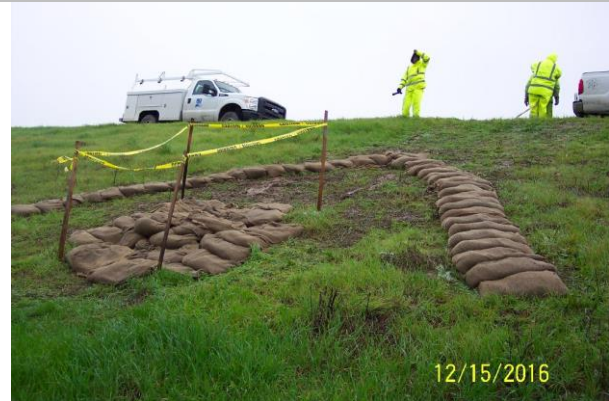
Photo 2 of 3 : UCIP_SP_2017_51715_76309.jpg

UCIP Comments: 12/15/2016 - Coordination email was received from RD0784 this afternoon. Patrick Meagher with Reclamation District is closely monitoring the eroded pipe area at the Horseshoe Levee due to periodic rainstorms and unpredictable water flow elevations. To avoid further damage at this location, Mr. Meagher has coordinated with LMA Consultant Sean Minard at MHM Engineering and DWR Levee Inspector Sterling York to address further deterioration at site. As a proactive measure by RD784, sandbags were used to fill in the sink hole on the WS. A "V" shape diversion dam was also built of sandbags above the sinkhole area to help divert running rainwater coming down the slope around the fill area. RD0784 used approximately 100 sandbags at the site to fill in sink hole and create the "V" shaped diversion dam. (O. Magana - DWR UCIP)07/29/2016 - Erosion scarp on LS cut into levee shoulder starting at inlet headwall. Cavity failure on WS shoulder approximately 2-feet in diameter and several feet in depth. (T. Hatch/UCIP)11/01/2015 - The concrete box weir structure on the landside inlet has slumped off the end of the pipe. DWR Chief inspector George Wilie inspected the site on 8/13/2015 with Steve Fordice, General Manager of RD784. (P. Meagher - RD784)

WS view: Sink hole filled in with sandbags and "V" shaped diversion dam built to help divert rainwater.

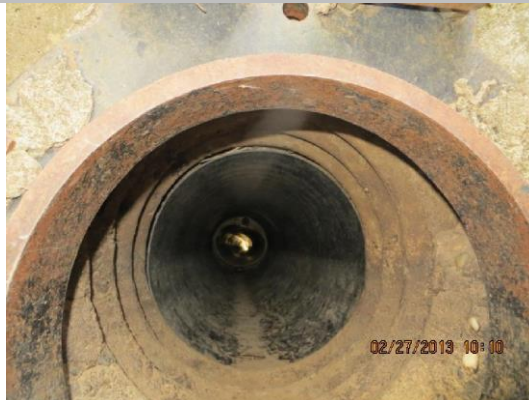
Photo 2 of 3 : UCIP_SP_2017_51714_54262.jpg

FS_ID:51714
DS_ID:18596
EP_NO: N/A
Repair Type: Non-Urgent
Crossing Status: Found
UCIP Comments: Pipe has been sliplined with PVC, but the liner appears to be eroding at outlet and may be disjointed internal to the levee. See pic. Good candidate for video inspection.
FIELD_STRUCT_DESC: 12-inch CM drain pipe through the levee, 12.0 feet below the crown. Flap gate and concrete "U" headwall on the waterward side. PVC weir on inlet at LS toe. Originally included in O+M manual (1955).
FS Date: 9/11/2015 9:26:00 AM

Pipe showing sliplined PVC insert. some erosion of PV at outlet and it may be disjointed internally.

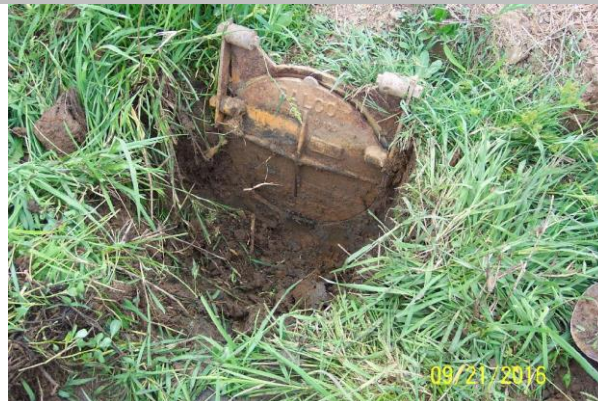
Photo 1 of 3 : UCIP_SP_2017_51712_76147.jpg

Flap gate on the WS toe is exposed

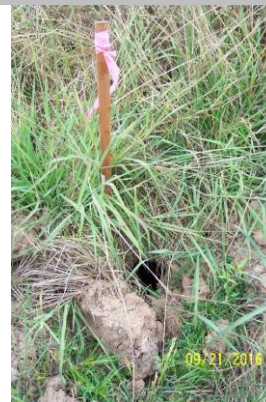
Photo 2 of 3 : UCIP_SP_2017_51712_76148.jpg

Possible location of the inlet on the LS toe

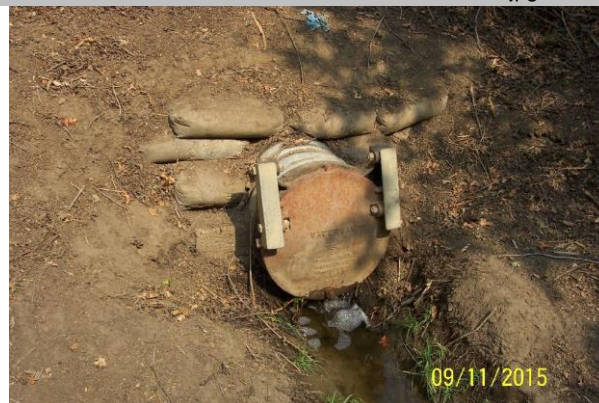
Photo 1 of 3 : UCIP_SP_2017_51716_74682.jpg

Flap Gate is clear as of 9/11/15.
