**Flood Control Project Maintenance
Levee Inspections**

Maintenance Issue Types Only, Levee Inspection Report By Mile - Spring 2018

Reclamation District No. 0784 Plumas Lake

Waterway	Bank	Unit Miles	Inspection Start/End	Inspector
Unit No. 01 Yuba River	Left	2.21	03/21/2018 03/21/2018	Sterling York

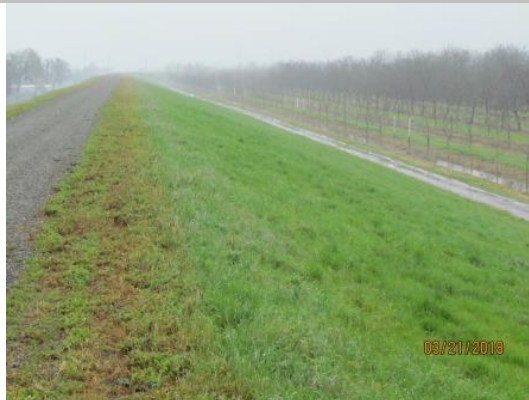
Photo 1 of 1 : SP_2018_RD0784_178_3_20180409_00007.jpg

LM Start	0.04	Rating **	A	Issue No.	3	
LM End	2.20	Issue Type +	Ma	Location *	WS	
Category	Earthen Levee			GPS Latitude/Longitude		
				Start		End
Item	Vegetation			39.134439 °		39.125908 °
				-121.552688 °		-121.588626 °
DWR ID	DWR_RD0784_01_s_2018_3					
Comment Code						
V1 : Control annual grass and weeds on the levee slopes and easements.						
Inspector Comment

View looking downstream waterside of the well maintained annual vegetation, Spring 2018.

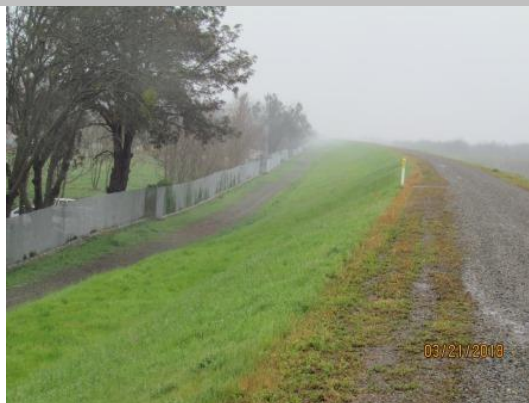
Photo 1 of 1 : SP_2018_RD0784_178_2_20180409_00008.jpg

View looking downstream landside of the well maintained annual vegetation, Spring 2018.

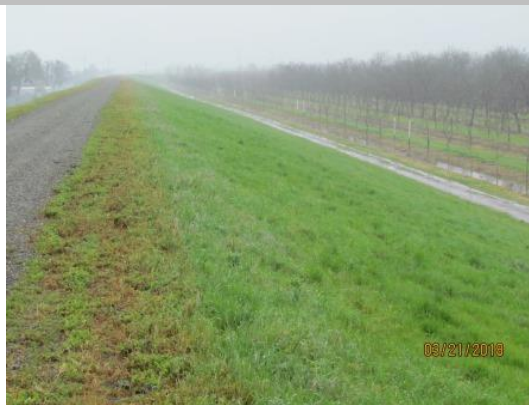
Photo 1 of 1 : SP_2018_RD0784_531_3_20180409_00004.jpg

View looking downstream waterside of the well maintained annual vegetation, Spring 2018.

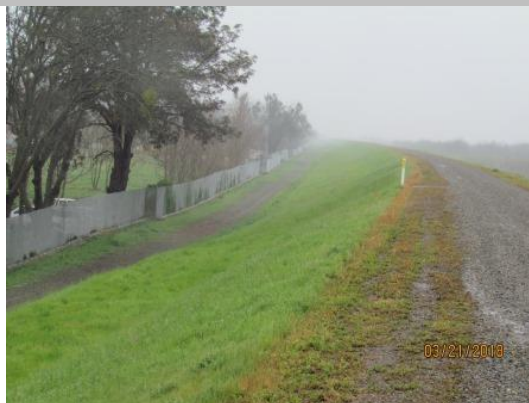
Photo 1 of 1 : SP_2018_RD0784_531_2_20180409_00005.jpg

View looking downstream landside of the well maintained annual vegetation, Spring 2018.

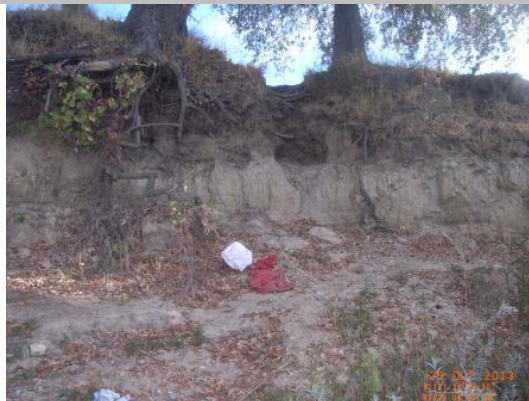
Photo 1 of 1 : SP_2018_RD0784_532_1_20180302_00001.jpg

Comment Code					
Inspector Comment					
2003 - Bank is near vertical. Identified as a Potentially Critical site. 2004 - Eddy flow off downstream end of Modesto formation eroding the fluvial sediments. 2005 - Some new slumping. Actively eroding but berm width is greater than 50 ft. 2006 - Downgraded to regular erosion site. Still actively eroding. Large old rotational failures in high bank on the downstream end. 2008 - Removed from inventory due to wide berm width does not meet criteria for an erosion site. 2010 - Added back to the inventory after 10 ft of bank erosion in the winter 2009 storm. Steep vertical face. 2011 - Bank has retreated an additional 2.5 ft from last year. New tree popouts and erosion throughout the site. 2012 - Site continues to worsen with new tree popouts and many sections of new erosion. 2015: Last observed in 2013. [2015 Site ID: FHR_17-8_L]

USACE 2013 Photo #1

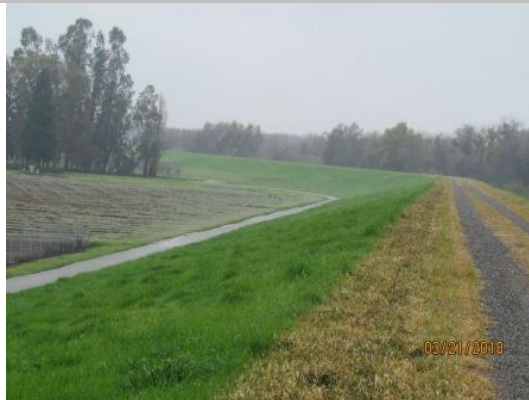
Photo 1 of 1 : SP_2018_RD0784_532_2_20180409_00007.jpg

LM Start	8.97	Rating **	A	Issue No.	2
LM End	12.85	Issue Type +	Ma	Location *	LS
Category	Earthen Levee			GPS Latitude/Longitude	
				Start	End
Item	Vegetation			39.009879 °	38.954721 °
				-121.579154 °	-121.574747 °
DWR ID	DWR_RD0784_02B_s_2018_2				
Comment Code					
V1 : Control annual grass and weeds on the levee slopes and easements.					
Inspector Comment					
Annual vegetation is well maintained, Spring 2018.

View looking downstream landside of the well maintained annual vegetation, Spring 2018.

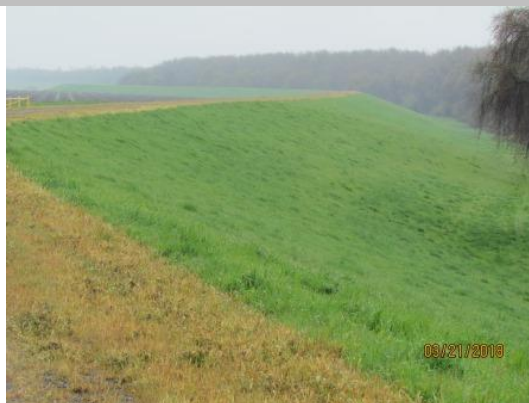
Photo 1 of 1 : SP_2018_RD0784_532_3_20180409_00008.jpg

View looking downstream waterside of the well maintained annual vegetation, Spring 2018.

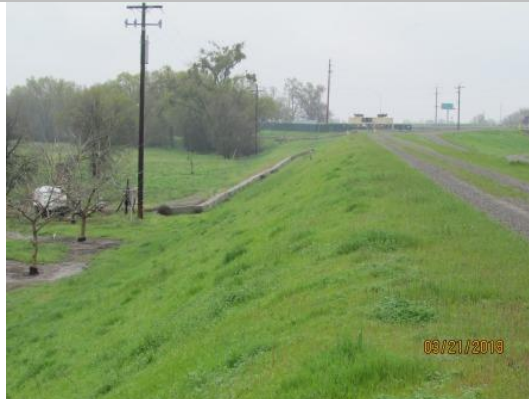
Photo 1 of 1 : SP_2018_RD0784_533_1_20180409_00001.jpg

View looking upstream landside of the well maintained annual vegetation, Spring 2018.

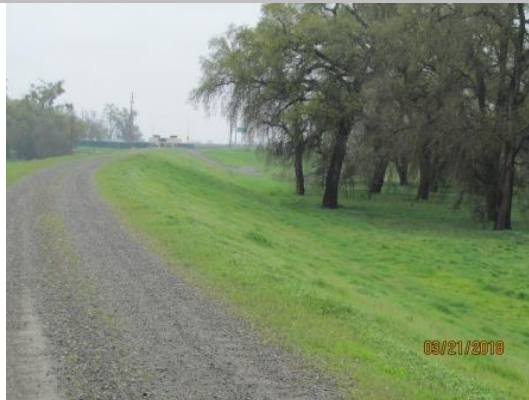
Photo 1 of 1 : SP_2018_RD0784_533_2_20180409_00002.jpg

LM Start	2.44	Rating **	A	Issue No.	2
LM End	3.20	Issue Type +	Ma	Location *	WS
Category	Earthen Levee			GPS Latitude/Longitude	
				Start	End
Item	Vegetation			38.970776 °	38.974685 °
				-121.547447 °	-121.535306 °
DWR ID	DWR_RD0784_03A_s_2018_2				
Comment Code					
V1 : Control annual grass and weeds on the levee slopes and easements.					
Inspector Comment					
Annual vegetation is well maintained, 2018.

View looking upstream waterside of the well maintained annual vegetation, Spring 2018.

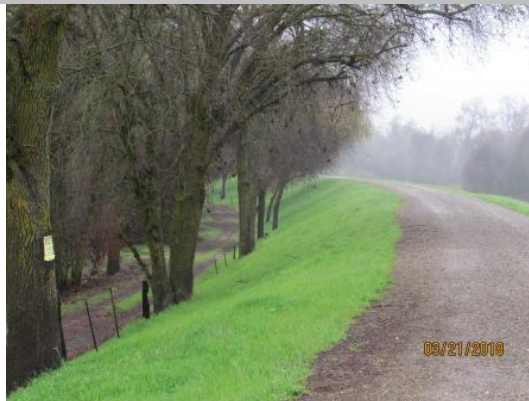
Photo 1 of 1 : SP_2018_RD0784_534_3_20180409_00005.jpg

View looking upstream landside of the well maintained annual vegetation, Spring 2018.

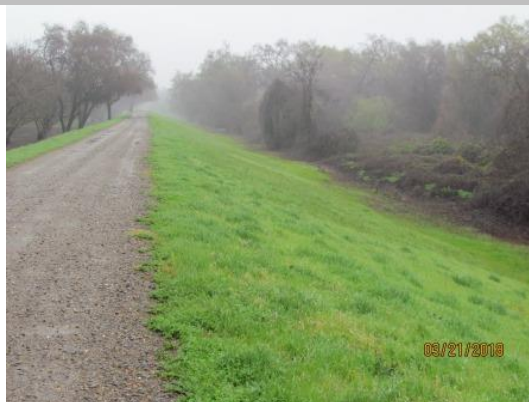
Photo 1 of 1 : SP_2018_RD0784_534_4_20180409_00006.jpg

LM Start	3.23	Rating **	A	Issue No.	4
LM End	4.68	Issue Type +	Ma	Location *	WS
Category	Earthen Levee			GPS Latitude/Longitude	
				Start	End
Item	Vegetation			38.974358 °	38.985412 °
				-121.532189 °	-121.510795 °
DWR ID	DWR_RD0784_03B_s_2018_4				
Comment Code					
V1 : Control annual grass and weeds on the levee slopes and easements.					
Inspector Comment					
Annual vegetation is well maintained, Spring 2018.

View looking upstream waterside of the well maintained annual vegetation, Spring 2018.

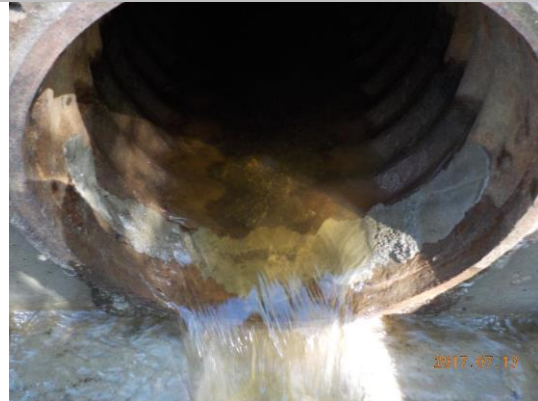
Photo 1 of 3 : UCIP_SP_2018_52571_77114.jpg

01/16/2017 - Landowner who utilizes this pipe reported to RD784 staff on 1/11/2017 that he suspected this pipe at the waterside flap gate ring area was rusted out at the bottom. After investigating, we could see what was reported is correct. Sandbags have been temporarily placed around the 2" +/- gapped area underneath the flap gate ring. A permanent solution is anticipated to be completed in the next 3 to 6 months. The plan is to pour a concrete ring / headwall around the open corroded pipe end. Photos attached. (P. Meagher - RD784).11/04/2016 - Flap gate on waterside has been cleared again as of 10/17/2016. The LS inlet area has been cleared as of 9/21/2016. See updated photos attached. (P.Meagher - RD784)09/22/2016 - vegetation at inlet of pipe has been cleared by owner. photos added showing pipe inlet. (T. Hatch - DWR UCIP)08/09/2016 - vegetation partially obscuring outlet on WS. Heavy vegetation on landside (LS) limiting inspection of inlet. Owner asked by RD0784 to clear vegetation and debris. (T. Hatch - DWR UCIP)11/1/2015 - Flap Gate has been cleared as of 12/9/2014 and again during summer of 2015 (P. Meagher/RD0784)2/27/2013 - Flap gate blocked by vegetation on WS toe. Unable to locate inlet. (W. Wylie - DWR UCIP)

Close up photo of concrete seal where the rusted out void used to be. Farmer irrigation was currently flowing at the time the photo was taken.

FS_ID:52571
DS_ID:18627
EP_NO: N/A
Repair Type: Urgent
Crossing Status: Found
UCIP Comments: 11/30/2017 Crossing remains Urgent due to uncertainty of pipe condition through levee -- recommend an internal inspection of the pipe through the levee as a precaution measure to determine integrity of pipe. Repair of the rusted out collar (void) found at the WS pipe outlet has been repaired by the LMA. Received additional photos from DWR levee inspector, S. York, of the WS concrete headwall installed and vegetation cleared from WS. (O. Magana - DWR UCIP)07/13/2017 - The rusted out collar at the bottom of the waterside flap gate has been sealed with concrete. Internal pipe inspections still pending. (P.Meagher-RD784).04/13/2017 - Spoke to LMA representative, P. Meagher, regarding the status of this crossing. The report has been updated to indicate vegetation has been cleared from WS outlet and LS inlet. The crossing remains Urgent--WS pipe collar is rusted out on the bottom. Recommend internal pipe inspection to determine pipe integrity through the levee. Owner will need to coordinate with the CVFPB to address issue. (O. Magana - DWR UCIP)

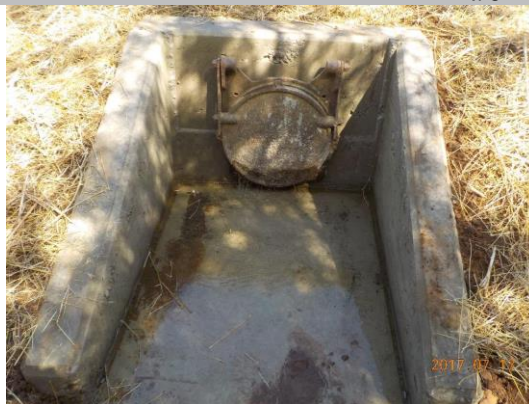
Photo 2 of 3 : UCIP_SP_2018_52571_77115.jpg

Concrete collar completed around the waterside exterior flap gate section.

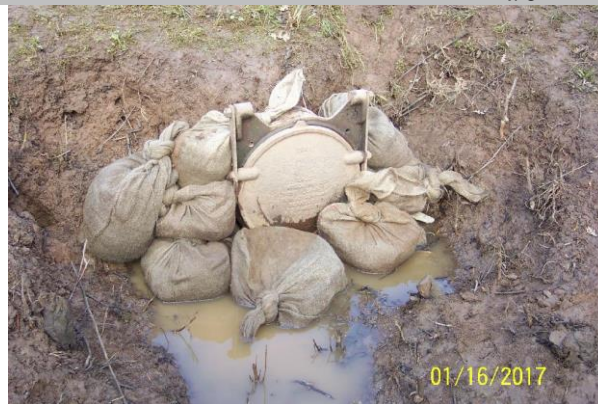
Photo 3 of 3 : UCIP_SP_2018_52571_76618.jpg

Sandbags temporarily placed in front of flapgate.

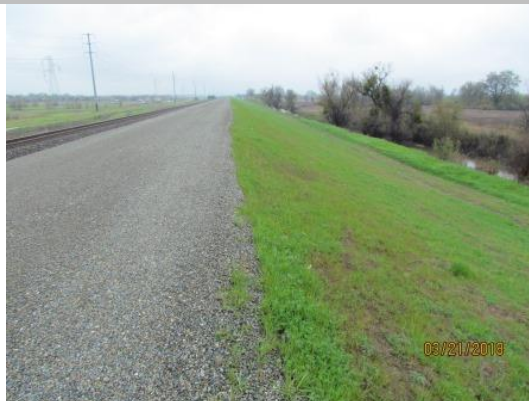
Photo 1 of 1 : SP_2018_RD0784_181_3_20180409_00004.jpg

View looking upstream waterside of the well maintained annual vegetation, Spring 2018.

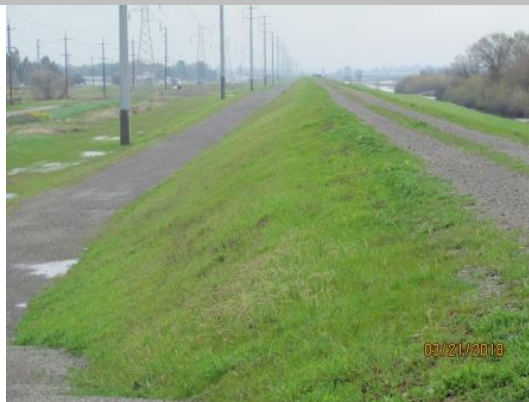
Photo 1 of 1 : SP_2018_RD0784_181_2_20180409_00006.jpg

LM Start	0.00	Rating **	A	Issue No.	2
LM End	6.32	Issue Type +	Ma	Location *	LS
Category	Earthen Levee			GPS Latitude/Longitude	
				Start	End
Item	Vegetation			38.974776 °	39.059297 °
				-121.535089 °	-121.551067 °
DWR ID	DWR_RD0784_04_s_2018_2				
Comment Code					
V1 : Control annual grass and weeds on the levee slopes and easements.					
Inspector Comment					
Annual vegetation is well maintained, Spring 2018.

View looking upstream landside of the well maintained annual vegetation, Spring 2018.

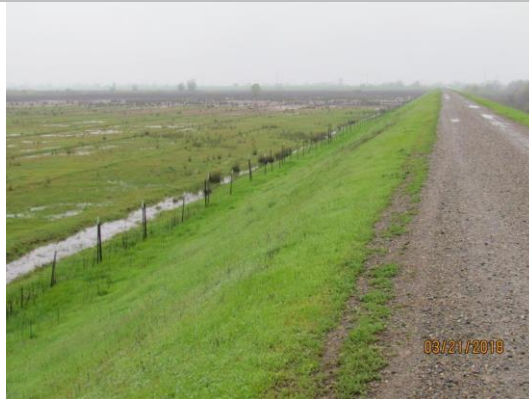
Photo 1 of 1 : SP_2018_RD0784_182_14_20180409_00037.jpg

View looking downstream landside of well maintained annual vegetation, Spring 2018.

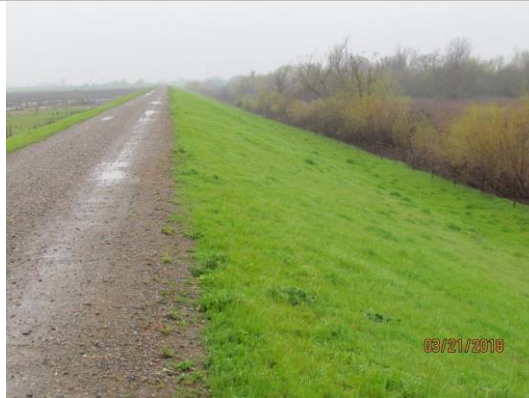
Photo 1 of 1 : SP_2018_RD0784_182_15_20180409_00039.jpg

LM Start	0.02	Rating **	A	Issue No.	15
LM End	4.20	Issue Type +	Ma	Location *	WS
Category	Earthen Levee			GPS Latitude/Longitude	
				Start	End
Item	Vegetation			38.974658 °	39.020572 °
				-121.532691 °	-121.509044 °
DWR ID	DWR_RD0784_05_s_2018_15				
Comment Code					
V1 : Control annual grass and weeds on the levee slopes and easements.					
Inspector Comment					
Annual vegetation is well maintained, Spring 2018.

View looking downstream waterside of well maintained annual vegetation, Spring 2018.

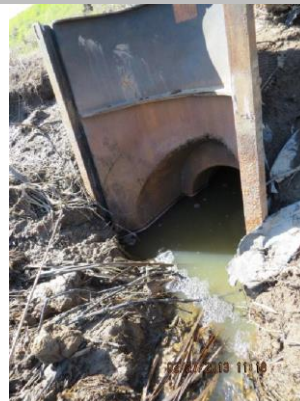
Photo 1 of 3 : UCIP_SP_2018_51711_16552.jpg

inlet control structure on LS toe.

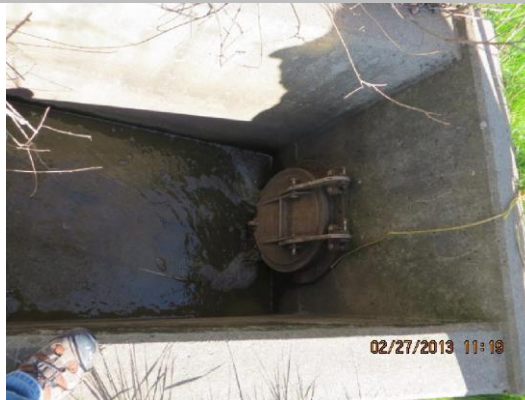
Photo 2 of 3 : UCIP_SP_2018_51711_16555.jpg

Concrete U-shaped outlet with flap gate on WS toe.

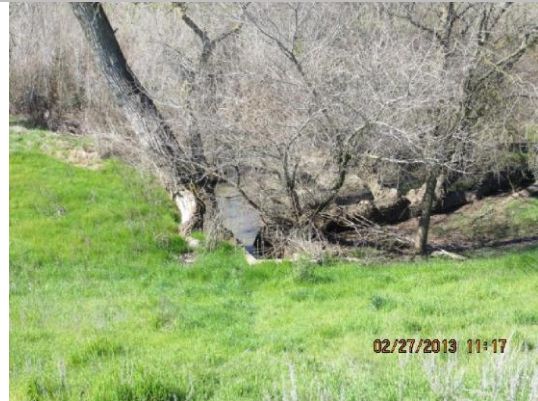
Photo 3 of 3 : UCIP_SP_2018_51711_16554.jpg

Concrete U-shaped outlet on WS toe.

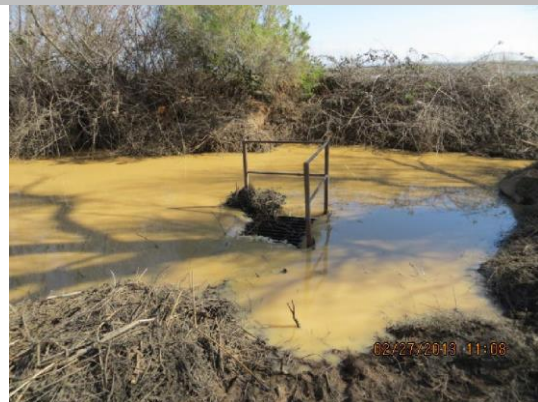
Photo 1 of 2 : UCIP_SP_2018_51710_54246.jpg

Concrete drop-inlet at LS toe.

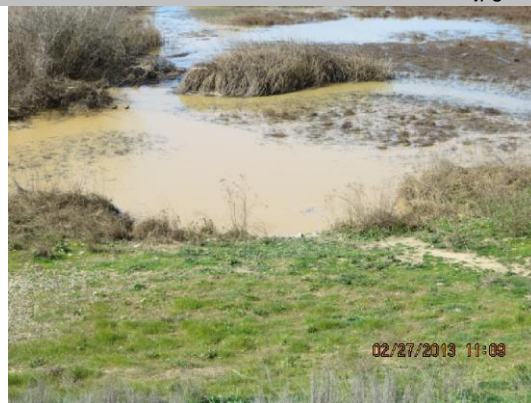
Photo 2 of 2 : UCIP_SP_2018_51710_54245.jpg

Outlet with riprap on WS toe.

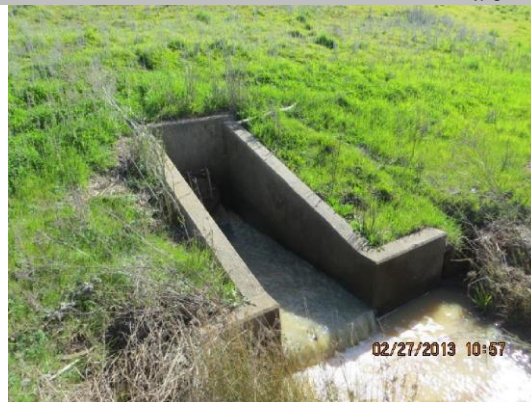
Photo 1 of 3 : UCIP_SP_2018_51709_16565.jpg

Concrete U-shaped headwall and flap gate on WS toe.

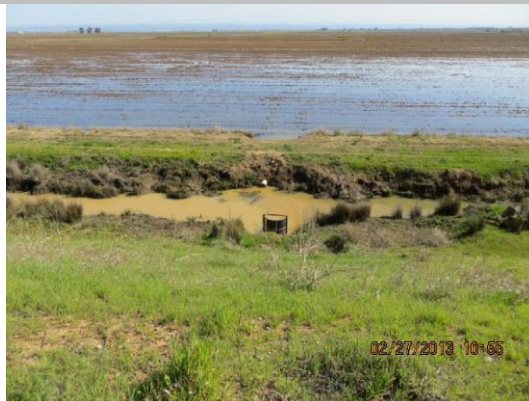
Photo 2 of 3 : UCIP_SP_2018_51709_16563.jpg

Pvc weir on inlet at LS toe.

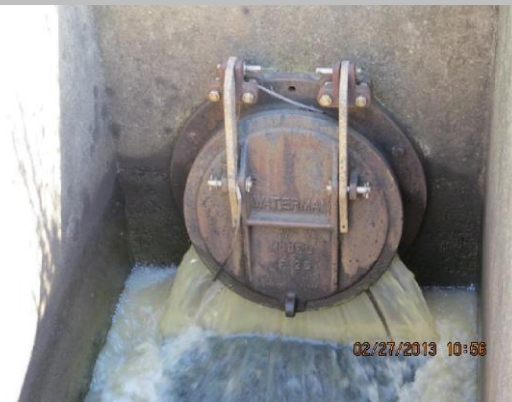
Photo 3 of 3 : UCIP_SP_2018_51709_16562.jpg

Concrete U-shaped headwall and flap gate on WS toe.

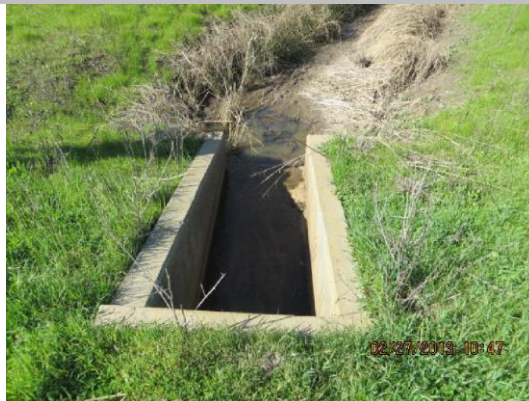
Photo 1 of 3 : UCIP_SP_2018_51719_54247.jpg

FS_ID:51719
DS_ID:18588
EP_NO: N/A
Repair Type: Non-Urgent
Crossing Status: Found
UCIP Comments: 09/11/2015 Inlet buried. Good candidate for video inspection as pipe is corroded. (G. Wylie - FPIIB)
FIELD_STRUCT_DESC: 18-inch corrugated metal drainage pipe through the levee, 14.5 feet below the crown. Flap gate on the waterside (WS) end. Concrete U-shaped headwall on the WS.
[Additional Reference(s): DWR Levee Log, 2005. USACE Sacramento O&M Manual 145, August 1955 (Station 116+78)].
FS Date: 9/11/2015 9:36:00 AM

Concrete U-shaped outlet and flap-gate on WS toe.

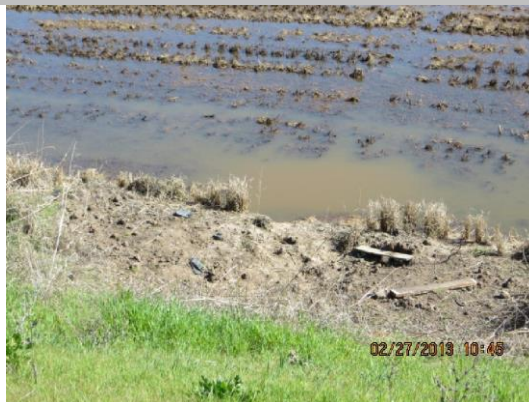
Photo 2 of 3 : UCIP_SP_2018_51719_54248.jpg

Debris covered inlet on LS toe.

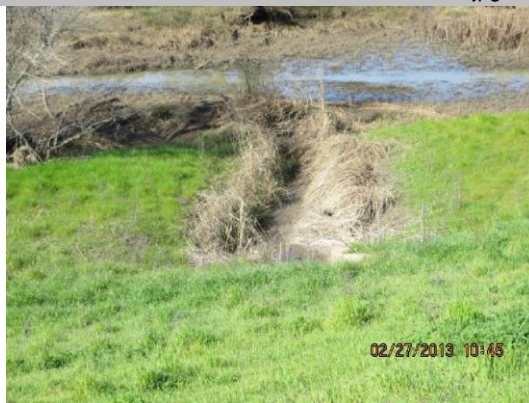
Photo 3 of 3 : UCIP_SP_2018_51719_54249.jpg

Drainage outlet on WS toe.

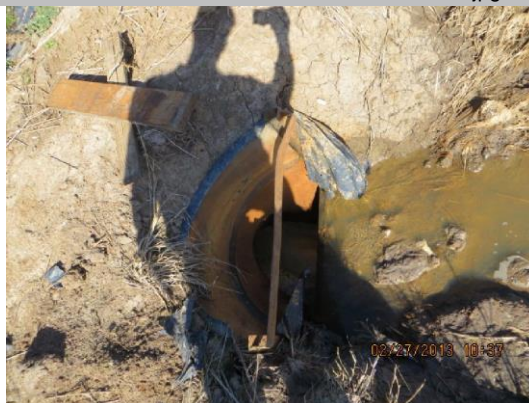
Photo 1 of 3 : UCIP_SP_2018_51707_54250.jpg

FS_ID:51707
DS_ID:18587
EP_NO: N/A
Repair Type: Non-Urgent
Crossing Status: Found
UCIP Comments: On 1/31/2017 The waterside excess pipe end was discovered to be floating to the surface due to landside water runoff through the pipe. Because of the floating pipe, the water was not draining all the way through the pipe. Instead, the water was overtopping the levee shelf area. In order to resolve this issue, the excess portion of the pipe was cut off. After doing so, the water immediately started draining properly again. (P. Meagher, RD784 2/3/2017). Erosion at outlet may or may not be an issue.
FIELD_STRUCT_DESC: 18-inch corrugated metal drainage pipe through the levee, 14.5 feet below the crown. Flap gate on the waterside (WS) end. Concrete U-shaped headwall on the WS. Polyvinyl chloride weir on inlet. [Additional Reference(s): DWR Levee Log, 2005. USACE Sacramento O&M Manual 145, August 1955 (Station 126+53)].

Inlet with PVC weir on LS toe.

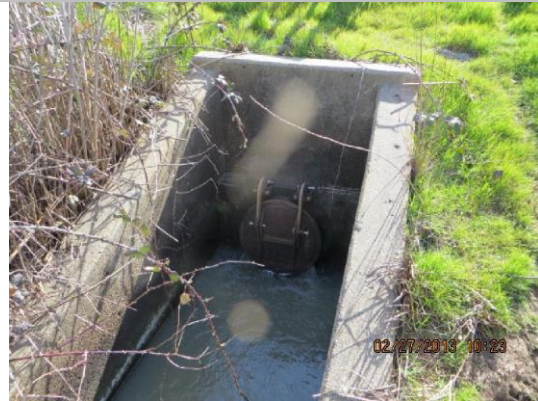
Photo 1 of 3 : UCIP_SP_2018_52570_54258.jpg

FS_ID:52570
DS_ID:18597
EP_NO: N/A
Repair Type: Urgent
Crossing Status: Found
UCIP Comments: 11/30/2017 - same as previous inspection - crossing remains Urgent. Received updated photos from DWR levee inspector, S. York, showing current condition of levee LS and WS. (O. Magana - DWR UCIP) 12/15/2016 - Coordination email was received from RD0784 this afternoon. Patrick Meagher with Reclamation District is closely monitoring the eroded pipe area at the Horseshoe Levee due to periodic rainstorms and unpredictable water flow elevations. To avoid further damage at this location, Mr. Meagher has coordinated with LMA Consultant Sean Minard at MHM Engineering and DWR Levee Inspector Sterling York to address further deterioration at site. As a proactive measure by RD784, sandbags were used to fill in the sink hole on the WS. A "V" shape diversion dam was also built of sandbags above the sinkhole area to help divert running rainwater coming down the slope around the fill area. RD0784 used approximately 100 sandbags at the site to fill in sink hole and create the "V" shaped diversion dam. (O. Magana - DWR UCIP)07/29/2016 - Erosion scarp on LS cut into levee shoulder starting at inlet headwall. Cavity failure on WS shoulder approximately 2-feet in diameter and several feet in depth. (T. Hatch/UCIP)11/01/2015 - The concrete box weir structure on the landside inlet has slumped off the end of the pipe. DWR Chief inspector George Wilie inspected the site on 8/13/2015 with Steve Fordice, General Manager of RD784. (P. Meagher - RD784)

Concrete U-shaped headwall and flap gate on WS toe.

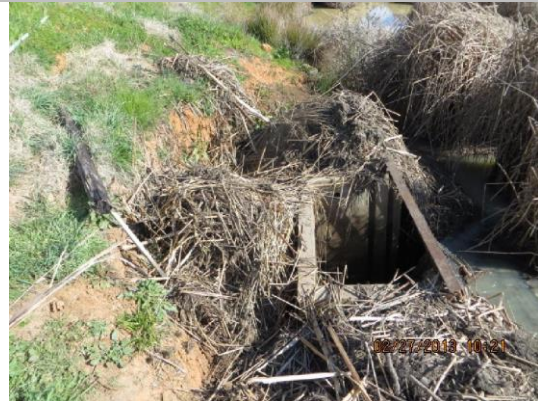
Photo 3 of 3 : UCIP_SP_2018_52570_54254.jpg

Erosion and debris from Beaver activity.

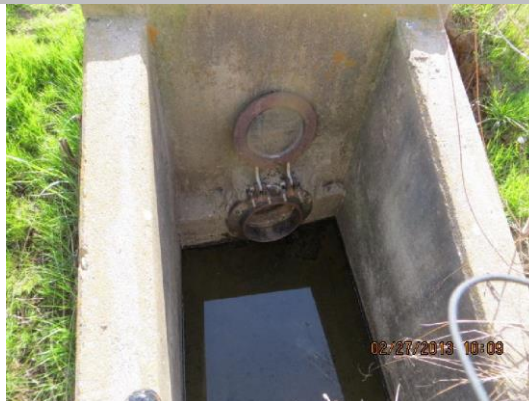
Photo 1 of 3 : UCIP_SP_2018_51714_54259.jpg

FS_ID:51714
DS_ID:18596
EP_NO: N/A
Repair Type: Non-Urgent
Crossing Status: Found
UCIP Comments: Pipe has been sliplined with PVC, but the liner appears to be eroding at outlet and may be disjointed internal to the levee. See pic. Good candidate for video inspection.
FIELD_STRUCT_DESC: 12-inch corrugated metal drainage pipe through the levee, 12 feet below the crown. Flap gate and concrete U-shaped headwall on the waterside (WS). Polyvinyl chloride weir on inlet at the landside (LS) toe. [Additional Reference(s): DWR Levee Log, 2005. USACE Sacramento O&M Manual 145, August 1955 (Station 44+96)].
FS Date: 9/11/2015 9:26:00 AM

Concrete U-shaped headwall and flap gate on WS toe.

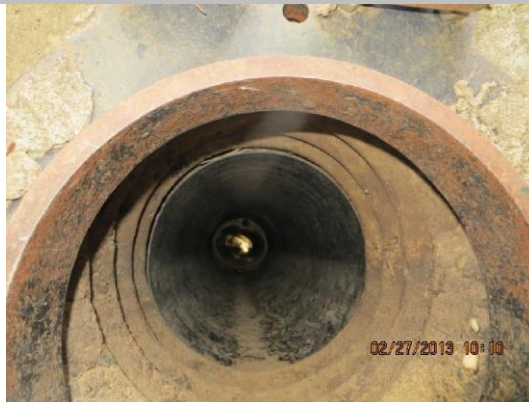
Photo 2 of 3 : UCIP_SP_2018_51714_54262.jpg

Pipe showing sliplined PVC insert. some erosion of PV at outlet and it may be disjointed internally.

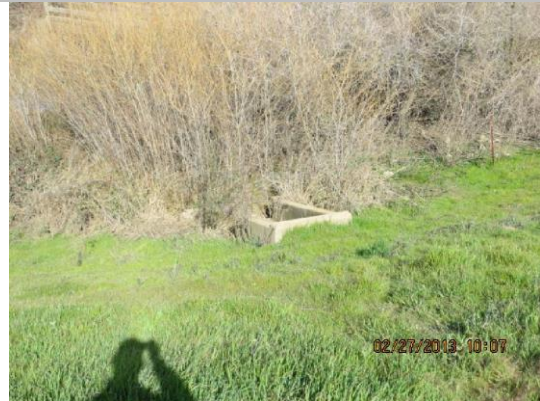
Photo 3 of 3 : UCIP_SP_2018_51714_54261.jpg

Concrete U-shaped headwall on WS toe.

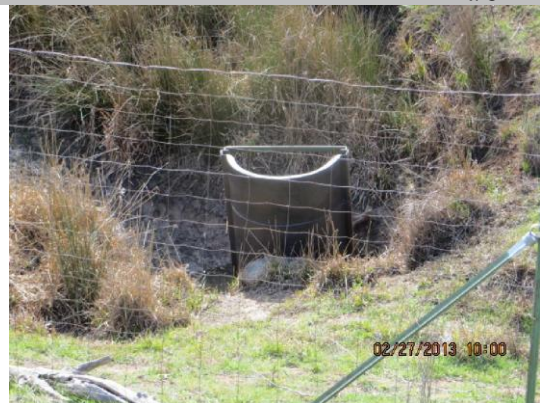
Photo 1 of 2 : UCIP_SP_2018_9566_16594.jpg

PVC weir inlet on LS toe.

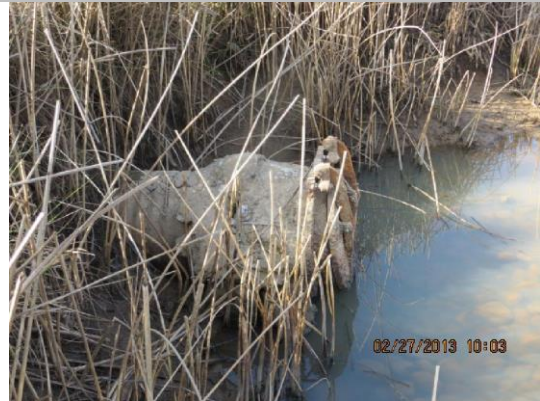
Photo 2 of 2 : UCIP_SP_2018_9566_16593.jpg

Flap gate at WS toe.

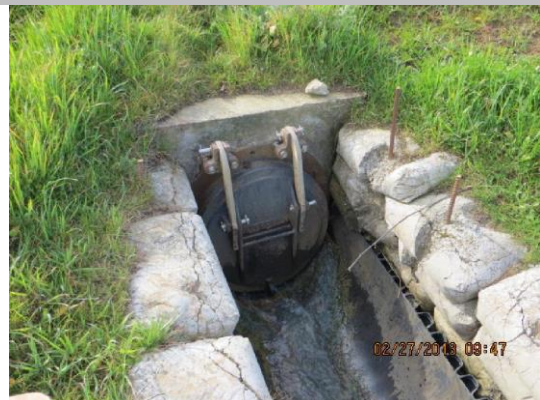
Photo 1 of 3 : UCIP_SP_2018_51713_16590.jpg

Concrete outlet and flap gate on WS toe.

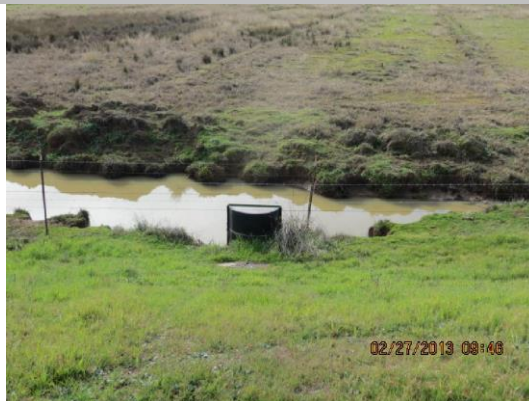
Photo 2 of 3 : UCIP_SP_2018_51713_16591.jpg

PVC weir at inlet on LS toe.

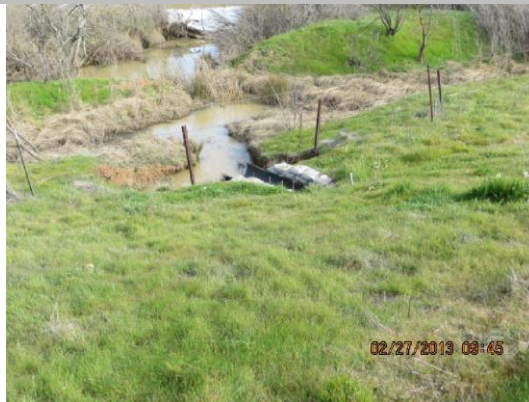
Photo 3 of 3 : UCIP_SP_2018_51713_16592.jpg

Concrete outlet on WS toe.

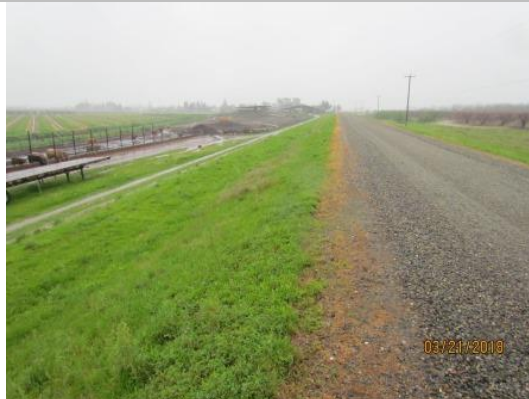
Photo 1 of 1 : SP_2018_RD0784_183_2_20180409_00005.jpg

View looking upstream landside of the well maintained annual vegetation, Spring 2018.

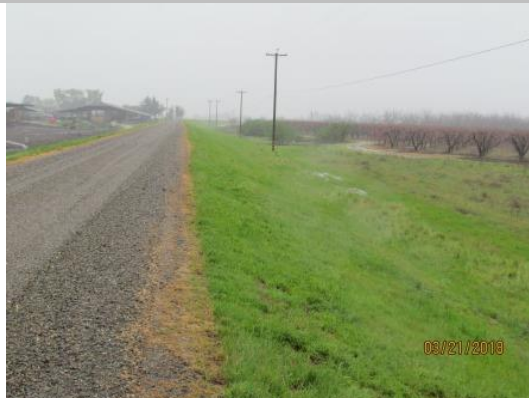
Photo 1 of 1 : SP_2018_RD0784_183_3_20180409_00004.jpg

View looking upstream waterside of the well maintained annual vegetation, Spring 2018.

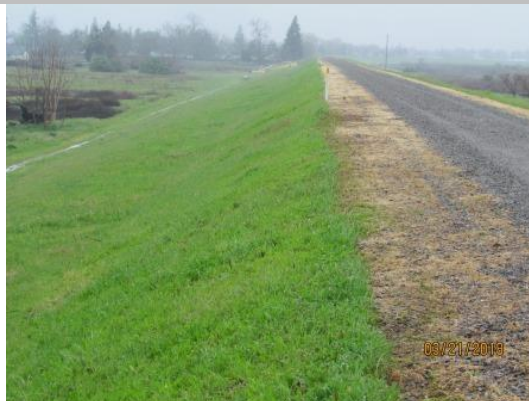
Photo 1 of 1 : SP_2018_RD0784_184_1_20180409_00002.jpg

View looking downstream landside of the well maintained annual vegetation, Spring 2018.

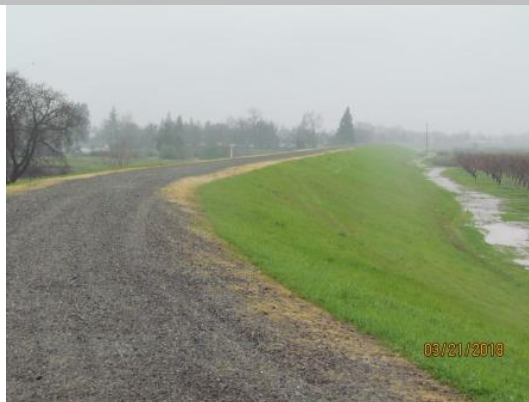
Photo 1 of 1 : SP_2018_RD0784_184_2_20180409_00004.jpg

View looking downstream waterside of the well maintained annual vegetation, Spring 2018.

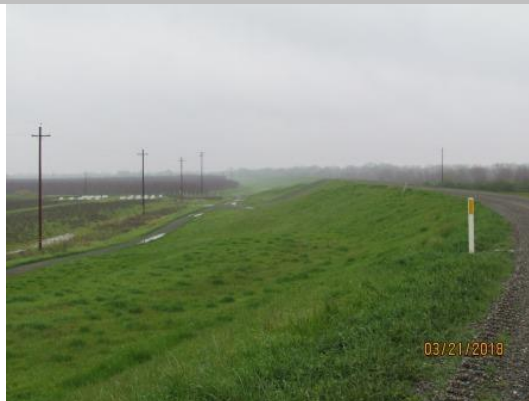
Photo 1 of 1 : SP_2018_RD0784_437_1_20180409_00002.jpg

View looking upstream landside of the well maintained annual vegetation, Spring 2018.

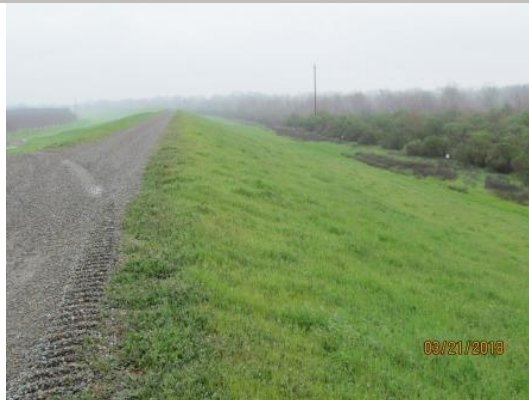
Photo 1 of 1 : SP_2018_RD0784_437_2_20180409_00001.jpg

View looking upstream waterside of the well maintained annual vegetation, Spring 2018.

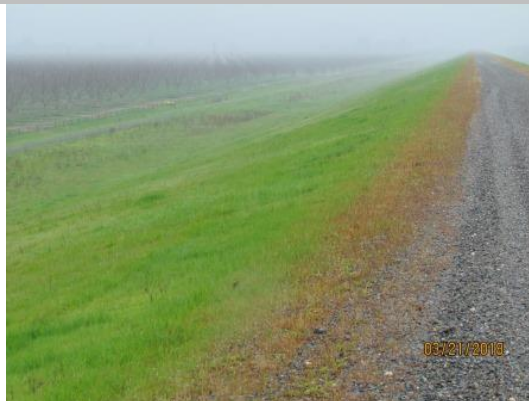
Photo 1 of 1 : SP_2018_RD0784_530_1_20180409_00001.jpg

View looking downstream landside of the well maintained annual vegetation, Spring 2018.

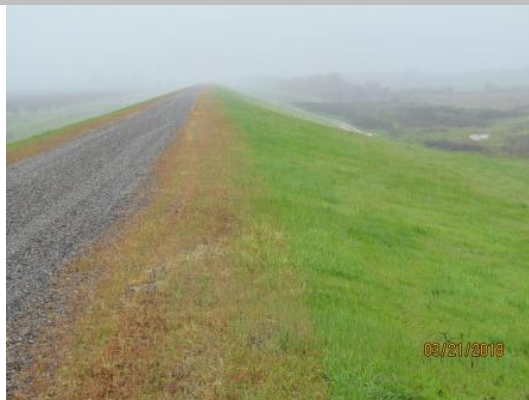
Photo 1 of 1 : SP_2018_RD0784_530_2_20180409_00002.jpg

View looking downstream waterside of the well maintained annual vegetation, Spring 2018.
